ALASKAN OIL, INC.
PRELIMINARY SUBSURFACE INVESTIGATION

ROUTE 13 & CEMETERY STREET
ALTMAR, NEW YORK

NYSDEC SPILL ID #9614774

May 30, 1997

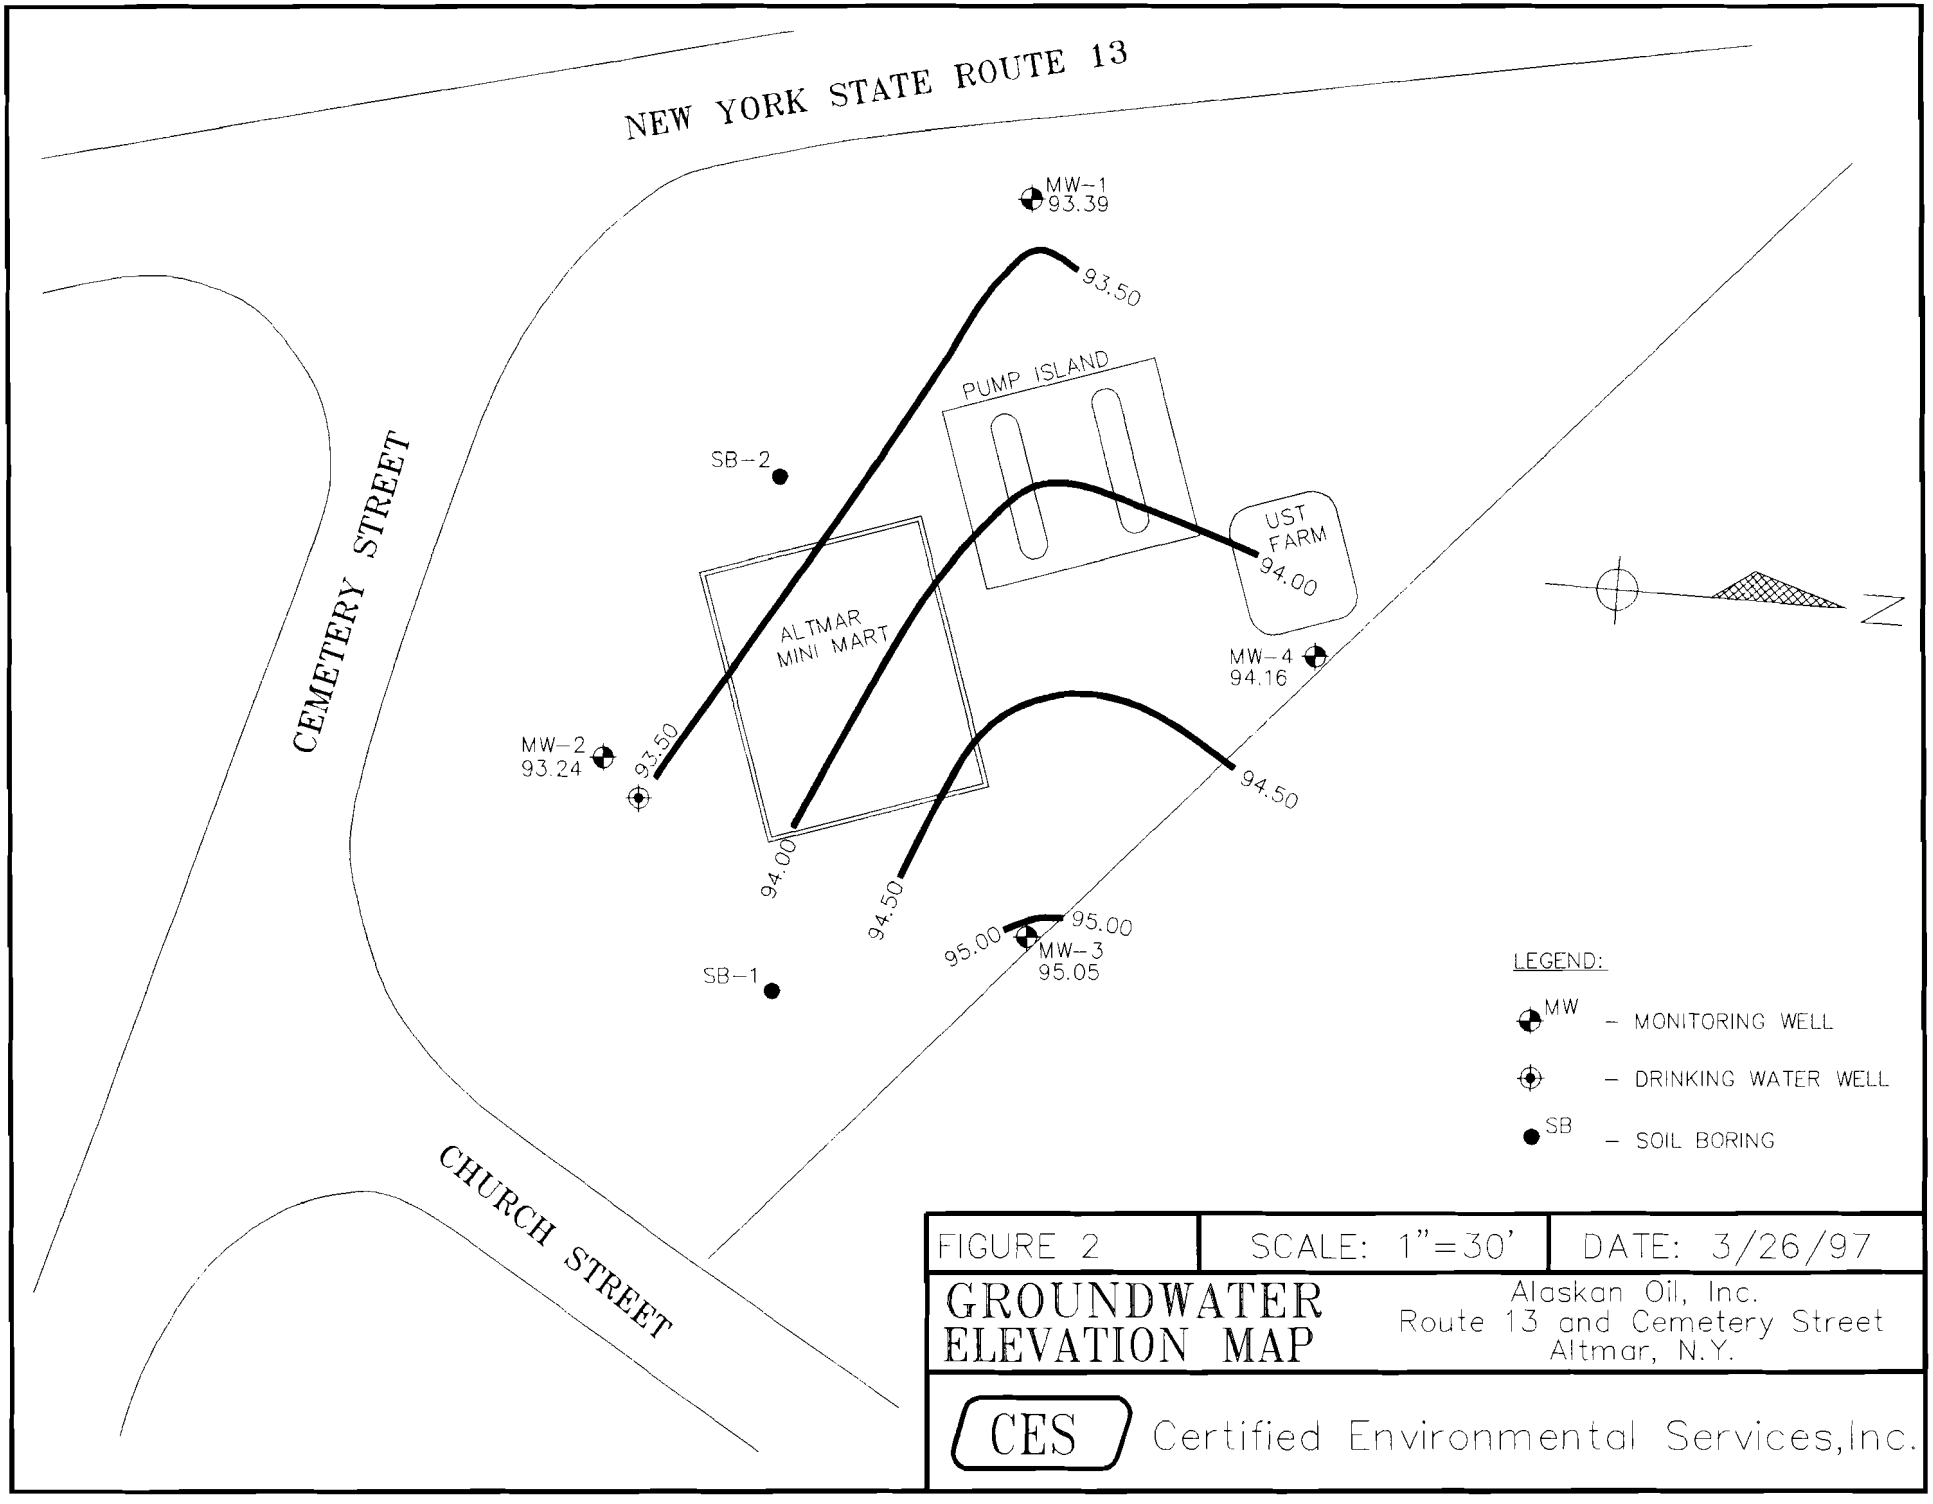
FIGURE 1

In an effort to identify and delineate soil and groundwater petroleum hydrocarbon contamination, on March 24, 1997 six (6) soil borings were advanced and four groundwater monitoring wells were installed beneath the AOI property. A scaled map of the site which illustrates the location of the soil borings and groundwater monitoring well locations is included as Figure 1 in Appendix A.

A preliminary subsurface investigation was conducted to identify and delineate soil and groundwater petroleum hydrocarbon contamination beneath the Alaskan Oil, Inc. (AOI) property located at Route 13 & Cemetery Street in Altmar, New York. A total of six (6) soil borings (MW-1, MW-2, MW-3, MW-4, SB-1 and SB-2) were advanced across the AOI property. Four of the soil borings were completed as monitoring wells MW-1, MW-2, MW-3 and MW-4. A scaled map of the site illustrating the location of the soil borings and groundwater monitoring well locations is included as Figure 1 in Appendix A.

CES recommends that three additional groundwater monitoring wells be installed surrounding the Alaskan Oil property. Proposed well MW-5 should be installed on the west side of Route 13 to delineate the downgradient edge of the plume. Proposed well MW-6 should be installed in the northwest corner of the AOI property or in the NYSDOT Route 13 Right-of-Way. Monitoring well MW-7 should be installed in the NYSDOT Right-of-Way on the south side of Cemetery Street. CES recommends that monitoring wells MW-1 through MW-4 and proposed wells MW-5, MW-6 and MW-7 be sampled on a quarterly basis for analyses in accordance with USEPA Methods 8021 and 8100.
