OLD GENERAL CABLE SITE

PROGRESS REPORT

VOLUNTARY REMEDIAL AGREEMENT

Old General Cable Site
Rome, New York

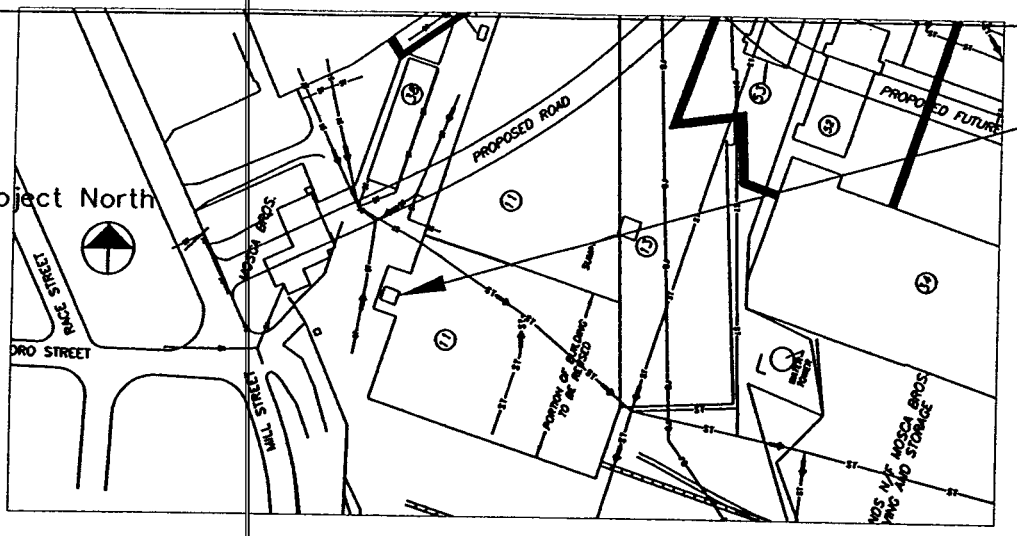
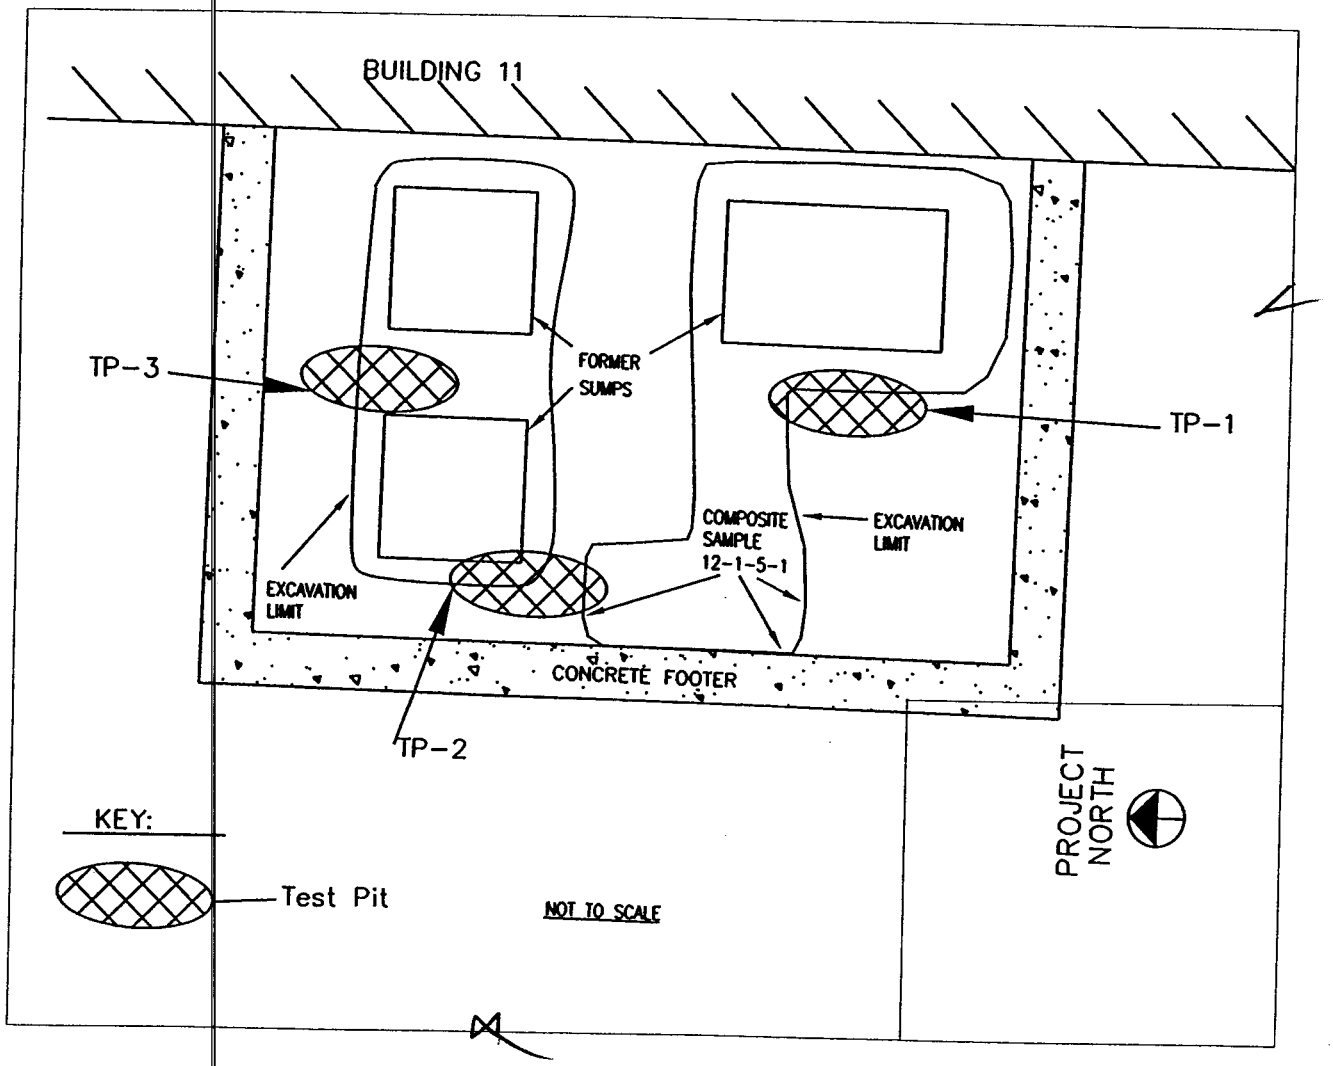
Jack Eisenbach Engineering, P.C. 291 Genesee Street, Utica, NY 13501 315-735-1916 Fax 315-735-6365 www.jackeisenbachengineering.com	DATE: 11/27/02 DRAWN: MPR NO.: 8514	GENERAL CABLE ROD MILL PARCEL BUILDING 37 SUMP REMOVAL TEST PIT SAMPLE LOCATION PLAN	FIG. 1

Five (5) soil samples were collected from the former sump at Building #11, and one (1) sample was collected from the petroleum-contaminated soil adjacent to the former above-ground storage tank, located along the canal. The samples were analyzed for the presence of PCB's and the results reveal no detection of the analyzed compounds. The sample results and sample location plans are attached for your record.

Based on the sampling results, JEE requests closure on the required PCBs testing at the Rod Mill Parcel.

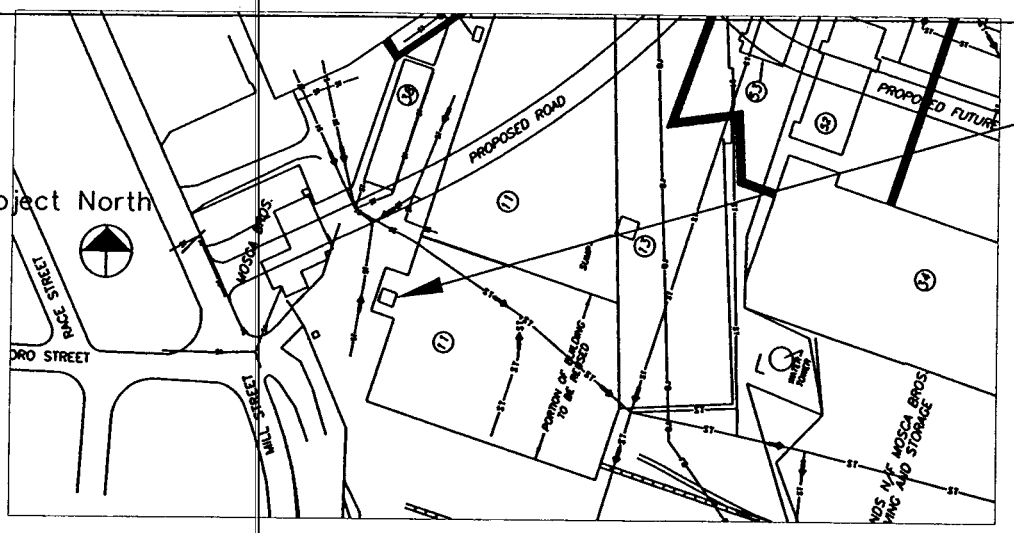
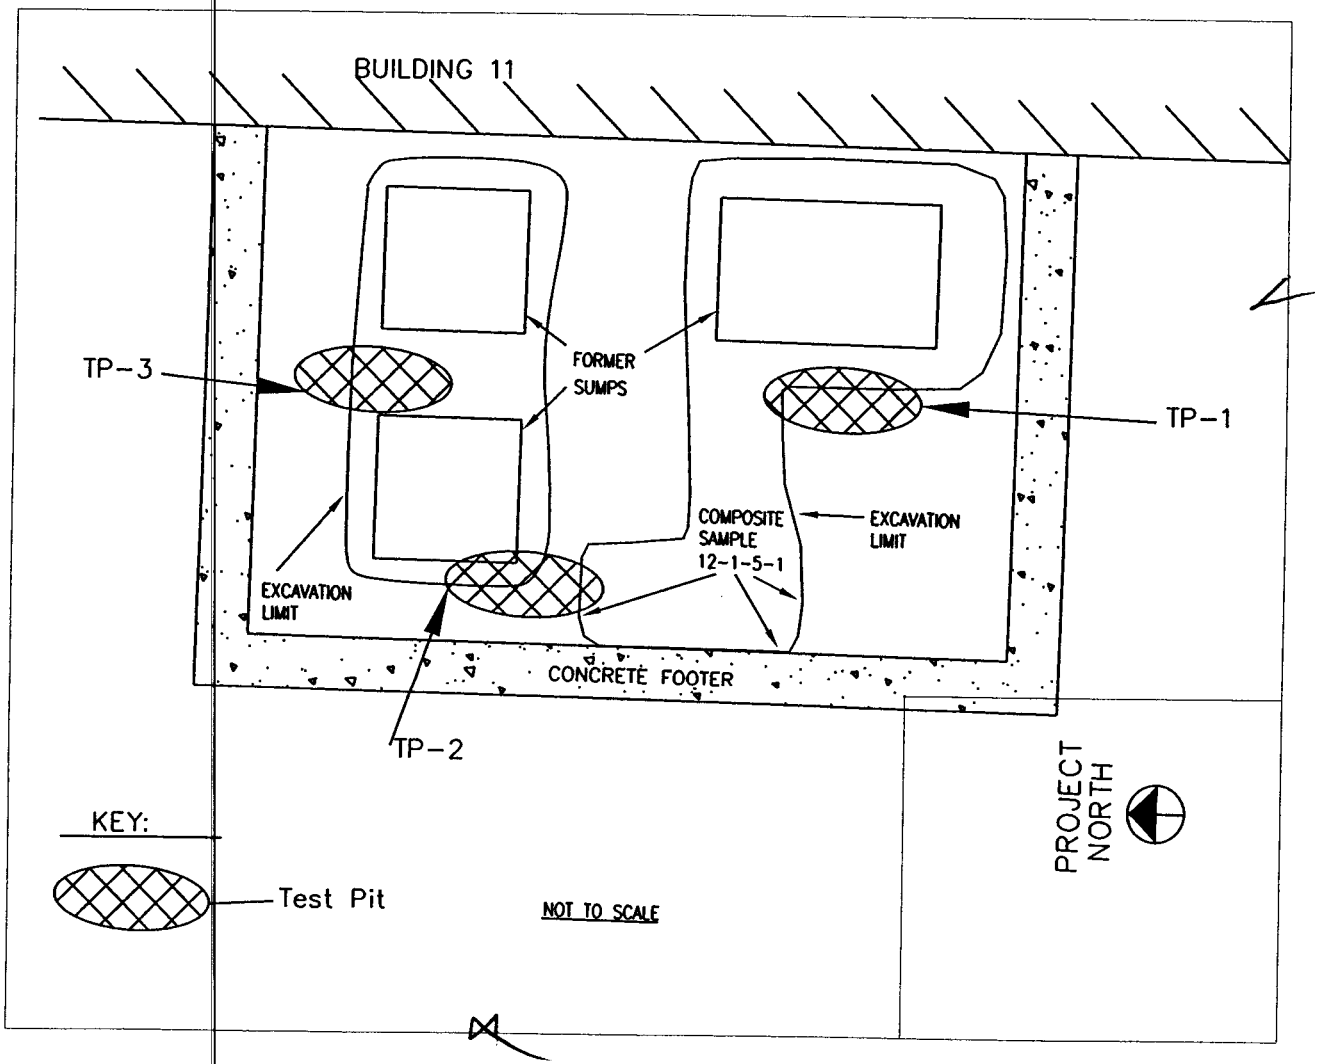
Jack Eisenbach Engineering, P.C. 291 Genesee Street, Utica, NY 13501 315-735-1916 Fax 315-735-6365 www.jackeisenbachengineering.com	DATE: 11/27/02 DRAWN: MPR NO.: 8514	GENERAL CABLE ROD MILL PARCEL BUILDING 37 SUMP REMOVAL TEST PIT SAMPLE LOCATION PLAN	FIG. 1

Five (5) soil samples were collected from the former sump at Building #11, and one (1) sample was collected from the petroleum-contaminated soil adjacent to the former above-ground storage tank, located along the canal. The samples were analyzed for the presence of PCB's and the results reveal no detection of the analyzed compounds. The sample results and sample location plans are attached for your record.

Based on the sampling results, JEE requests closure on the required PCBs testing at the Rod Mill Parcel.
