Soil Vapor Intrusion Investigation Report

NYSDEC Site No. 152021

50 Engineers Lane
Farmingdale, New York

Revised June 2014
123150

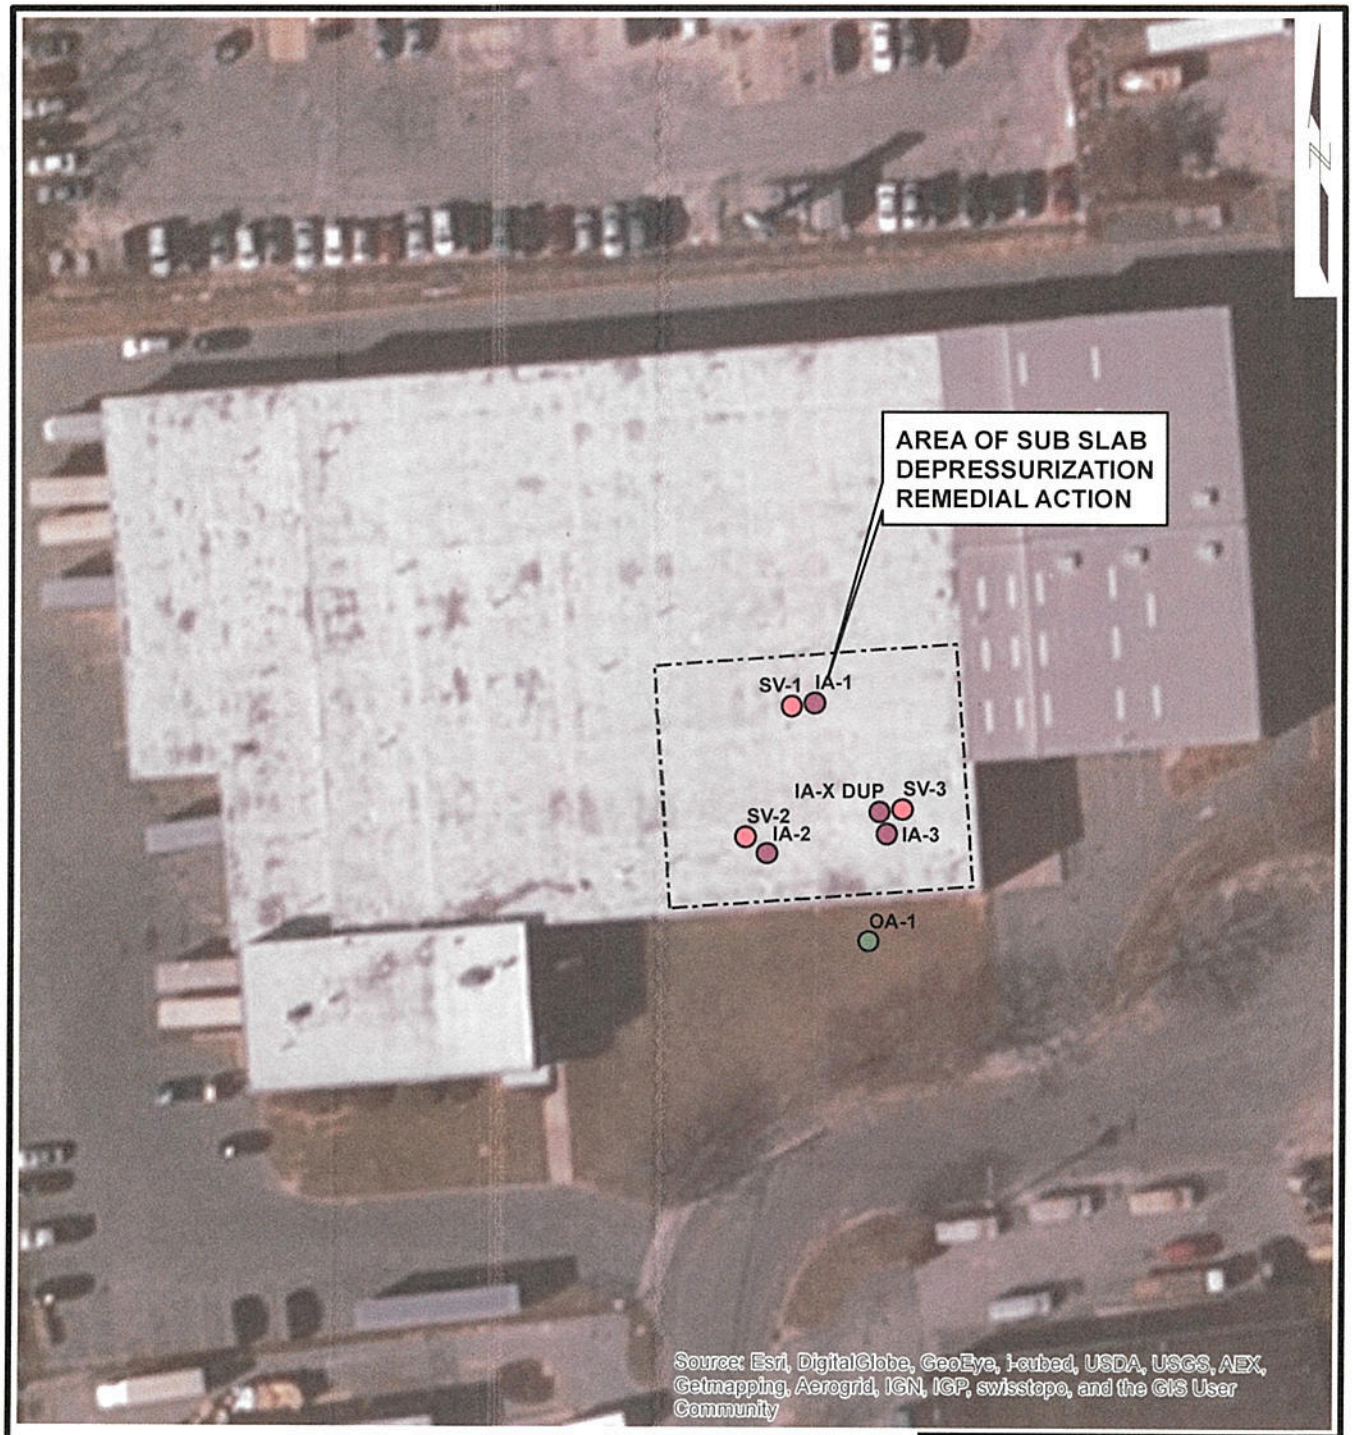
April 2014 Fig. 2

Tetrachlorethene (PCE) was detected in all three soil vapor samples performed. The laboratory results found PCE in the following concentrations: SV-1 (650ug/m3), SV-2 (250ug/m3), and SV-3 (600ug/m3).

Regarding compounds included in the Volatile Chemical Matrix Tables within the NYSDOH Guidance, which compare sub-slab soil vapor to indoor air concentrations, additional monitoring of PCE in soil vapor at the subject property is recommended. Should the detected concentrations of PCE at the subject property increase, particularly in indoor air, the re-installation of a sub-slab depressurization system (SSDS) may be warranted.

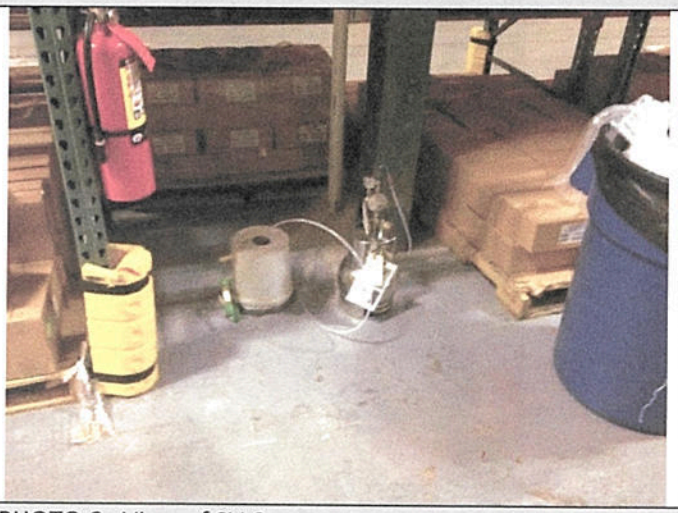
PHOTO 6: View of SV-2

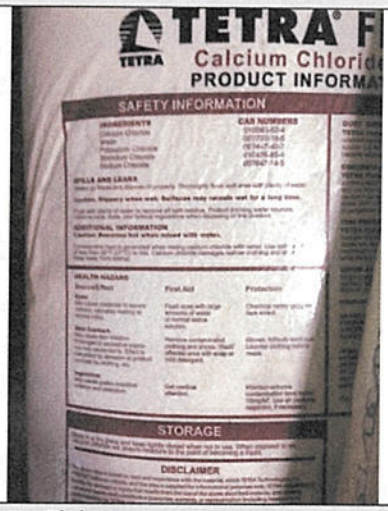
PHOTO 9: Tetra Flakes

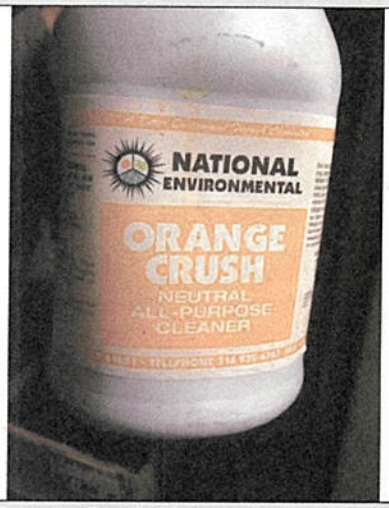
PHOTO 10: Orange Crush Cleaner

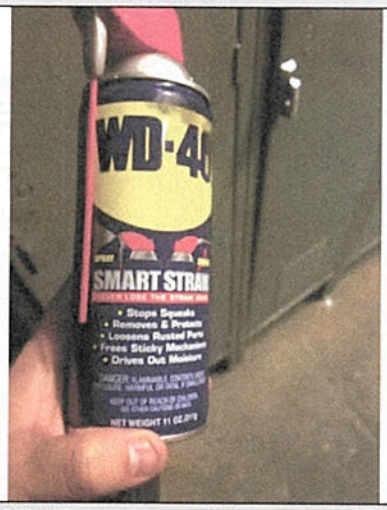
PHOTO 11: WD-40

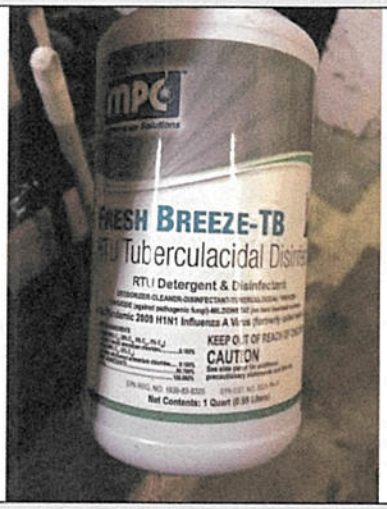
PHOTO 12: Fresh Breeze
