Subject: **Site Management Periodic Review Report and IC/EC Certification Submittal - 2019**
Mineral Springs Road MGP Site (NYSDEC Site #V00195)

Site Management Periodic Review Report and IC/EC Certification (2019)

NFG - Mineral Springs MGP - Site No. V00195
West Seneca, New York

October 2019
Project 1801042

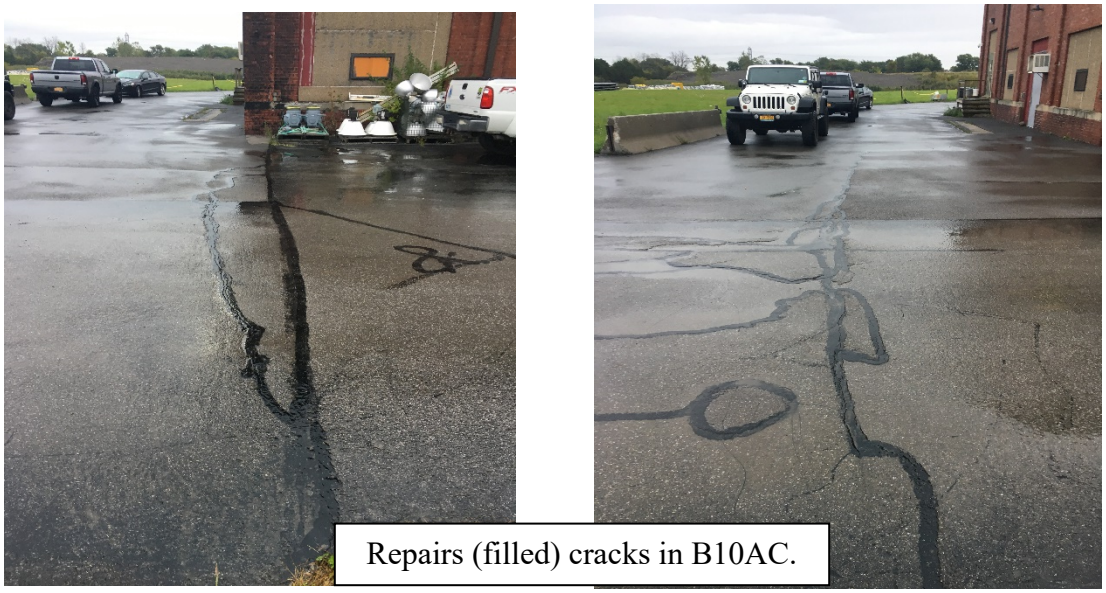
Building 10 Asphalt Cap (B10AC): This cap was repaired in 2017. An approximate 20 foot-long, 3 -5 mm crack as well as several additional cracks were observed in 2019 and repaired with additional filler in September 2019 (see photos below). No blue stained soil or edge erosion was observed.

Repairs (filled) cracks in B10AC.

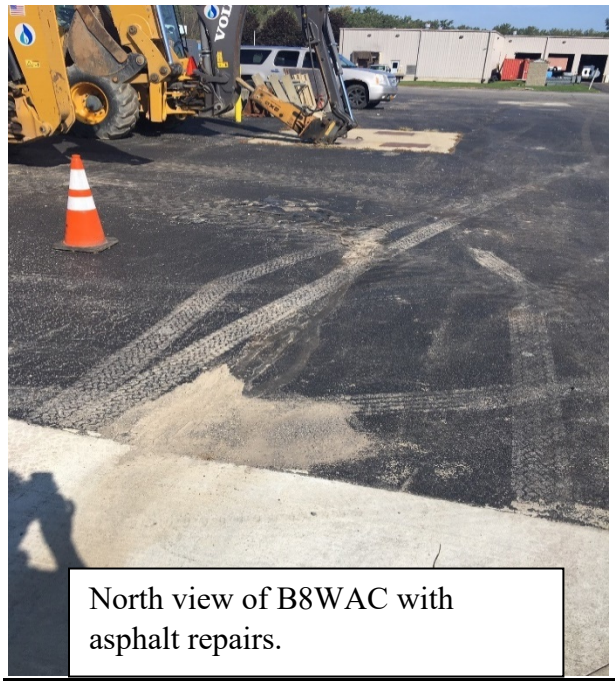
Building 8 West Asphalt Cap (B8WAC): No blue stained soil or edge erosion was observed. Cap repairs which include asphalt material repairs and re-sealing were performed during 2018 maintenance and deterioration of asphalt was identified north and south of the new concrete apron. These areas were repaired in 2019 under the direction of NFG (photos below).

North view of B8WAC with asphalt repairs.

Repairs and sealing of the B8WAC near the concrete catch basin apron.

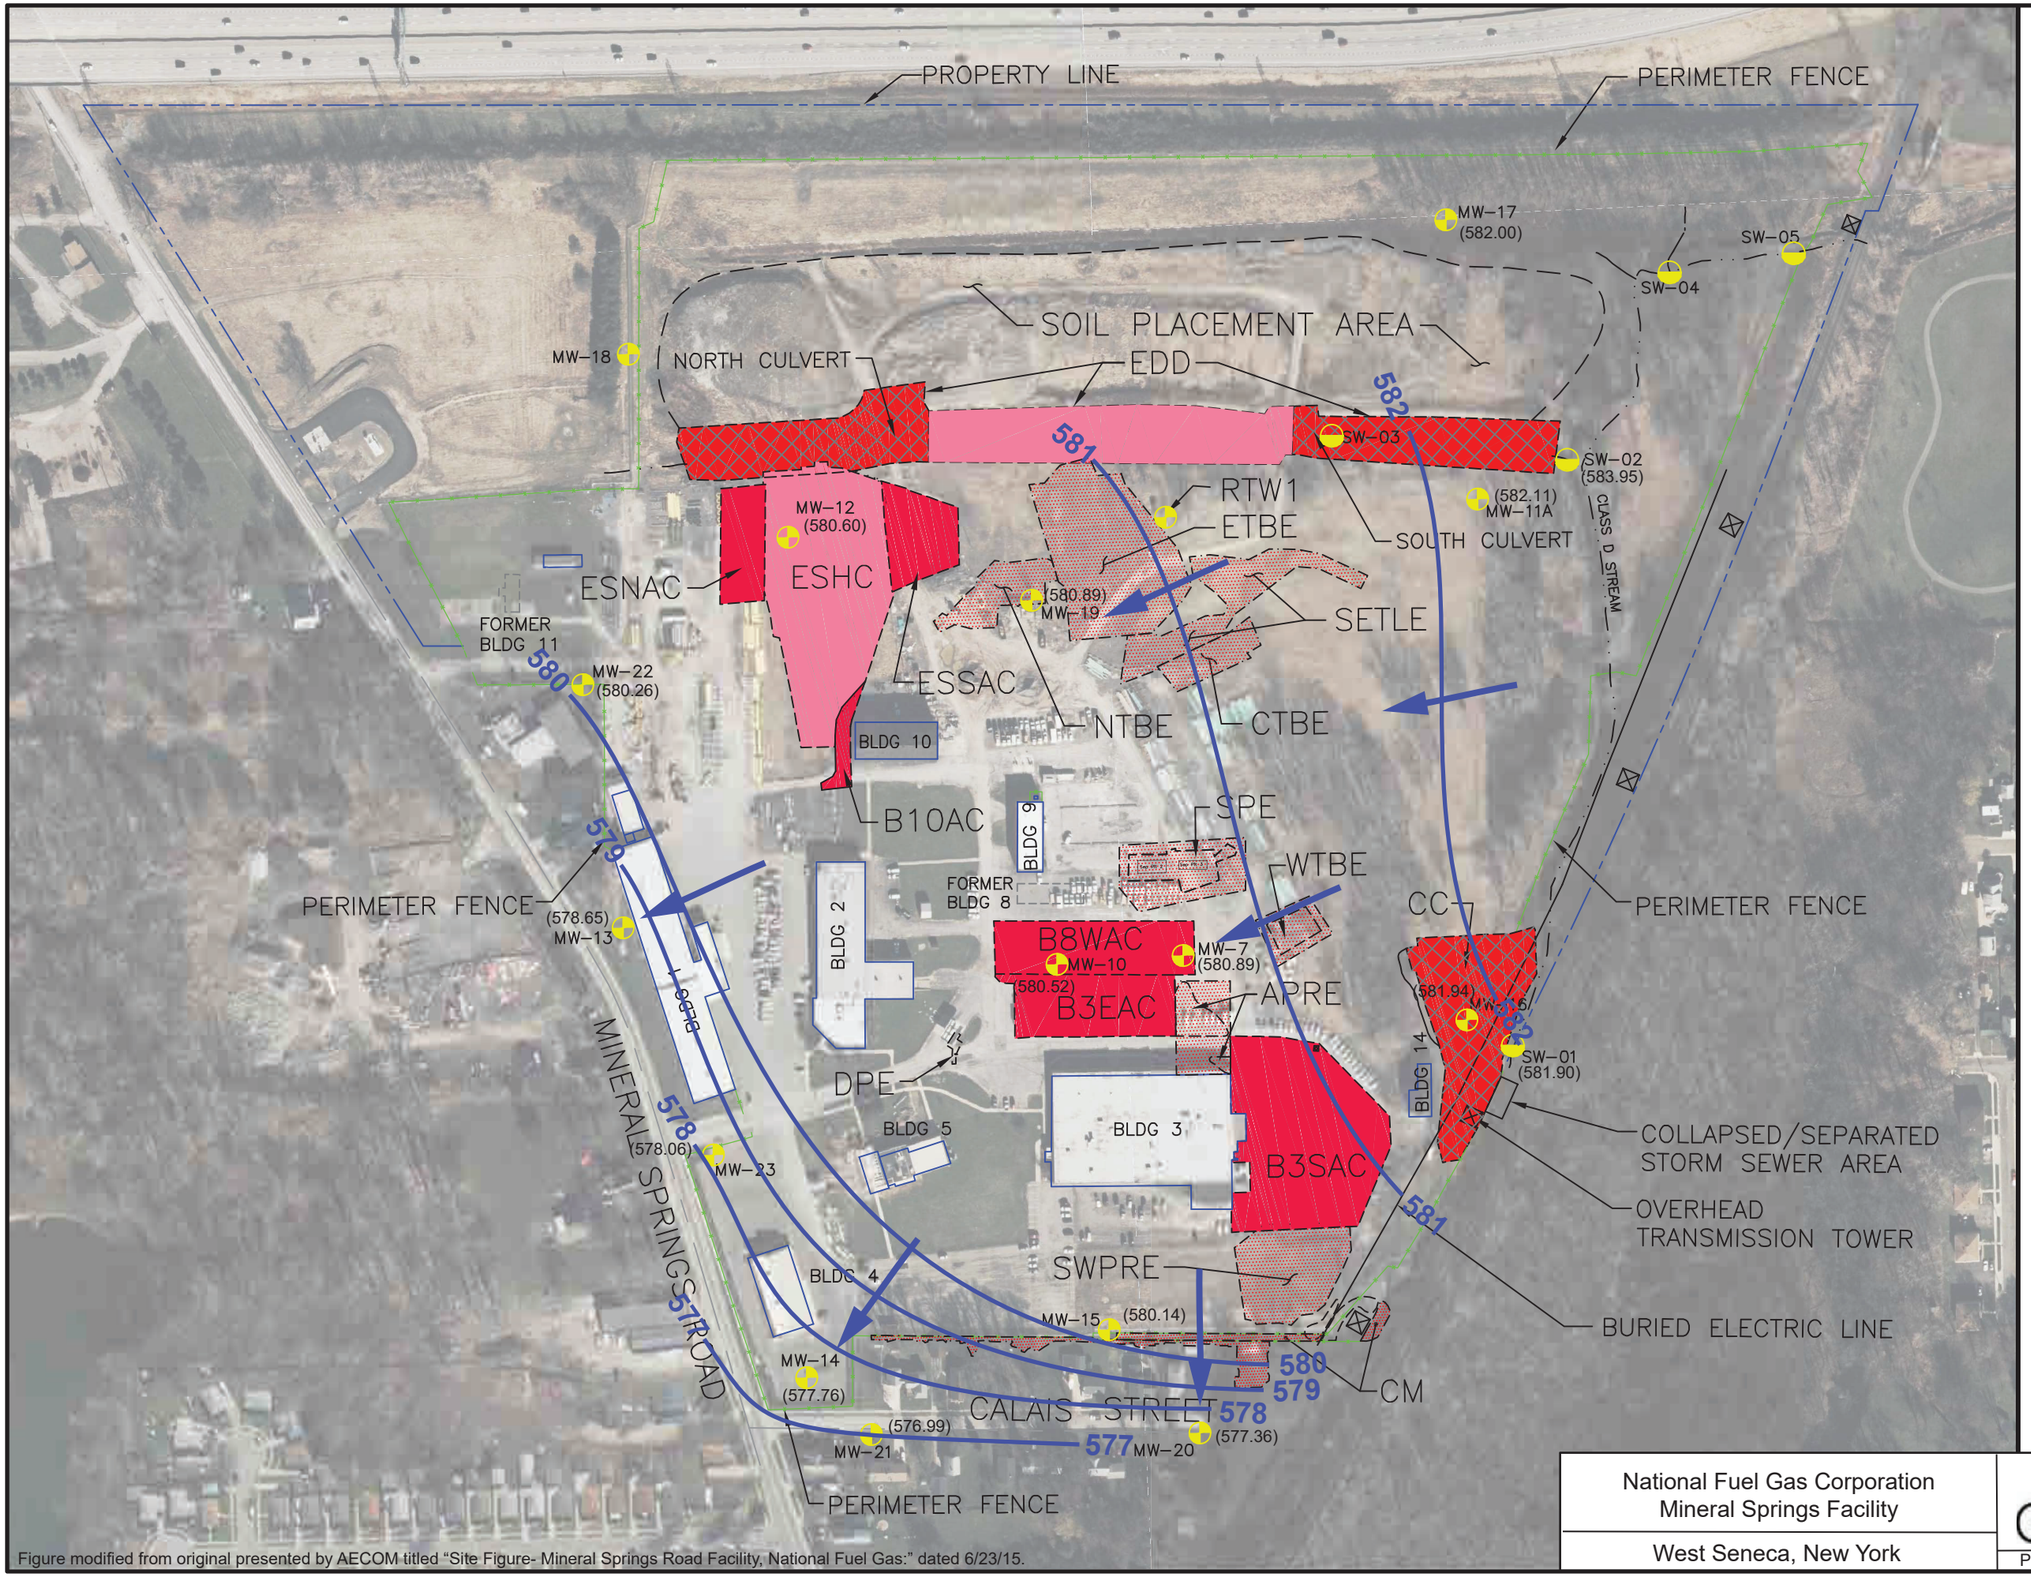
September 2019 Figure 2

SITE LAYOUT
