LEGGETTE, BRASHEARS & GRAHAM, INC.

INTERIM REMEDIAL MEASURES REPORT
FORMER CHARLTON CLEANERS FACILITY
FOREST AVENUE SHOPPERS TOWN
BOROUGH OF STATEN ISLAND
CITY OF NEW YORK

November 2009

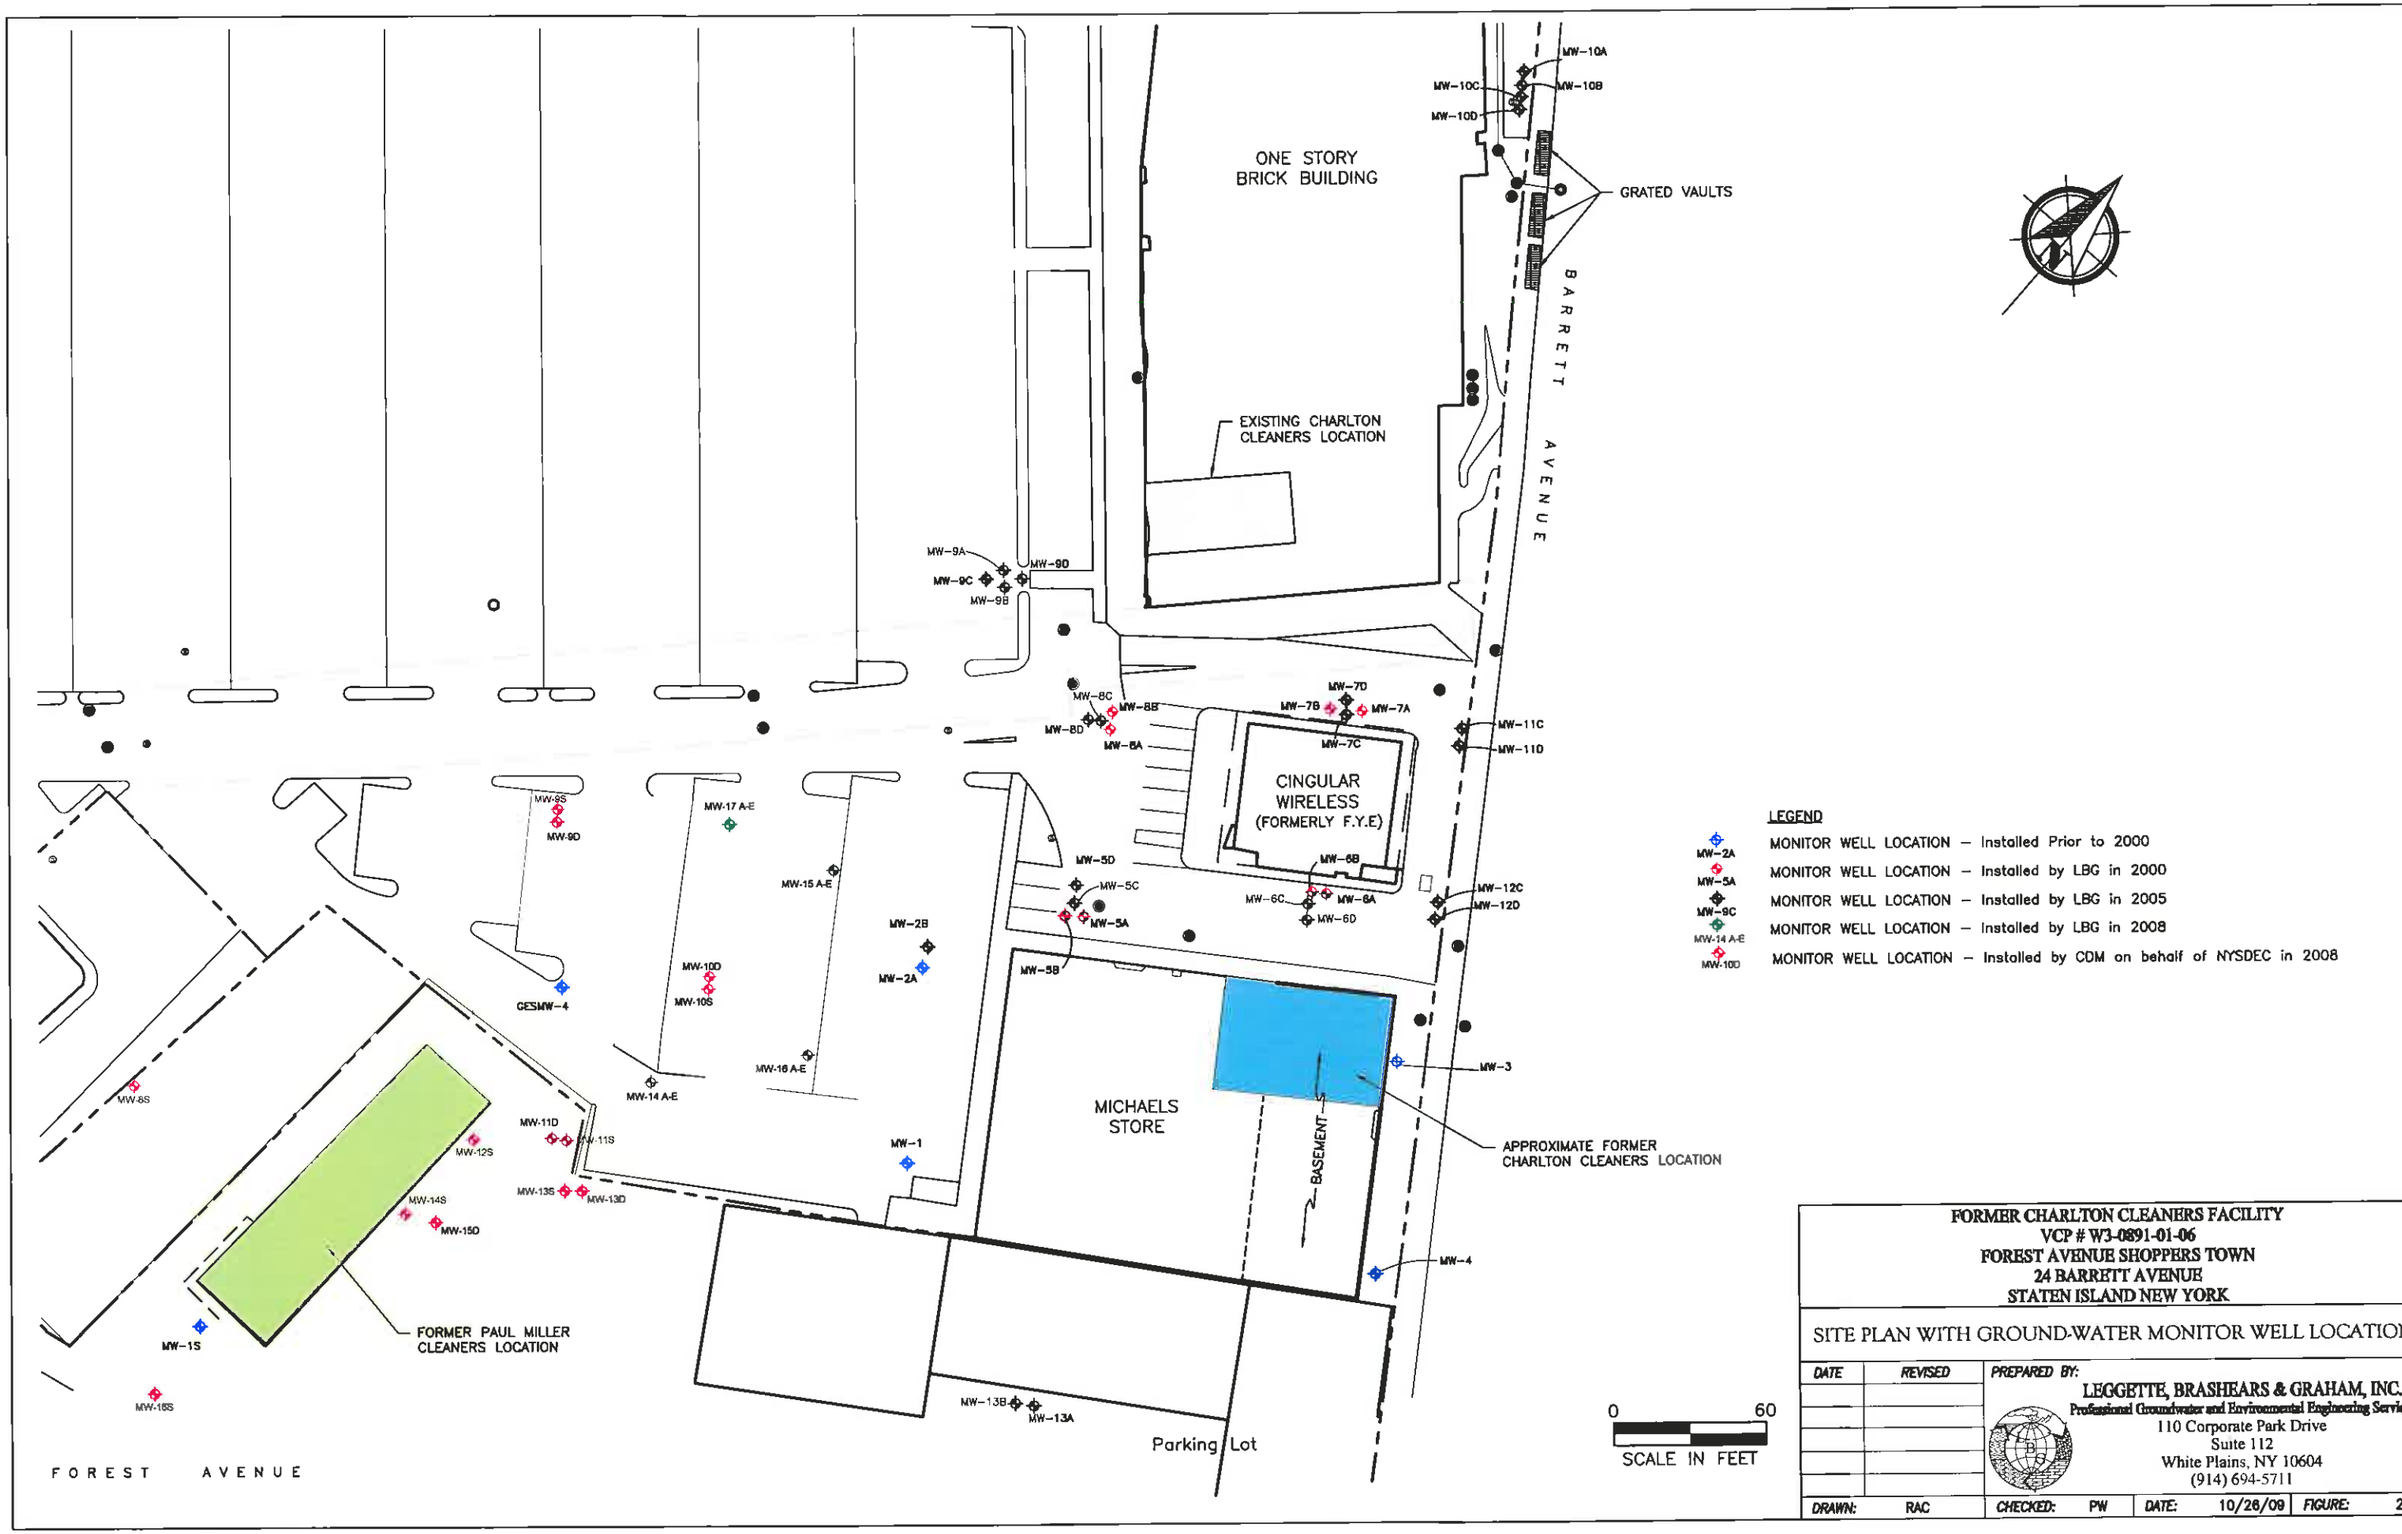
FILE: Charlton floorplan	DRAWN BY: JAM	CHECKED BY: SG	DATE: 8/28/06
			FIGURE: 3

The basement is approximately 35 feet by 115 feet, the long dimension runs north-south beneath the east side of the Michaels building. The remainder of the Michaels building is slab-on-grade construction. A masonry wall, running east-west, divides the basement into two zones: (1) the main basement used for Michaels product storage (south of the wall), and (2) two small rooms and the exterior basement entrance (north of the wall), shown on figure 3.

The 2009 IRM field work was performed within the two rooms to the north of the fire wall, herein referred to as the "equipment room" and the "west room" (figure 3). A large sump pit exists in the floor of the equipment room. The dimensions of the sump are approximately 4 feet in diameter and 3 feet deep. The sump appears to date to the building's construction and thus existed during the Charlton Cleaners operation. The walls of the sump are cast iron and the bottom is solid. Water enters the sump through two 2-inch pipes and through the backfill material surrounding the pipes. Water may also enter through a gap between the sump floor and wall. The Appendix contains photographs of the IRM.

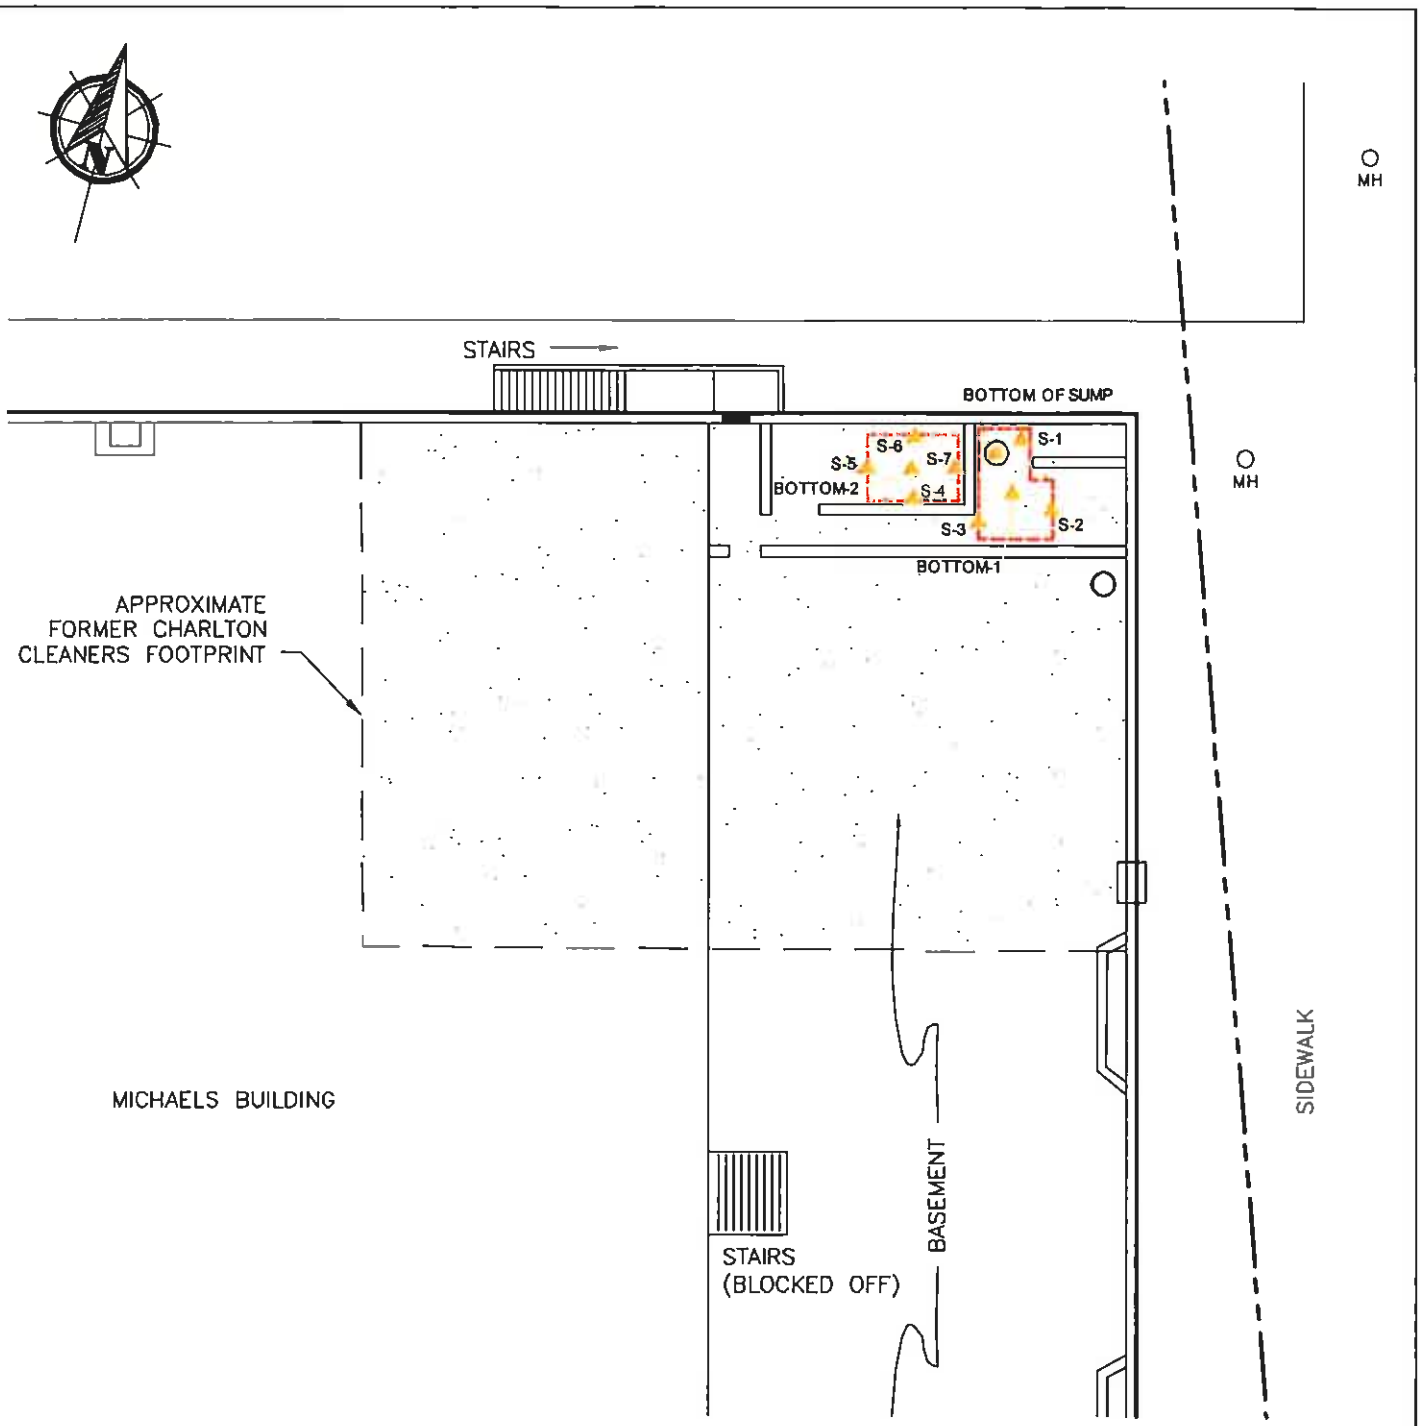
DRAWN:	RAC	CHECKED:	PW	DATE:	10/26/09	FIGURE:	5

On September 17, 18 and 21, 2009, 10 endpoint soil samples were collected to document the condition of the soil which remains beneath the floor. Sample locations and the limits of excavation are shown on figure 5. The excavations were backfilled with clean gravel. The vapor barrier was repaired and the concrete floor above the barrier was repoured.

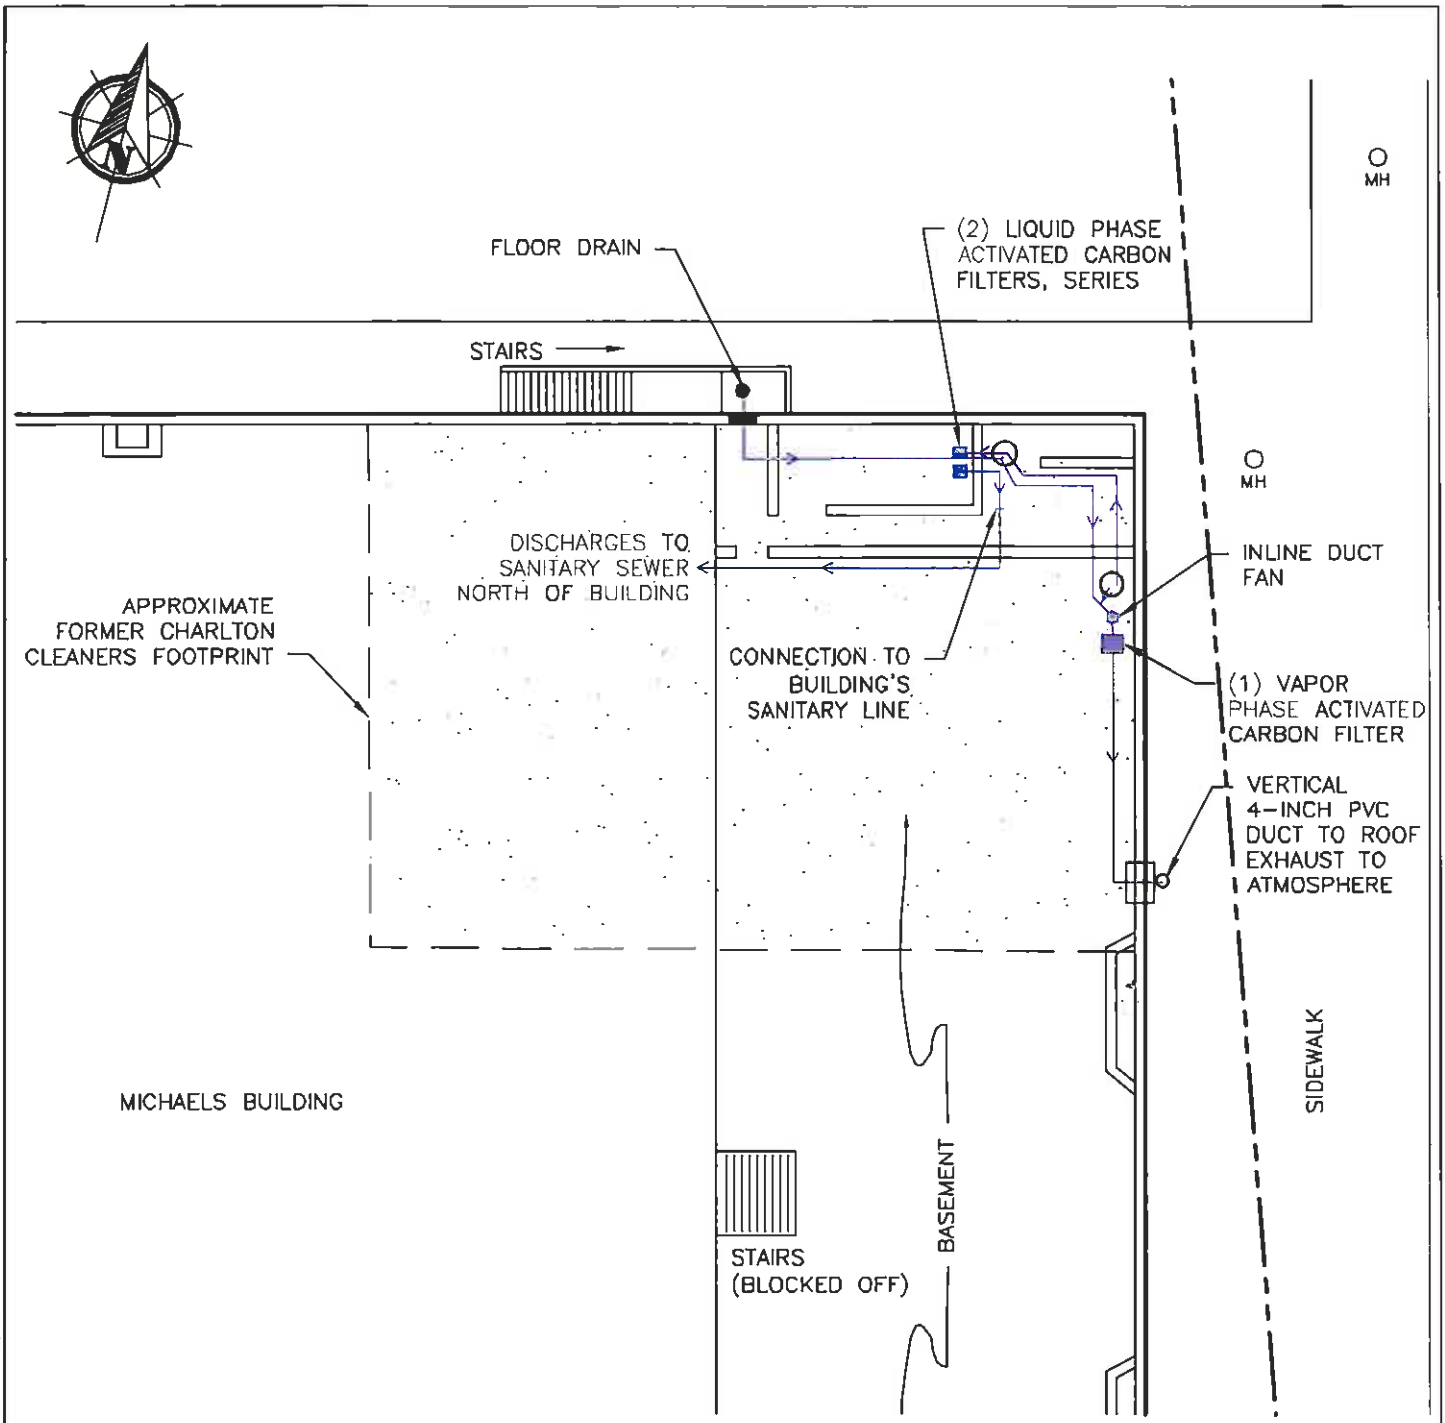
low-flow groundwater extraction system, gradually removing contaminated groundwater from beneath the floor. The extracted water is piped through a pair of activated carbon filters prior to discharge to the sanitary sewer. The installation of this filtration system is performed at the request of the NYSDEC case manager. The water discharged from a second small sump pit located in the northeast corner of the main basement was piped into the large sump. In this way, water from both sumps is treated prior to discharge (figure 6).

In order to prevent vapor infiltration from the sumps into the basement air, a ventilation system was added to both the large sump in the equipment room and a smaller sump in the northeast corner of the main basement (figure 6). Three-inch diameter PVC pipe was attached to the lids of both sumps and routed to an inline vent fan and vapor-phase activated carbon filter in the main basement. The treated air is ducted through 4-inch PVC pipe out the east basement wall and up to the roof of the Michaels building where it exhausts to the atmosphere (see photographs in the Appendix).
