SUBSURFACE INVESTIGATION
FYN PAINT & LACQUER CO., CONSOLIDATED EDISON
NORTH FIRST STREET AND VICINITY
BROOKLYN, NEW YORK

Keane & Beane, P.C.

February 2002

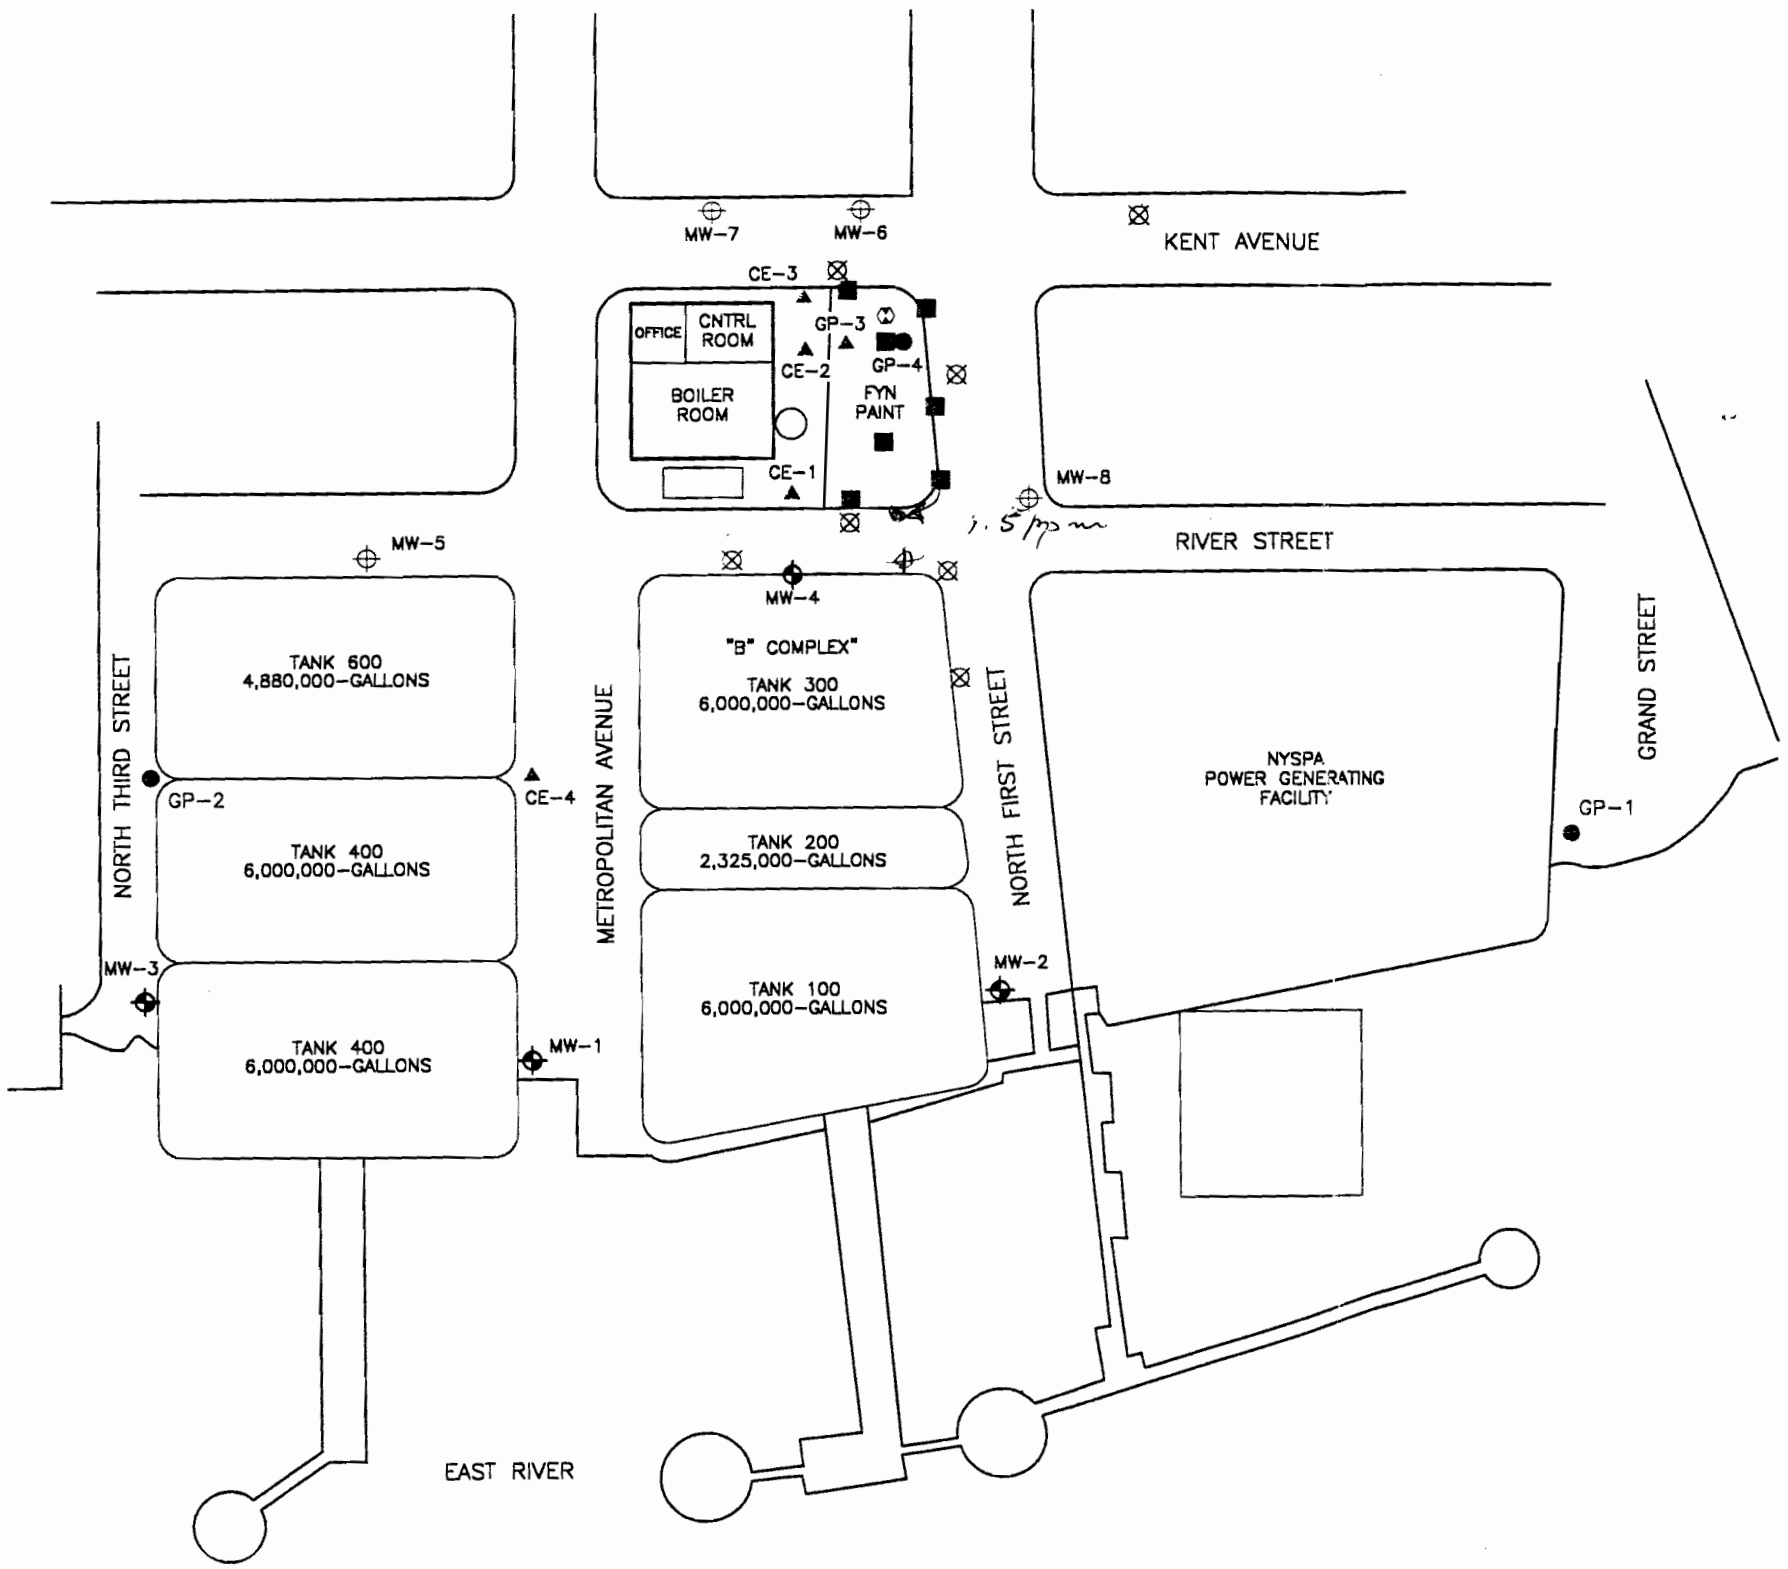
The area investigated by LBG encompasses Kent Avenue to the east, North Third Street to the north, Grand Street to the south, and East River to the west. The two facilities subject to the subsurface investigation are Con Edison property located at 214 Kent Avenue and Fyn Paint property located at 230 Kent Avenue. A site map is shown on figure 1.

Soil impacted by VOCs including acetone, ethylbenzene, isopropylbenzene, toluene and xylenes was encountered beneath the Con Edison and the adjacent Fyn property. These compounds were detected in soil samples collected from CE-1, CE-2 and CE–3 drilled on Con Edison parking lot and GP-3 and GP-4 drilled inside of Fyn Paint building (see figure 1 for locations).

Ground water impacted by dissolved VOCs was detected beneath the Fyn Paint and Con Edison properties located between Kent Avenue and River Street (figure 1). The dissolved VOCs
