REMEDIAL ACTION REPORT

Waters Edge
200 East Main Street
Port Jervis, New York
Site Identification # V00433-3

IVI Project No.: E1066016
Volume 1 of 2

September 4, 2002

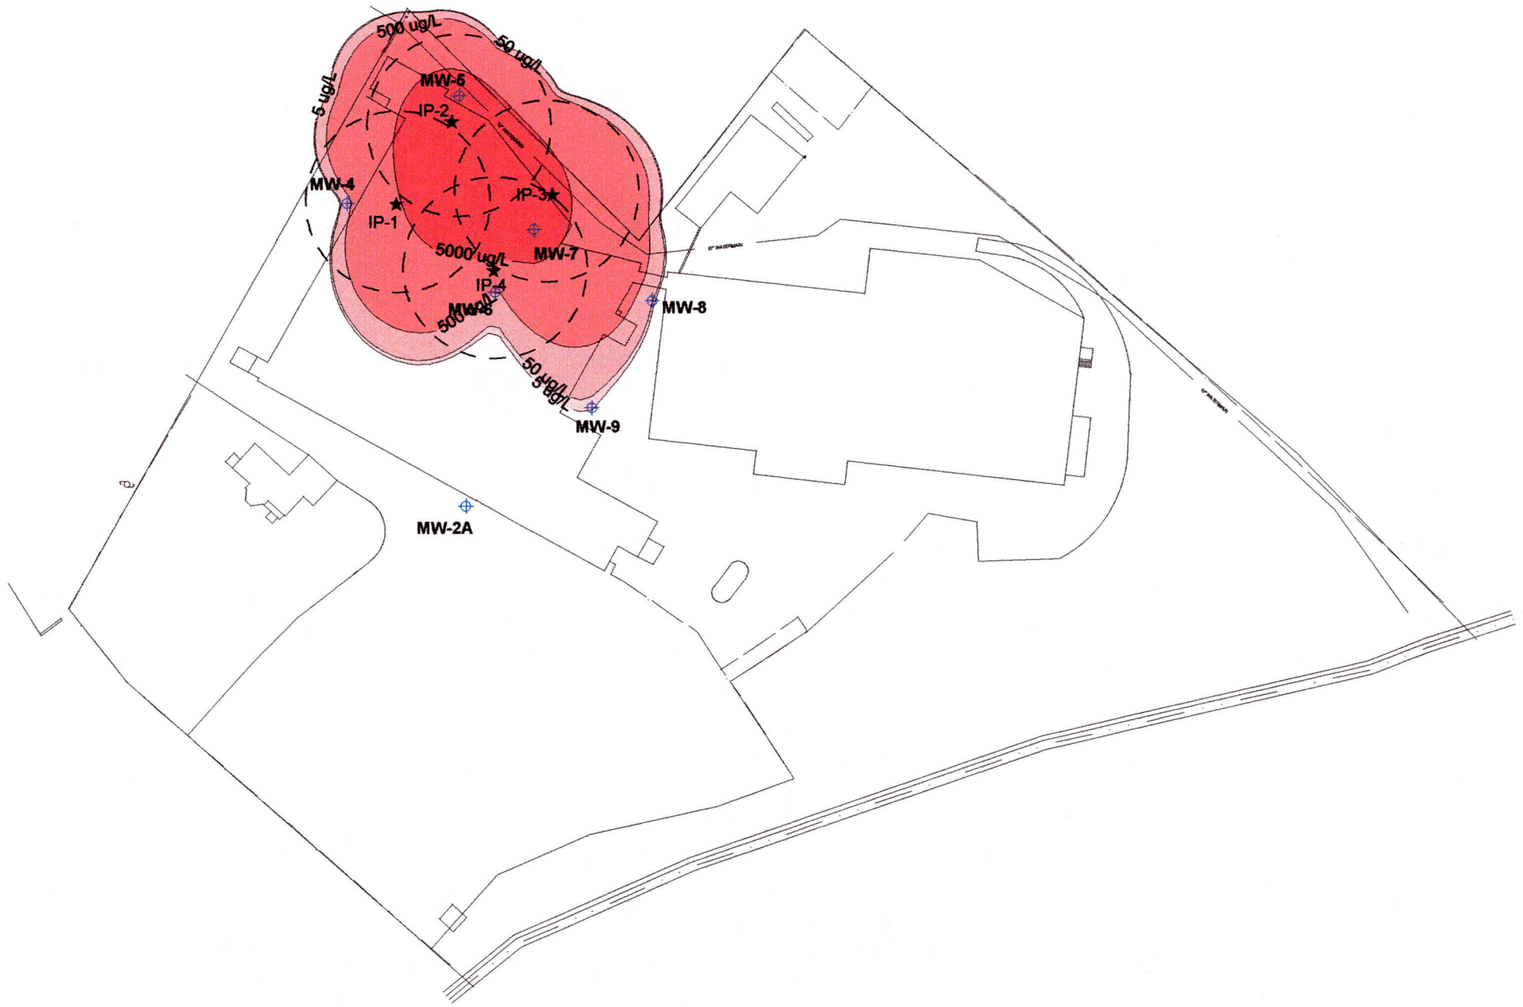
Figure 2: Pre-Remediation Total VOC Concentration Isopleth Map - October 2001

IVI advanced four (4) 2" ID injection points in to the water table within the 500 ppb total chlorinated VOCs contour area as shown in Figure 2 in Appendix A. The injection points consist of an expendable drive point and five foot sections of schedule 40 stainless steel casings. These injection points were advanced using a cone penetrometer unit to depths of 30' bgs, approximately 5' below the soil/groundwater interface. The injection point placement was designed to achieve the maximum distribution of the treatment chemical reagents to the groundwater contamination to ensure the most effective and efficient contaminant destruction.

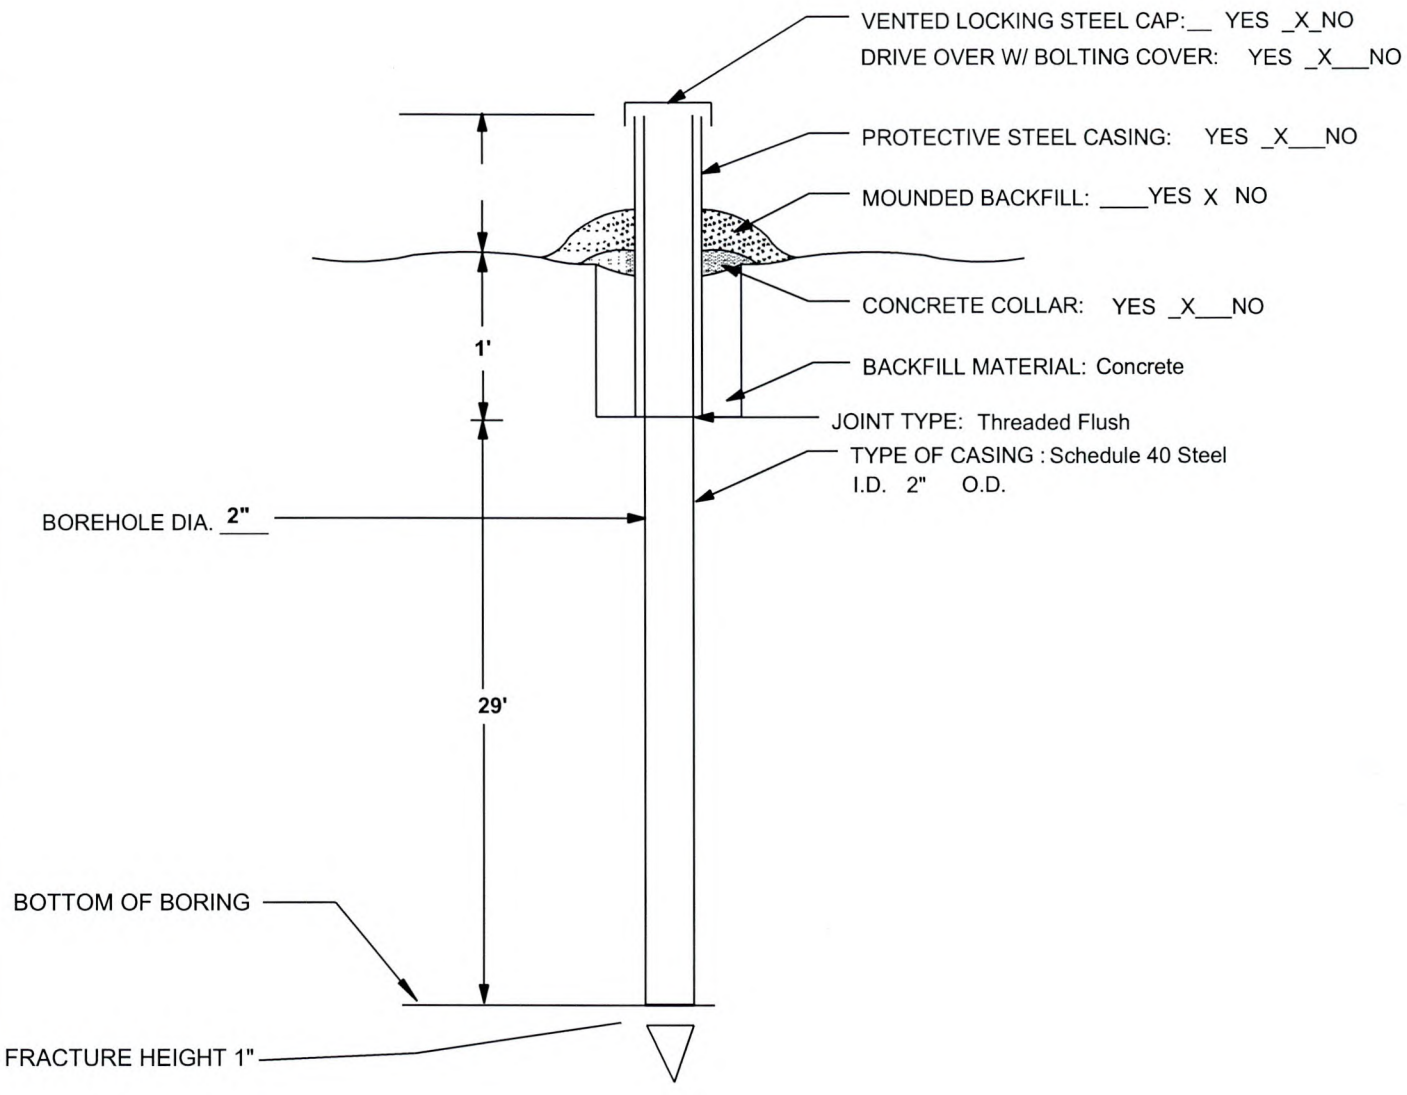
Figure 6 - Typical Groundwater Injection Point Construction Detail

Following the advancement of the injection points, their respective drive points were dislodged for the creation of propagations for transference of chemical reagents associated with the in-situ chemical remediation process into the groundwater and saturated zone soils. The propagations were created using a hydraulic-fracturing technology which involved the injection of high pressure water into the points. Following the advancement of the propagations, a coarse sand mixture was injected into the points to prop the fractures and create precise preferential pathways with a high hydraulic conductivity inside the in-situ volume to be treated. A typical injection point construction detail is shown on Figure 6 in Appendix A.

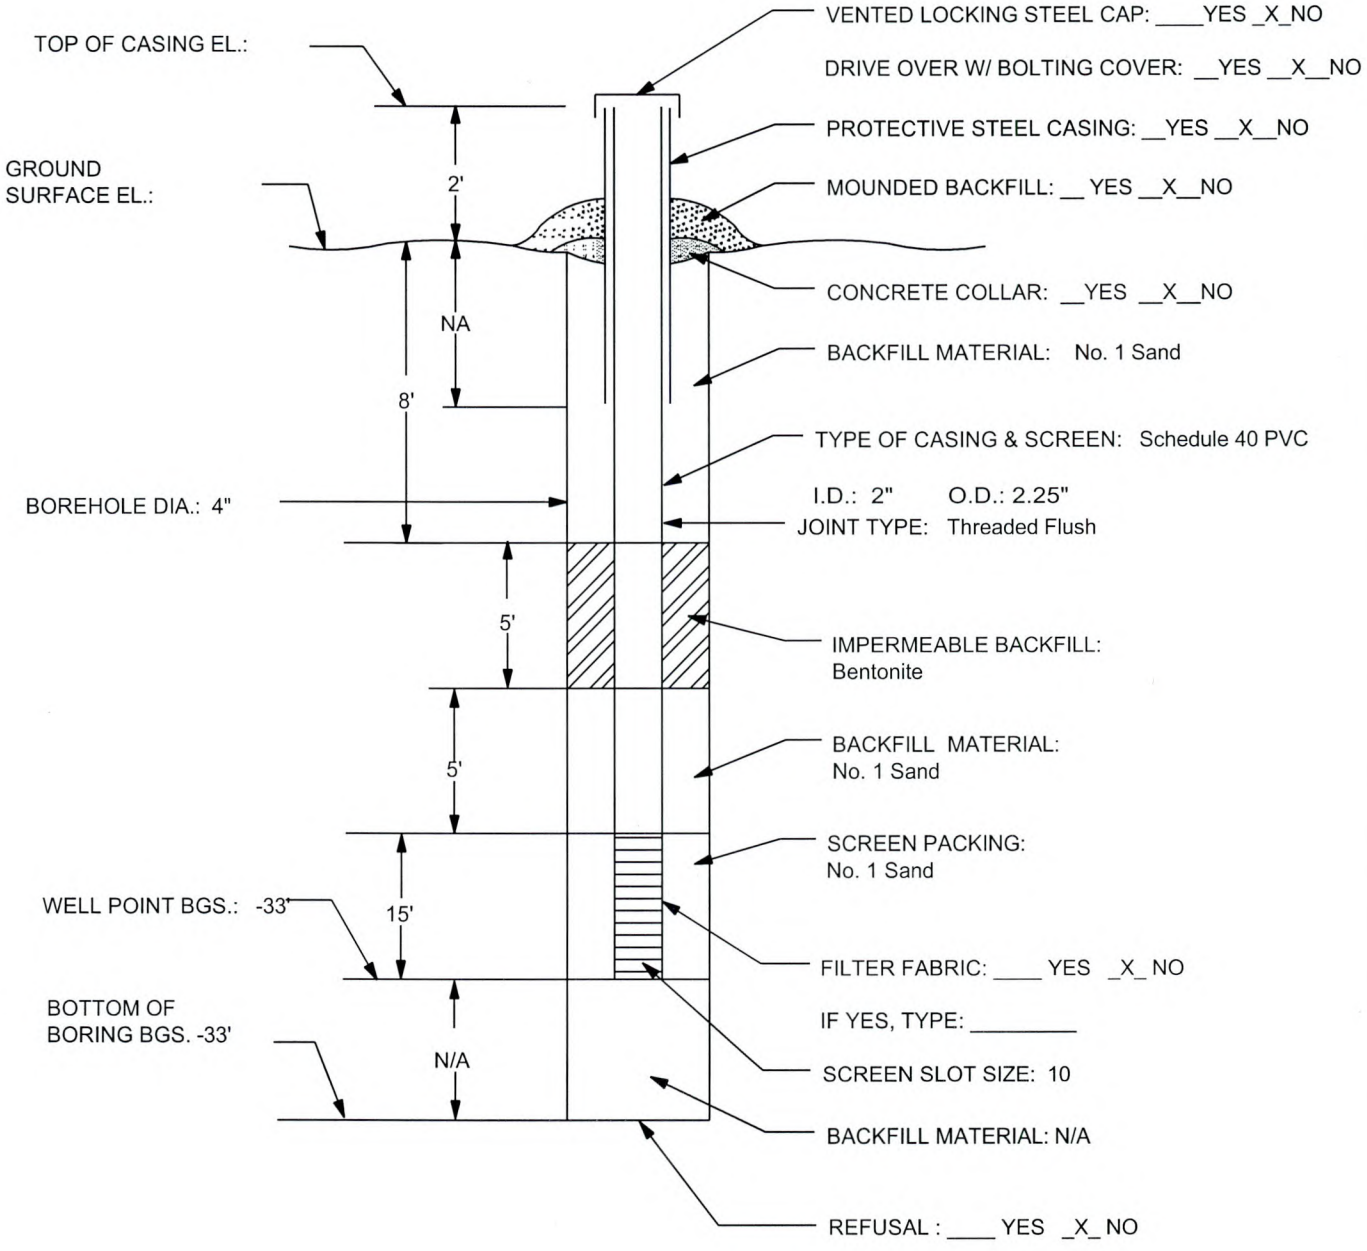
MONITORING WELL NO.: MW-7

9. MW-7 was destroyed during site redevelopment activities and was replaced approximatly 20' to the west of the original position.
10. The replaced MW-7 was rendered unusable due to heavy silting caused during the second round of remediation. As such the well was removed and replaced in the same location.
