ENGINEERING INVESTIGATIONS AT INACTIVE HAZARDOUS WASTE SITES

PHASE I INVESTIGATION

Hanna Furnace — Site No. 915029

City of Buffalo — Erie County

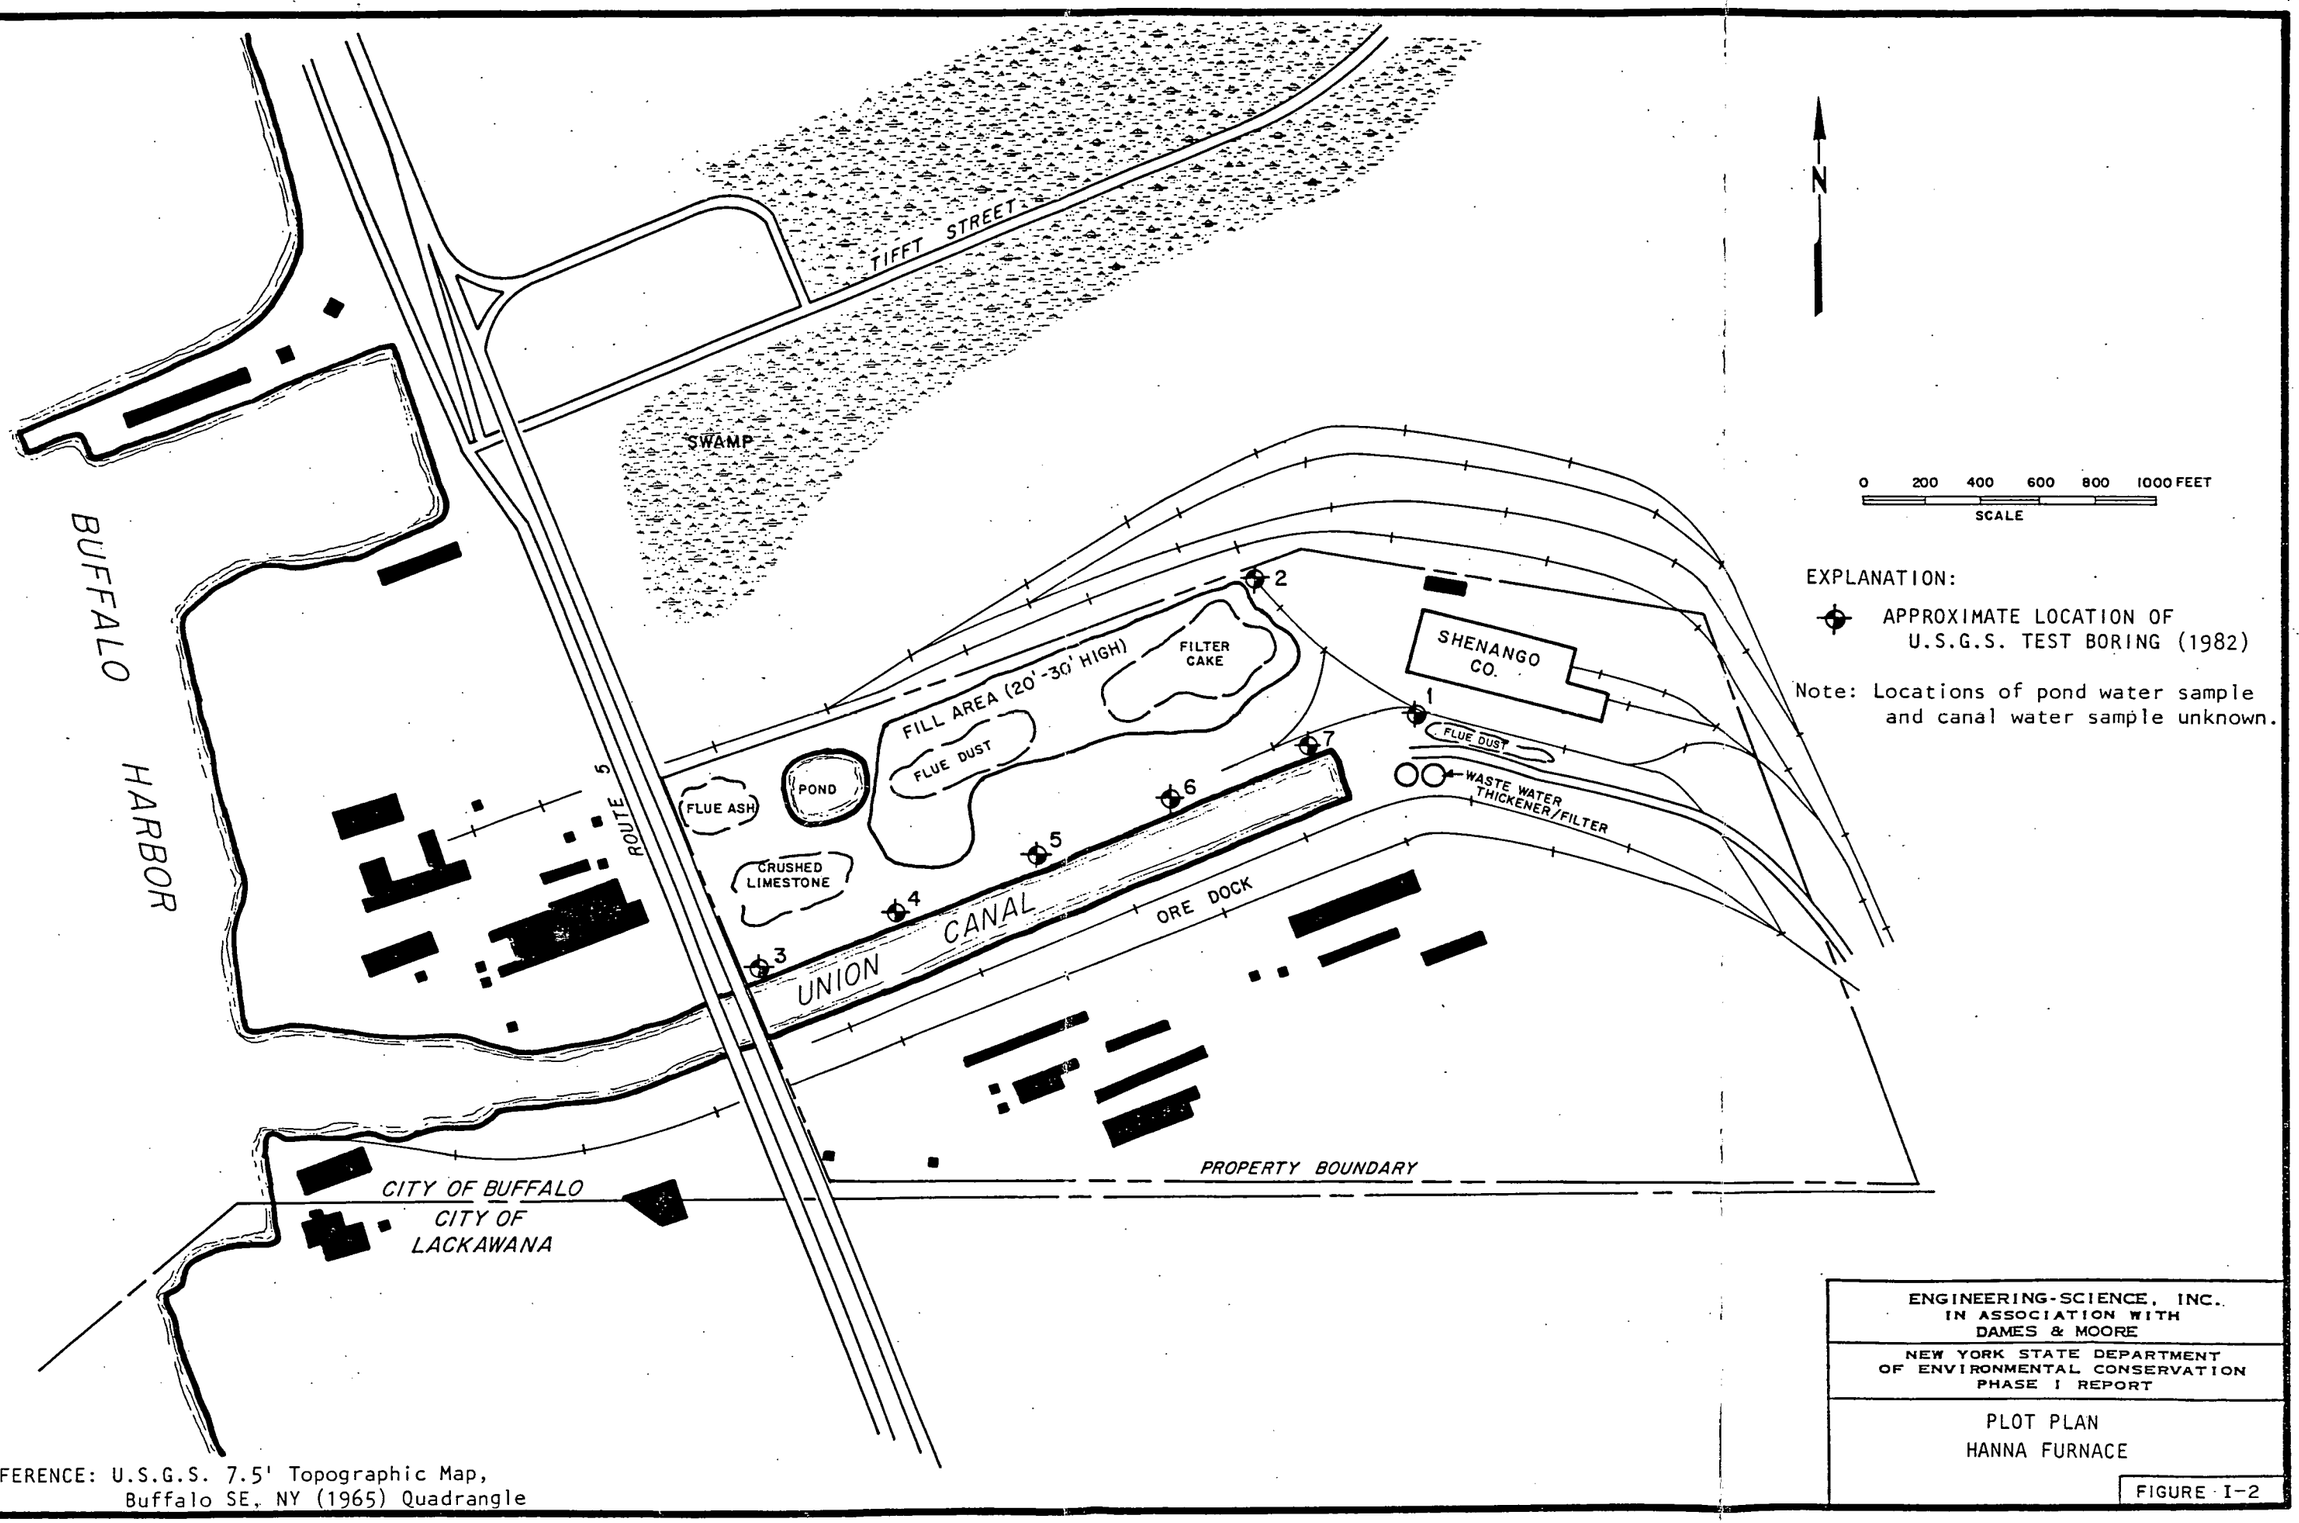
FIGURE I-2

PLOT PLAN
HANNA FURNACE

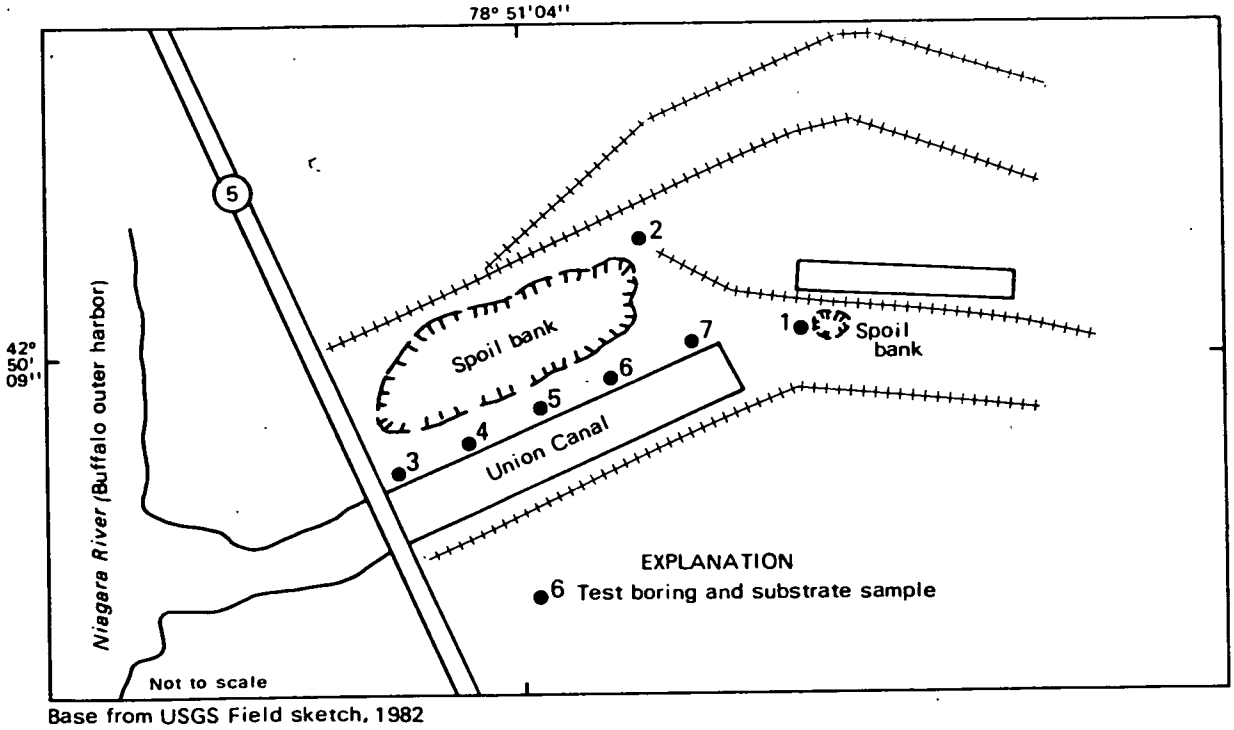
Figure A-5. Location of sampling holes at Hanna Furnace Corporation, site 135, Buffalo.

Constituents	Sample number and depth below land surface (ft)		
	5 (6)	6 (5.5)	7 (10)
Chromium	4,000	10,000	3,000
Copper	11,000	28,000	12,000
Iron	4,200,000	6,000,000	5,000,000
Lead	30,000	30,000	10,000

†† Exceeds concentrations in samples from undisturbed soils in the Buffalo area. Undisturbed soils were not analyzed for iron.

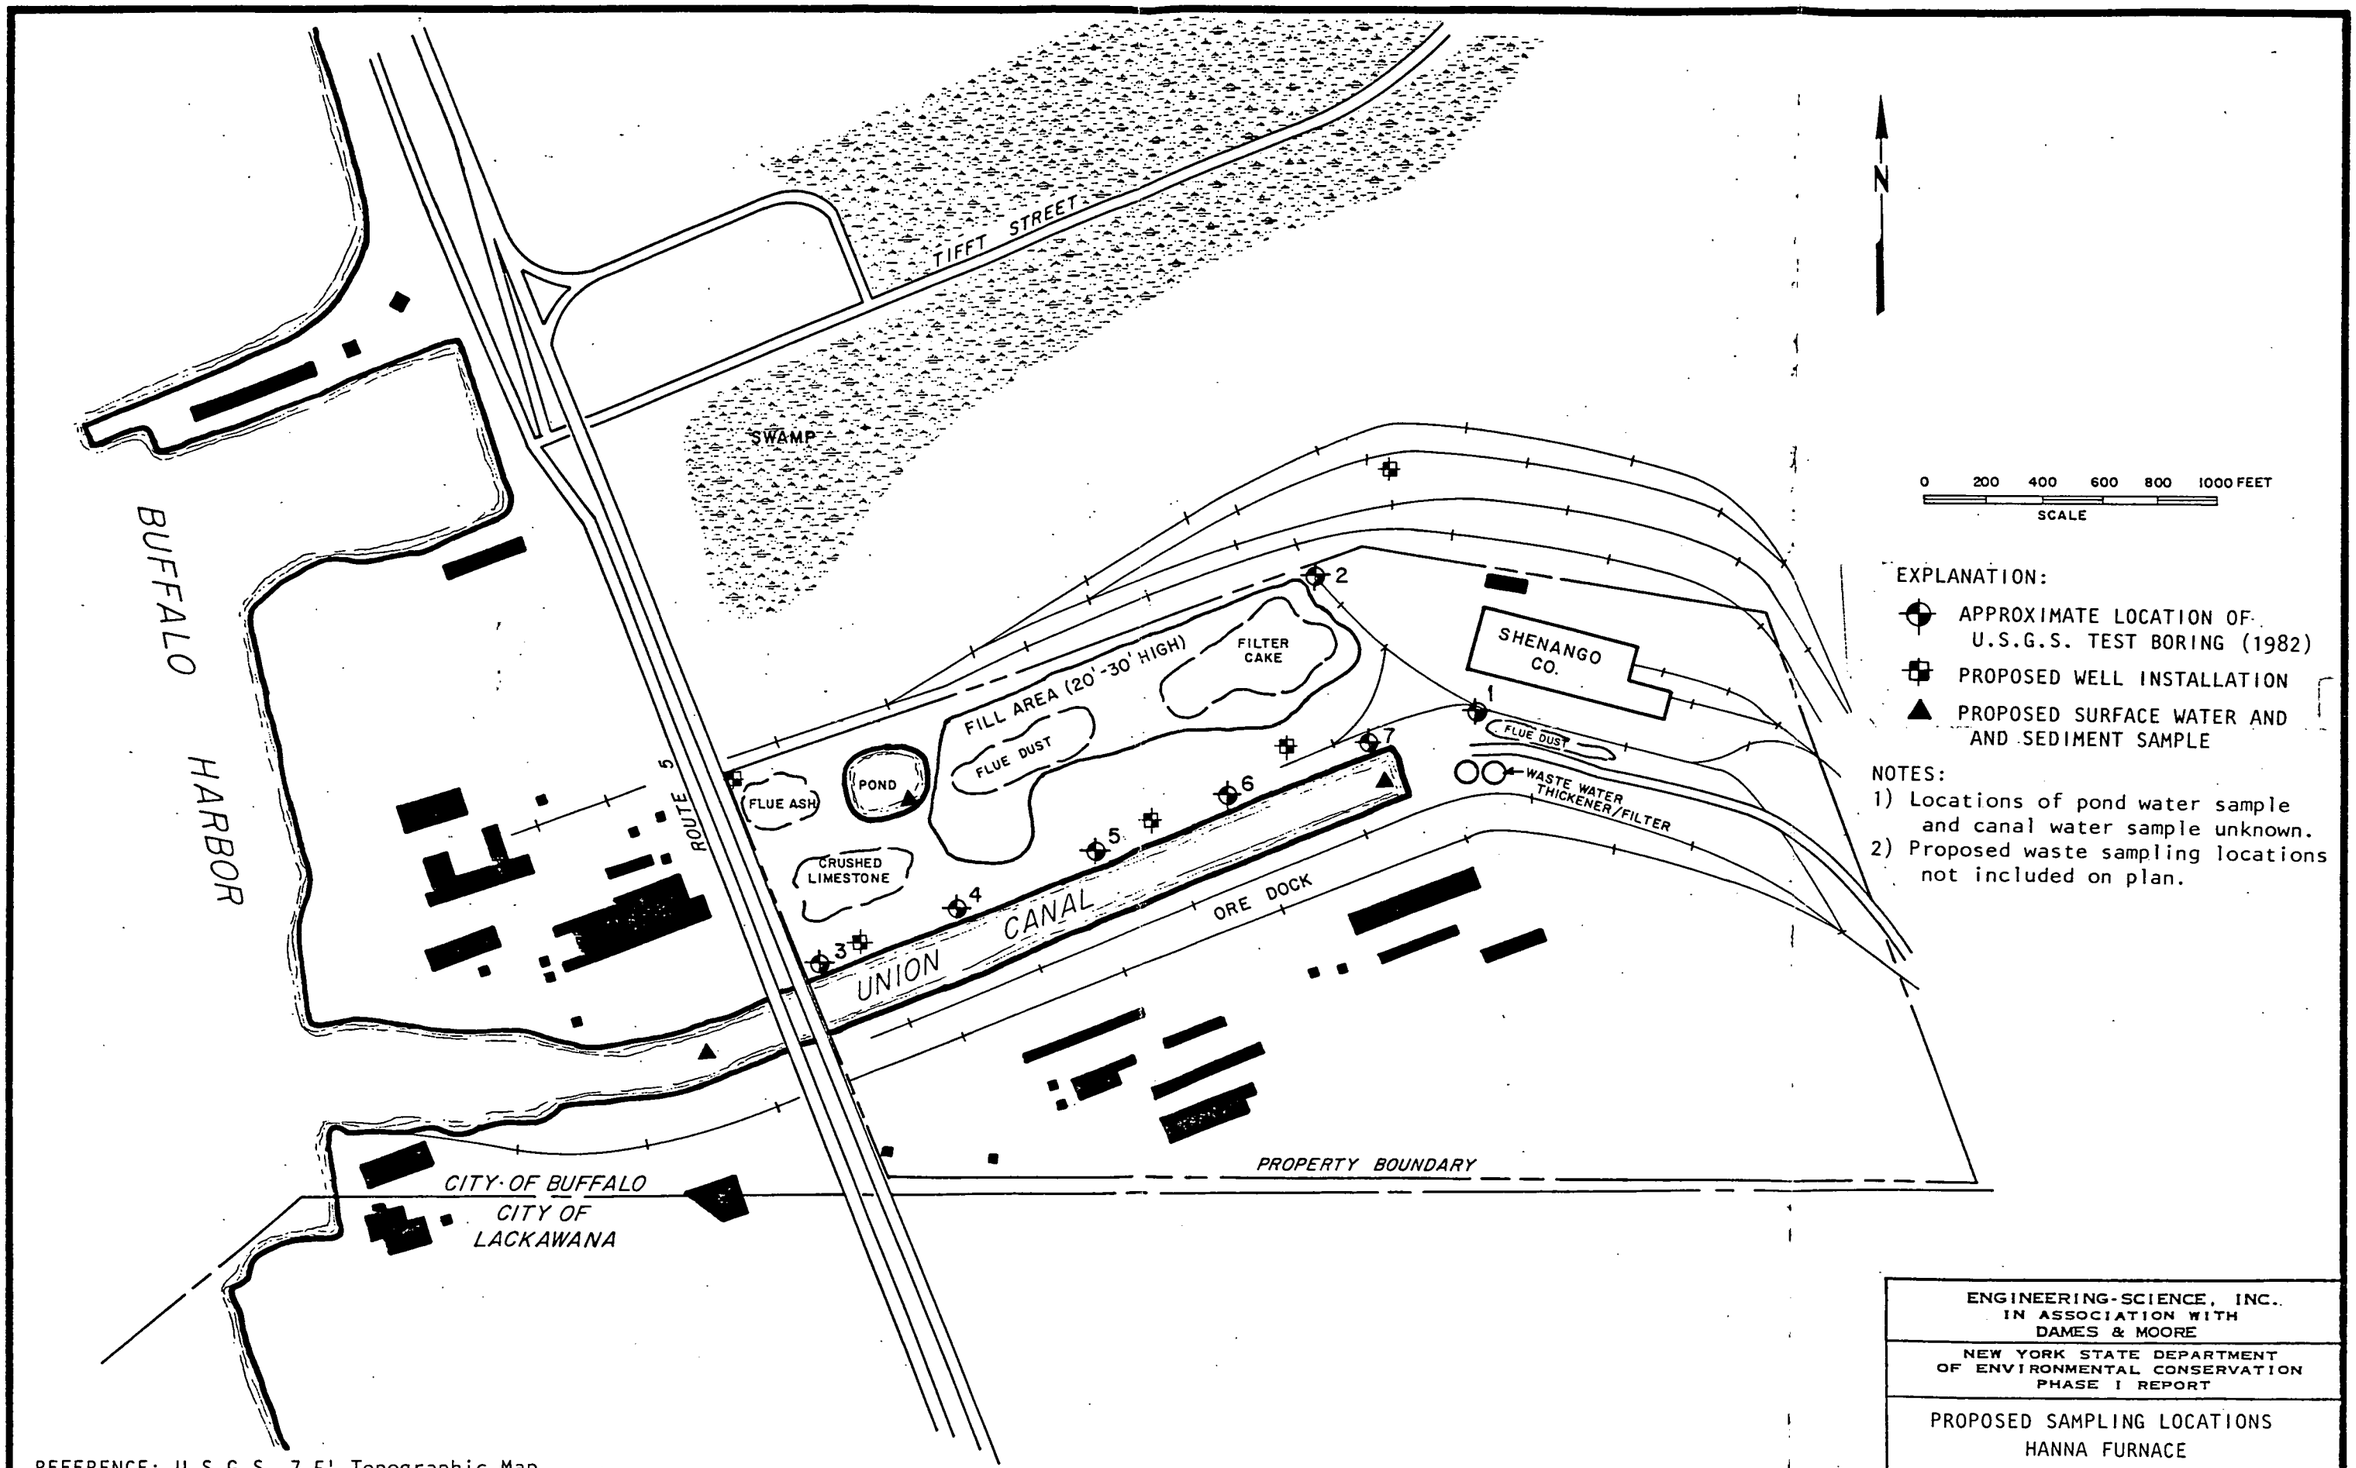
- APPROXIMATE LOCATION OF U.S.G.S. TEST BORING (1982)
- PROPOSED WELL INSTALLATION
- PROPOSED SURFACE WATER AND AND SEDIMENT SAMPLE

- Topographic survey to estimate volume of wastes on-site.
