NYSDEC Site Number V-00463-9 Periodic Review Report
2017 Calendar Year
Former Gowanda Day Habilitation Center, Gowanda, New York

2017 PERIODIC REVIEW REPORT

FORMER GOWANDA DAY HABILITATION CENTER

Issued: April 2018

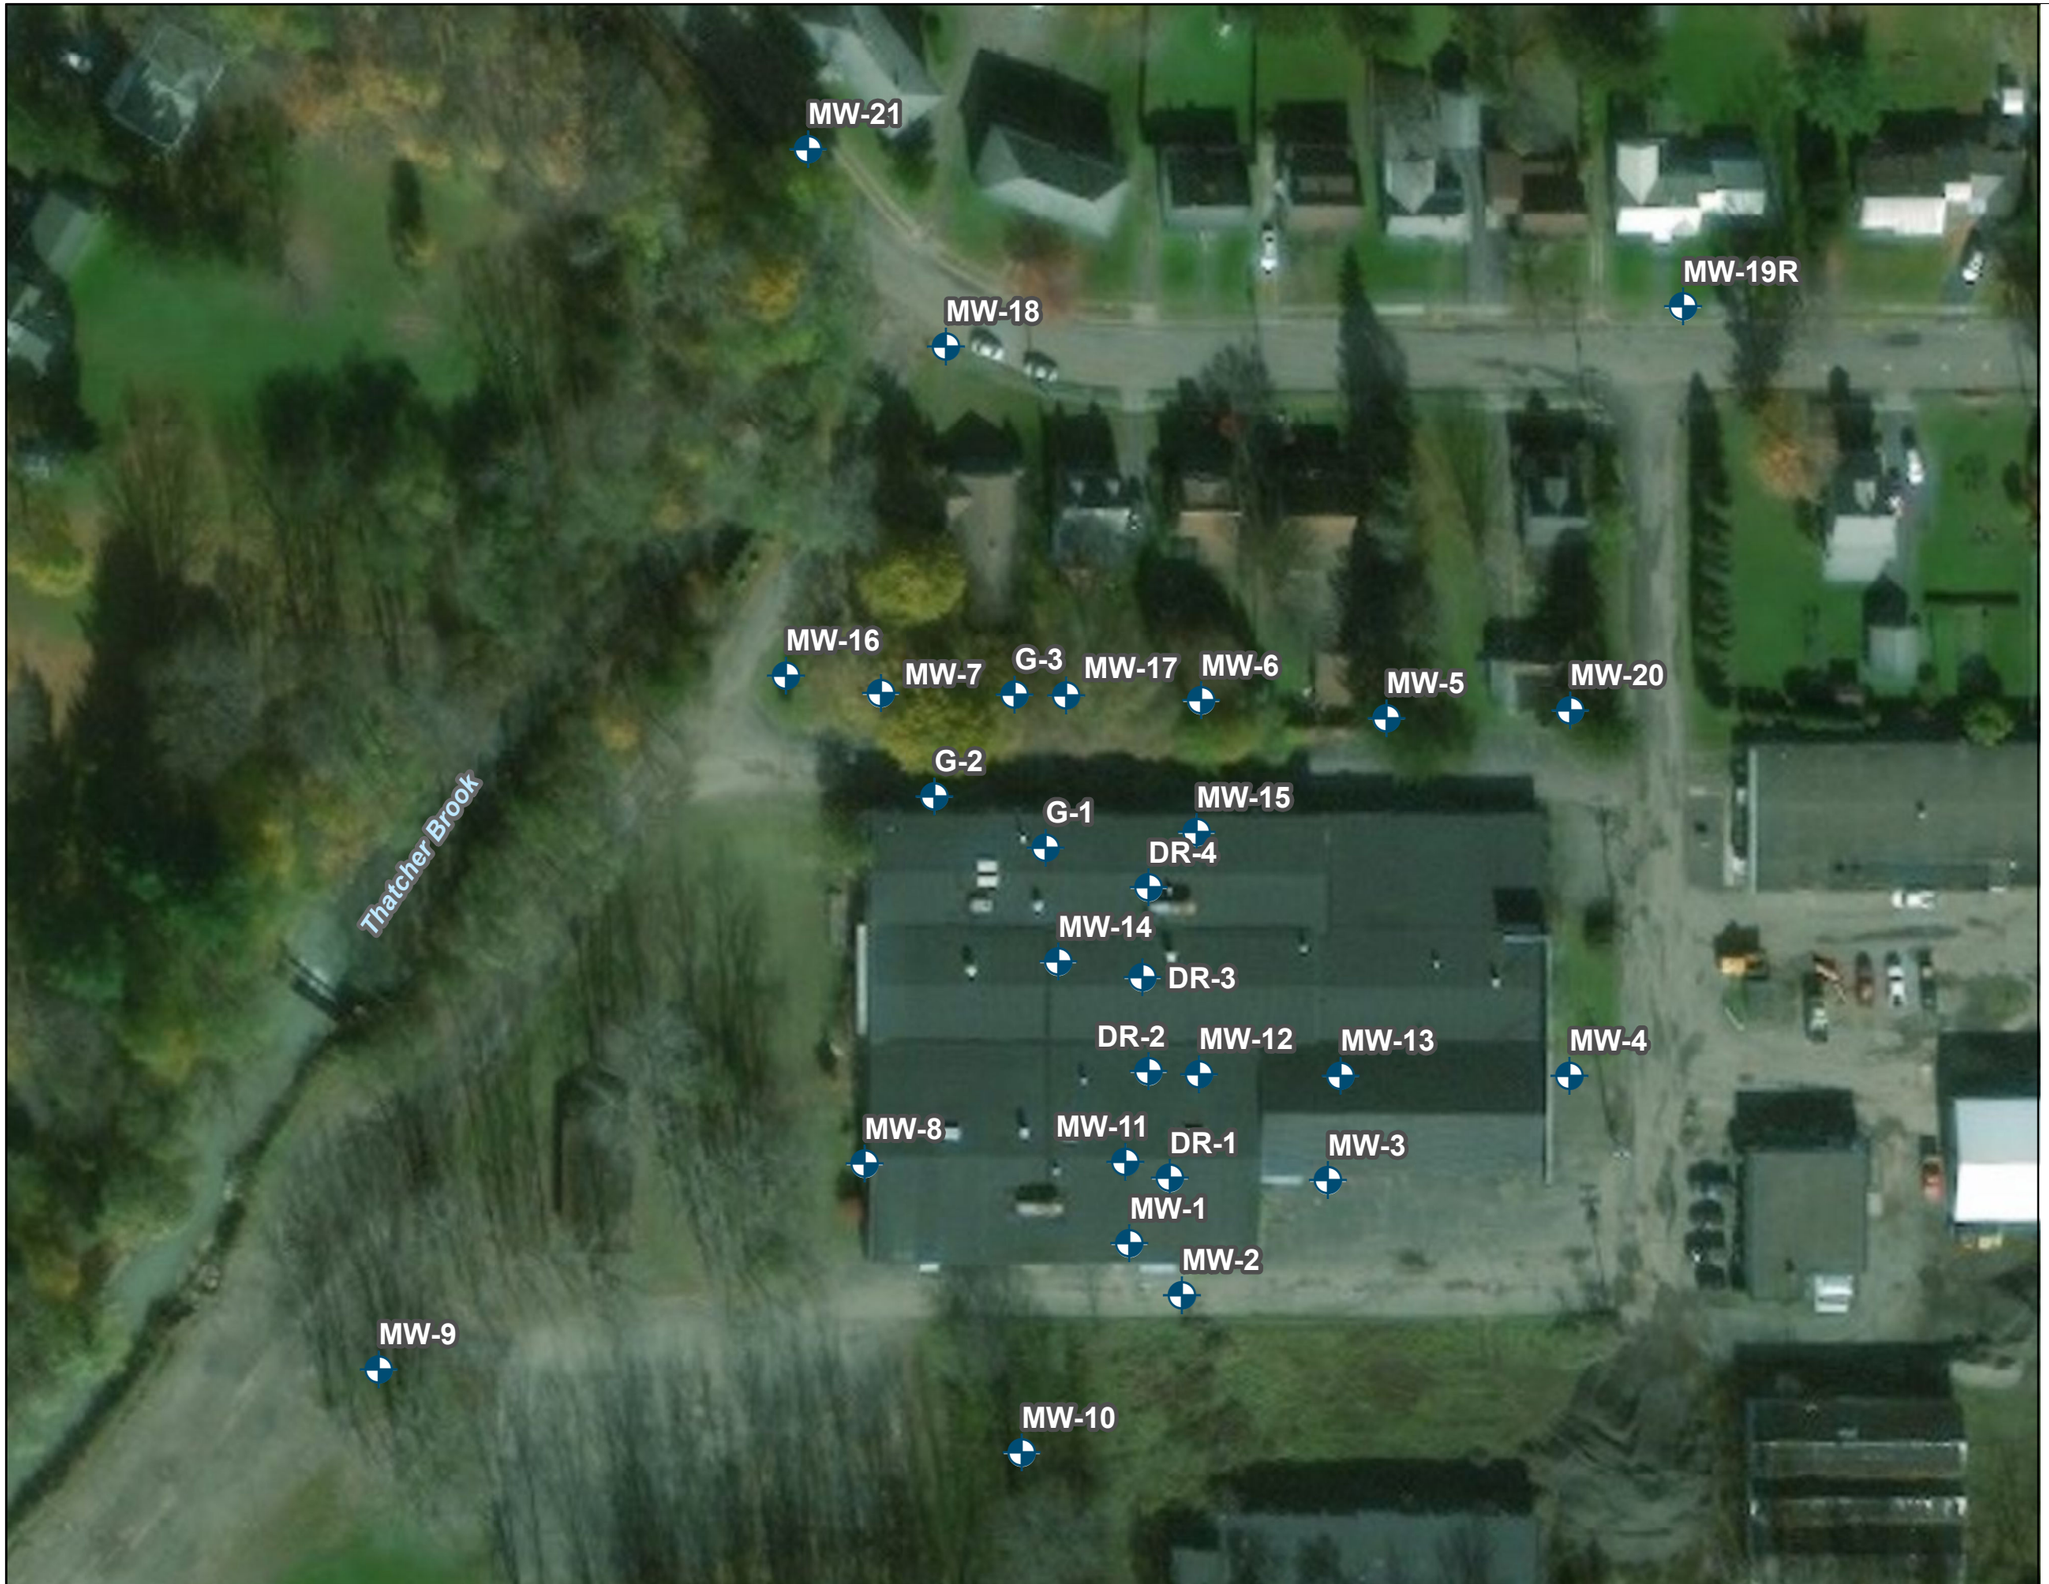
FIGURE 1

The August 2017 groundwater contour map shows a flow pattern similar to groundwater contours observed historically since 2002. Groundwater at the Site is flowing in a northerly direction. Torrance Place is hydraulically down-gradient from the Day Habilitation Center building. The August 2017 depths

Measured depth to water at all gauged monitoring and recovery wells is presented Table 1 and August 2017 Groundwater Contours are presented on Figure 1 – August 2017 Groundwater Contour Map.

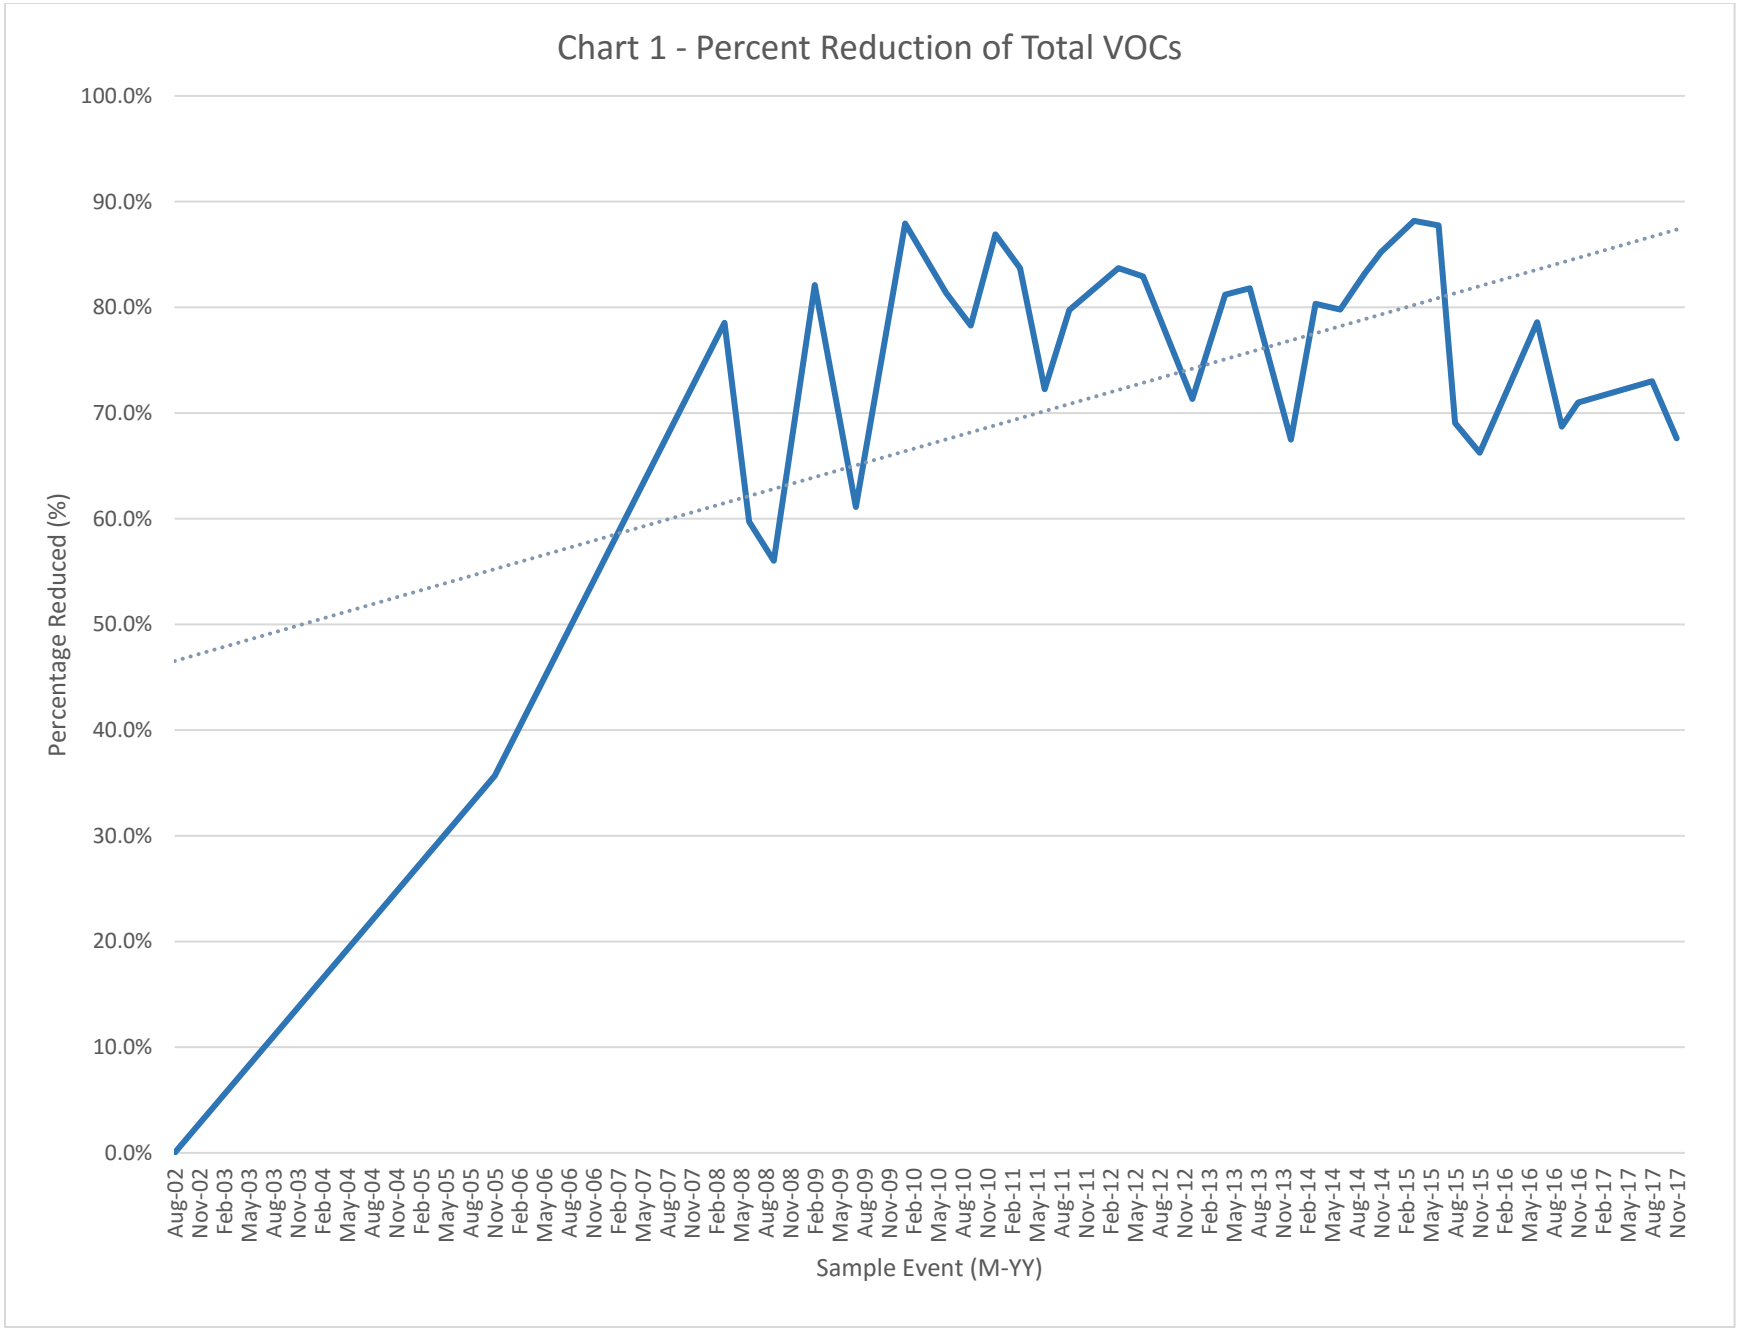
CHART 1

†Negative values indicate an increase in total VOCs since monitoring commenced in 2002. The percent increase in total groundwater VOCs is shown above for MW-1 and DR-3.

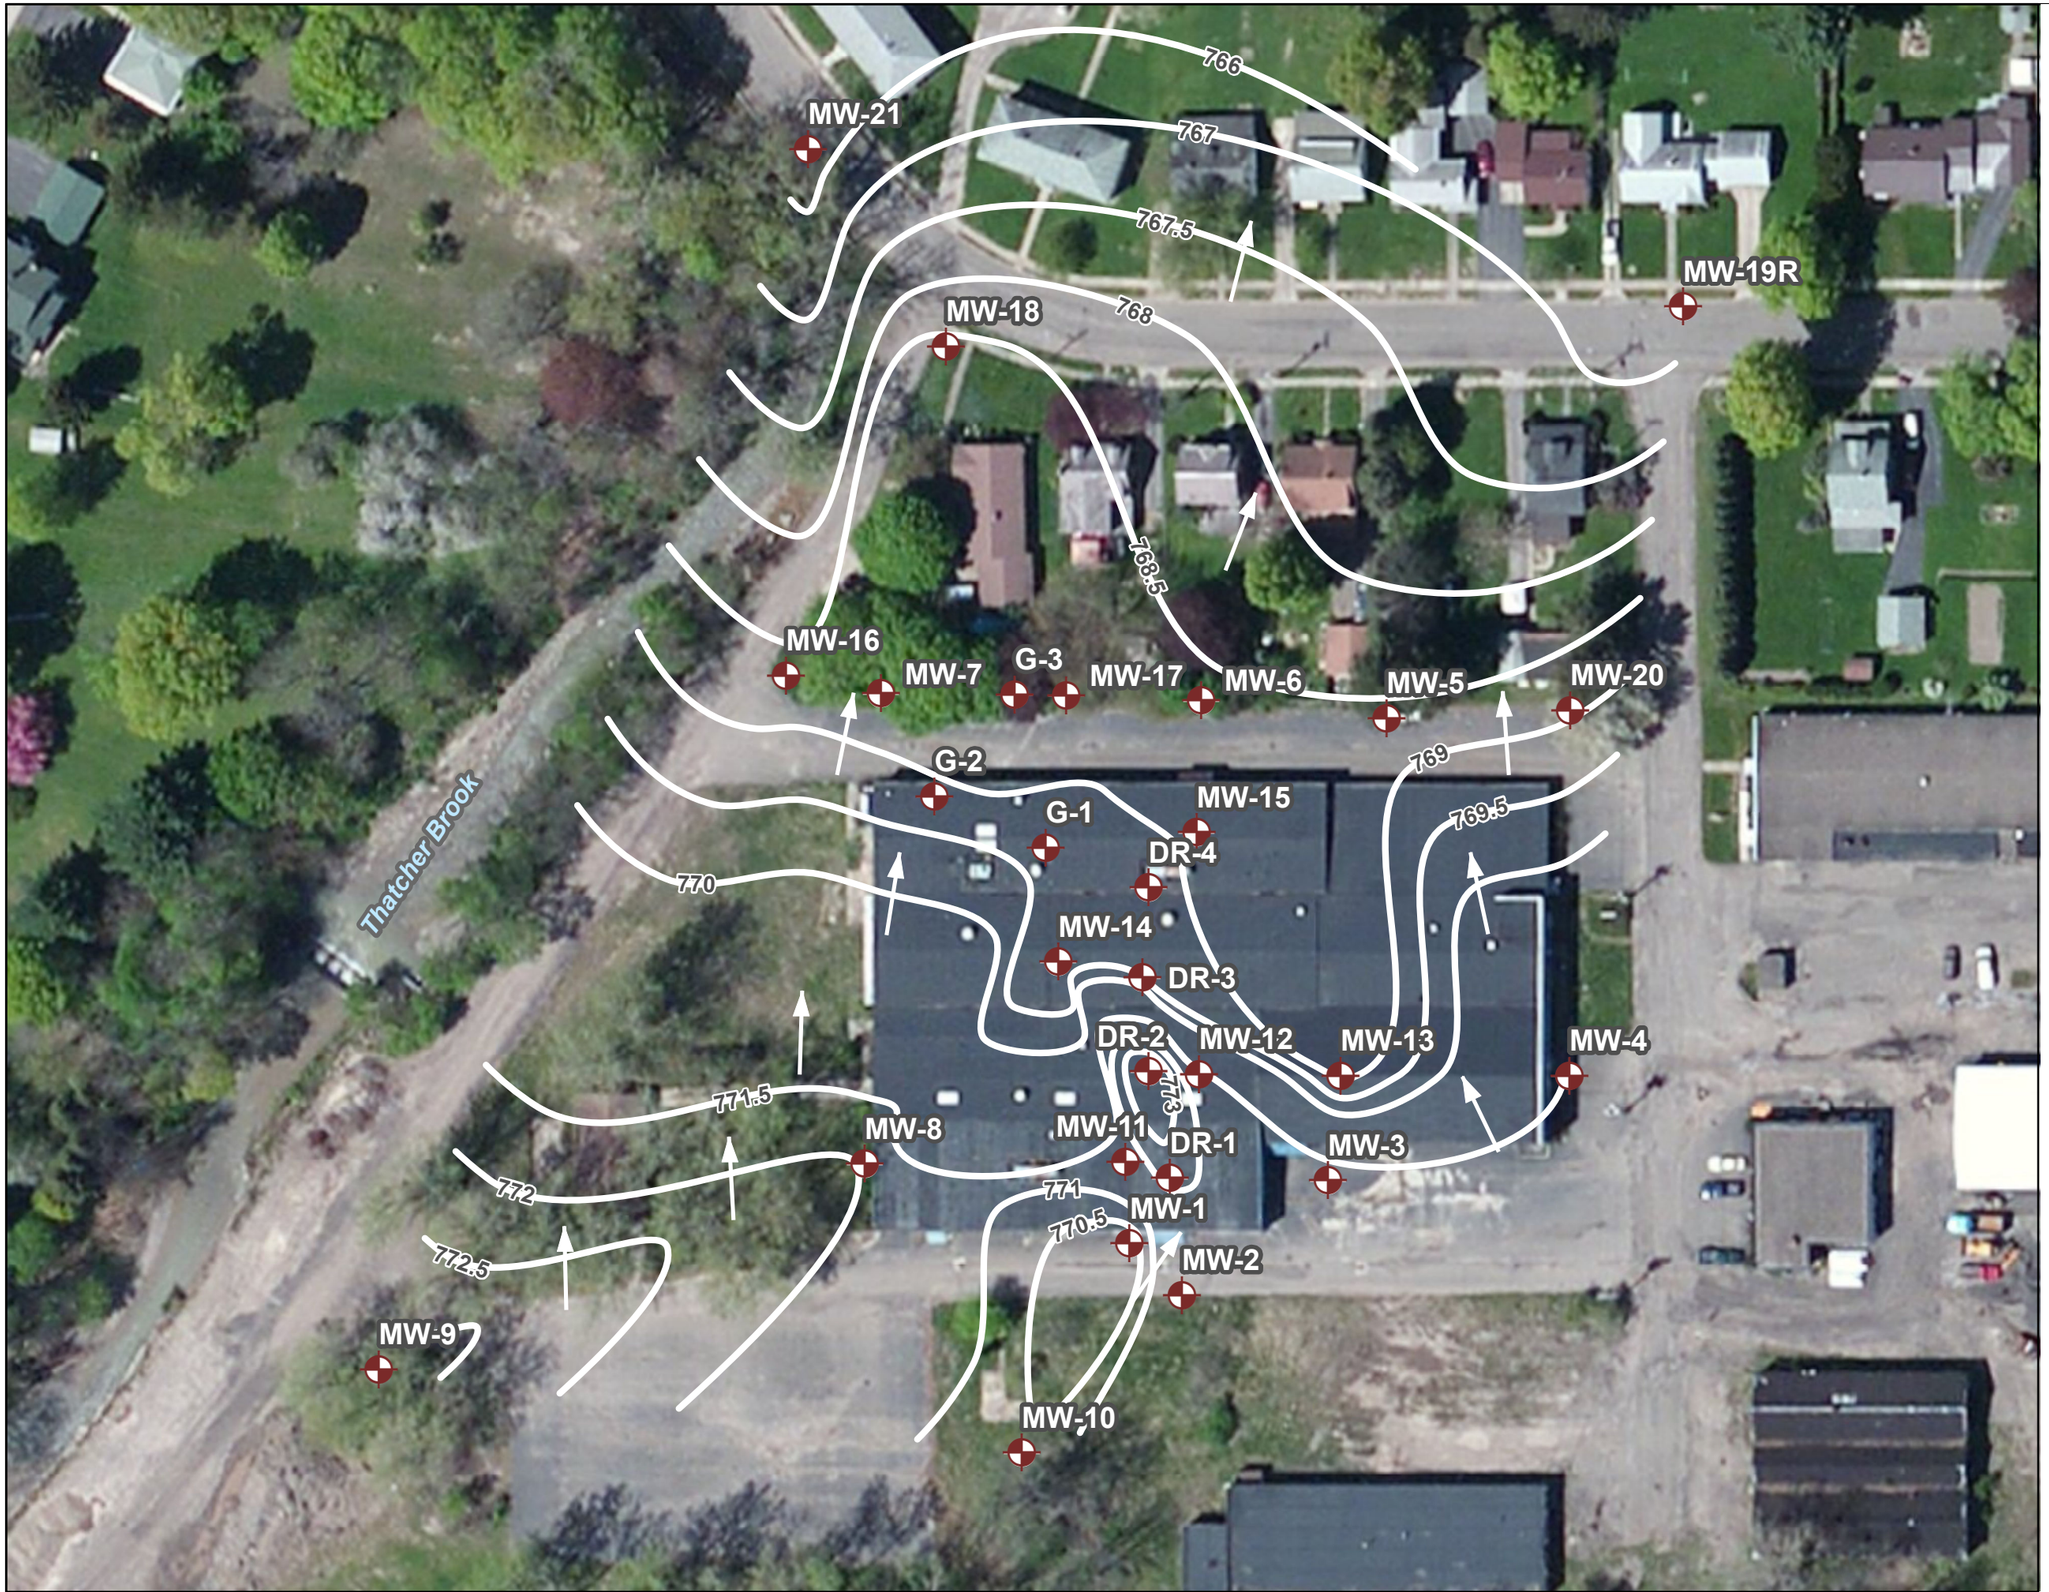
Figure 1

August 2017 Groundwater Contour Map

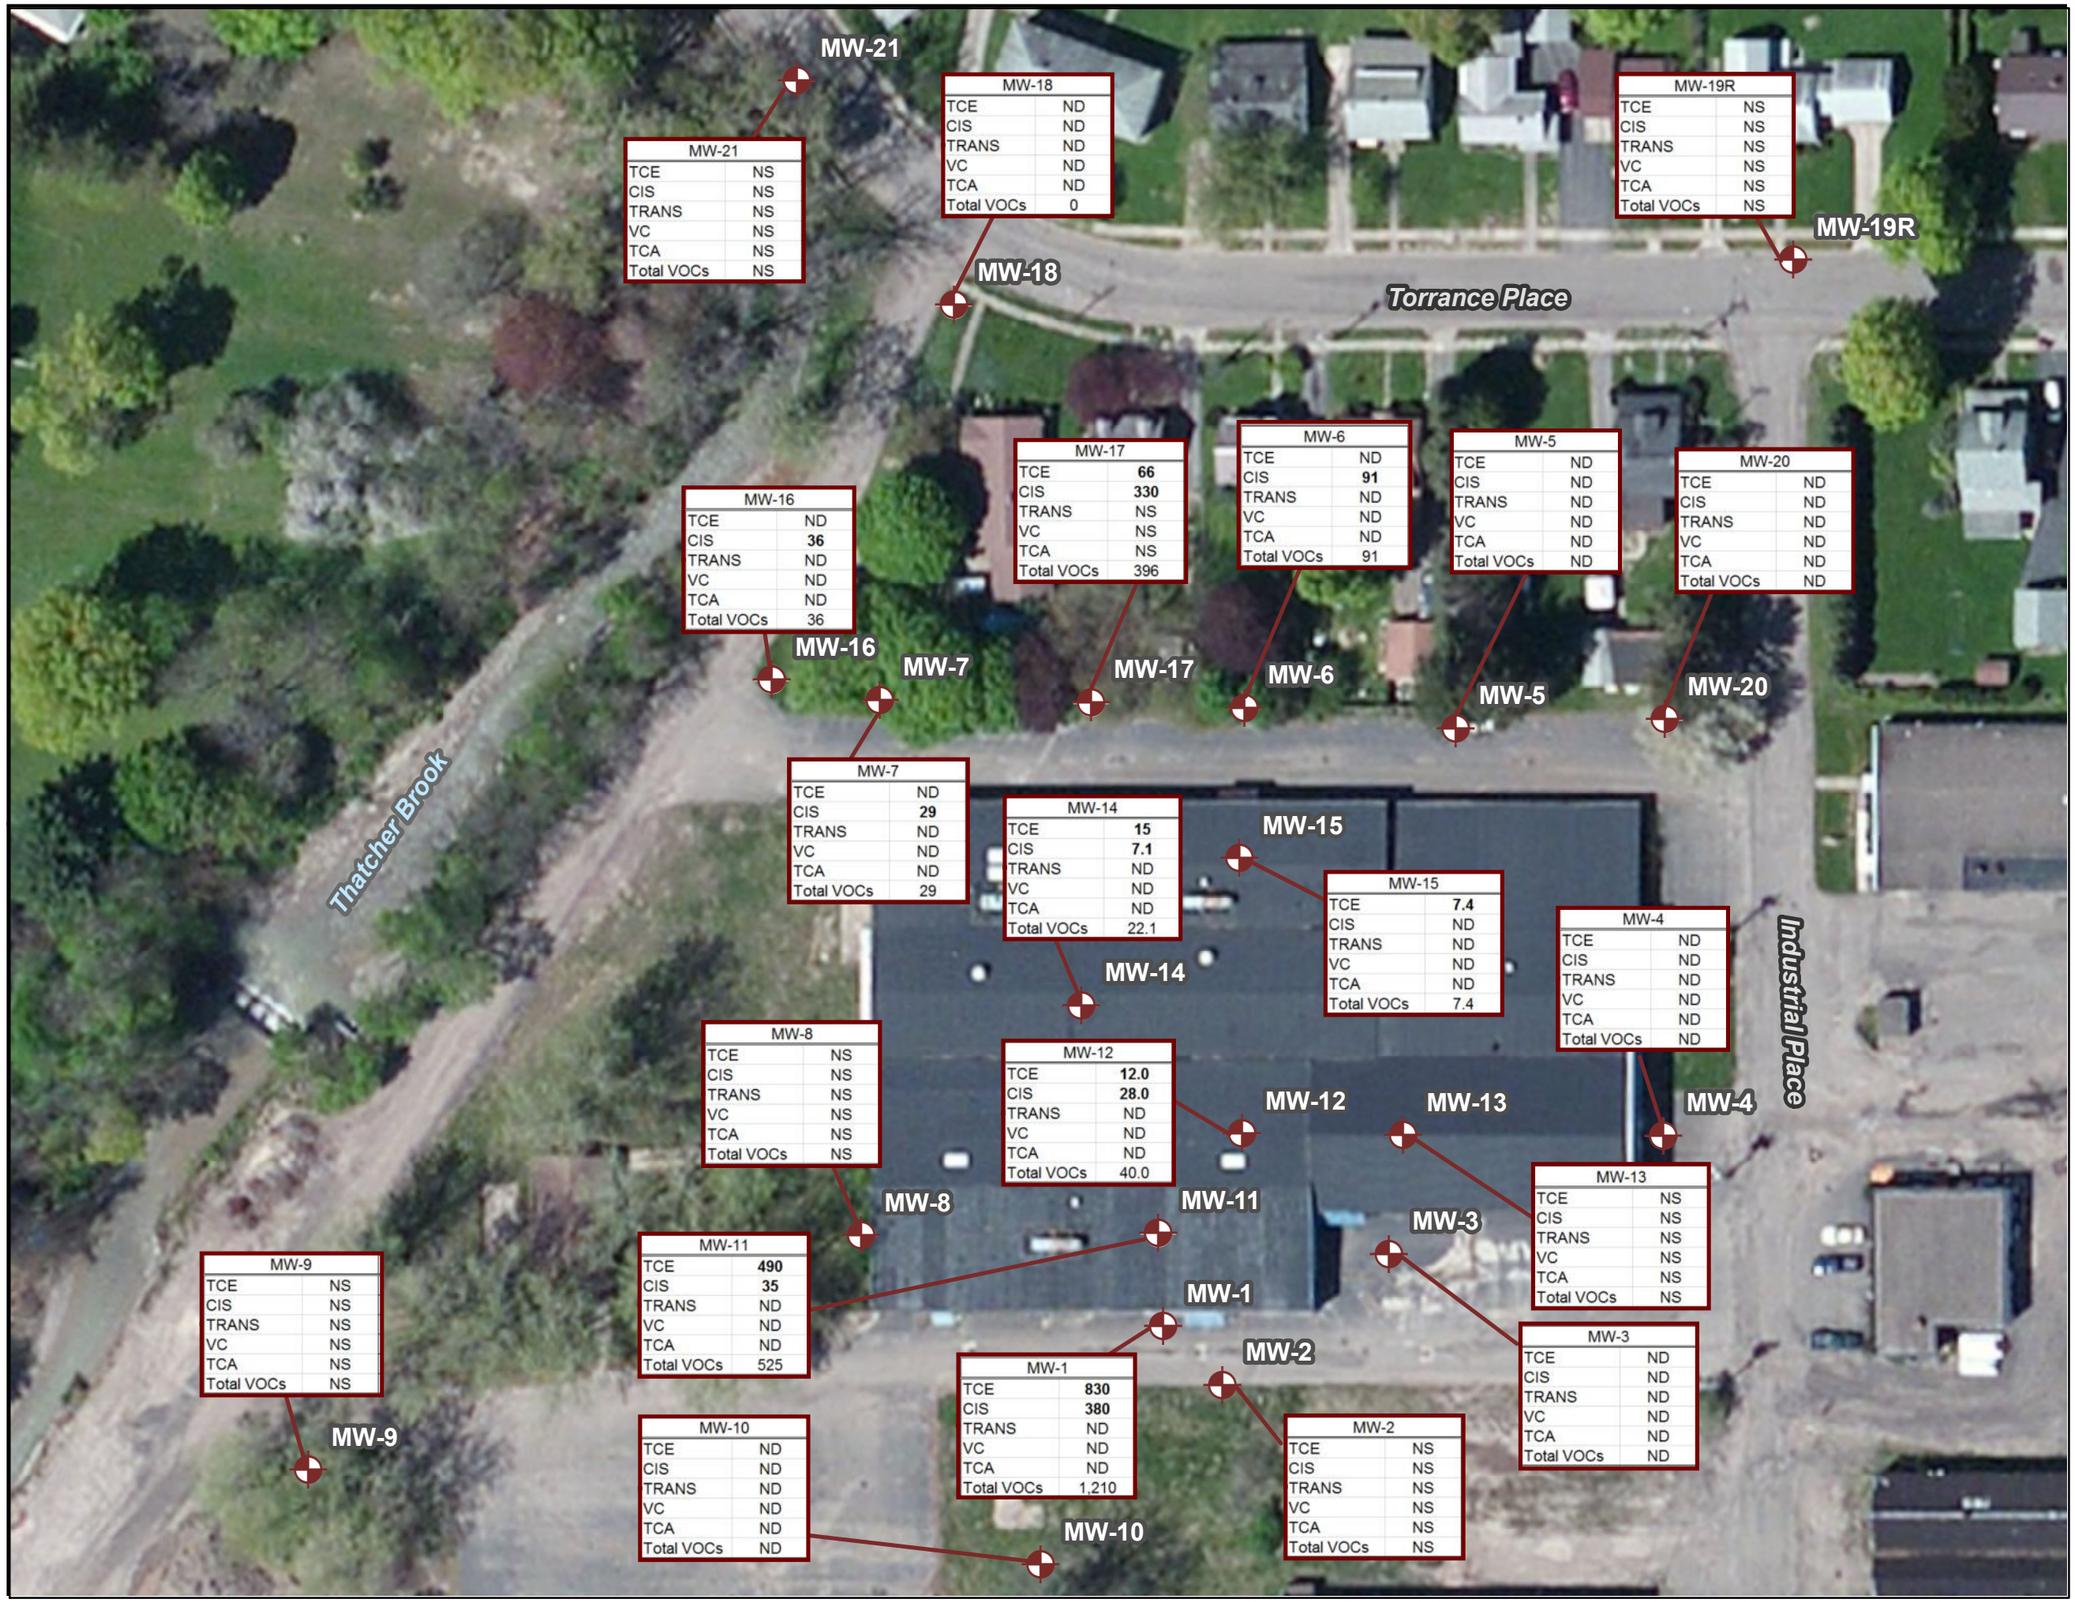
Figure 2

Monitoring wells MW-18, MW-19R and MW-21 are located off-site along Torrance Place. These three wells are considered to be beyond the radius of influence for the Day Habilitation groundwater treatment system. The current results indicate non-detect for MW-18. Monitoring well MW-21 was added to the sampling list at the request of the NYSDEC beginning with the June 2015 sampling event. At the time of the August 2017 sampling event, wells MW-19R and MW-21 were not sampled because they were inaccessible. It was observed that the wells were likely paved over by a recent re-sealing operation.

August 2017 Distribution of Groundwater Analytical Results: Monitoring Wells

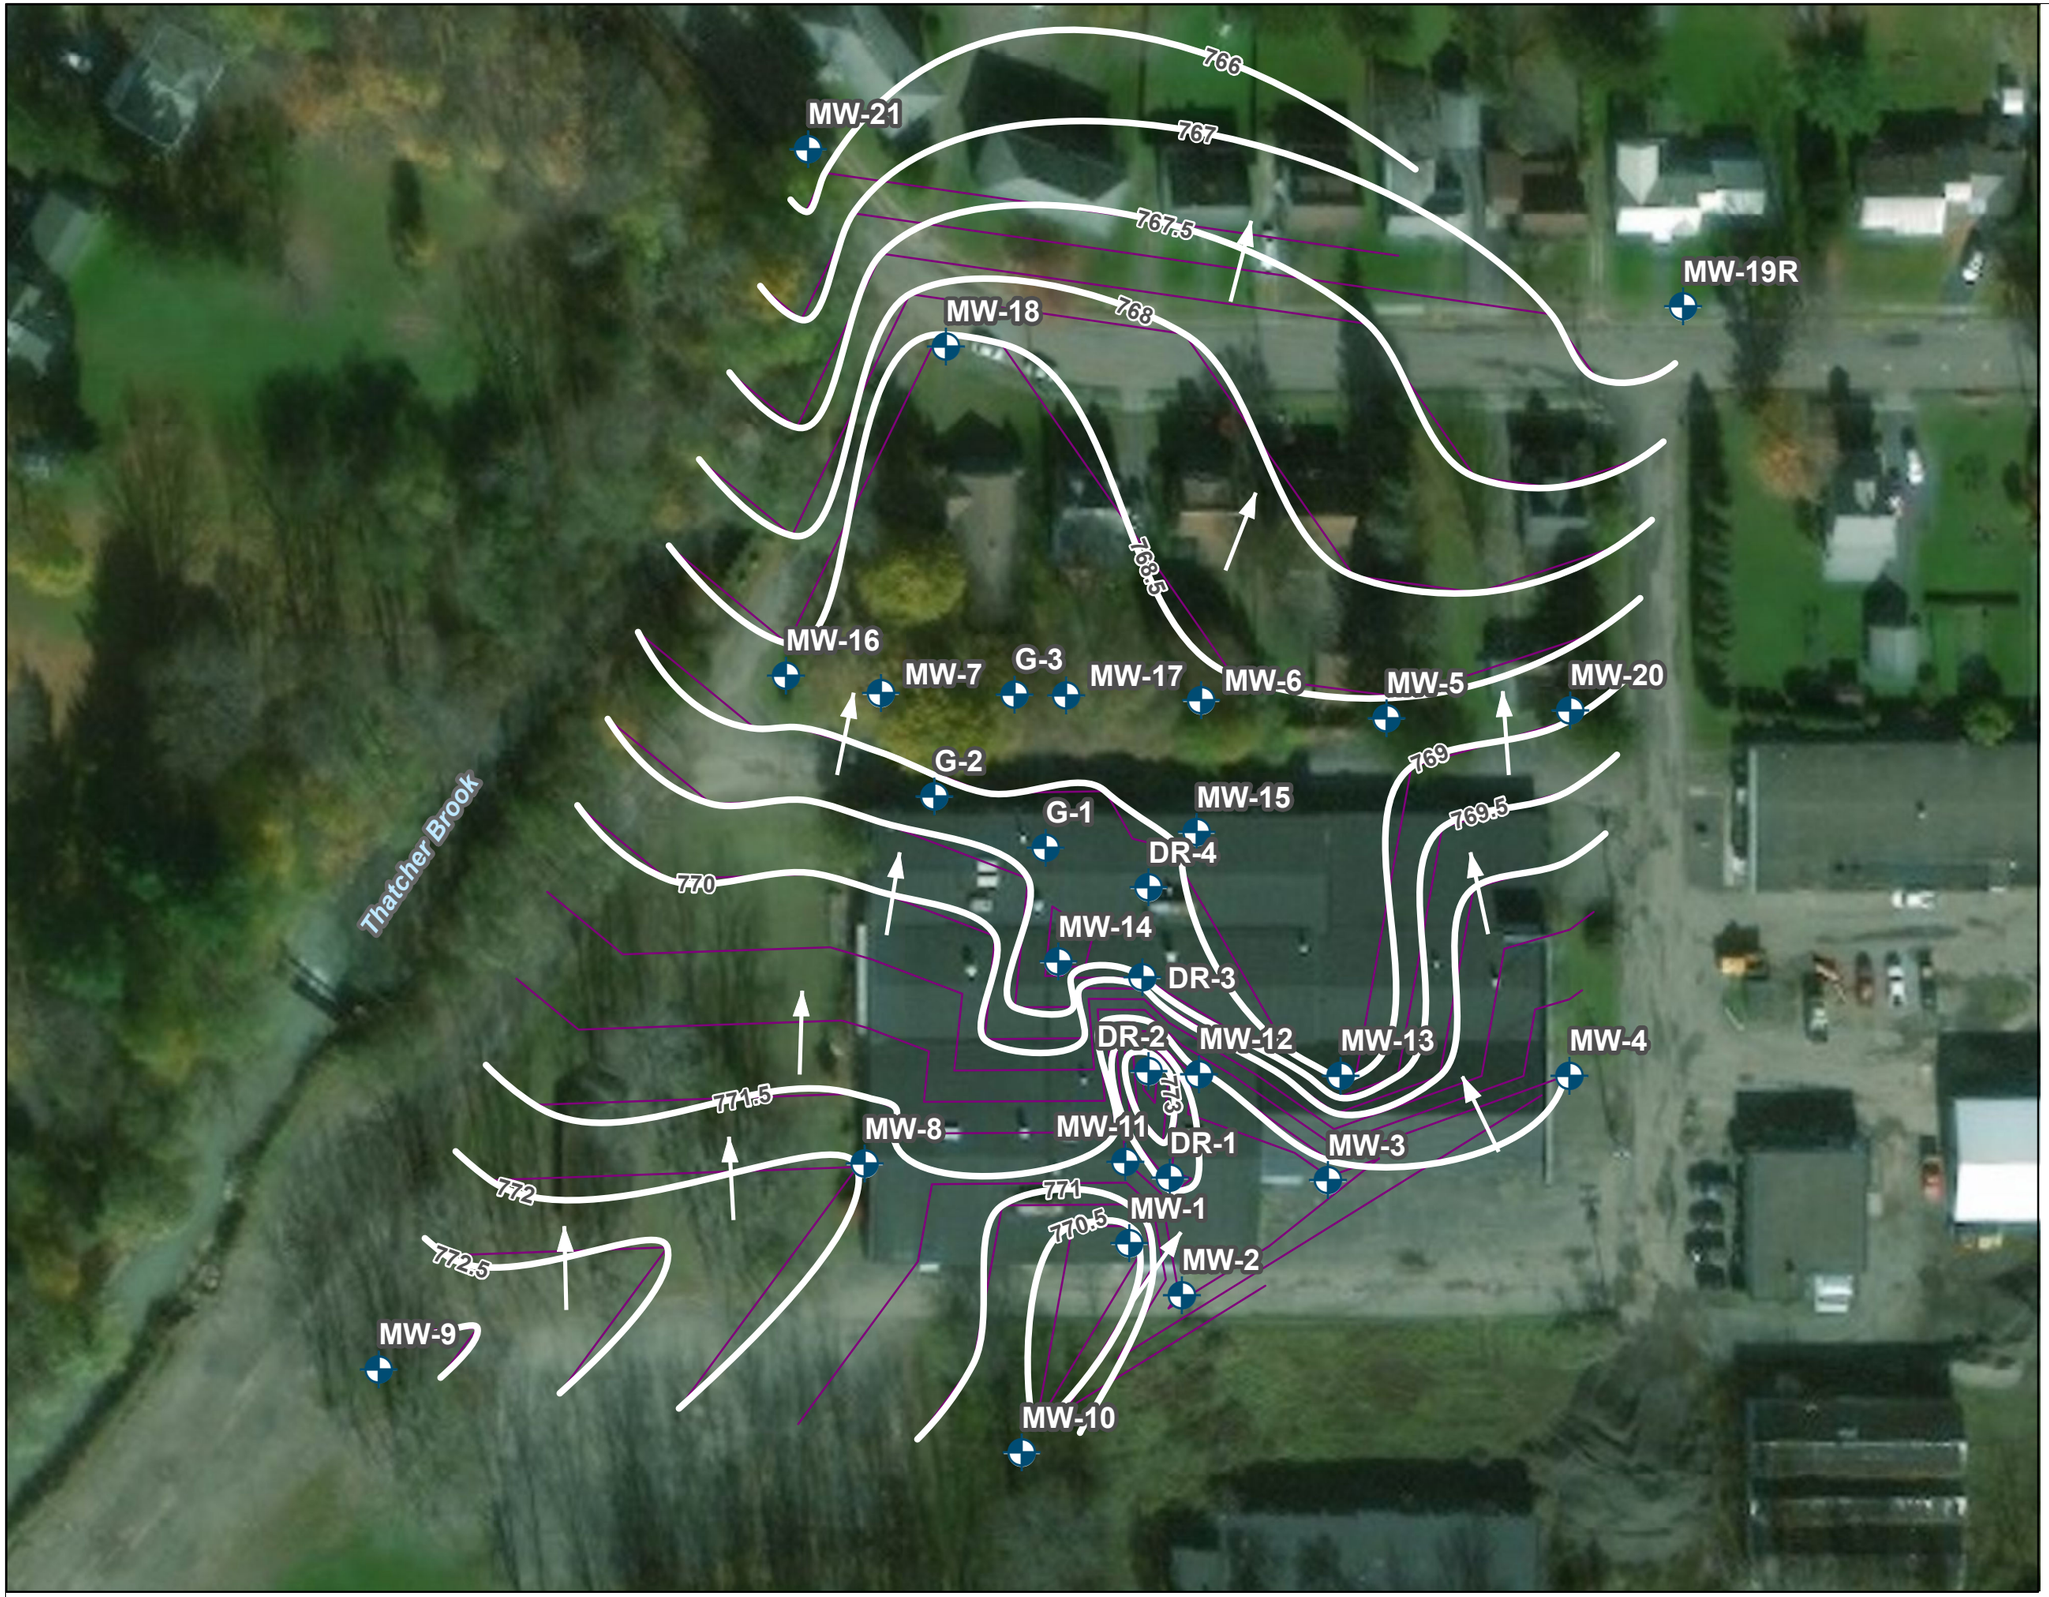
Measured depth to water at all gauged monitoring and recovery wells is presented Table 1 and November 2017 Groundwater Contours are presented on Figure 1 – November 2017 Water-level Contour Map.
