Subject: Groundwater Monitoring Results
Leica, Inc. Site; Erie County, Cheektowaga, NY
Inactive Hazardous Waste Disposal Site No. 915156

Rowan Road Groundwater Investigation Report
Leica, Area C, Cheektowaga, New York

Project No. LE-0614

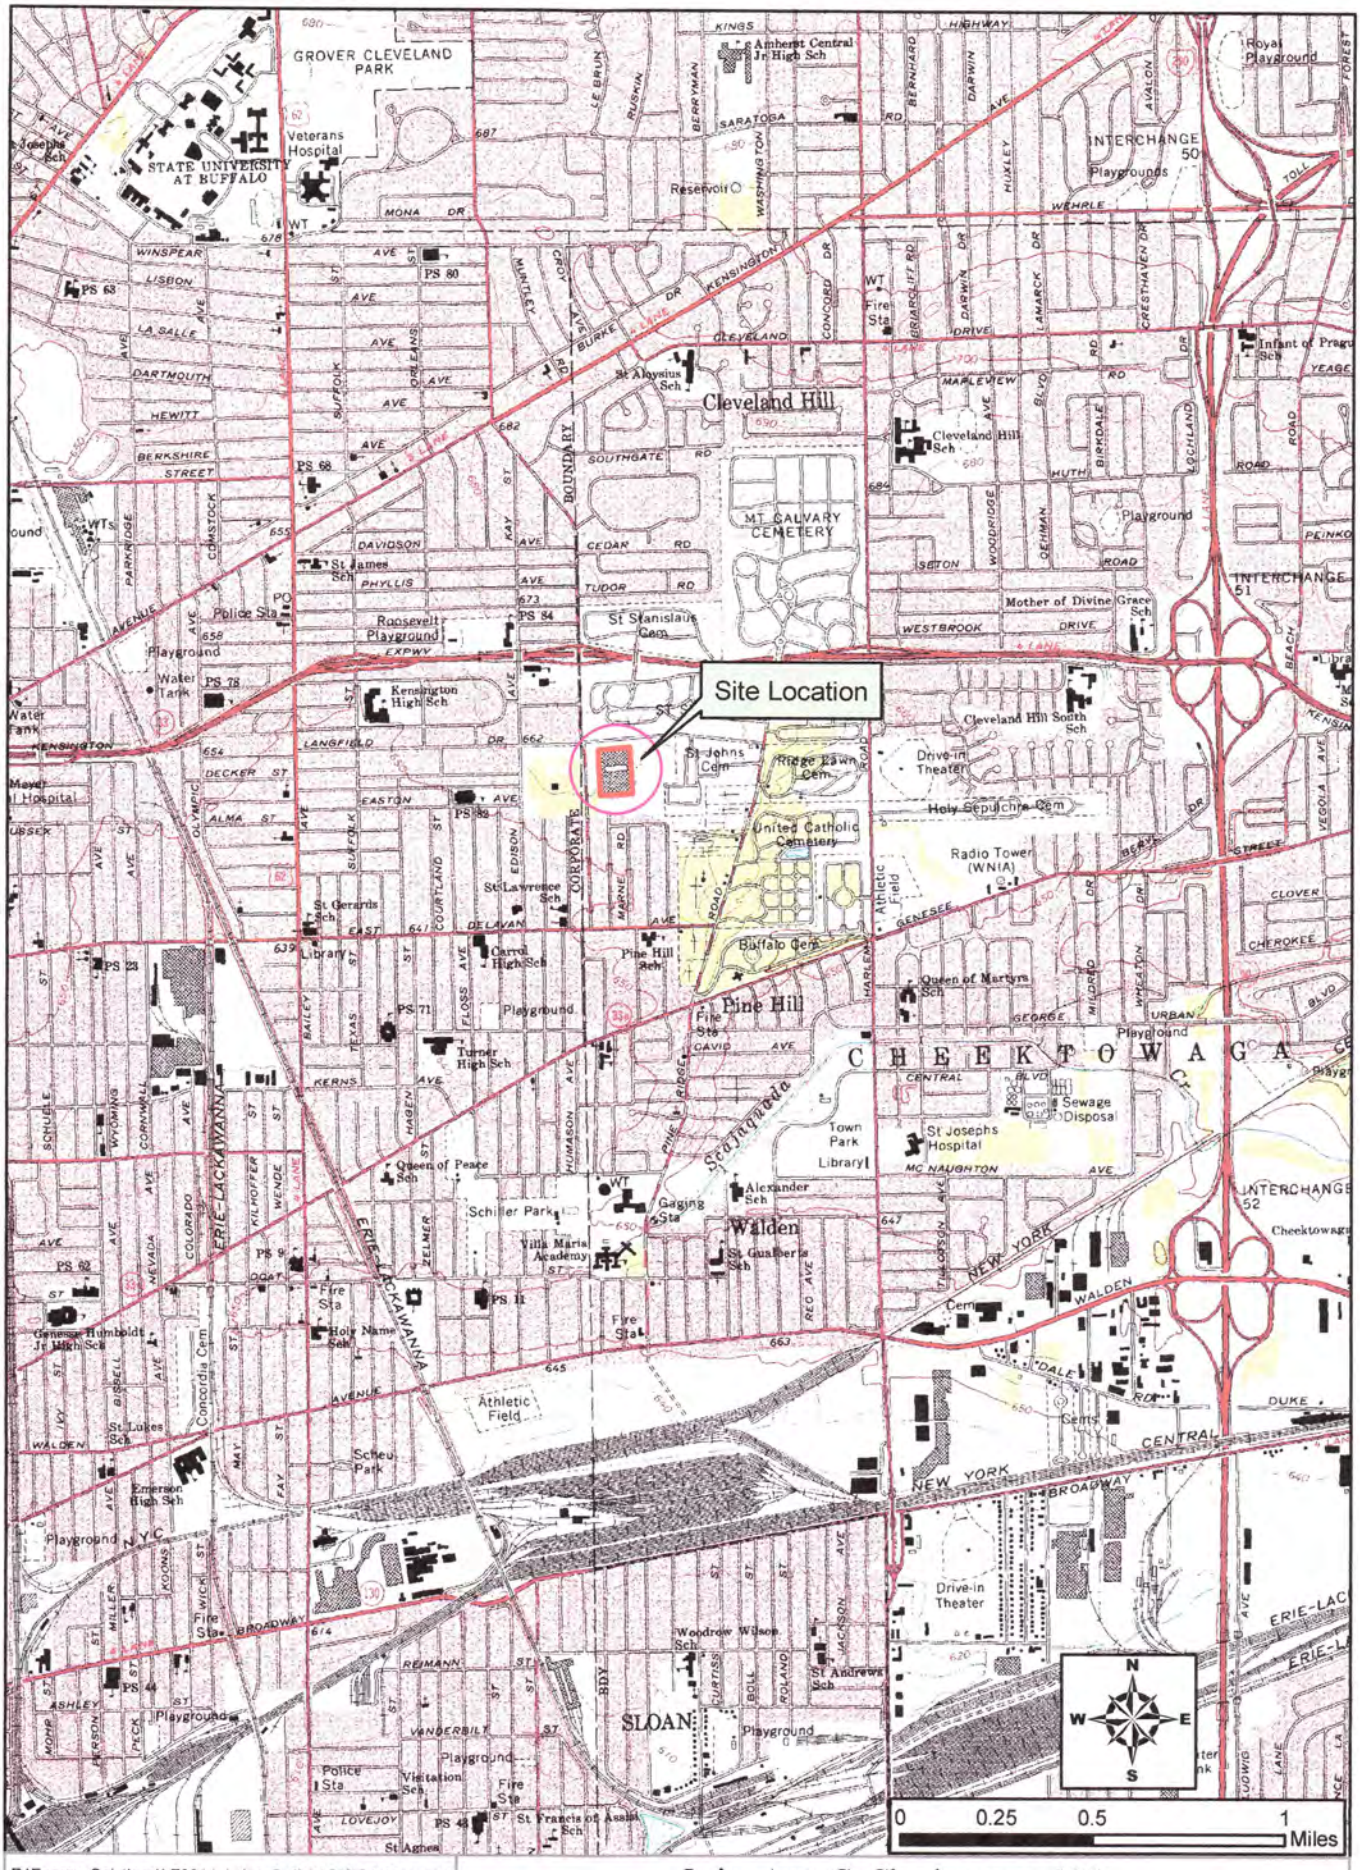
Figure 1
LE-0614

This report presents the results of a limited offsite groundwater investigation that was performed in conjunction with an offsite vapor intrusion assessment adjacent to Area C of the former Leica facility in Cheektowaga, New York (the Site), as shown in Figures 1 and 2. The investigation was conducted by EnviroGroup Limited (EnviroGroup) personnel on behalf of Energy*Solutions*.

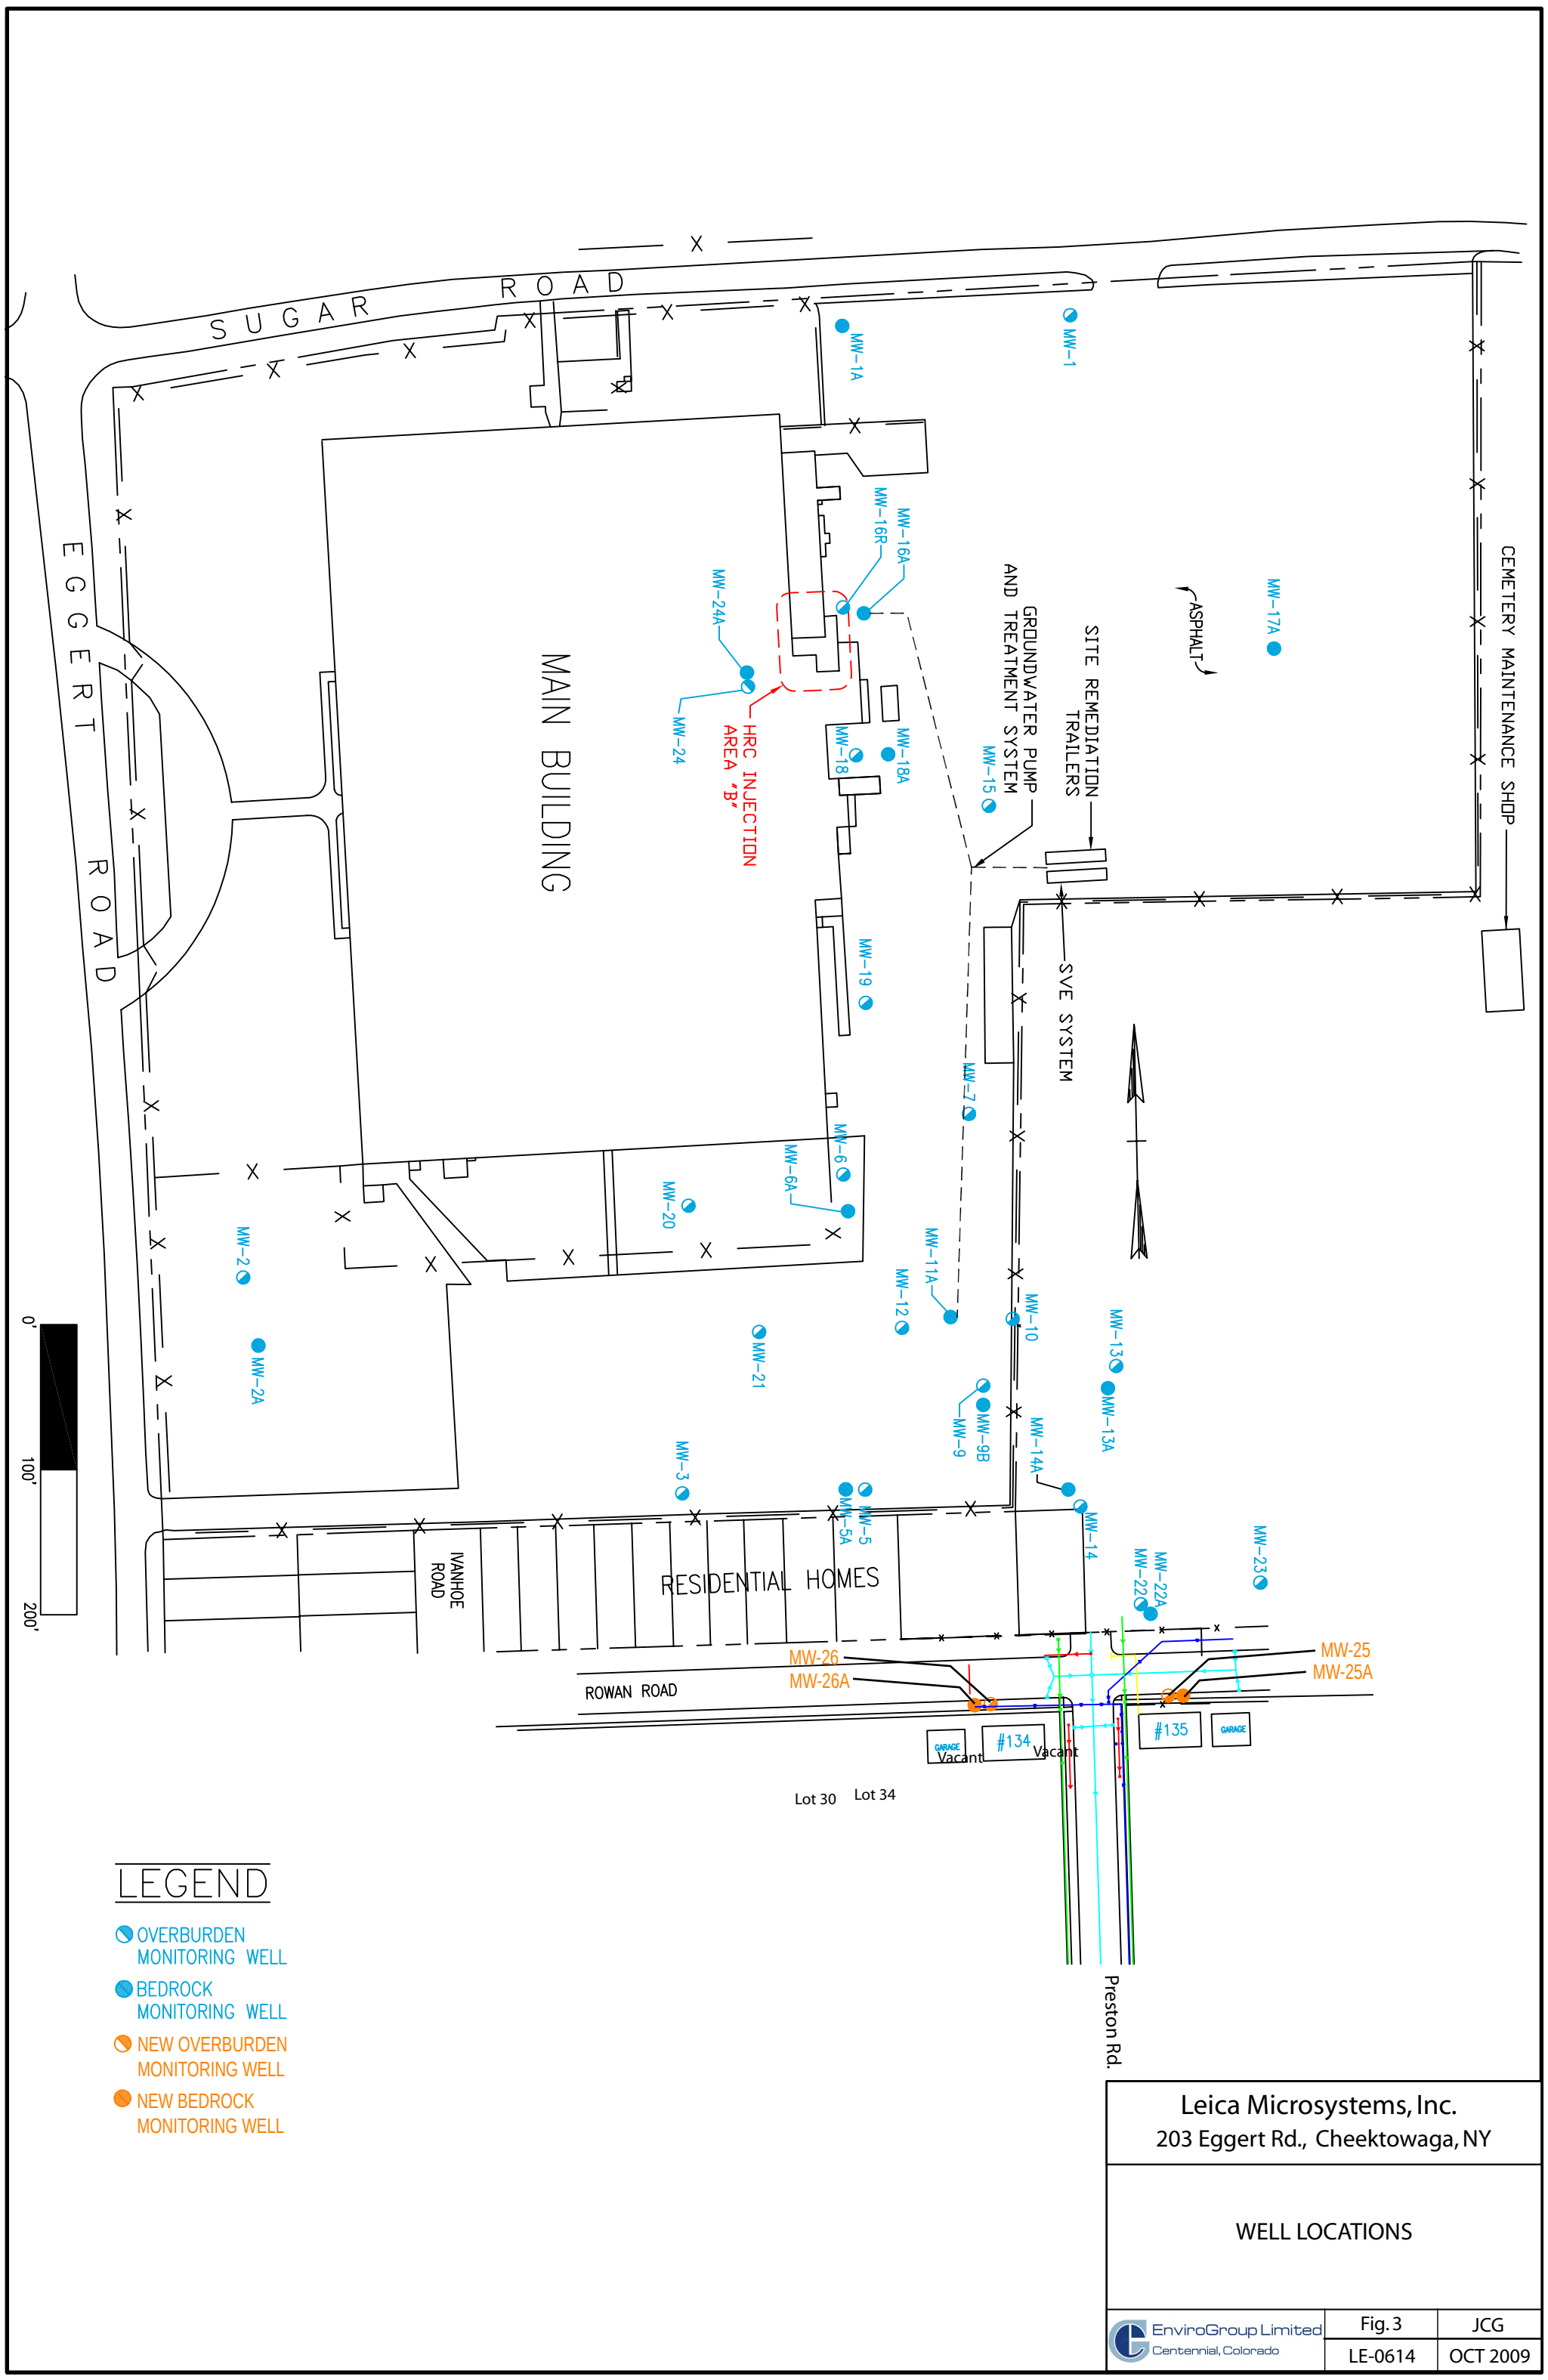
EnviroGroup Limited, Centennial, Colorado	Fig. 3	JCG
	LE-0614	OCT 2009

This section presents a description of the field investigations and laboratory procedures followed by EnviroGroup. Field activities included installation and sampling of two overburden monitoring wells (MW-25 & MW-26) and two shallow bedrock monitoring wells (MW-25A & MW-26A). The locations of these new monitoring wells are shown in Figure 3.

Two overburden monitoring wells (MW-25 and MW-26) were installed within the upper saturated section of each borehole at the locations shown on Figure 3. The screens for these wells were set at or near the water table with screened intervals of 5 feet to identify concentrations at the water table and evaluate any potential for vapor intrusion into nearby buildings**.**

Two bedrock wells (MW-25A and MW-26A) were installed at the locations shown in Figure 3. As noted above, the overburden was sealed off from the bedrock using grouted in place 4-inch ID steel casing. A bedrock open hole interval was then advanced from 16.5 to 35 feet BGS to be consistent with on-site bedrock well depths.

The results of this limited investigation indicate that VOCs from the Leica site may have migrated in bedrock groundwater to the locations of the MW-25 well pair, and in both shallow and bedrock groundwater to the location of the MW-26 well pair, on the south side of Rowan Road. The bedrock surface in the area of the MW-26 well pair was encountered deeper than has been observed at other locations during previous investigations by Energy*Solutions*. Although this deeper bedrock surface feature may be of significance to the migration of groundwater and VOCs from the site, the extent and actual relationship it may have to the Site contamination is unclear.
