Re: Supplemental Site Characterization Report
Former Nash Road Landfill
Town of Wheatfield
Niagara County, New York
NYSDEC Site # 932054

SUPPLEMENTAL SITE CHARACTERIZATION REPORT

Former Nash Road Landfill
Town of Wheatfield
Niagara County, New York
NYSDEC Site #932054

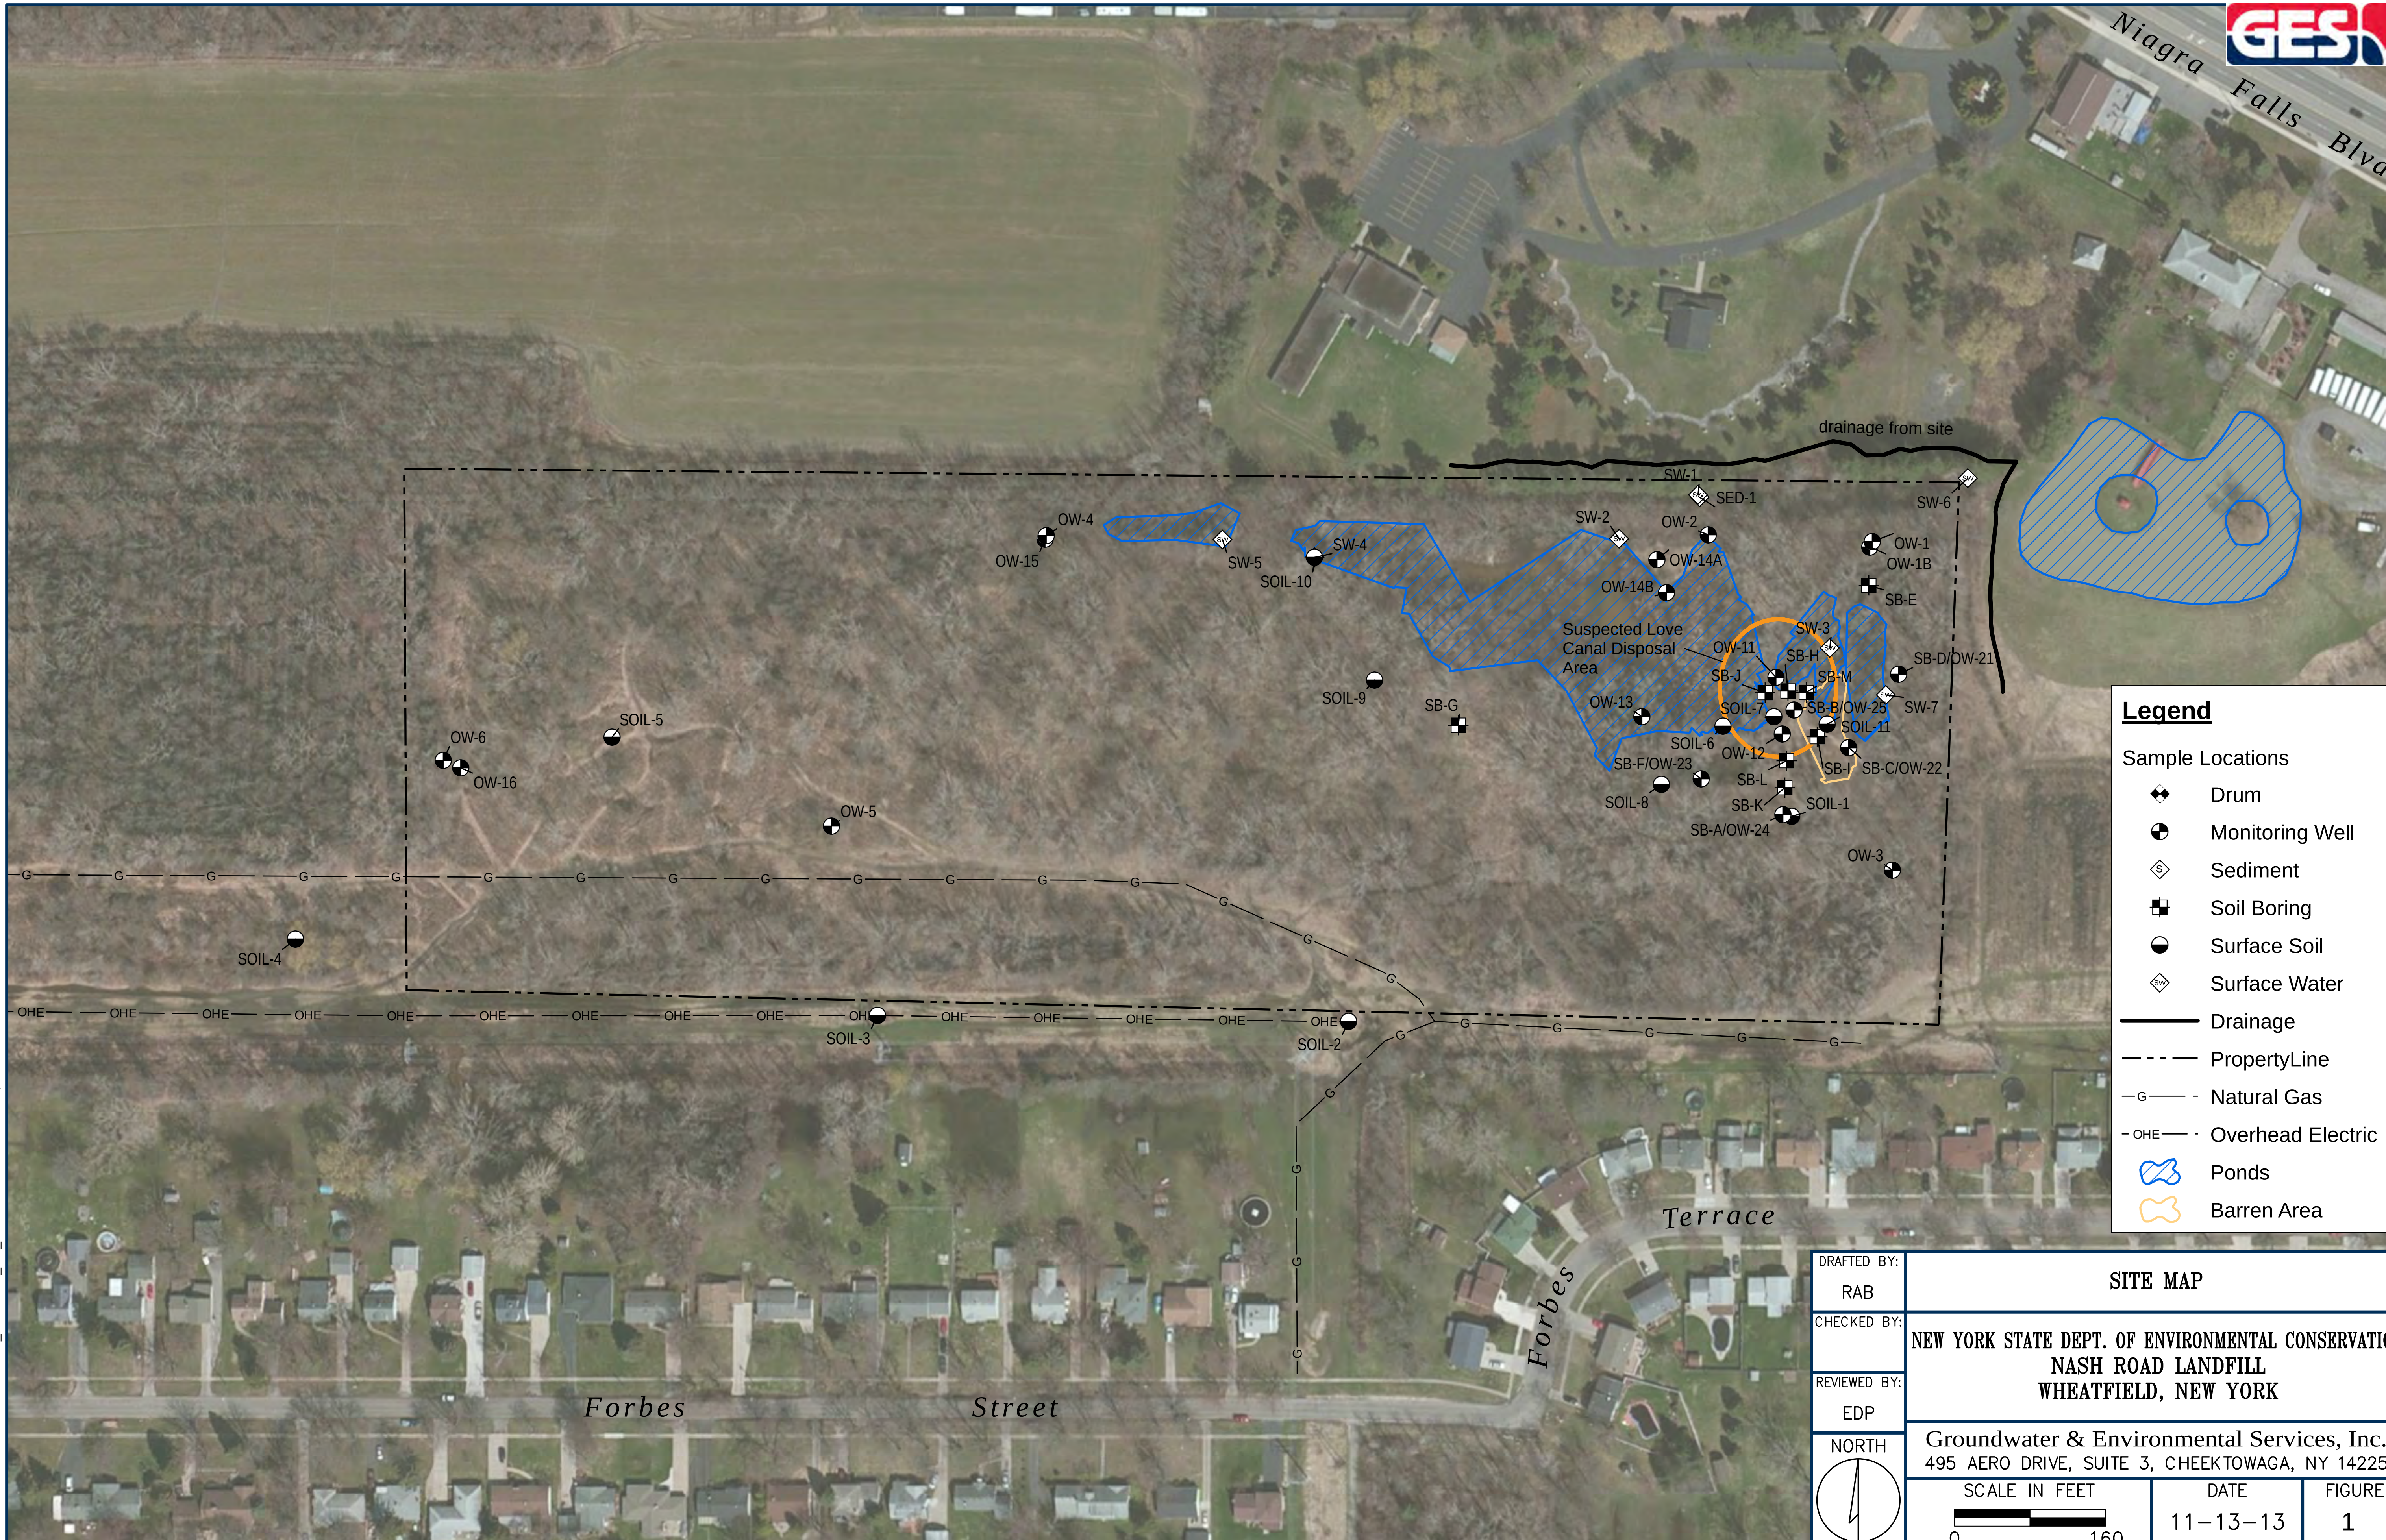
DRAFTED BY: RAB	SITE MAP
CHECKED BY:	NEW YORK STATE DEPT. OF ENVIRONMENTAL CONSERVATION NASH ROAD LANDFILL WHEATFIELD, NEW YORK
REVIEWED BY: EDP	Groundwater & Environmental Services, Inc. 495 AERO DRIVE, SUITE 3, CHEEKTOWAGA, NY 14225
NORTH	SCALE IN FEET 0 160 | DATE 11-13-13 | FIGURE 1

The site is wooded with mature trees, dense brush, and patches of phragmites in wet areas, as shown in **Figure 1**.

Site topographically overall is flat with less than ten feet of relief, however landfilling of wastes and excavation of a disposal trench has resulted in irregular ground surface topography. Numerous mounds of soil/fill material were observed. Waste material was observed to be obtruding from the mounds. During the visit, evidence of partially buried waste were observed across the site, including tires, drums, battery casings, metal and plastic debris, and mounds of fill material. These observations were used to determine surface soil and water sample locations.

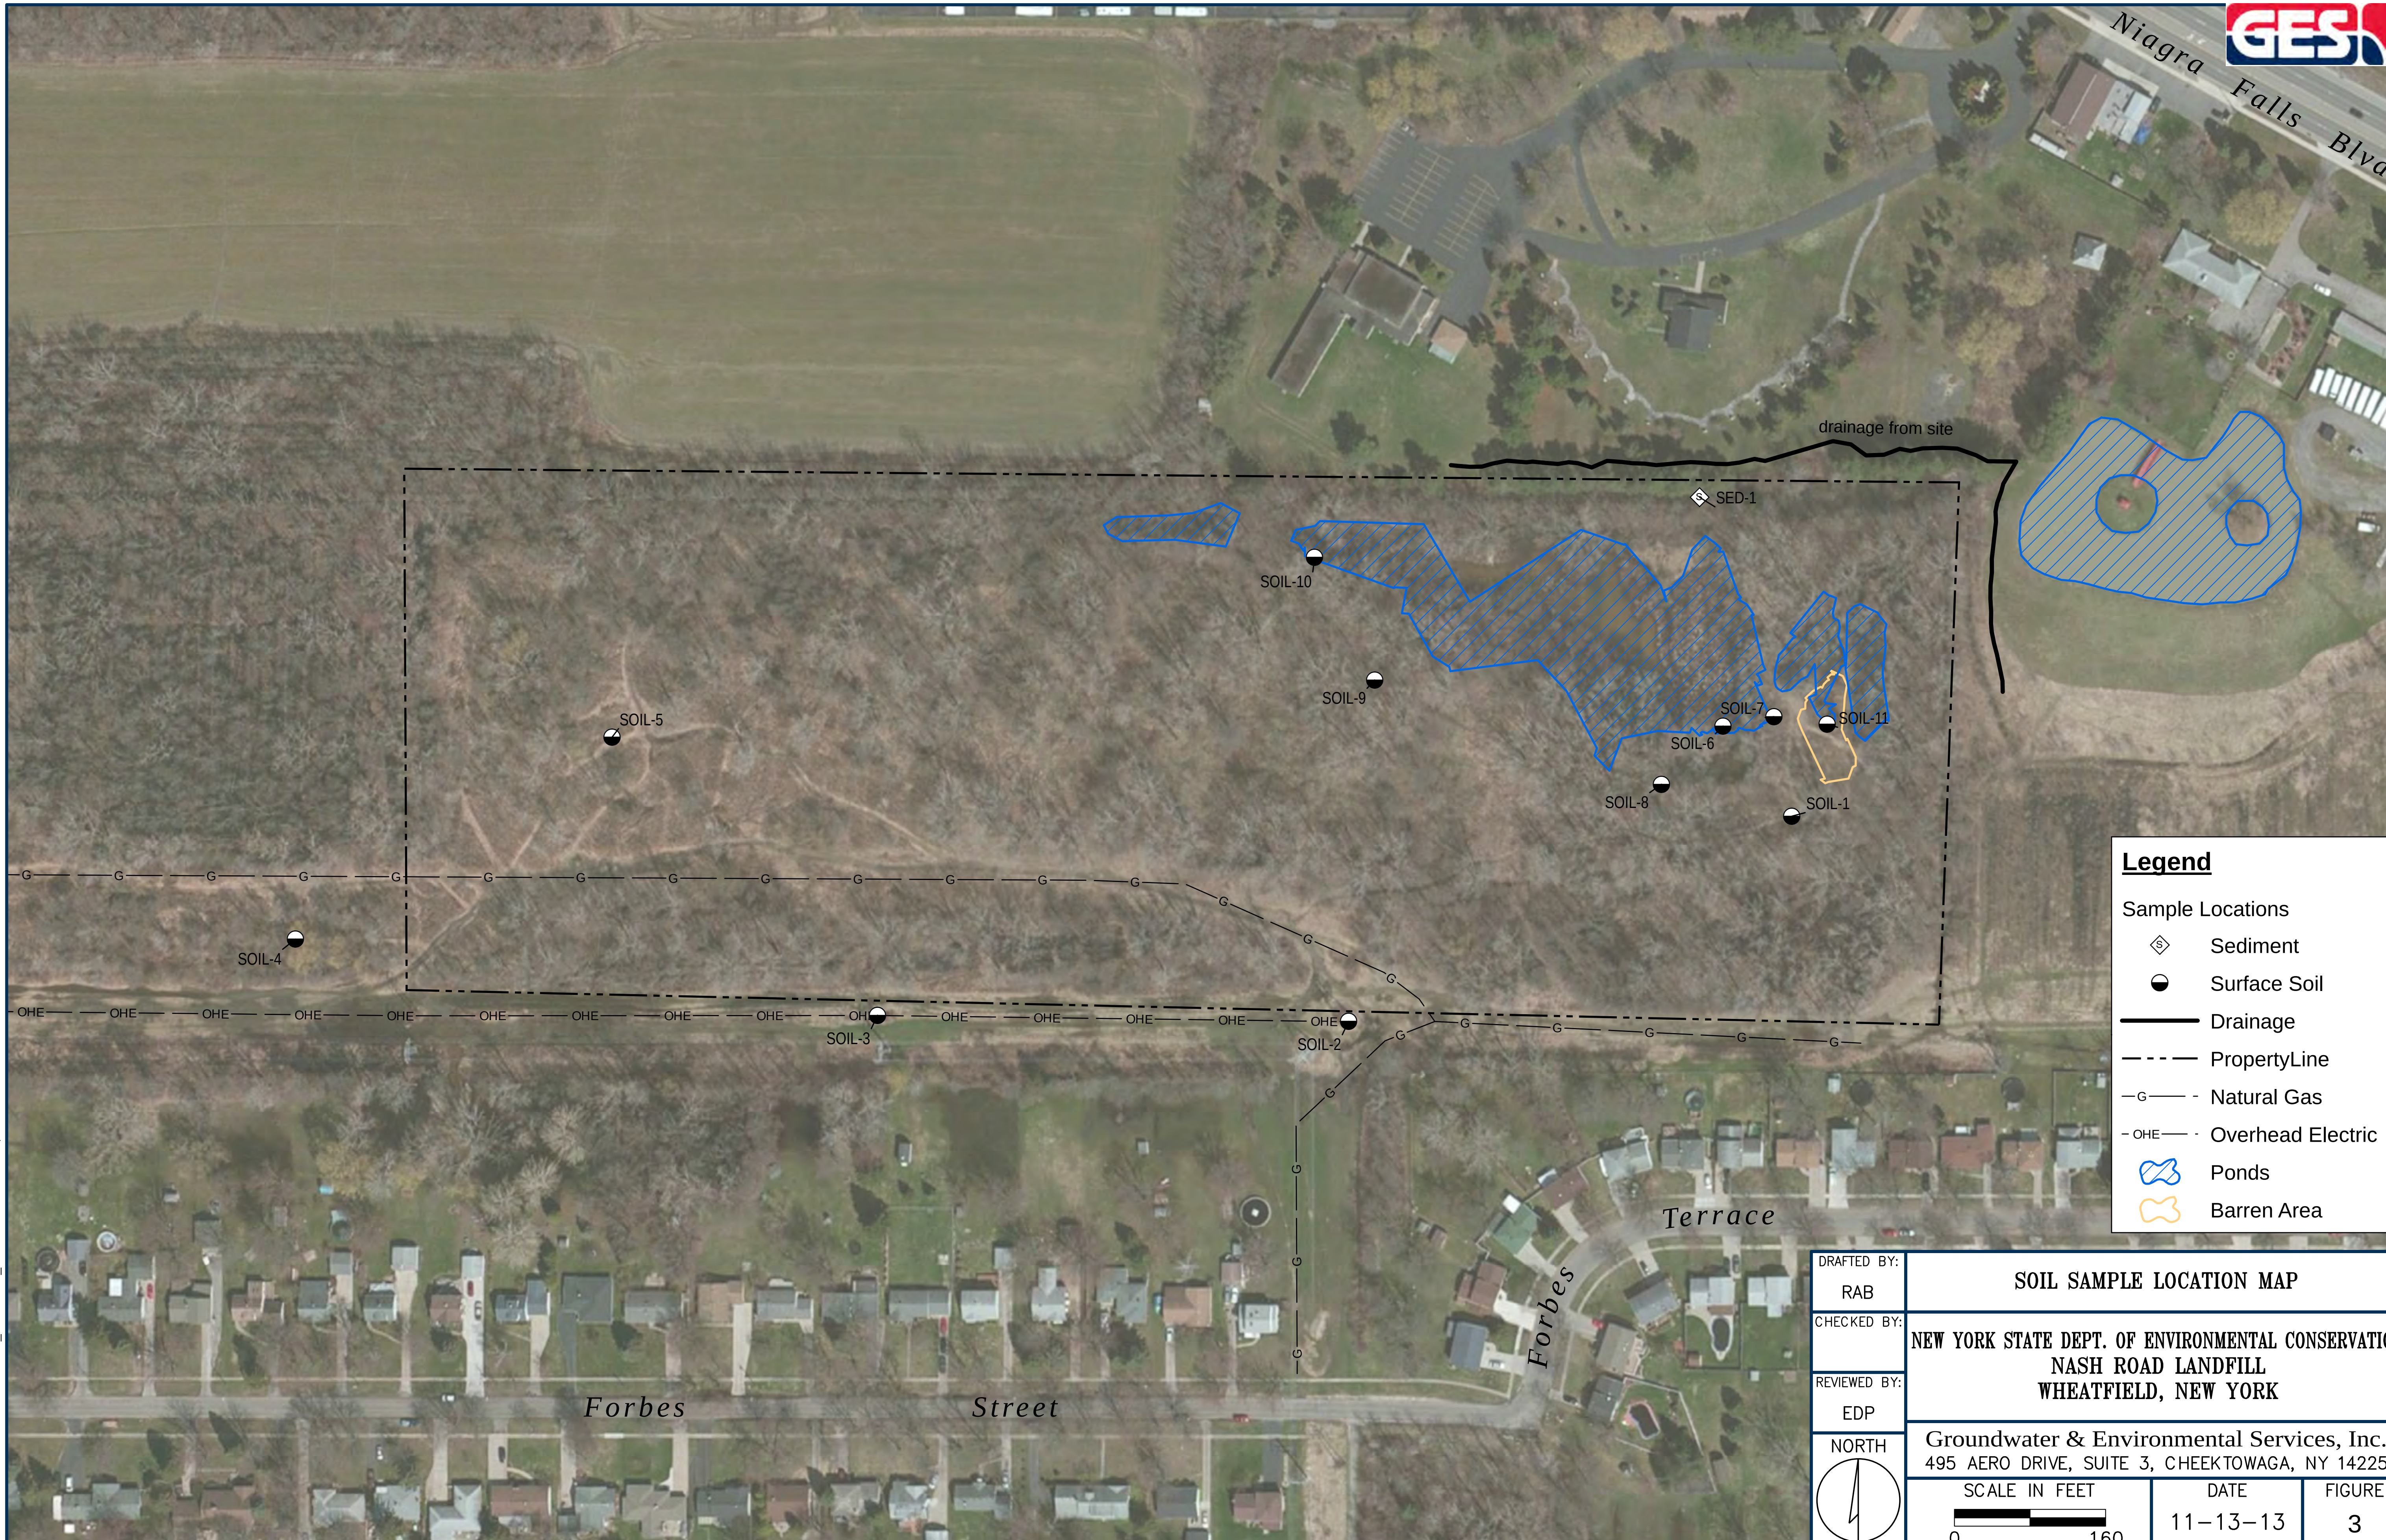
DRAFTED BY: RAB	SOIL SAMPLE LOCATION MAP
CHECKED BY:	NEW YORK STATE DEPT. OF ENVIRONMENTAL CONSERVATION NASH ROAD LANDFILL WHEATFIELD, NEW YORK
REVIEWED BY: EDP	Groundwater & Environmental Services, Inc. 495 AERO DRIVE, SUITE 3, CHEEKTOWAGA, NY 14225
DATE	11-13-13
FIGURE	3

The surface soil sample locations, with respect to the site layout are illustrated on **Figure 3**. Surface soil analytical data are tabulated in **Table 2**. The laboratory analytical reports are included in **Appendix C**. Surface soil analytical results were compared to residential guidelines provided in Title 6 of the Official Compilation of New York State Codes, Rules and Regulations (6 NYCRR) Part 375, Restricted Use Soil Cleanup Objectives (SCOs). A summary of the analyzed compounds is provided below:

- Metals – Concentrations of metals were detected above residential SCOs at soil sample SOIL-9 (battery casings along path), including cadmium, mercury, and total chromium. While concentrations of lead at this location were the highest detected on-site, the concentration was below residential SCOs.
- SVOCs – Concentrations of SVOCs were detected above residential SCOs at soil samples SOIL-3 (proximate to Nimo Electric Tower #364), SOIL-8 (mound of fill material), SOIL-9 (battery casings along path), and SOIL-10 (near drums at the edge of one of the ponds). Typical compounds that were detected above residential SCOs included polycyclic aromatic hydrocarbons. (PAHs).

As described in Section 6.1, concentrations of metals were detected above residential SCOs at soil sample SOIL-9. This sample was located at an area along one of the trails where black, broken battery casings were observed. Concentrations of SVOCs were detected above residential SCOs at soil samples SOIL-3 (proximate to Nimo Tower #364), SOIL-8 (mound of fill materials), SOIL-9 (battery casings along path), and SOIL-10 (near drums at the edge of one of the ponds). Typical compounds that were detected included PAHs.

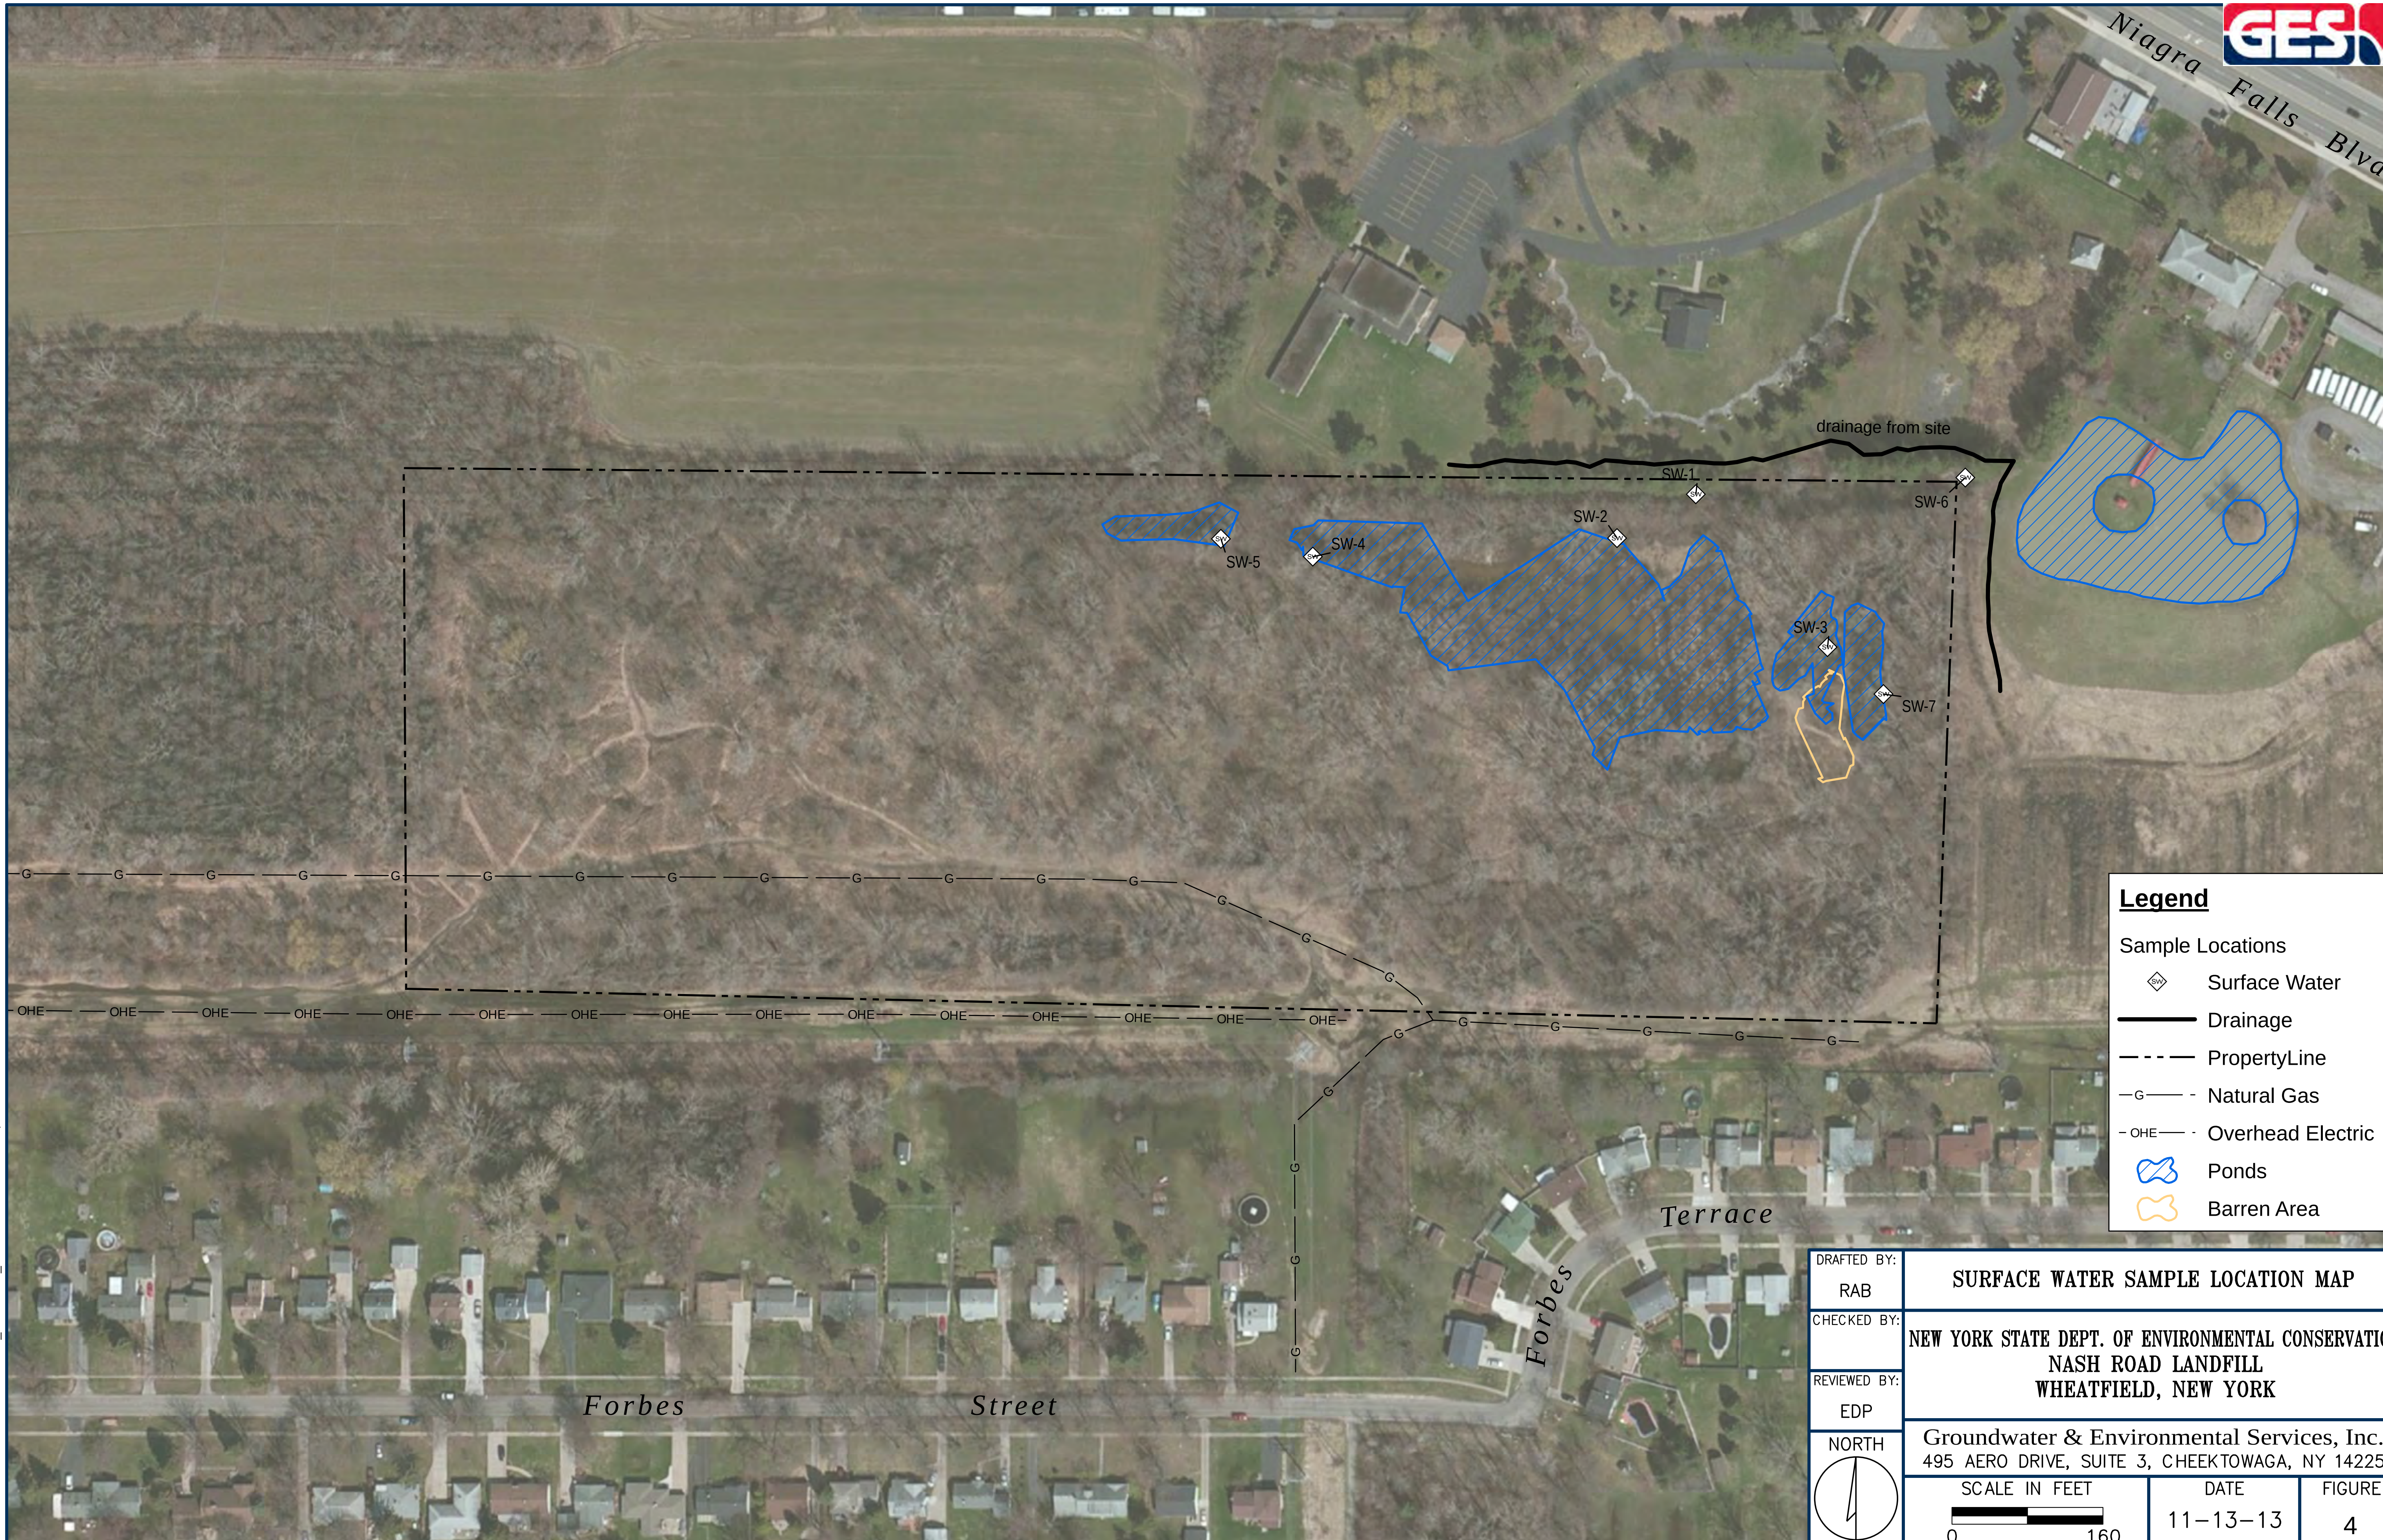
The surface water sample locations, with respect to the site layout are illustrated on **Figure 4**. Surface water sample analytical data are tabulated in **Table 3**. The laboratory analytical reports are included in **Appendix C**. All surface water analytical results were compared to NYSDEC Technical and Operational Guidance Series (TOGS) 1.1.1 standards (or guidance values where no standard exists). A summary of the analyzed compounds is provided below:

- Pesticides – Concentrations of pesticides were detected above TOGS 1.1.1 standards or guidance values at water samples SW-2 (pond sample), SW-3 (pond sample), and SW-5 (pond sample).
- Herbicides – Herbicides were not detected above laboratory detection limits in any of the surface water samples.
- VOCs – VOCs were not detected above laboratory limits in any of the surface water samples.
- SVOCs – SVOCs were not detected above laboratory limits in any of the surface water samples.

As described in Section 6.2, concentrations of pesticides were detected above TOGS 1.1.1 standards or guidance values at water samples SW-2, SW-3, and SW-5. All three samples were collected from the ponds on-site. Apart from the drainage pipe that was found at the northeast corner of the site, the site is relatively isolated hydraulically from outside sources of surface water. The drainage ditch along the north side of the site provides a hydraulic barrier from surface drainage from the neighboring property to the north (religious shrine). There does not appear to be any other surface water bodies that supply the site, therefore it is likely that past dumping activities have had an effect on surface water quality in the northeastern area of the site.

While three pond samples were found to contain elevated concentrations of pesticides, the sample SW-1, (collected from what appeared to be a drainage outlet for the large pond) did not contain any detected concentrations of pesticides. Additional surface water sampling may be needed along the outlet ditch and the ponds to further study surface water quality as it relates to drainage patterns on-site and for possible seasonal influences.

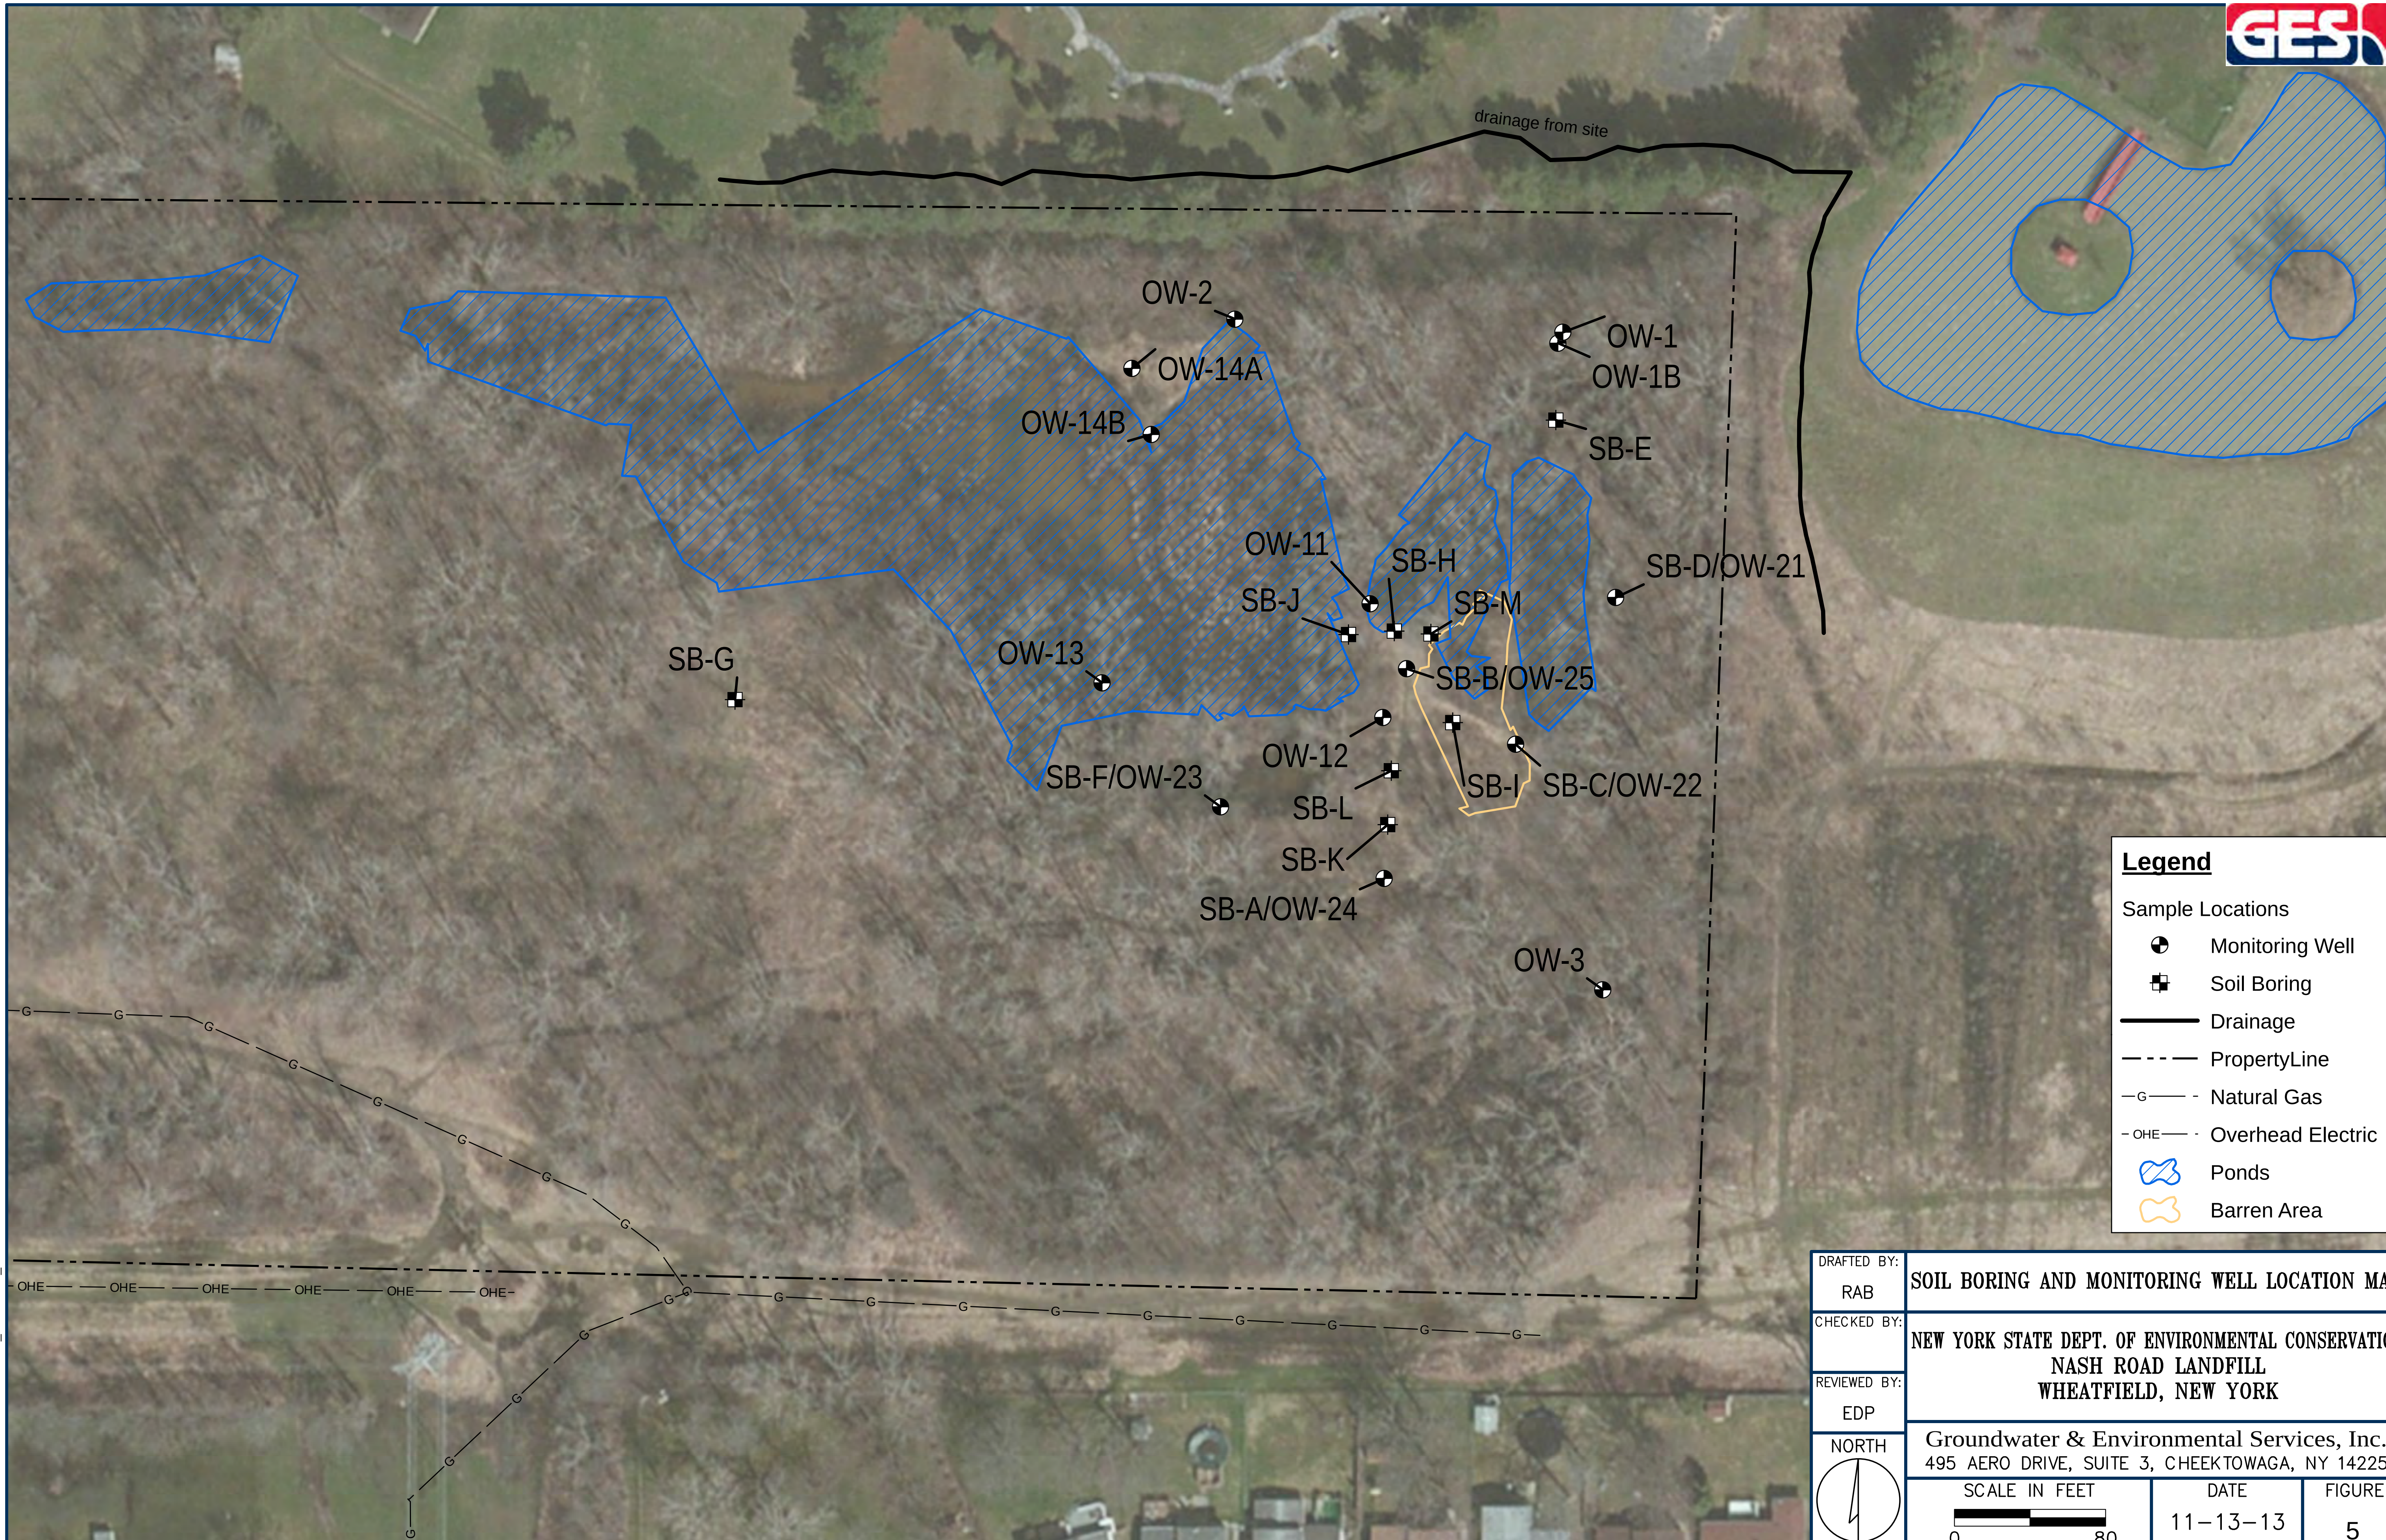
The soil boring locations, with respect to the site layout are illustrated on **Figure 5**. Soil boring logs containing soil lithology, field screening readings and general observations are included in **Appendix D**.

- FILL – Fill material containing varying degrees of silt, clay & sand, organics, and debris. The debris consisted of a mixture of glass, plastic and metal. Fill material was generally observed from the surface to depths ranging from one to four ftbg. Deeper intervals of fill material were observed at SB-A (assumed 8 ft due to low recovery), SB-B (10 ft), and SB-H (minimum 12 ftbg before refusal was met). Fill material was not observed at SB-L, where the shallow lithology consisted of hard clay to a depth of four ftbg before encountering the shallow sand layer. While shallow soil observed at SB-B was not initially classified as fill material, based on past site investigations, the observed solvent odors, softness of the material relative to other presumed shallow native clay on-site, and a review of historical documents for the site, the clay material may have been re-worked fill material related to past chemical dumping at the site. This material was also observed at SB-M.

- Solvent odors were observed in several soil borings, including SB-B, SB-H, SB-J, AND SB-M. These odors were generally observed in the fill material and the sand interval.

- Elevated PID screening results (greater than 20 ppmv) were observed from soil samples collected from soil borings SB-B, SB-H, SB-J, and SB-M. Elevated PID screening results were generally observed from approximately 0 to 8 ftbg and located in the fill material. The highest readings were recorded in soil boring SB-H throughout its entirety and ranged from 940 ppmv to 1,214 ppmv with strong solvent odors.

- NAPL was observed at SB-H from 4 to 12 ftbg. The NAPL consisted of a dark brown highly viscous material with strong solvent odors.

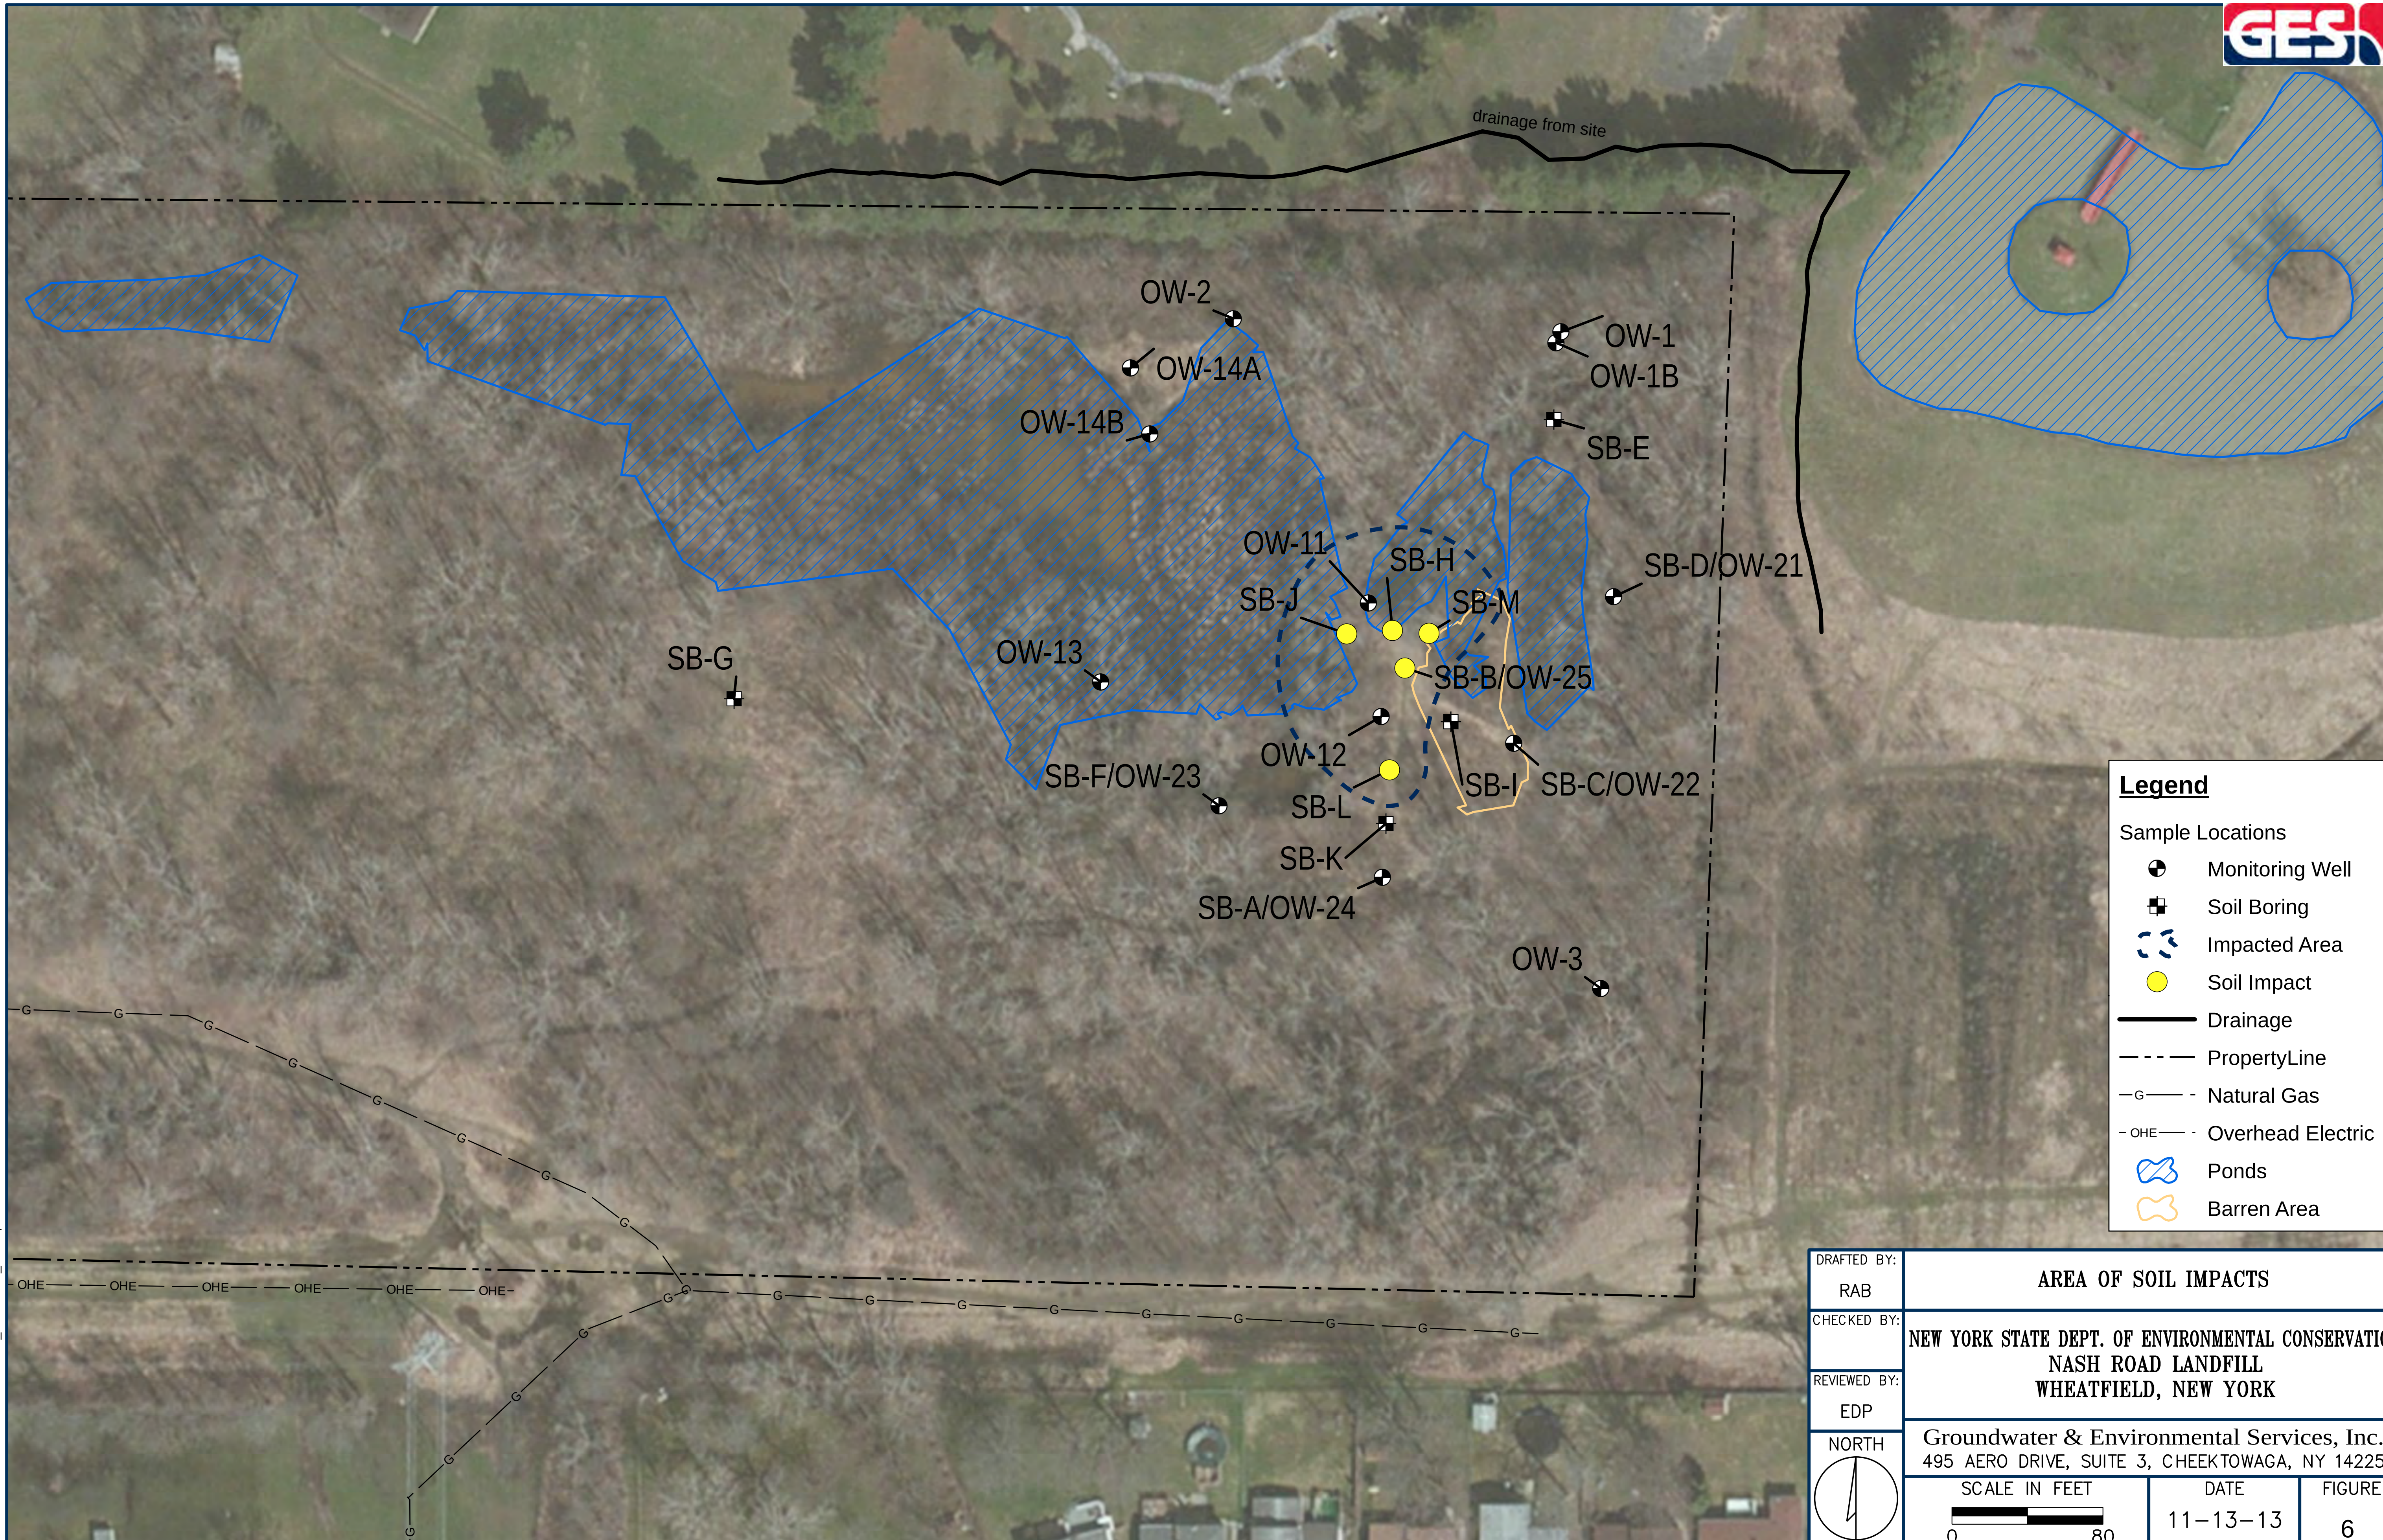
DRAFTED BY: RAB	AREA OF SOIL IMPACTS		
CHECKED BY:	NEW YORK STATE DEPT. OF ENVIRONMENTAL CONSERVATION NASH ROAD LANDFILL WHEATFIELD, NEW YORK		
REVIEWED BY: EDP	Groundwater & Environmental Services, Inc. 495 AERO DRIVE, SUITE 3, CHEEKTOWAGA, NY 14225		
NORTH	SCALE IN FEET 0 80	DATE 11-13-13	FIGURE 6

Figure 6 shows the approximate delineated limits of the area of the site that are impacted by Pesticides, VOCs, and SVOCs based on the soil boring analytical results of the investigation as well as previous site investigations. The limits were based on analytical exceedences above residential SCOs. It should be noted that the western and northern bounds of the delineated area are estimated, as site access was limited due to ponding and heavy brush.

As described in Section 8.2, elevated concentrations of contaminants, including pesticides, VOCs, SVOCs, and metals were detected in the area identified in **Figure 6**. The investigation delineated the impacts to the south and east, and to a less precise degree to the west and north due to limiting factors including ponds and dense brush. Exposure to the public may lie in the fact that at several of the soil borings discussed in Section 8.1, the highest contaminant impacts (based on field observations and PID readings) were often located in the top four feet. Shallow surface penetrations or erosion may lead to exposure to high concentrations of pesticides, VOCs, SVOCs, and metals. Several of the pesticides that were detected in elevated concentrations are known persistent organic pollutants and banned substances. Several trails run near or through this part of the site and may present an exposure risk if the surface is penetrated or exposed through erosion.

It is recommended that additional soil borings are advanced along the north and west sides of the area identified in **Figure 6** to more precisely delineate the impacts in this area. It is also recommended that site access be restricted in this area including the construction of fencing due to the shallow impacts.
