Re: Supplemental Site Characterization Report
Former Nash Road Landfill
Town of Wheatfield
Niagara County, New York
NYSDEC Site # 932054

SUPPLEMENTAL SITE CHARACTERIZATION REPORT

Former Nash Road Landfill
Town of Wheatfield
Niagara County, New York
NYSDEC Site #932054

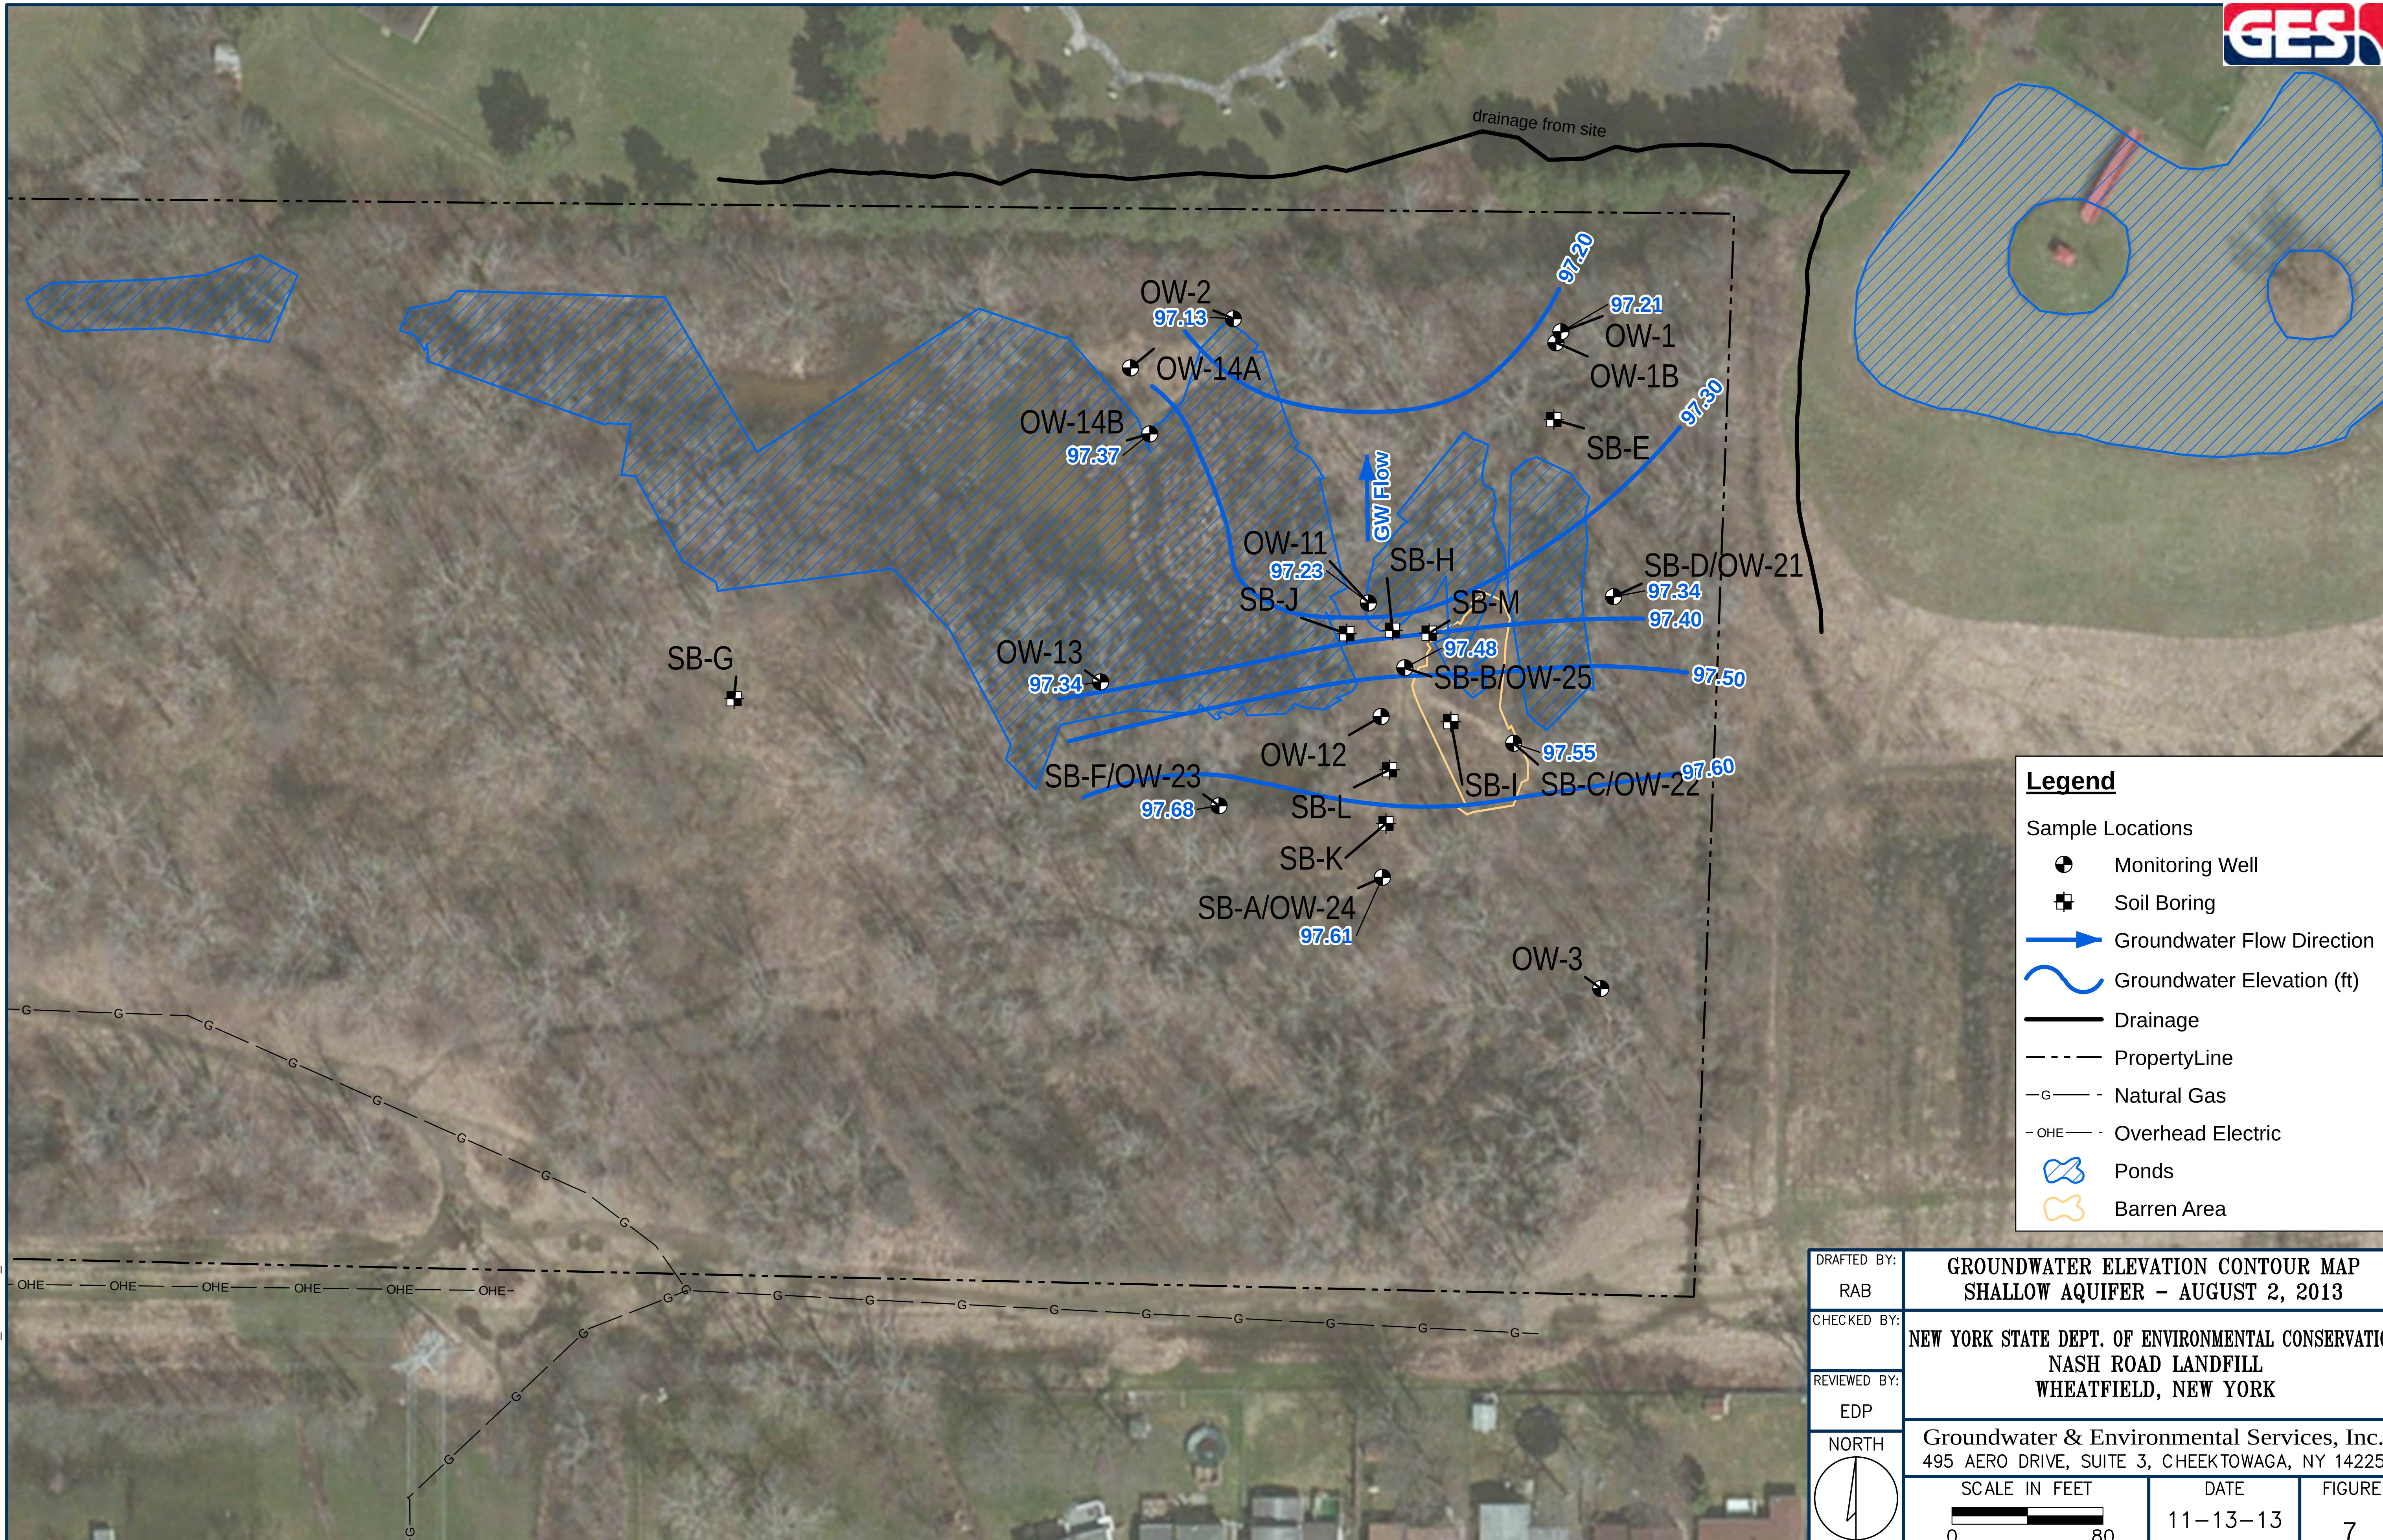
DRAFTED BY: RAB	AREA OF SOIL IMPACTS		
CHECKED BY:	NEW YORK STATE DEPT. OF ENVIRONMENTAL CONSERVATION NASH ROAD LANDFILL WHEATFIELD, NEW YORK		
REVIEWED BY: EDP	Groundwater & Environmental Services, Inc. 495 AERO DRIVE, SUITE 3, CHEEKTOWAGA, NY 14225		
NORTH	SCALE IN FEET 0 80	DATE 11-13-13	FIGURE 6

Figure 6 shows the approximate delineated limits of the area of the site that are impacted by Pesticides, VOCs, and SVOCs based on the soil boring analytical results of the investigation as well as previous site investigations. The limits were based on analytical exceedences above residential SCOs. It should be noted that the western and northern bounds of the delineated area are estimated, as site access was limited due to ponding and heavy brush.

As described in Section 8.2, elevated concentrations of contaminants, including pesticides, VOCs, SVOCs, and metals were detected in the area identified in **Figure 6**. The investigation delineated the impacts to the south and east, and to a less precise degree to the west and north due to limiting factors including ponds and dense brush. Exposure to the public may lie in the fact that at several of the soil borings discussed in Section 8.1, the highest contaminant impacts (based on field observations and PID readings) were often located in the top four feet. Shallow surface penetrations or erosion may lead to exposure to high concentrations of pesticides, VOCs, SVOCs, and metals. Several of the pesticides that were detected in elevated concentrations are known persistent organic pollutants and banned substances. Several trails run near or through this part of the site and may present an exposure risk if the surface is penetrated or exposed through erosion.

It is recommended that additional soil borings are advanced along the north and west sides of the area identified in **Figure 6** to more precisely delineate the impacts in this area. It is also recommended that site access be restricted in this area including the construction of fencing due to the shallow impacts.
