2008 FACILITY NOISE SURVEY

NORLITE CORPORATION
COHOES, NEW YORK

Technical Report AA-2159

April 20, 2009

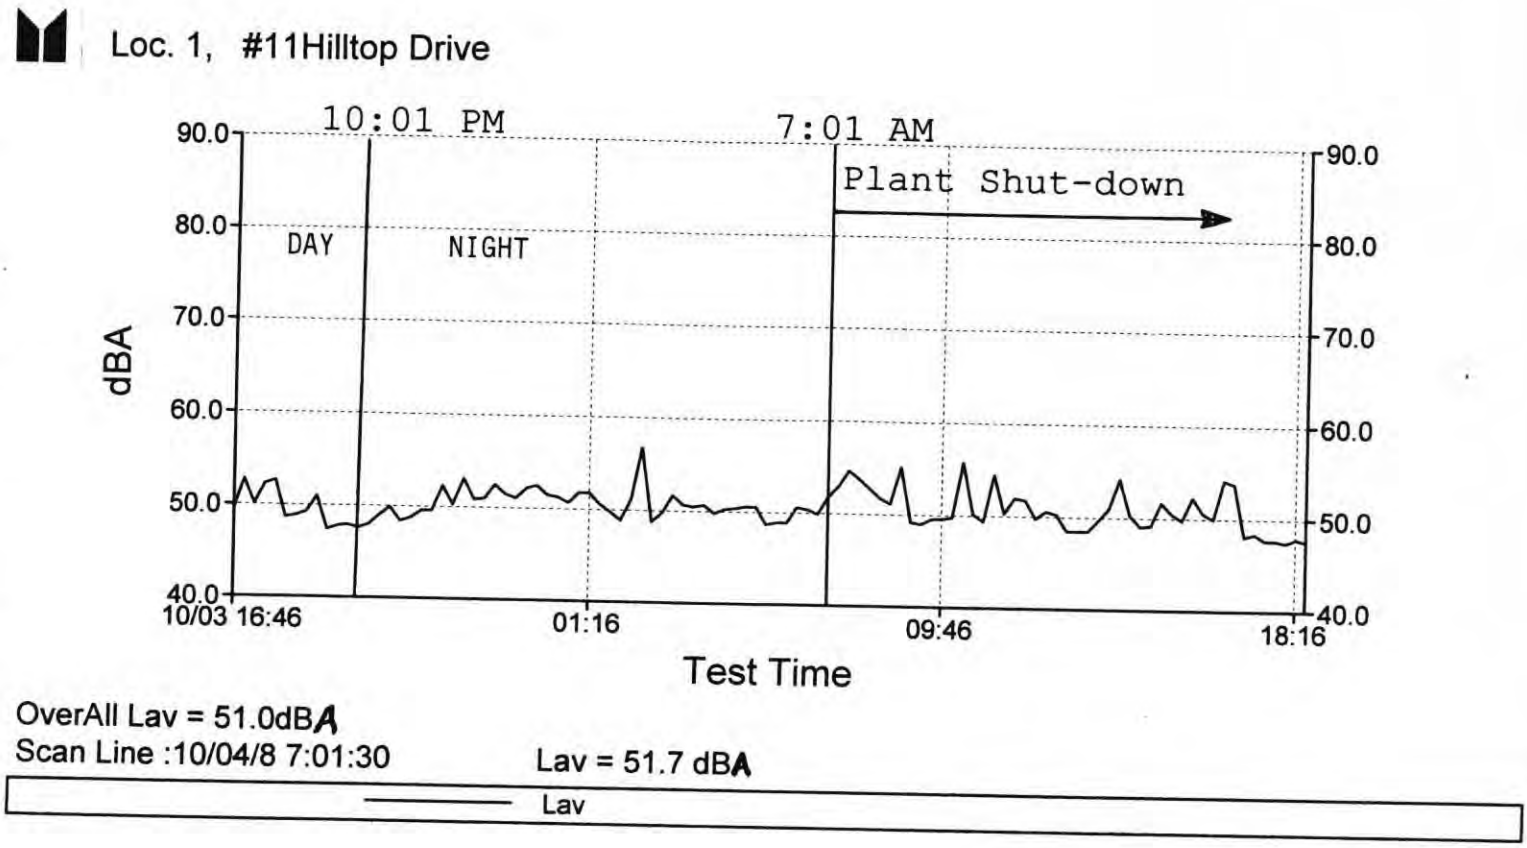
Figure 2. $L_{eqA\text{-}15min}$ plotted in increments of one-quarter hour.

Notes:
Figure 2 presents data for Location 1 at a residence at 11 Hilltop Drive at Brighton Pointe north of the facility. Sound levels for both night and day are below the 57 dBA threshold. It is evident from the graph that Norlite appears to have little to no effect on the baseline noise levels at the Brighton Pointe development.

In late summer of 2008 repots were received that regarding a "humming noise" being sporadically perceived allegedly from Norlite. This was identified to emissions from a vacuum truck having a defective muffler. After repair and replacement attention was focused on additional surveys to confirm that the potential problem was resolved. (See: Survey to Explore Tonal Components.)

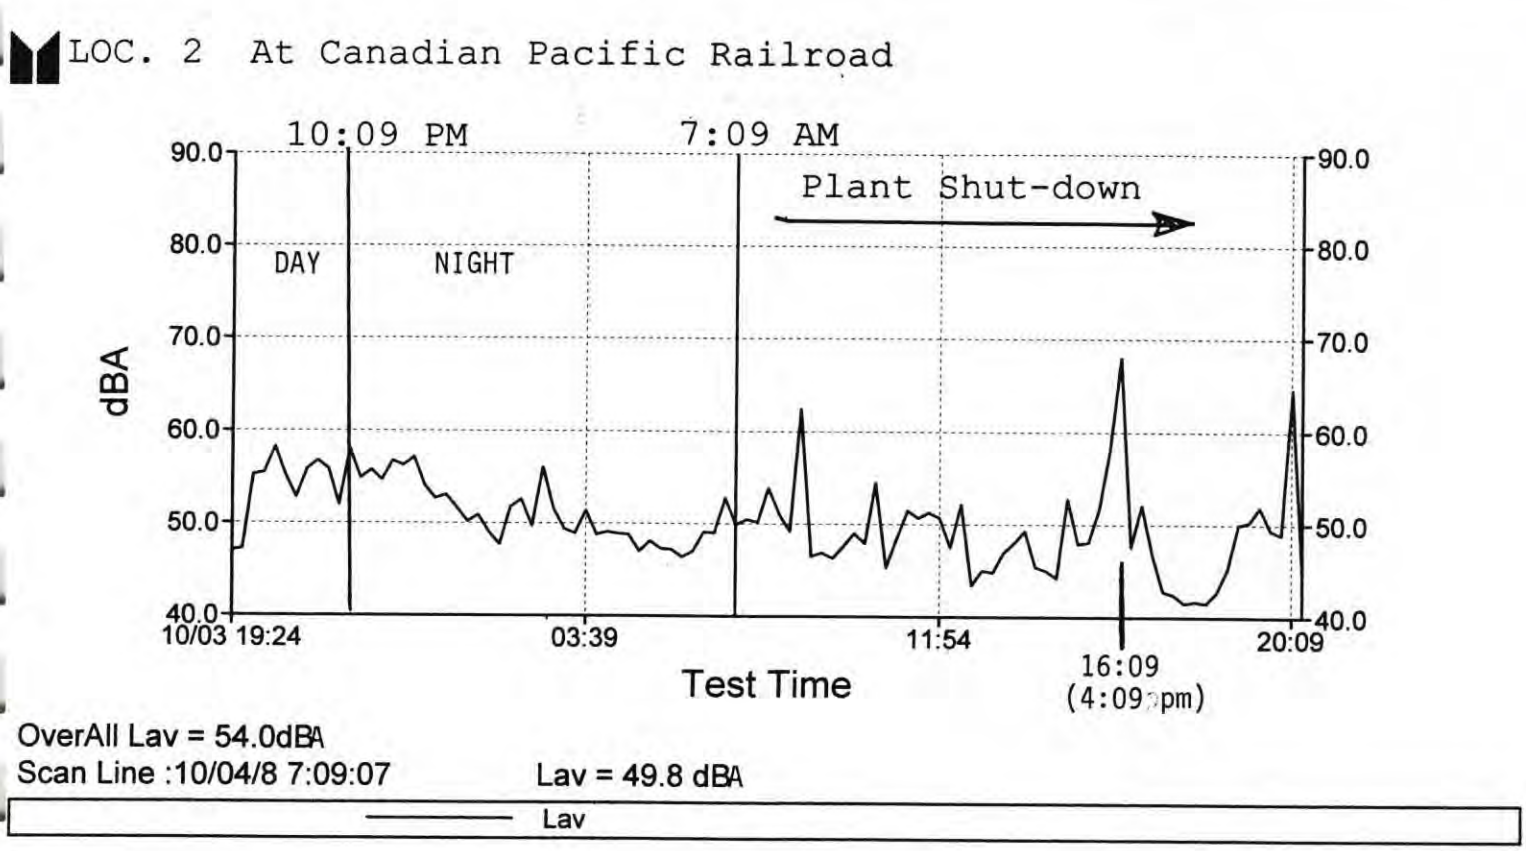
Figure 3. $L_{eqA\text{-}15min}$ plotted in increments of one-quarter hour.

Notes:
Figure 3 presents data for Location 2 which is at the southeast corner of the facility. The logger was located approximately 70 feet west of the active Canadian Pacific (D & H) railroad line. There are multiple road crossings along the couple of miles of track running north and south through the City of Cohoes. Under Federal Railroad Administration mandates, these types of crossings require full horn sounding. Furthermore the full horn sound levels must peak between 90 and 110 dBA at a distance of 100 feet in front of the locomotive. Such short duration high levels from the railroad may not skew the data to be over the Part 360 standards which pertain to hour long averages.

Consider the highest quarter hour average level of 68.0 dBA during plant shutdown at 4:09 p.m. (16:09:07). From the table, the single maximum level (L_{max}) during the quarter was 85.5 dBA. This illustrates how a short duration of a single high level may not exceed the Part 360 standards.

Night limits can be exceeded by RR source.

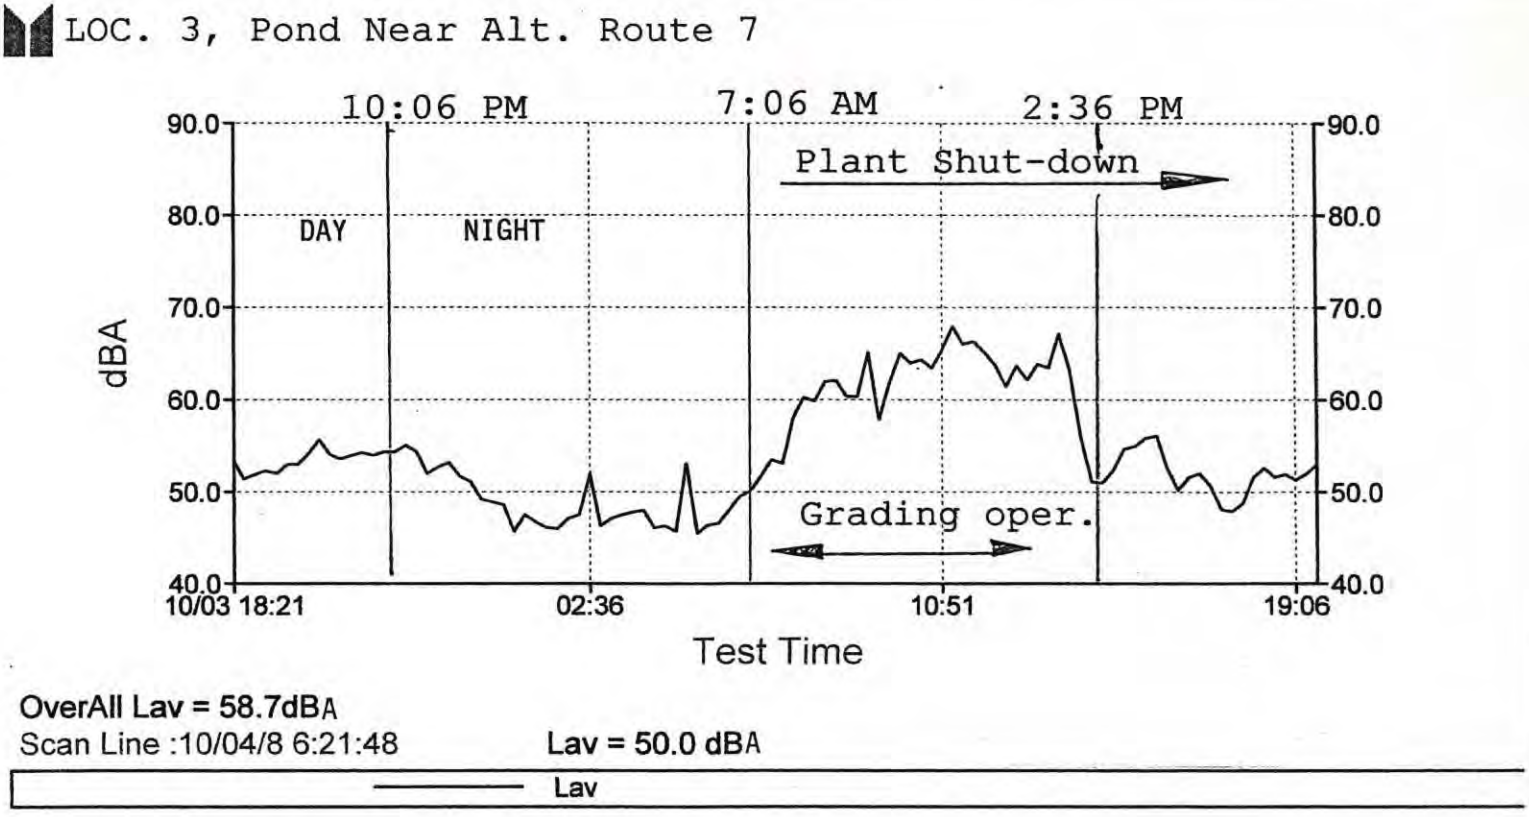
Figure 4. $L_{eqA\text{-}15min.}$ plotted in increments of one-quarter hour.

Notes:
Figure 4 presents data for Location 3 near Alternate Route 7 at the southeastern end of the Southern Overburden Storage Area near the storm water retention ponds. Grading operations occurred during the recording period. Grading was conducted from approximately 7:00 a.m. to 2:00 p.m. on Saturday, October 4, 2008. All standards are met for both day and night activities.

Night and day limits are met.

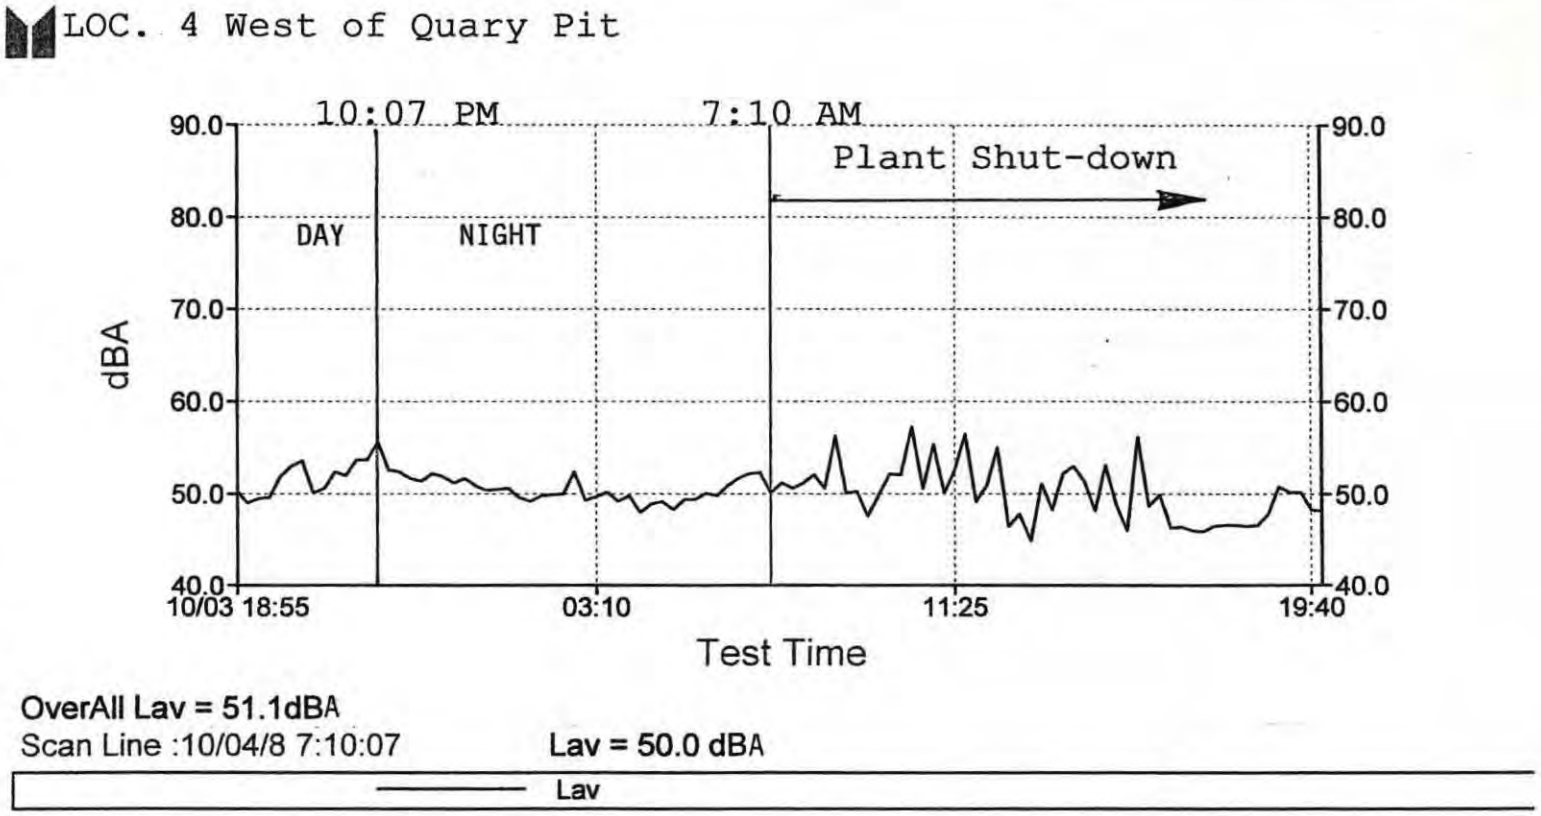
Figure 5. $L_{eqA\text{-}15min.}$ plotted in increments of one-quarter hour.

Figure 5 presents data for Location 4 on the west side of the quarry. Little to no plant activity affects the overall noise levels at this location. Noise levels are within the standard.

Night and day limits met.

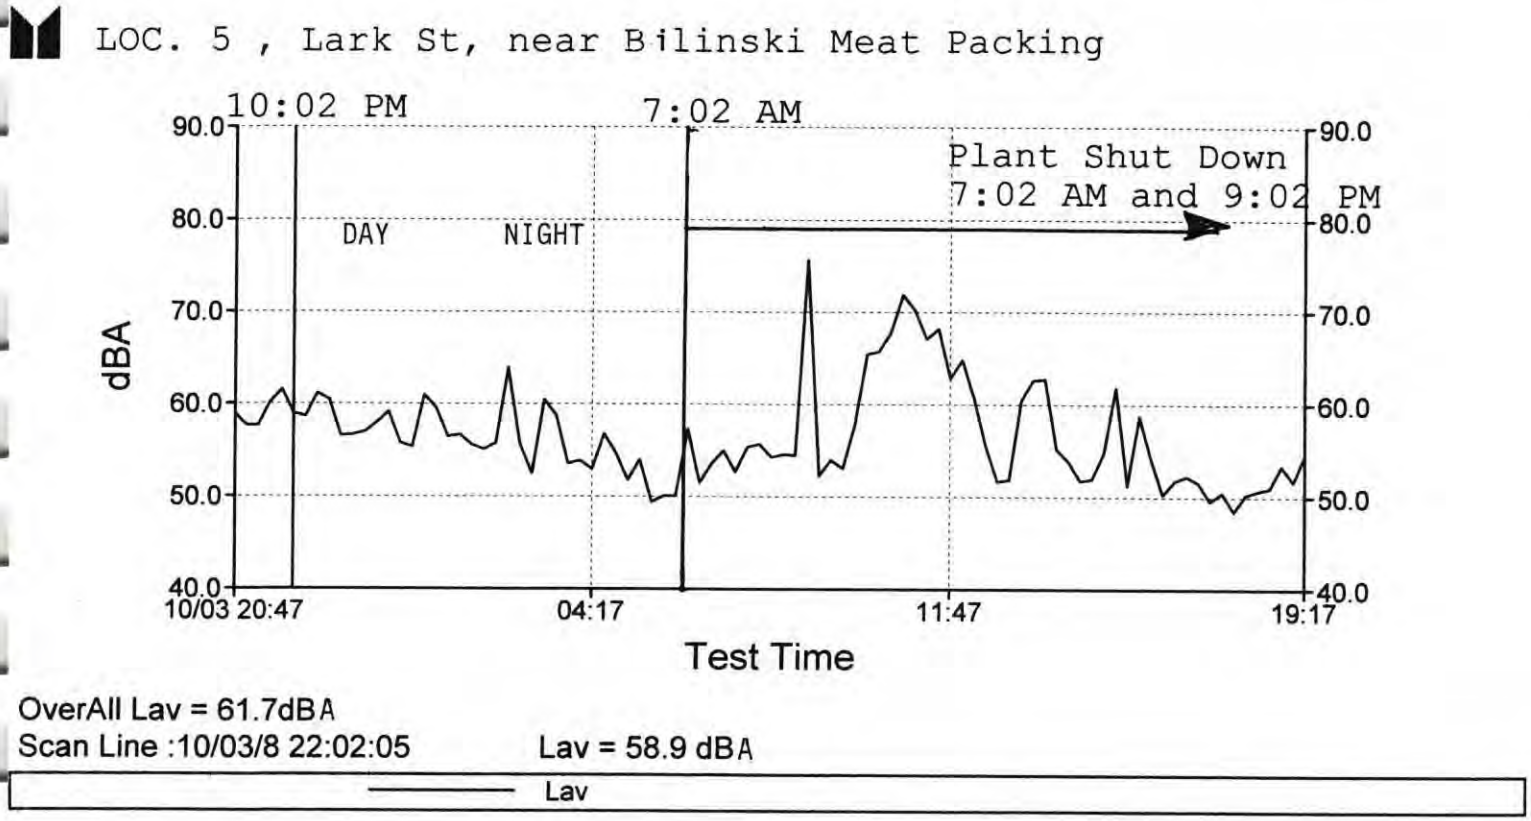
Figure 6. $L_{eqA\text{-}15min.}$ plotted in increments of one-quarter hour.

Figure 6 presents data for Location 5 on the north side of the facility near the Bilinski Meat Packing Plant. During the set up and spot measurements done on Friday night, October 3, 2008, a group of teenagers were seen and heard in the area. The area shows evidence that this is a "hang out" area for the teenagers. There is a strong indication that the high noise levels are caused by local sources near the microphone of the logger rather than any operation from Norlite. This is particularly evident for the data recordings during Saturday daytime, October 4, 2008 with the facility in shutdown mode. Results were contaminated by local contributions which cannot be attributed to Norlite.

There is a strong indication that high noise levels recorded were caused by local noise sources close to the microphone of the logger. Thus the data are not reliable.

Night and day measured levels are not within the 67 and 57 dBA limits, but cannot be attributed to Norlite operating. Records for this monitoring location are not reliable.

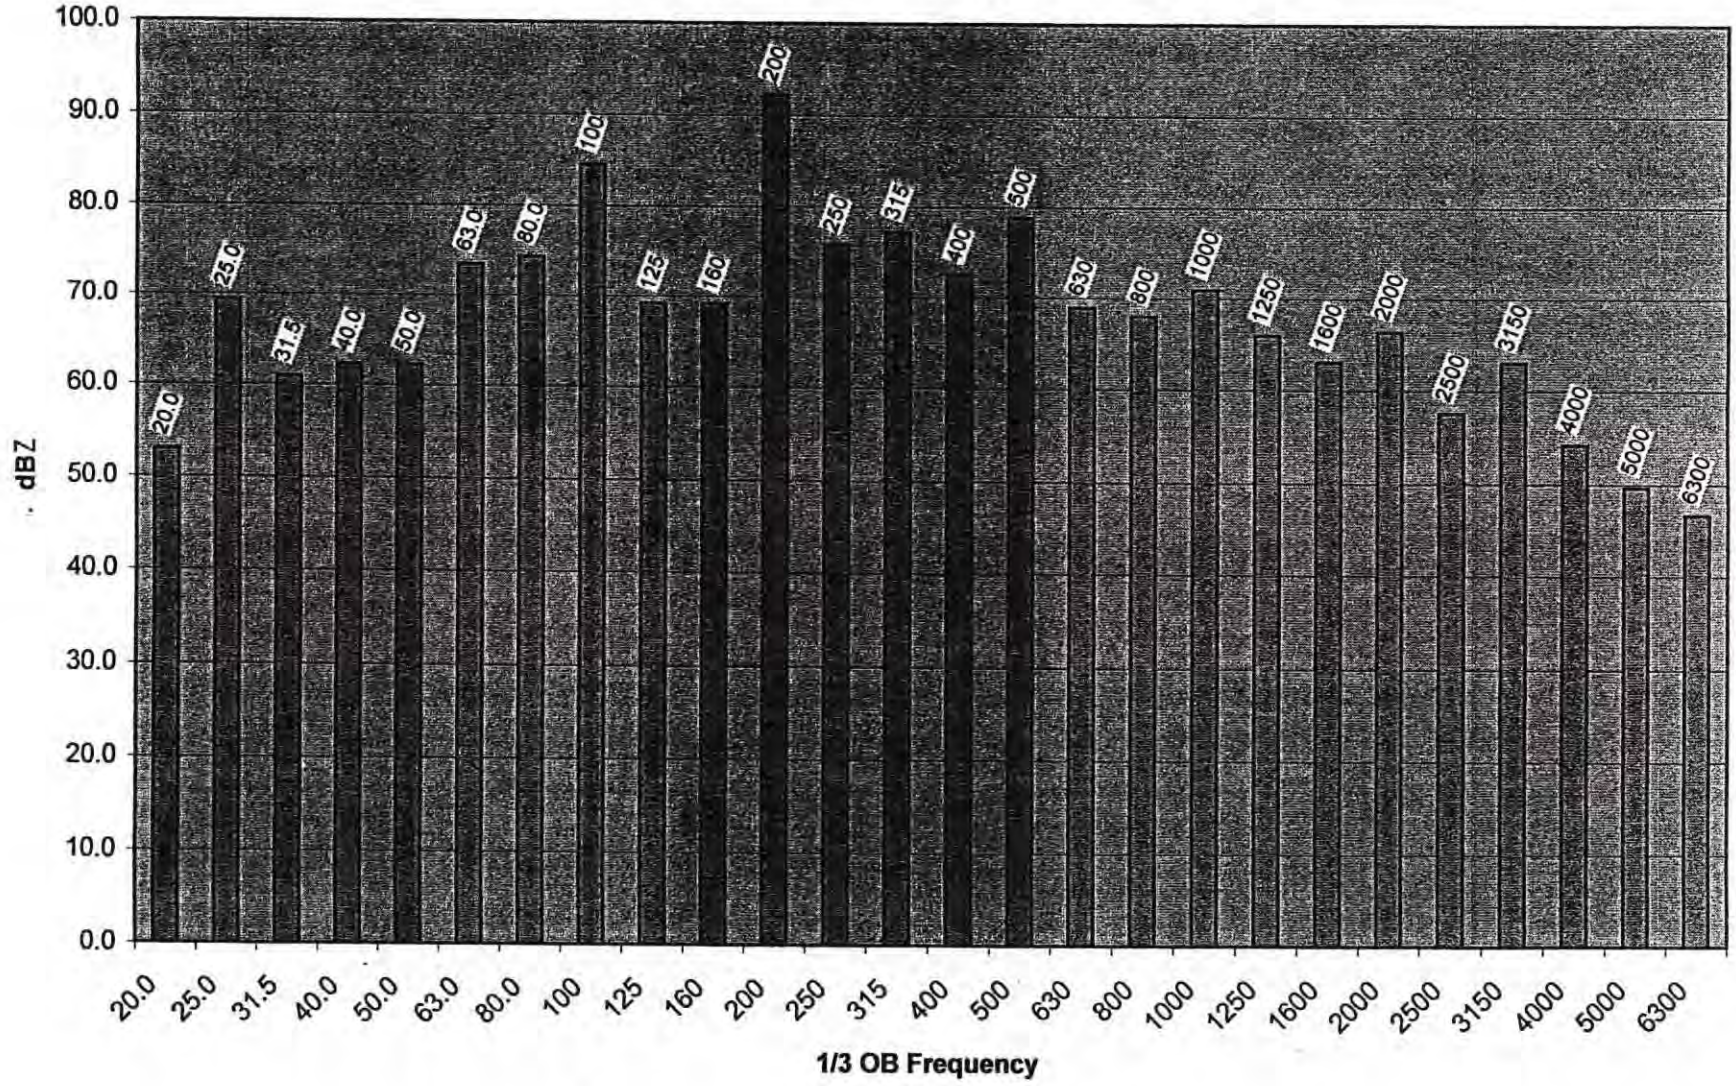
Measurements in 1/3 octave bands were made at a distance of 50 feet from a vacuum truck with the defective muffler. Results are shown in Figure 7 with throttle set at 3/4. Next measurements were made with the throttle set on FULL. Curiously the truck made more noise at the 3/4 setting.

Figures 7 and 8 show 1/3 octave band levels in dBZ for operation at 3/4 and full throttle settings. Note that the 1/3 octave band levels are in dBZ and thus not A-weighted. Along with each are noted A-weighted L_{eqA} levels of 83.4 and 81.1 dBA for 3/4 and full throttle respectively. There is no error here. The vacuum truck was found to be noisier at the lower setting. After repairs and replacement of a muffler, the truck was substantially quieter and fully compliant with Part 360 requirements of less than 80 dBA at 50 feet.

Figure 7. **Vacuum at 50', 3/4 throtle, 10-04-08, File 042**
(Before repairs — level was 83.4 dBA - NOT AN ERROR)

Of particular interest at Location 1 were some sounds associated with Norlite's operation. In late August and September 2008 reports were received by Norlite from neighbors to the north at Brighton Pointe. They commented that a loud periodic "humming" sound was coming from the facility. Norlite investigated the issue and determined the sound was coming from its vacuum truck. The vacuum truck is used to remove material from process equipment prior to maintenance activities. The use of the vacuum truck is infrequent about once every few weeks. Depending on plant needs the unit maybe used on day or night shift. Norlite determined the exhaust muffler needed to be replaced. A new muffler was ordered from the manufacturer and the replacement was complete on October 8, 2008.

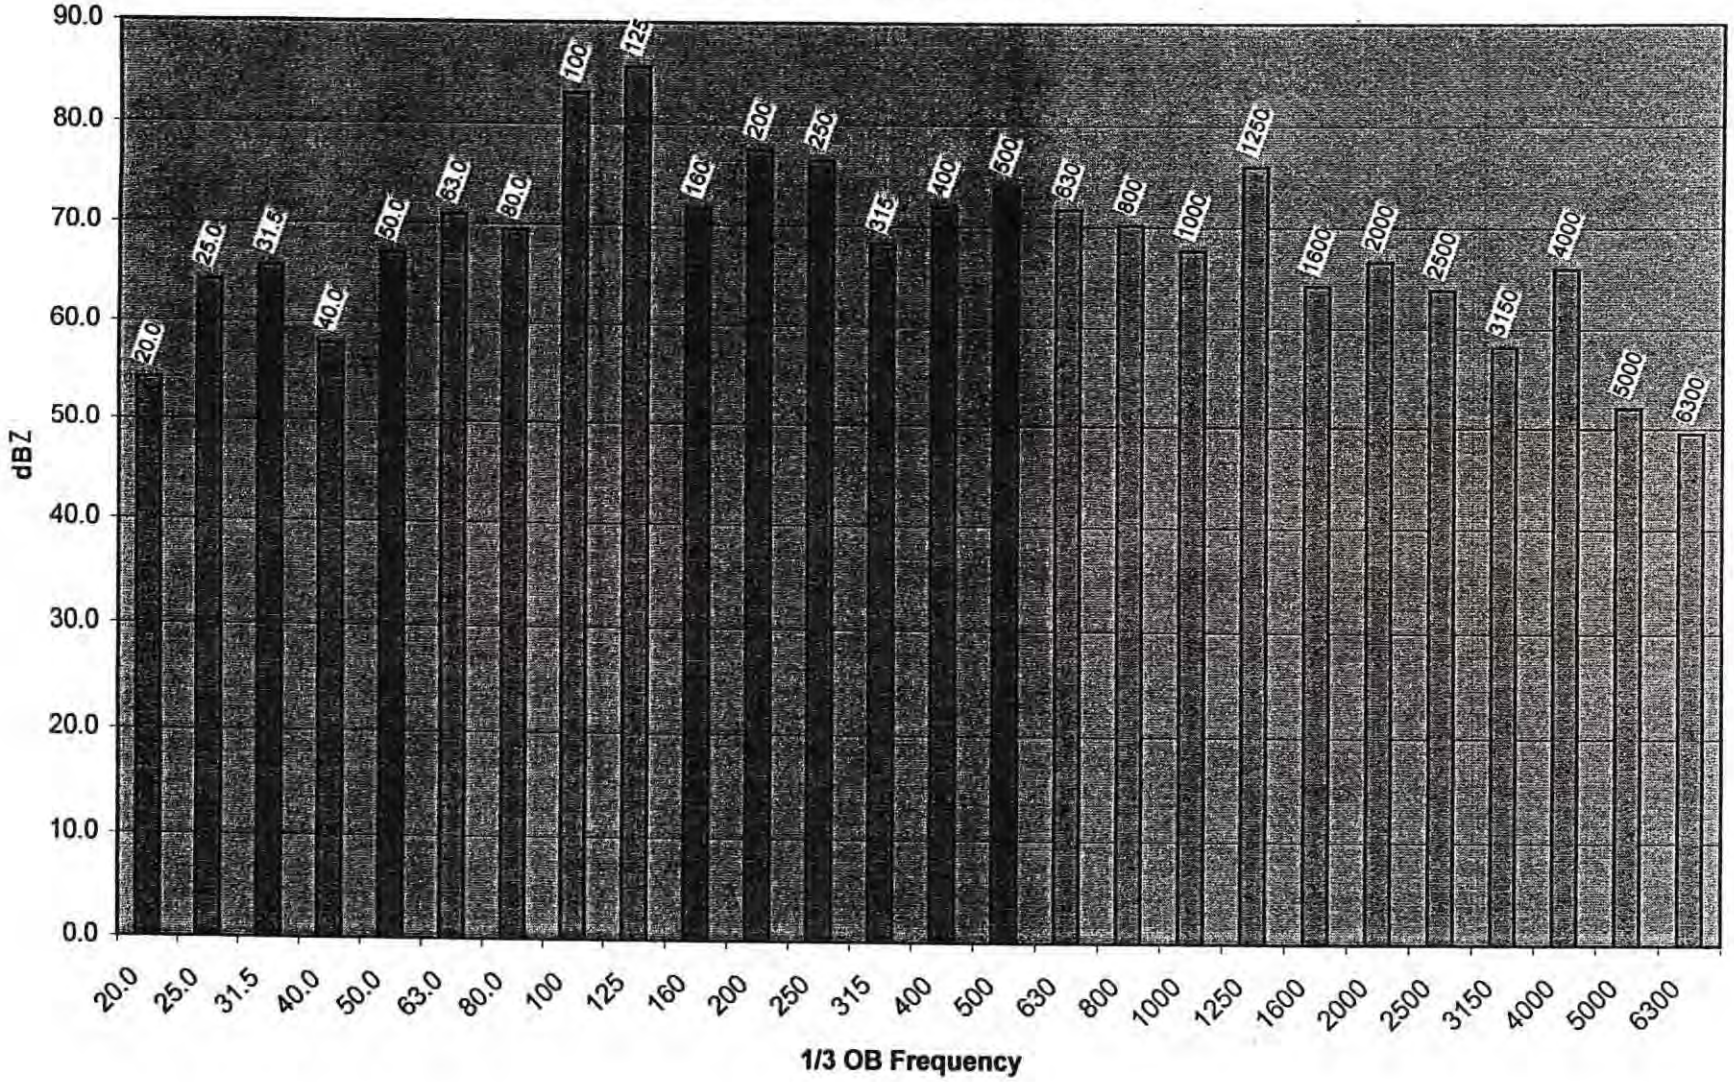
Figure 8. **Vacuum at 50', Full throtle, 10-04-08, File 043**

(Before repairs -- level was 81.1 dBA)

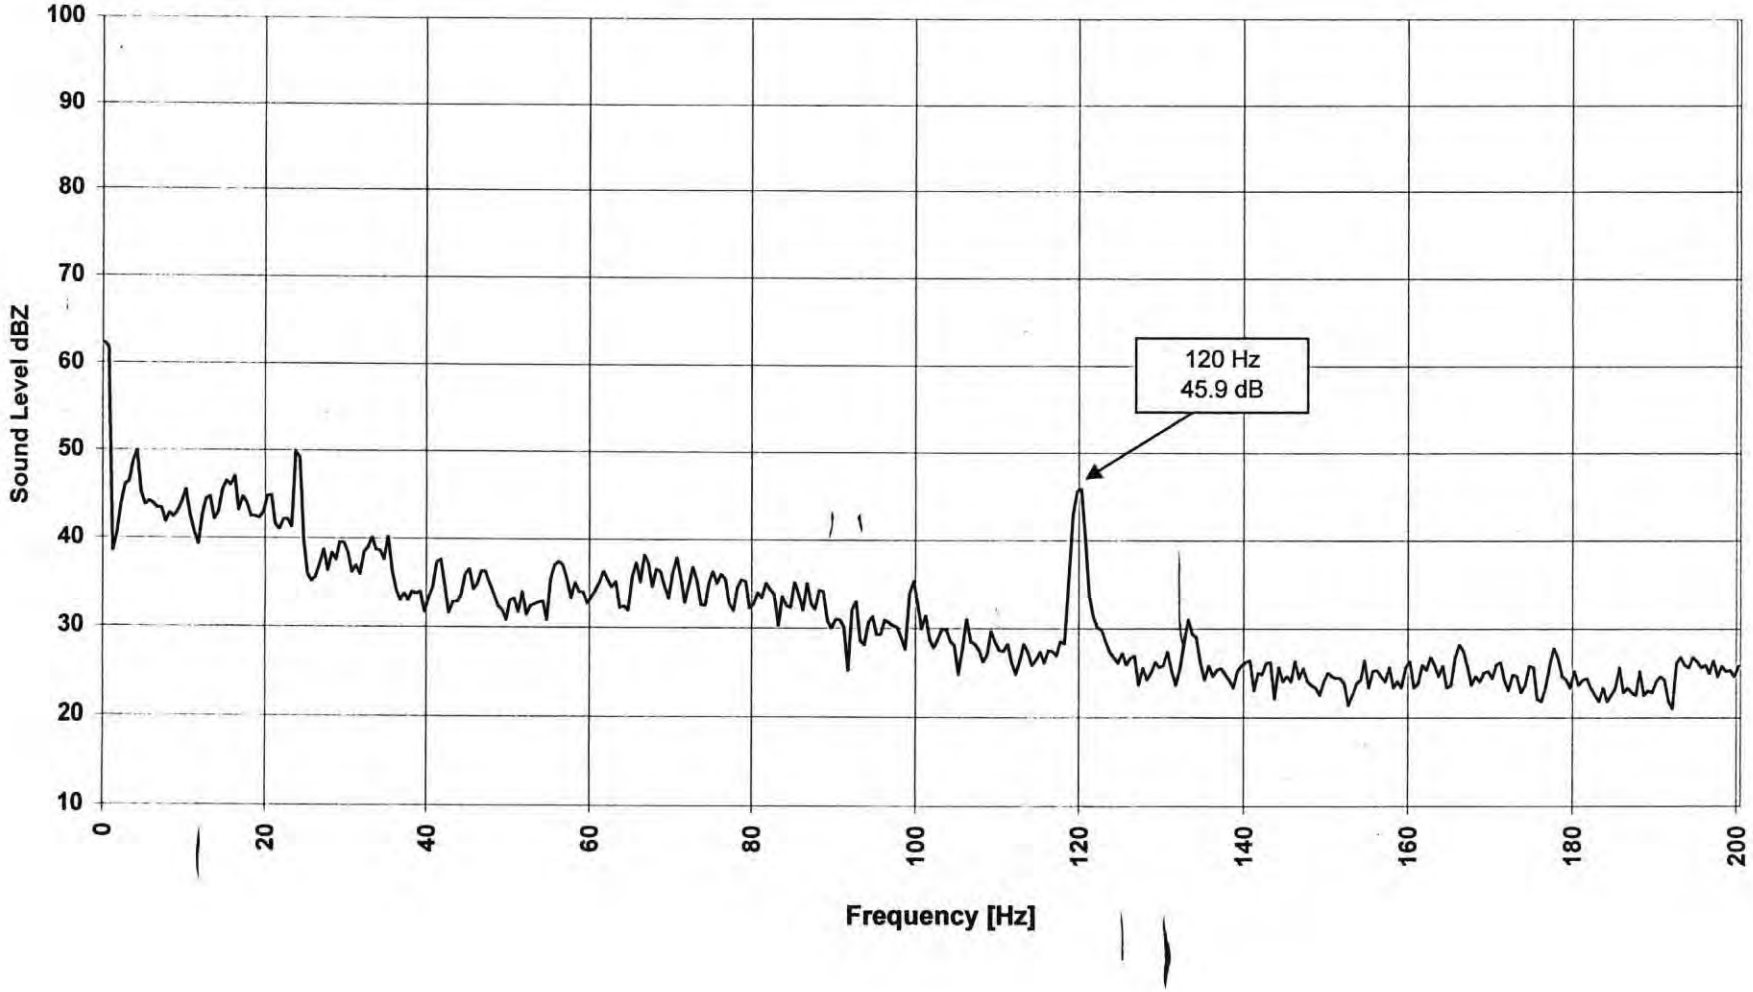
In response to a follow-on request, a spot, high resolution survey was made on Tuesday, November 25, 2008, at Tailfeather Court in Morning View Farms. The development is located northwest of the facility and is shown on Figure 1 as Location D. This measurement was made with the plant in full operation and was based on comments received from NYSDEC in its letter to Norlite dated October 10, 2008. Figure 9 shows the only frequency (not A-weighted) recorded at the site. The adjusted level with A-weighting would be approximately 30dBA. The recorded level is low and could not be perceived by the surveyors. The frequency detected is presumed to be emitted from a nearby small power transformer in the area.

Figure 9, Norlite Surveys 11/25/08, Tuesday morning, Plant in Operation
Location D, Tailfeather Ct. (NW of Plant)
No wind, 120 Hz. Prominent, Power Transformer
Address 1, 200 Hz 80N122
