Subject: Annual LUC Inspection Report, Sites 1, 2, and 3 — NWIRP Bethpage

Date: February 2016

This memorandum documents the inventory of 123 groundwater monitoring wells for NWIRP Bethpage shown in Figure 1. The purpose of the well inventory was to locate, photograph, evaluate the physical condition of, and measure the groundwater level and depth of each well to assure that data collected from these wells is representative of subsurface conditions, and to evaluate the physical condition of each well.

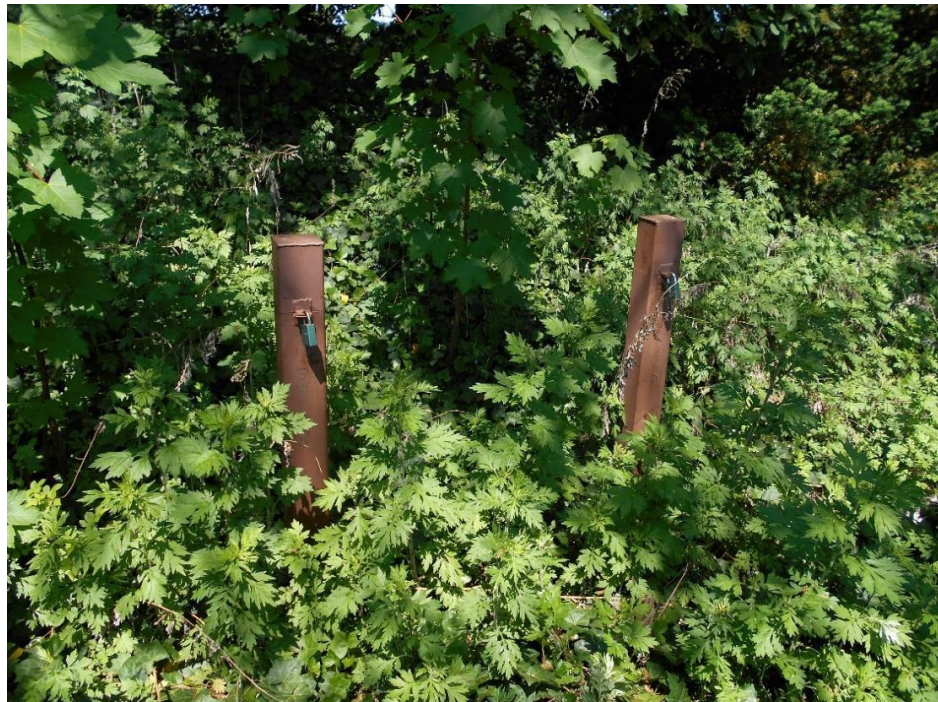
*Photo 12:* Site 1- SVE 103I + SVE 103D

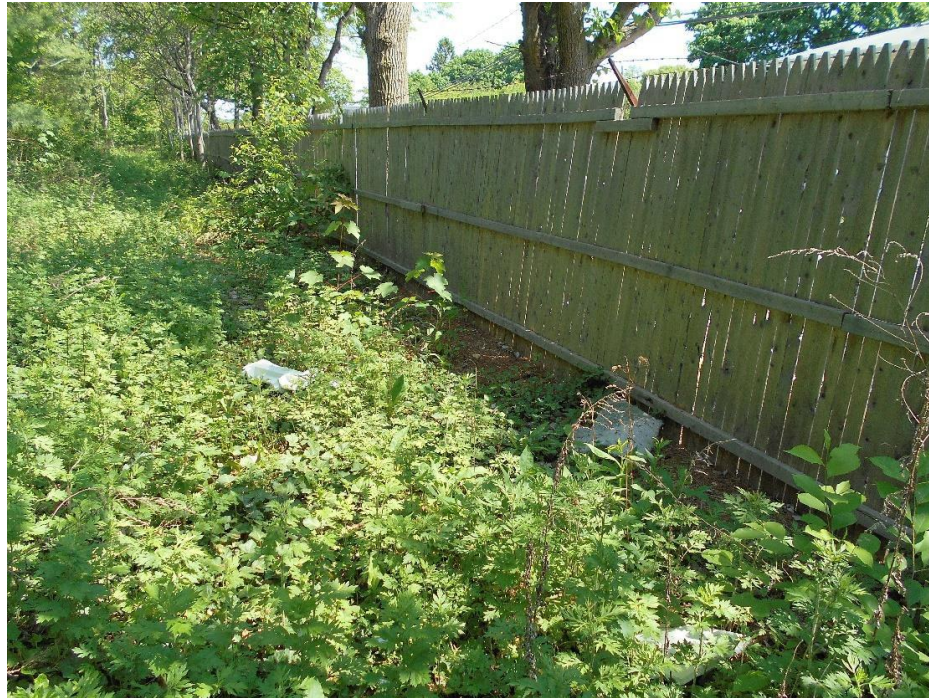
*Photo 13:* Site 1- Debris at SVE 103I + SVE 103D

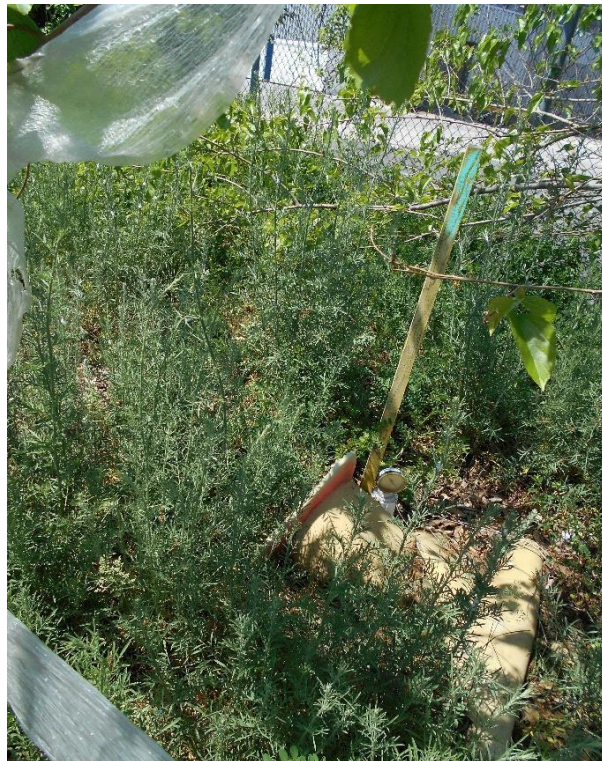
*Photo 20:* Site 1- SVE point, east side

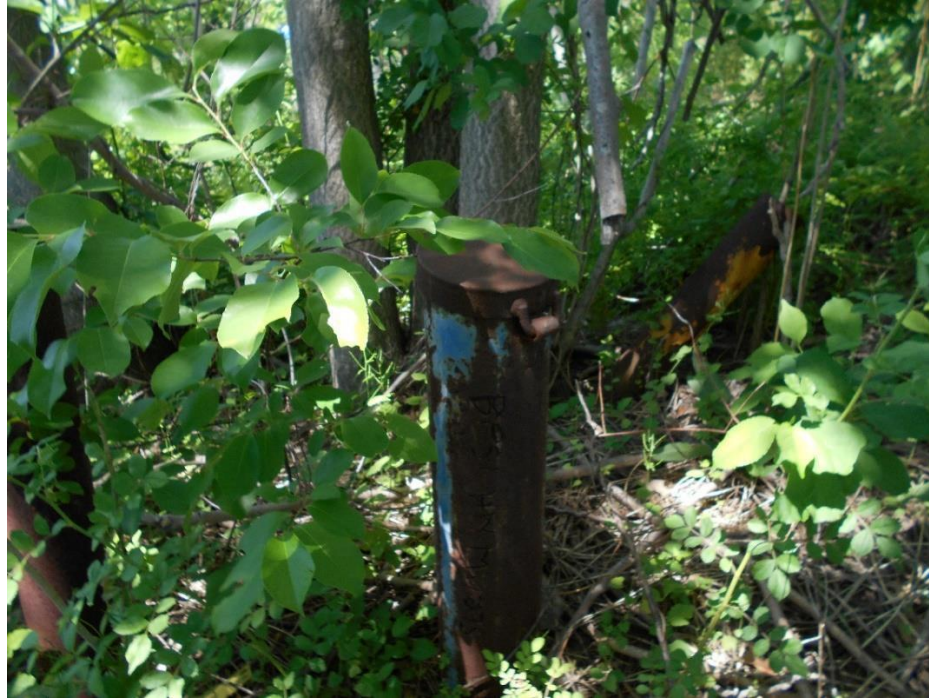
*Photo 23:* Site 1- BPS1-HN-MW27S, locked on inside, not outside

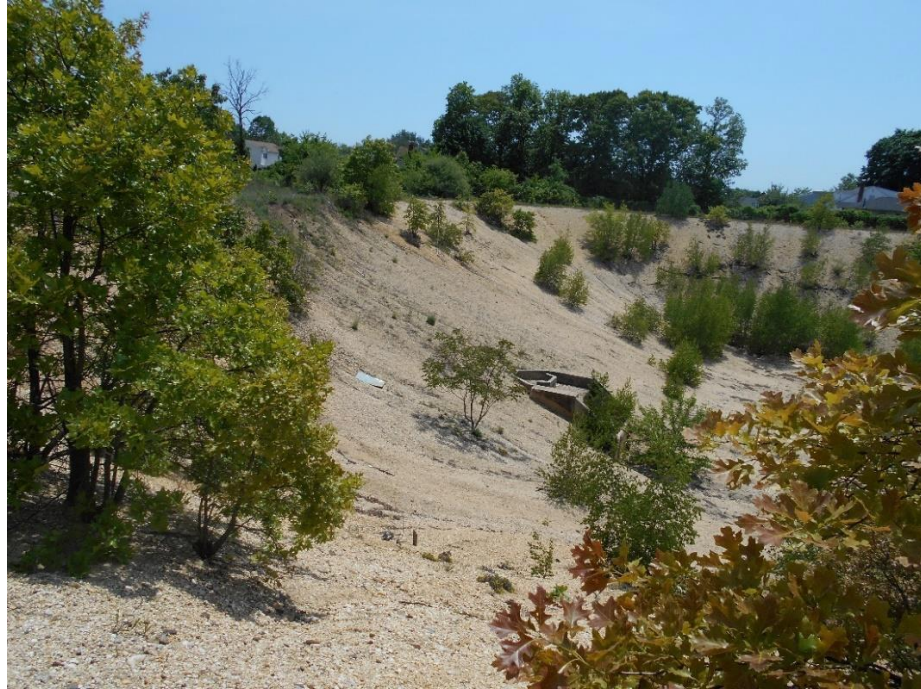
*Photo 27:* Site 2- Southeast basin facing east, slope erosion

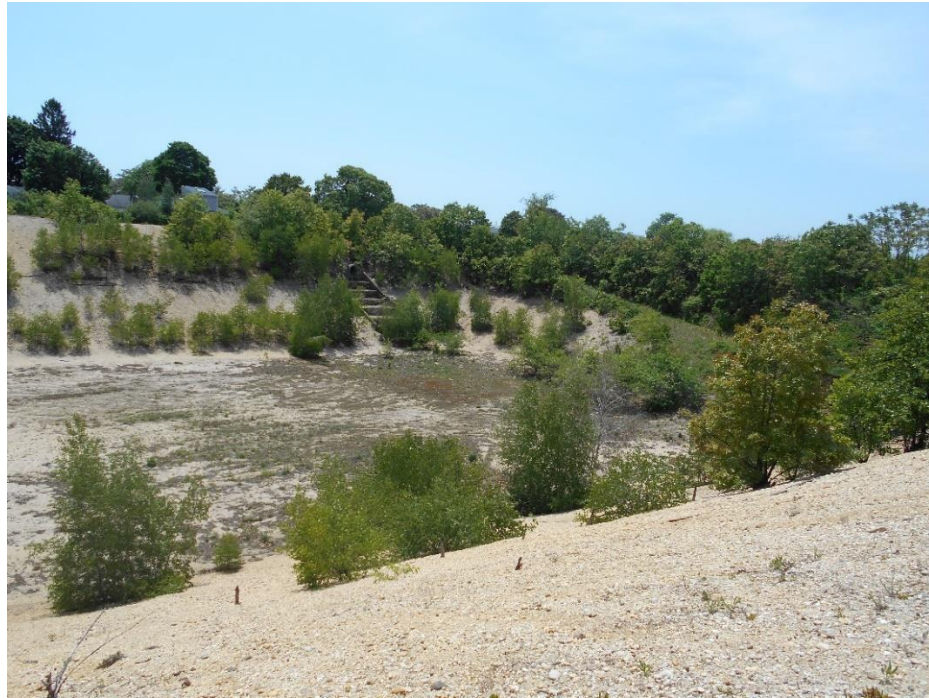
*Photo 29:* Site 2- Southeast basin outfall

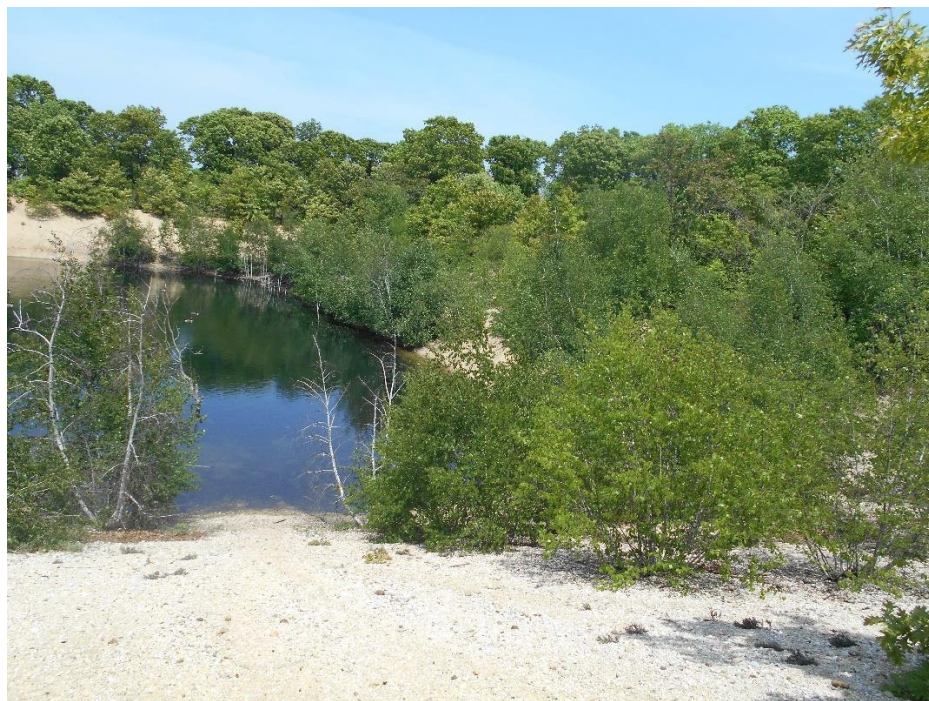
*Photo 30:* Site 2- Northeast basin facing north

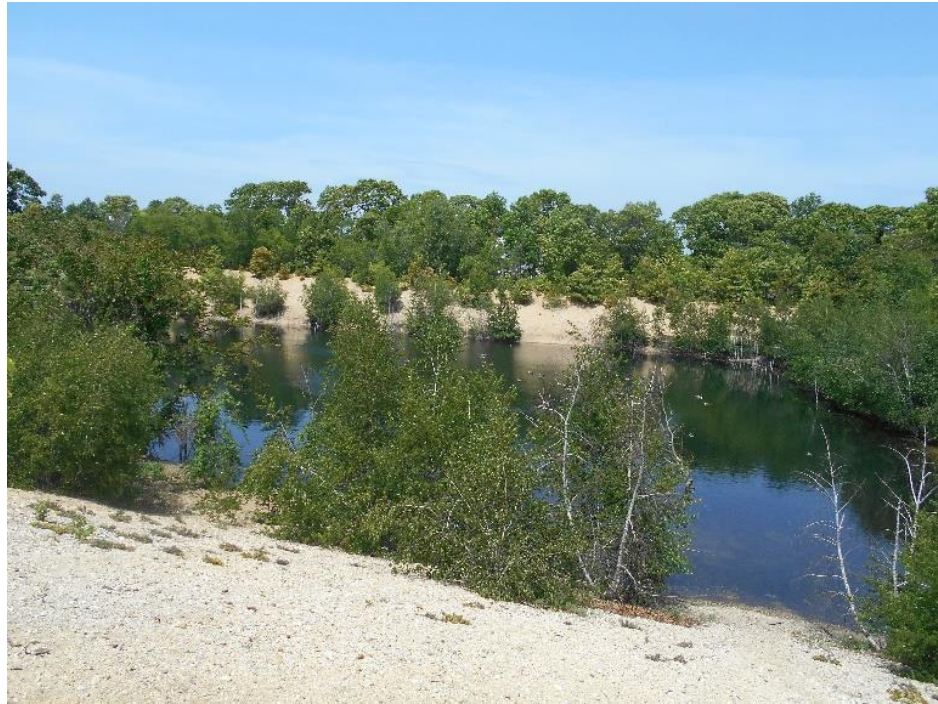
*Photo 31:* Site 2- Northeast basin facing north

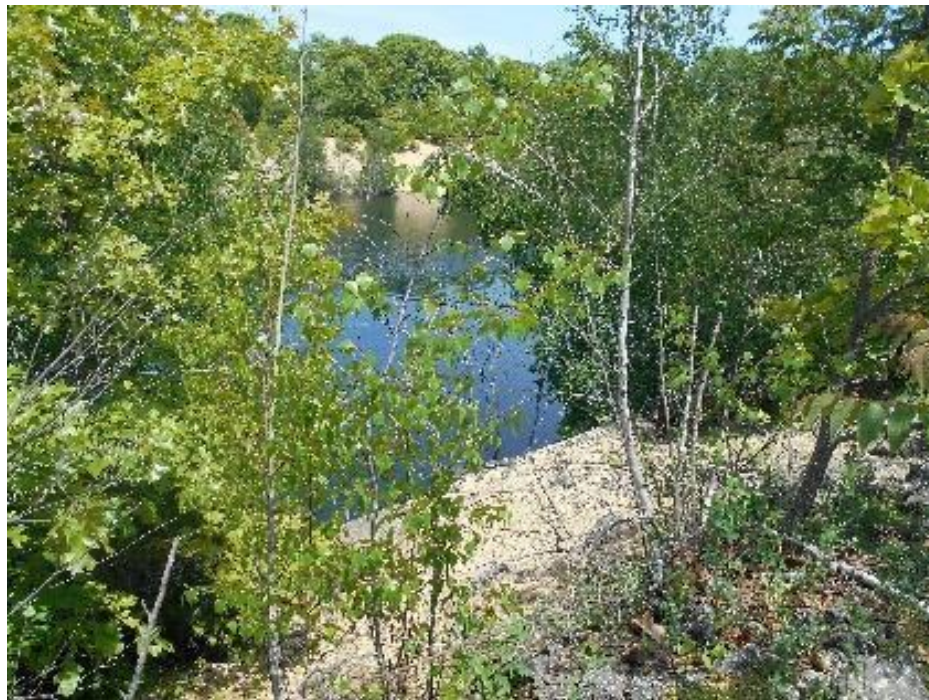
*Photo 32:* Site-2 Northeast basin facing north

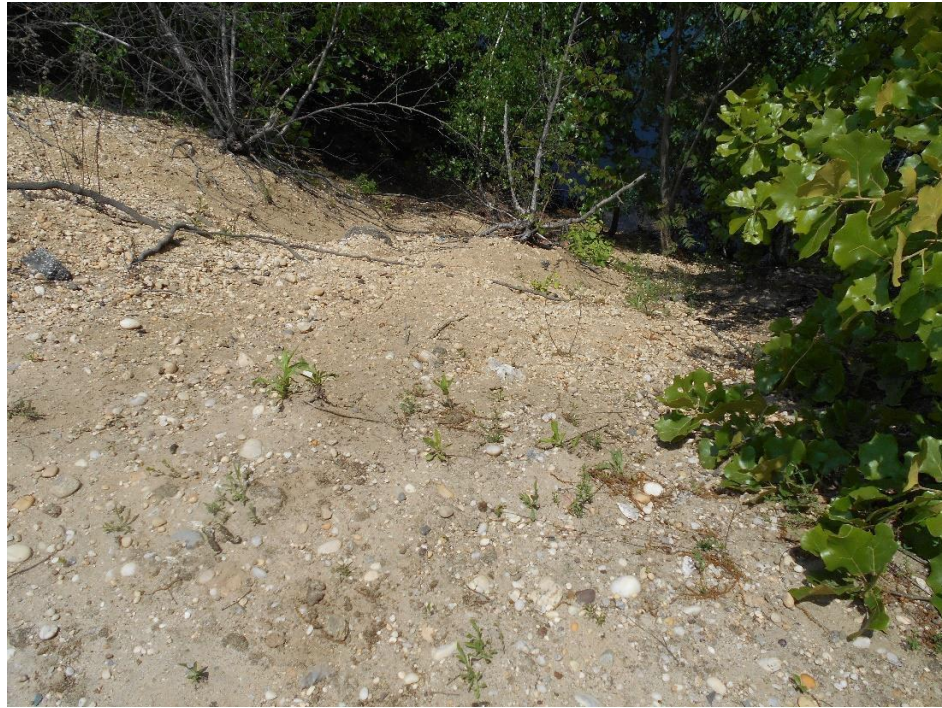
*Photo 33:* Site-2 Southeast basin down slope

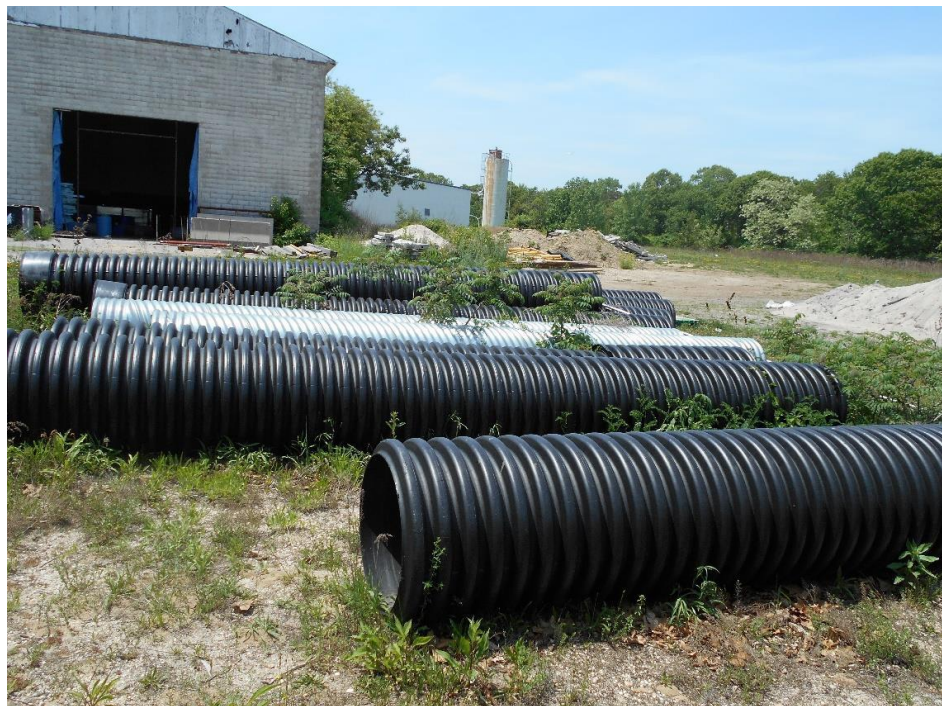
*Photo 34:* Site-2 Pipes outside salt shed

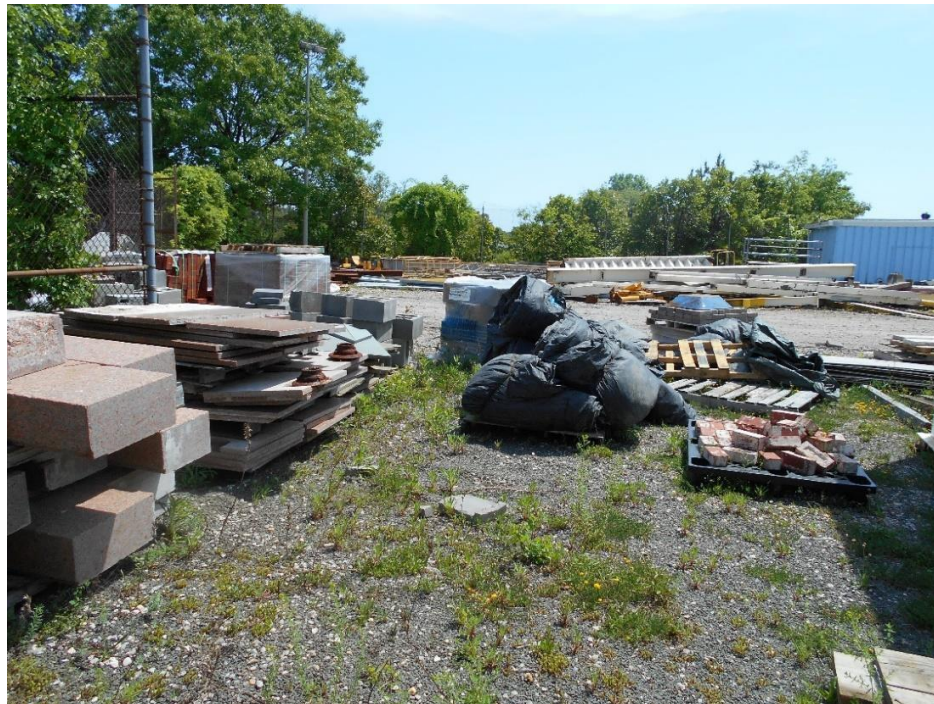
*Photo 42:* Site 3- Looking south building county building, granite blocks and various metals

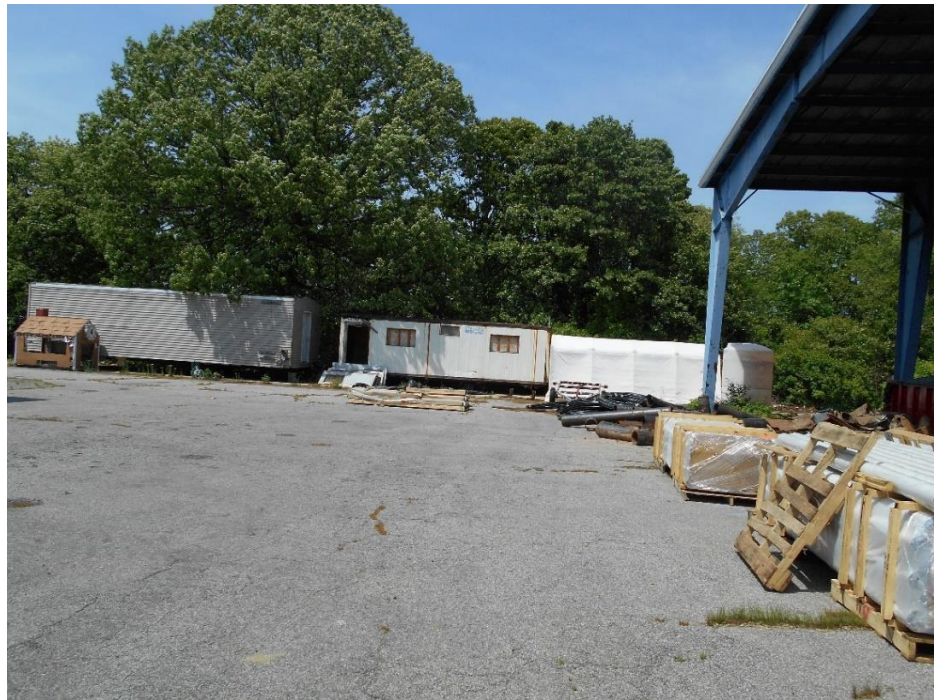
*Photo 46:* Site 3- Trailers on north side

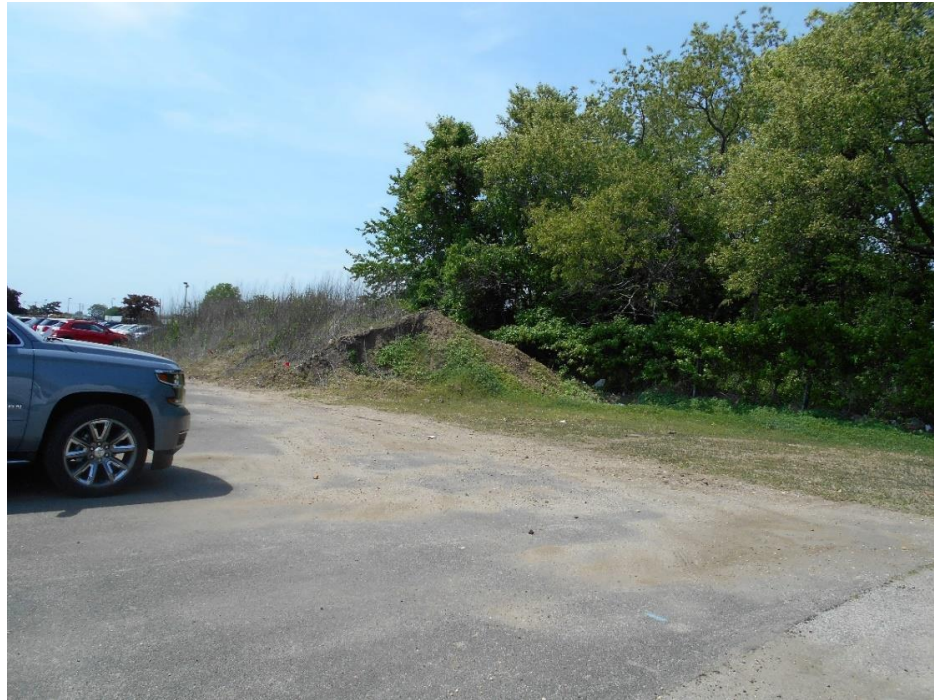
*Photo 47:* Site 3- Berm on north side
