RESOLUTION CONSULTANTS

Subject: **Well Inventory Memorandum – Navy-Owned Wells, NWIRP Bethpage**

Date: October 2020

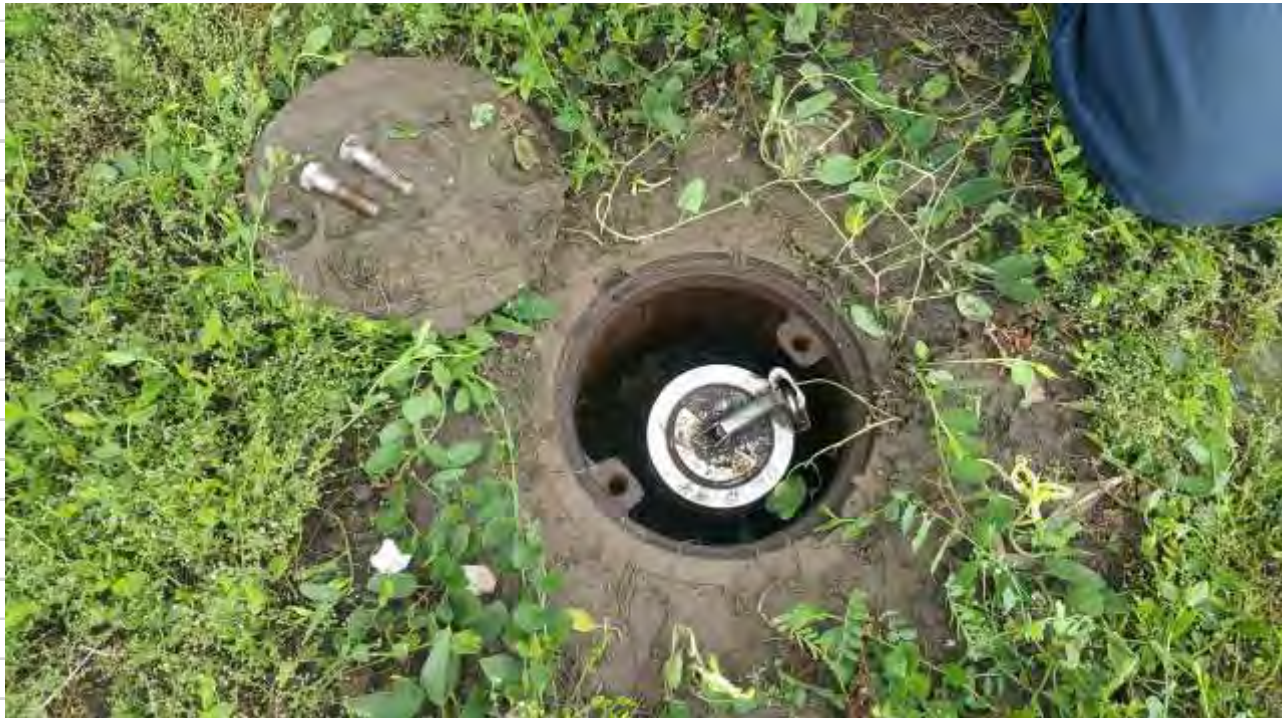
Notes: GM-73D is in good condition. There is tubing present in the well, there is a sampling port.

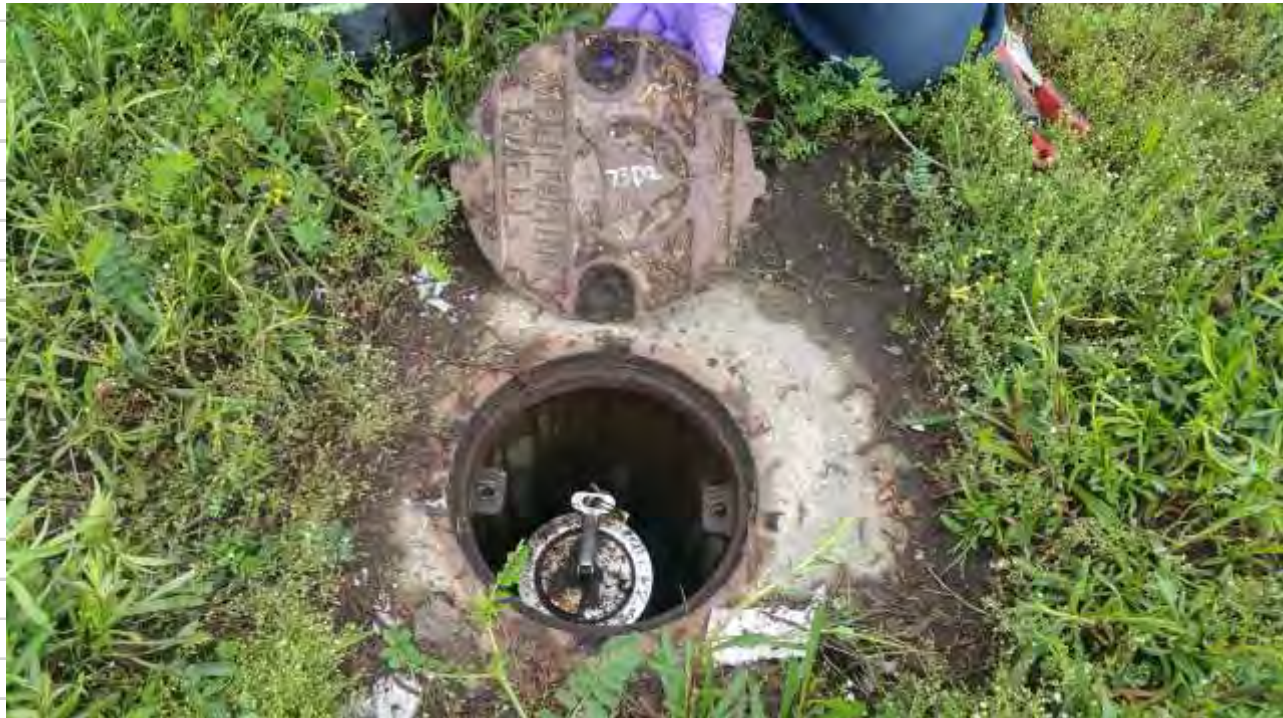
Notes: GM-73D2 is in good condition. There is tubing present in the well, there is a sampling port.

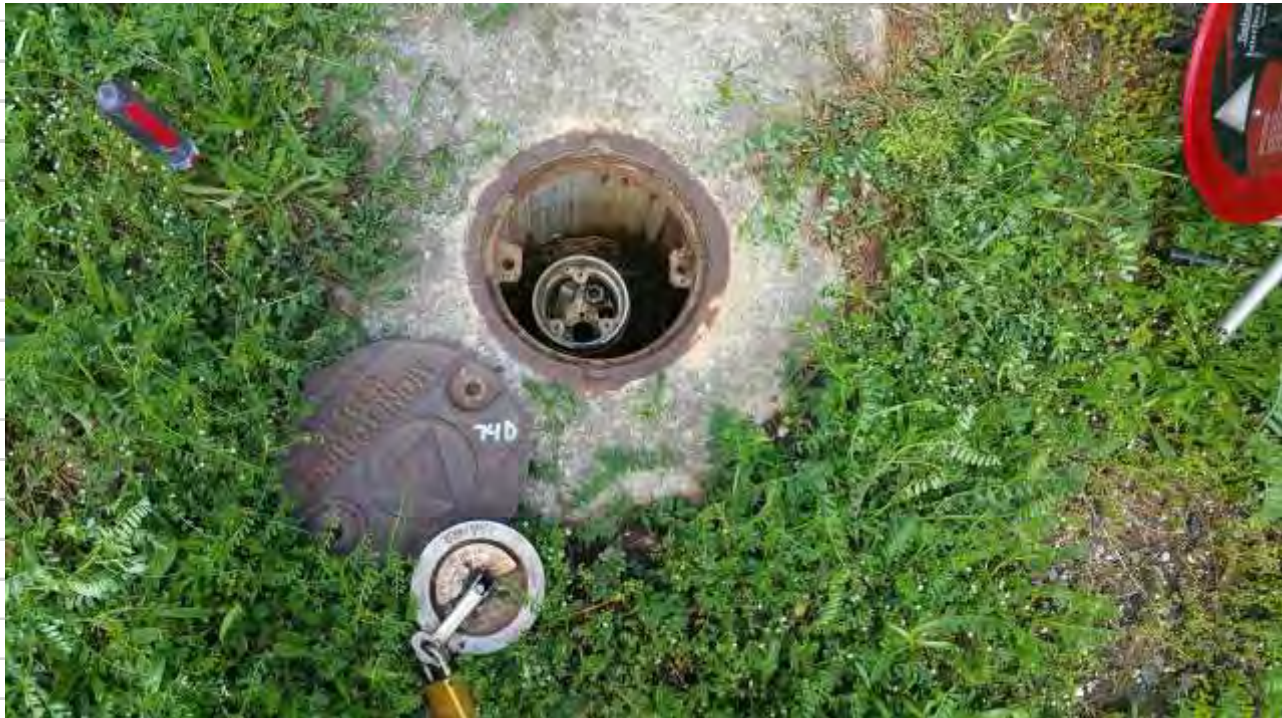
Notes: GM-74D is in fair condition. GM-74D is missing 1 bolt. there is tubing present in the well, there is a sampling port.

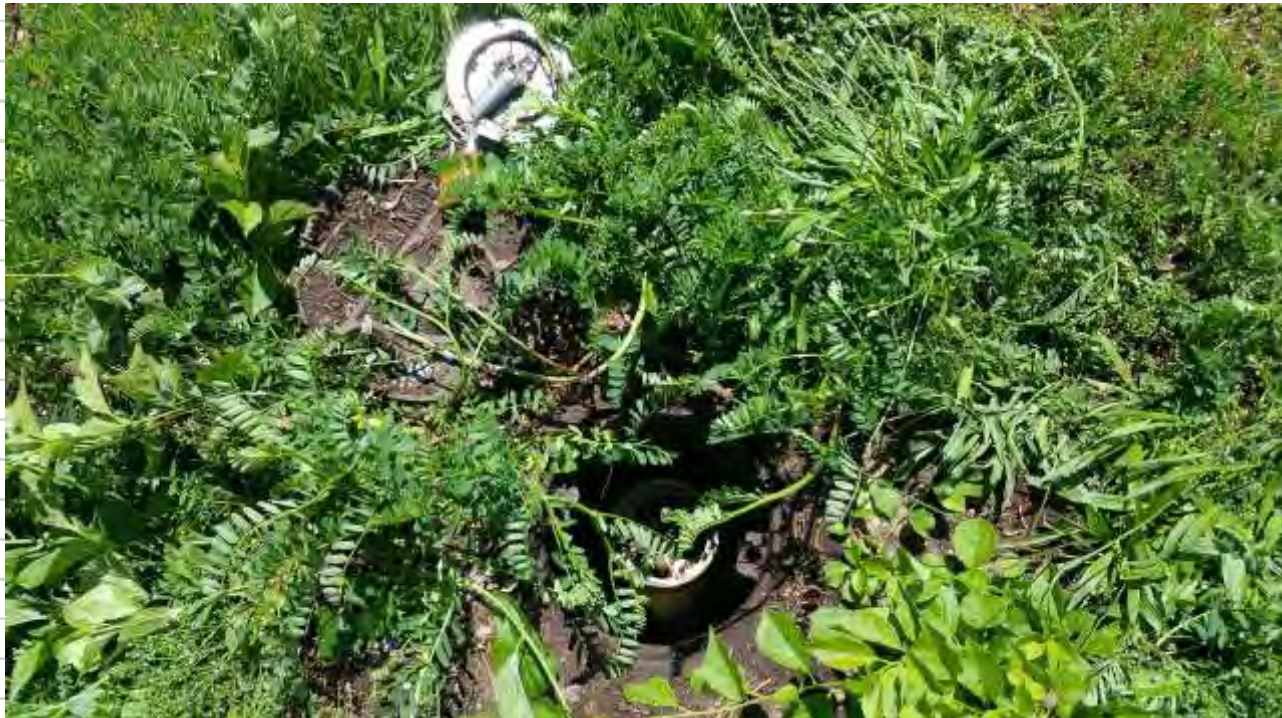
Notes: GM-74D2 is in good condition. There is tubing present in the well, there is a sampling port.

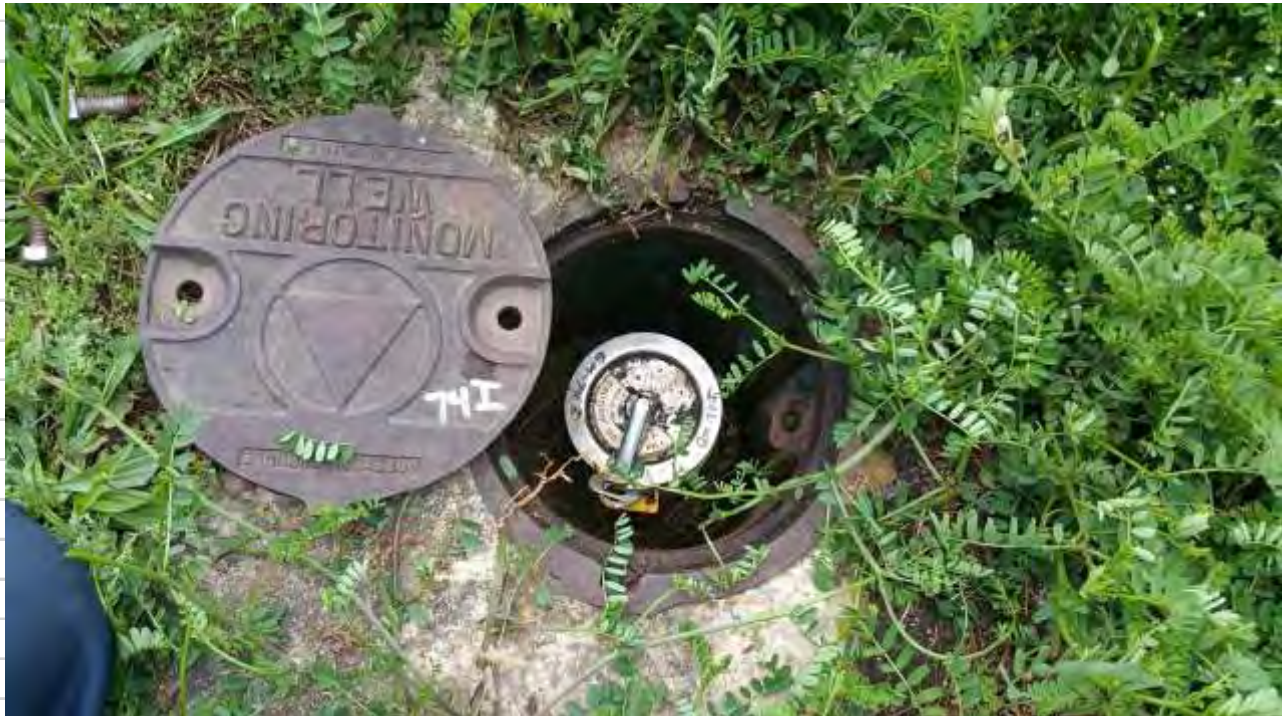
Notes: GM-74I is in good condition. There is tubing present in the well, there is a sampling port.

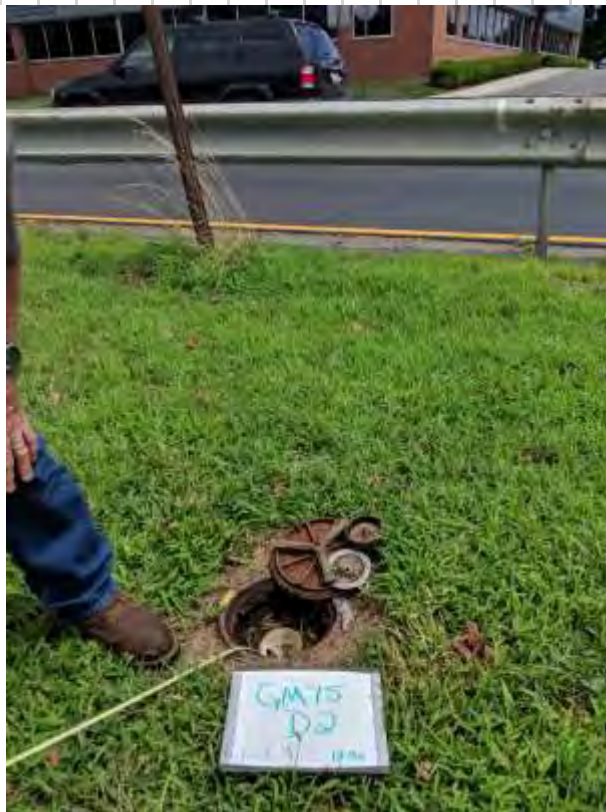
Notes: GM-75D2 is in good condition. There is tubing present in the well, there is a sampling port.

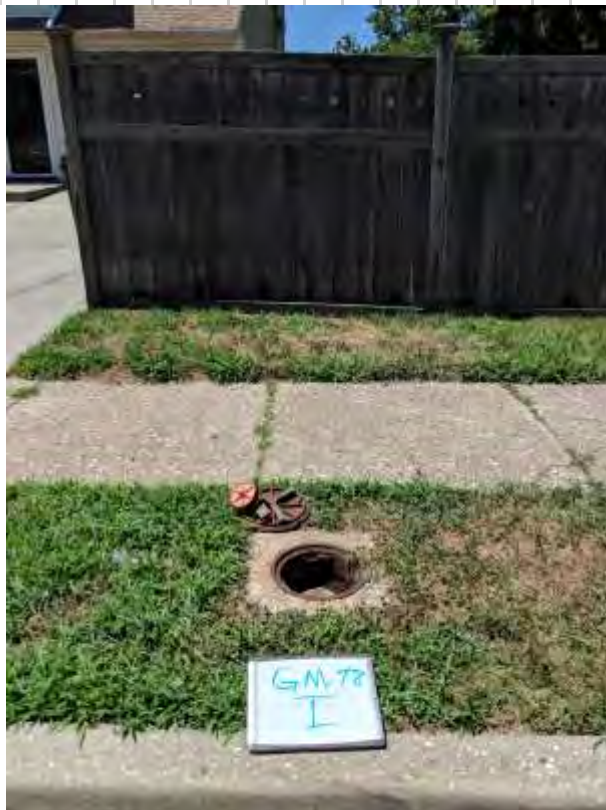
Notes: GM-78I is in good condition. There is tubing present in the well.

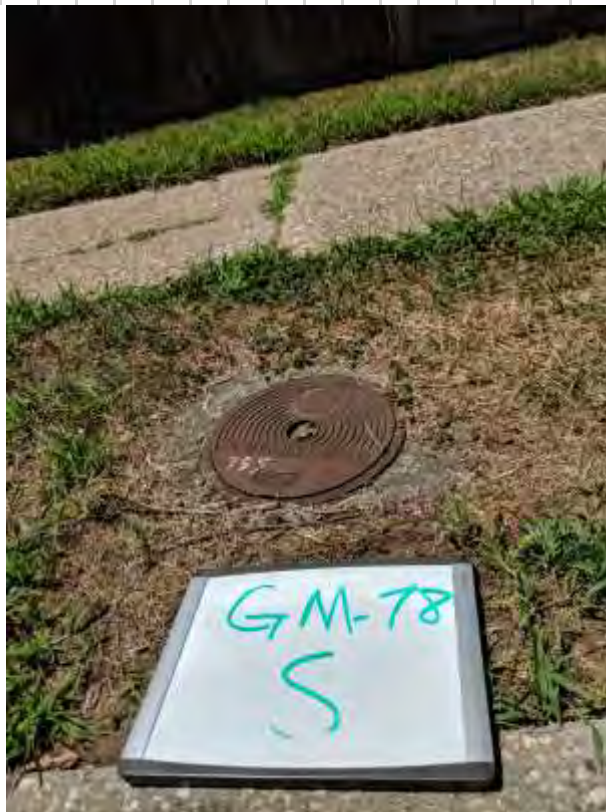
Needs Bolts: No
Needs Lock: No
Date/Time Measured: 2018-07-19 17:00:00
Depth of Water: 42.80
Depth of Boring: 69.60
Notes: GM-78S is in good condition. There is tubing present in the well.

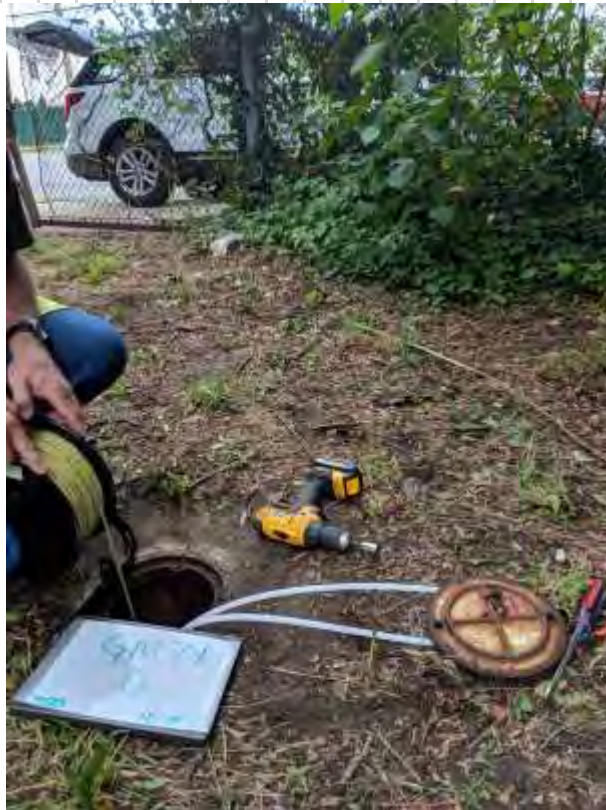
Notes: GM-79D is in fair condition. GM-79-D has no lock. There is tubing present in the well, there is a sampling port.

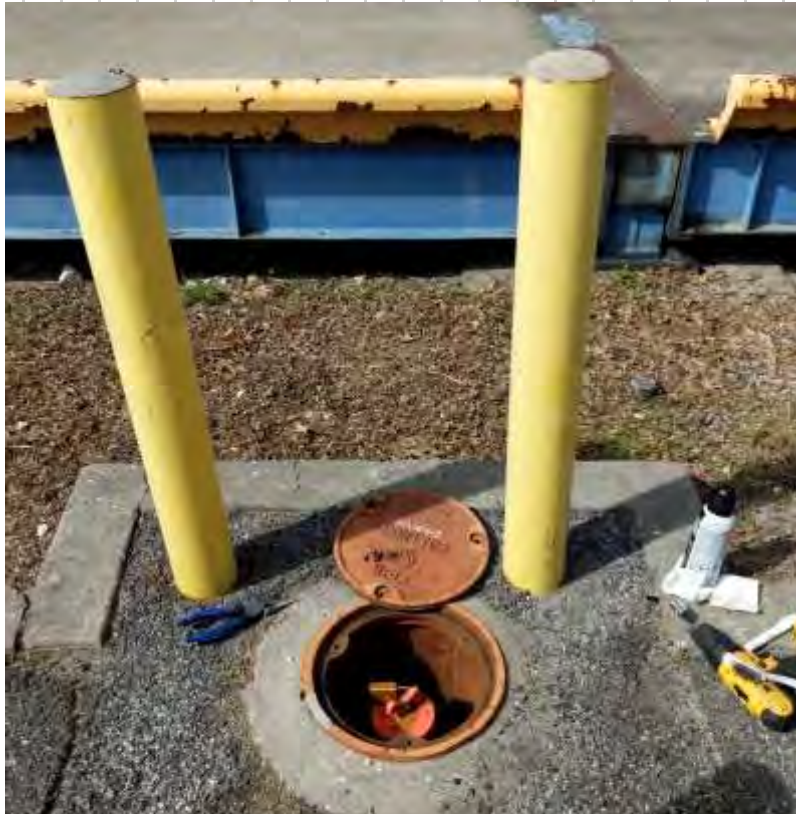
Needs Bolts: No
Needs Lock: No
Date/Time Measured: 2018-07-24 13:39:04
Depth of Water: 54.04
Depth of Boring: 159.3
Notes: HN-24I is in good condition.
 There is tubing present in the well.

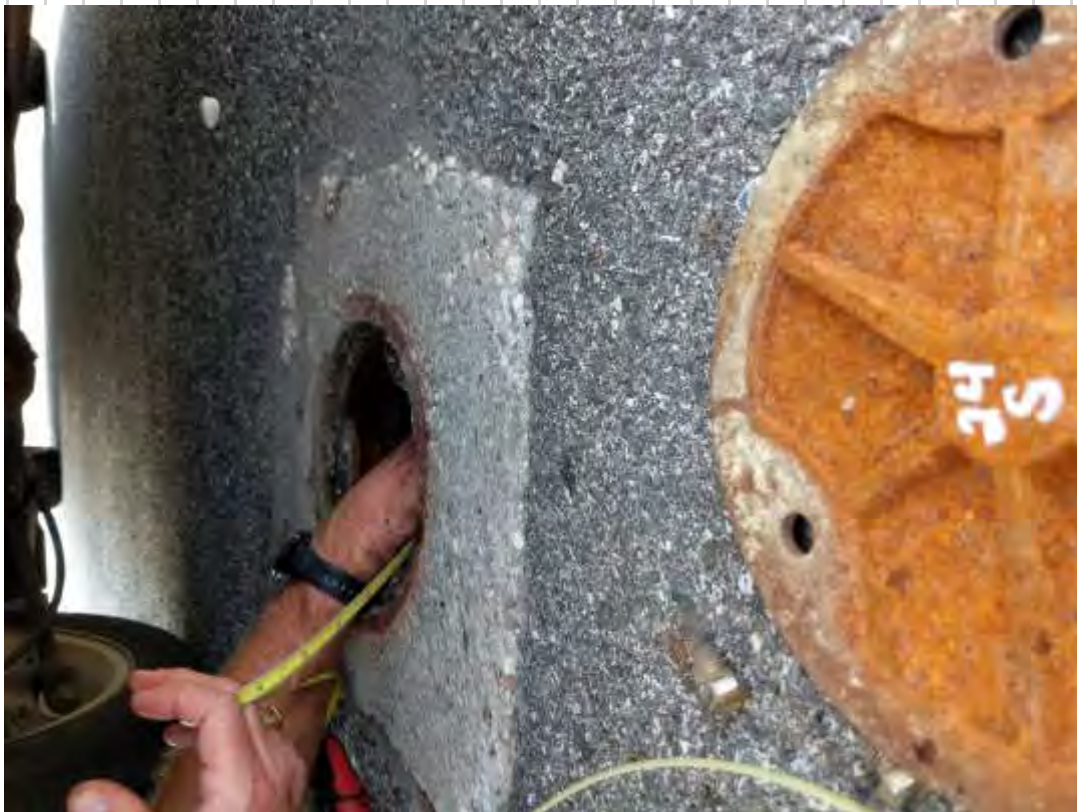
Notes: HN-24S is in good condition. There is tubing present in the well.

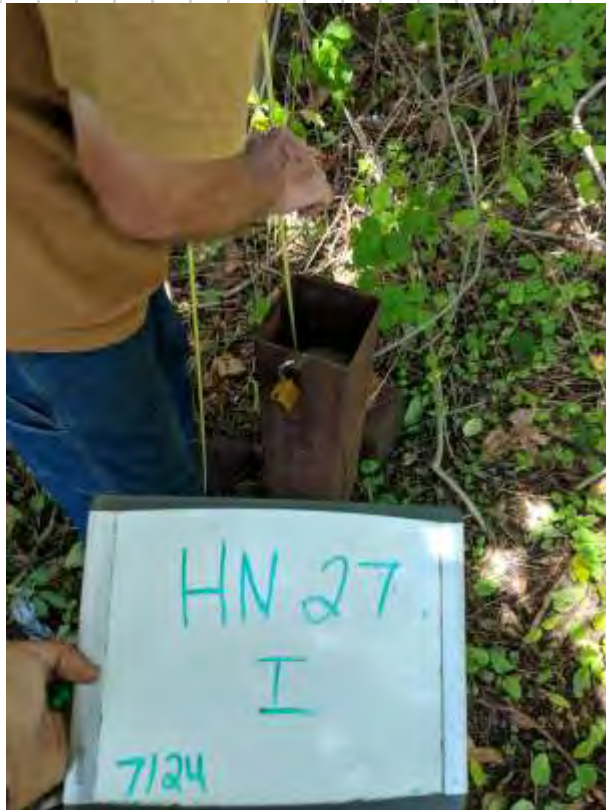
Notes: HN-27I is in good condition. There is tubing present in the well.

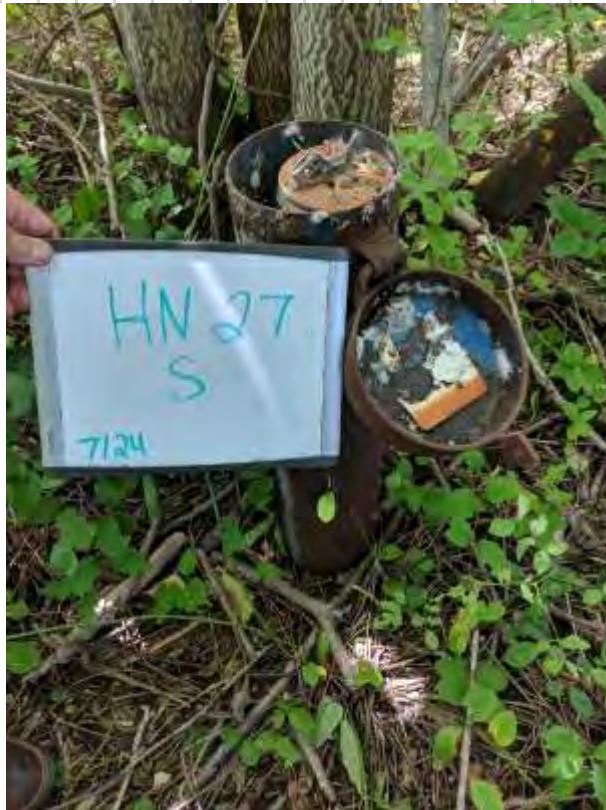
Needs Bolts: No
Needs Lock: No
Date/Time Measured: 2018-07-24 18:00:00
Depth of Water: 55.09
Depth of Boring: 55.40
Notes: HN-27S is in good condition. The well is dry.

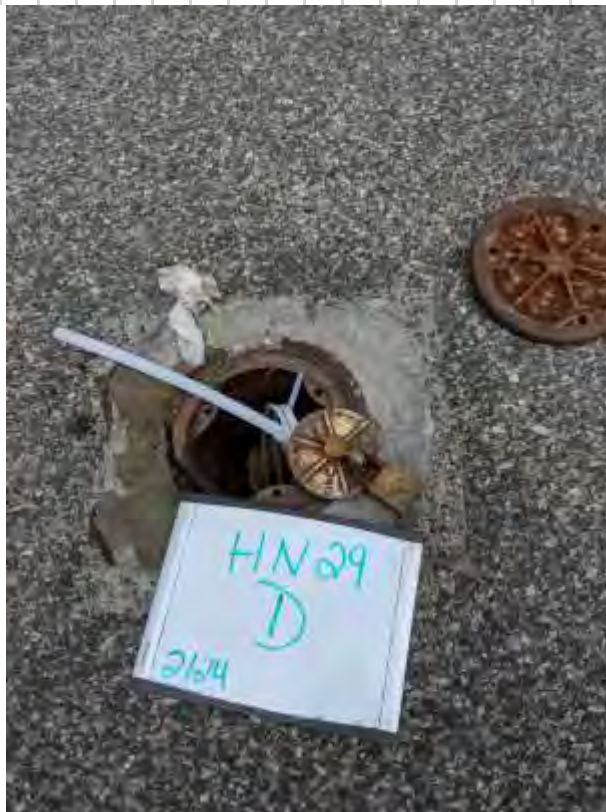
Notes: HN-29D is in good condition. There is tubing present in the well.

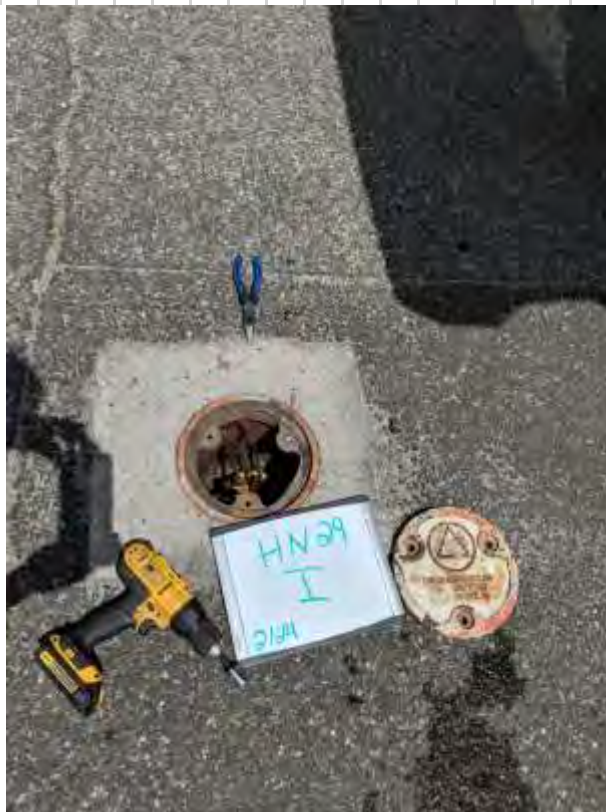
Needs Bolts: No
Needs Lock: No
Date/Time Measured: 2018-07-24 16:45:00
Depth of Water: 48.56
Depth of Boring: 127.25
Notes: HN-29I is in poor condition. 28% of screen is silted.

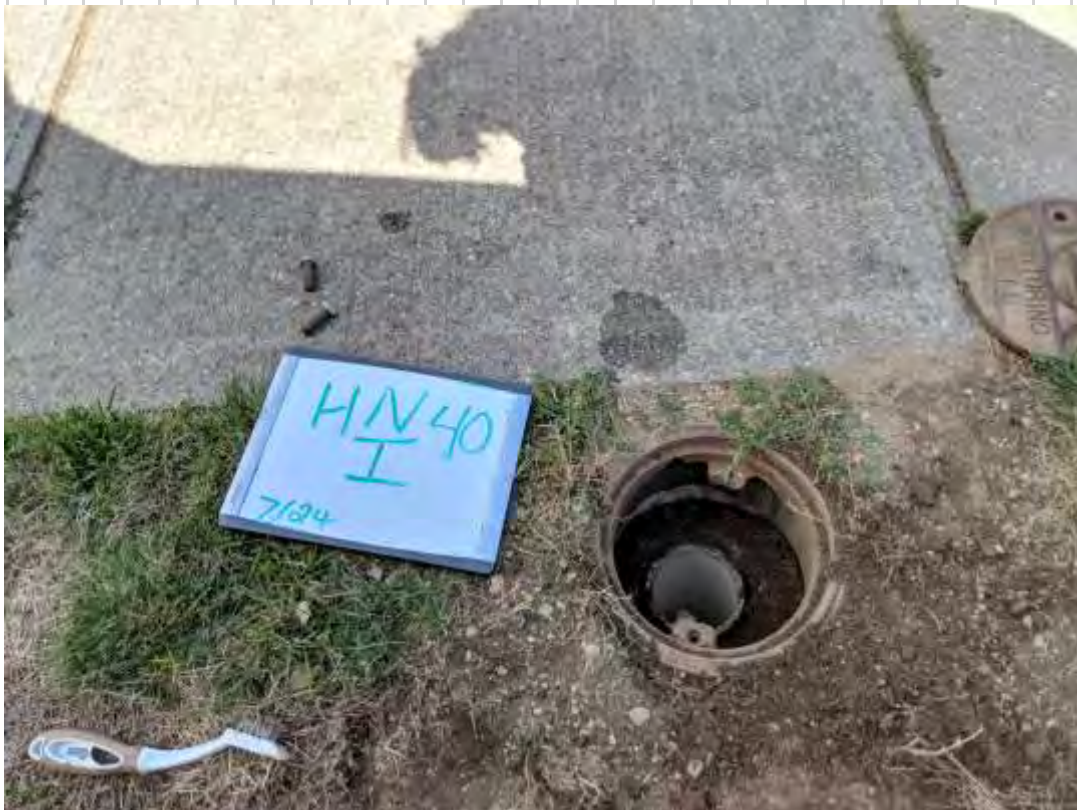
Notes: HN-40I is in good condition. There is tubing present in the well.

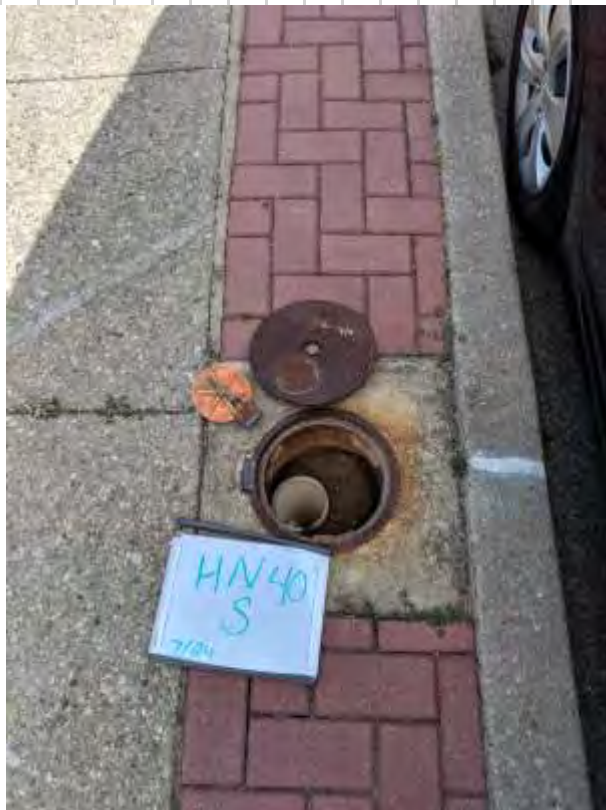
Notes: HN-40S is in good condition. There is tubing present in the well.

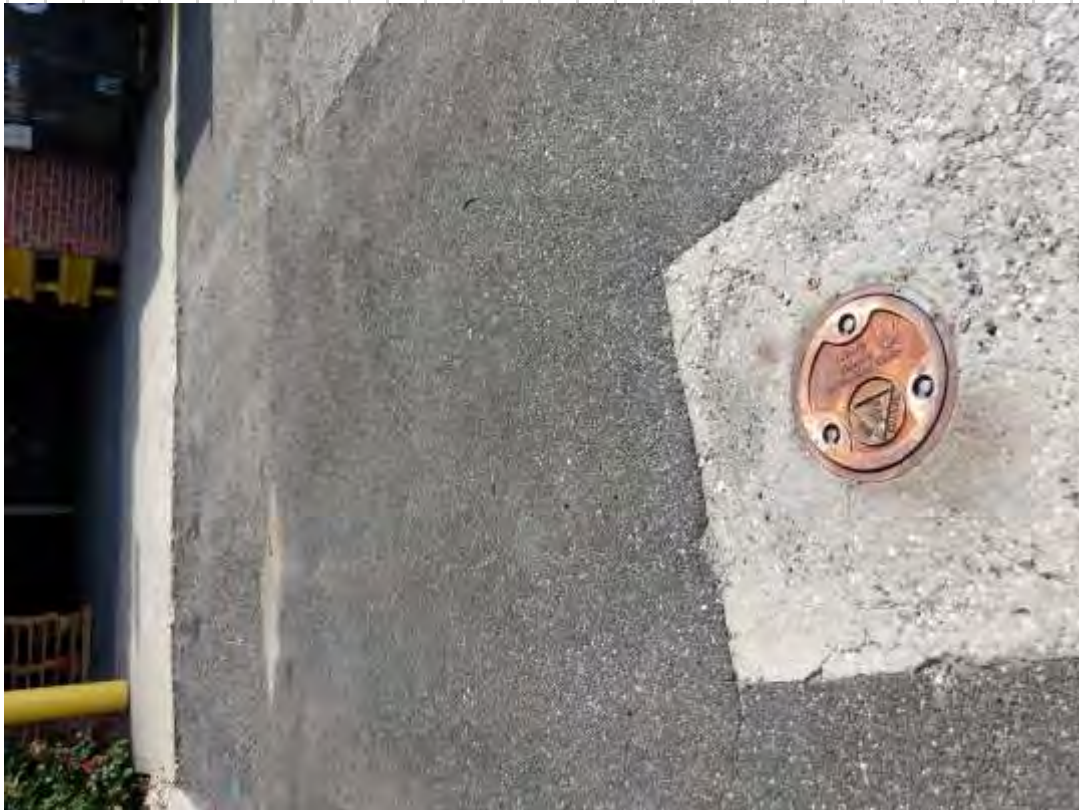
Needs Bolts: No
Needs Lock: No
Date/Time Measured: 2018-07-24 13:13:55
Depth of Water: 54.44
Depth of Boring: 64.6
Notes: MW-03 is in good condition.
 There is a bailer present in the well.

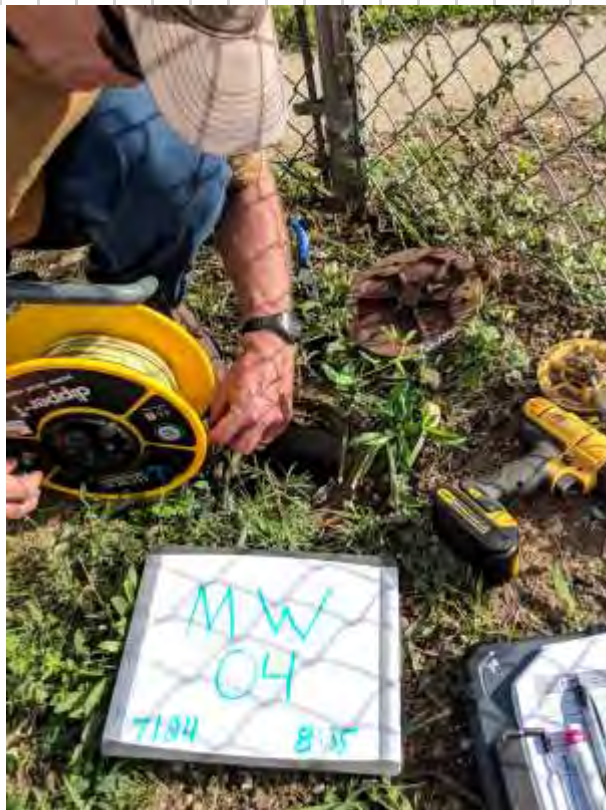
Notes: MW-04 is in fair condition. MW-04 is missing 2 bolts. There is tubing present in the well.

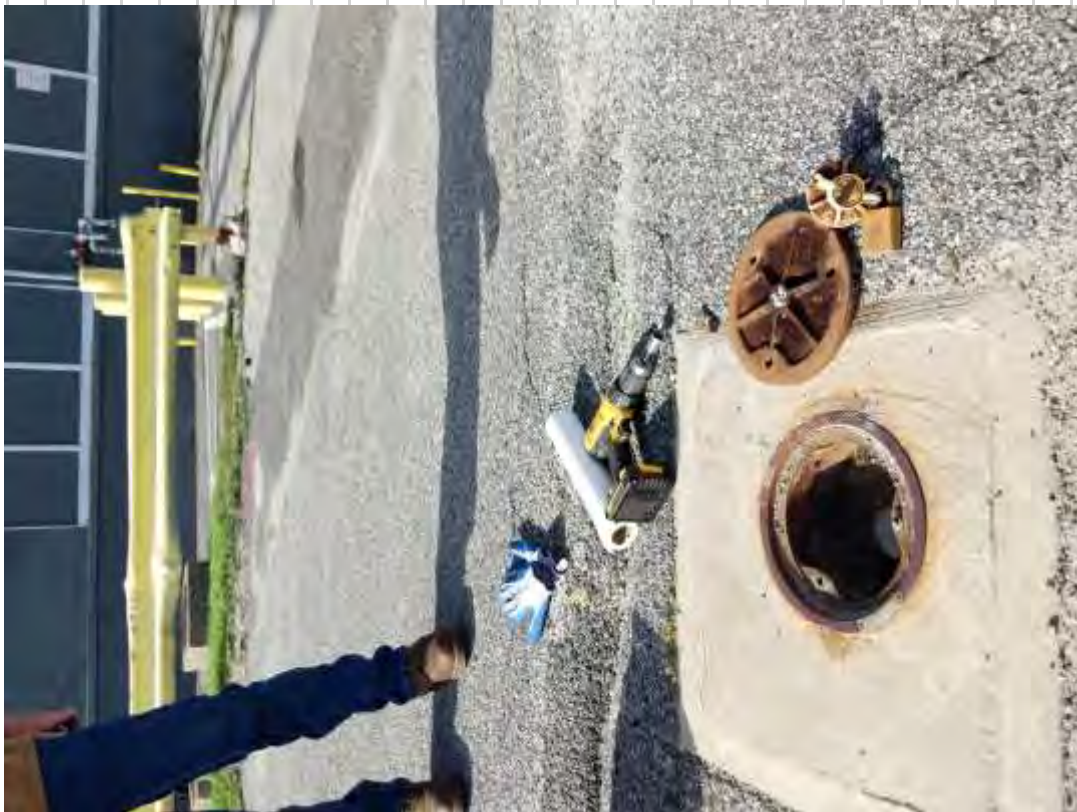
Needs Bolts: Yes
Needs Lock: No
Date/Time Measured: 2018-07-24 12:49:20
Depth of Water: 50.63
Depth of Boring: 61.9
Notes: MW-06 is in fair condition. MW-06 is missing 1 bolt.

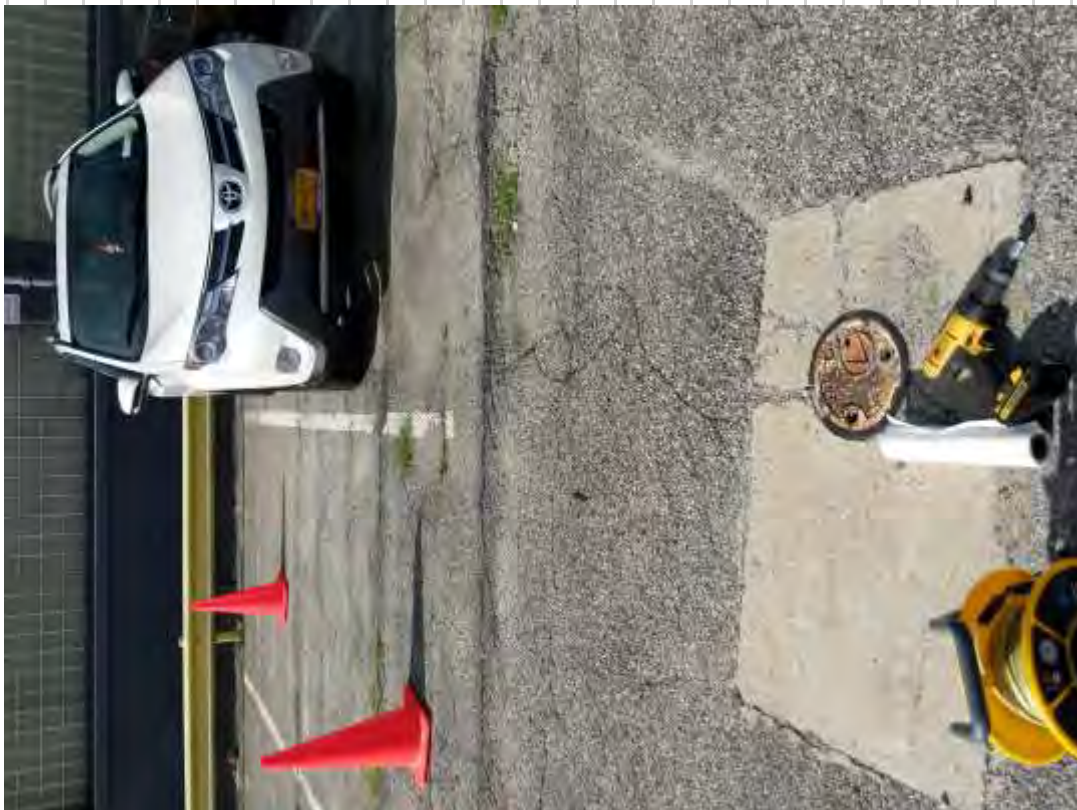
Needs Bolts: Yes
Needs Lock: No
Date/Time Measured: 2018-07-24 12:58:59
Depth of Water: 50.34
Depth of Boring: 61.75
Notes: MW-07 is in fair condition. Cracked pad, tubing in well, missing 1 bolt.

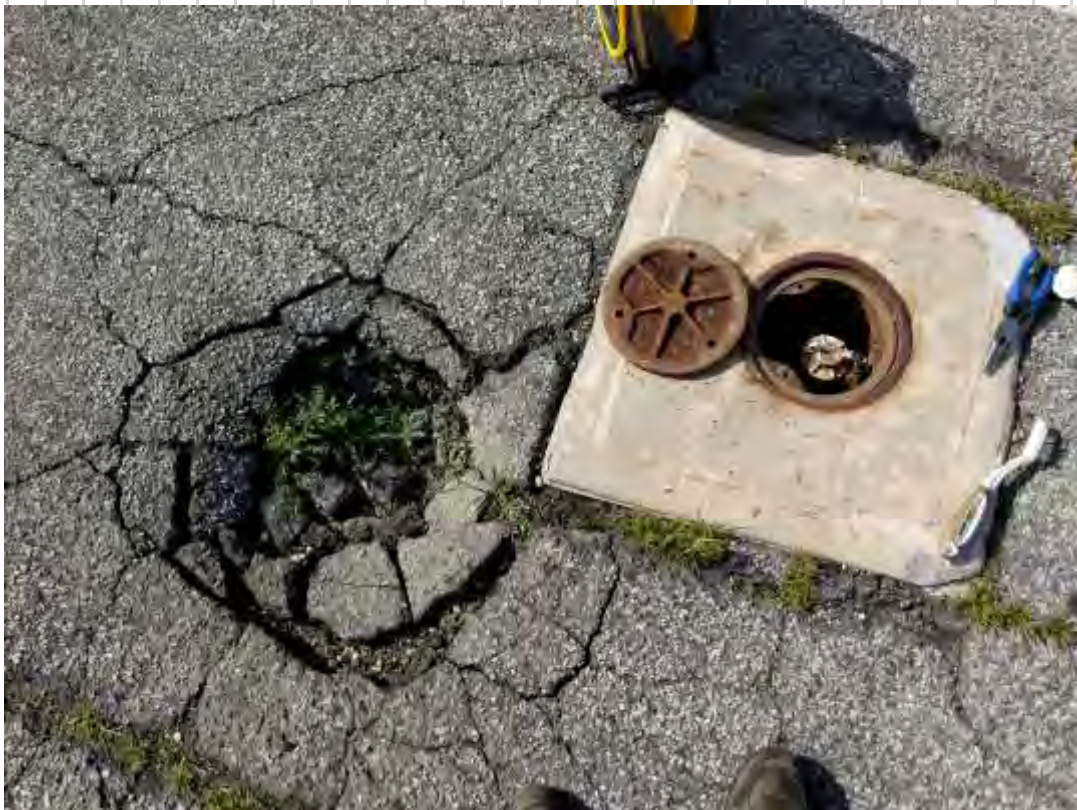
Needs Bolts: Yes
Needs Lock: No
Date/Time Measured: 2018-07-24 13:03:31
Depth of Water: 51.10
Depth of Boring: 61.80
Notes: MW-08 is in fair condition. MW-08 is missing 3 bolts.

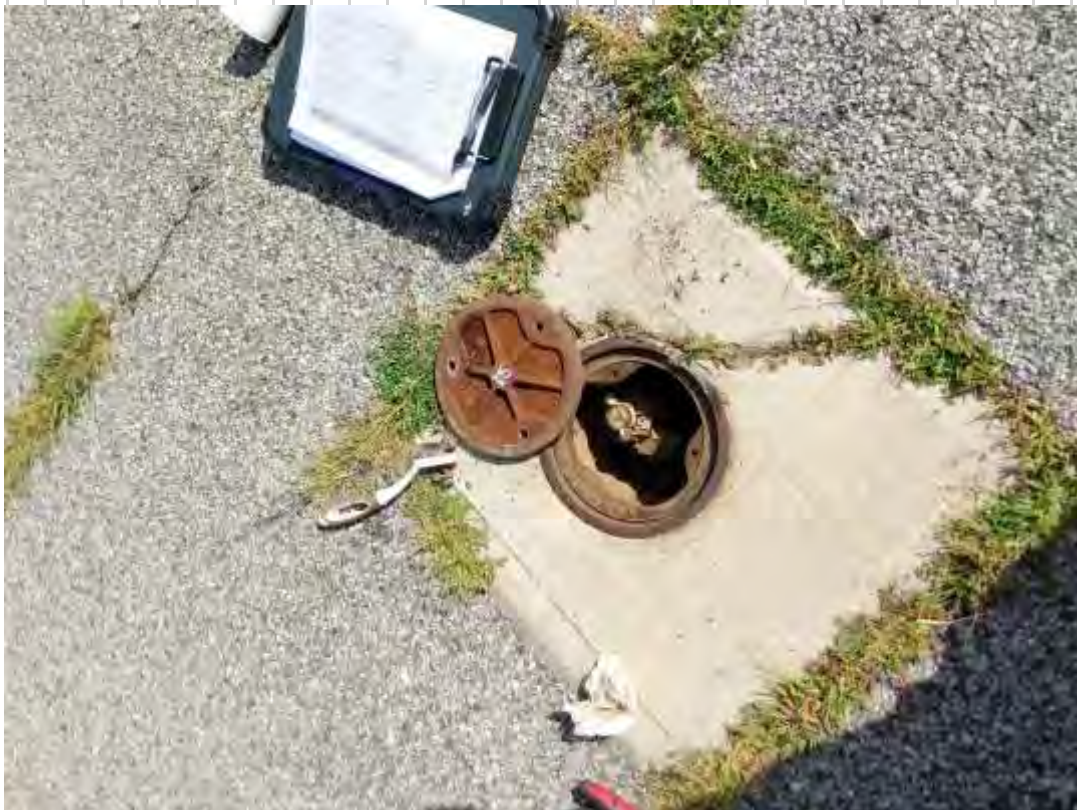
Needs Bolts: No
Needs Lock: No
Date/Time Measured: 2018-07-24 13:07:22
Depth of Water: 51.75
Depth of Boring: 62.80
Notes: MW-09 is in fair condition. The pad is cracked

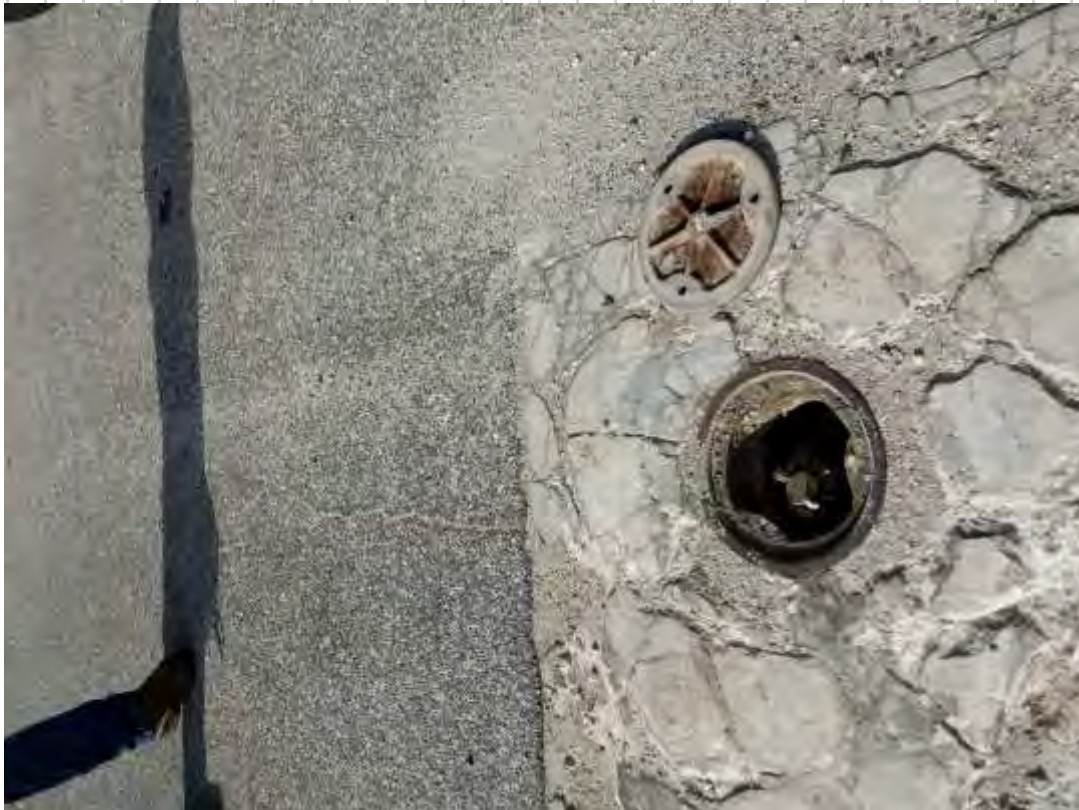
Needs Bolts: Yes
Needs Lock: No
Date/Time Measured: 2018-07-24 12:45:15
Depth of Water: 49.06
Depth of Boring: 59.05
Notes: MW-10 is in fair condition. Needs three bolts, pad is cracked.

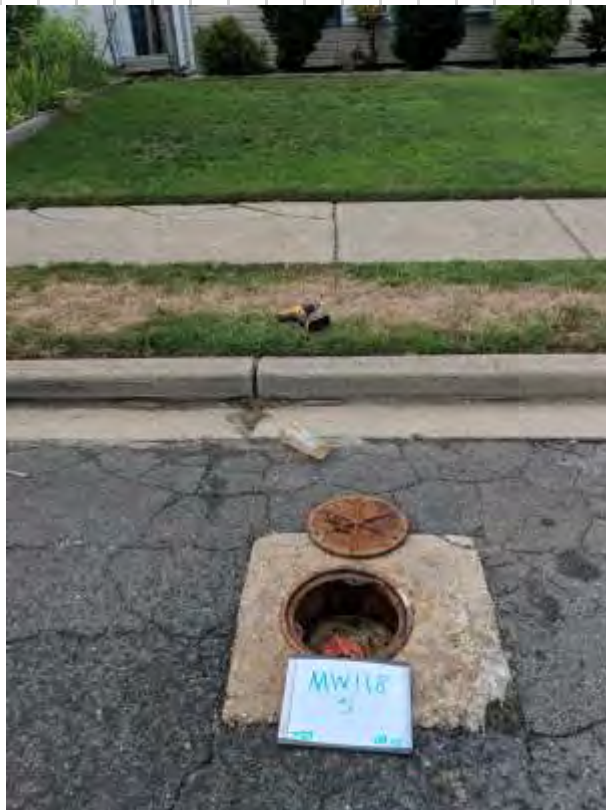
Needs Bolts: No
Needs Lock: Yes
Date/Time Measured: 2018-07-23 13:41:28
Depth of Water: 38.20
Depth of Boring: 742.25
Notes: MW-118-5 is in fair condition. MW-118-5 has no lock.

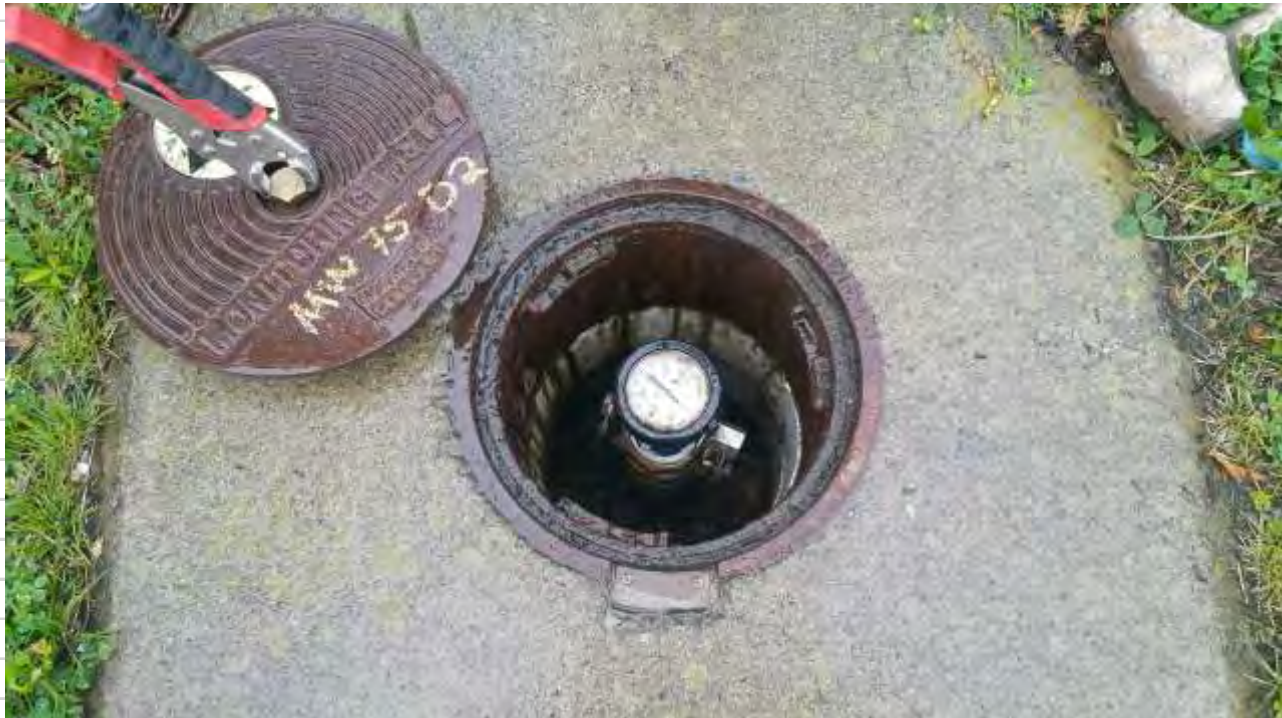
Notes: MW-75D2 is in good condition. MW-75D2 has a pressure gauge attached to the well cap.

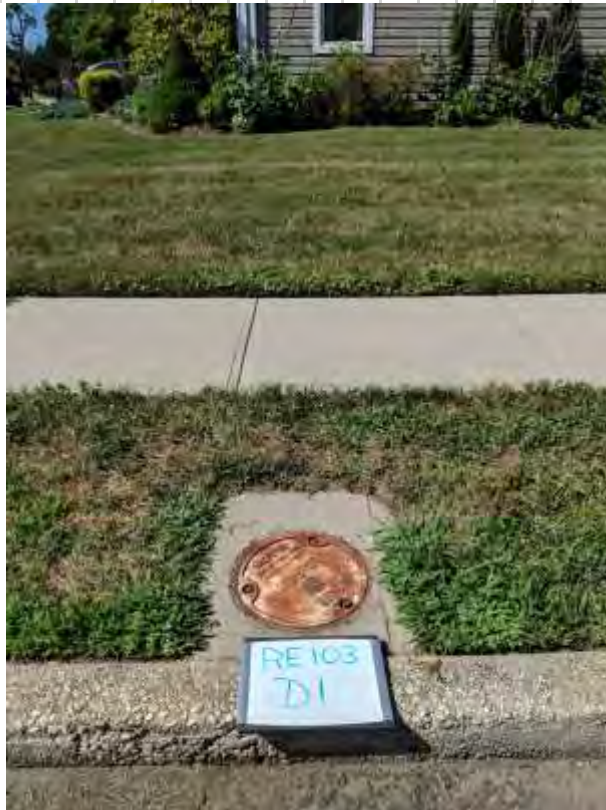
Notes: RE103D1 is in fair condition. RE103D1 has 3 stripped tabs, which need to be retapped.

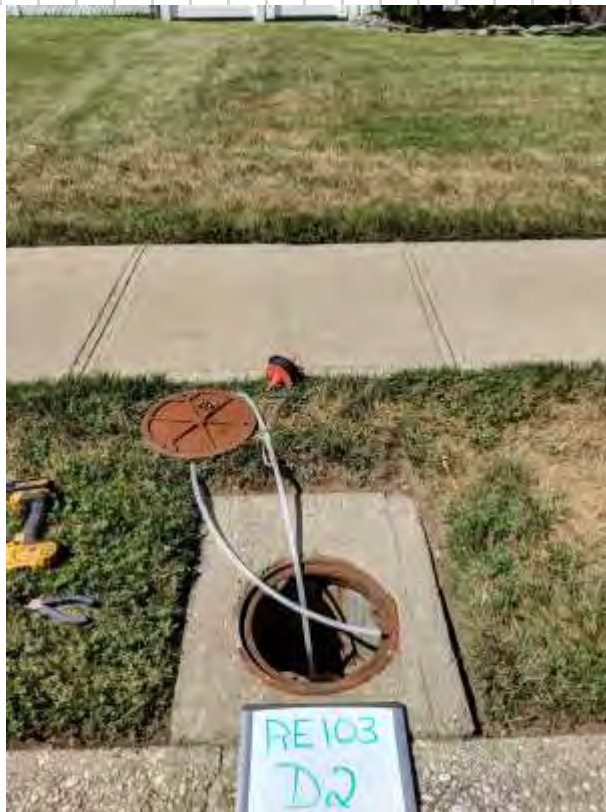
Notes: RE103D2 is in good condition. There is tubing present in the well.

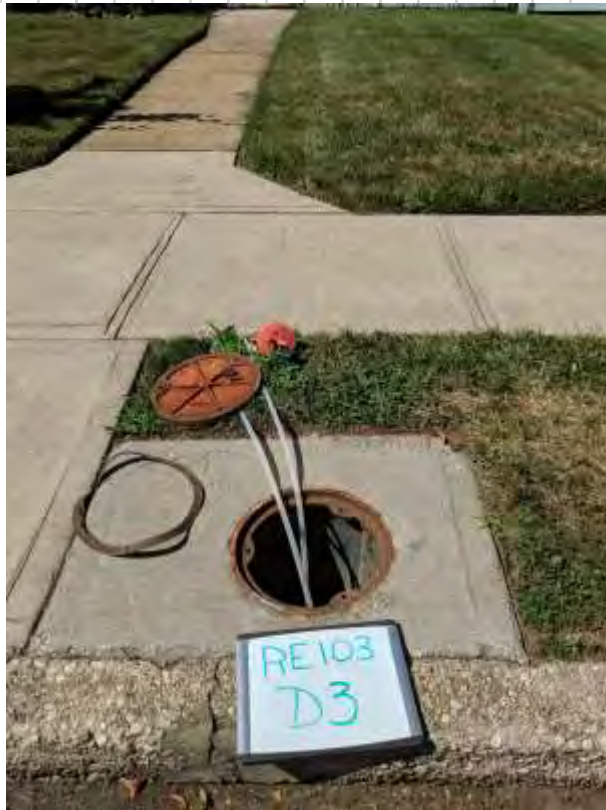
Notes: RE103D3 is in good condition. There is tubing present in the well.

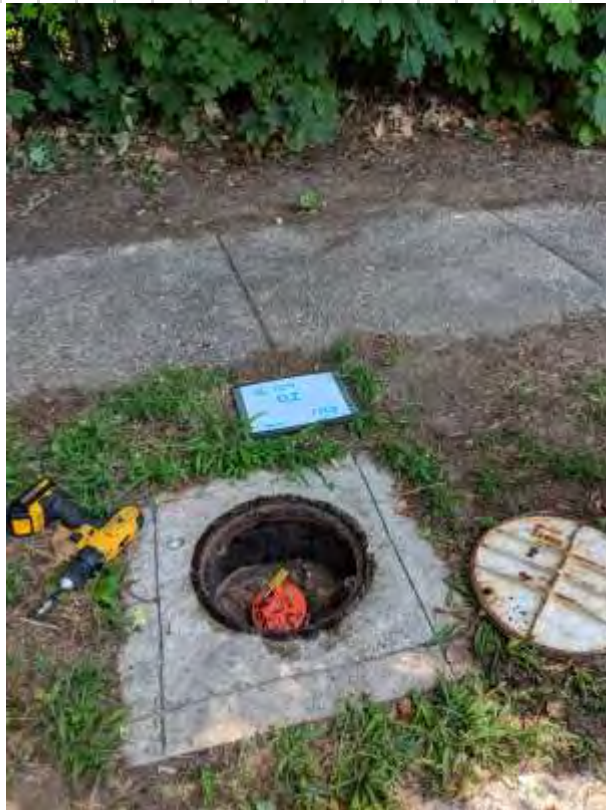
Needs Bolts: No
Needs Lock: No
Date/Time Measured: 2018-07-20 18:15:00
Depth of Water: 37.29
Depth of Boring: 375.55
Notes: RE104D1 is in good condition.

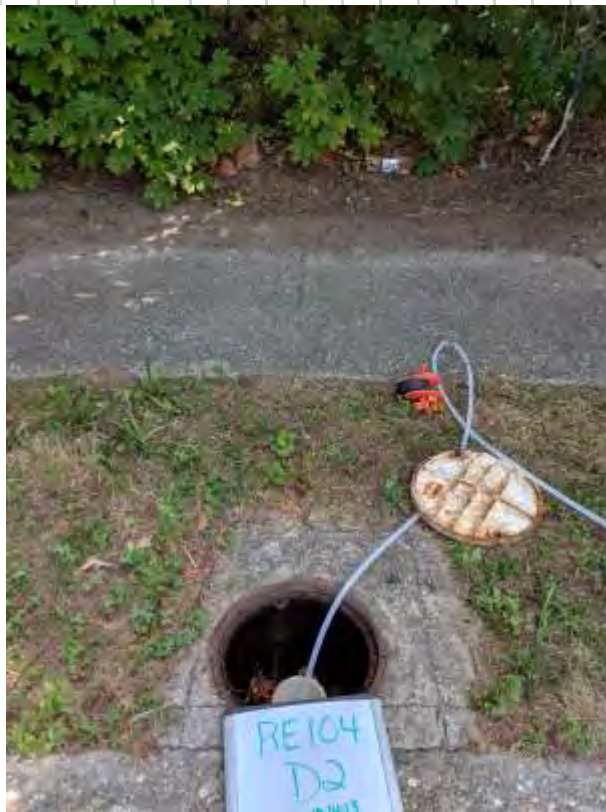
Notes: RE104D2 is in good condition. There is tubing present in the well.

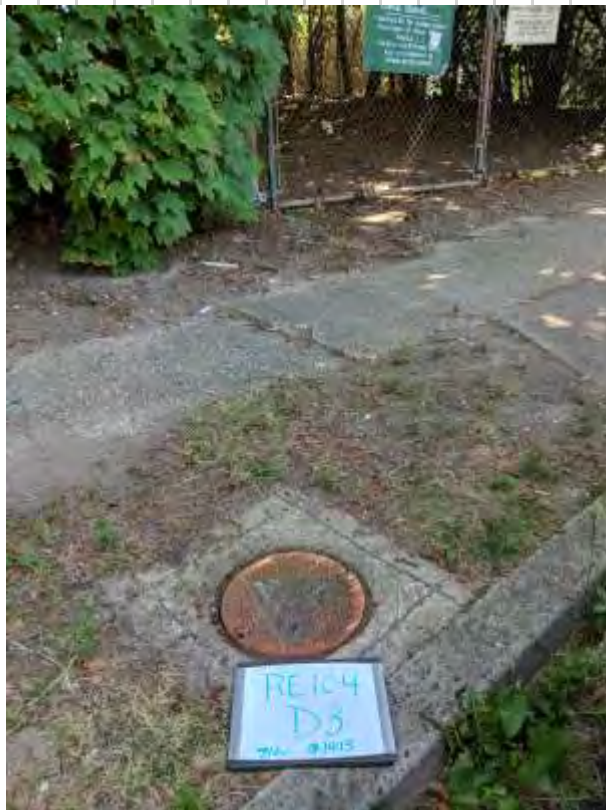
Notes: RE104D3 is in fair condition. RE104D3 is missing 1 bolt. There is tubing present in the well.

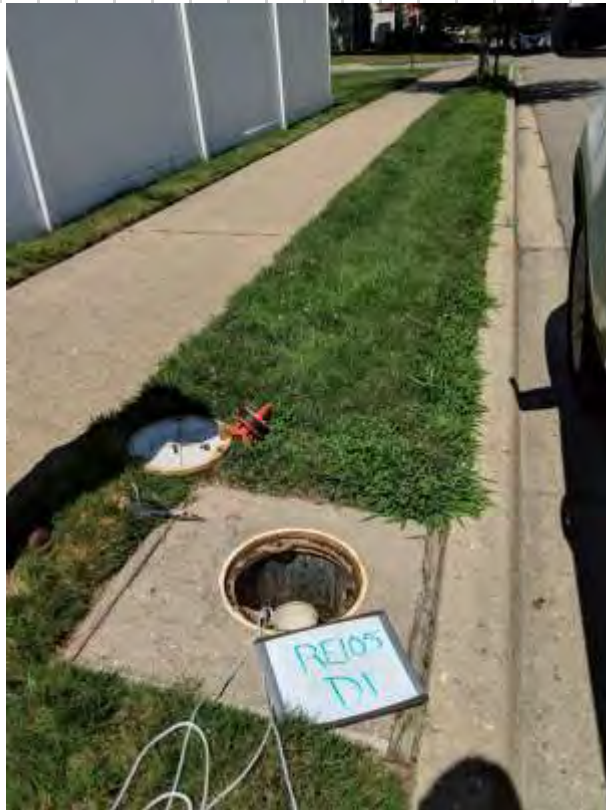
Needs Bolts: Yes
Needs Lock: No
Date/Time Measured: 2018-07-19 18:45:00
Depth of Water: 40.15
Depth of Boring: 555.35
Notes: RE105D1 is in fair condition. RE105D1 is missing 1 bolt.
