RESOLUTION CONSULTANTS

Subject: **Well Inventory Memorandum – Navy-Owned Wells, NWIRP Bethpage**

Date: October 2020

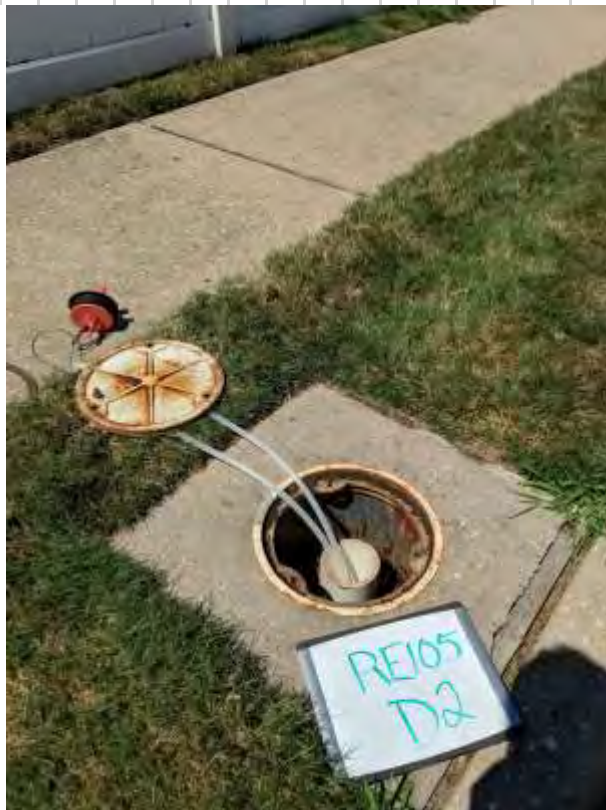
Notes: RE105D2 is in fair condition. RE105D2 needs 1 bolt. There is tubing present in the well.

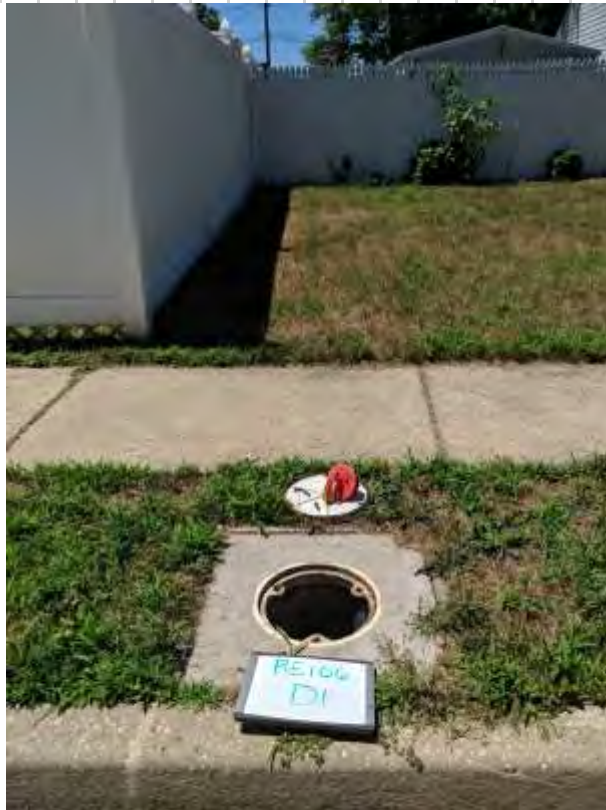
Notes: RE106D1 is in good condition. There is tubing present in the well.

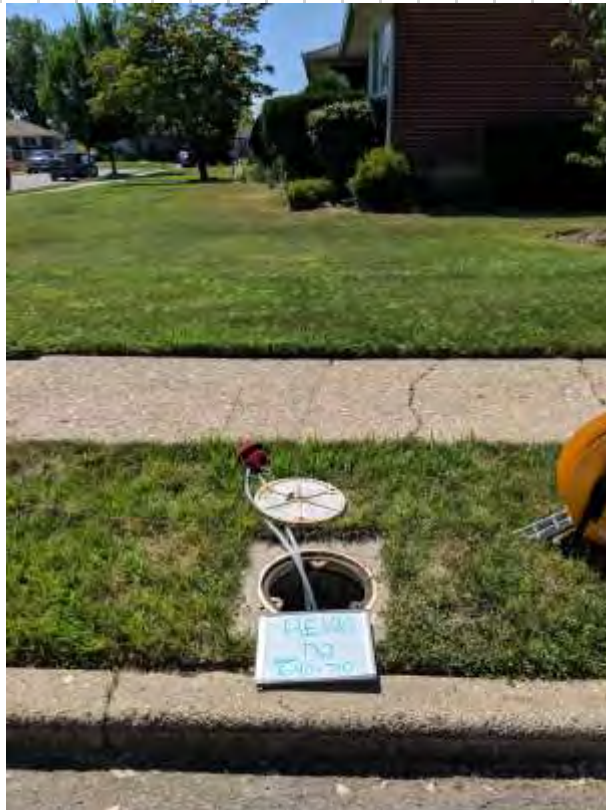
Notes: RE120D3 is in fair condition. RE120D3 missing 1 bolt. There is tubing present in the well.

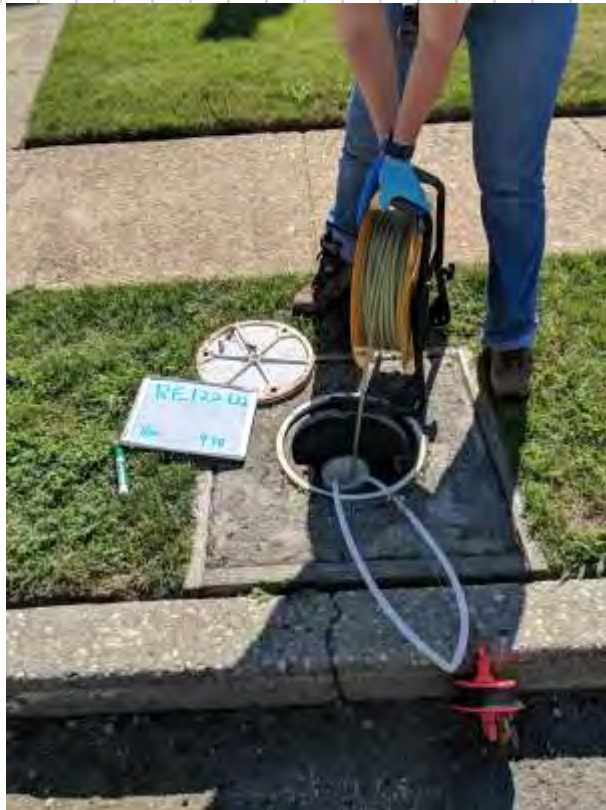
Notes: RE122D3 is in fair condition. RE122D3 missing 1 bolt. There is tubing present in the well.

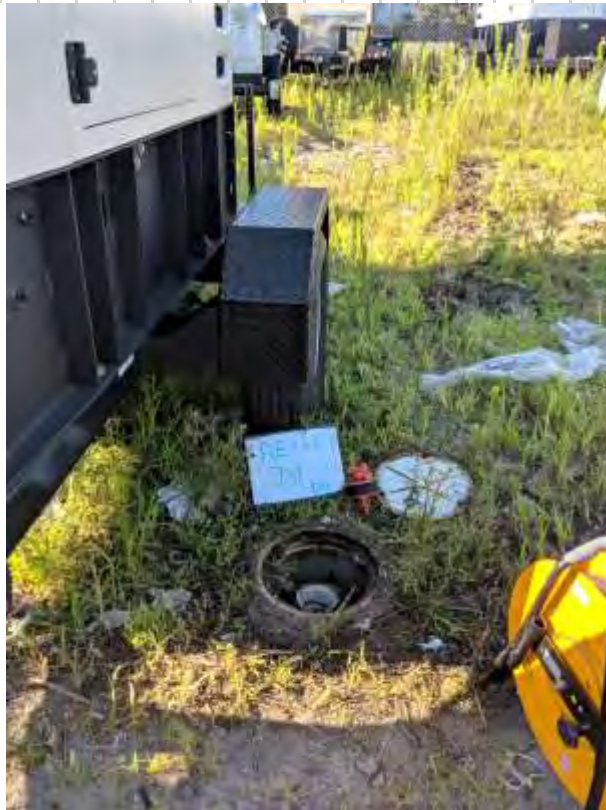
Notes: RE123D2 is in fair condition. RE123D2 needs lock. There is tubing present in the well.

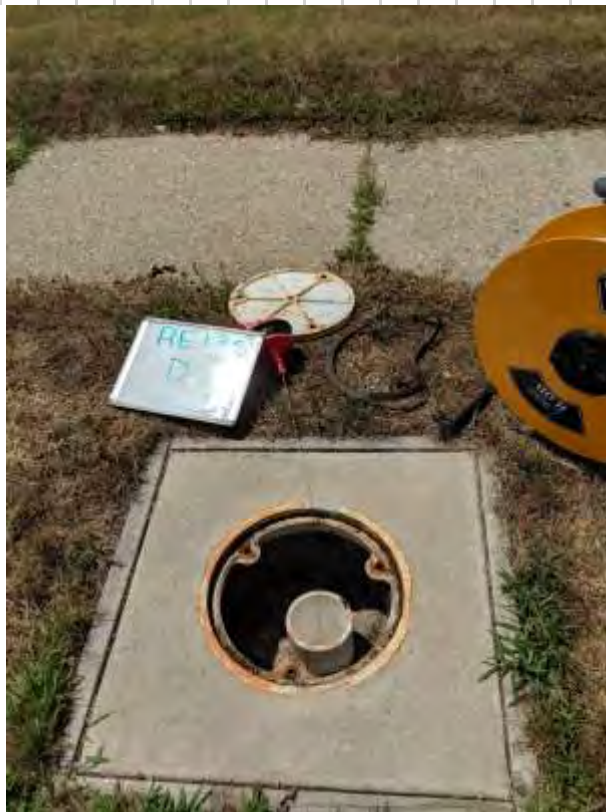
Needs Bolts: No
Needs Lock: No
Date/Time Measured: 2018-07-16 18:15:00
Depth of Water: 25.12
Depth of Boring: 576.90
Notes: RE130D1 is in good condition.

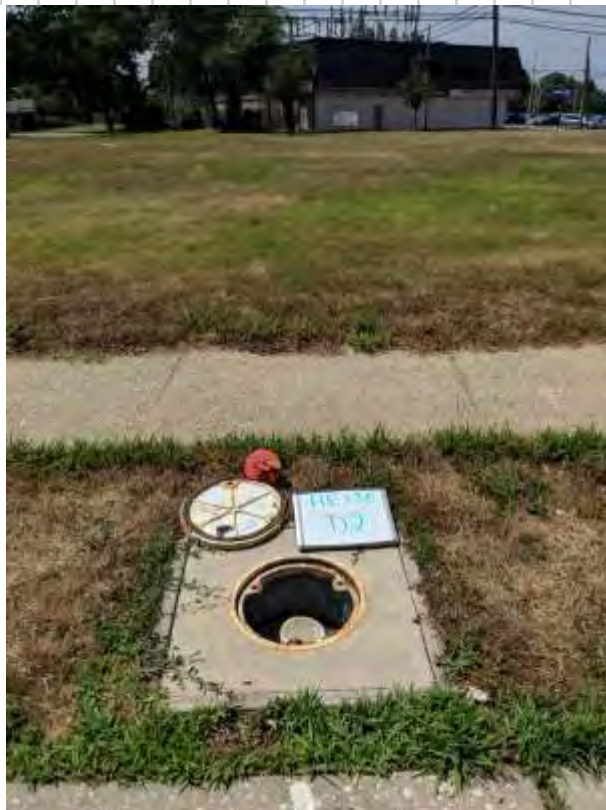
Needs Bolts: No
Needs Lock: No
Date/Time Measured: 2018-07-16 18:30:00
Depth of Water: 25.25
Depth of Boring: 664.25
Notes: RE130D2 is in good condition.

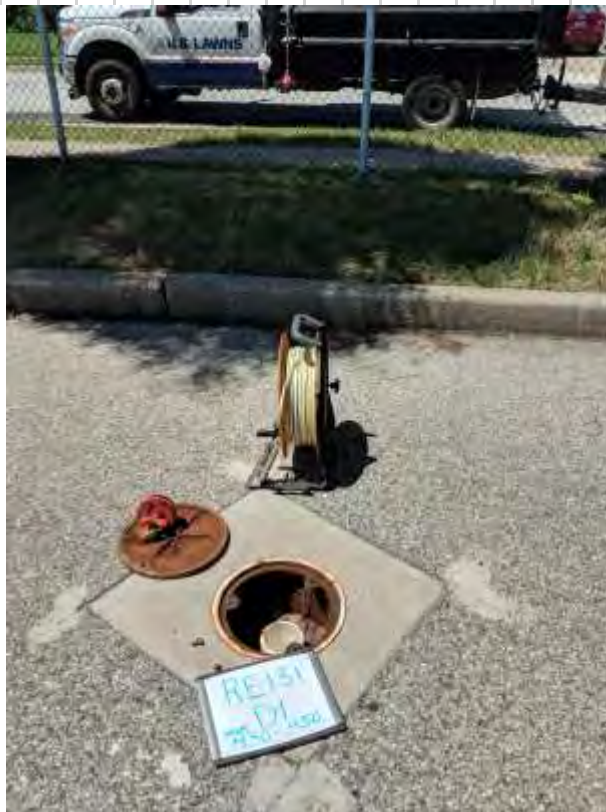
Needs Bolts: Yes
Needs Lock: No
Date/Time Measured: 2018-07-18 18:00:00
Depth of Water: 37.96
Depth of Boring: 450.00
Notes: RE131D1 is in fair condition. RE131D1 missing 1 bolt.

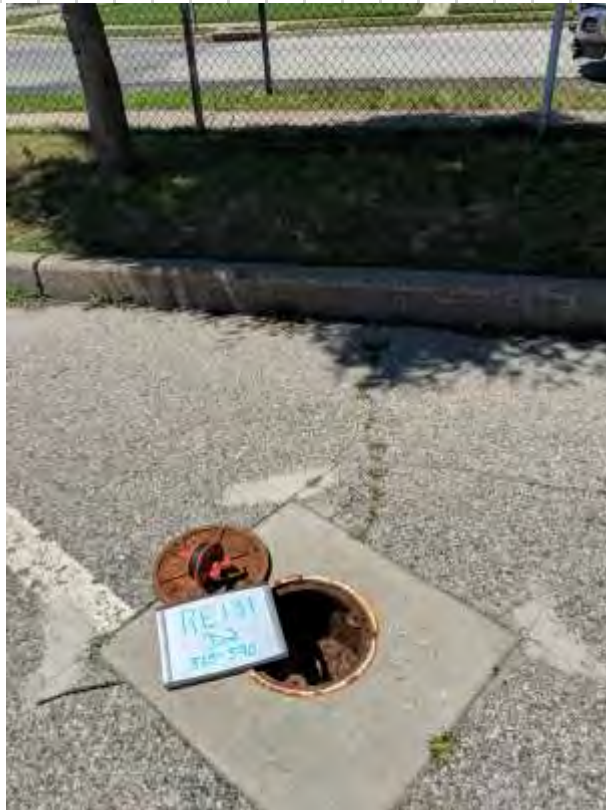
Needs Bolts: Yes
Needs Lock: No
Date/Time Measured: 2018-07-18 18:00:00
Depth of Water: 38.84
Depth of Boring: 589.30
Notes: RE131D2 is in fair condition. RE131D2 missing 3 bolts.

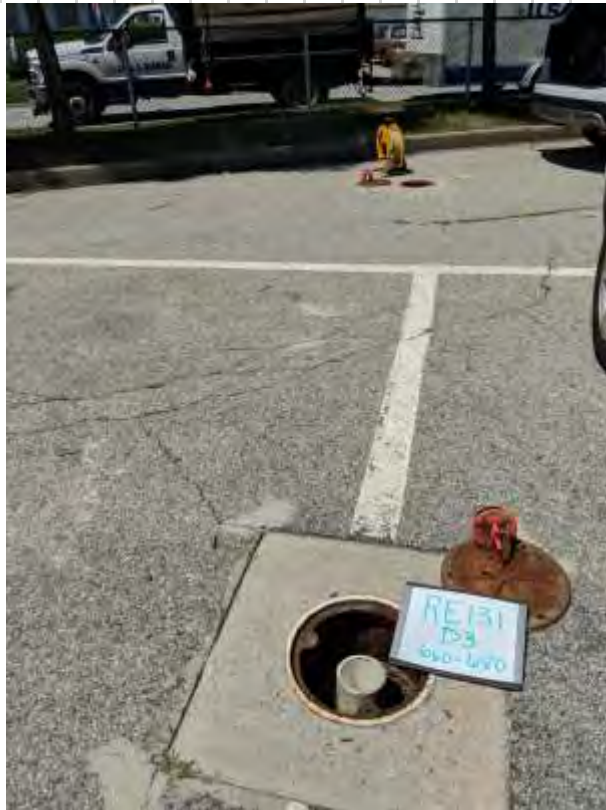
Needs Bolts: Yes
Needs Lock: No
Date/Time Measured: 2018-07-18 18:00:00
Depth of Water: 39.35
Depth of Boring: 683.52
Notes: RE131D3 is in fair condition. RE131D3 missing 2 bolts.

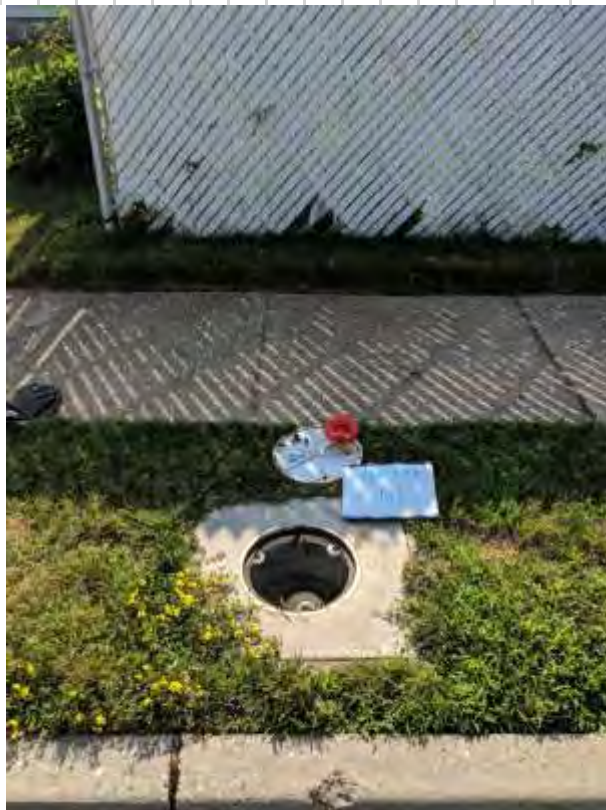
Notes: RE133D1 is in good condition. There is tubing present in the well.

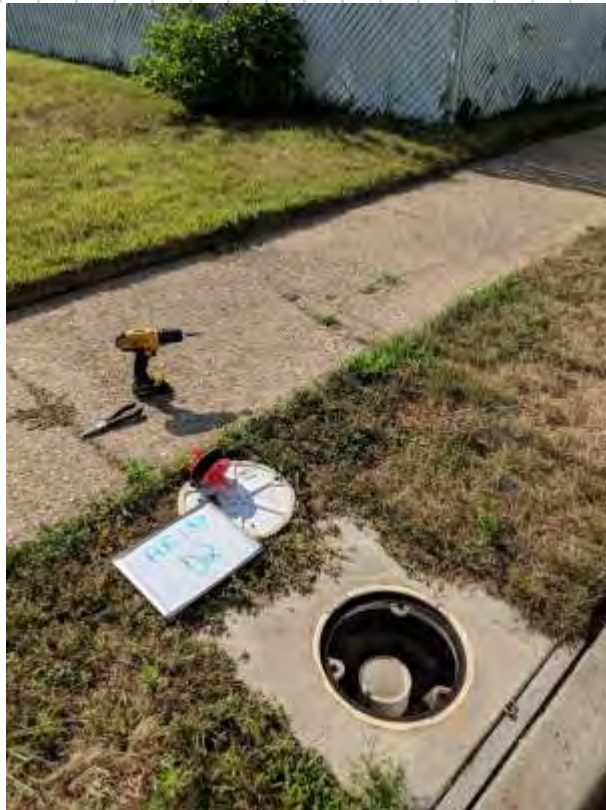
Needs Bolts: No
Needs Lock: No
Date/Time Measured: 2018-07-16 13:15:00
Depth of Water: 25.33
Depth of Boring: 800.85
Notes: RE133D2 is in good condition. There is tubing present in the well.

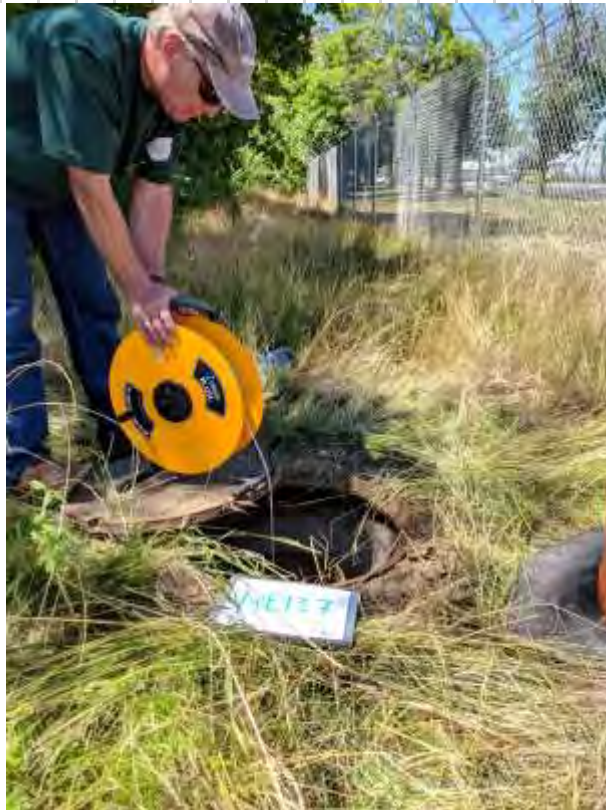
Needs Bolts: No
Needs Lock: Yes
Date/Time Measured: 2018-07-19 18:15:00
Depth of Water: 39.28
Depth of Boring: 749.45
Notes: RE137 appears in fair condition. RE137 has no lock.

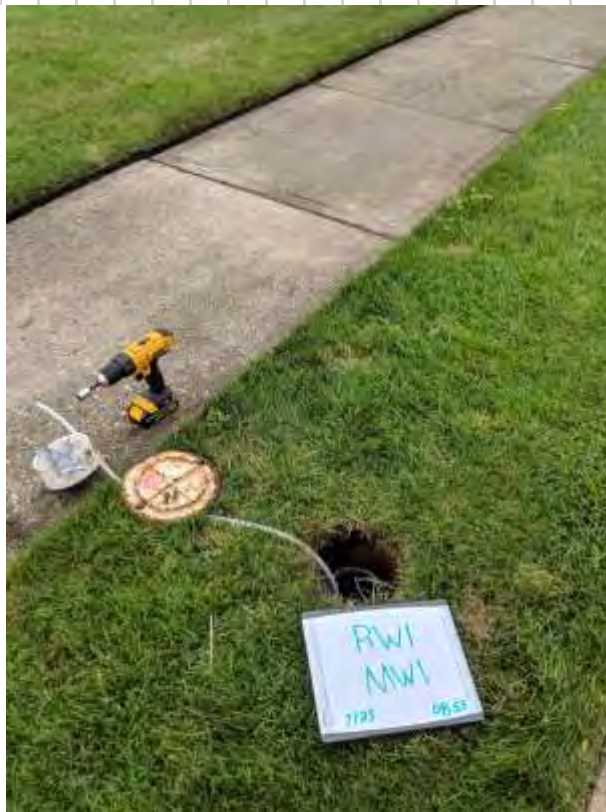
Notes: RW1-MW1 is in fair condition. RW1-MW1 has a pvc cap with sampling ports.

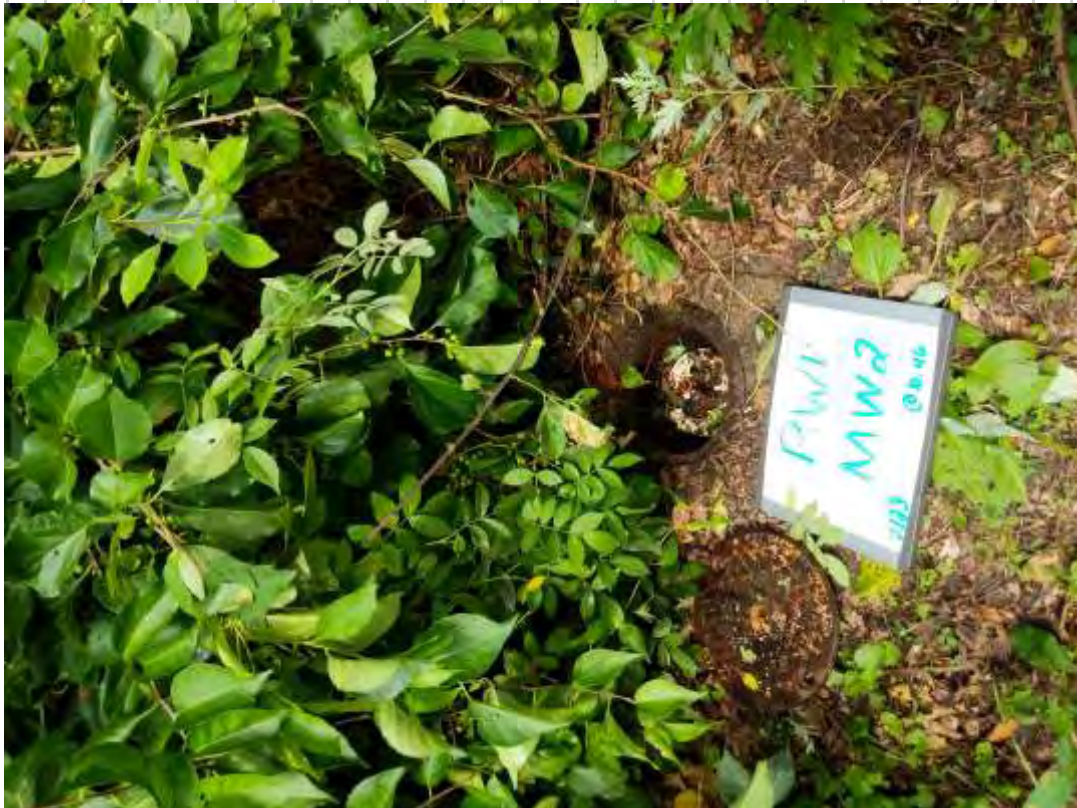
Notes: RW1-MW2 in fair condition. RW1-MW-2 needs bolt. RW1-MW2 has a pvc cap with sampling ports. Could not sound bottom

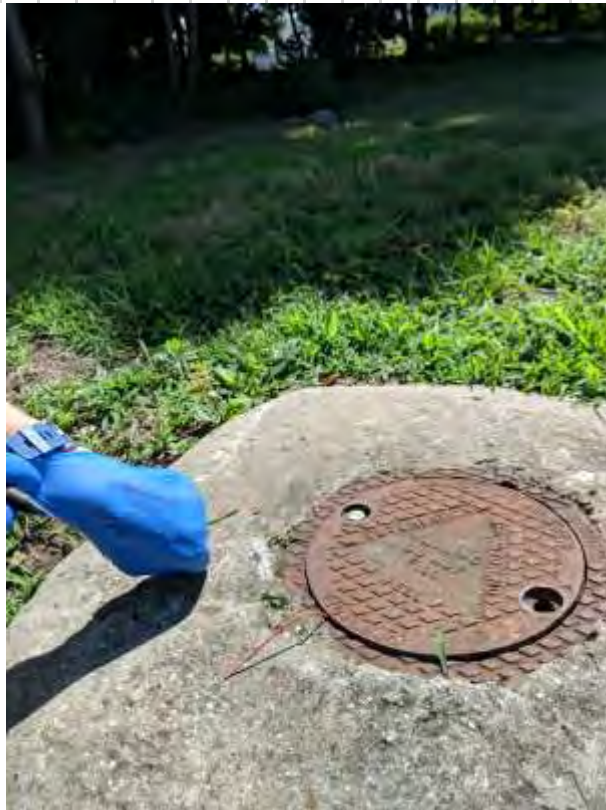
Notes: RW2-MW1 is in fair condition. RW2-MW1 is missing 1 bolt and 1 tab. Tubing is present in the well.

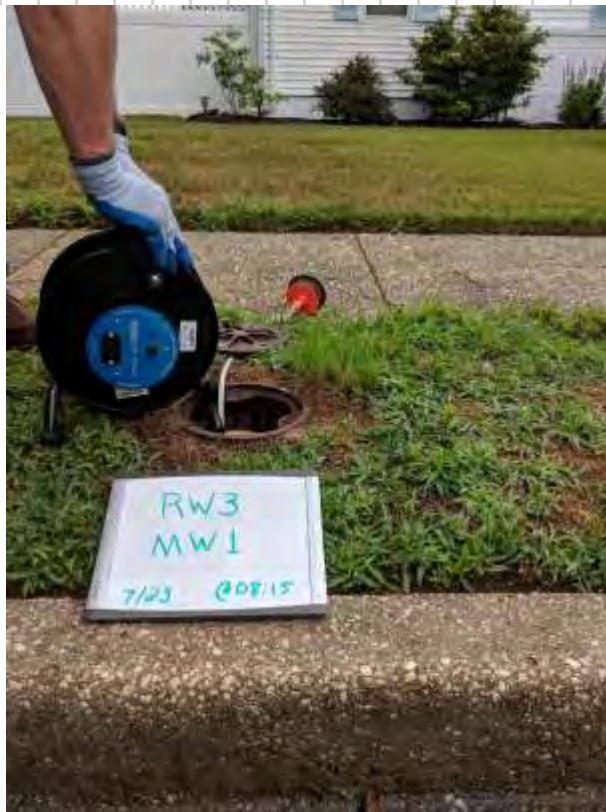
Needs Bolts: No
Needs Lock: No
Date/Time Measured: 2018-07-23 12:15:00
Depth of Water: 39.59
Depth of Boring: 350.50
Notes: RW3-MW1 is in good condition. There is tubing present in the well.

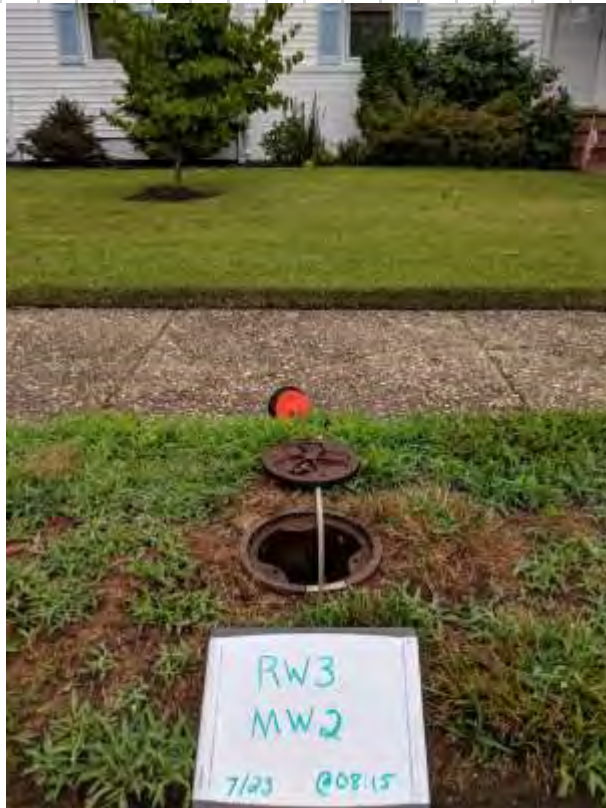
Notes: RW3-MW2 is in poor condition. The well measured 85 ft shallower than as installed. The screen is completely silted and there is a large annular void. There is tubing in the well.

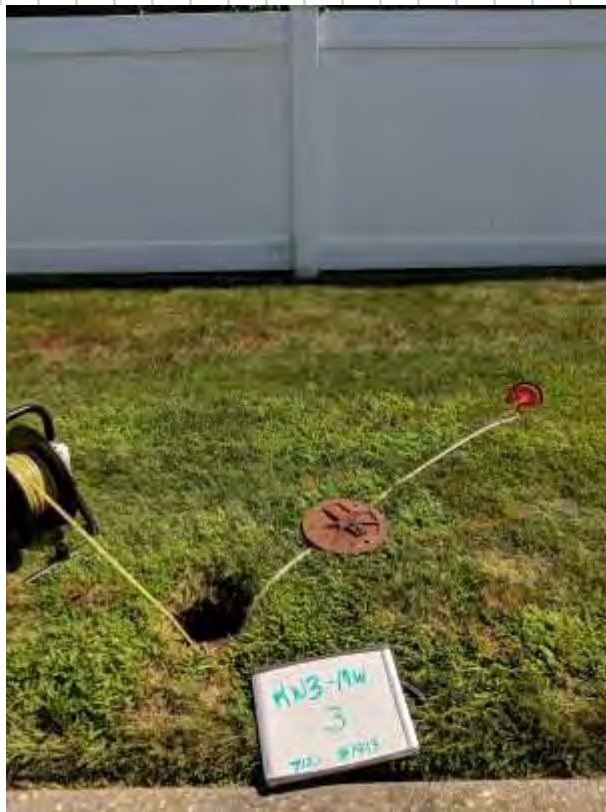
Notes: RW3-MW3 is in good condition. There is tubing present in the well.

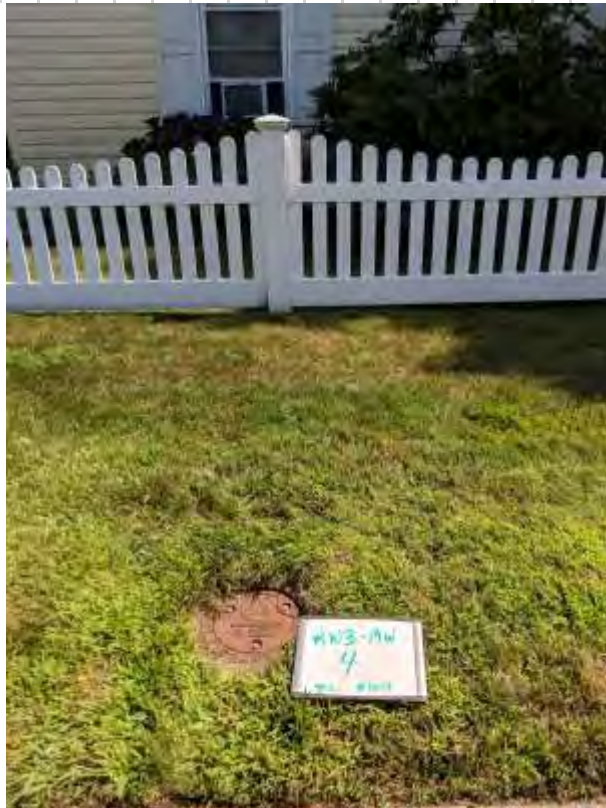
Notes: RW3-MW4 is in good condition. There is tubing present in the well, and a large annular void.

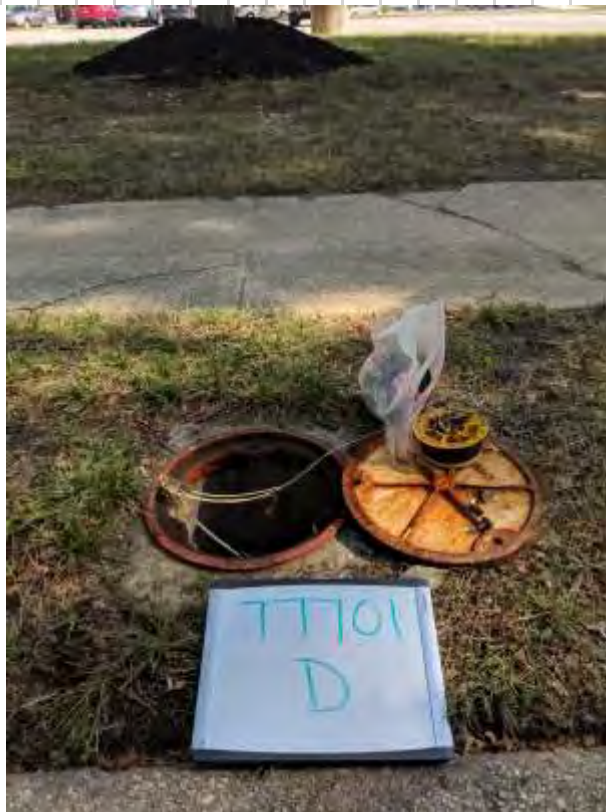
Notes: TT-101D is in fair condition. TT-101D is missing 1 tab. There is a bladder pump assembly present in the well.

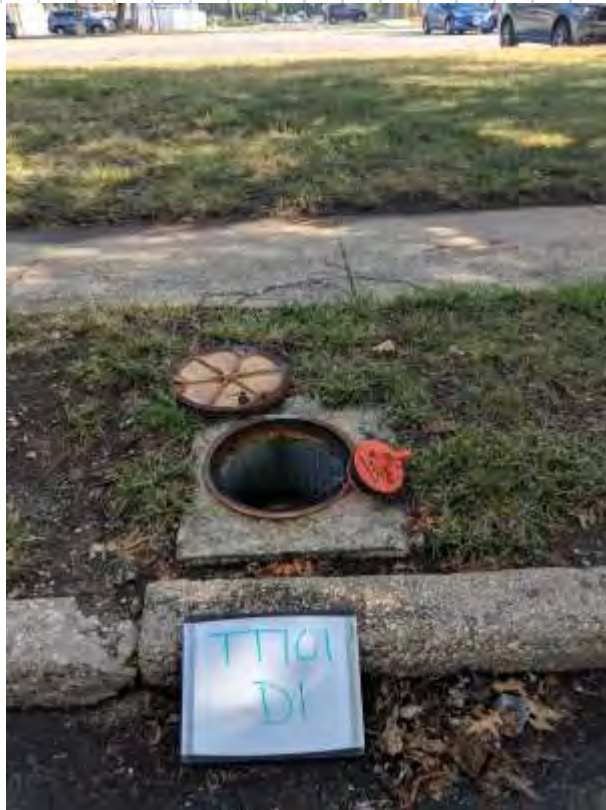
Notes: TT-101D1 is in fair condition. TT-101D1 has 1 missing bolt. There is a bladder pump assembly present in the well.

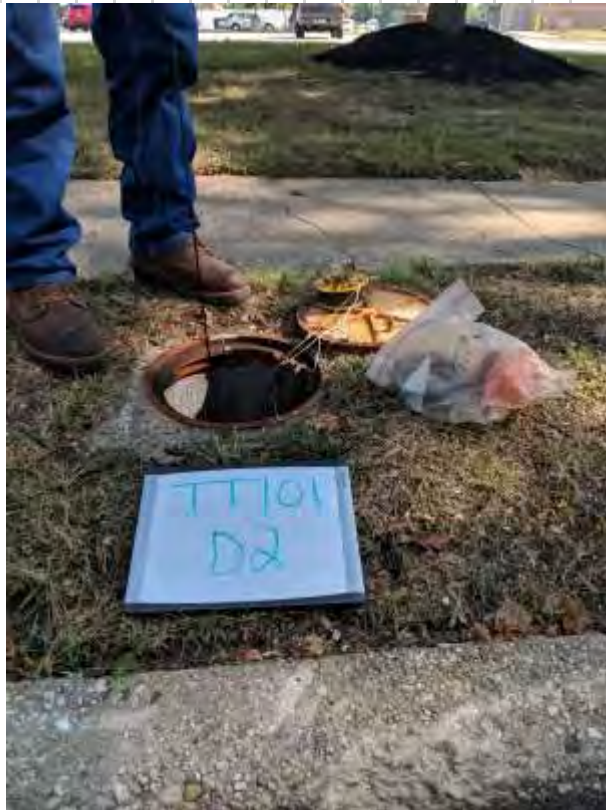
Notes: TT-101D2 is in fair condition. TT-101D2 is missing 1 bolt. There is a bladder pump assembly present in the well.

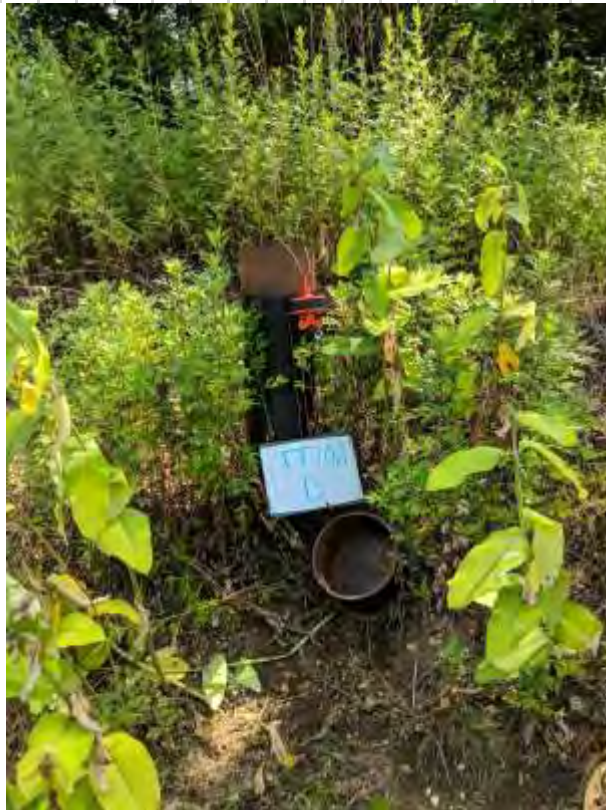
Notes: TT-102D is in good condition. There is a bladder pump assembly present in the well.

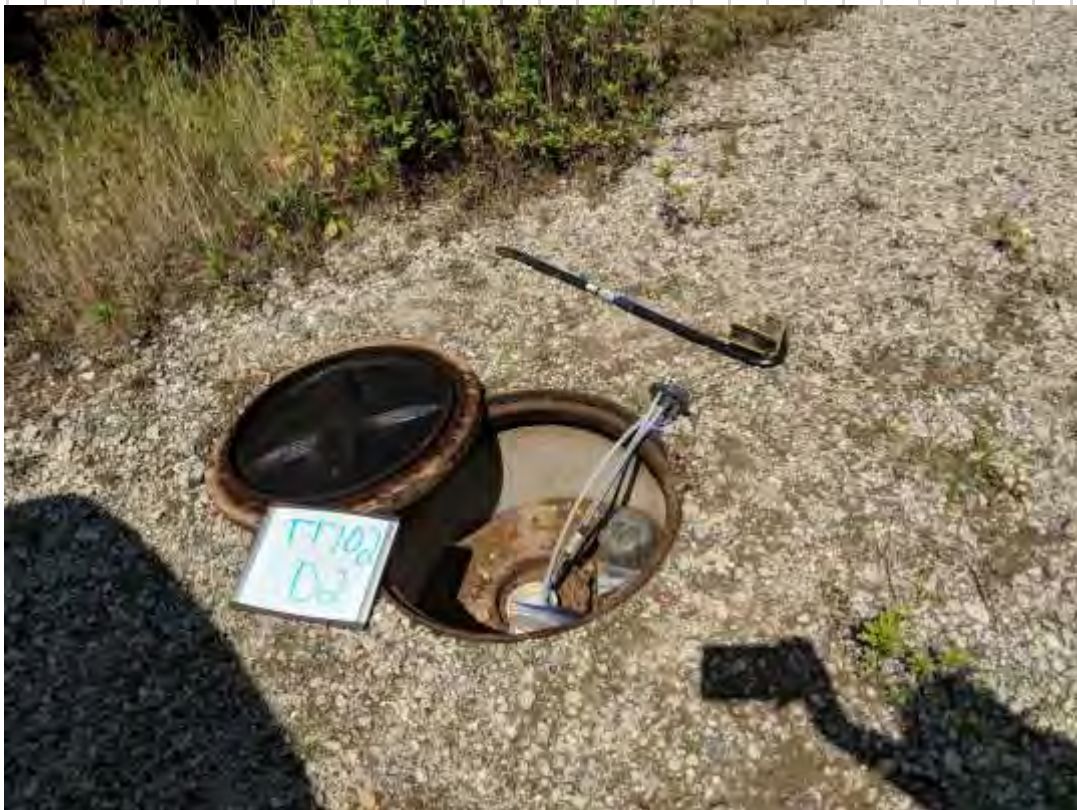
Notes: TT-102D2 is in good condition. There is a bladder pump assembly present in the well.

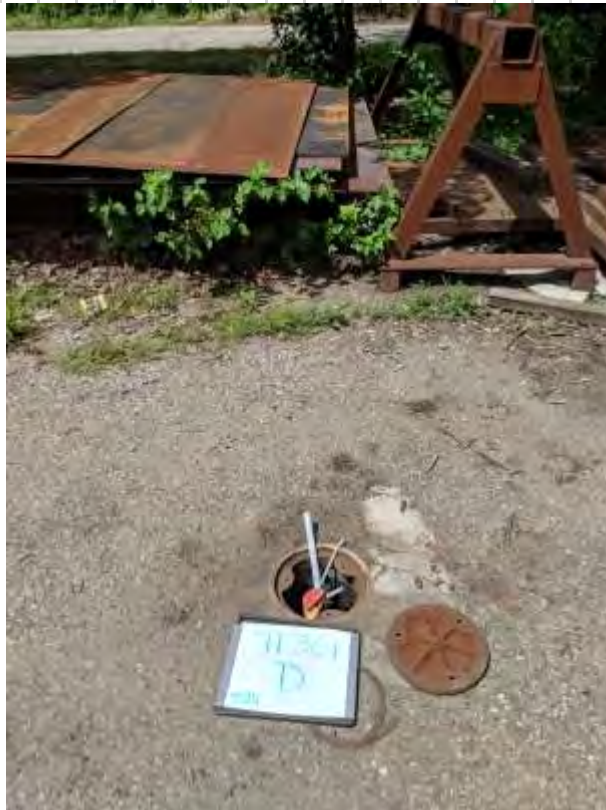
Needs Bolts: No
Needs Lock: No
Date/Time Measured: 2018-07-24 18:30:00
Depth of Water: 58.52
Depth of Boring: 220.10
Notes: TT-301D is in good condition.

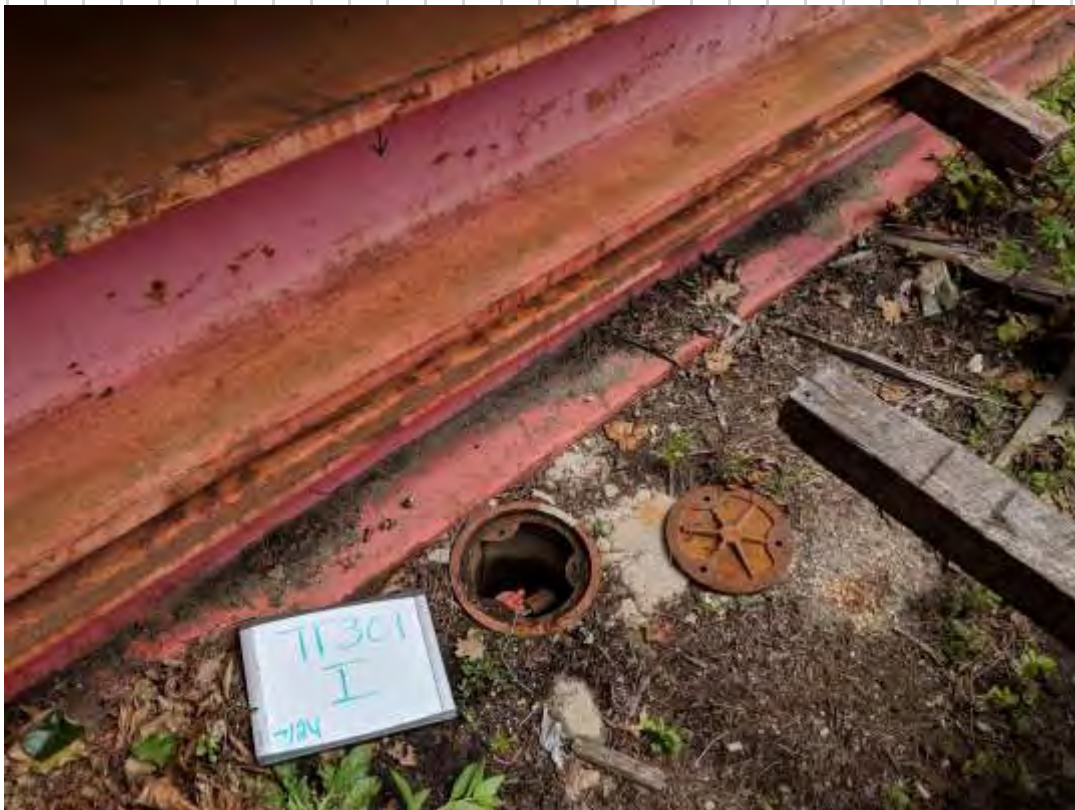
Needs Bolts: No
Needs Lock: No
Date/Time Measured: 2018-07-24 18:30:00
Depth of Water: 57.58
Depth of Boring: 139.35
Notes: TT-301I is in good condition.

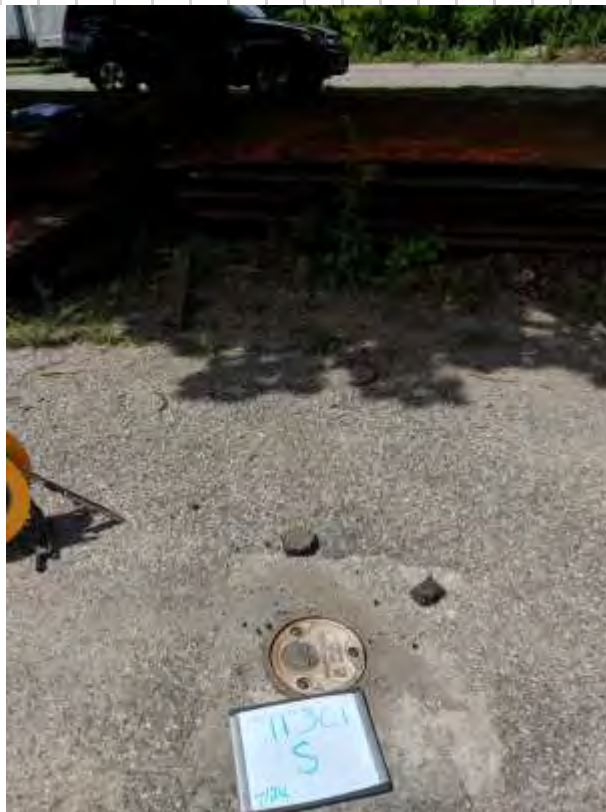
Needs Bolts: No
Needs Lock: No
Date/Time Measured: 2018-07-24 18:15:00
Depth of Water: 57.41
Depth of Boring: 60.80
Notes: TT-301S is in good condition.

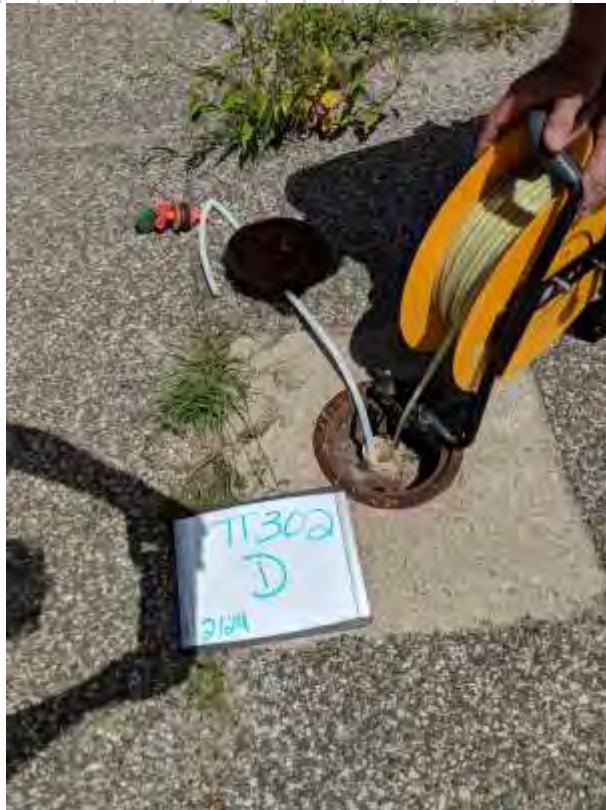
Needs Bolts: No
Needs Lock: No
Date/Time Measured: 2018-07-24 06:15:00
Depth of Water: 49.32
Depth of Boring: 211.05
Notes: TT-302D is in good condition. There is tubing present in the well.

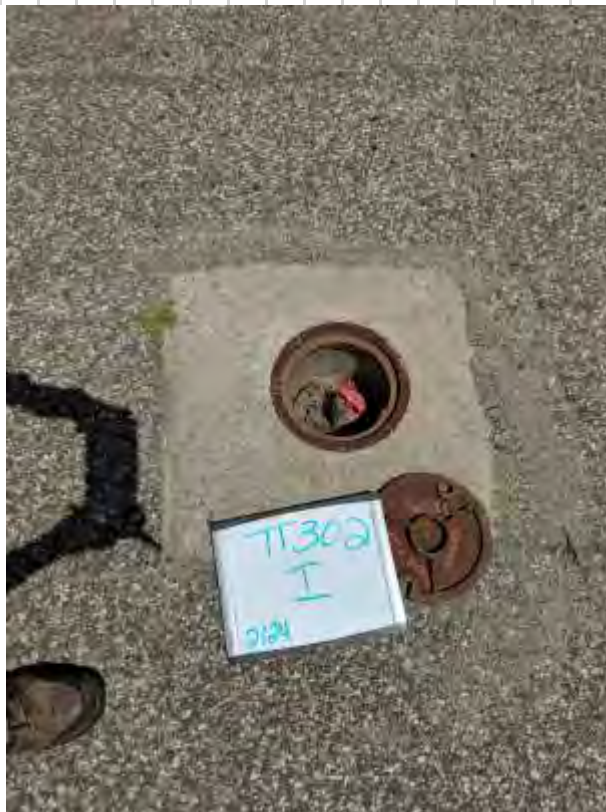
Notes: TT-30211 is in good condition. There is tubing in the well.

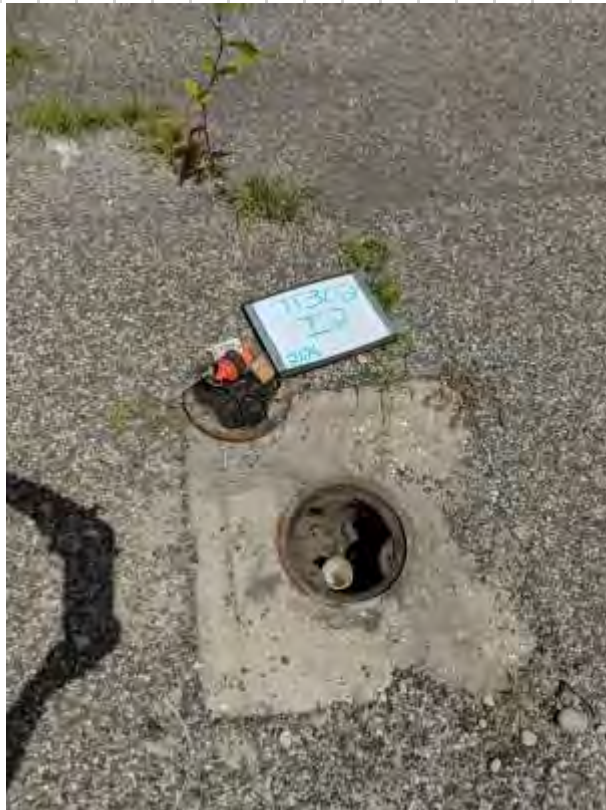
Notes: TT-30212 is in fair condition. TT-30212 is missing 1 bolt and 1 tab. There is tubing present in the well.

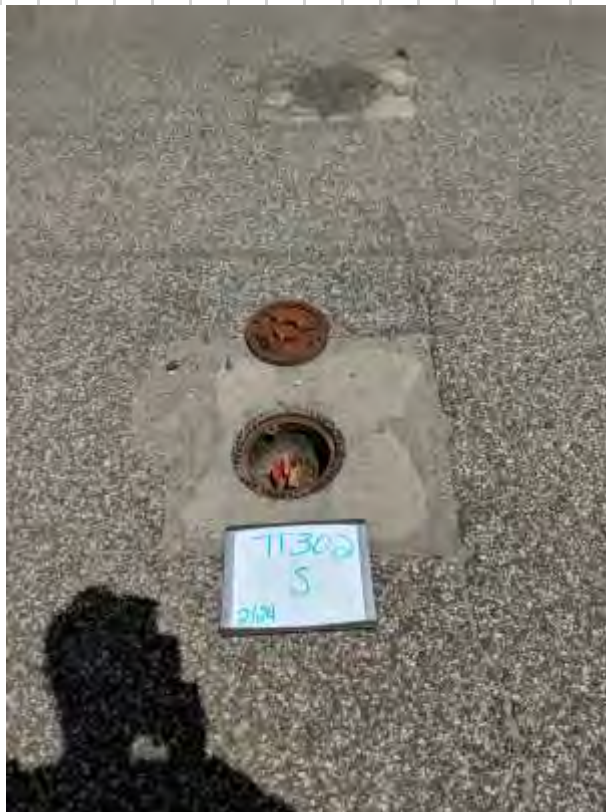
Notes: TT-302S is in good condition. There is tubing present in the well.

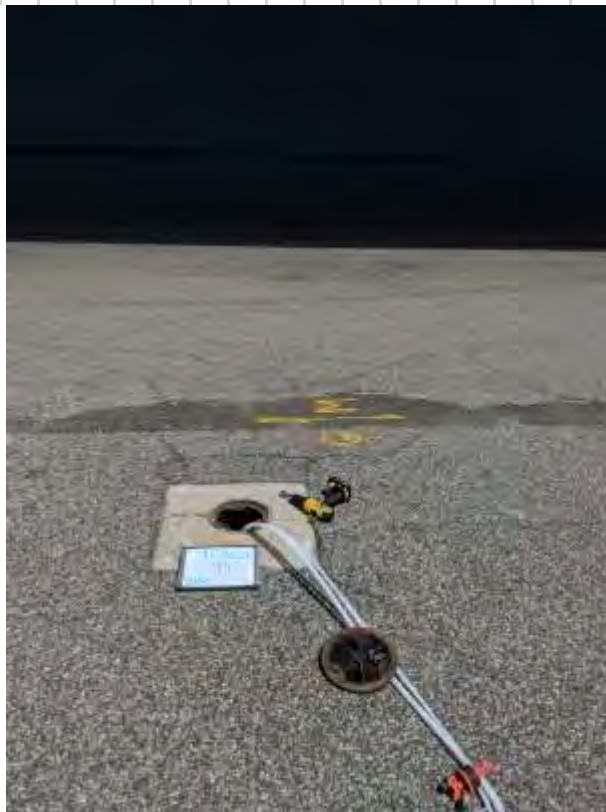
Notes: TT-303D is in good condition. There is tubing present in the well. The pad is cracked.

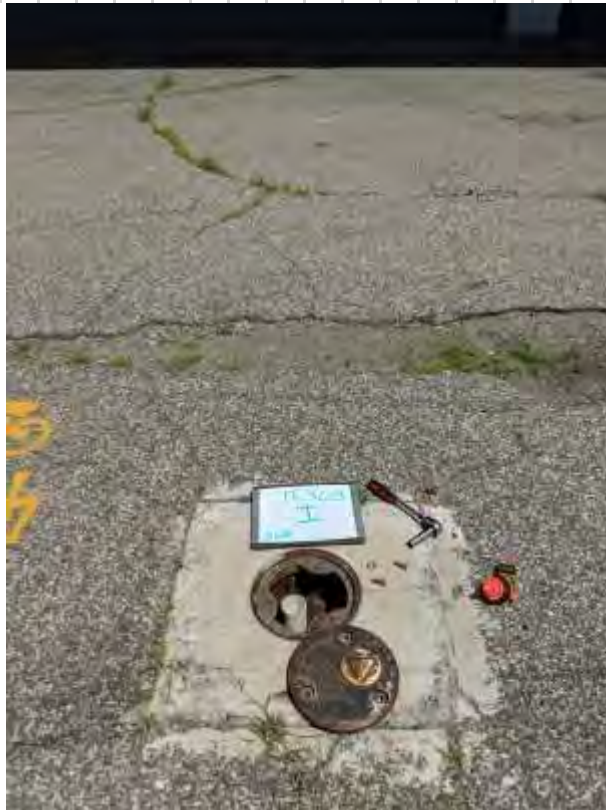
Needs Bolts: No
Needs Lock: No
Date/Time Measured: 2018-07-24 04:00:00
Depth of Water: 48.80
Depth of Boring: 104.50
Notes: TT-30311 is in good condition. There is tubing present in the well.

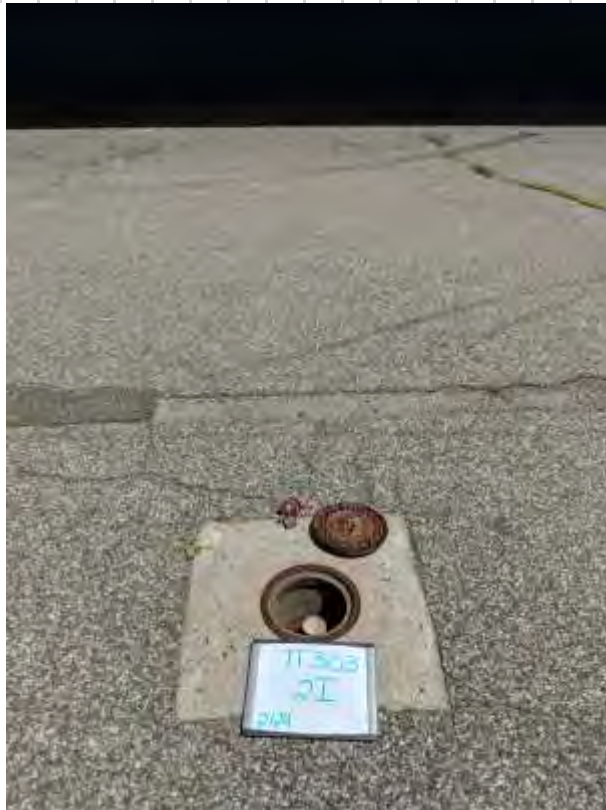
Needs Bolts: No
Needs Lock: No
Date/Time Measured: 2018-07-24 16:00:00
Depth of Water: 49.23
Depth of Boring: 156.35
Notes: TT-30312 is in good condition. There is tubing present in the well.

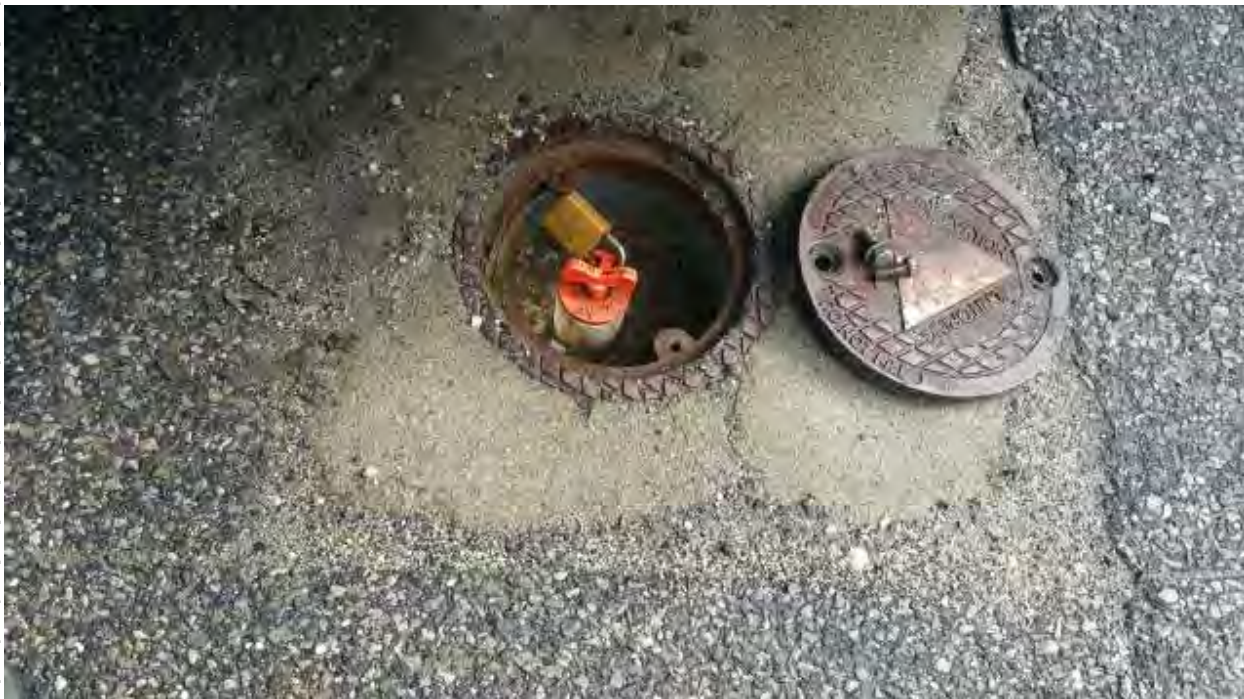
Notes: TT-303S is in Fair condition. There is tubing present in the well. The pad is cracked.

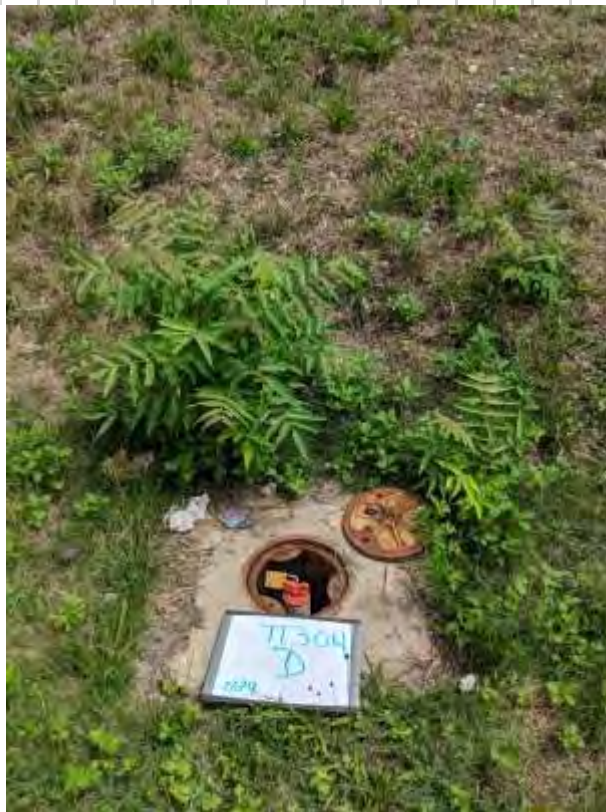
Needs Bolts: No
Needs Lock: No
Date/Time Measured: 2018-07-24 17:30:00
Depth of Water: 50.62
Depth of Boring: 189.20
Notes: TT-304D is in good condition.

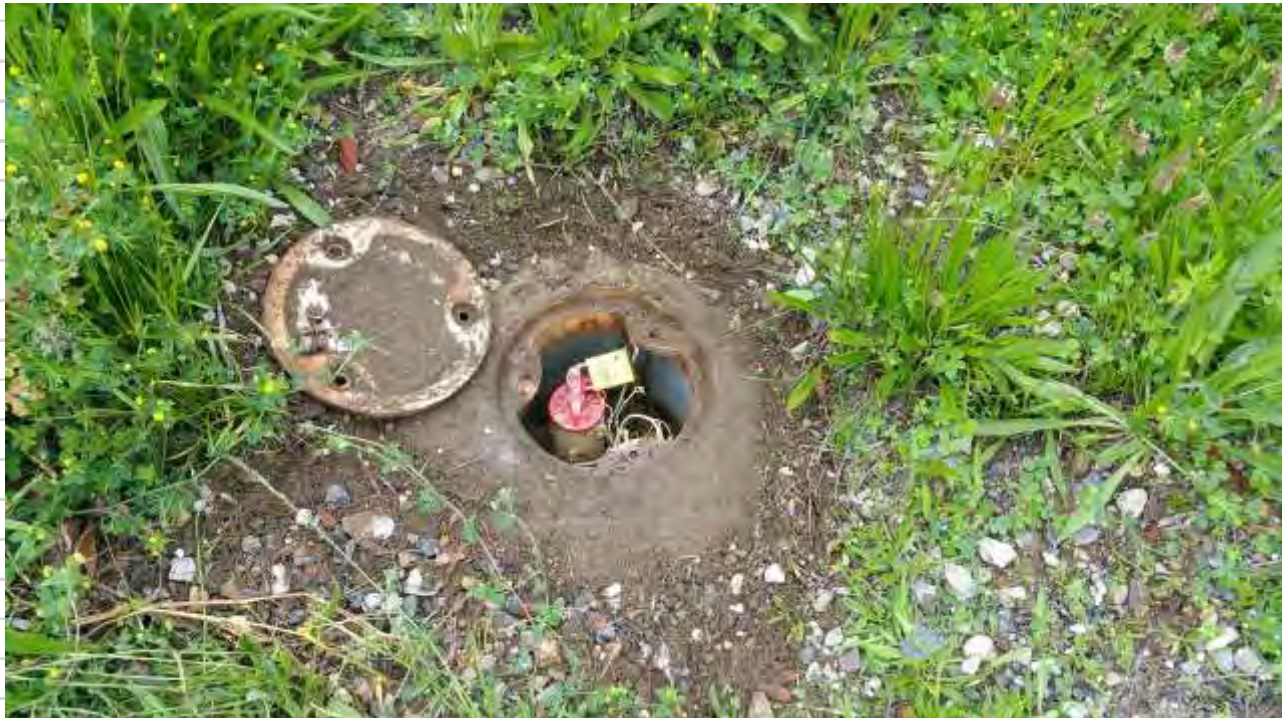
Needs Bolts: No
Needs Lock: No
Date/Time Measured: 2018-07-24 17:30:00
Depth of Water: 50.05
Depth of Boring: 111.40
Notes: TT-30411 is in good condition.

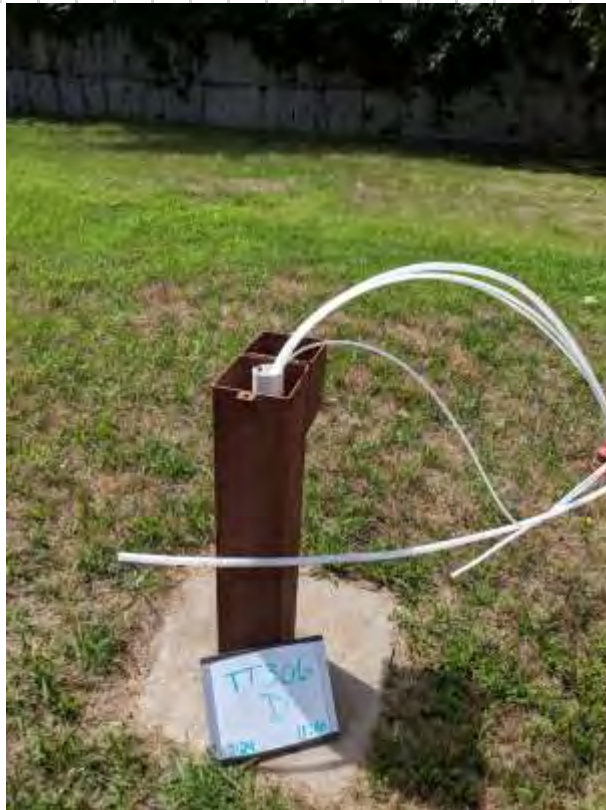
Needs Bolts: No
Needs Lock: No
Date/Time Measured: 2018-07-24 15:00:00
Depth of Water: 52.31
Depth of Boring: 296.74
Notes: TT-306D is in good condition.

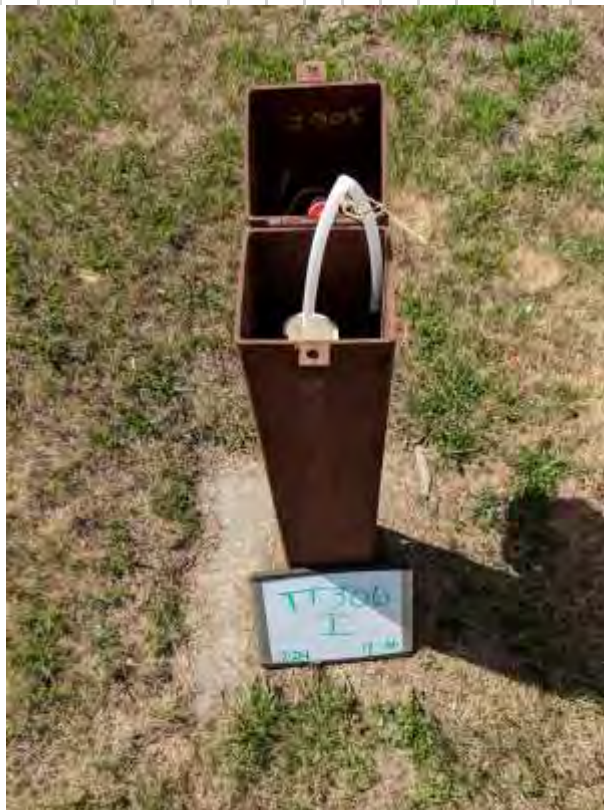
Needs Bolts: No
Needs Lock: No
Date/Time Measured: 2018-07-24 15:00:00
Depth of Water: 51.60
Depth of Boring: 201.70
Notes: TT-306I is in good condition.
