RESOLUTION CONSULTANTS

Subject: **Well Inventory Memorandum – Navy-Owned Wells, NWIRP Bethpage**

Date: October 2020

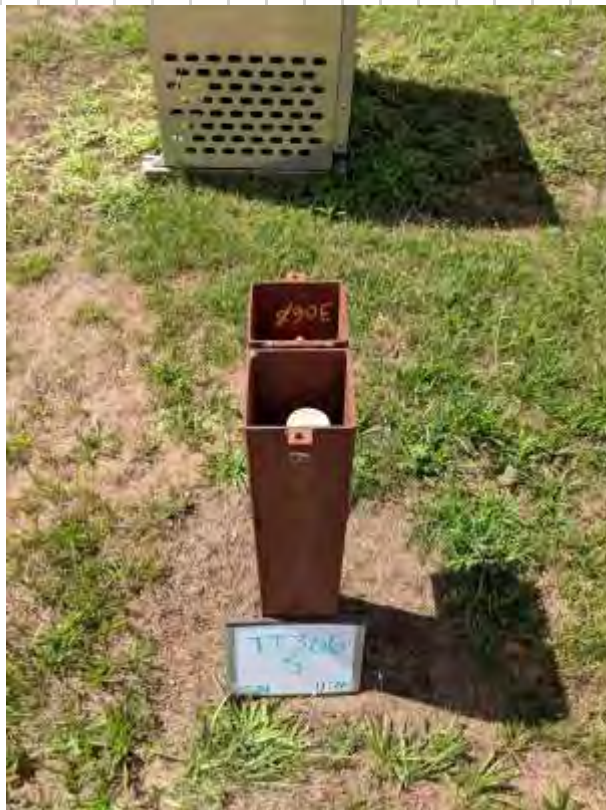
Needs Bolts: No
Needs Lock: No
Date/Time Measured: 2018-07-24 14:45:00
Depth of Water: 50.98
Depth of Boring: 62.53
Notes: TT-306S is in good condition.

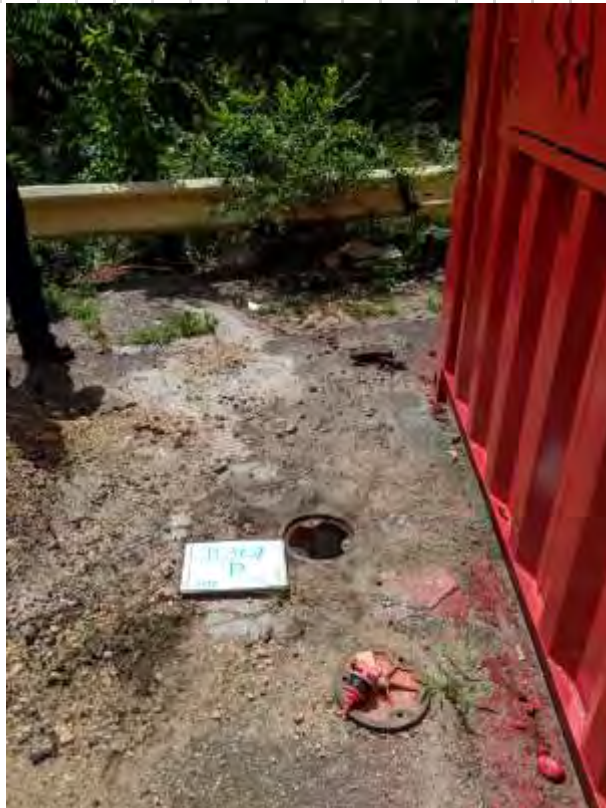
Notes: TT-307D is in fair condition. There is a large annular void. The pad is cracked.

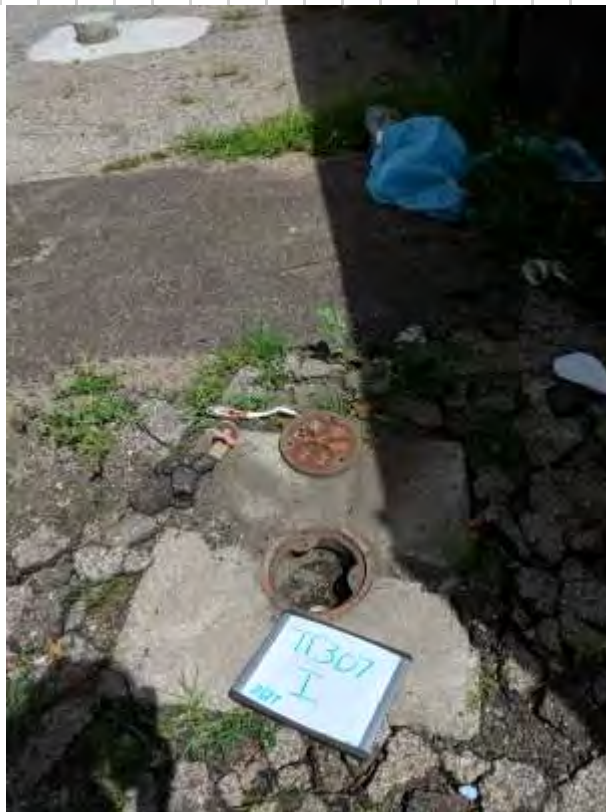
Notes: TT-307I is in fair condition. TT-307I is missing 1 tab. There is a large annular void. The pad is cracked.

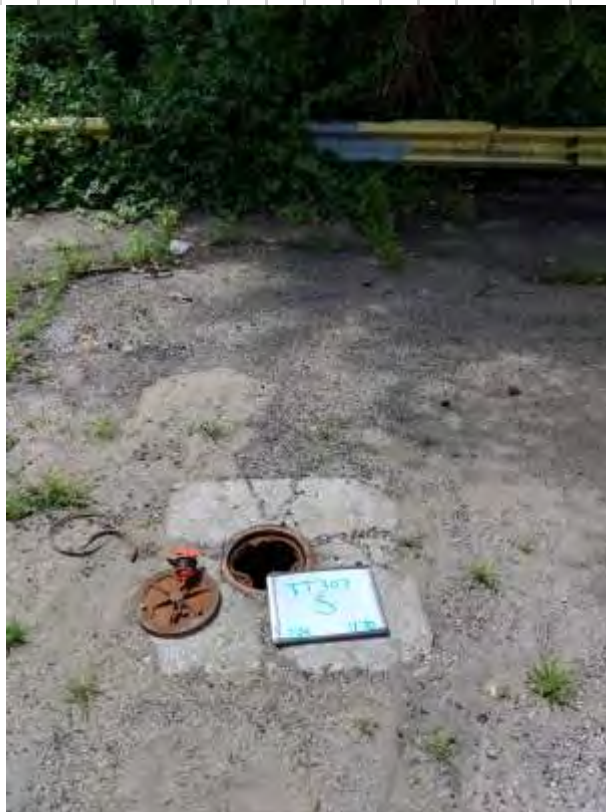
Notes: TT-307S is in fair condition. TT-307S is missing 1 tab.
 The pad is cracked.

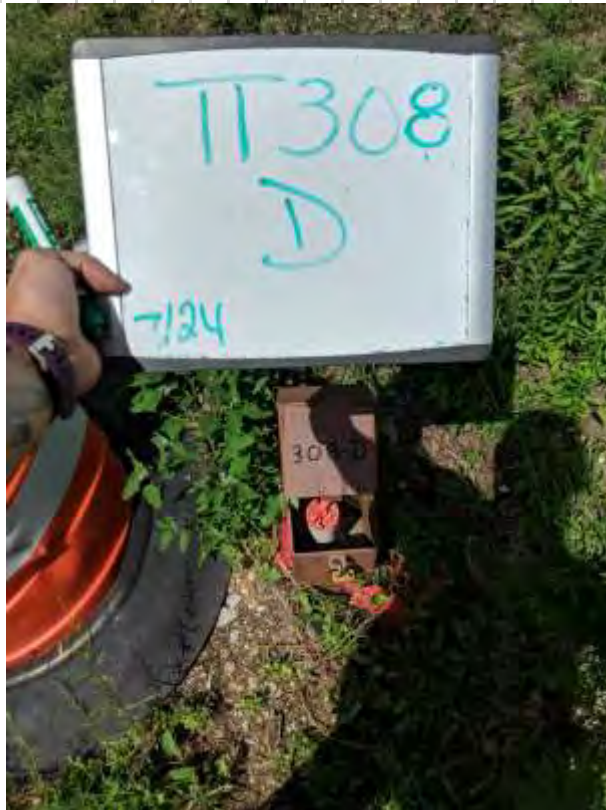
Needs Bolts: No
Needs Lock: No
Date/Time Measured: 2018-07-24 18:45:00
Depth of Water: 62.30
Depth of Boring: 265.04
Notes: TT-308D is in good condition. There is tubing present in the well.

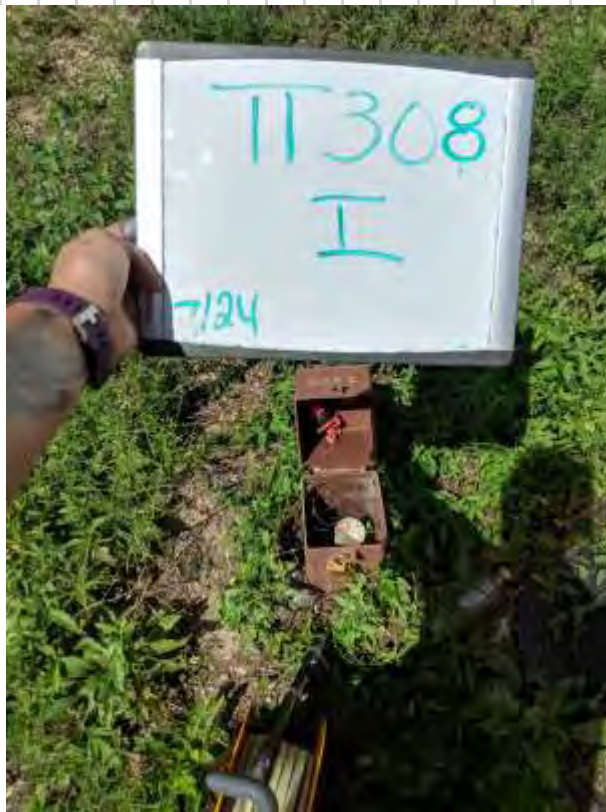
Notes: TT-308I is in good condition. There is tubing present in the well.

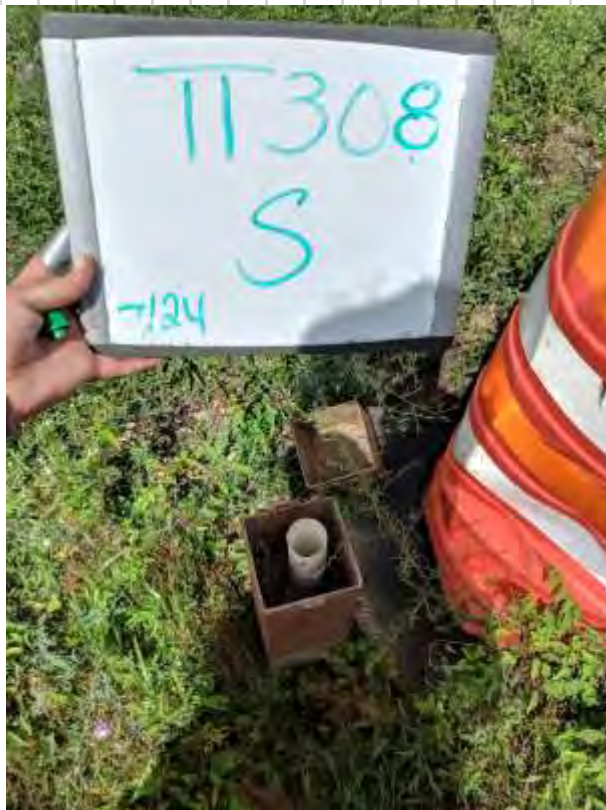
Notes: TT-308S is in good condition. There is tubing present in the well.

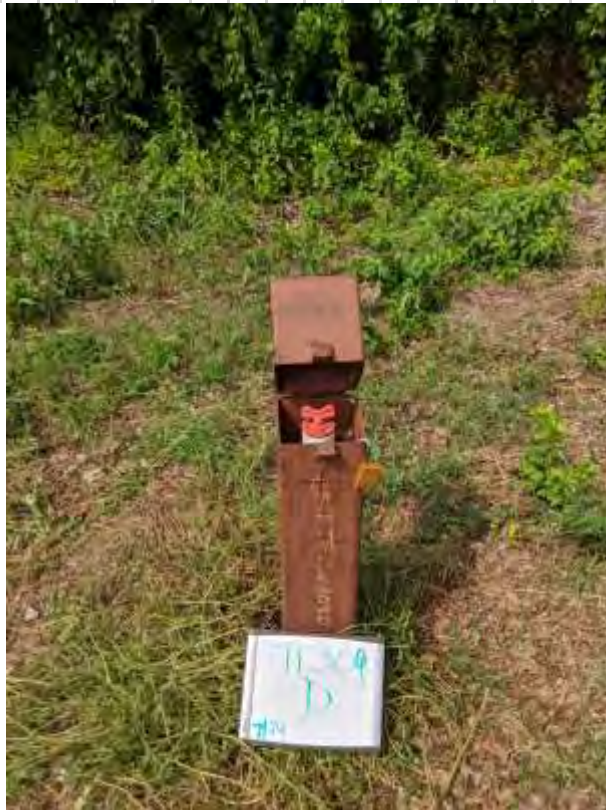
Needs Bolts: No
Needs Lock: No
Date/Time Measured: 2018-07-24 18:45:00
Depth of Water: 63.94
Depth of Boring: 264.20
Notes: TT-309D is in good condition.

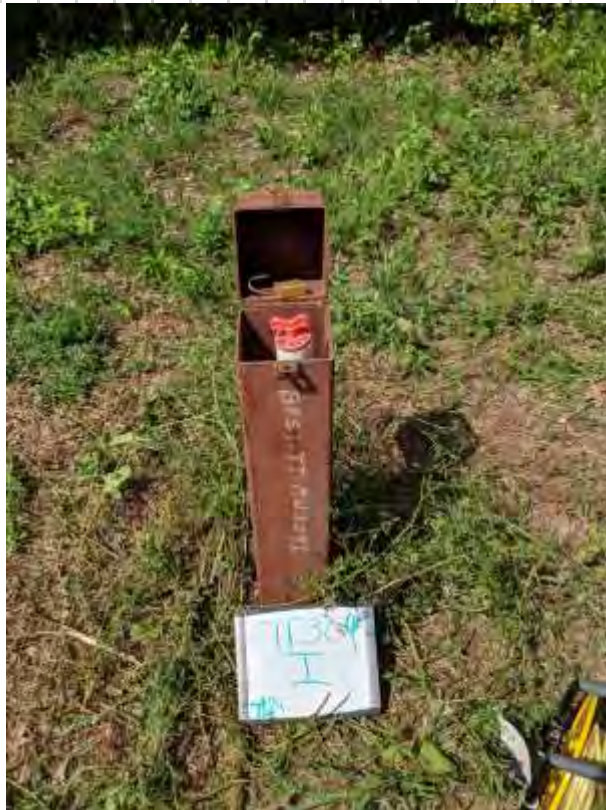
Notes: TT-309I is in good condition. There is tubing present in the well.

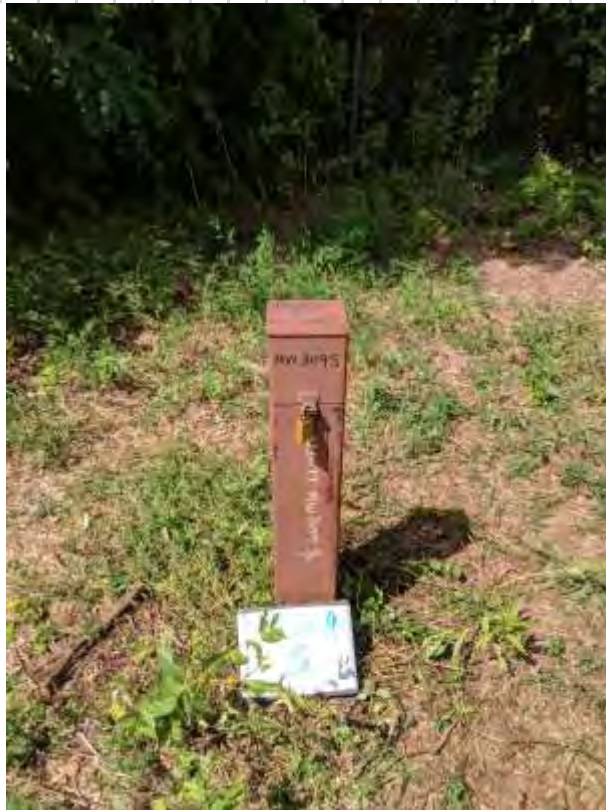
Notes: TT-309S is in good condition. There is tubing present in the well.

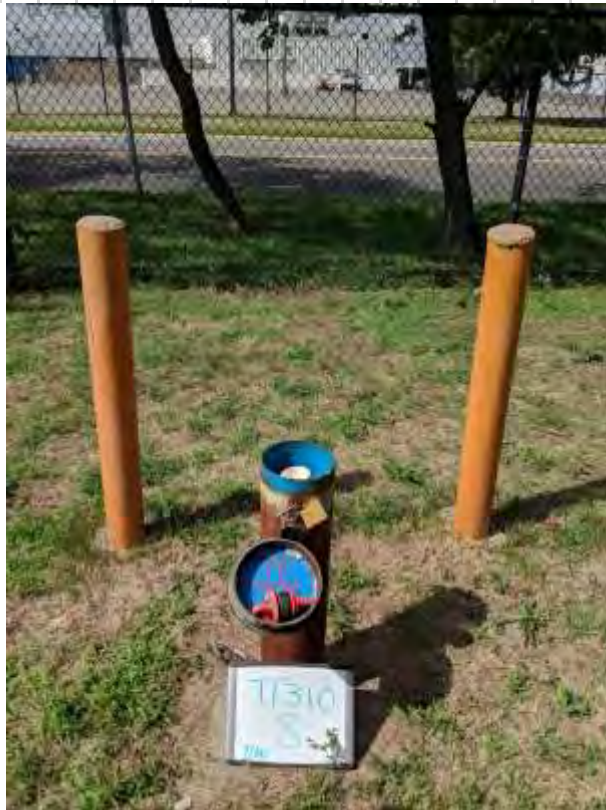
Needs Bolts: No
Needs Lock: No
Date/Time Measured: 2018-07-24 19:30:00
Depth of Water: 50.63
Depth of Boring: 69.80
Notes: TT-310S is in good condition.

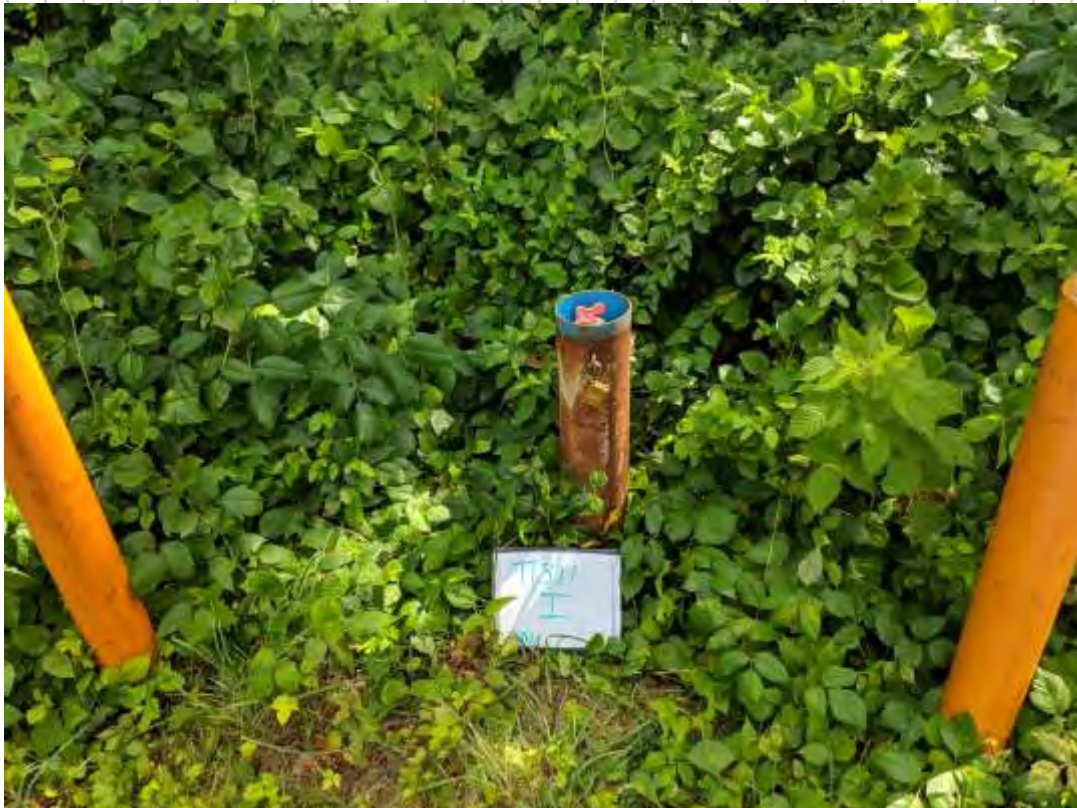
Needs Bolts: No
Needs Lock: No
Date/Time Measured: 2018-07-24 19:45:00
Depth of Water: 61.83
Depth of Boring: 172.80
Notes: TT-311I is in good condition.

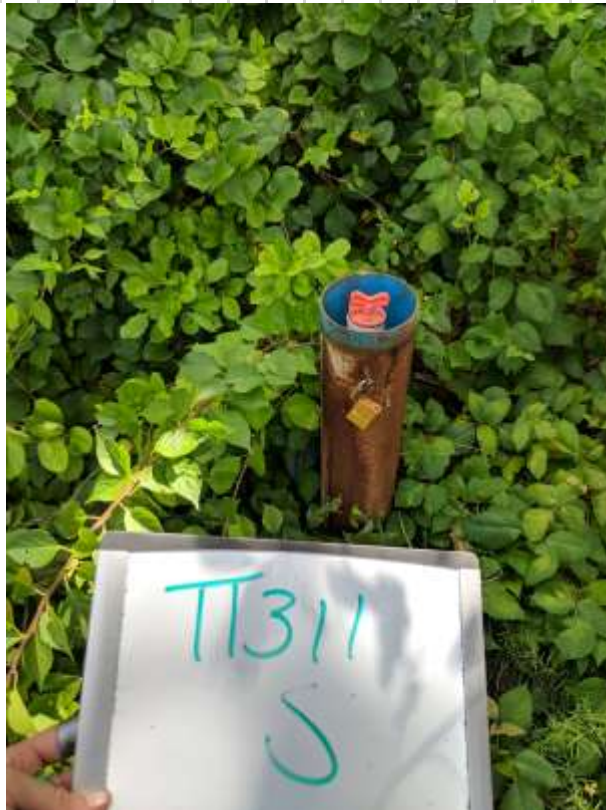
Needs Bolts: No
Needs Lock: No
Date/Time Measured: 2018-07-24 19:45:00
Depth of Water: 61.56
Depth of Boring: 67.35
Notes: TT-311S is in good condition.

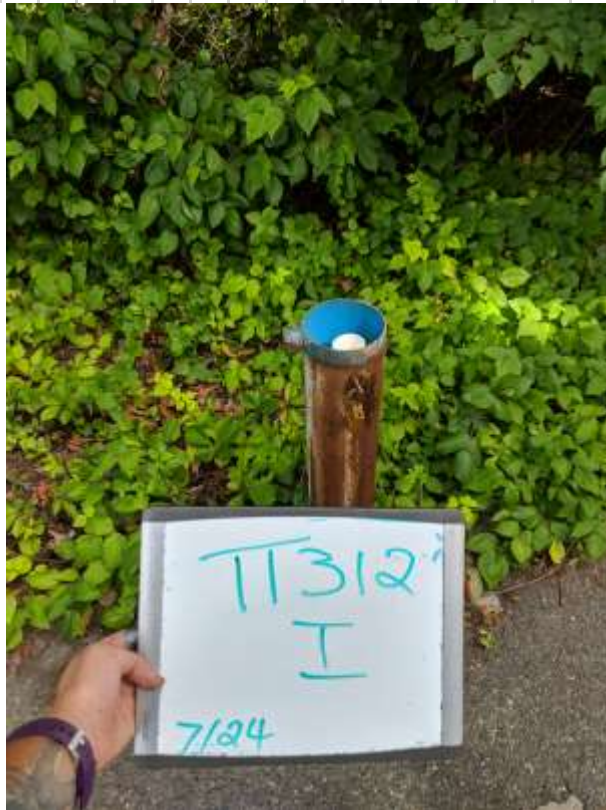
Needs Bolts: No
Needs Lock: No
Date/Time Measured: 2018-07-24 20:00:00
Depth of Water: 61.62
Depth of Boring: 172.75
Notes: TT-312I is in good condition.

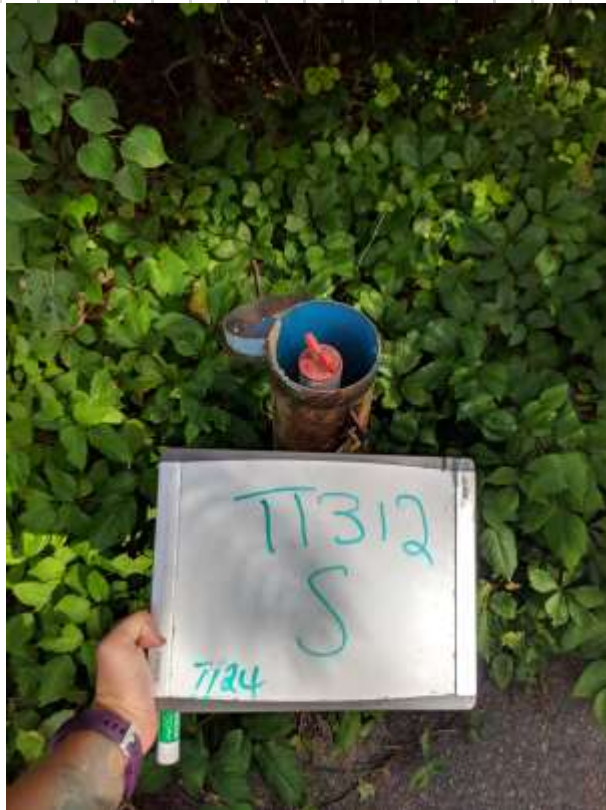
Needs Bolts: No
Needs Lock: No
Date/Time Measured: 2018-07-24 20:00:00
Depth of Water: 60.86
Depth of Boring: 65.90
Notes: TT-312S is in good condition.

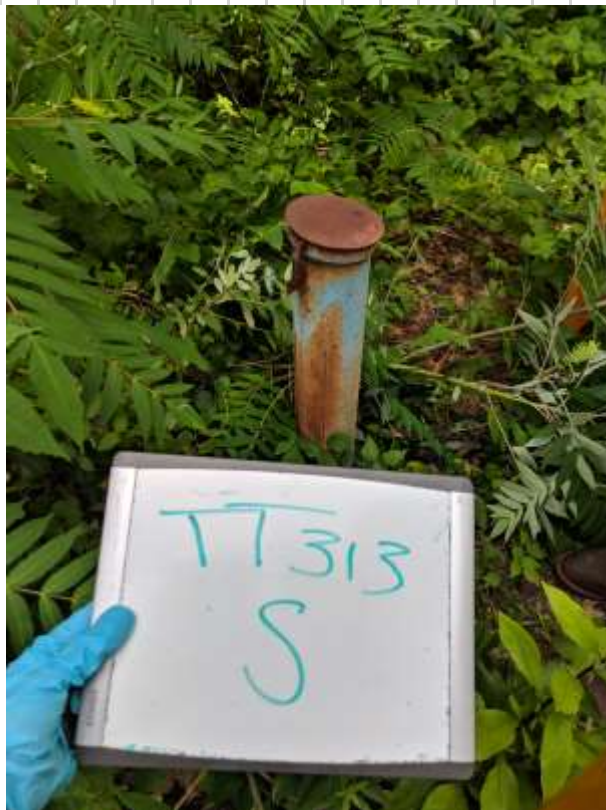
Needs Bolts: No
Needs Lock: No
Date/Time Measured: 2018-07-24 21:15:00
Depth of Water: 61.33
Depth of Boring: 65.10
Notes: TT-313S is in good condition.

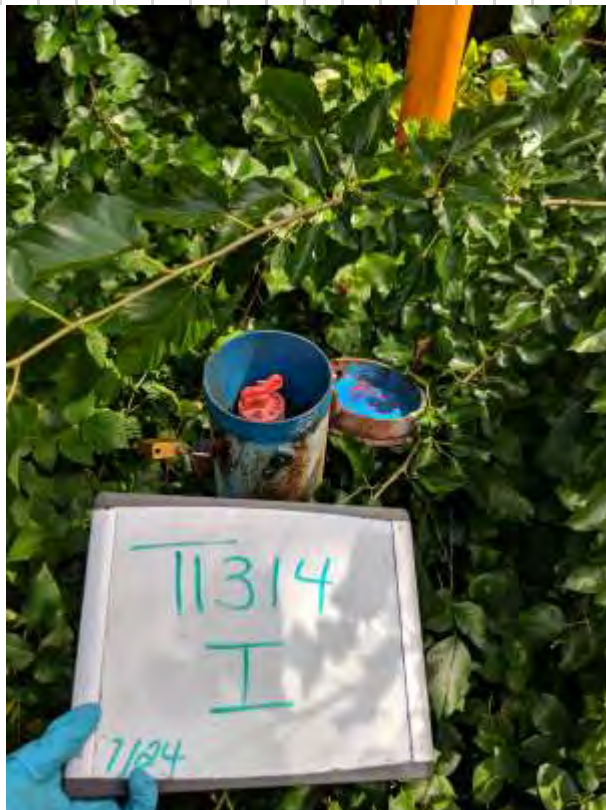
Needs Bolts: No
Needs Lock: No
Date/Time Measured: 2018-07-24 19:30:00
Depth of Water: 61.40
Depth of Boring: 156.20
Notes: TT-314I is in good condition.

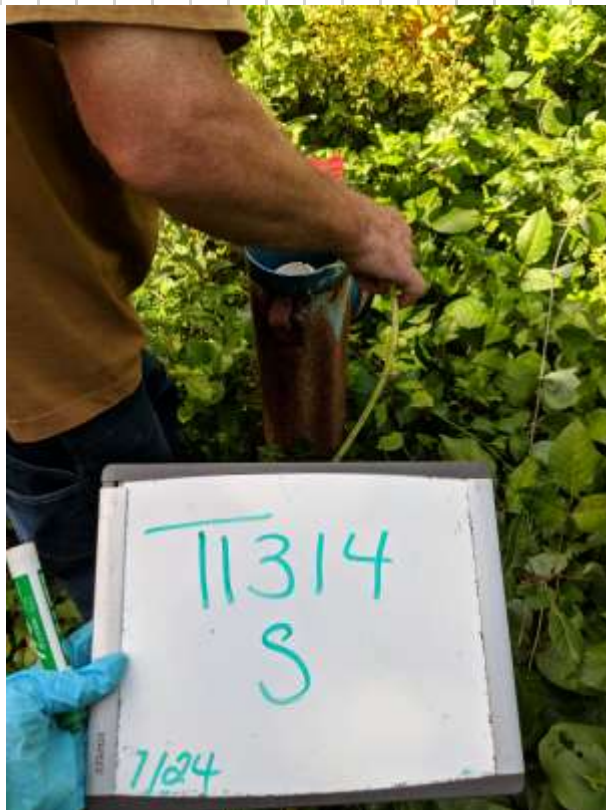
Needs Bolts: No
Needs Lock: No
Date/Time Measured: 2018-07-24 19:30:00
Depth of Water: 60.88
Depth of Boring: 67.40
Notes: TT-314S is in good condition.
