Memorandum

To: Scott Sokolowski, NAVFAC MIDLANT
From: Richard Moore, Tetra Tech
Date: September 27, 2024
Re: Annual LUC Inspection and Operation Summary Report: Sites 1, 2, 3, and 4 –
NWIRP Bethpage
Contract/CTO Number: N6247016D9008/WE16

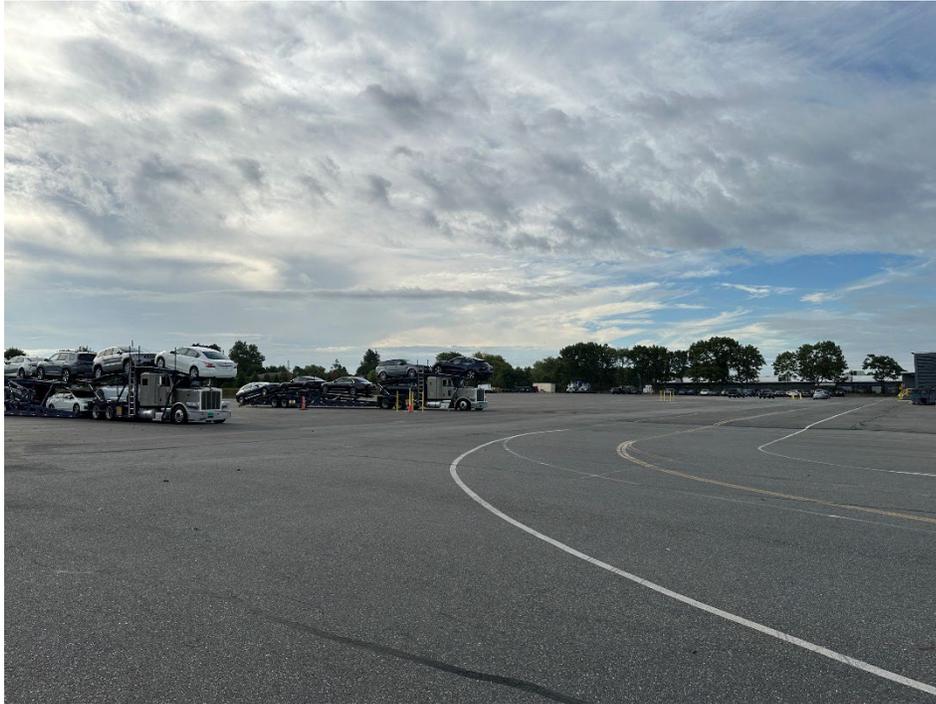
Photo 1A – Northwest corner of Site 1 looking east-southeast

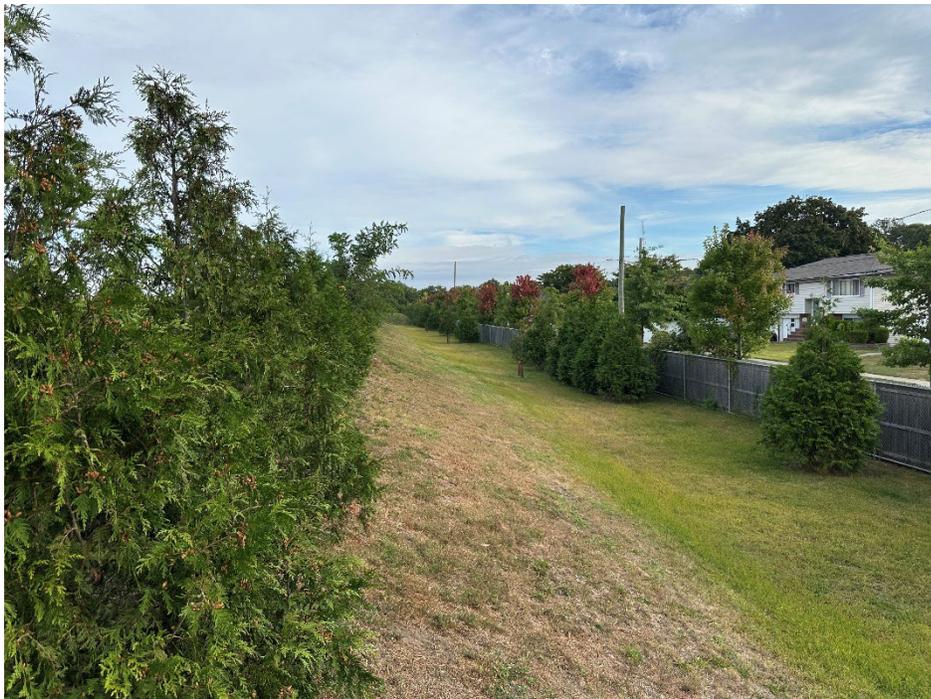
Photo 1B – Site 1 eastern boundary looking north towards SVE wells

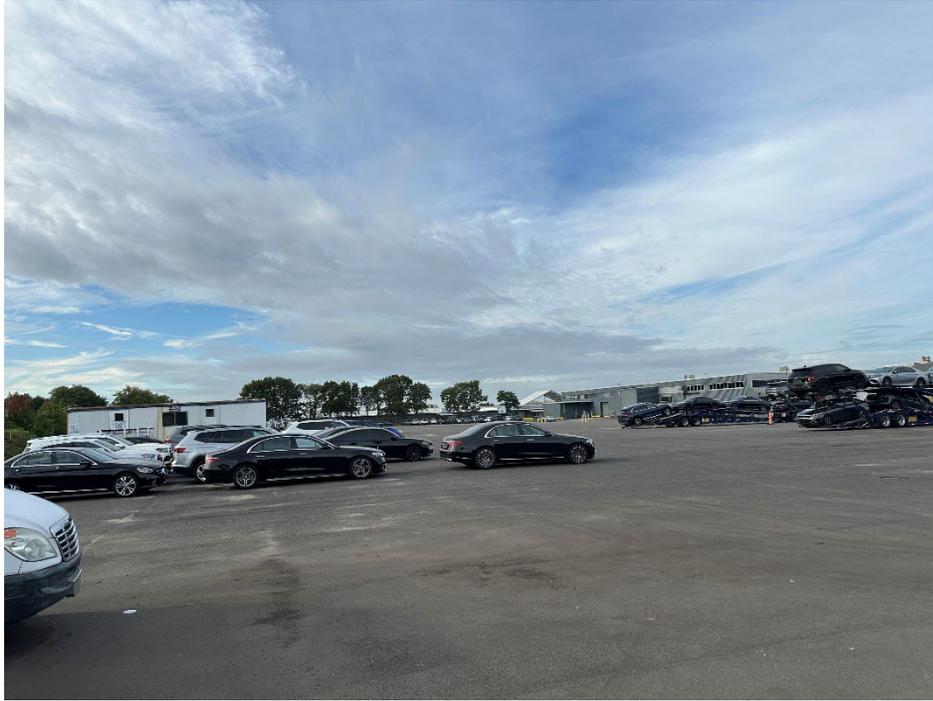
Photo 1C – Northeast corner of Site 1 looking south

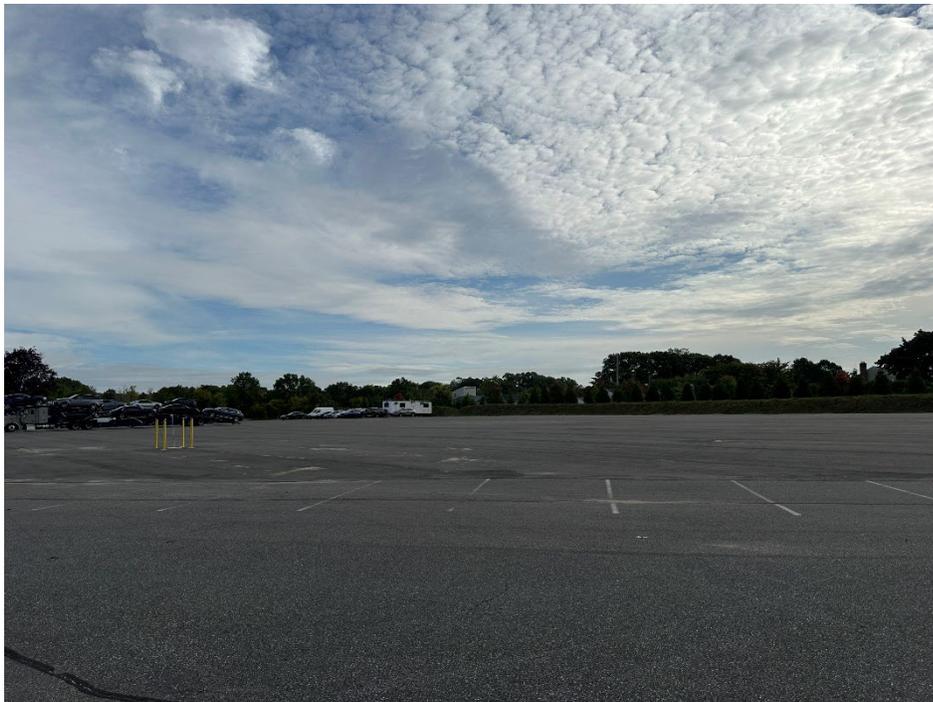
Photo 1D – Site 1 southern boundary looking north

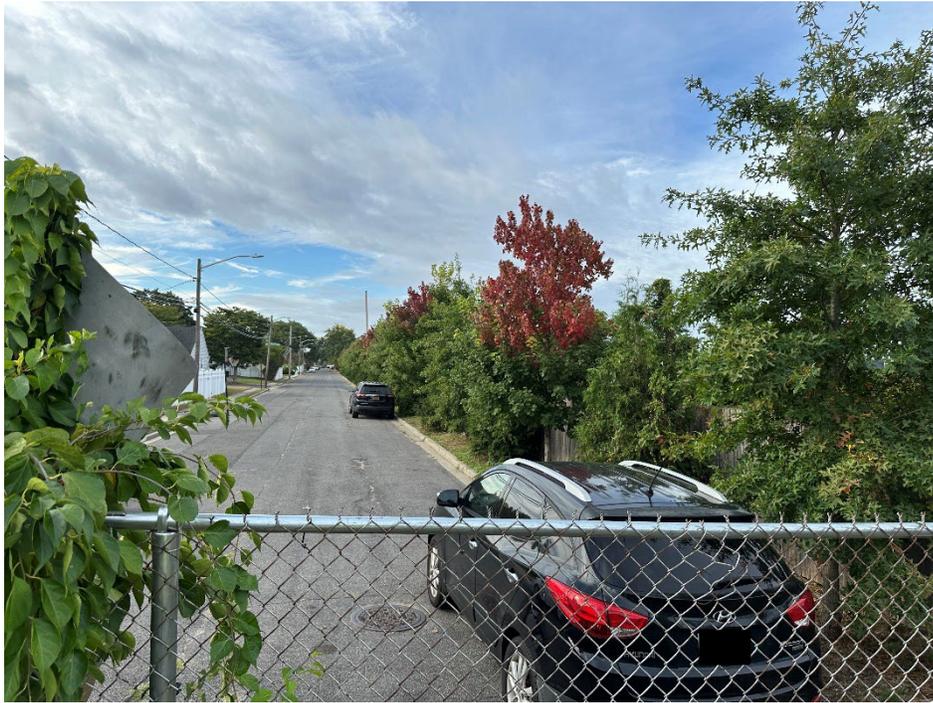
Photo 1E – Site 1 eastern boundary on 11th St looking south

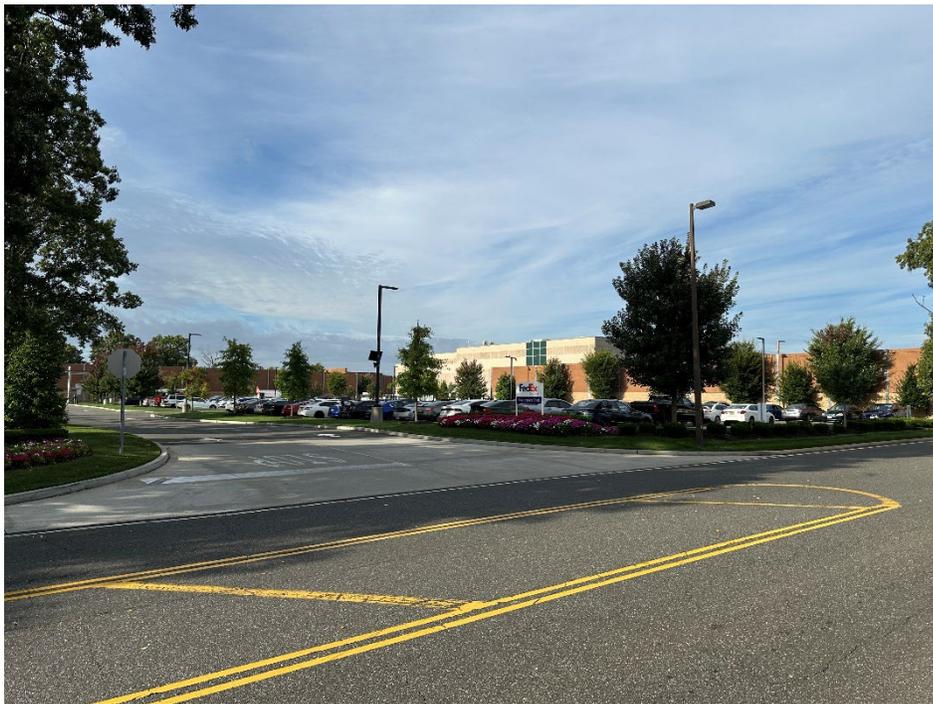
Photo 2A – Northwest portion of Site 2 looking southwest from Aerospace Blvd at FEDEX facility entrance

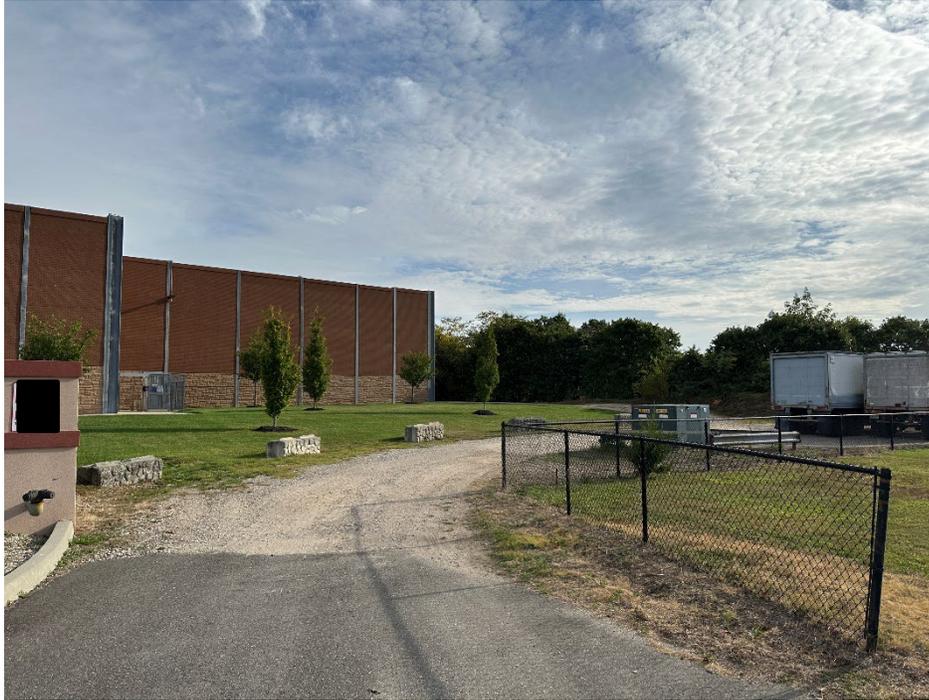
Photo 2B –Southwest corner of Site 2 looking northeast at FEDEX facility sound walls

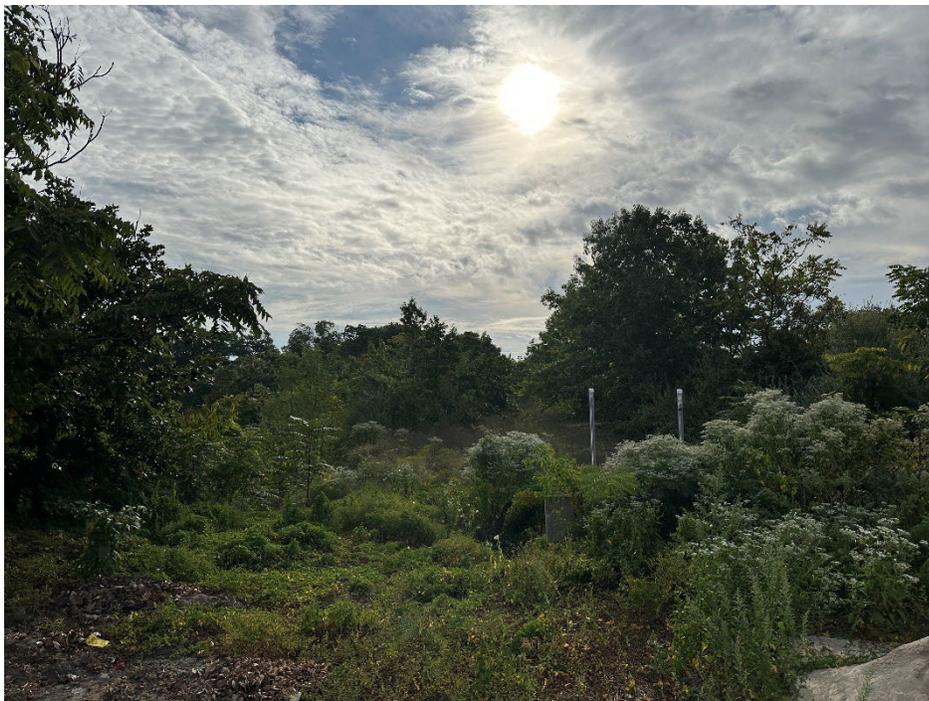
Photo 2C –Center of Site 2 looking east between the north and south basins at sluice gate

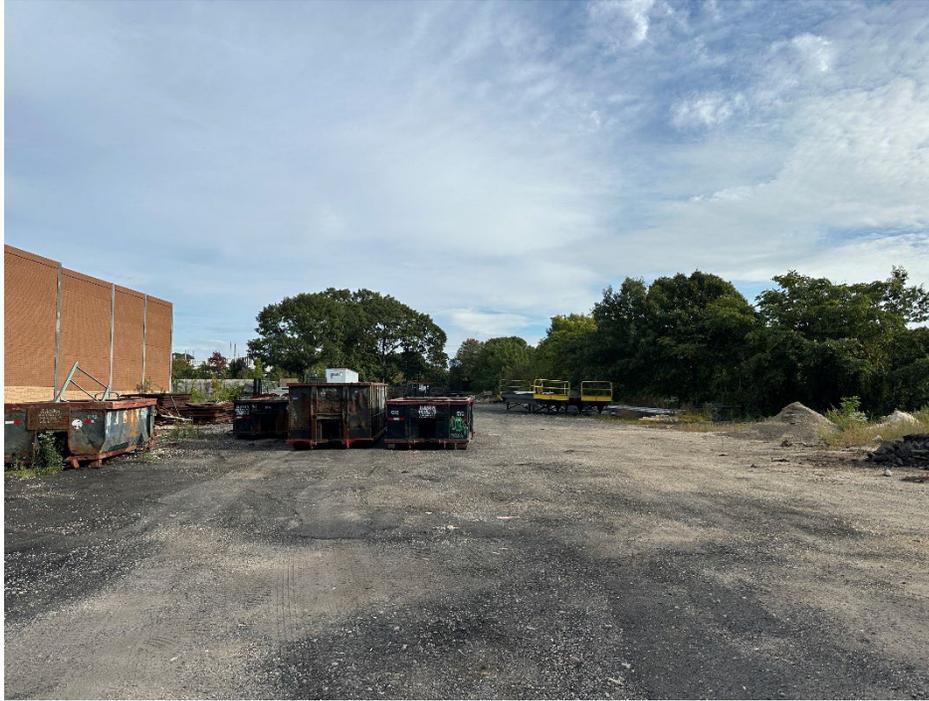
Photo 2D –Center of Site 2 looking north at Steel Equities laydown/storage area between the FEDEX hub terminal and north basin

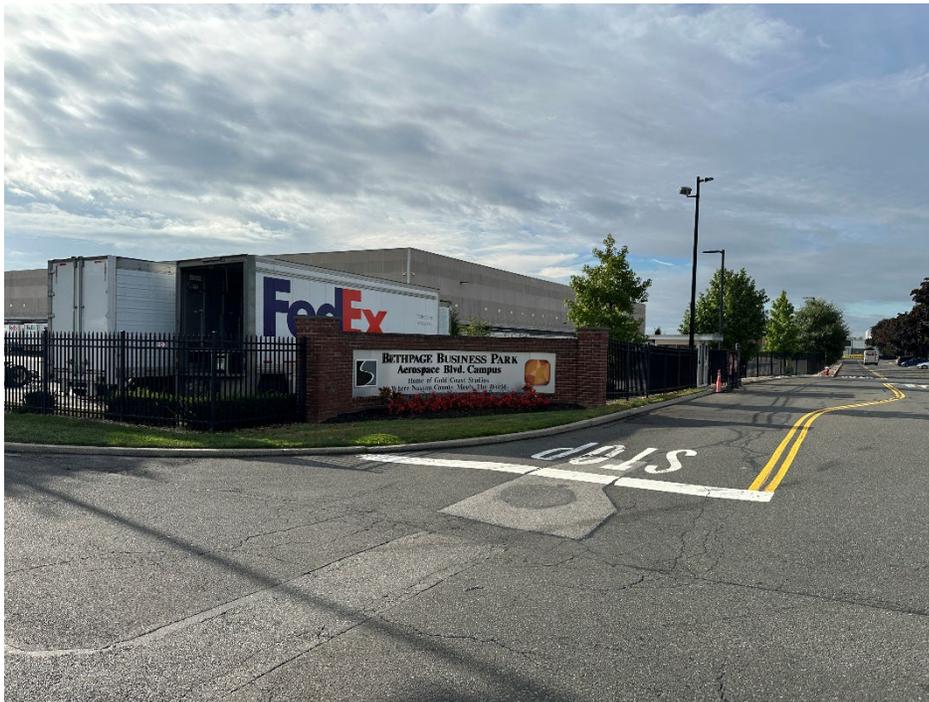
Photo 3A – Northwest corner of Site 3 looking southeast at FEDEX hub terminal

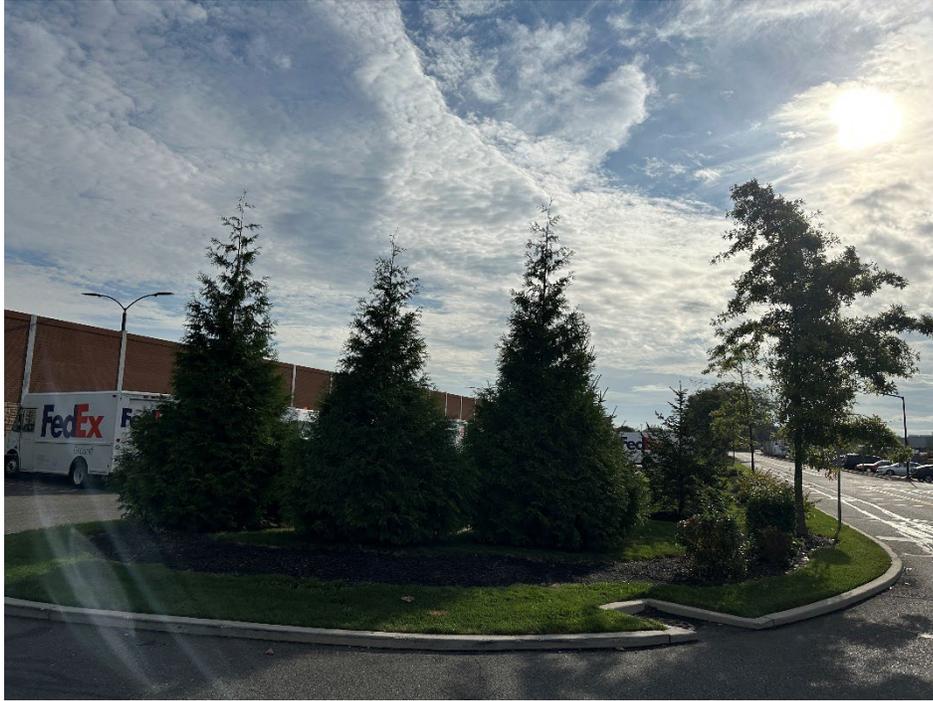
Photo 3B – Southwest corner of Site 3 looking east-northeast at FEDEX hub terminal sound walls and southern parking area

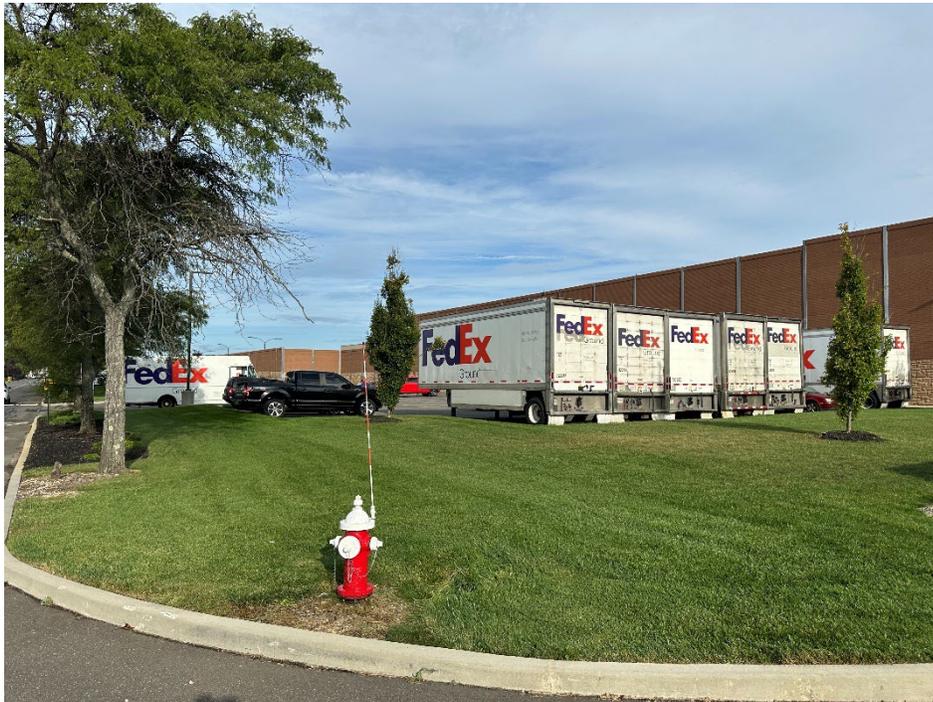
Photo 3C – Southeast corner of Site 3 facing northwest showing the FEDEX hub terminal sound walls and southern parking area

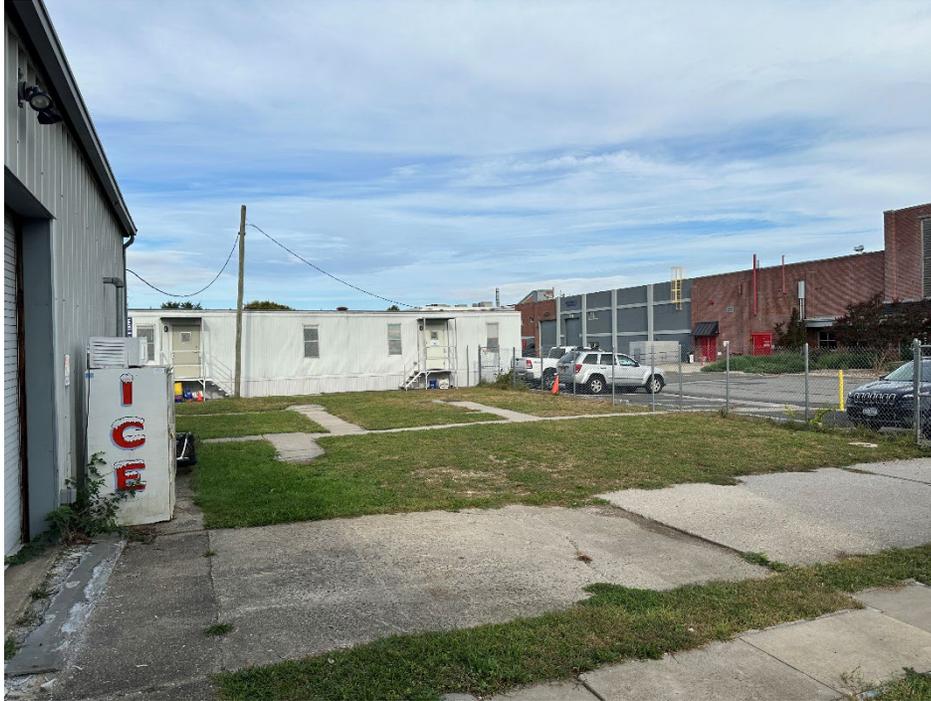
Photo 4A – Southeast corner of Site 4 facing northwest

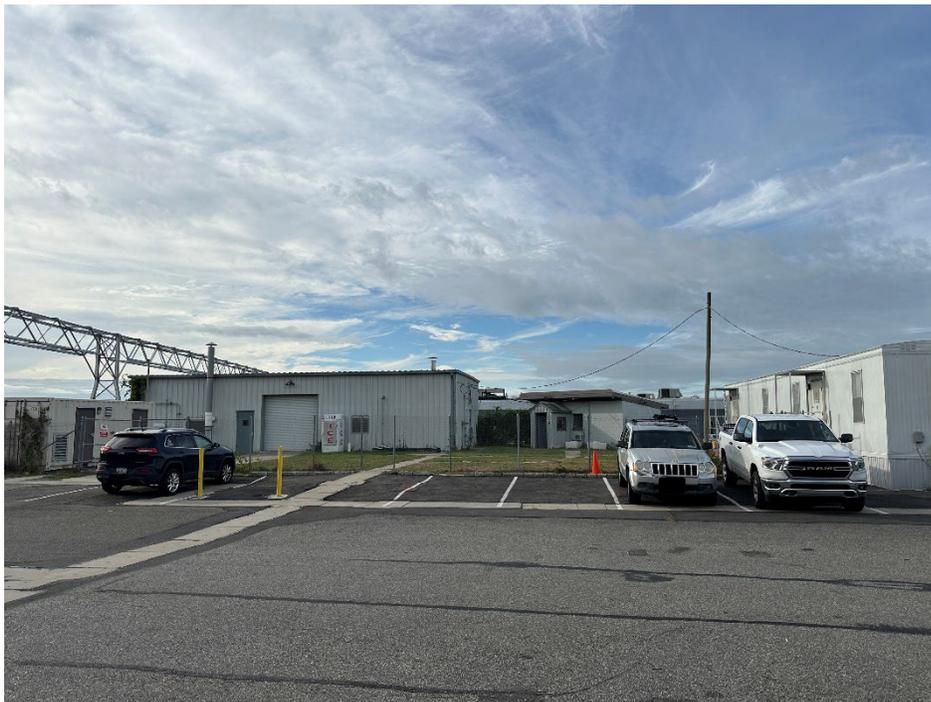
Photo 4B – Northern portion of Site 4 facing south looking at Navy trailer, warehouse and pavement/parking spaces.

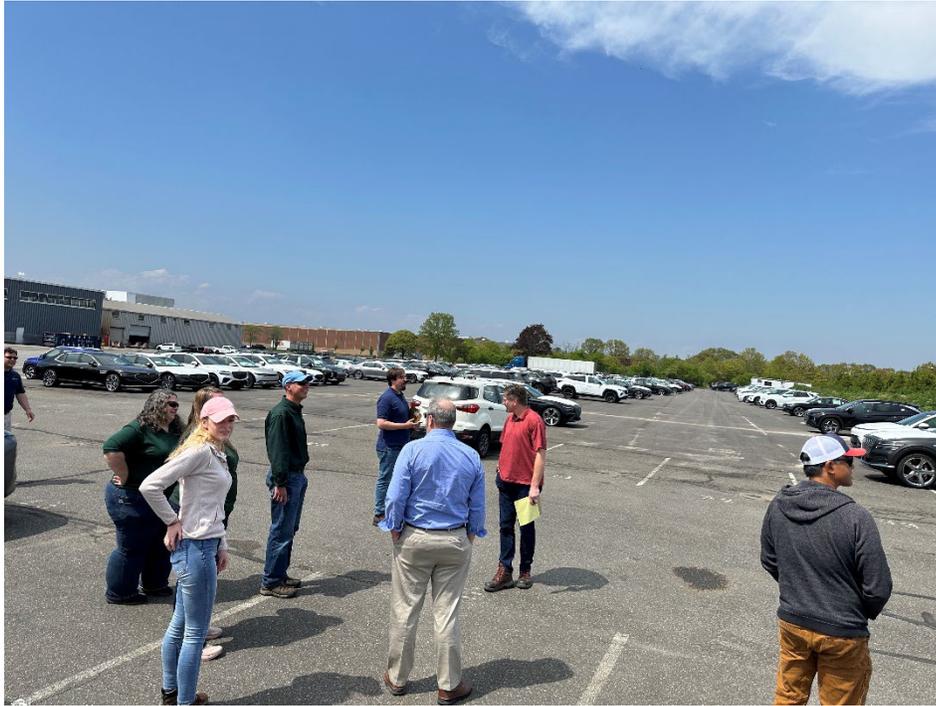
View looking north of Site 1 paved area

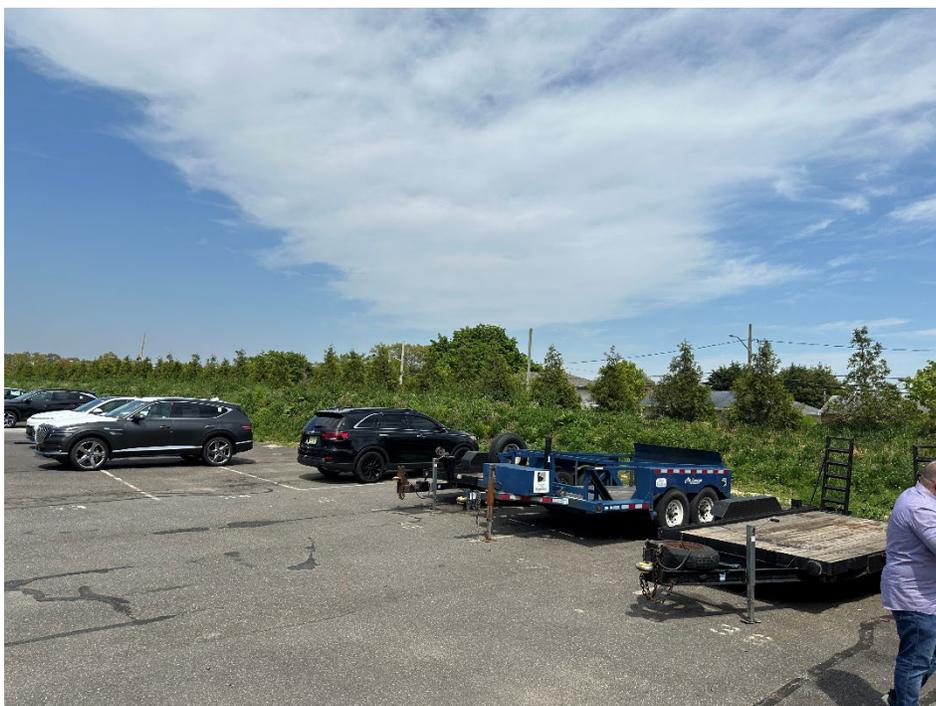
View looking northeast of Site 1 berm and tree line

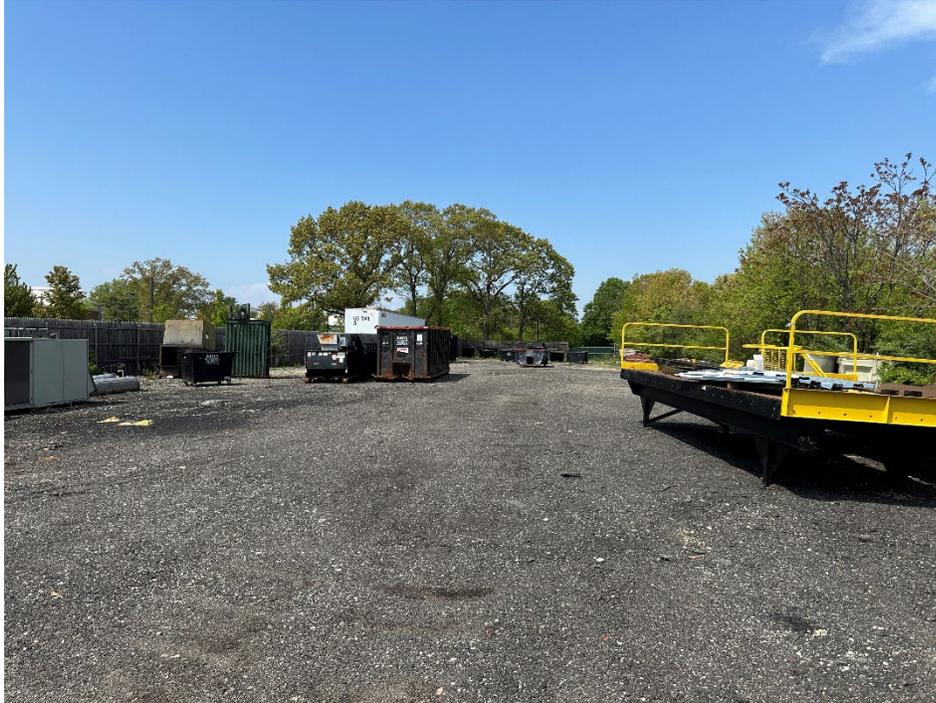
View looking north of drying bed area used for Steel Equalities laydown area

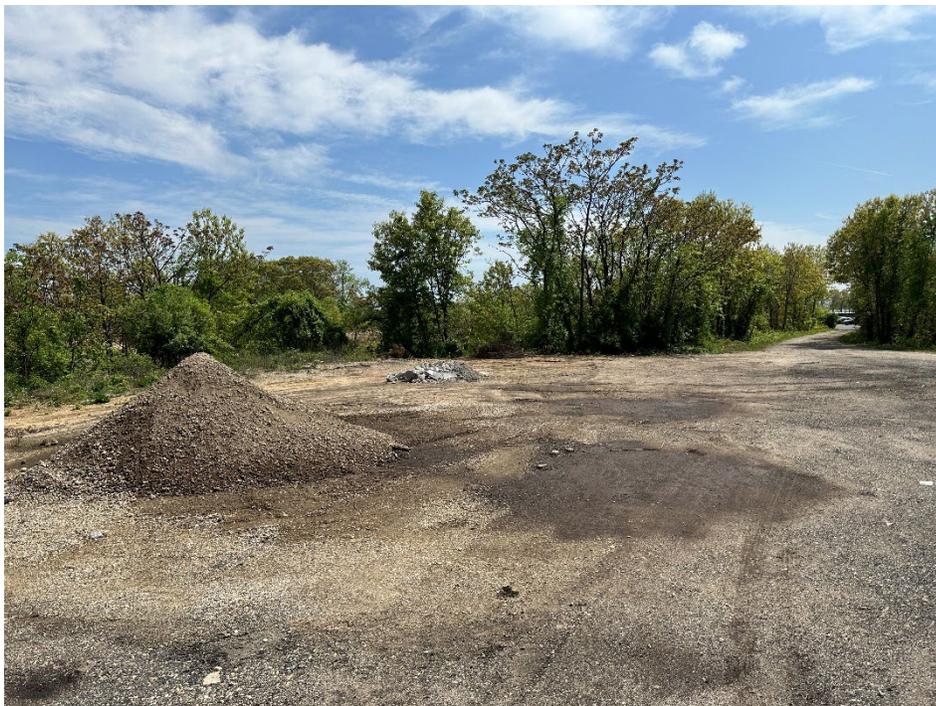
During the May 2024 site walk with NYSDEC, soil disturbances were observed on the western portion of Site 2. Inquiries with Steel Equities indicated that they were unaware of any activities in that area. To ensure no PCB-containing soil was disturbed, three surface soil samples were collected on May 22, 2024. The locations of the soil samples are presented on Figure 4. The three soil samples (SS01, SS02, and SS03) had reported detections of Aroclor-1248 and Aroclor-1254 with all other PCBs below

View looking southeast of Site 2 area with new gravel storage

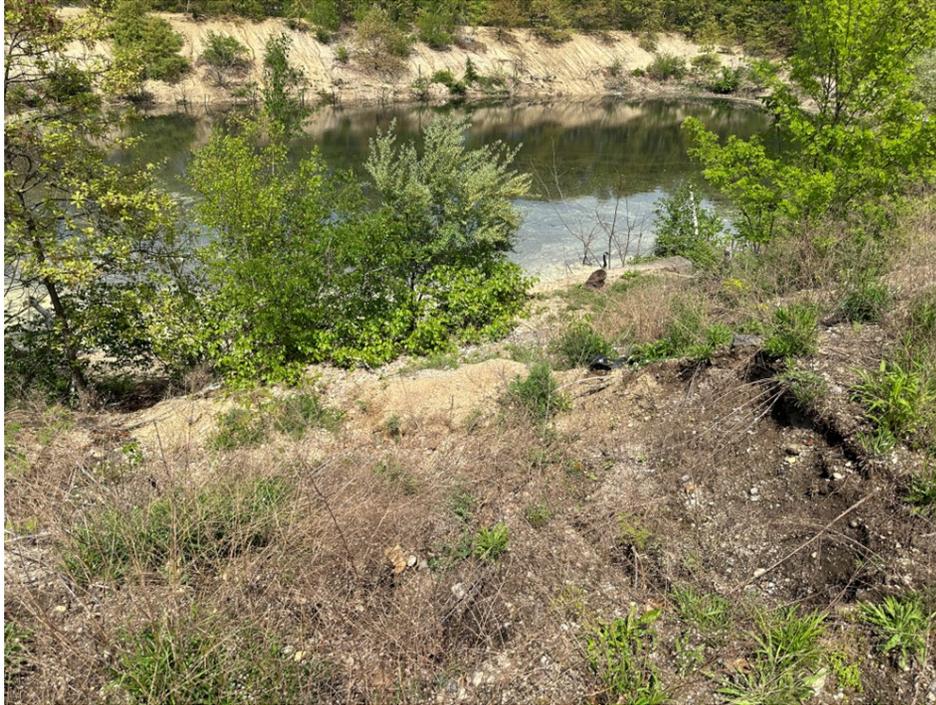
View looking northeast of northeast settling pond with erosion on southwest corner

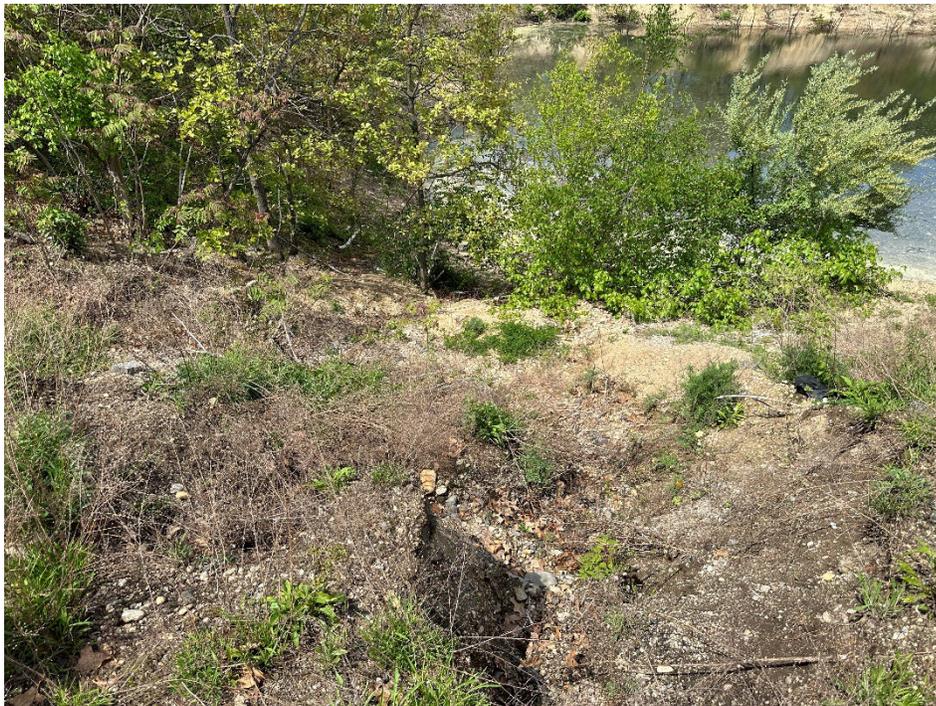
View looking north of northeast settling pond with erosion on southwest corner

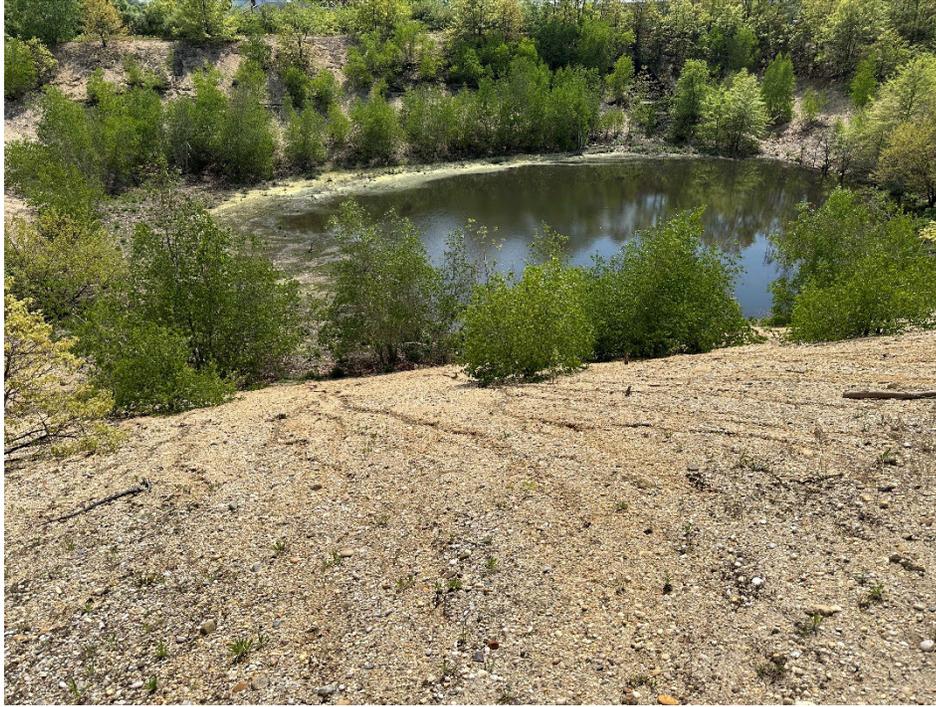
View looking south of southeast settling pond

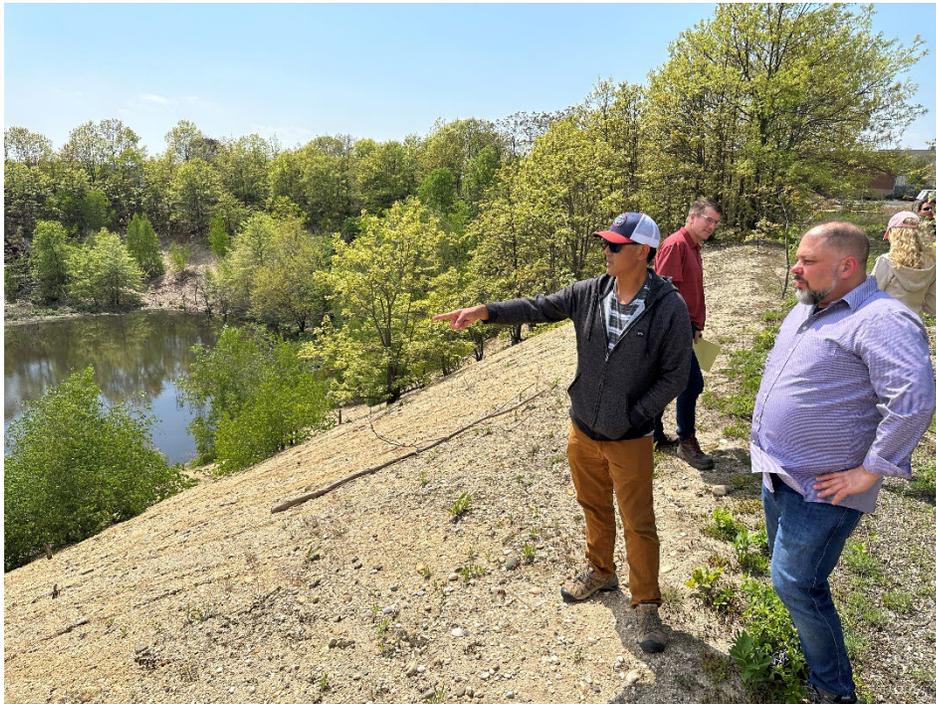
View looking west of southeast settling pond

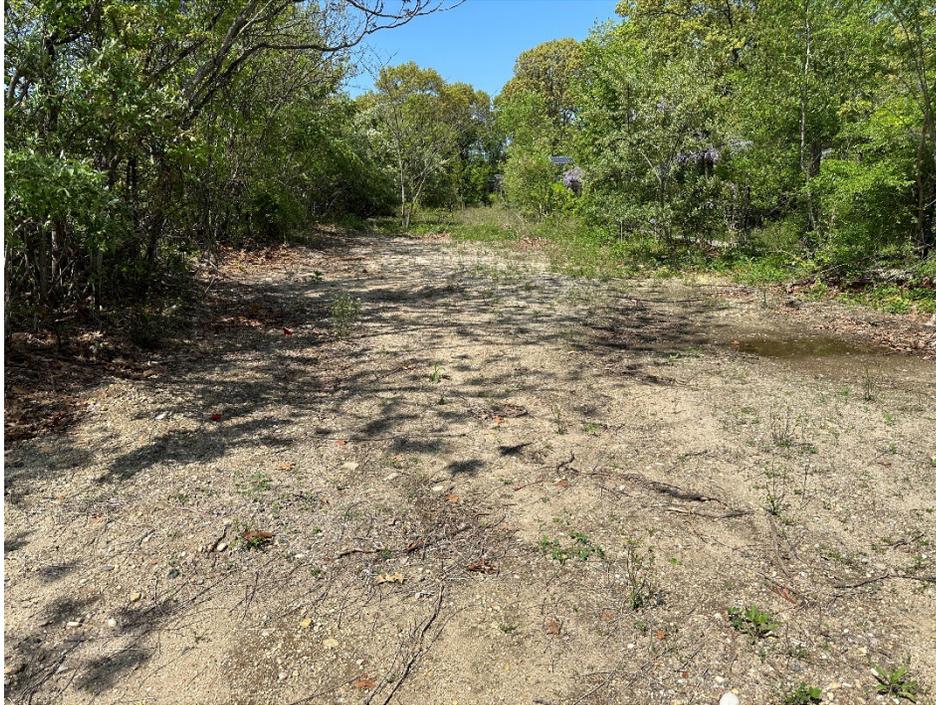
View looking north of access road from Aerospace Boulevard to Site 2

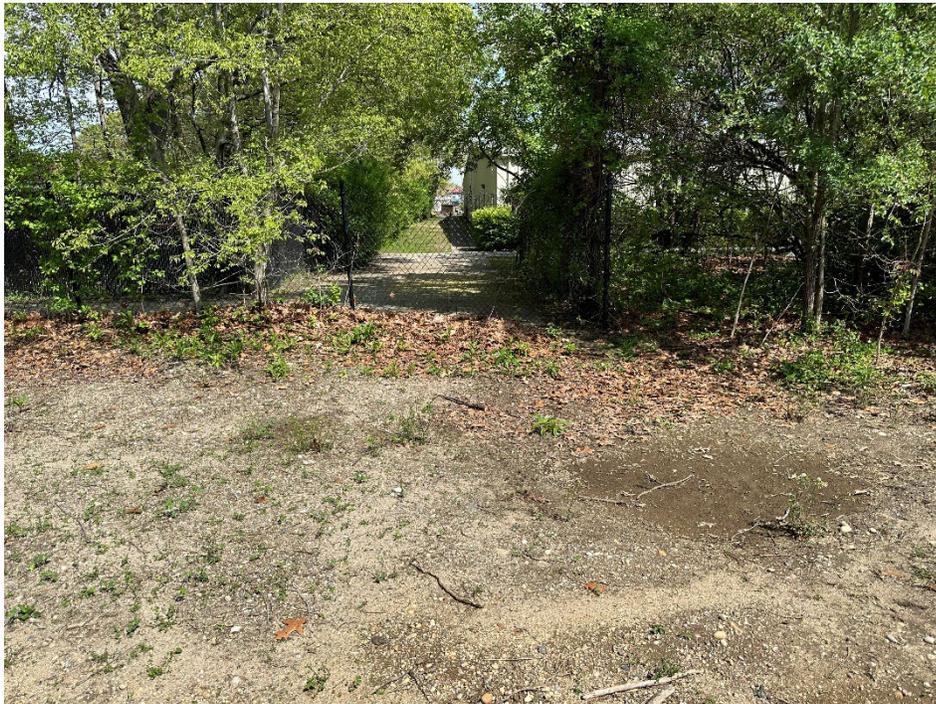
View looking east of access from Arumdaun Presbyterian Church to Site 2

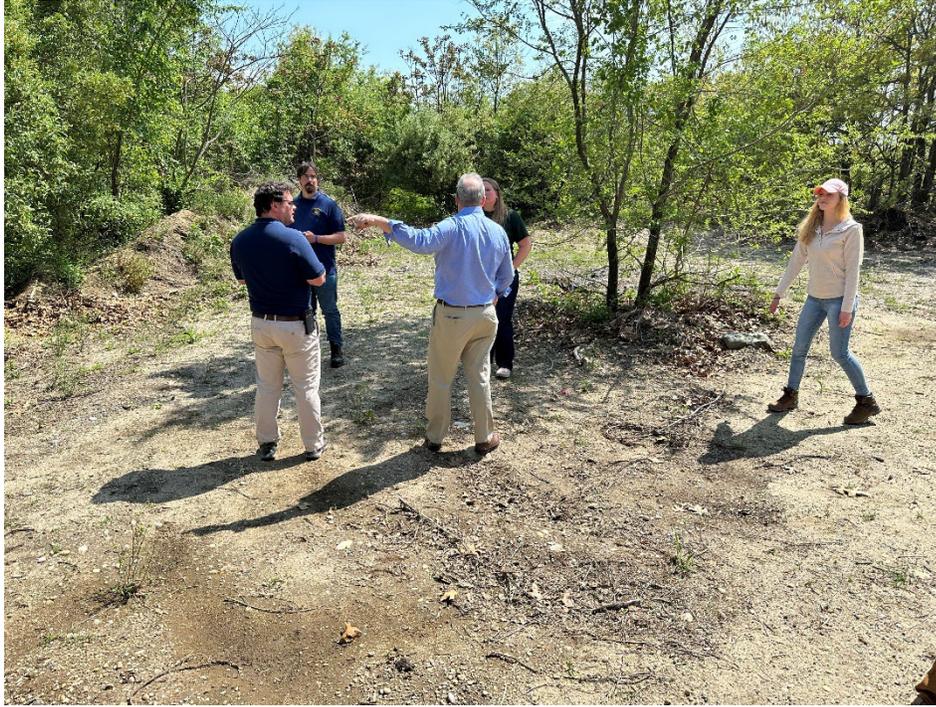
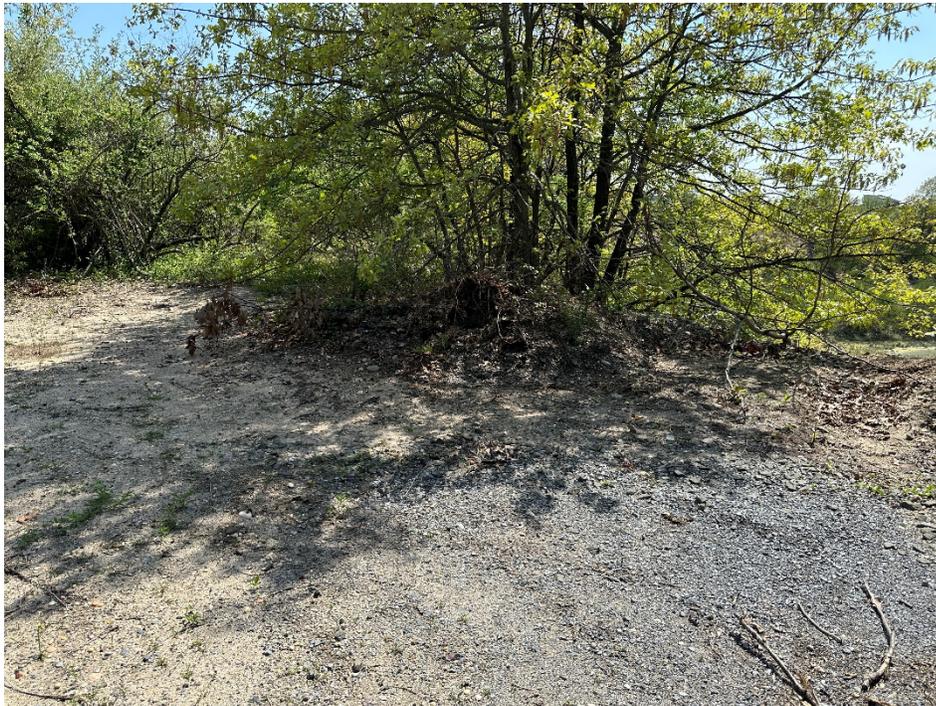
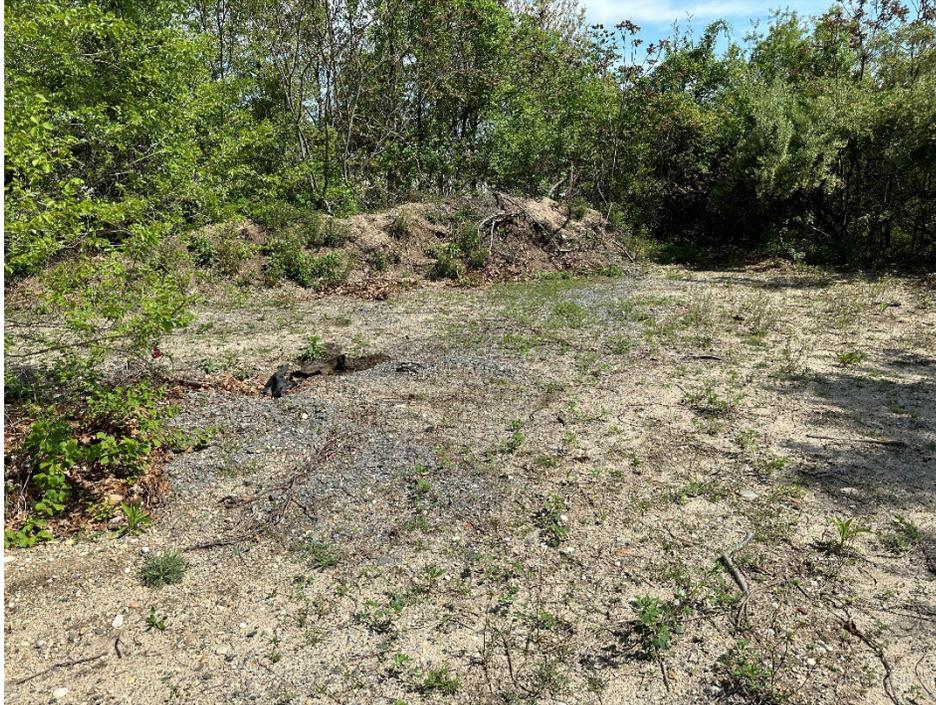
View looking south of access road from Aerospace Boulevard to Site 2 where new grading has occurred

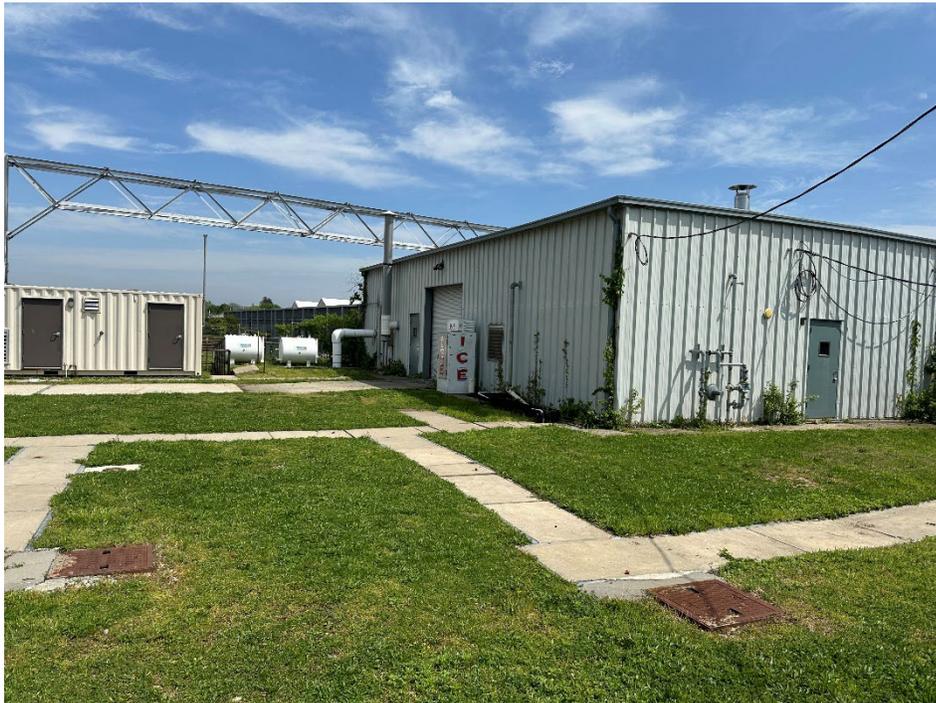
View looking south of Site 4 SCE system blower building looking southeast

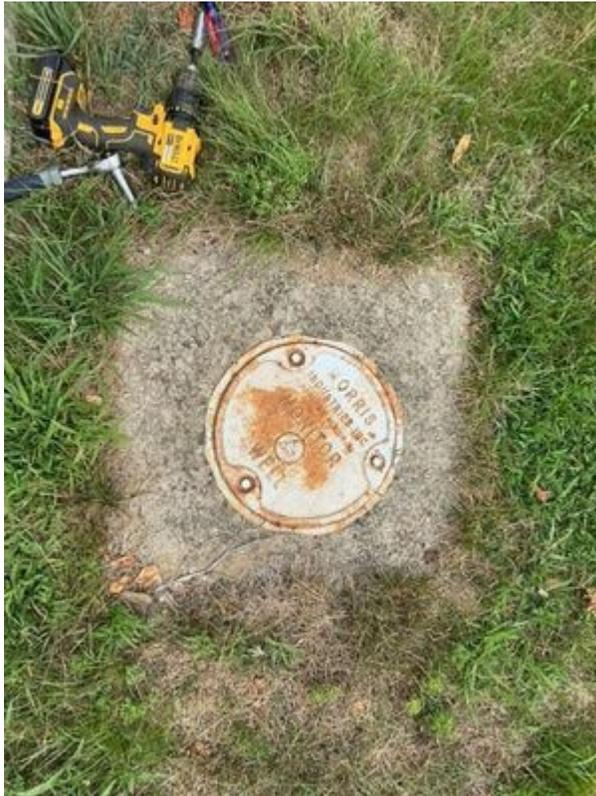
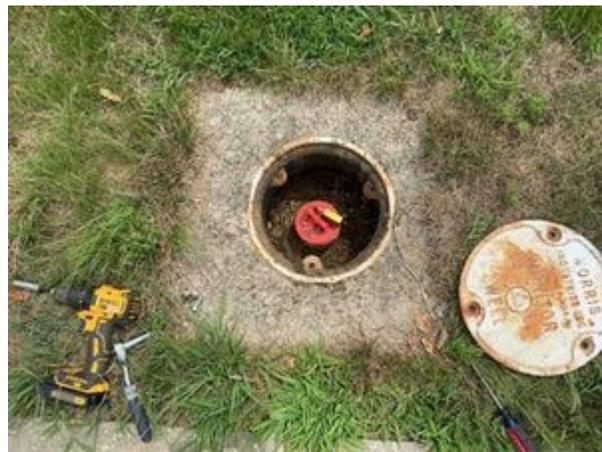
Client: Navy CLEAN	Facility: NWIRP Bethpage
Project Number: 112G08005-WE13	Location: Bethpage, New York
Date: July 9, 2024 11:42	Personnel: Jake Marlow
Well ID: RE127D1	Well Location: 199120.113150435 1131243.69614773
Well Status: In Use (Confirmed)	Screen Interval: 660-680
WELL INVENTORY CONDITION	
Concrete pad in acceptable condition i.e. no cracks?	YES
Manhole cover present and in working condition?	YES
All bolts on manhole present and not stripped?	YES
Well plug present, locked and in good working condition?	YES
OVERALL CONDITION:	GOOD
Notes (Explain if answered No to any of the above) Replaced missing bolt

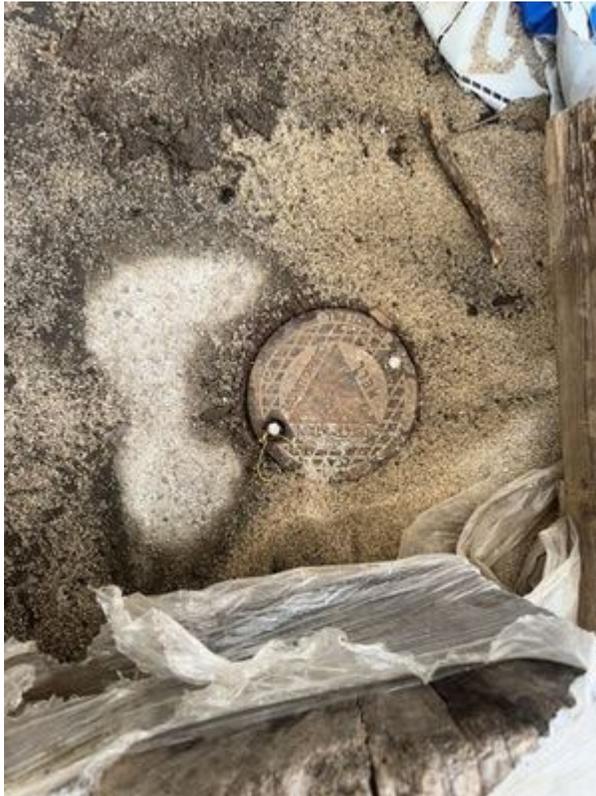
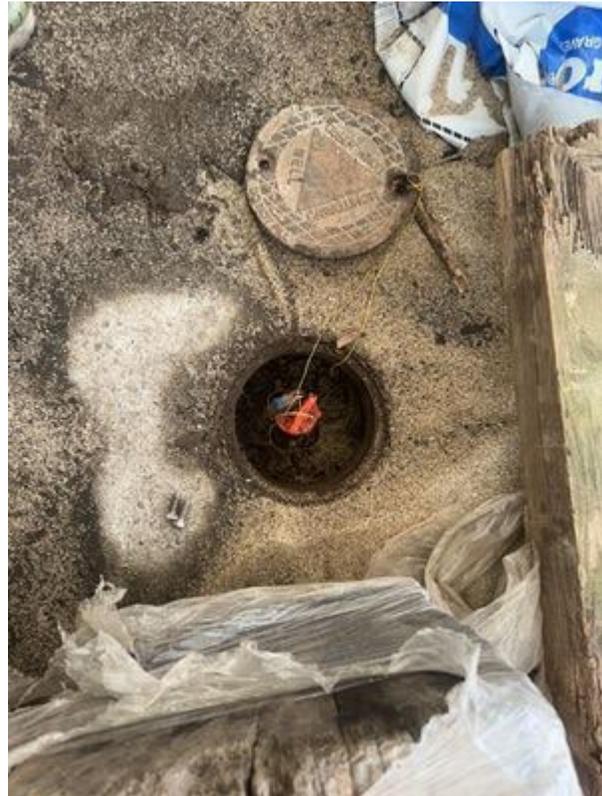
Client: Navy CLEAN	Facility: NWIRP Bethpage
Project Number: 112G08005-WE13	Location: Bethpage, New York
Date: August 6, 2024 09:26	Personnel: Jake Marlow
Well ID: BPS1-TT-MW30312	Well Location: 213787.286995785 1124566.22380942
Well Status: In Use (Confirmed)	Screen Interval: 146-156
WELL INVENTORY CONDITION	
Concrete pad in acceptable condition i.e. no cracks?	YES
Manhole cover present and in working condition?	YES
All bolts on manhole present and not stripped?	YES
Well plug present, locked and in good working condition?	YES
OVERALL CONDITION:	GOOD
Notes (Explain if answered No to any of the above)

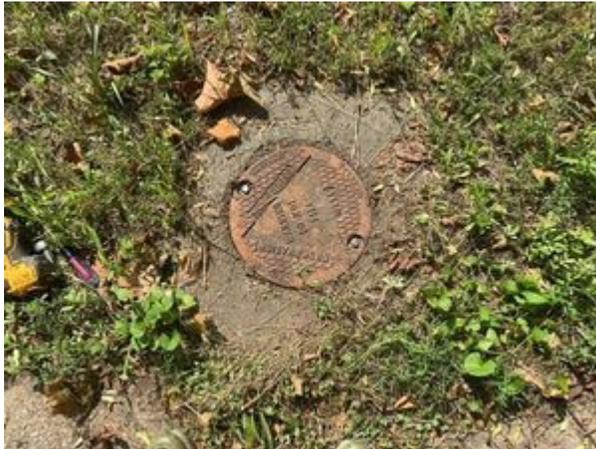
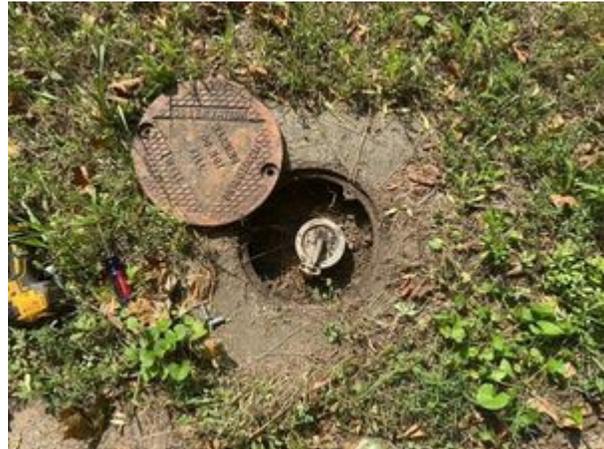
Client: Navy CLEAN	Facility: NWIRP Bethpage
Project Number: 112G08005-WE13	Location: Bethpage, New York
Date: July 9, 2024 16:25	Personnel: Jake Marlow
Well ID: RE104D1	Well Location: 207044.871873386 1127739.83854447
Well Status: In Use (Confirmed)	Screen Interval:
WELL INVENTORY CONDITION	
Concrete pad in acceptable condition i.e. no cracks?	YES
Manhole cover present and in working condition?	YES
All bolts on manhole present and not stripped?	YES
Well plug present, locked and in good working condition?	YES
OVERALL CONDITION:	GOOD
Notes (Explain if answered No to any of the above) Replaced two missing bolts

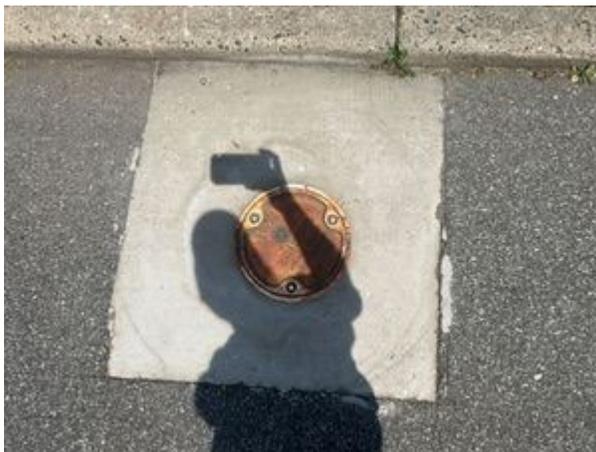
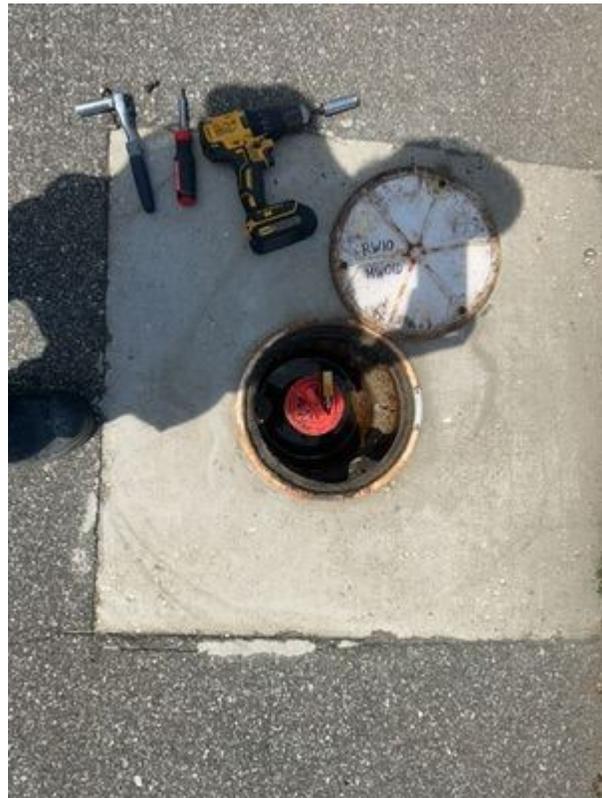
Client: Navy CLEAN	Facility: NWIRP Bethpage
Project Number: 112G08005-WE13	Location: Bethpage, New York
Date: June 13, 2024 13:54	Personnel: Jake Marlow
Well ID: RW10-MW01D	Well Location: 195582.680443788 1128248.57128801
Well Status: In Use (Confirmed)	Screen Interval:
WELL INVENTORY CONDITION	
Concrete pad in acceptable condition i.e. no cracks?	YES
Manhole cover present and in working condition?	YES
All bolts on manhole present and not stripped?	YES
Well plug present, locked and in good working condition?	YES
OVERALL CONDITION:	GOOD
Notes (Explain if answered No to any of the above)
