Memorandum

To: Scott Sokolowski, NAVFAC MIDLANT
From: Richard Moore, Tetra Tech
Date: September 27, 2024
Re: Annual LUC Inspection and Operation Summary Report: Sites 1, 2, 3, and 4 –
NWIRP Bethpage
Contract/CTO Number: N6247016D9008/WE16

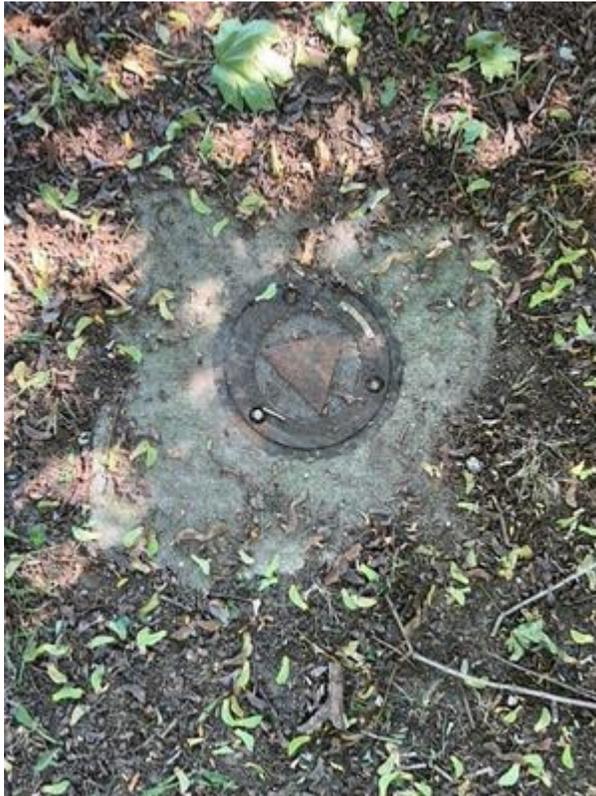
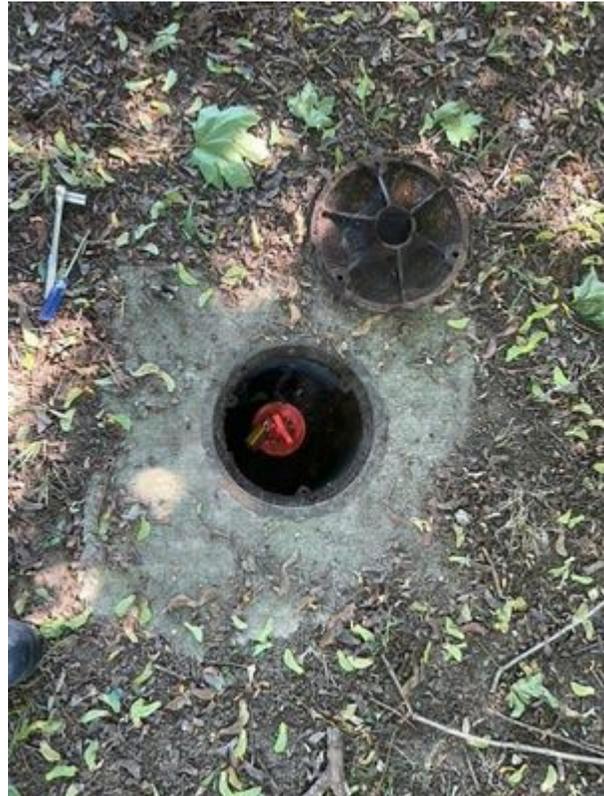
Client: Navy CLEAN	Facility: NWIRP Bethpage
Project Number: 112G08005-WE13	Location: Bethpage, New York
Date: September 11, 2024 15:39	Personnel: Jake Marlow
Well ID: BPGMMW79D	Well Location: 208837.888846164 1127543.31365568
Well Status: In Use (Confirmed)	Screen Interval: 280-290
WELL INVENTORY CONDITION	
Concrete pad in acceptable condition i.e. no cracks?	YES
Manhole cover present and in working condition?	YES
All bolts on manhole present and not stripped?	YES
Well plug present, locked and in good working condition?	YES
OVERALL CONDITION:	GOOD
Notes (Explain if answered No to any of the above)

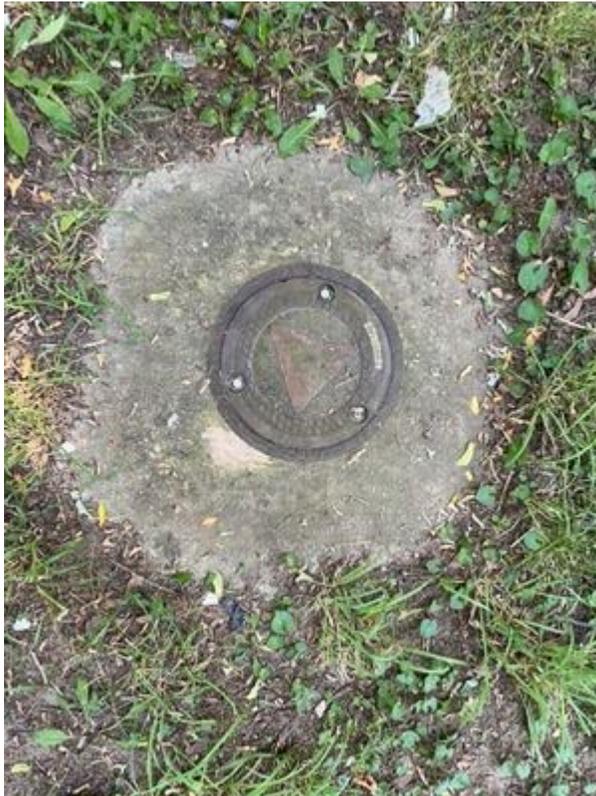
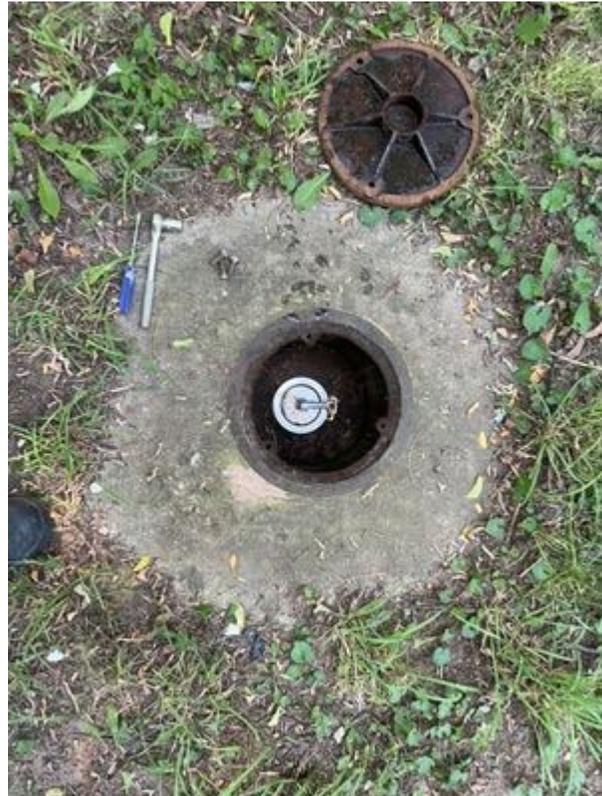
Client: Navy CLEAN	Facility: NWIRP Bethpage
Project Number: 112G08005-WE13	Location: Bethpage, New York
Date: September 11, 2024 15:37	Personnel: Jake Marlow
Well ID: BPGMMW79I	Well Location: 208826.779153379 1127535.67073771
Well Status: In Use (Confirmed)	Screen Interval: 170-180
WELL INVENTORY CONDITION	
Concrete pad in acceptable condition i.e. no cracks?	YES
Manhole cover present and in working condition?	YES
All bolts on manhole present and not stripped?	YES
Well plug present, locked and in good working condition?	YES
OVERALL CONDITION:	GOOD
Notes (Explain if answered No to any of the above)

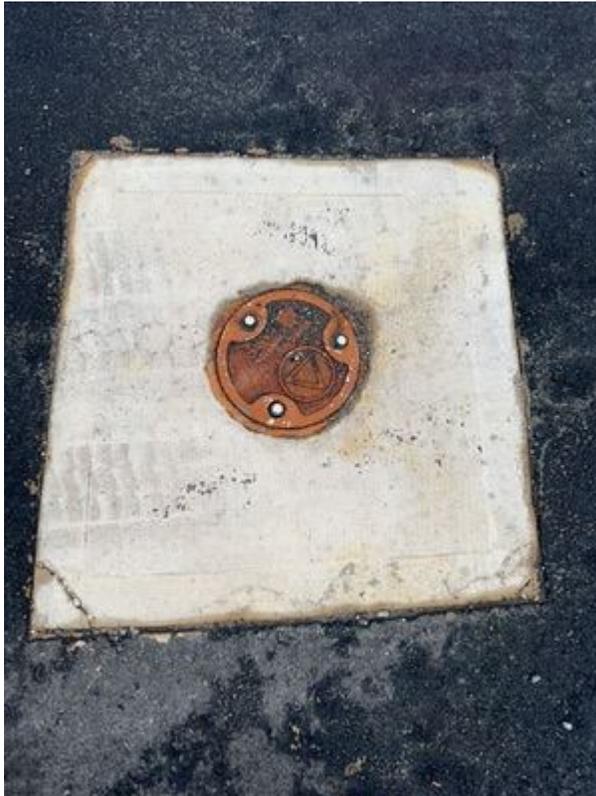
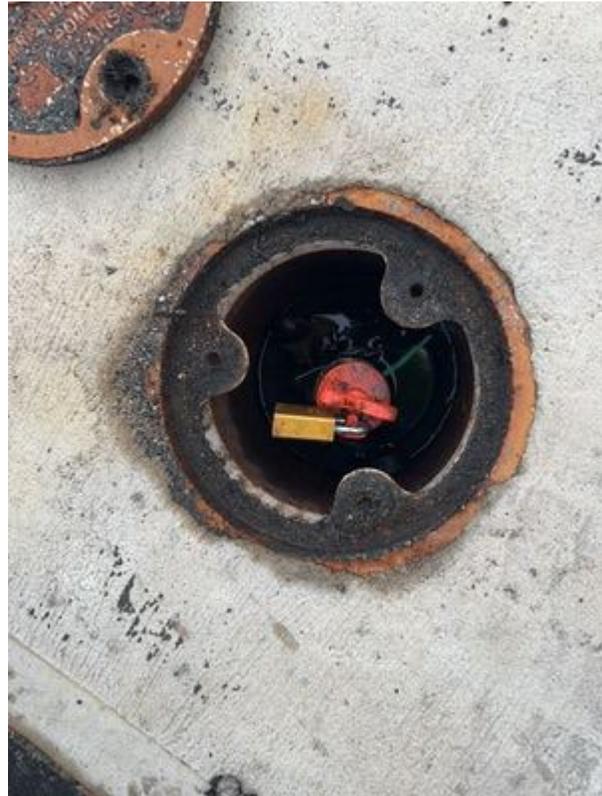
Client: Navy CLEAN	Facility: NWIRP Bethpage
Project Number: 112G08005-WE13	Location: Bethpage, New York
Date: August 7, 2024 12:25	Personnel: Other
Well ID: BPS1-TT-MW301D	Well Location: 214569.005632913 1124881.38374296
Well Status: In Use (Confirmed)	Screen Interval: 210-220
WELL INVENTORY CONDITION	
Concrete pad in acceptable condition i.e. no cracks?	YES
Manhole cover present and in working condition?	YES
All bolts on manhole present and not stripped?	YES
Well plug present, locked and in good working condition?	YES
OVERALL CONDITION:	GOOD
Notes (Explain if answered No to any of the above)

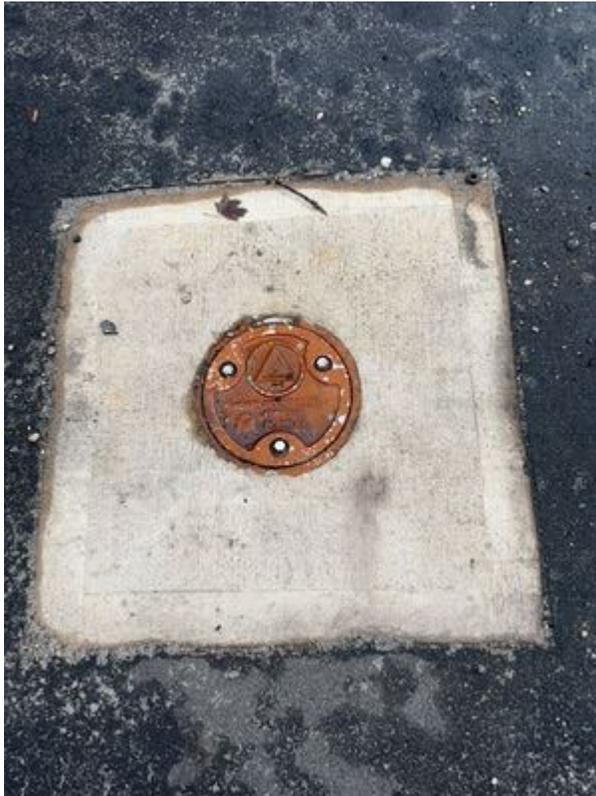
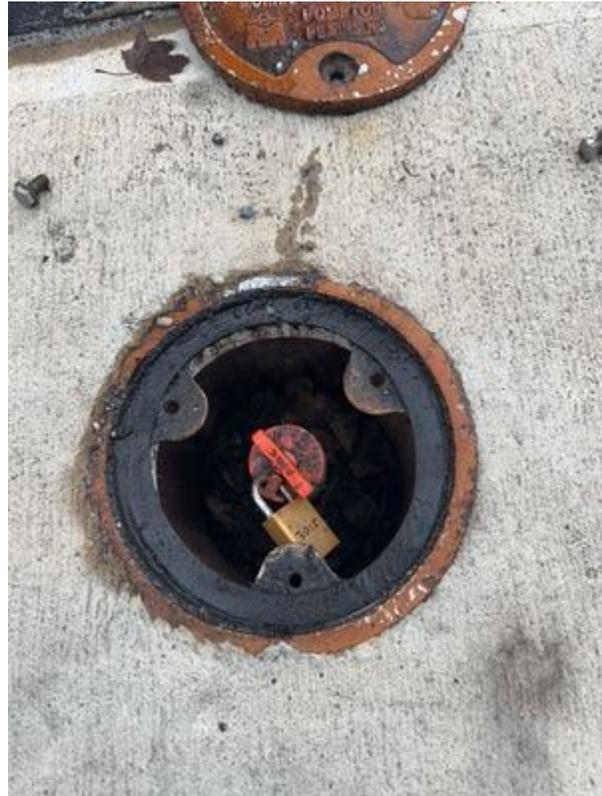
Client: Navy CLEAN	Facility: NWIRP Bethpage
Project Number: 112G08005-WE13	Location: Bethpage, New York
Date: August 7, 2024 12:21	Personnel: Other
Well ID: BPS1-TT-MW301S	Well Location: 214568.935471289 1124882.8567166
Well Status: In Use (Confirmed)	Screen Interval: 51-61
WELL INVENTORY CONDITION	
Concrete pad in acceptable condition i.e. no cracks?	YES
Manhole cover present and in working condition?	YES
All bolts on manhole present and not stripped?	YES
Well plug present, locked and in good working condition?	YES
OVERALL CONDITION:	GOOD
Notes (Explain if answered No to any of the above)

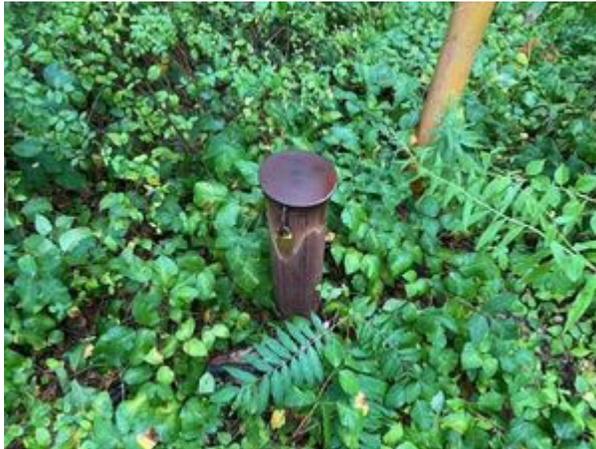
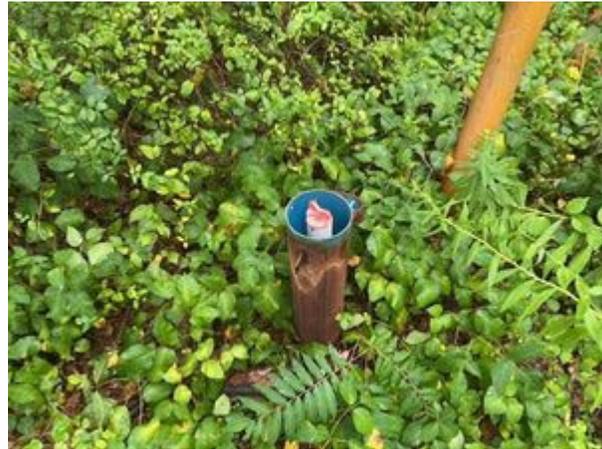
Client: Navy CLEAN	Facility: NWIRP Bethpage
Project Number: 112G08005-WE13	Location: Bethpage, New York
Date: August 6, 2024 16:42	Personnel: Jake Marlow
Well ID: BPS1-TT-MW313S	Well Location: 215153.33183115 1125592.19758698
Well Status: In Use (Confirmed)	Screen Interval: 53-63
WELL INVENTORY CONDITION	
Concrete pad in acceptable condition i.e. no cracks?	YES
Manhole cover present and in working condition?	YES
All bolts on manhole present and not stripped?	YES
Well plug present, locked and in good working condition?	YES
OVERALL CONDITION:	GOOD
Notes (Explain if answered No to any of the above)

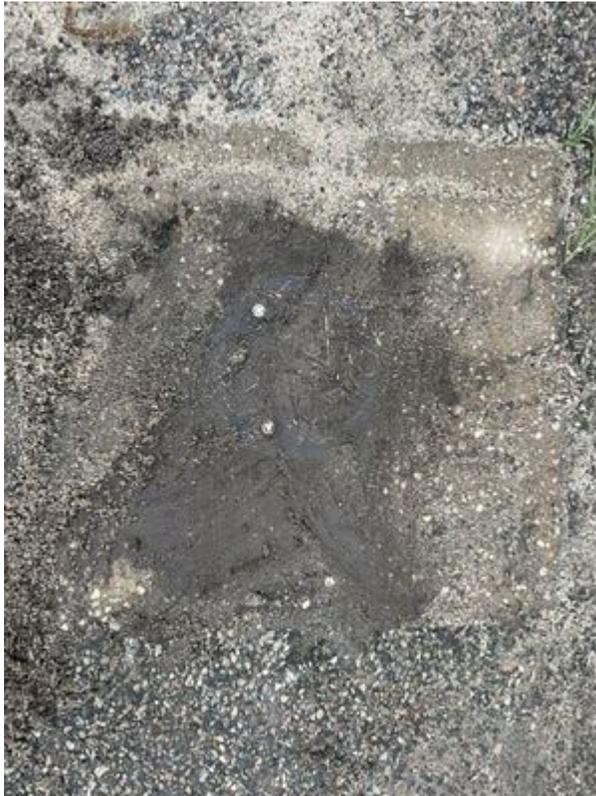
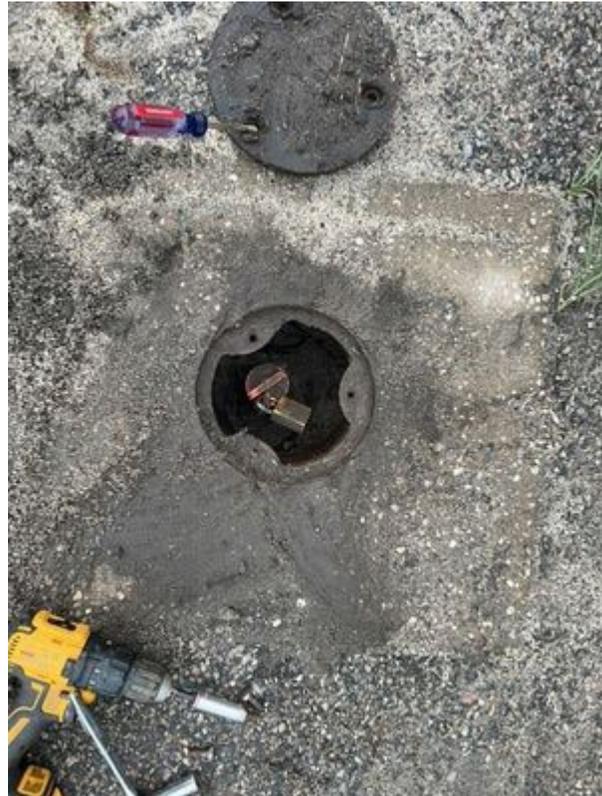
Client: Navy CLEAN	Facility: NWIRP Bethpage
Project Number: 112G08005-WE13	Location: Bethpage, New York
Date: August 6, 2024 16:30	Personnel: Jake Marlow
Well ID: BPS1-TT-MW30212	Well Location: 213826.268241654 1124239.91009823
Well Status: In Use (Confirmed)	Screen Interval: 140-150
WELL INVENTORY CONDITION	
Concrete pad in acceptable condition i.e. no cracks?	YES
Manhole cover present and in working condition?	YES
All bolts on manhole present and not stripped?	YES
Well plug present, locked and in good working condition?	YES
OVERALL CONDITION:	GOOD
Notes (Explain if answered No to any of the above)

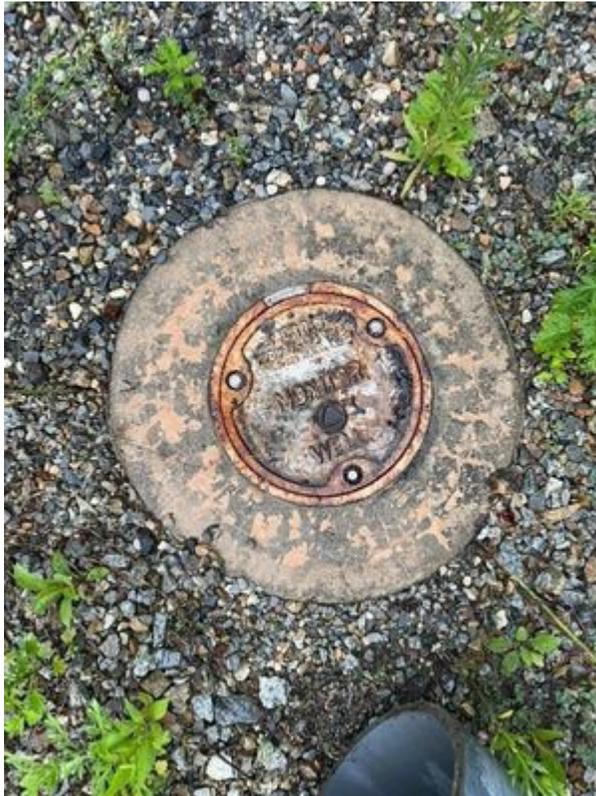
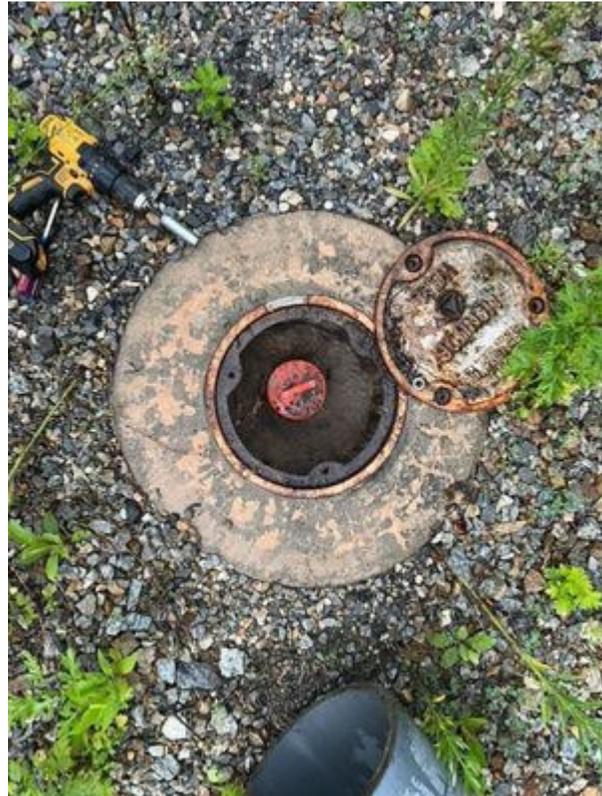
Client: Navy CLEAN	Facility: NWIRP Bethpage
Project Number: 112G08005-WE13	Location: Bethpage, New York
Date: August 6, 2024 14:43	Personnel: Jake Marlow
Well ID: GM38-TP-1	Well Location: 206473.262641347 1129708.69983611
Well Status: In Use (Confirmed)	Screen Interval: 450-470
WELL INVENTORY CONDITION	
Concrete pad in acceptable condition i.e. no cracks?	YES
Manhole cover present and in working condition?	YES
All bolts on manhole present and not stripped?	YES
Well plug present, locked and in good working condition?	YES
OVERALL CONDITION:	GOOD
Notes (Explain if answered No to any of the above)

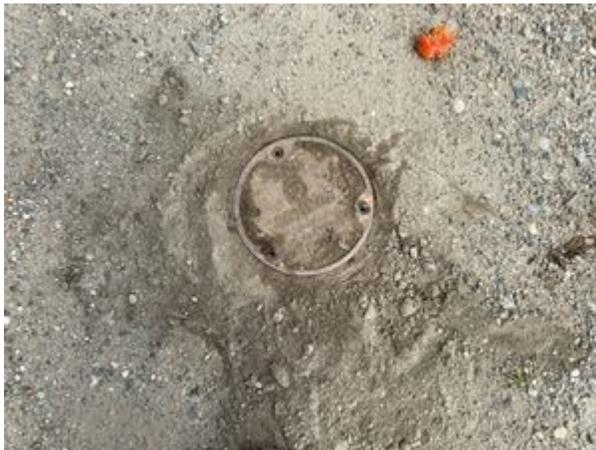
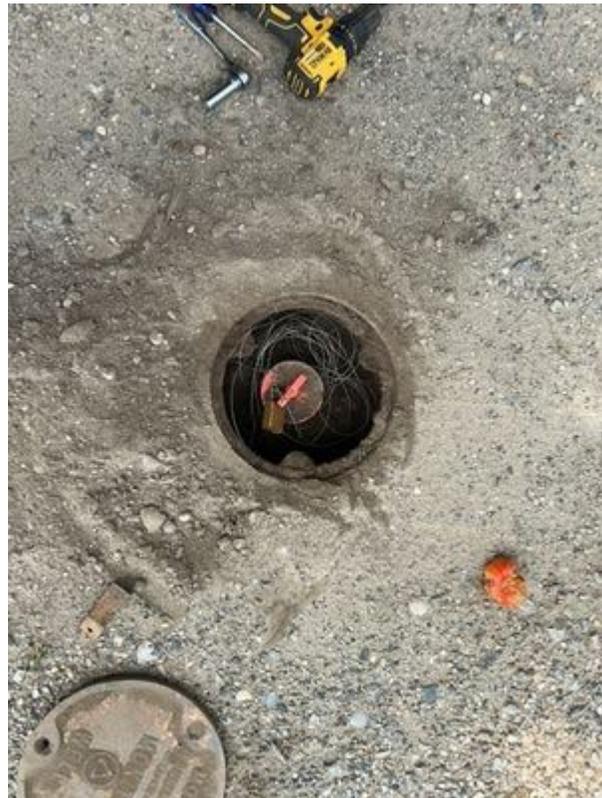
Client: Navy CLEAN	Facility: NWIRP Bethpage
Project Number: 112G08005-WE13	Location: Bethpage, New York
Date: August 6, 2024 14:27	Personnel: Jake Marlow
Well ID: RE128D1	Well Location: 200550.884741351 1129219.33501153
Well Status: In Use (Confirmed)	Screen Interval: 660-680
WELL INVENTORY CONDITION	
Concrete pad in acceptable condition i.e. no cracks?	YES
Manhole cover present and in working condition?	YES
All bolts on manhole present and not stripped?	NO
Well plug present, locked and in good working condition?	YES
OVERALL CONDITION:	FAIR
Notes (Explain if answered No to any of the above) Bolts sheared off in manhole

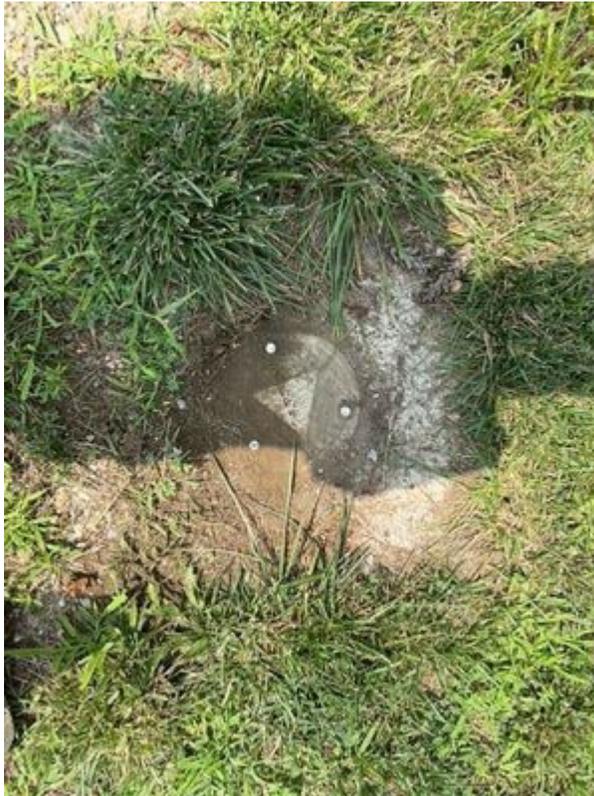
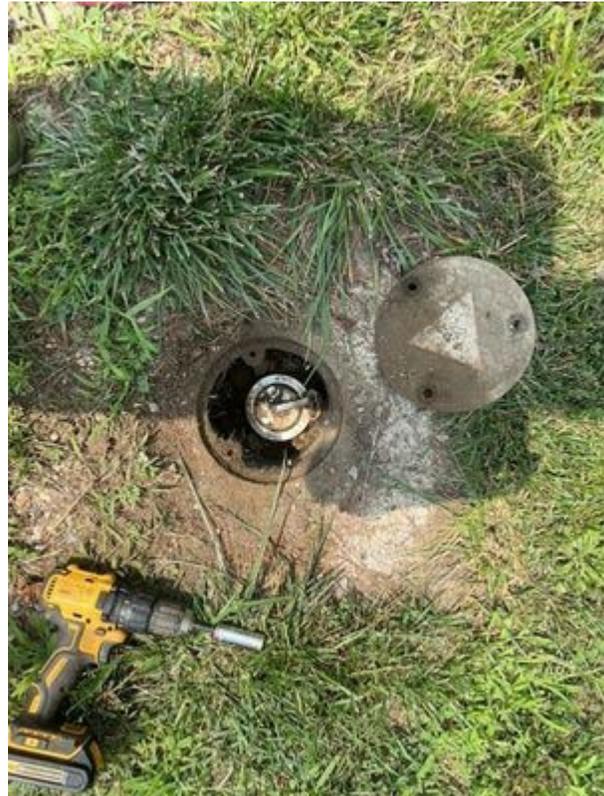
Client: Navy CLEAN	Facility: NWIRP Bethpage
Project Number: 112G08005-WE13	Location: Bethpage, New York
Date: August 6, 2024 13:01	Personnel: Jake Marlow
Well ID: BPGMMW74I	Well Location: 209747.691326394 1126051.5116011
Well Status: In Use (Confirmed)	Screen Interval: 94-114
WELL INVENTORY CONDITION	
Concrete pad in acceptable condition i.e. no cracks?	YES
Manhole cover present and in working condition?	YES
All bolts on manhole present and not stripped?	YES
Well plug present, locked and in good working condition?	YES
OVERALL CONDITION:	GOOD
Notes (Explain if answered No to any of the above)

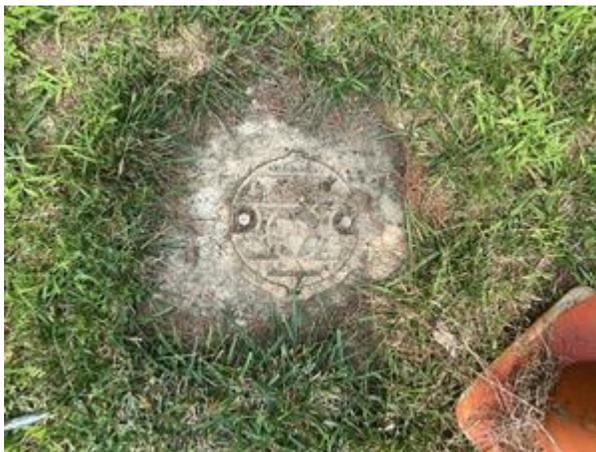
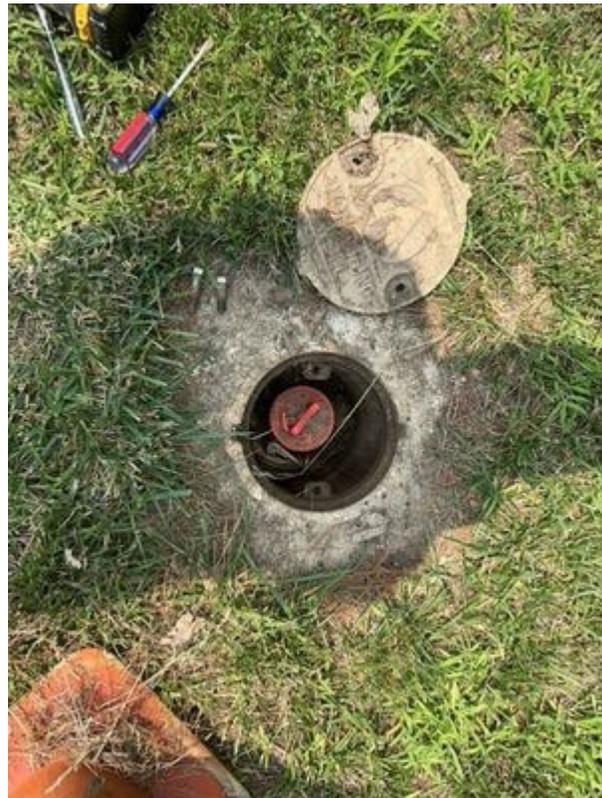
Client: Navy CLEAN	Facility: NWIRP Bethpage
Project Number: 112G08005-WE13	Location: Bethpage, New York
Date: August 6, 2024 12:58	Personnel: Jake Marlow
Well ID: BPGMMW74D	Well Location: 209754.233990131 1126030.84641242
Well Status: In Use (Confirmed)	Screen Interval: 295-305
WELL INVENTORY CONDITION	
Concrete pad in acceptable condition i.e. no cracks?	YES
Manhole cover present and in working condition?	YES
All bolts on manhole present and not stripped?	YES
Well plug present, locked and in good working condition?	YES
OVERALL CONDITION:	GOOD
Notes (Explain if answered No to any of the above)

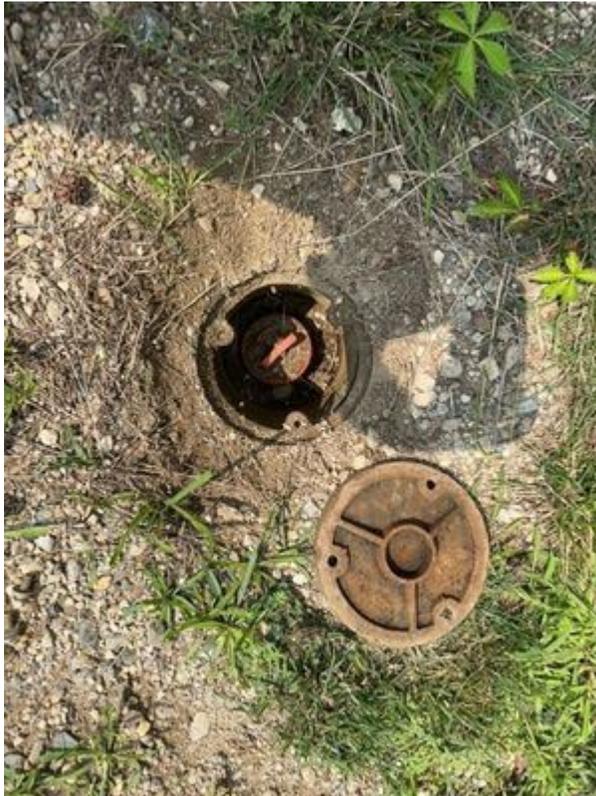
Client: Navy CLEAN	Facility: NWIRP Bethpage
Project Number: 112G08005-WE13	Location: Bethpage, New York
Date: August 6, 2024 12:56	Personnel: Jake Marlow
Well ID: BPGMMW74D2	Well Location: 209756.970074171 1126016.29581252
Well Status: In Use (Confirmed)	Screen Interval: 542-562
WELL INVENTORY CONDITION	
Concrete pad in acceptable condition i.e. no cracks?	YES
Manhole cover present and in working condition?	YES
All bolts on manhole present and not stripped?	YES
Well plug present, locked and in good working condition?	YES
OVERALL CONDITION:	GOOD
Notes (Explain if answered No to any of the above)

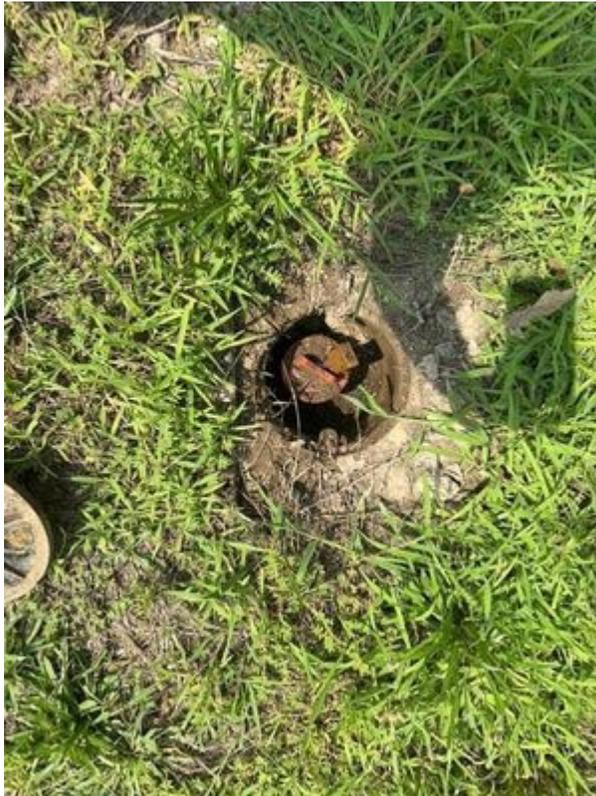
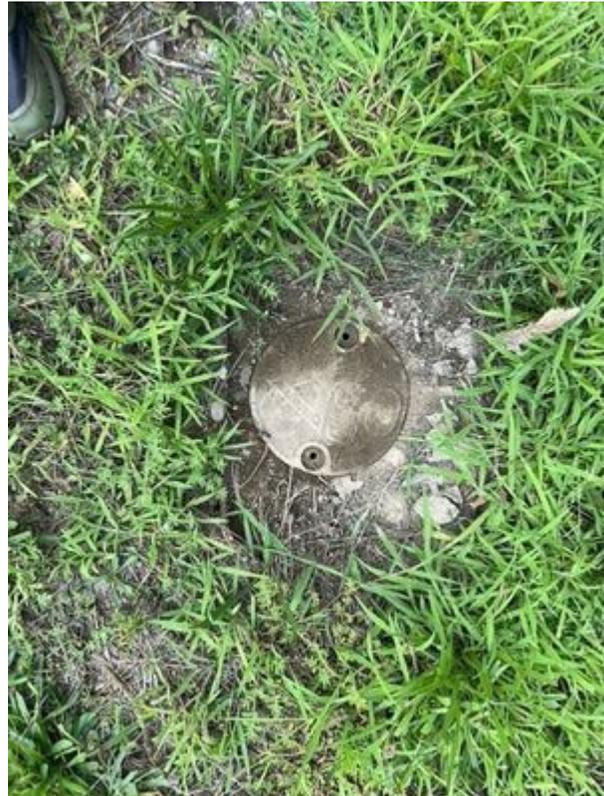
Client: Navy CLEAN	Facility: NWIRP Bethpage
Project Number: 112G08005-WE13	Location: Bethpage, New York
Date: August 6, 2024 12:53	Personnel: Jake Marlow
Well ID: BPGMMW74D3	Well Location: 209748.003256735 1126000.55767735
Well Status: In Use (Confirmed)	Screen Interval: 625-645
WELL INVENTORY CONDITION	
Concrete pad in acceptable condition i.e. no cracks?	YES
Manhole cover present and in working condition?	YES
All bolts on manhole present and not stripped?	NO
Well plug present, locked and in good working condition?	YES
OVERALL CONDITION:	FAIR
Notes (Explain if answered No to any of the above) Part of manhole where bolts screw in is stripped

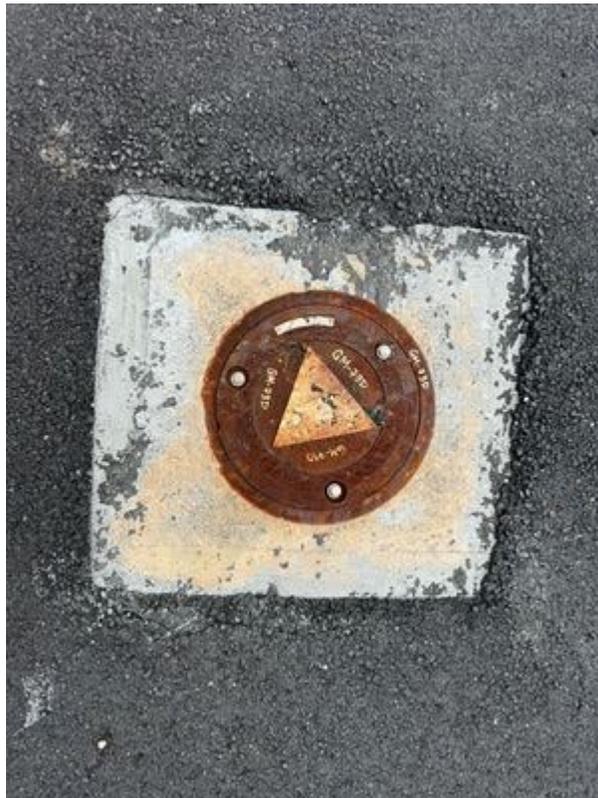
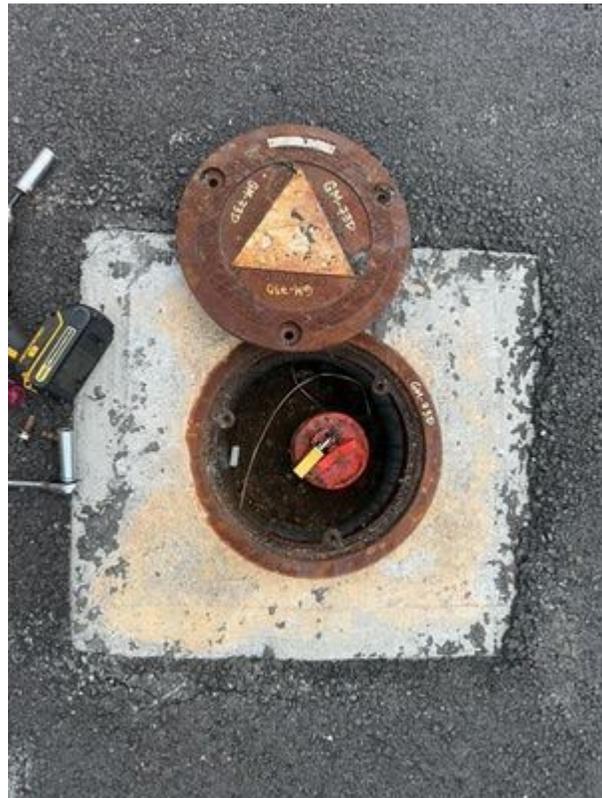
Client: Navy CLEAN	Facility: NWIRP Bethpage
Project Number: 112G08005-WE13	Location: Bethpage, New York
Date: August 6, 2024 12:47	Personnel: Jake Marlow
Well ID: BPGMMW73D	Well Location: 209852.496438587 1124686.14103848
Well Status: In Use (Confirmed)	Screen Interval: 401-411
WELL INVENTORY CONDITION	
Concrete pad in acceptable condition i.e. no cracks?	YES
Manhole cover present and in working condition?	YES
All bolts on manhole present and not stripped?	YES
Well plug present, locked and in good working condition?	YES
OVERALL CONDITION:	GOOD
Notes (Explain if answered No to any of the above)

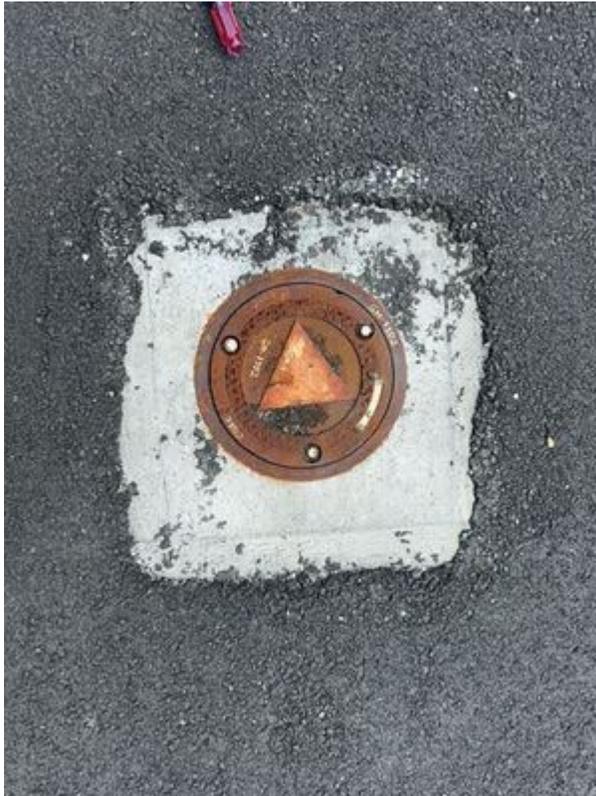
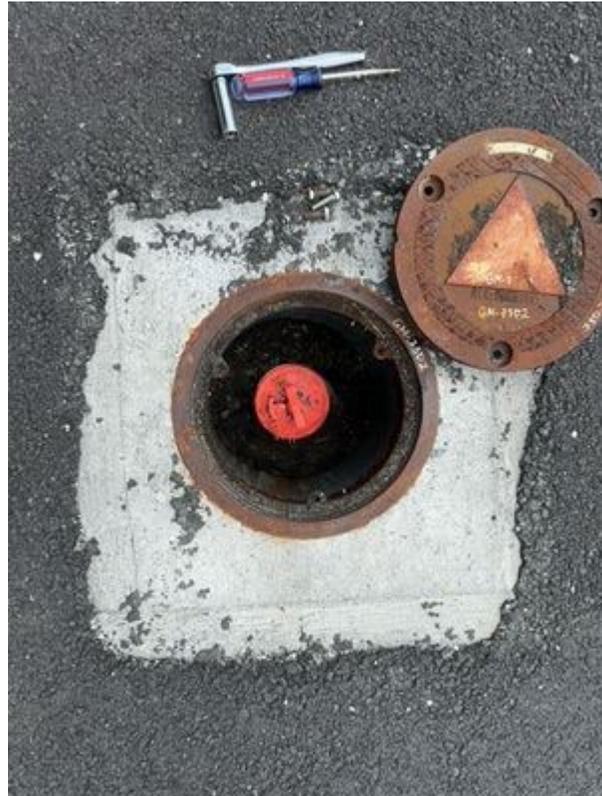
Client: Navy CLEAN	Facility: NWIRP Bethpage
Project Number: 112G08005-WE13	Location: Bethpage, New York
Date: August 6, 2024 12:40	Personnel: Jake Marlow
Well ID: BPGMMW73D2	Well Location: 209853.946443248 1124666.73338803
Well Status: In Use (Confirmed)	Screen Interval: 532-552
WELL INVENTORY CONDITION	
Concrete pad in acceptable condition i.e. no cracks?	YES
Manhole cover present and in working condition?	YES
All bolts on manhole present and not stripped?	YES
Well plug present, locked and in good working condition?	YES
OVERALL CONDITION:	GOOD
Notes (Explain if answered No to any of the above)

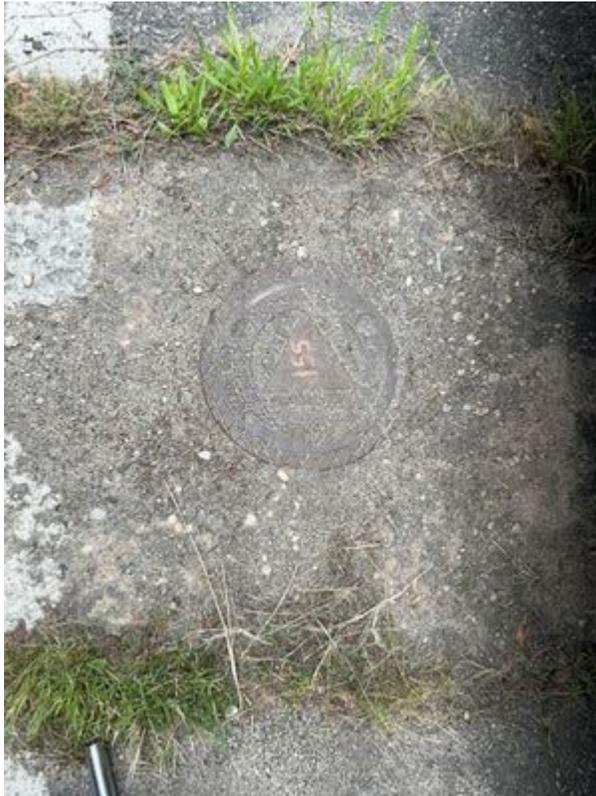
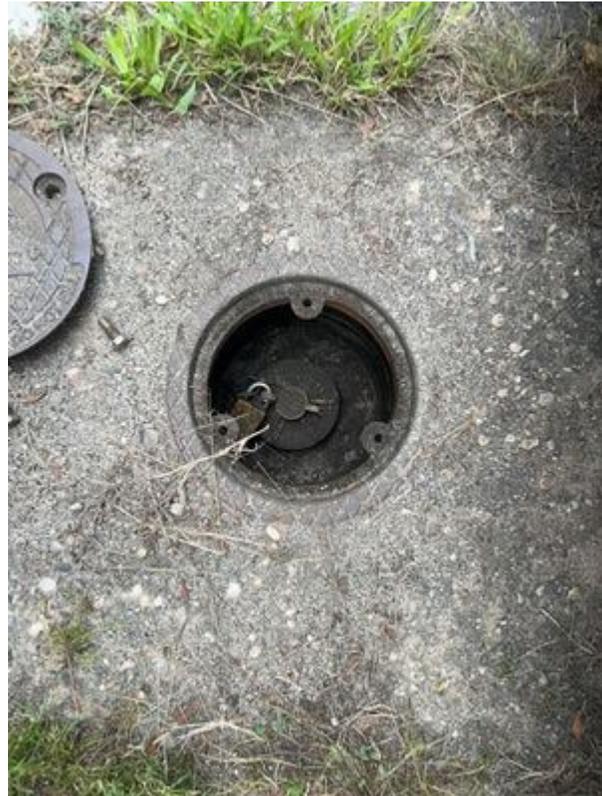
Client: Navy CLEAN	Facility: NWIRP Bethpage
Project Number: 112G08005-WE13	Location: Bethpage, New York
Date: August 6, 2024 12:10	Personnel: Jake Marlow
Well ID: BPGMMW15SR	Well Location: 210598.84852301 1127075.46764179
Well Status: In Use (Confirmed)	Screen Interval: 63-67
WELL INVENTORY CONDITION	
Concrete pad in acceptable condition i.e. no cracks?	YES
Manhole cover present and in working condition?	YES
All bolts on manhole present and not stripped?	NO
Well plug present, locked and in good working condition?	YES
OVERALL CONDITION:	FAIR
Notes (Explain if answered No to any of the above) Part of manhole where bolts screw in is stripped

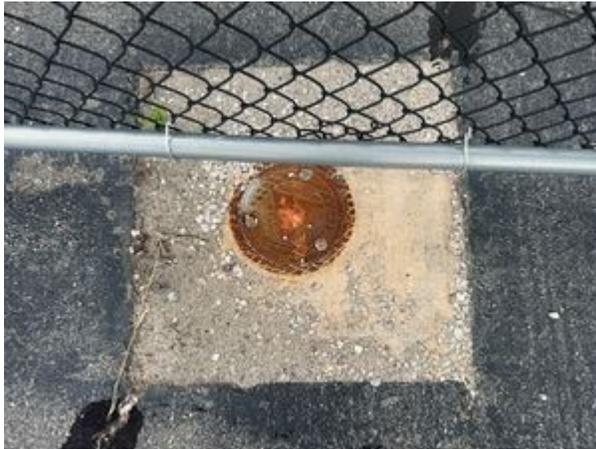
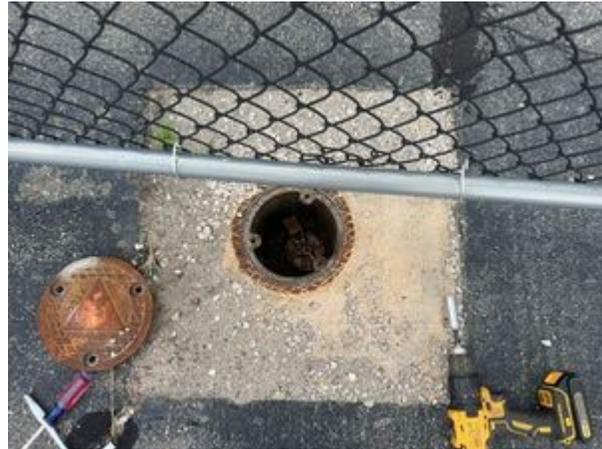
Client: Navy CLEAN	Facility: NWIRP Bethpage
Project Number: 112G08005-WE13	Location: Bethpage, New York
Date: August 6, 2024 12:07	Personnel: Jake Marlow
Well ID: BPGMMW15D2	Well Location: 210574.261187685 1127073.73770461
Well Status: In Use (Confirmed)	Screen Interval: 536-556
WELL INVENTORY CONDITION	
Concrete pad in acceptable condition i.e. no cracks?	YES
Manhole cover present and in working condition?	YES
All bolts on manhole present and not stripped?	YES
Well plug present, locked and in good working condition?	YES
OVERALL CONDITION:	GOOD
Notes (Explain if answered No to any of the above)

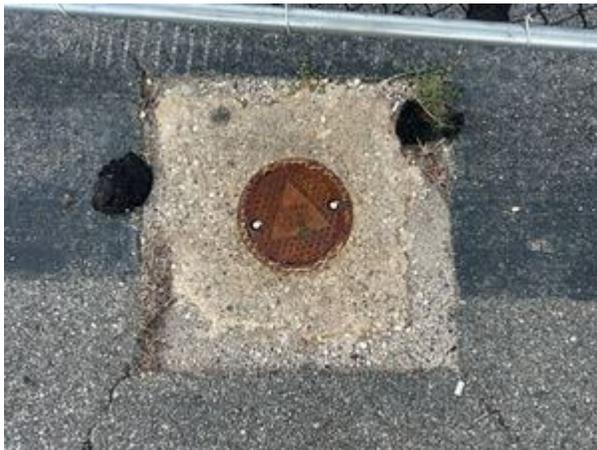
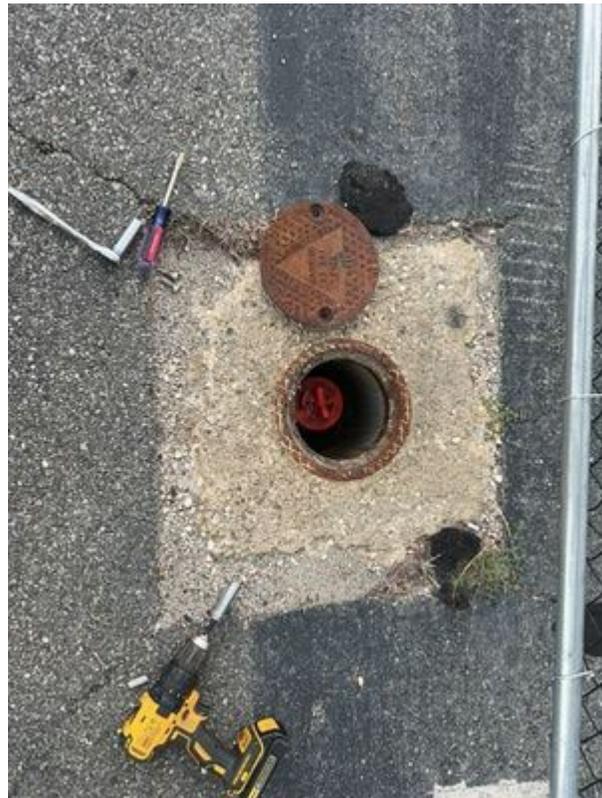
Client: Navy CLEAN	Facility: NWIRP Bethpage
Project Number: 112G08005-WE13	Location: Bethpage, New York
Date: August 6, 2024 12:02	Personnel: Jake Marlow
Well ID: BPGMMW15D	Well Location: 210628.438859597 1127043.1234175
Well Status: In Use (Confirmed)	Screen Interval: 332-342
WELL INVENTORY CONDITION	
Concrete pad in acceptable condition i.e. no cracks?	YES
Manhole cover present and in working condition?	NO
All bolts on manhole present and not stripped?	YES
Well plug present, locked and in good working condition?	YES
OVERALL CONDITION:	FAIR
Notes (Explain if answered No to any of the above) Part of manhole where bolts screw in is broken off

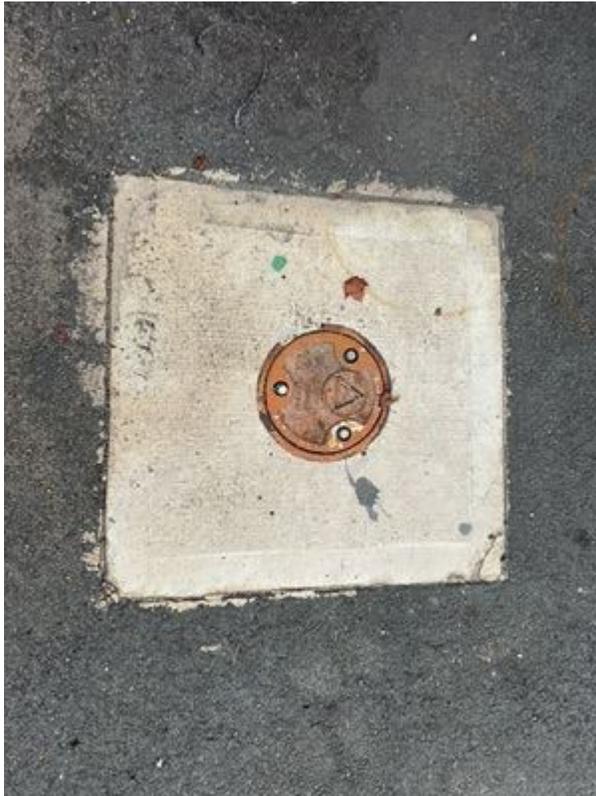
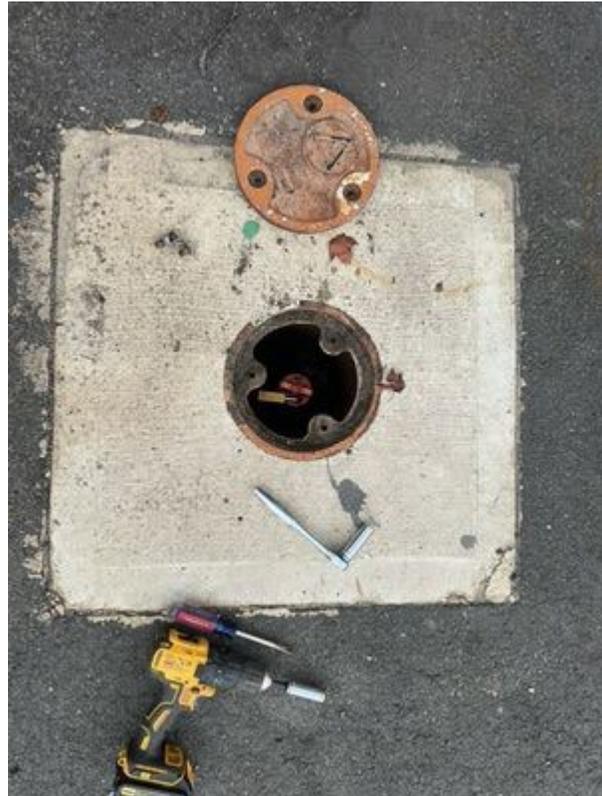
Client: Navy CLEAN	Facility: NWIRP Bethpage
Project Number: 112G08005-WE13	Location: Bethpage, New York
Date: August 6, 2024 11:32	Personnel: Jake Marlow
Well ID: BPS1-TT-MW301I	Well Location: 214567.126493216 1124906.17448843
Well Status: In Use (Confirmed)	Screen Interval: 130-140
WELL INVENTORY CONDITION	
Concrete pad in acceptable condition i.e. no cracks?	YES
Manhole cover present and in working condition?	YES
All bolts on manhole present and not stripped?	YES
Well plug present, locked and in good working condition?	YES
OVERALL CONDITION:	GOOD
Notes (Explain if answered No to any of the above)

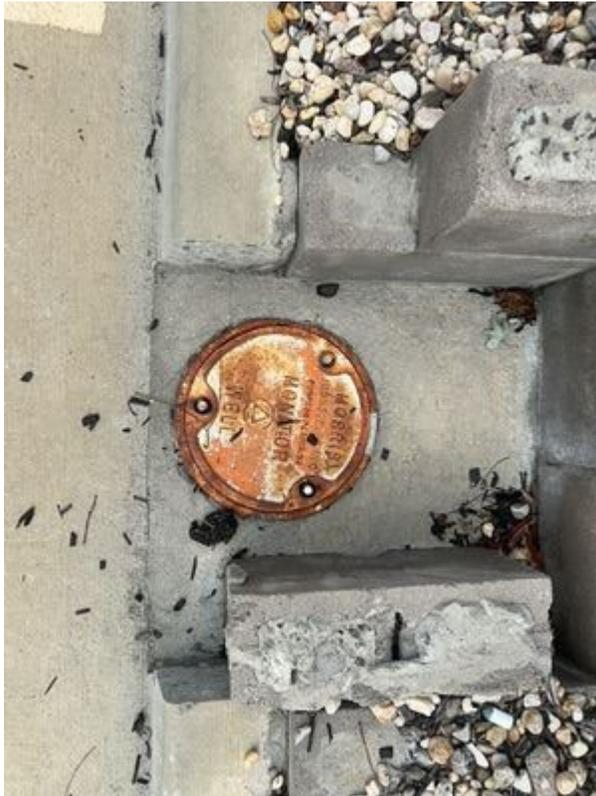
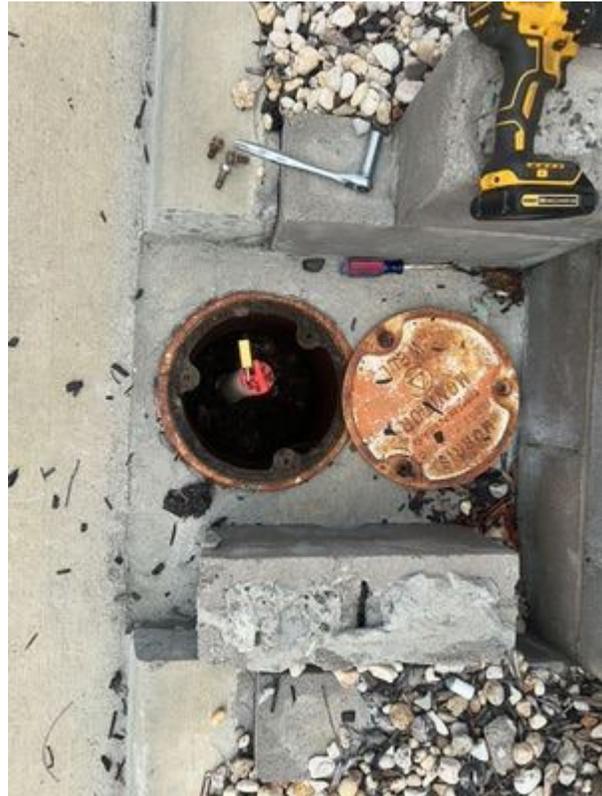
Client: Navy CLEAN	Facility: NWIRP Bethpage
Project Number: 112G08005-WE13	Location: Bethpage, New York
Date: August 6, 2024 11:12	Personnel: Jake Marlow
Well ID: BPS1-TT-MW311I	Well Location: 215426.845682256 1124601.79501679
Well Status: In Use (Confirmed)	Screen Interval: 160-170
WELL INVENTORY CONDITION	
Concrete pad in acceptable condition i.e. no cracks?	NO
Manhole cover present and in working condition?	YES
All bolts on manhole present and not stripped?	YES
Well plug present, locked and in good working condition?	YES
OVERALL CONDITION:	FAIR
Notes (Explain if answered No to any of the above) Crack in pad

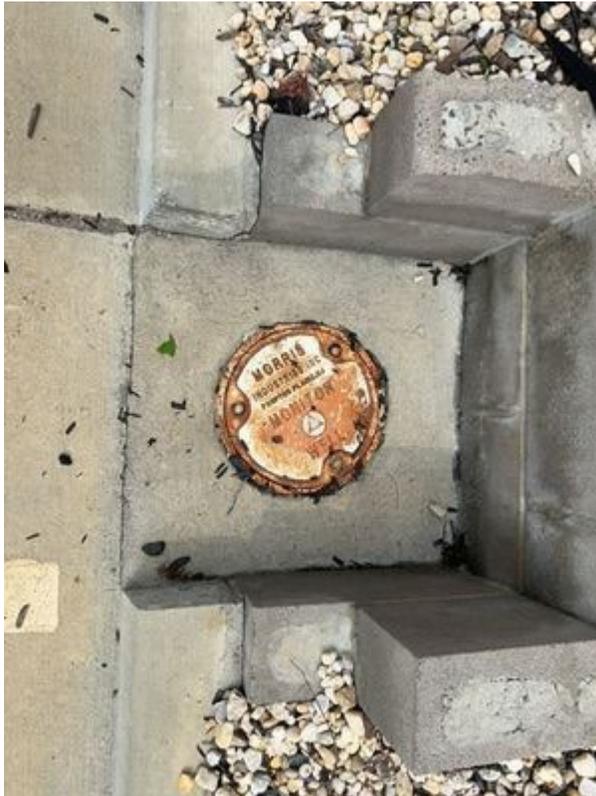
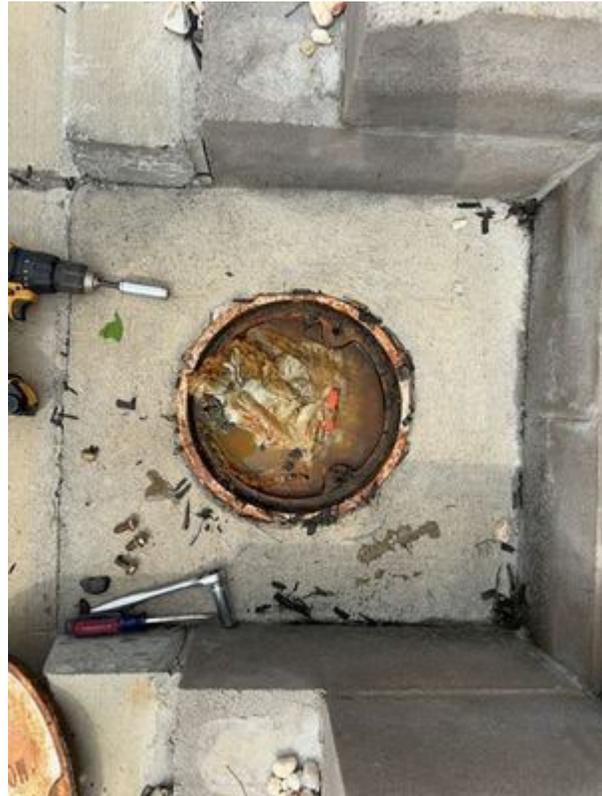
Client: Navy CLEAN	Facility: NWIRP Bethpage
Project Number: 112G08005-WE13	Location: Bethpage, New York
Date: August 6, 2024 11:09	Personnel: Jake Marlow
Well ID: BPS1-TT-MW311S	Well Location: 215426.309094476 1124597.5254721
Well Status: In Use (Confirmed)	Screen Interval: 55-65
WELL INVENTORY CONDITION	
Concrete pad in acceptable condition i.e. no cracks?	YES
Manhole cover present and in working condition?	YES
All bolts on manhole present and not stripped?	YES
Well plug present, locked and in good working condition?	YES
OVERALL CONDITION:	FAIR
Notes (Explain if answered No to any of the above) Bentonite has expanded in well

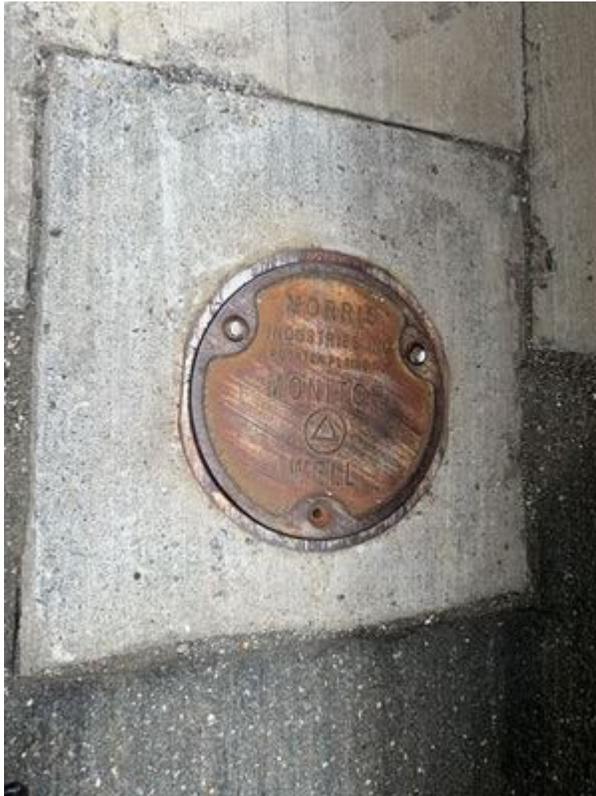
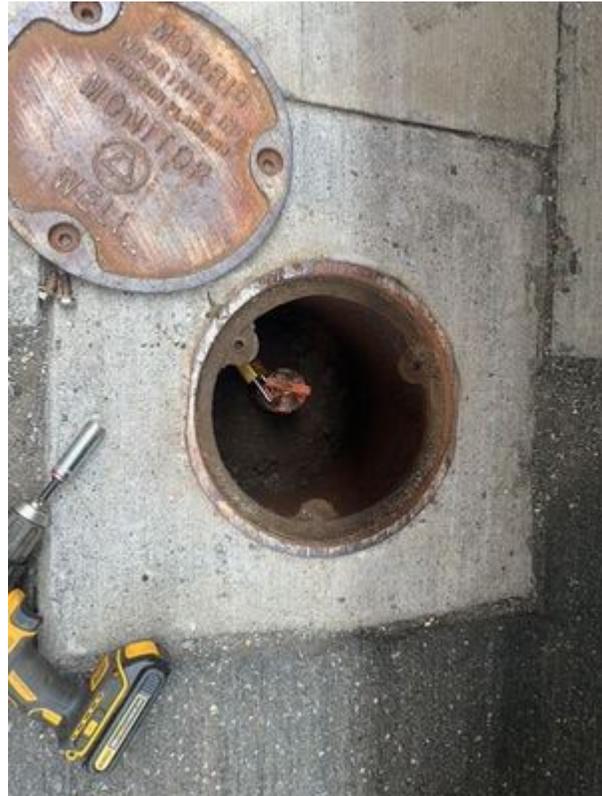
Client: Navy CLEAN	Facility: NWIRP Bethpage
Project Number: 112G08005-WE13	Location: Bethpage, New York
Date: August 6, 2024 11:03	Personnel: Jake Marlow
Well ID: BPS1-TT-MW310S	Well Location: 215489.8224241 1124098.94666073
Well Status: In Use (Confirmed)	Screen Interval: 57.5-67.5
WELL INVENTORY CONDITION	
Concrete pad in acceptable condition i.e. no cracks?	YES
Manhole cover present and in working condition?	YES
All bolts on manhole present and not stripped?	NO
Well plug present, locked and in good working condition?	YES
OVERALL CONDITION:	FAIR
Notes (Explain if answered No to any of the above) Bolt sheared off in manhole

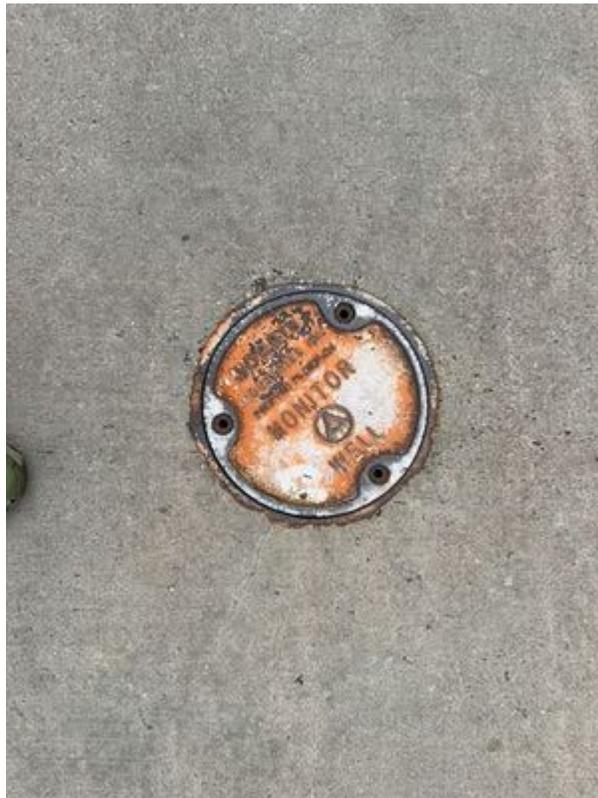
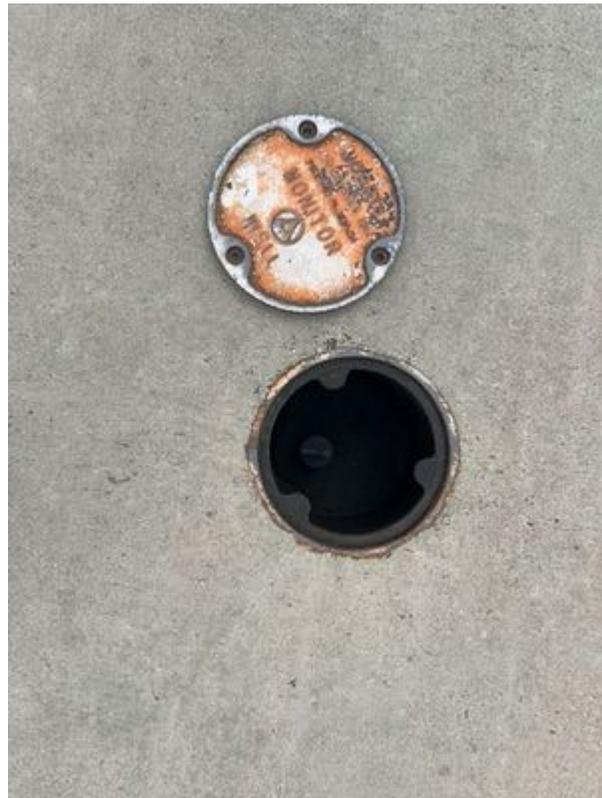
Client: Navy CLEAN	Facility: NWIRP Bethpage
Project Number: 112G08005-WE13	Location: Bethpage, New York
Date: August 6, 2024 10:58	Personnel: Jake Marlow
Well ID: BPS1-TT-MW308S	Well Location: 214990.898498957 1124919.19077539
Well Status: In Use (Confirmed)	Screen Interval: 54-64
WELL INVENTORY CONDITION	
Concrete pad in acceptable condition i.e. no cracks?	YES
Manhole cover present and in working condition?	YES
All bolts on manhole present and not stripped?	NO
Well plug present, locked and in good working condition?	YES
OVERALL CONDITION:	FAIR
Notes (Explain if answered No to any of the above) Bolts broken where they screw into manhole
