Memorandum

To: Scott Sokolowski, NAVFAC MIDLANT
From: Richard Moore, Tetra Tech
Date: September 27, 2024
Re: Annual LUC Inspection and Operation Summary Report: Sites 1, 2, 3, and 4 –
NWIRP Bethpage
Contract/CTO Number: N6247016D9008/WE16

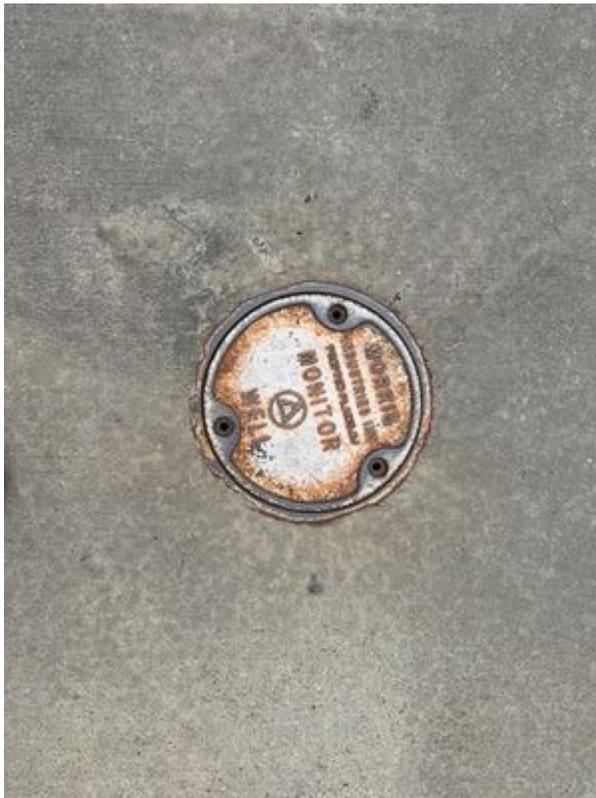
Client: Navy CLEAN	Facility: NWIRP Bethpage
Project Number: 112G08005-WE13	Location: Bethpage, New York
Date: August 6, 2024 10:57	Personnel: Jake Marlow
Well ID: BPS1-TT-MW308I	Well Location: 214990.080681704 1124924.24039046
Well Status: In Use (Confirmed)	Screen Interval: 156-166
WELL INVENTORY CONDITION	
Concrete pad in acceptable condition i.e. no cracks?	YES
Manhole cover present and in working condition?	YES
All bolts on manhole present and not stripped?	YES
Well plug present, locked and in good working condition?	YES
OVERALL CONDITION:	FAIR
Notes (Explain if answered No to any of the above) Bolts broken off where they screw into manhole

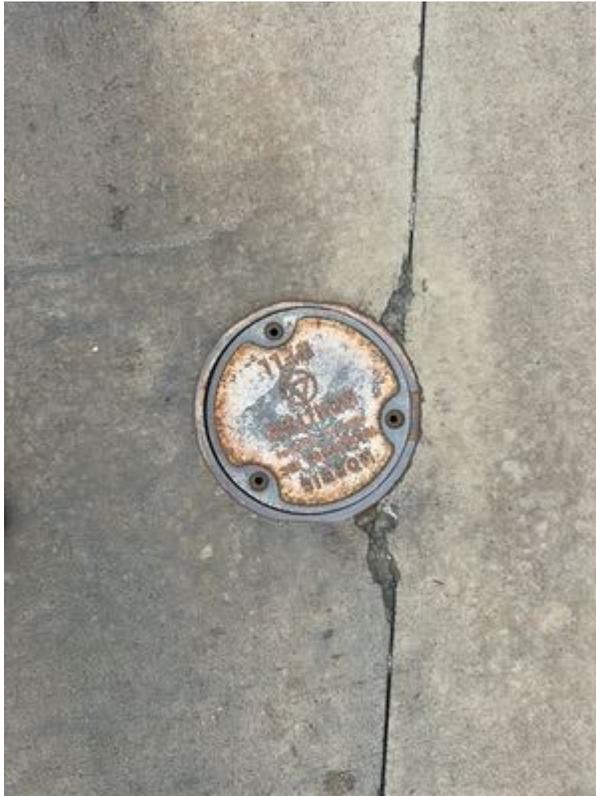
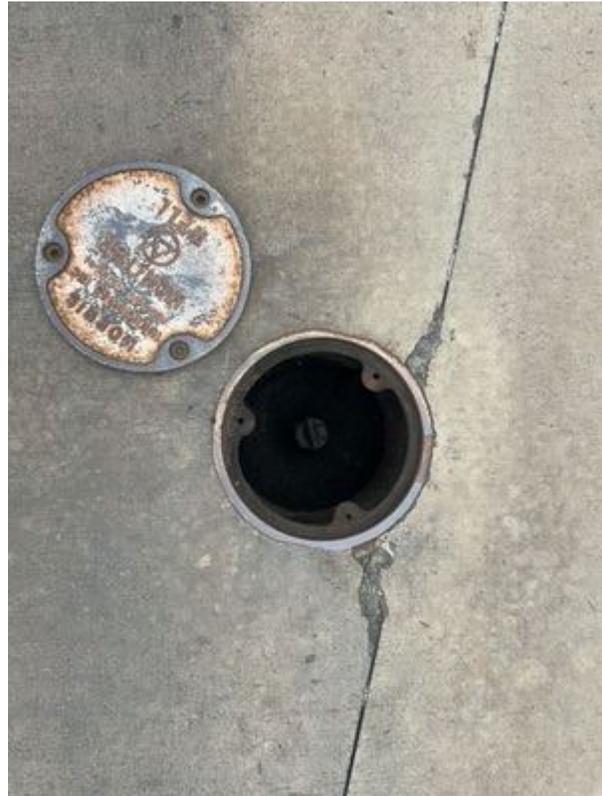
Client: Navy CLEAN	Facility: NWIRP Bethpage
Project Number: 112G08005-WE13	Location: Bethpage, New York
Date: August 6, 2024 10:52	Personnel: Jake Marlow
Well ID: BPS1-TT-MW308D	Well Location: 215281.622364681 1124941.29596879
Well Status: In Use (Confirmed)	Screen Interval: 250-260
WELL INVENTORY CONDITION	
Concrete pad in acceptable condition i.e. no cracks?	YES
Manhole cover present and in working condition?	YES
All bolts on manhole present and not stripped?	NO
Well plug present, locked and in good working condition?	YES
OVERALL CONDITION:	FAIR
Notes (Explain if answered No to any of the above) Manhole is dropped where bolts screw in

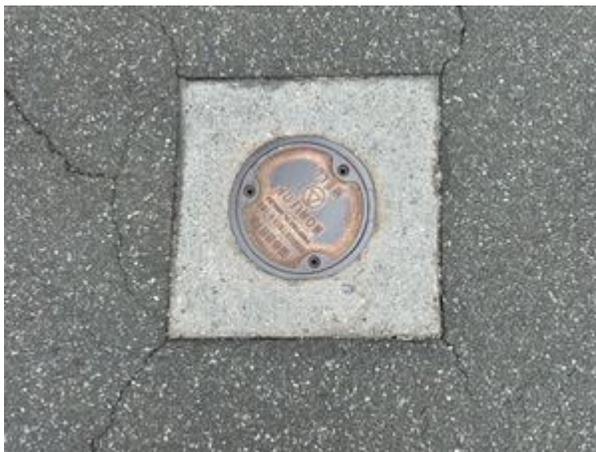
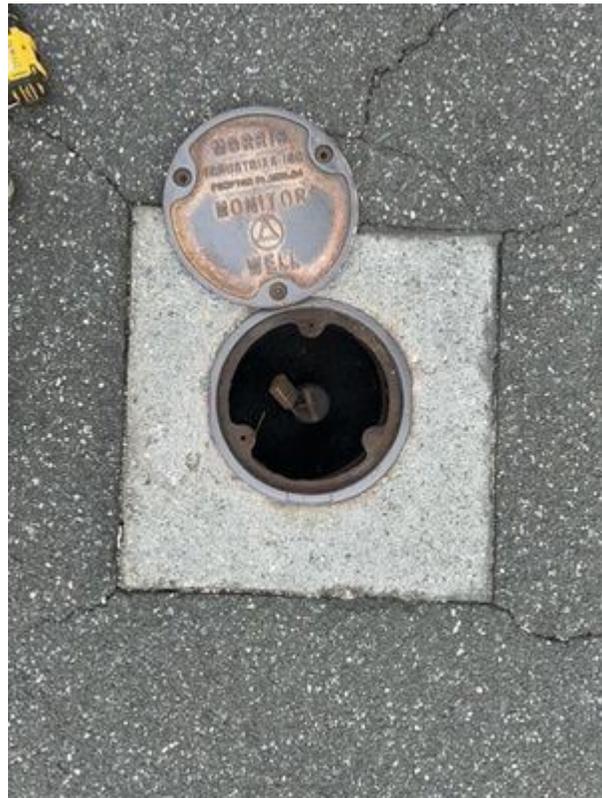
Client: Navy CLEAN	Facility: NWIRP Bethpage
Project Number: 112G08005-WE13	Location: Bethpage, New York
Date: August 6, 2024 10:39	Personnel: Jake Marlow
Well ID: BPS1-TT-MW309D	Well Location: 215276.43944675 1124942.51816488
Well Status: In Use (Confirmed)	Screen Interval: 252-262
WELL INVENTORY CONDITION	
Concrete pad in acceptable condition i.e. no cracks?	YES
Manhole cover present and in working condition?	YES
All bolts on manhole present and not stripped?	NO
Well plug present, locked and in good working condition?	YES
OVERALL CONDITION:	FAIR
Notes (Explain if answered No to any of the above) Bolt sheared off in manhole

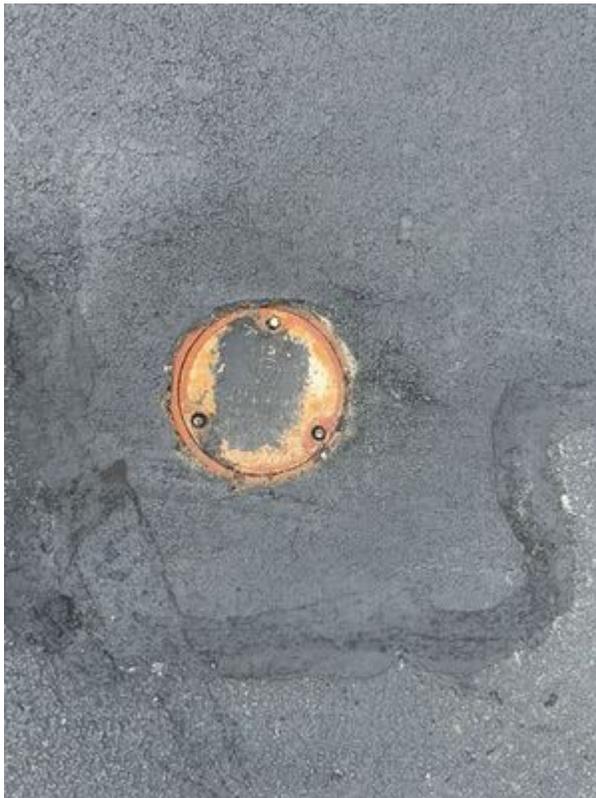
Client: Navy CLEAN	Facility: NWIRP Bethpage
Project Number: 112G08005-WE13	Location: Bethpage, New York
Date: August 6, 2024 10:29	Personnel: Jake Marlow
Well ID: BP-TT-MW203D	Well Location: 215518.58282118 1123748.7962003
Well Status: In Use (Confirmed)	Screen Interval: 275-290
WELL INVENTORY CONDITION	
Concrete pad in acceptable condition i.e. no cracks?	YES
Manhole cover present and in working condition?	NO
All bolts on manhole present and not stripped?	YES
Well plug present, locked and in good working condition?	YES
OVERALL CONDITION:	POOR
Notes (Explain if answered No to any of the above) Could not open manhole cover

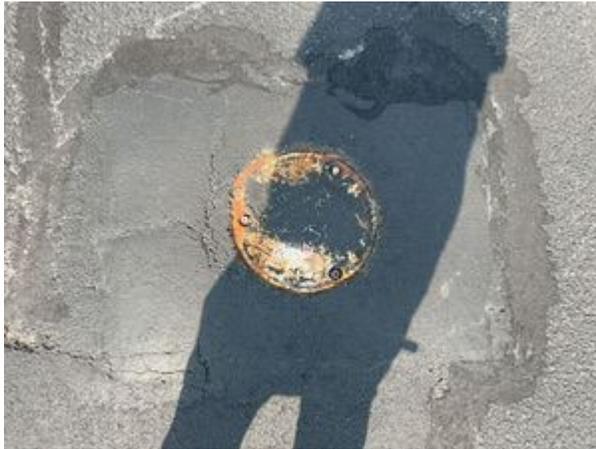
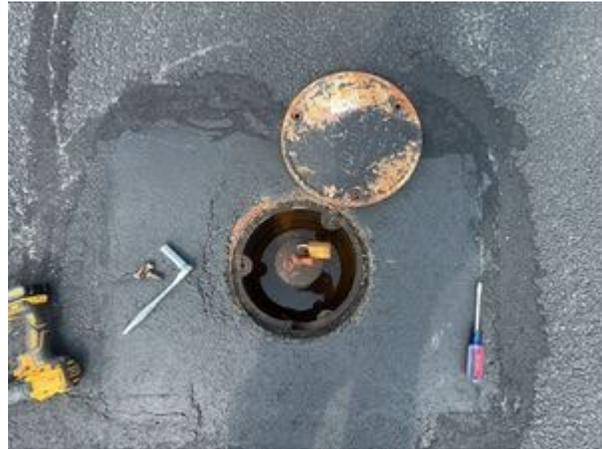
Client: Navy CLEAN	Facility: NWIRP Bethpage
Project Number: 112G08005-WE13	Location: Bethpage, New York
Date: August 6, 2024 10:23	Personnel: Jake Marlow
Well ID: BP-TT-MW203D2	Well Location: 215507.767782869 1123777.75667513
Well Status: In Use (Confirmed)	Screen Interval: 435-450
WELL INVENTORY CONDITION	
Concrete pad in acceptable condition i.e. no cracks?	NO
Manhole cover present and in working condition?	YES
All bolts on manhole present and not stripped?	YES
Well plug present, locked and in good working condition?	YES
OVERALL CONDITION:	FAIR
Notes (Explain if answered No to any of the above) Cracks in pad

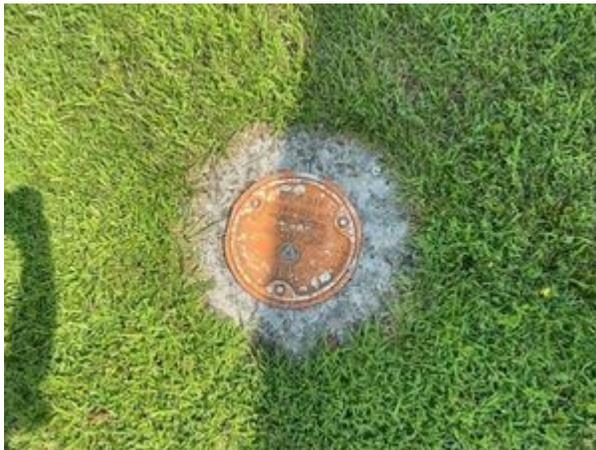
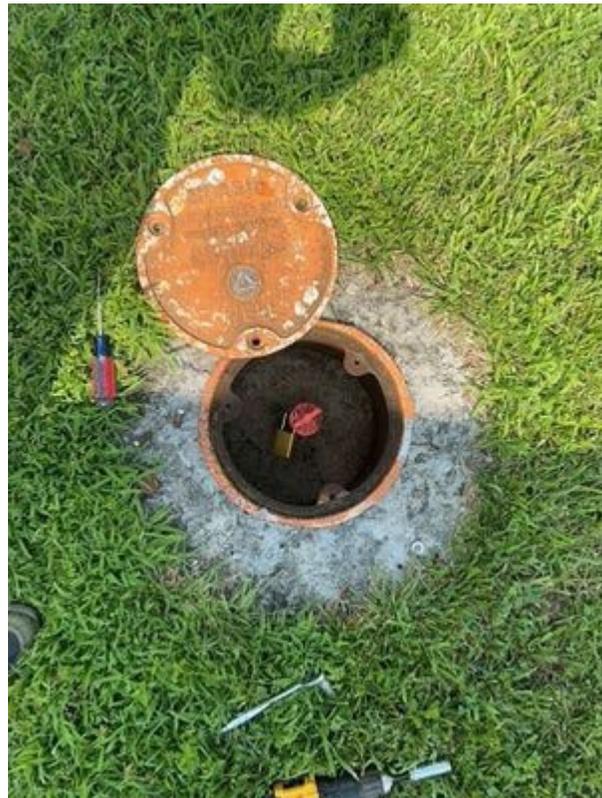
Client: Navy CLEAN	Facility: NWIRP Bethpage
Project Number: 112G08005-WE13	Location: Bethpage, New York
Date: August 6, 2024 10:19	Personnel: Jake Marlow
Well ID: BP-TT-MW203I	Well Location: 215523.697200754 1123807.12356875
Well Status: In Use (Confirmed)	Screen Interval: 136-146
WELL INVENTORY CONDITION	
Concrete pad in acceptable condition i.e. no cracks?	NO
Manhole cover present and in working condition?	YES
All bolts on manhole present and not stripped?	YES
Well plug present, locked and in good working condition?	YES
OVERALL CONDITION:	FAIR
Notes (Explain if answered No to any of the above) Crack in pad

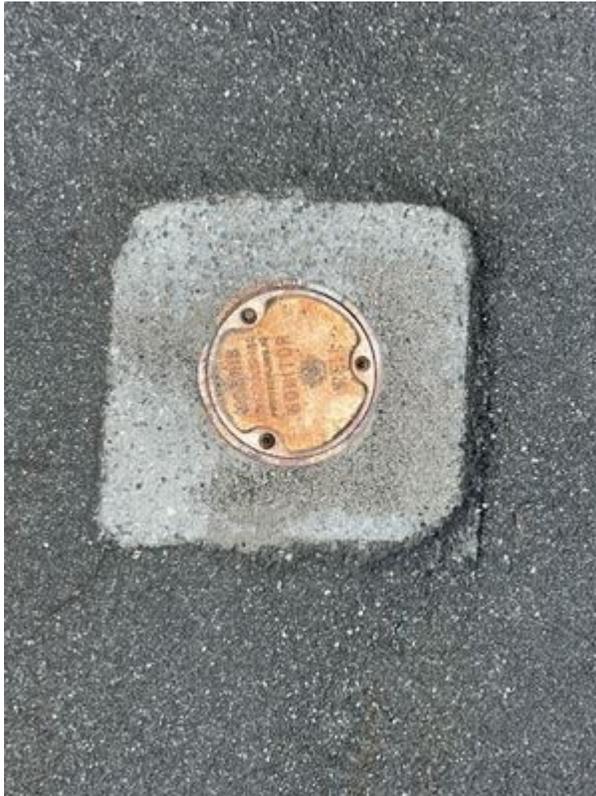
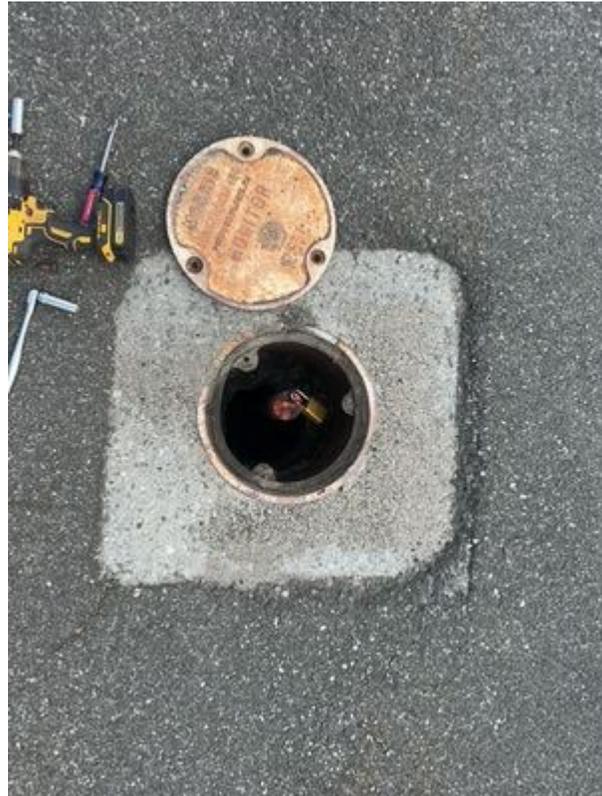
Client: Navy CLEAN	Facility: NWIRP Bethpage
Project Number: 112G08005-WE13	Location: Bethpage, New York
Date: August 6, 2024 10:13	Personnel: Jake Marlow
Well ID: BP-TT-MW202S	Well Location: 215102.989636835 1122994.73035238
Well Status: In Use (Confirmed)	Screen Interval: 54-64
WELL INVENTORY CONDITION	
Concrete pad in acceptable condition i.e. no cracks?	YES
Manhole cover present and in working condition?	YES
All bolts on manhole present and not stripped?	NO
Well plug present, locked and in good working condition?	YES
OVERALL CONDITION:	FAIR
Notes (Explain if answered No to any of the above) Bolts sheared off in manhole

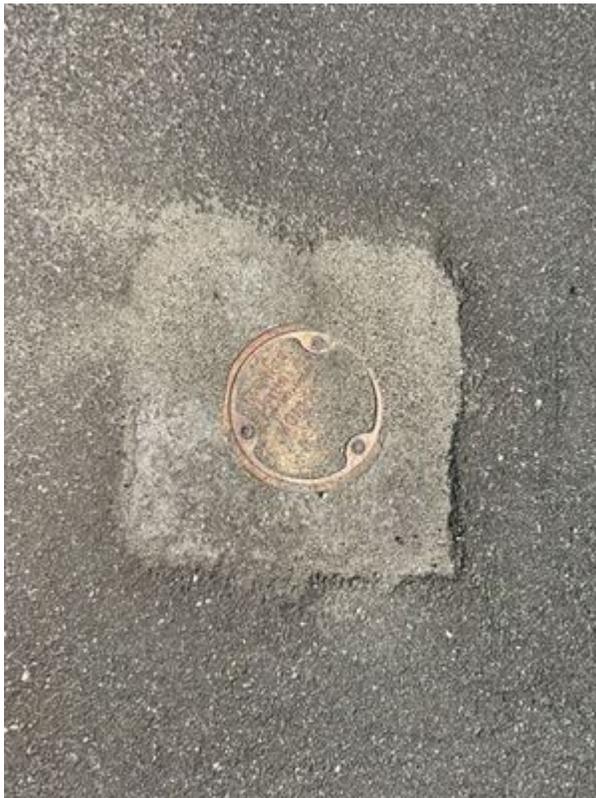
Client: Navy CLEAN	Facility: NWIRP Bethpage
Project Number: 112G08005-WE13	Location: Bethpage, New York
Date: August 6, 2024 10:08	Personnel: Jake Marlow
Well ID: BP-TT-MW202I	Well Location: 215092.684242189 1122994.26979581
Well Status: In Use (Confirmed)	Screen Interval: 140-150
WELL INVENTORY CONDITION	
Concrete pad in acceptable condition i.e. no cracks?	YES
Manhole cover present and in working condition?	YES
All bolts on manhole present and not stripped?	NO
Well plug present, locked and in good working condition?	YES
OVERALL CONDITION:	FAIR
Notes (Explain if answered No to any of the above) Bolts sheared off in manhole

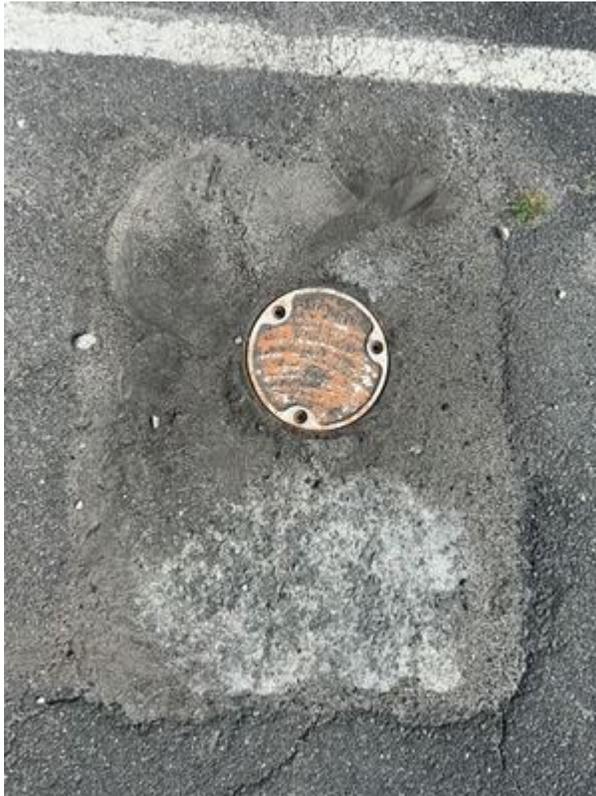
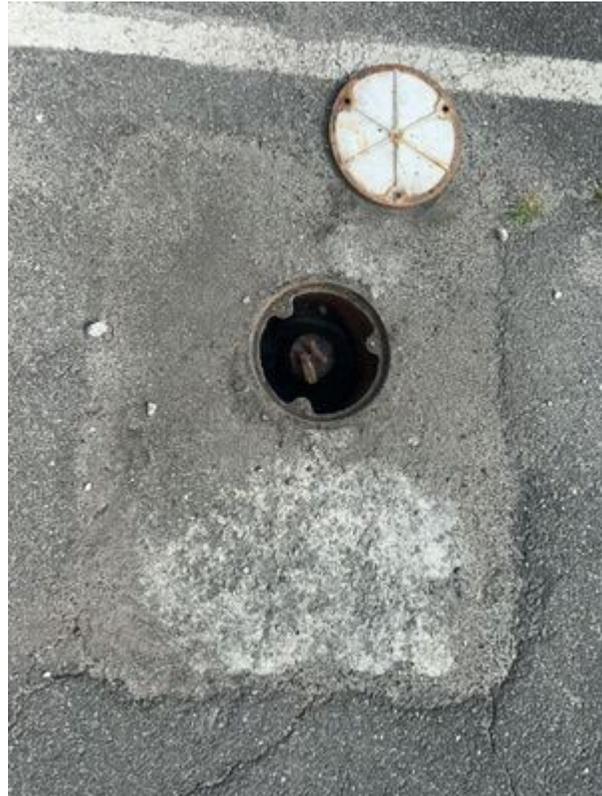
Client: Navy CLEAN	Facility: NWIRP Bethpage
Project Number: 112G08005-WE13	Location: Bethpage, New York
Date: August 6, 2024 10:06	Personnel: Jake Marlow
Well ID: BP-TT-MW202D1	Well Location: 215082.786999131 1122982.35382794
Well Status: In Use (Confirmed)	Screen Interval: 425-440
WELL INVENTORY CONDITION	
Concrete pad in acceptable condition i.e. no cracks?	YES
Manhole cover present and in working condition?	YES
All bolts on manhole present and not stripped?	NO
Well plug present, locked and in good working condition?	YES
OVERALL CONDITION:	FAIR
Notes (Explain if answered No to any of the above) Bolts are sheared off in manhole

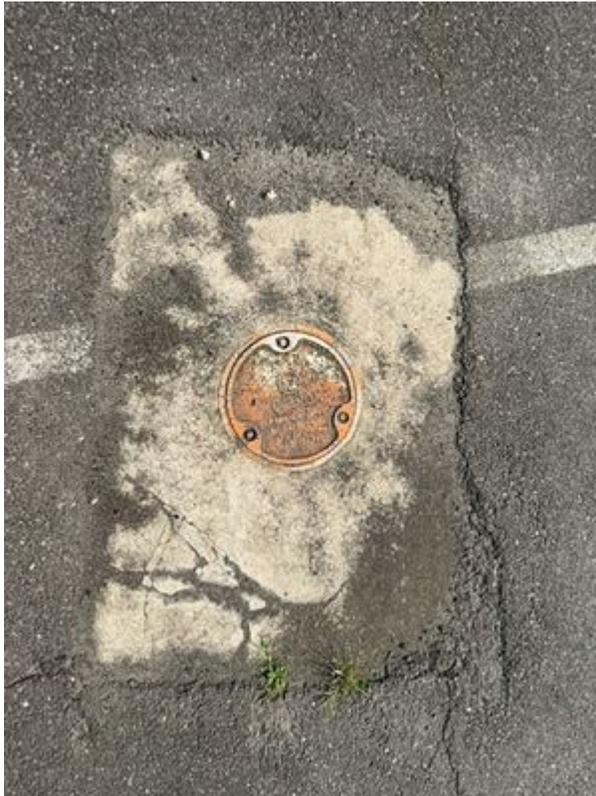
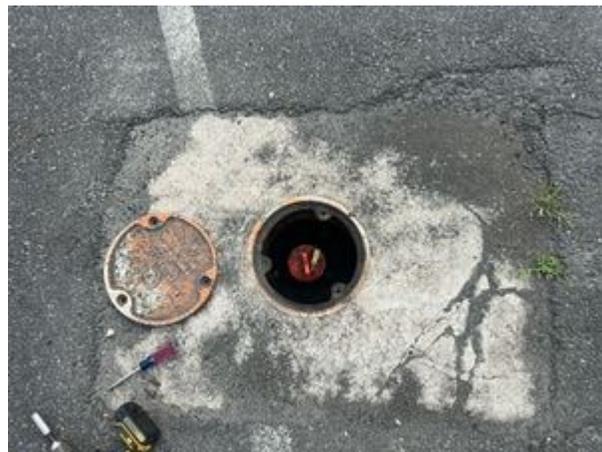
Client: Navy CLEAN	Facility: NWIRP Bethpage
Project Number: 112G08005-WE13	Location: Bethpage, New York
Date: August 6, 2024 10:02	Personnel: Jake Marlow
Well ID: BP-TT-MW202D	Well Location: 215065.665618977 1122984.3888567
Well Status: In Use (Confirmed)	Screen Interval: 335-350
WELL INVENTORY CONDITION	
Concrete pad in acceptable condition i.e. no cracks?	NO
Manhole cover present and in working condition?	YES
All bolts on manhole present and not stripped?	YES
Well plug present, locked and in good working condition?	YES
OVERALL CONDITION:	FAIR
Notes (Explain if answered No to any of the above) Cracks in pad

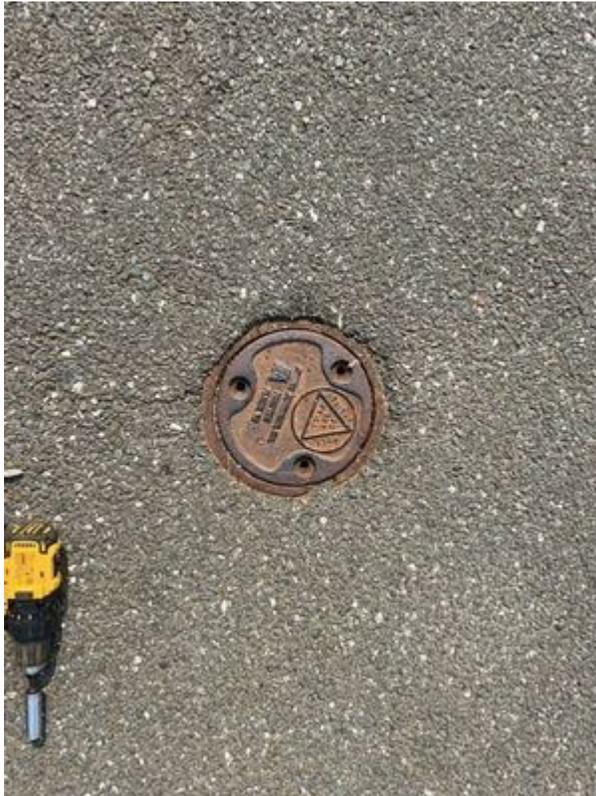
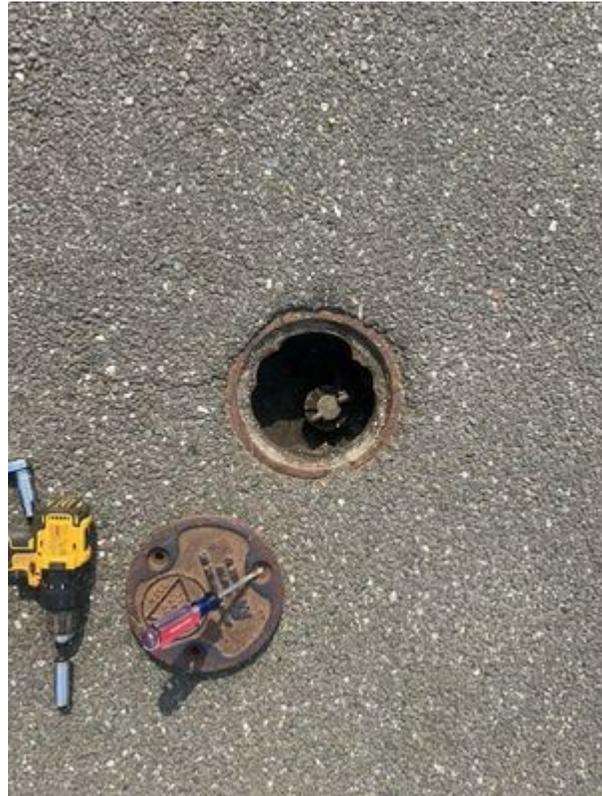
Client: Navy CLEAN	Facility: NWIRP Bethpage
Project Number: 112G08005-WE13	Location: Bethpage, New York
Date: August 6, 2024 09:46	Personnel: Jake Marlow
Well ID: BPTTAOC22MW11	Well Location: 214146.640736664 1123549.39779192
Well Status: In Use (Confirmed)	Screen Interval: 53-63
WELL INVENTORY CONDITION	
Concrete pad in acceptable condition i.e. no cracks?	YES
Manhole cover present and in working condition?	NO
All bolts on manhole present and not stripped?	NO
Well plug present, locked and in good working condition?	YES
OVERALL CONDITION:	FAIR
Notes (Explain if answered No to any of the above) Part of manhole where bolts screw in is broken off

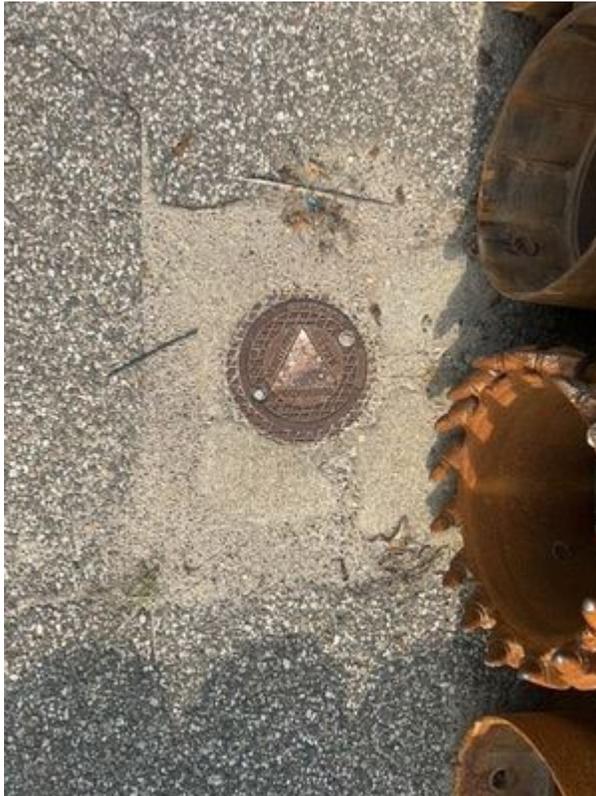
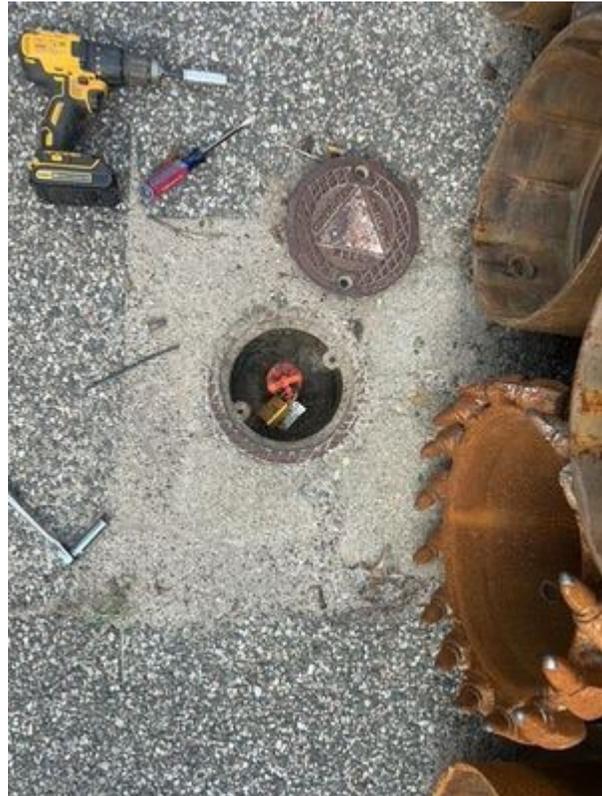
Client: Navy CLEAN	Facility: NWIRP Bethpage
Project Number: 112G08005-WE13	Location: Bethpage, New York
Date: August 6, 2024 09:39	Personnel: Jake Marlow
Well ID: BPS1-TT-MW302S	Well Location: 213822.243897227 1124259.70288377
Well Status: In Use (Confirmed)	Screen Interval: 41-51
WELL INVENTORY CONDITION	
Concrete pad in acceptable condition i.e. no cracks?	NO
Manhole cover present and in working condition?	YES
All bolts on manhole present and not stripped?	YES
Well plug present, locked and in good working condition?	YES
OVERALL CONDITION:	FAIR
Notes (Explain if answered No to any of the above) Cracks in pad

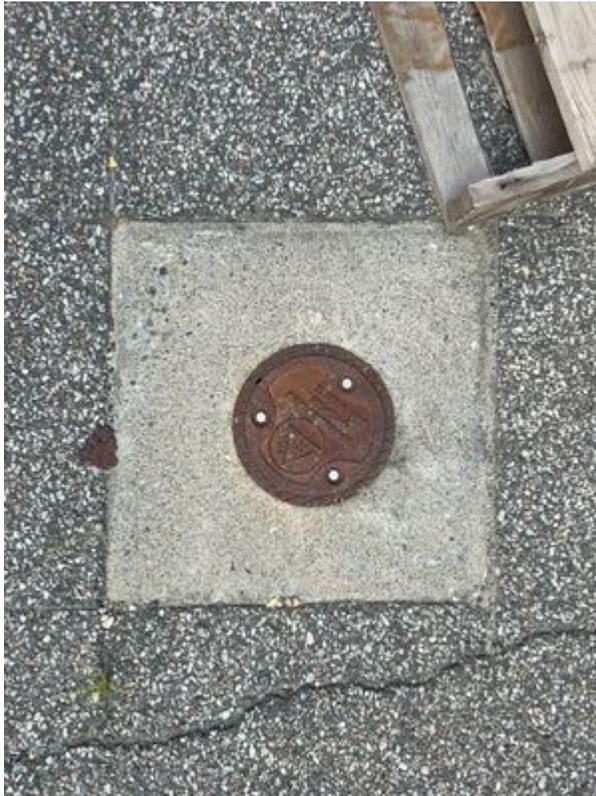
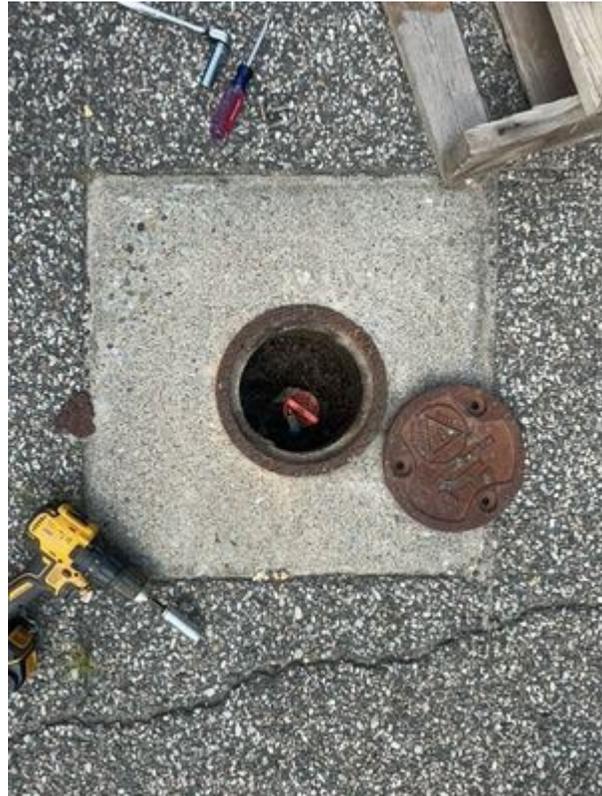
Client: Navy CLEAN	Facility: NWIRP Bethpage
Project Number: 112G08005-WE13	Location: Bethpage, New York
Date: August 6, 2024 09:37	Personnel: Jake Marlow
Well ID: BPS1-TT-MW30211	Well Location: 213822.485964905 1124249.37048436
Well Status: In Use (Confirmed)	Screen Interval: 110-120
WELL INVENTORY CONDITION	
Concrete pad in acceptable condition i.e. no cracks?	YES
Manhole cover present and in working condition?	NO
All bolts on manhole present and not stripped?	YES
Well plug present, locked and in good working condition?	YES
OVERALL CONDITION:	FAIR
Notes (Explain if answered No to any of the above) Part of manhole where bolts screw in is broken off

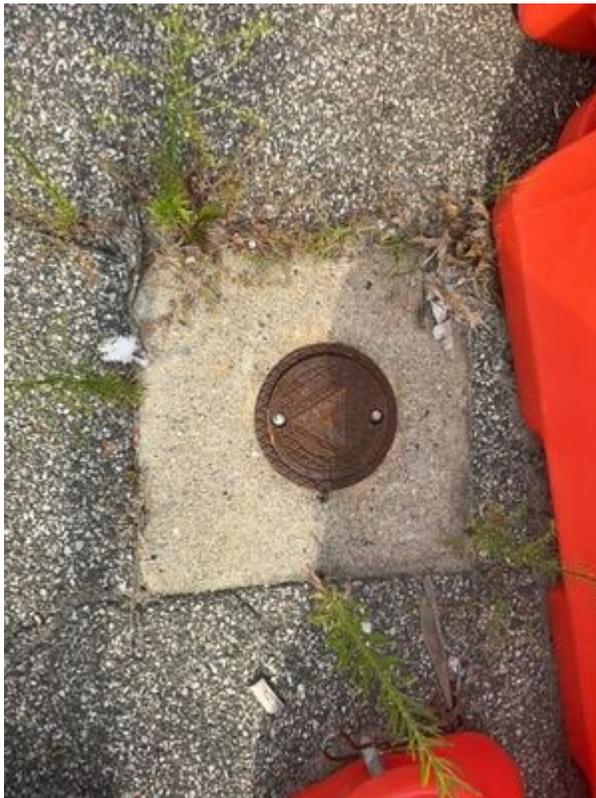
Client: Navy CLEAN	Facility: NWIRP Bethpage
Project Number: 112G08005-WE13	Location: Bethpage, New York
Date: August 6, 2024 09:34	Personnel: Jake Marlow
Well ID: BPS1-TT-MW302D	Well Location: 213825.176122337 1124232.3591149
Well Status: In Use (Confirmed)	Screen Interval: 203-213
WELL INVENTORY CONDITION	
Concrete pad in acceptable condition i.e. no cracks?	YES
Manhole cover present and in working condition?	NO
All bolts on manhole present and not stripped?	YES
Well plug present, locked and in good working condition?	YES
OVERALL CONDITION:	FAIR
Notes (Explain if answered No to any of the above) Part of manhole where bolt screws in is broken off

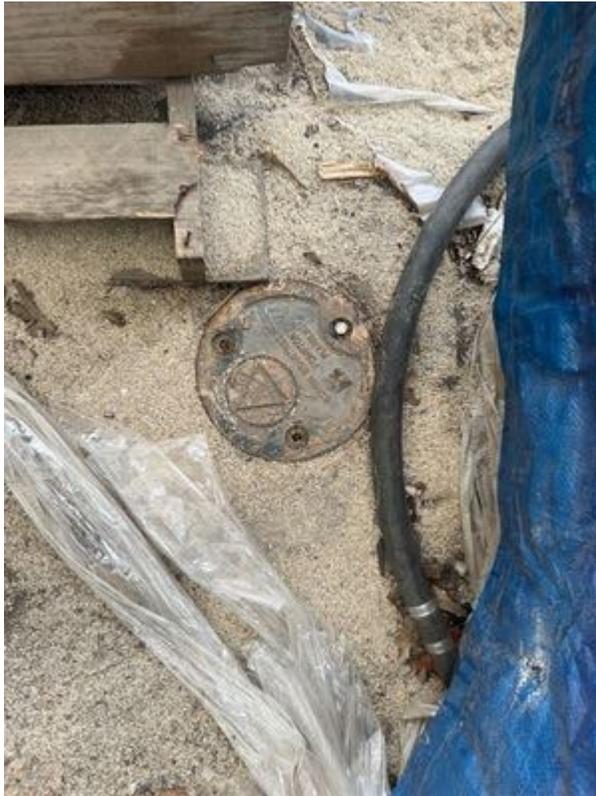
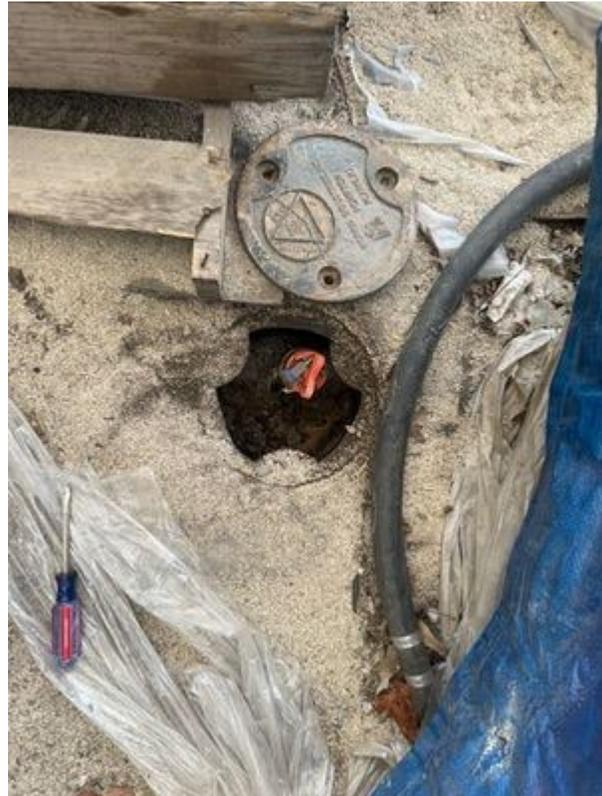
Client: Navy CLEAN	Facility: NWIRP Bethpage
Project Number: 112G08005-WE13	Location: Bethpage, New York
Date: August 6, 2024 09:30	Personnel: Jake Marlow
Well ID: BPS1-TT-MW303D	Well Location: 213779.558426555 1124554.14816654
Well Status: In Use (Confirmed)	Screen Interval: 208-218
WELL INVENTORY CONDITION	
Concrete pad in acceptable condition i.e. no cracks?	YES
Manhole cover present and in working condition?	YES
All bolts on manhole present and not stripped?	NO
Well plug present, locked and in good working condition?	YES
OVERALL CONDITION:	FAIR
Notes (Explain if answered No to any of the above) Bolts are sheared off in manhole

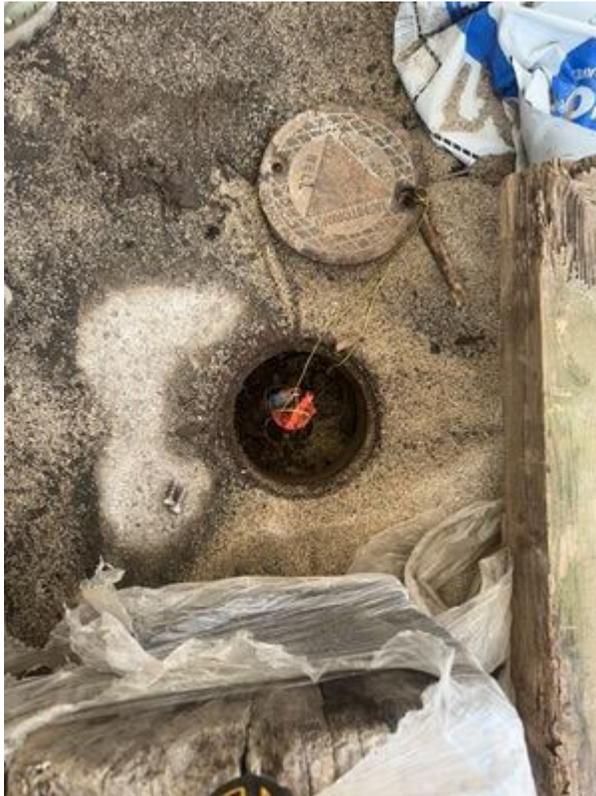
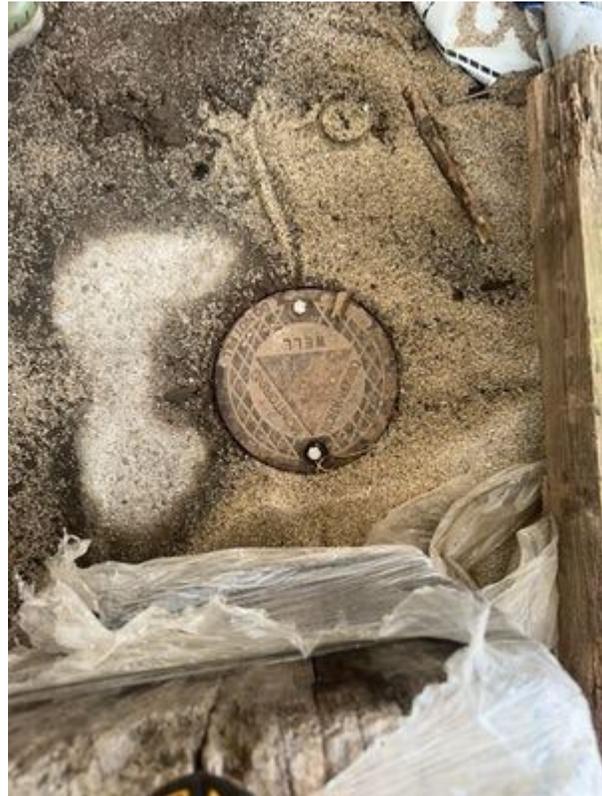
Client: Navy CLEAN	Facility: NWIRP Bethpage
Project Number: 112G08005-WE13	Location: Bethpage, New York
Date: August 6, 2024 09:26	Personnel: Jake Marlow
Well ID: BPS1-TT-MW30312	Well Location: 213787.286995785 1124566.22380942
Well Status: In Use (Confirmed)	Screen Interval: 146-156
WELL INVENTORY CONDITION	
Concrete pad in acceptable condition i.e. no cracks?	YES
Manhole cover present and in working condition?	NO
All bolts on manhole present and not stripped?	YES
Well plug present, locked and in good working condition?	YES
OVERALL CONDITION:	FAIR
Notes (Explain if answered No to any of the above) Part of manhole where bolts screw in is broken off

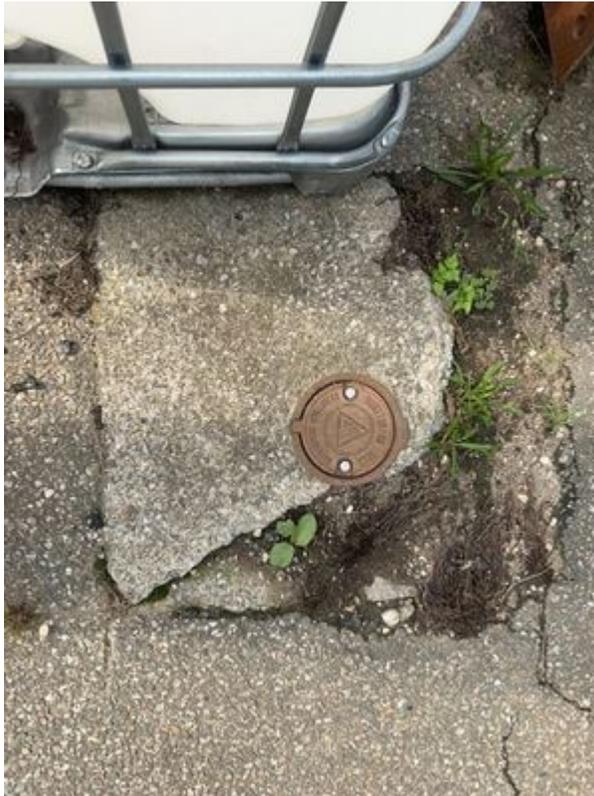
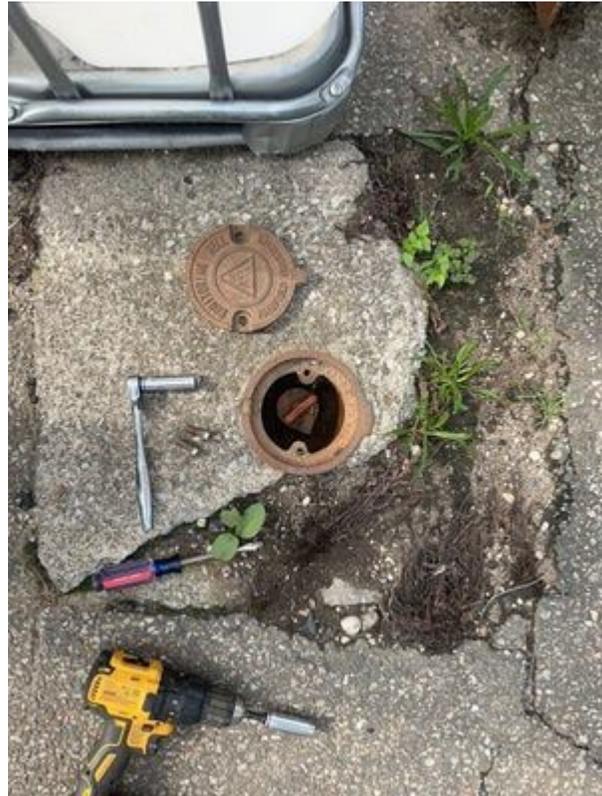
Client: Navy CLEAN	Facility: NWIRP Bethpage
Project Number: 112G08005-WE13	Location: Bethpage, New York
Date: August 6, 2024 09:22	Personnel: Jake Marlow
Well ID: BPS1-TT-MW303S	Well Location: 213782.777568507 1124582.60546118
Well Status: In Use (Confirmed)	Screen Interval: 46-56
WELL INVENTORY CONDITION	
Concrete pad in acceptable condition i.e. no cracks?	NO
Manhole cover present and in working condition?	YES
All bolts on manhole present and not stripped?	YES
Well plug present, locked and in good working condition?	YES
OVERALL CONDITION:	FAIR
Notes (Explain if answered No to any of the above) Cracked pad

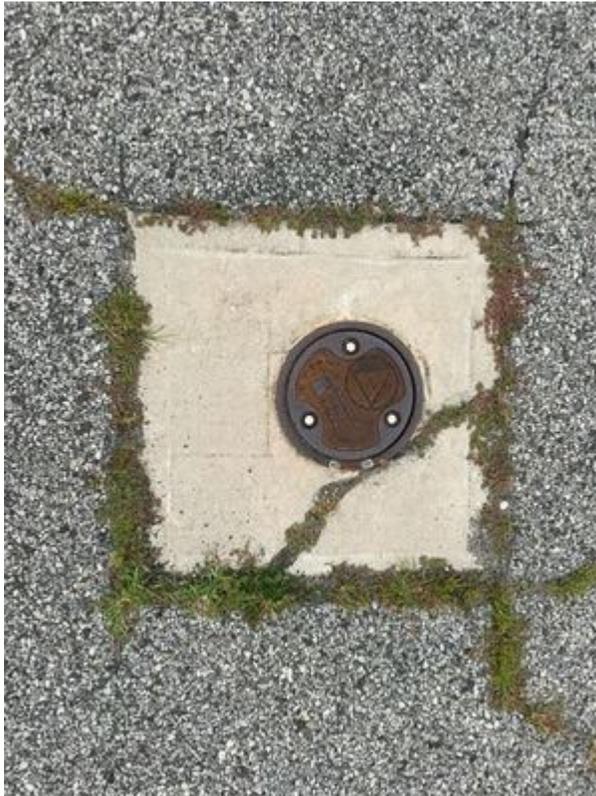
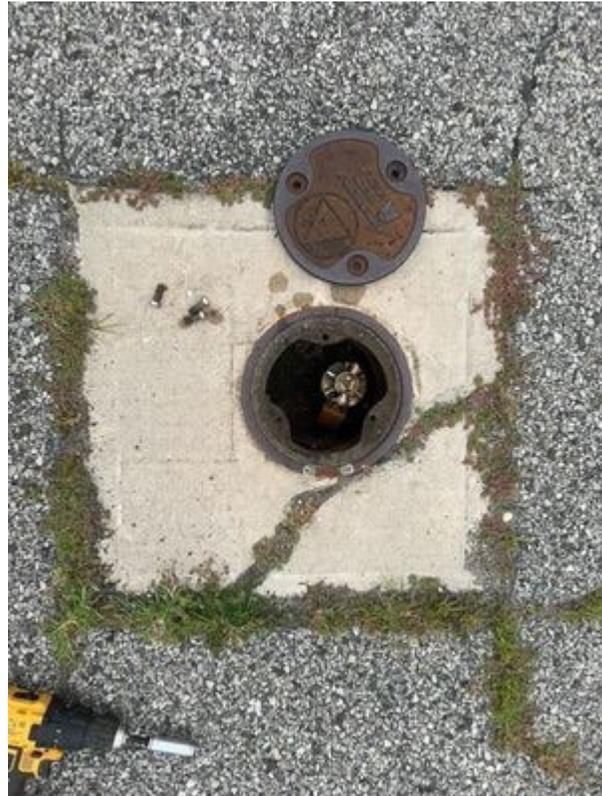
Client: Navy CLEAN	Facility: NWIRP Bethpage
Project Number: 112G08005-WE13	Location: Bethpage, New York
Date: August 6, 2024 08:27	Personnel: Jake Marlow
Well ID: BPTTAOC22MW09	Well Location: 214009.495992885 1123534.77073395
Well Status: In Use (Confirmed)	Screen Interval: 52-62
WELL INVENTORY CONDITION	
Concrete pad in acceptable condition i.e. no cracks?	NO
Manhole cover present and in working condition?	YES
All bolts on manhole present and not stripped?	YES
Well plug present, locked and in good working condition?	YES
OVERALL CONDITION:	FAIR
Notes (Explain if answered No to any of the above) Crack in pad

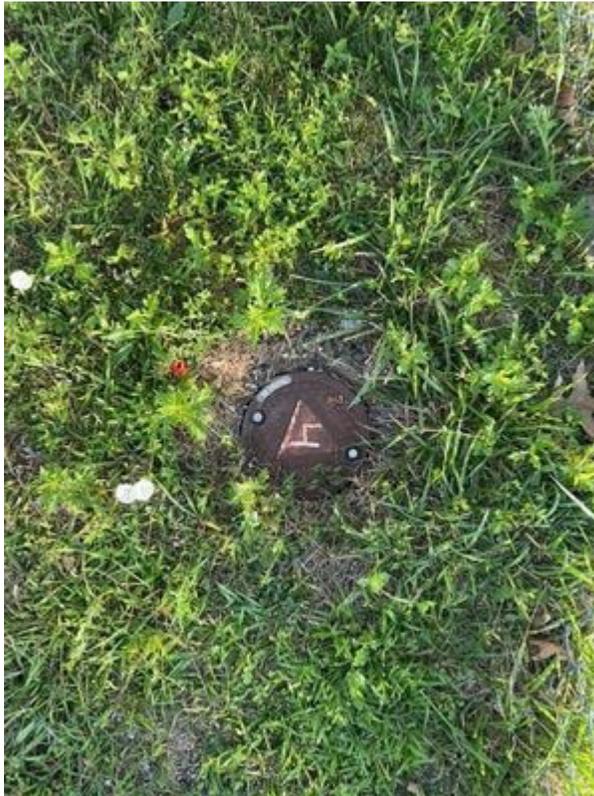
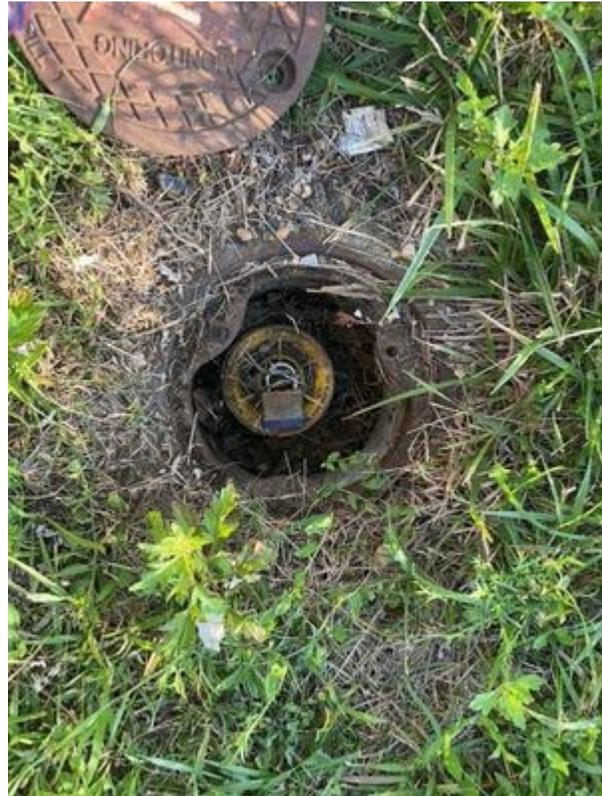
Client: Navy CLEAN	Facility: NWIRP Bethpage
Project Number: 112G08005-WE13	Location: Bethpage, New York
Date: August 2, 2024 07:46	Personnel: Jake Marlow
Well ID: BPTTAOC22MW04	Well Location: 214026.019576882 1123642.29034328
Well Status: In Use (Confirmed)	Screen Interval: 46-66
WELL INVENTORY CONDITION	
Concrete pad in acceptable condition i.e. no cracks?	YES
Manhole cover present and in working condition?	NO
All bolts on manhole present and not stripped?	YES
Well plug present, locked and in good working condition?	YES
OVERALL CONDITION:	FAIR
Notes (Explain if answered No to any of the above) Wrong manhole cover, need one with 3 holes not 2

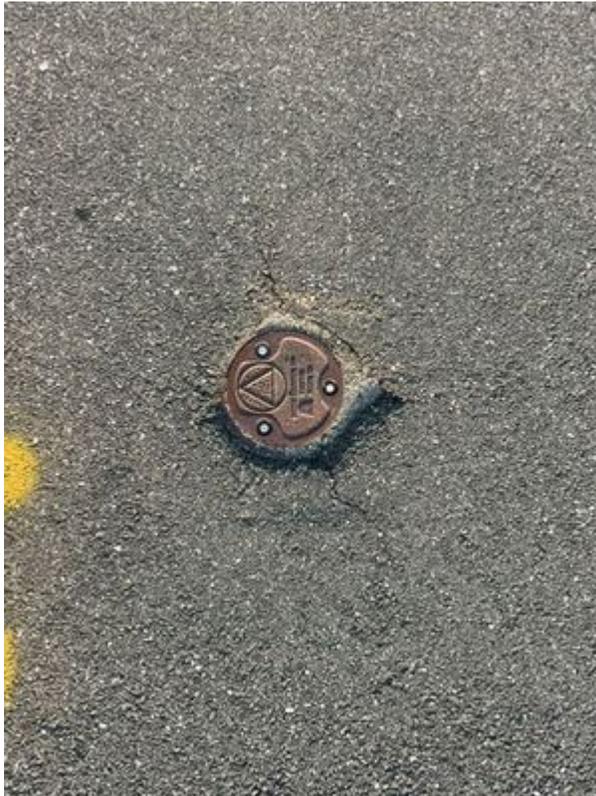
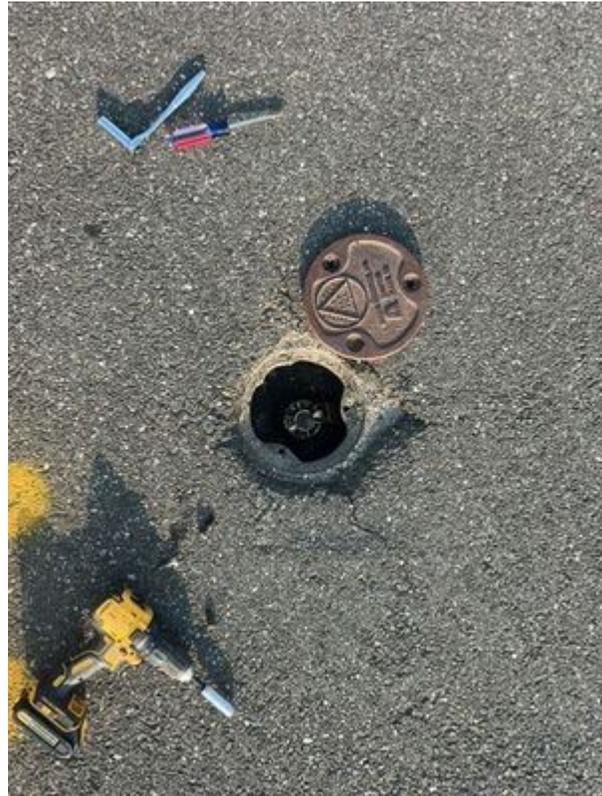
Client: Navy CLEAN	Facility: NWIRP Bethpage
Project Number: 112G08005-WE13	Location: Bethpage, New York
Date: August 2, 2024 07:37	Personnel: Jake Marlow
Well ID: BPTTAOC22MW06	Well Location: 213930.95603351 1123713.31441106
Well Status: In Use (Confirmed)	Screen Interval: 52-62
WELL INVENTORY CONDITION	
Concrete pad in acceptable condition i.e. no cracks?	YES
Manhole cover present and in working condition?	NO
All bolts on manhole present and not stripped?	YES
Well plug present, locked and in good working condition?	YES
OVERALL CONDITION:	FAIR
Notes (Explain if answered No to any of the above) Crack in manhole where bolt attaches

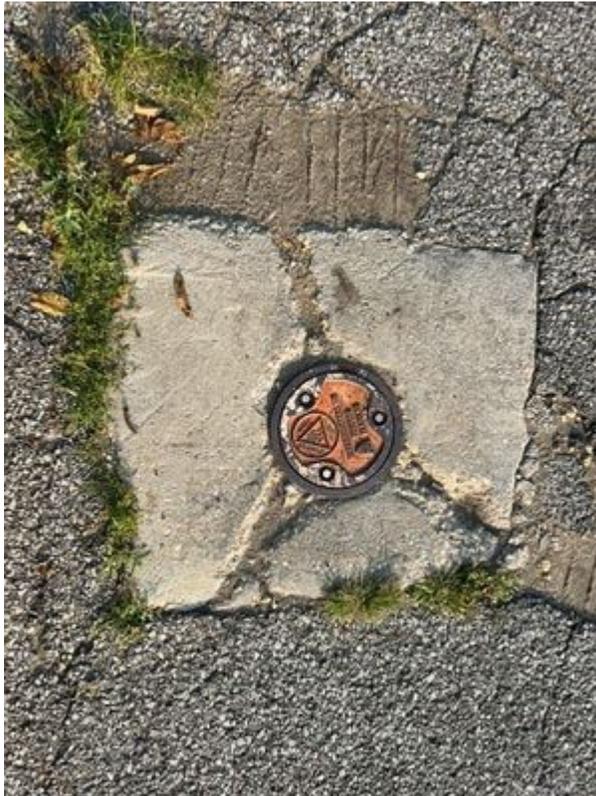
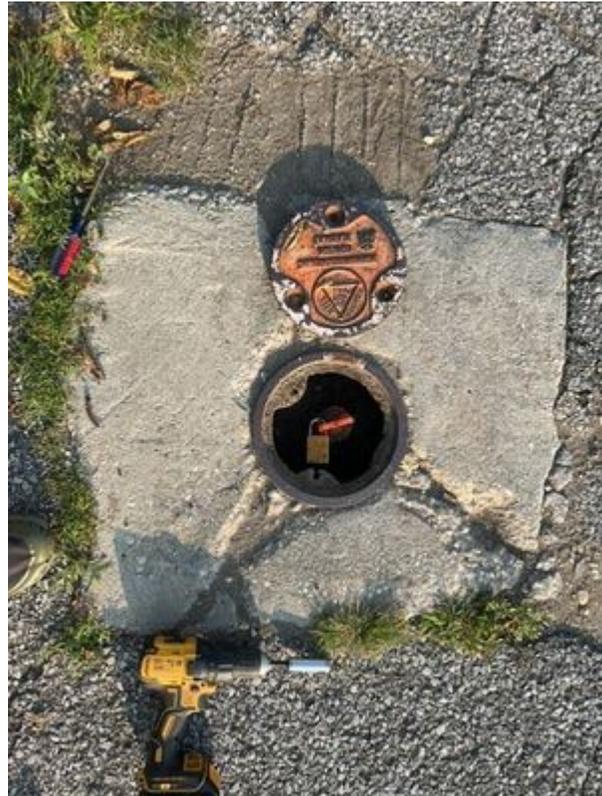
Client: Navy CLEAN	Facility: NWIRP Bethpage
Project Number: 112G08005-WE13	Location: Bethpage, New York
Date: August 2, 2024 07:26	Personnel: Jake Marlow
Well ID: BPS1-TT-MW305D	Well Location: 213404.687091753 1123947.68277699
Well Status: In Use (Confirmed)	Screen Interval: 286-296
WELL INVENTORY CONDITION	
Concrete pad in acceptable condition i.e. no cracks?	NO
Manhole cover present and in working condition?	NO
All bolts on manhole present and not stripped?	YES
Well plug present, locked and in good working condition?	YES
OVERALL CONDITION:	FAIR
Notes (Explain if answered No to any of the above) Cracks in pad, manhole broken where bolts screw in

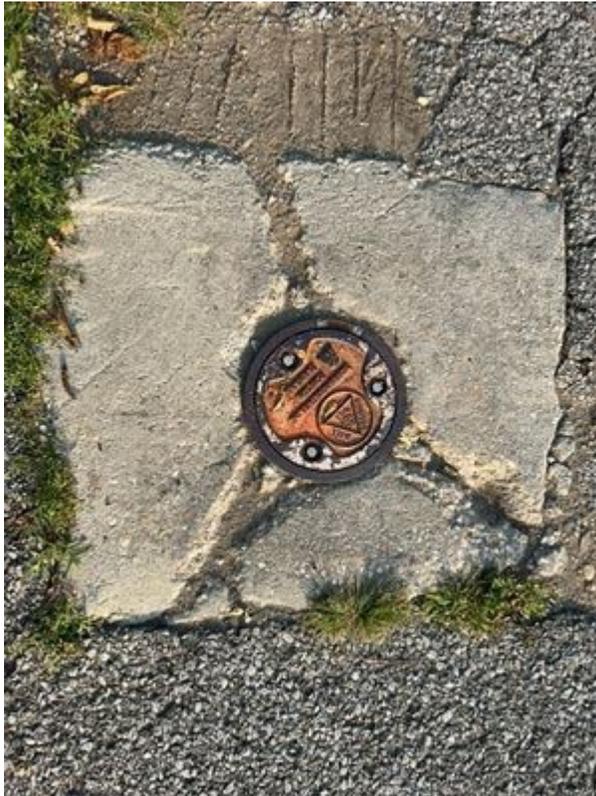
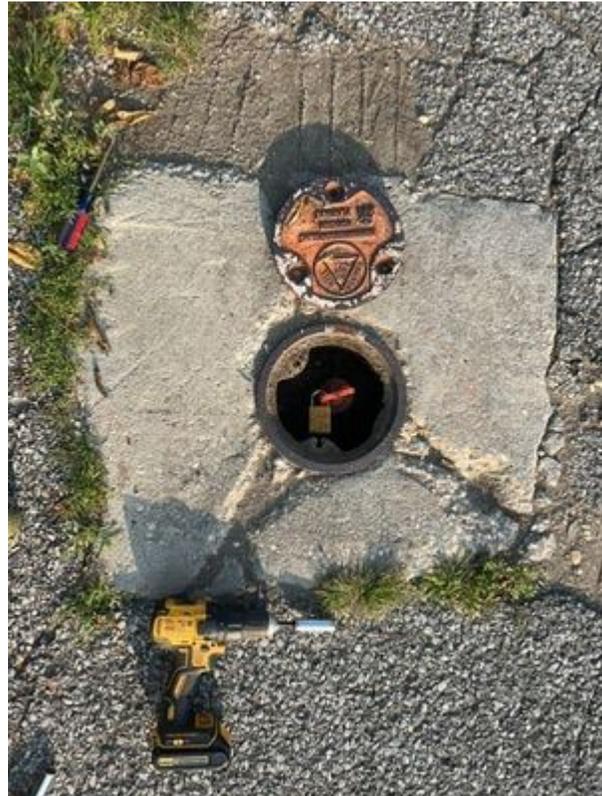
Client: Navy CLEAN	Facility: NWIRP Bethpage
Project Number: 112G08005-WE13	Location: Bethpage, New York
Date: August 2, 2024 07:26	Personnel: Jake Marlow
Well ID: BPS1-TT-MW305D	Well Location: 213404.687091753 1123947.68277699
Well Status: In Use (Confirmed)	Screen Interval: 286-296
WELL INVENTORY CONDITION	
Concrete pad in acceptable condition i.e. no cracks?	NO
Manhole cover present and in working condition?	YES
All bolts on manhole present and not stripped?	YES
Well plug present, locked and in good working condition?	YES
OVERALL CONDITION:	FAIR
Notes (Explain if answered No to any of the above) Cracks in pad
