Memorandum

To: Scott Sokolowski, NAVFAC MIDLANT
From: Richard Moore, Tetra Tech
Date: September 27, 2024
Re: Annual LUC Inspection and Operation Summary Report: Sites 1, 2, 3, and 4 –
NWIRP Bethpage
Contract/CTO Number: N6247016D9008/WE16

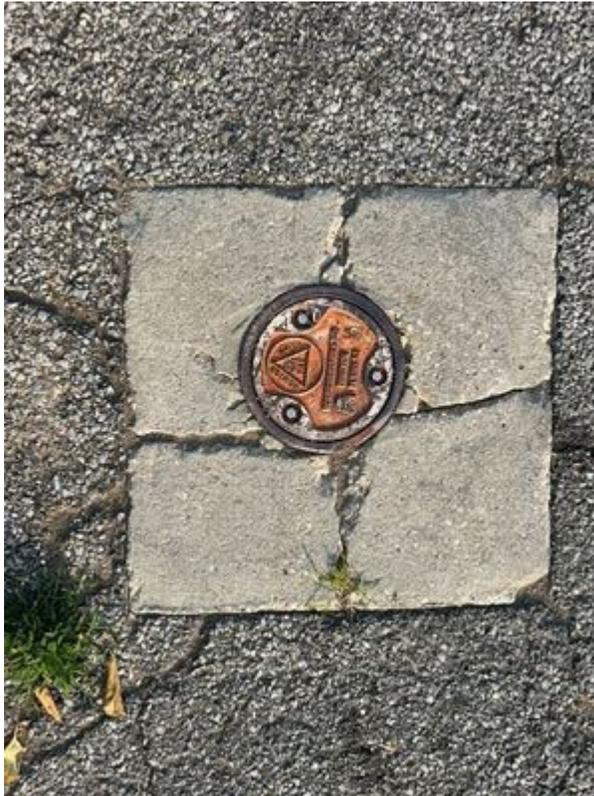
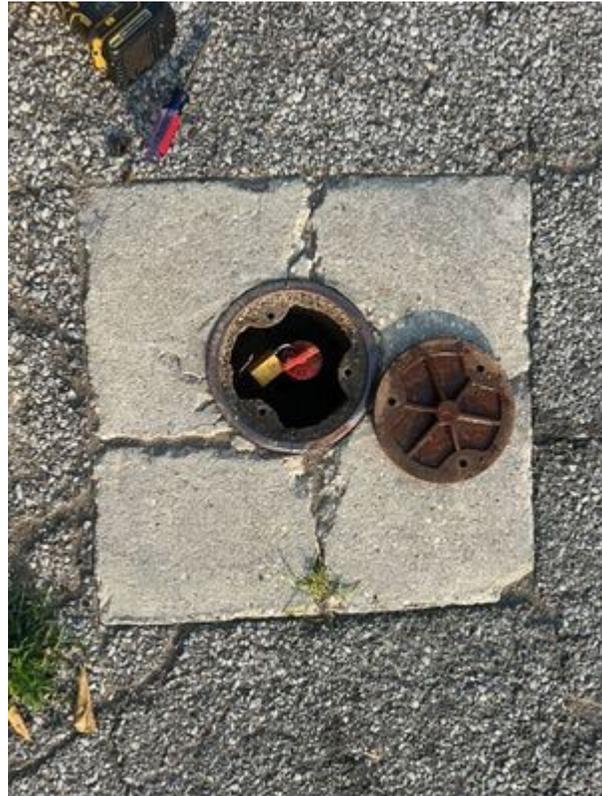
Client: Navy CLEAN	Facility: NWIRP Bethpage
Project Number: 112G08005-WE13	Location: Bethpage, New York
Date: August 2, 2024 07:23	Personnel: Jake Marlow
Well ID: BPS1-TT-MW305I	Well Location: 213407.208904585 1123937.78427735
Well Status: In Use (Confirmed)	Screen Interval: 190-200
WELL INVENTORY CONDITION	
Concrete pad in acceptable condition i.e. no cracks?	NO
Manhole cover present and in working condition?	YES
All bolts on manhole present and not stripped?	YES
Well plug present, locked and in good working condition?	YES
OVERALL CONDITION:	FAIR
Notes (Explain if answered No to any of the above) Cracks in pad

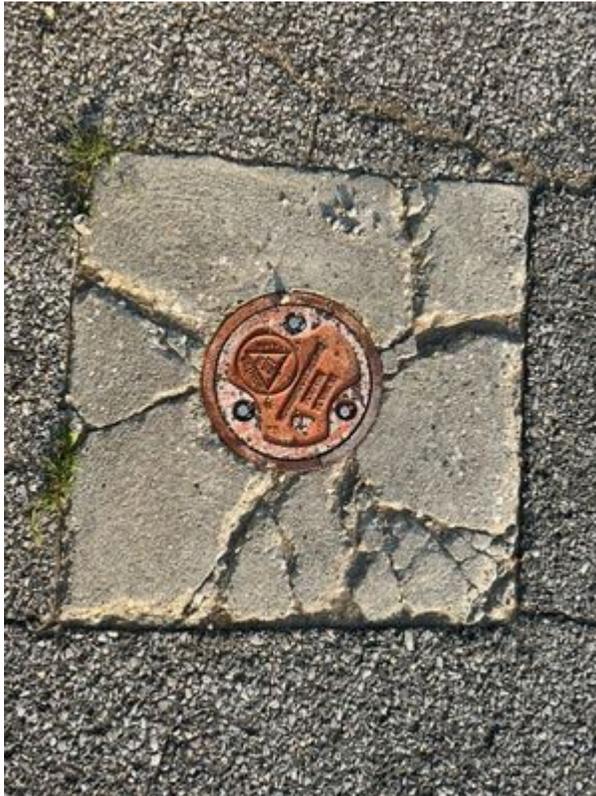
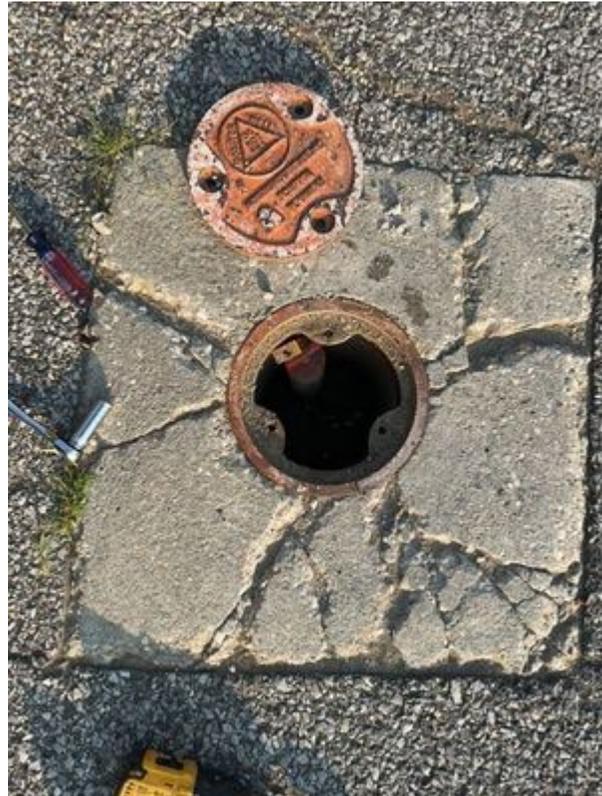
Client: Navy CLEAN	Facility: NWIRP Bethpage
Project Number: 112G08005-WE13	Location: Bethpage, New York
Date: August 2, 2024 07:20	Personnel: Jake Marlow
Well ID: BPS1-TT-MW305S	Well Location: 213408.773219831 1123926.17289083
Well Status: In Use (Confirmed)	Screen Interval: 40-50
WELL INVENTORY CONDITION	
Concrete pad in acceptable condition i.e. no cracks?	NO
Manhole cover present and in working condition?	YES
All bolts on manhole present and not stripped?	YES
Well plug present, locked and in good working condition?	YES
OVERALL CONDITION:	FAIR
Notes (Explain if answered No to any of the above) Cracks in pad

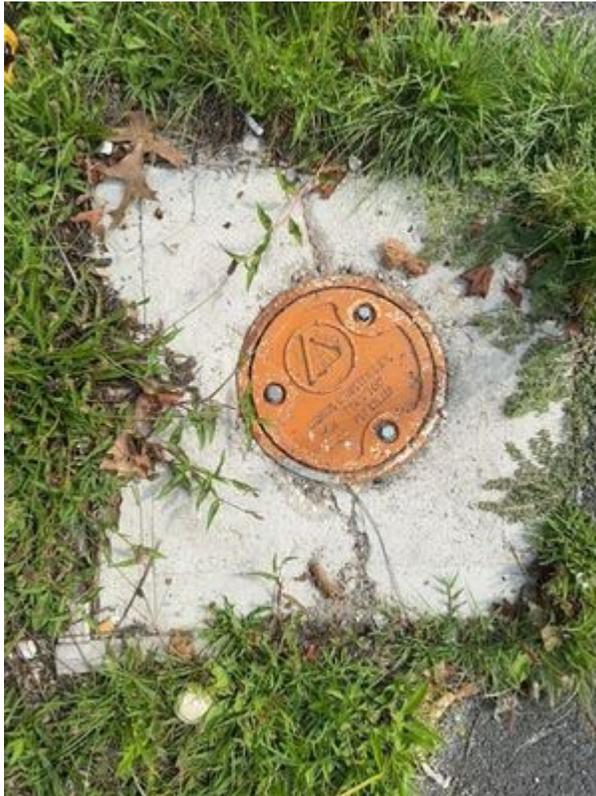
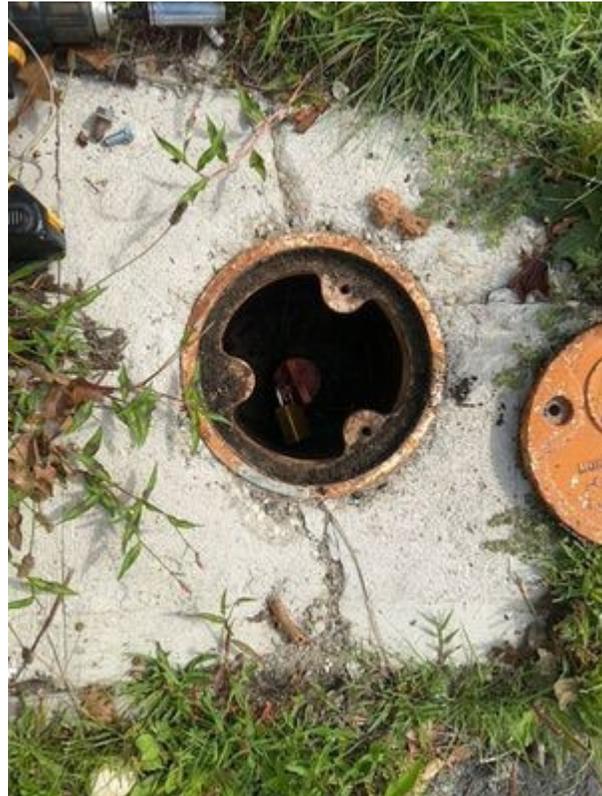
Client: Navy CLEAN	Facility: NWIRP Bethpage
Project Number: 112G08005-WE13	Location: Bethpage, New York
Date: July 24, 2024 16:08	Personnel: Jake Marlow
Well ID: BPS1-TT-MW50111	Well Location: 214108.989422232 1124979.51262269
Well Status: In Use (Confirmed)	Screen Interval: 88-98
WELL INVENTORY CONDITION	
Concrete pad in acceptable condition i.e. no cracks?	NO
Manhole cover present and in working condition?	YES
All bolts on manhole present and not stripped?	YES
Well plug present, locked and in good working condition?	YES
OVERALL CONDITION:	FAIR
Notes (Explain if answered No to any of the above) Cracks in pad

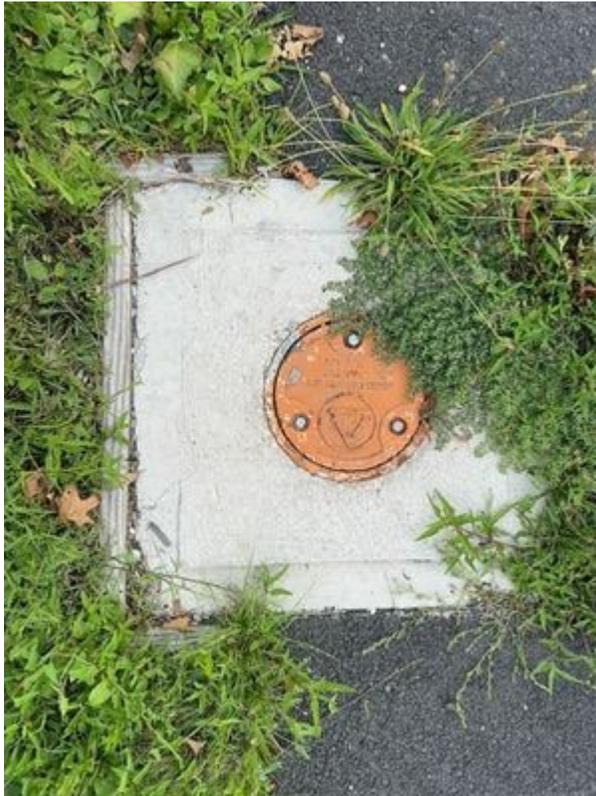
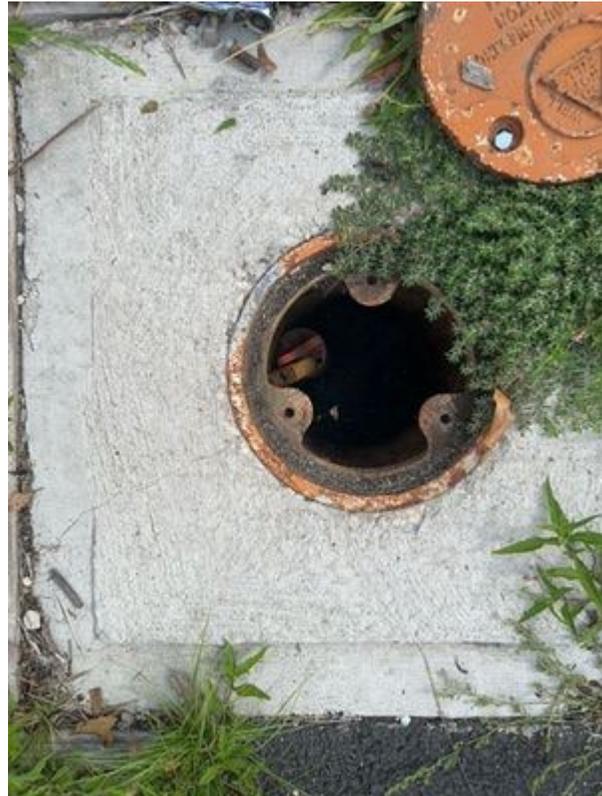
Client: Navy CLEAN	Facility: NWIRP Bethpage
Project Number: 112G08005-WE13	Location: Bethpage, New York
Date: July 24, 2024 16:05	Personnel: Jake Marlow
Well ID: BPS1-TT-MW501S	Well Location: 214103.167694225 1124981.34092458
Well Status: In Use (Confirmed)	Screen Interval: 51-61
WELL INVENTORY CONDITION	
Concrete pad in acceptable condition i.e. no cracks?	YES
Manhole cover present and in working condition?	YES
All bolts on manhole present and not stripped?	YES
Well plug present, locked and in good working condition?	YES
OVERALL CONDITION:	GOOD
Notes (Explain if answered No to any of the above)

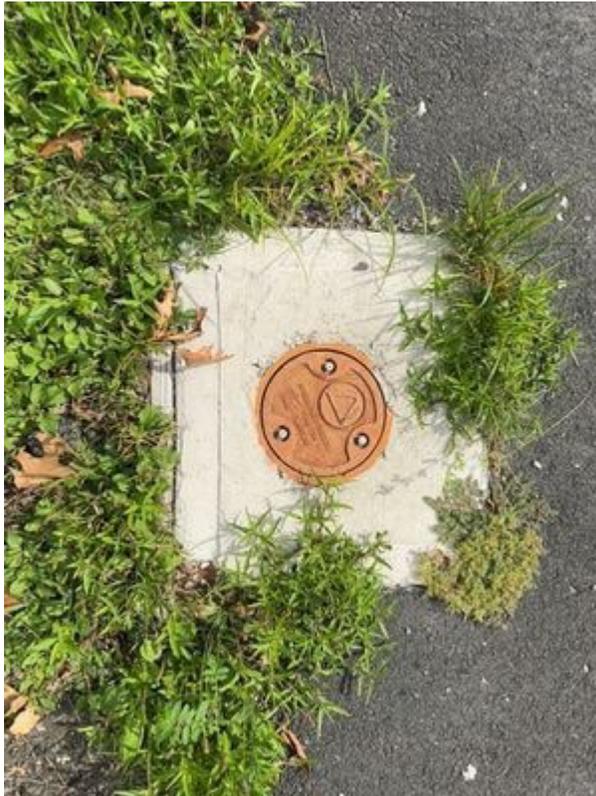
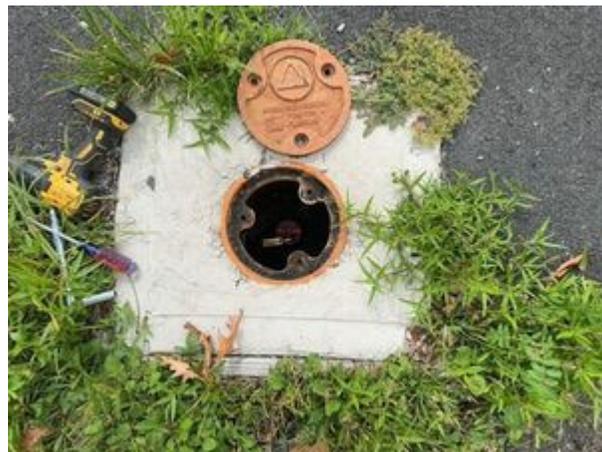
Client: Navy CLEAN	Facility: NWIRP Bethpage
Project Number: 112G08005-WE13	Location: Bethpage, New York
Date: July 24, 2024 16:01	Personnel: Jake Marlow
Well ID: BPS1-TT-MW50112	Well Location: 214105.678265964 1124970.01633633
Well Status: In Use (Confirmed)	Screen Interval: 120-130
WELL INVENTORY CONDITION	
Concrete pad in acceptable condition i.e. no cracks?	YES
Manhole cover present and in working condition?	YES
All bolts on manhole present and not stripped?	YES
Well plug present, locked and in good working condition?	YES
OVERALL CONDITION:	GOOD
Notes (Explain if answered No to any of the above)

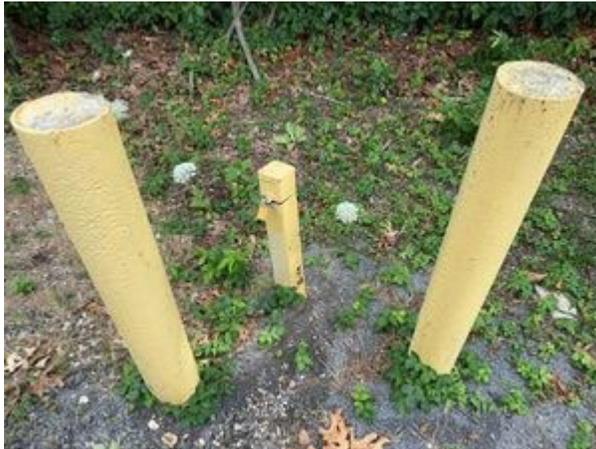
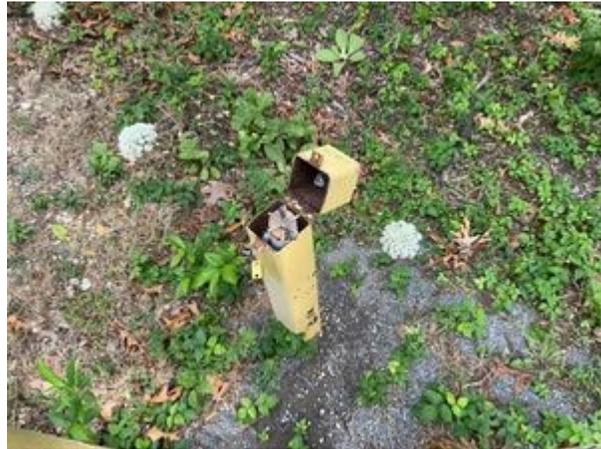
Client: Navy CLEAN	Facility: NWIRP Bethpage
Project Number: 112G08005-WE13	Location: Bethpage, New York
Date: July 24, 2024 15:57	Personnel: Jake Marlow
Well ID: BPS1FWMW01	Well Location: 213963.816747986 1124959.55787961
Well Status: In Use (Confirmed)	Screen Interval: 48.5-63.5
WELL INVENTORY CONDITION	
Concrete pad in acceptable condition i.e. no cracks?	YES
Manhole cover present and in working condition?	YES
All bolts on manhole present and not stripped?	YES
Well plug present, locked and in good working condition?	YES
OVERALL CONDITION:	GOOD
Notes (Explain if answered No to any of the above)

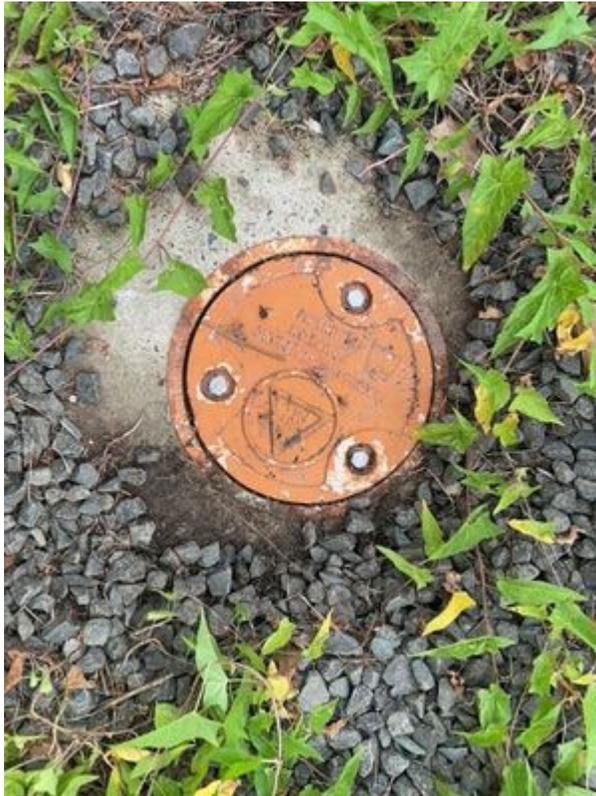
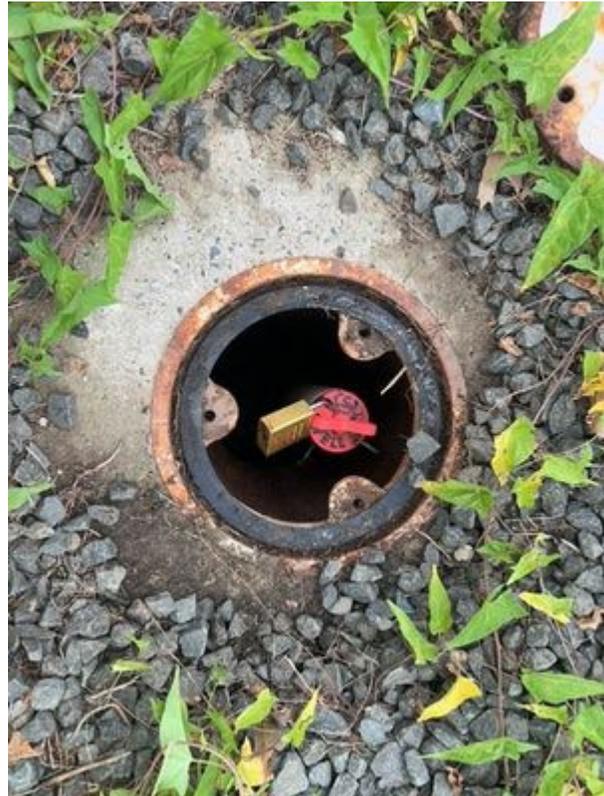
Client: Navy CLEAN	Facility: NWIRP Bethpage
Project Number: 112G08005-WE13	Location: Bethpage, New York
Date: July 24, 2024 15:55	Personnel: Jake Marlow
Well ID: BPS1-FW-MW01D	Well Location: 213975.712315676 1124978.77183925
Well Status: In Use (Confirmed)	Screen Interval: 195-205
WELL INVENTORY CONDITION	
Concrete pad in acceptable condition i.e. no cracks?	YES
Manhole cover present and in working condition?	YES
All bolts on manhole present and not stripped?	YES
Well plug present, locked and in good working condition?	YES
OVERALL CONDITION:	GOOD
Notes (Explain if answered No to any of the above)

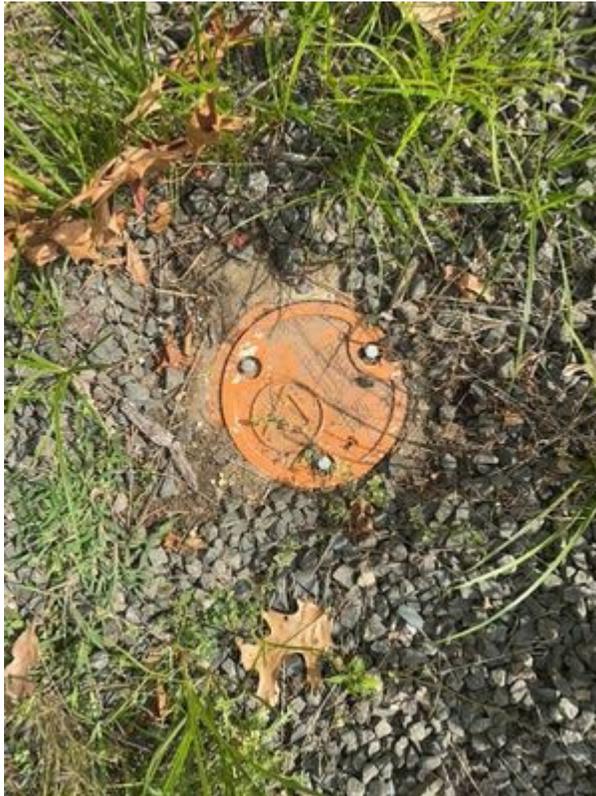
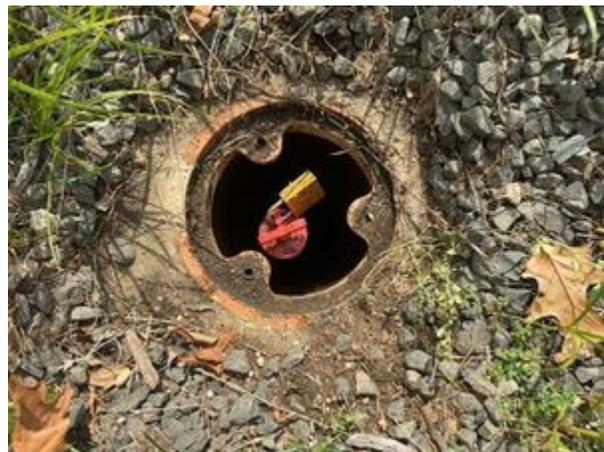
Client: Navy CLEAN	Facility: NWIRP Bethpage
Project Number: 112G08005-WE13	Location: Bethpage, New York
Date: July 24, 2024 15:53	Personnel: Jake Marlow
Well ID: BPS1-FW-MW0112	Well Location: 213982.732474011 1124977.71845824
Well Status: In Use (Confirmed)	Screen Interval: 115-125
WELL INVENTORY CONDITION	
Concrete pad in acceptable condition i.e. no cracks?	YES
Manhole cover present and in working condition?	YES
All bolts on manhole present and not stripped?	YES
Well plug present, locked and in good working condition?	YES
OVERALL CONDITION:	GOOD
Notes (Explain if answered No to any of the above)

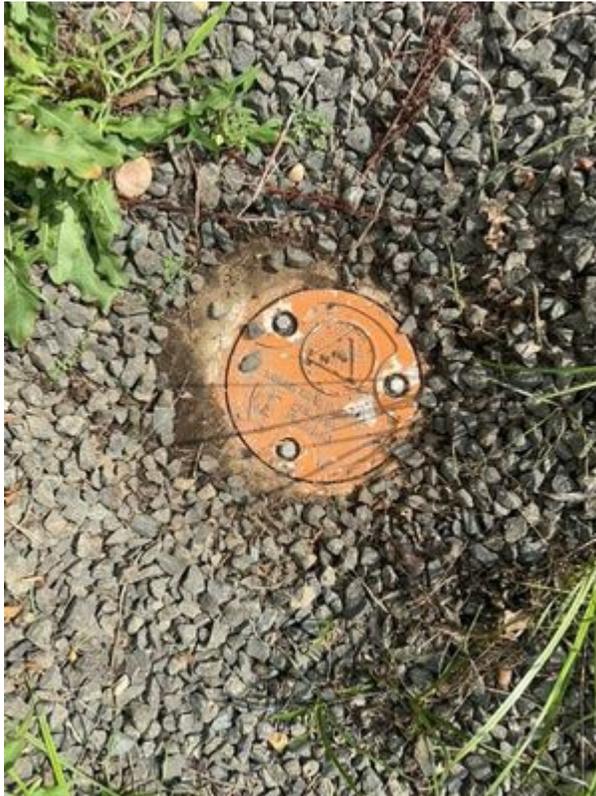
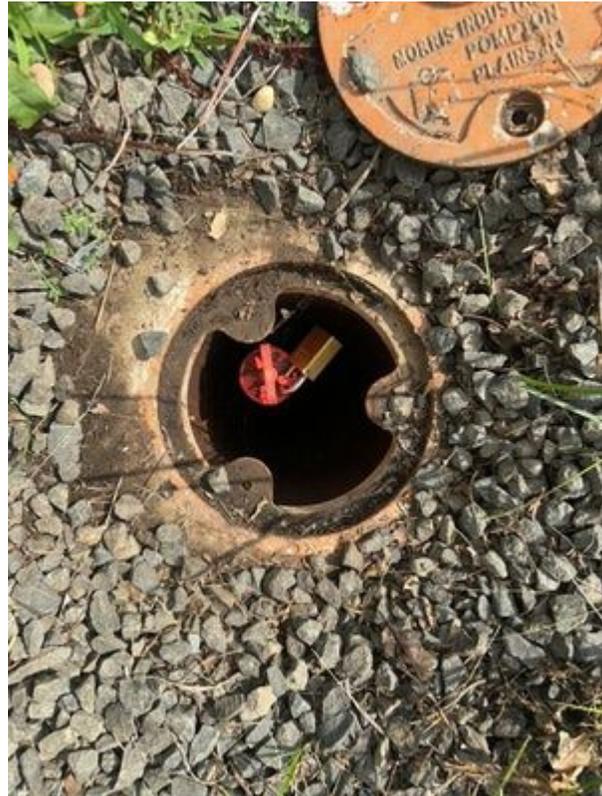
Client: Navy CLEAN	Facility: NWIRP Bethpage
Project Number: 112G08005-WE13	Location: Bethpage, New York
Date: July 24, 2024 15:49	Personnel: Jake Marlow
Well ID: BPS1-FW-MW0111	Well Location: 213993.269195322 1124981.18357079
Well Status: In Use (Confirmed)	Screen Interval: 94-104
WELL INVENTORY CONDITION	
Concrete pad in acceptable condition i.e. no cracks?	YES
Manhole cover present and in working condition?	YES
All bolts on manhole present and not stripped?	YES
Well plug present, locked and in good working condition?	YES
OVERALL CONDITION:	GOOD
Notes (Explain if answered No to any of the above)

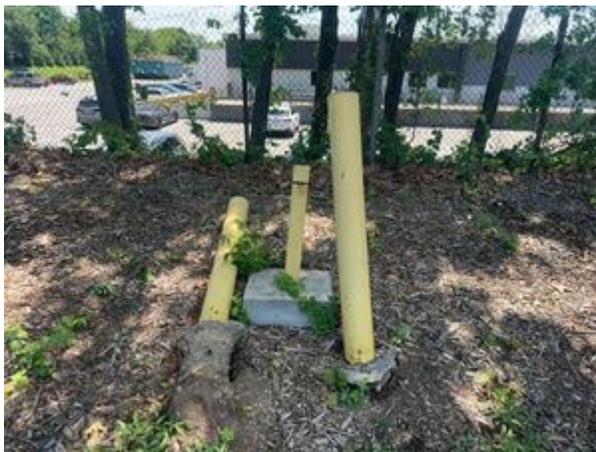
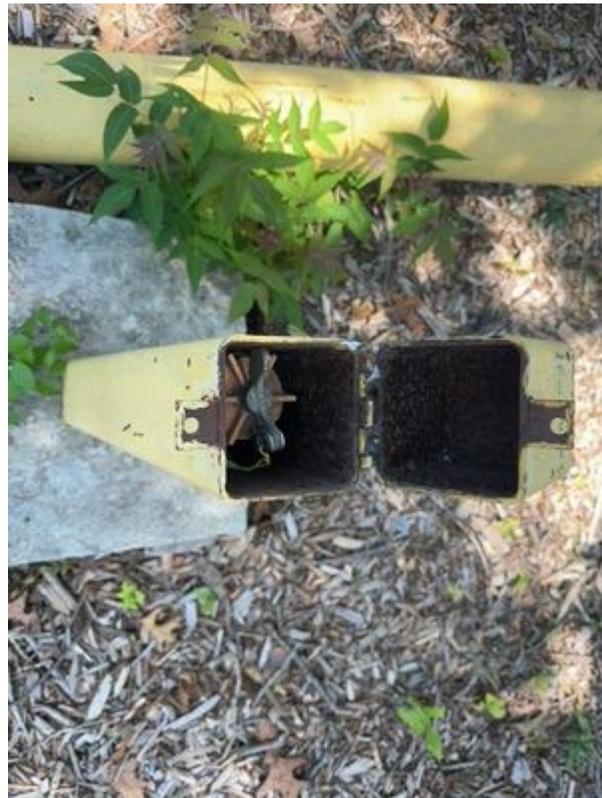
Client: Navy CLEAN	Facility: NWIRP Bethpage
Project Number: 112G08005-WE13	Location: Bethpage, New York
Date: July 19, 2024 13:41	Personnel: Jake Marlow
Well ID: BPS1FWMW02	Well Location: 213975.35948454 1124868.93459382
Well Status: In Use (Confirmed)	Screen Interval: 52-67
WELL INVENTORY CONDITION	
Concrete pad in acceptable condition i.e. no cracks?	YES
Manhole cover present and in working condition?	YES
All bolts on manhole present and not stripped?	YES
Well plug present, locked and in good working condition?	YES
OVERALL CONDITION:	FAIR
Notes (Explain if answered No to any of the above) Bollards knocked over

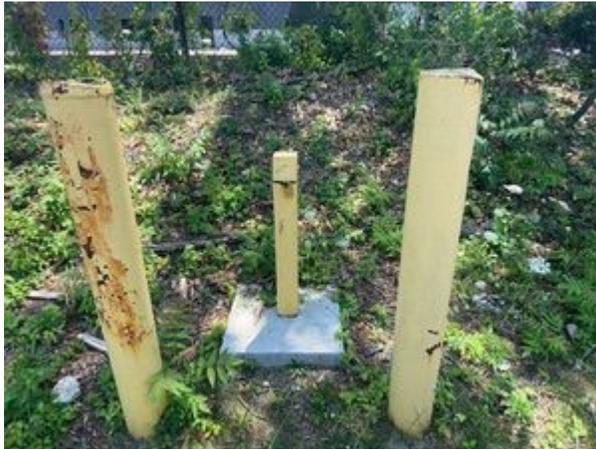
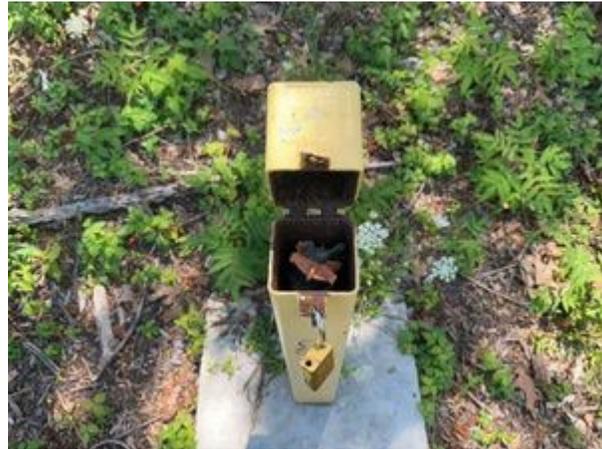
Client: Navy CLEAN	Facility: NWIRP Bethpage
Project Number: 112G08005-WE13	Location: Bethpage, New York
Date: July 19, 2024 13:39	Personnel: Jake Marlow
Well ID: BPS1FWMW03	Well Location: 213982.299373629 1124743.04739936
Well Status: In Use (Confirmed)	Screen Interval: 52-67
WELL INVENTORY CONDITION	
Concrete pad in acceptable condition i.e. no cracks?	YES
Manhole cover present and in working condition?	YES
All bolts on manhole present and not stripped?	YES
Well plug present, locked and in good working condition?	YES
OVERALL CONDITION:	GOOD
Notes (Explain if answered No to any of the above)

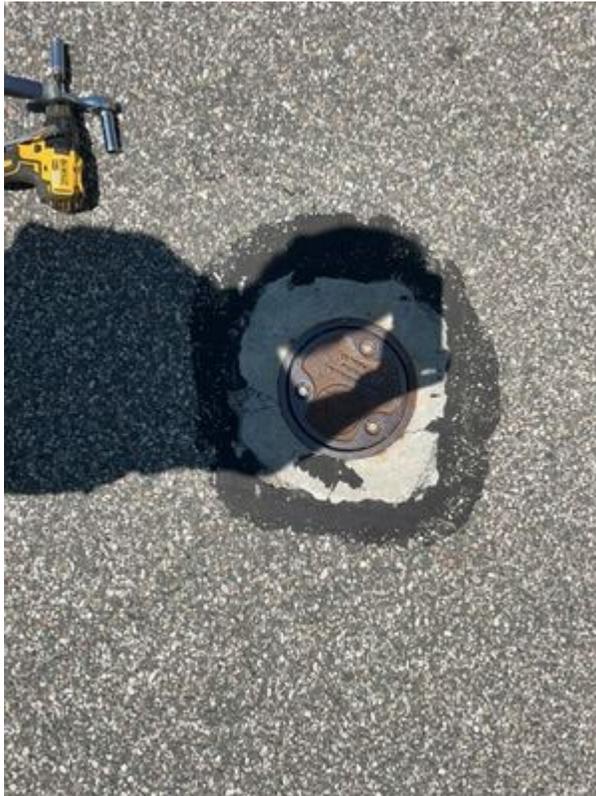
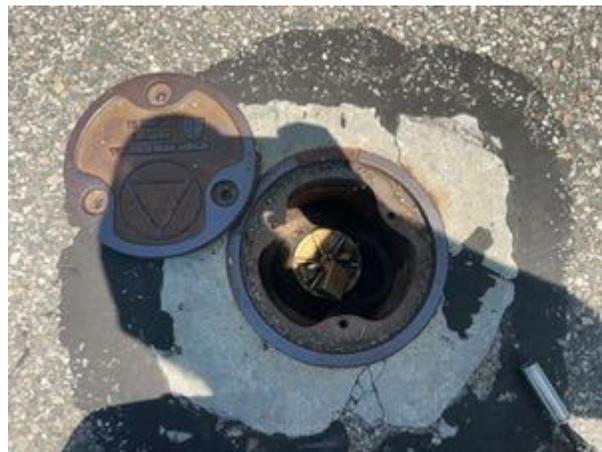
Client: Navy CLEAN	Facility: NWIRP Bethpage
Project Number: 112G08005-WE13	Location: Bethpage, New York
Date: July 19, 2024 12:11	Personnel: Jake Marlow
Well ID: BPHNMW29D	Well Location: 213927.364832596 1124706.35631445
Well Status: In Use (Confirmed)	Screen Interval: 210-220
WELL INVENTORY CONDITION	
Concrete pad in acceptable condition i.e. no cracks?	NO
Manhole cover present and in working condition?	YES
All bolts on manhole present and not stripped?	YES
Well plug present, locked and in good working condition?	YES
OVERALL CONDITION:	GOOD
Notes (Explain if answered No to any of the above) Cracked pad

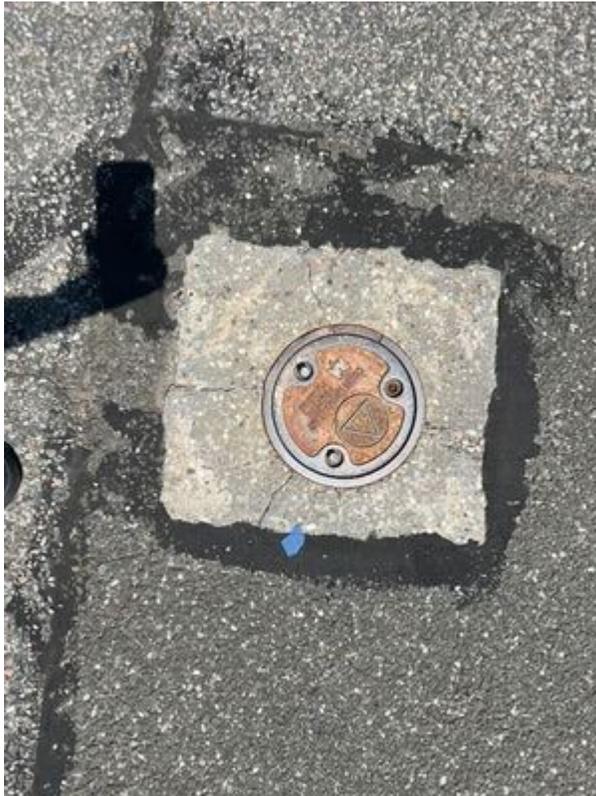
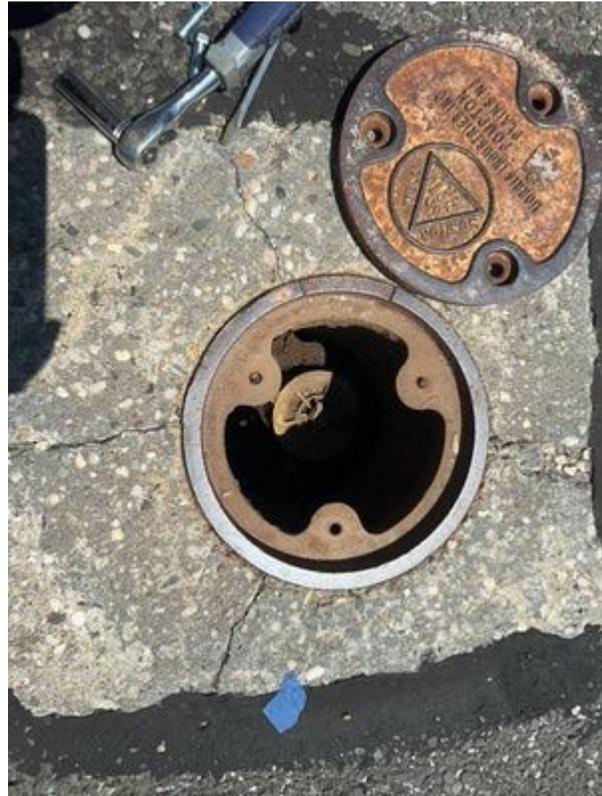
Client: Navy CLEAN	Facility: NWIRP Bethpage
Project Number: 112G08005-WE13	Location: Bethpage, New York
Date: July 19, 2024 12:08	Personnel: Jake Marlow
Well ID: BPHNMW29IR	Well Location: 213932.513785255 1124682.26389163
Well Status: In Use (Confirmed)	Screen Interval: 120-130
WELL INVENTORY CONDITION	
Concrete pad in acceptable condition i.e. no cracks?	NO
Manhole cover present and in working condition?	NO
All bolts on manhole present and not stripped?	YES
Well plug present, locked and in good working condition?	YES
OVERALL CONDITION:	FAIR
Notes (Explain if answered No to any of the above) Cracked pad, bolt sheared off in manhole

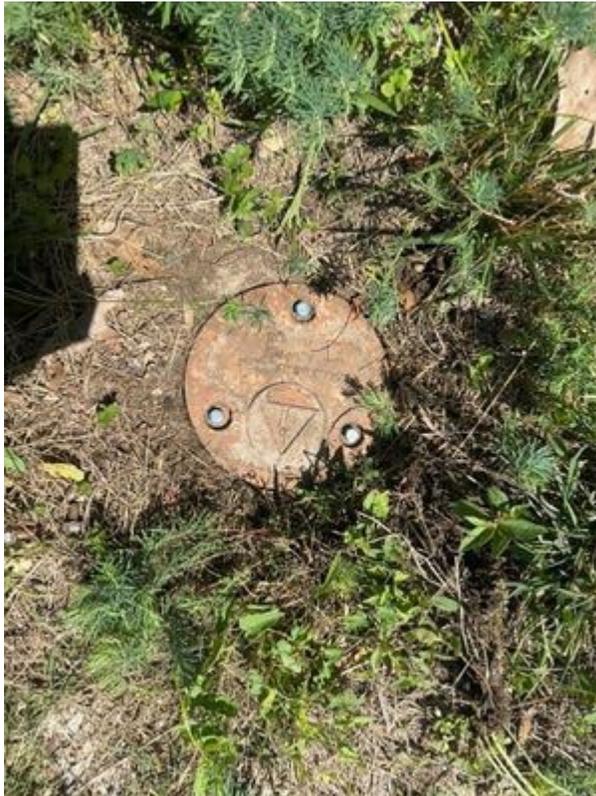
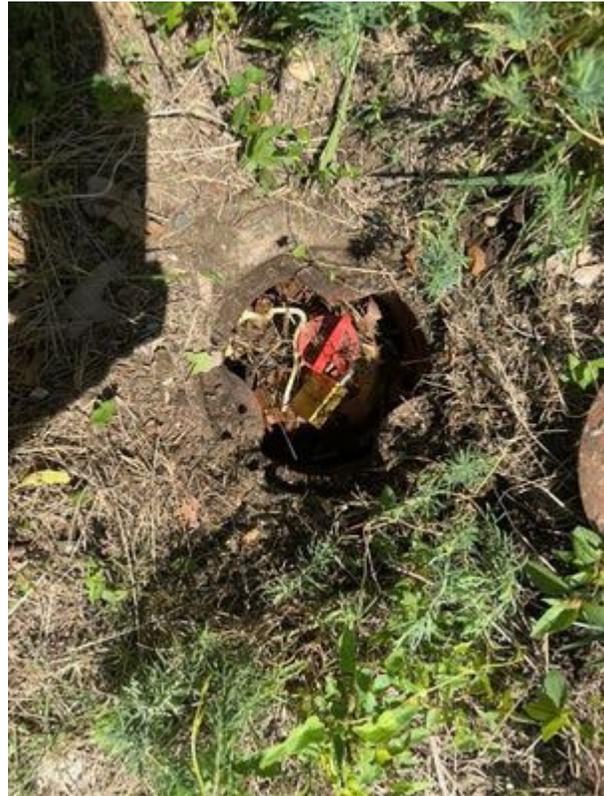
Client: Navy CLEAN	Facility: NWIRP Bethpage
Project Number: 112G08005-WE13	Location: Bethpage, New York
Date: July 19, 2024 11:57	Personnel: Jake Marlow
Well ID: BPS1-TT-MW30411	Well Location: 213720.204478647 1124999.15114867
Well Status: In Use (Confirmed)	Screen Interval: 102-112
WELL INVENTORY CONDITION	
Concrete pad in acceptable condition i.e. no cracks?	YES
Manhole cover present and in working condition?	YES
All bolts on manhole present and not stripped?	YES
Well plug present, locked and in good working condition?	YES
OVERALL CONDITION:	GOOD
Notes (Explain if answered No to any of the above)

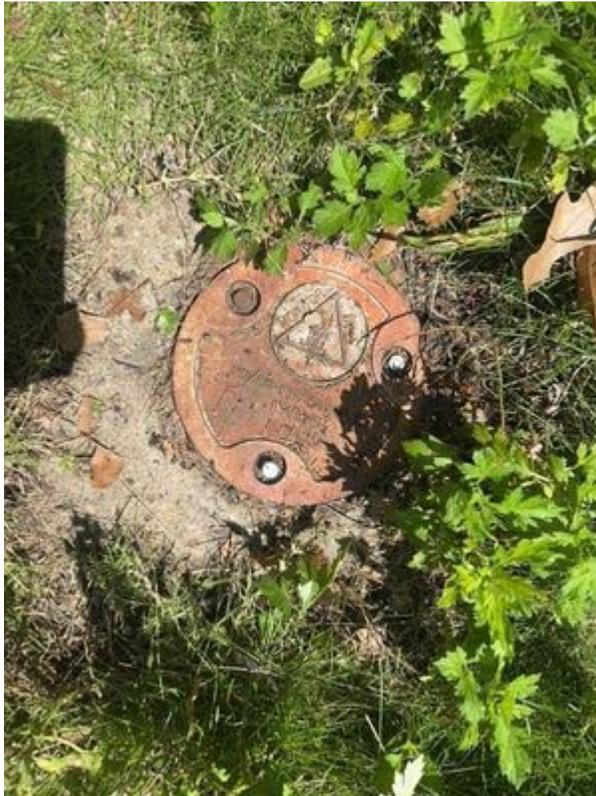
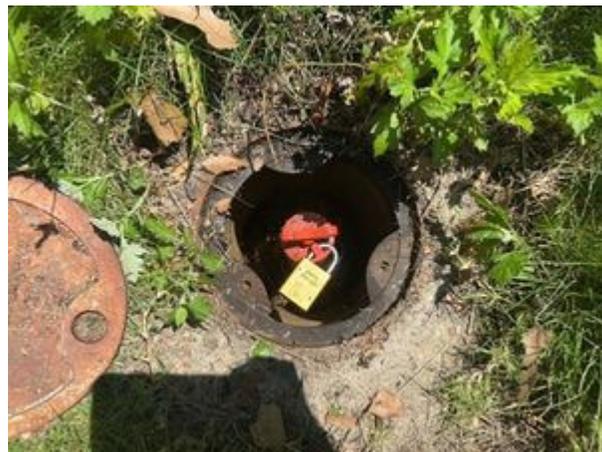
Client: Navy CLEAN	Facility: NWIRP Bethpage
Project Number: 112G08005-WE13	Location: Bethpage, New York
Date: July 19, 2024 12:01	Personnel: Jake Marlow
Well ID: BPS1-TT-MW304D	Well Location: 213694.406764623 1124995.94601072
Well Status: In Use (Confirmed)	Screen Interval: 180-190
WELL INVENTORY CONDITION	
Concrete pad in acceptable condition i.e. no cracks?	YES
Manhole cover present and in working condition?	YES
All bolts on manhole present and not stripped?	YES
Well plug present, locked and in good working condition?	YES
OVERALL CONDITION:	GOOD
Notes (Explain if answered No to any of the above)

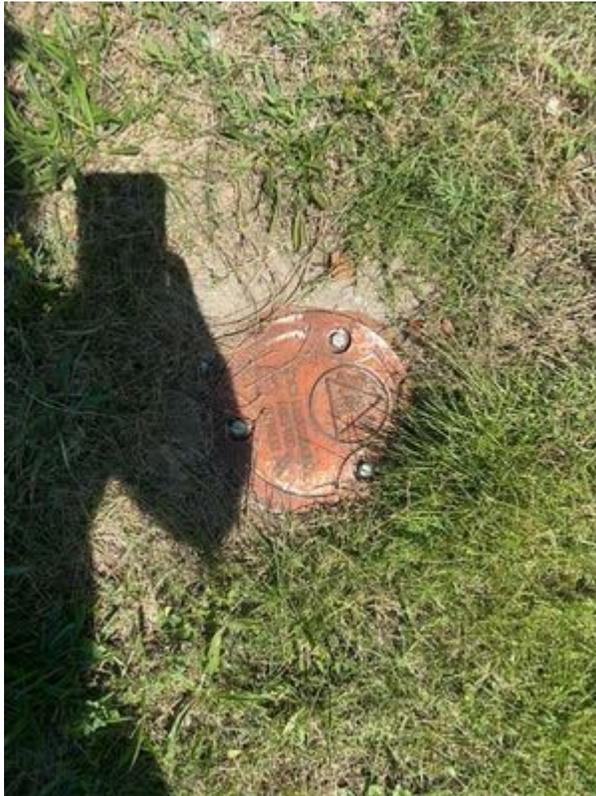
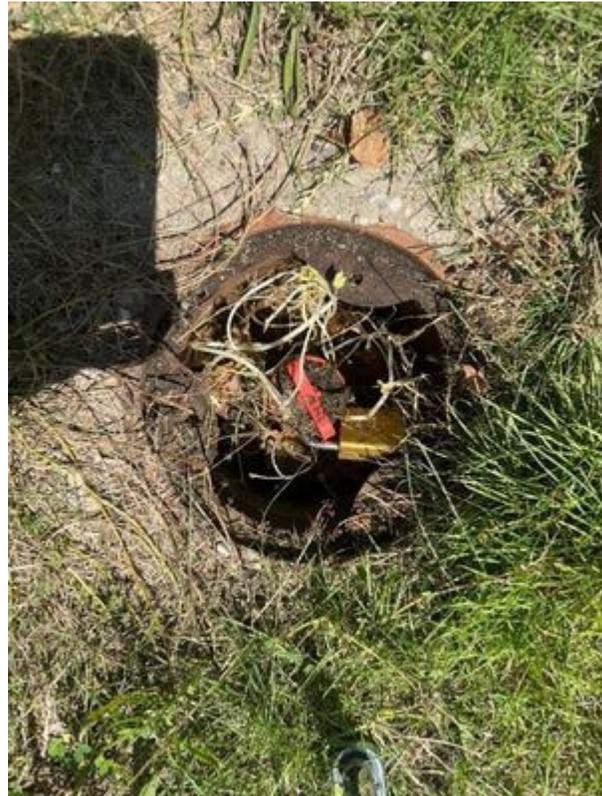
Client: Navy CLEAN	Facility: NWIRP Bethpage
Project Number: 112G08005-WE13	Location: Bethpage, New York
Date: July 19, 2024 11:54	Personnel: Jake Marlow
Well ID: BPS1-TT-MW30412	Well Location: 213705.685322997 1124992.13075773
Well Status: In Use (Confirmed)	Screen Interval: 140-150
WELL INVENTORY CONDITION	
Concrete pad in acceptable condition i.e. no cracks?	YES
Manhole cover present and in working condition?	YES
All bolts on manhole present and not stripped?	YES
Well plug present, locked and in good working condition?	YES
OVERALL CONDITION:	GOOD
Notes (Explain if answered No to any of the above)

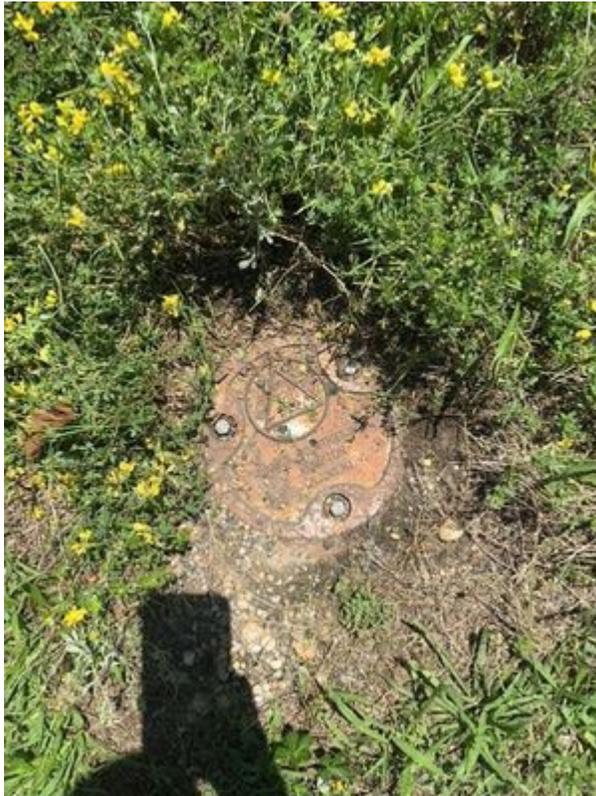
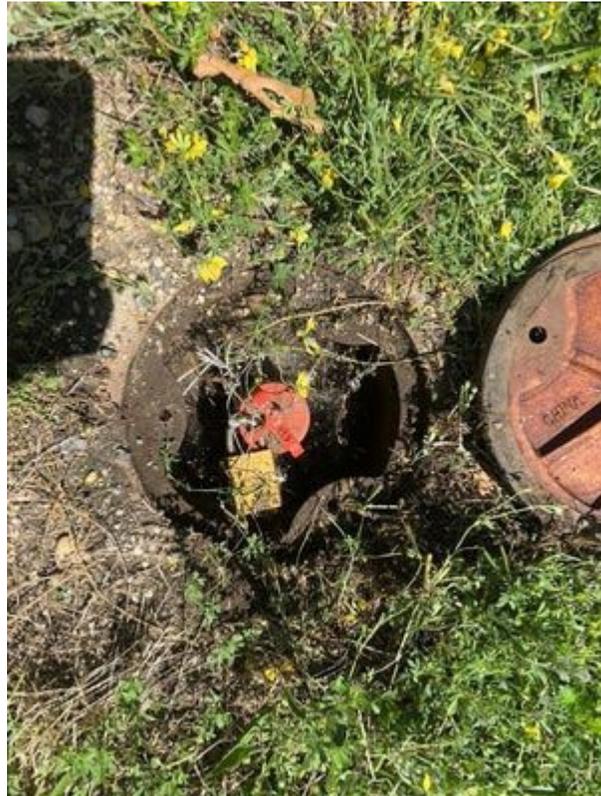
Client: Navy CLEAN	Facility: NWIRP Bethpage
Project Number: 112G08005-WE13	Location: Bethpage, New York
Date: July 19, 2024 11:49	Personnel: Jake Marlow
Well ID: BPS1-TT-MW304S	Well Location: 213737.350639216 1124982.13032451
Well Status: In Use (Confirmed)	Screen Interval: 43-53
WELL INVENTORY CONDITION	
Concrete pad in acceptable condition i.e. no cracks?	YES
Manhole cover present and in working condition?	YES
All bolts on manhole present and not stripped?	YES
Well plug present, locked and in good working condition?	YES
OVERALL CONDITION:	GOOD
Notes (Explain if answered No to any of the above)

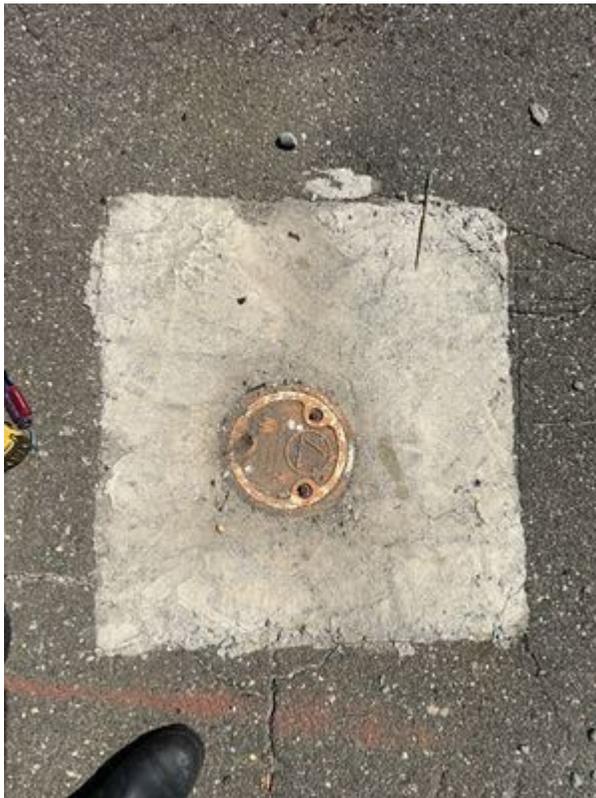
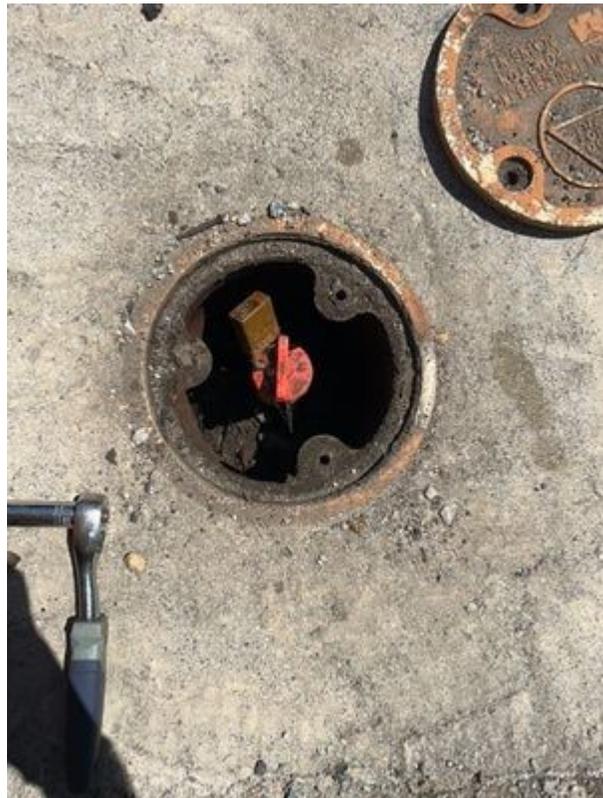
Client: Navy CLEAN	Facility: NWIRP Bethpage
Project Number: 112G08005-WE13	Location: Bethpage, New York
Date: July 19, 2024 11:45	Personnel: Jake Marlow
Well ID: BOS1-TT-MW307D	Well Location: 213360.437536474 1124929.22031979
Well Status: In Use (Confirmed)	Screen Interval:
WELL INVENTORY CONDITION	
Concrete pad in acceptable condition i.e. no cracks?	NO
Manhole cover present and in working condition?	NO
All bolts on manhole present and not stripped?	YES
Well plug present, locked and in good working condition?	YES
OVERALL CONDITION:	FAIR
Notes (Explain if answered No to any of the above) Cracks in pad, one bolt seared off in manhole

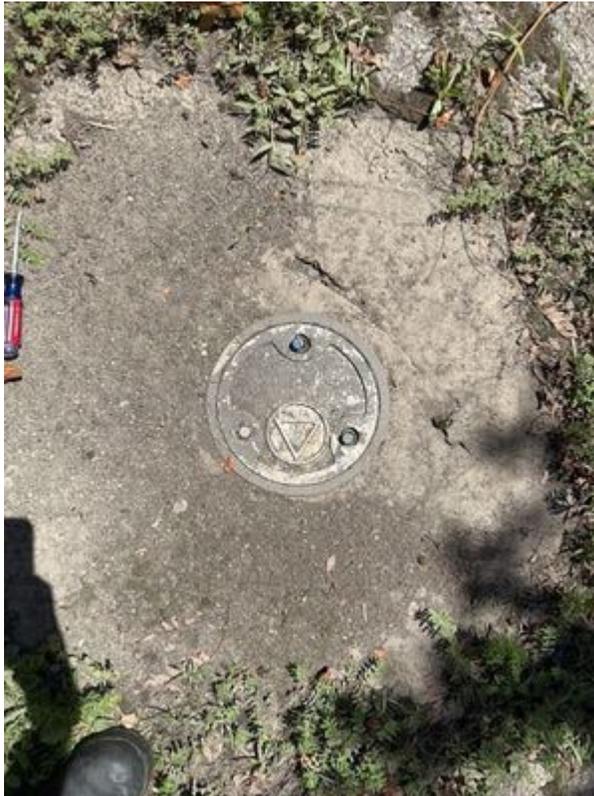
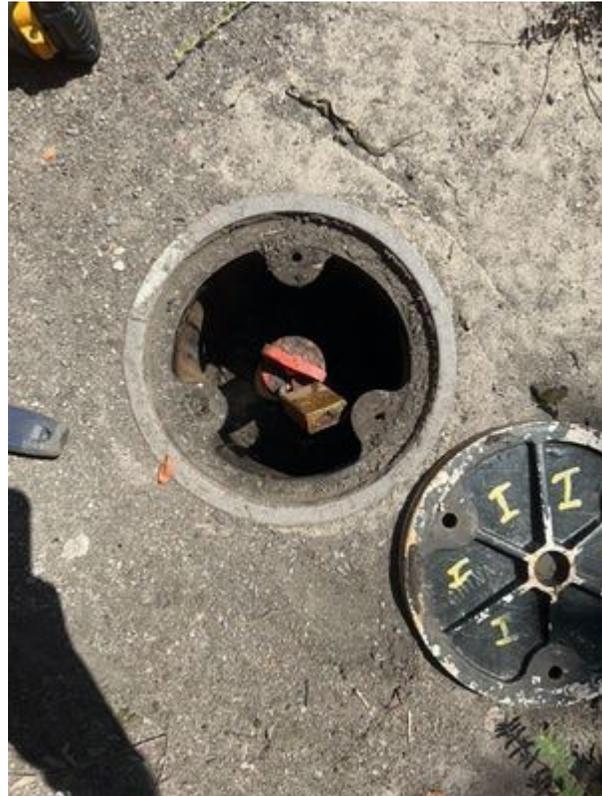
Client: Navy CLEAN	Facility: NWIRP Bethpage
Project Number: 112G08005-WE13	Location: Bethpage, New York
Date: July 19, 2024 11:42	Personnel: Jake Marlow
Well ID: BPS1-TT-MW3071	Well Location: 213357.2278784 1124918.43669659
Well Status: In Use (Confirmed)	Screen Interval: 188-198
WELL INVENTORY CONDITION	
Concrete pad in acceptable condition i.e. no cracks?	YES
Manhole cover present and in working condition?	YES
All bolts on manhole present and not stripped?	YES
Well plug present, locked and in good working condition?	YES
OVERALL CONDITION:	GOOD
Notes (Explain if answered No to any of the above)

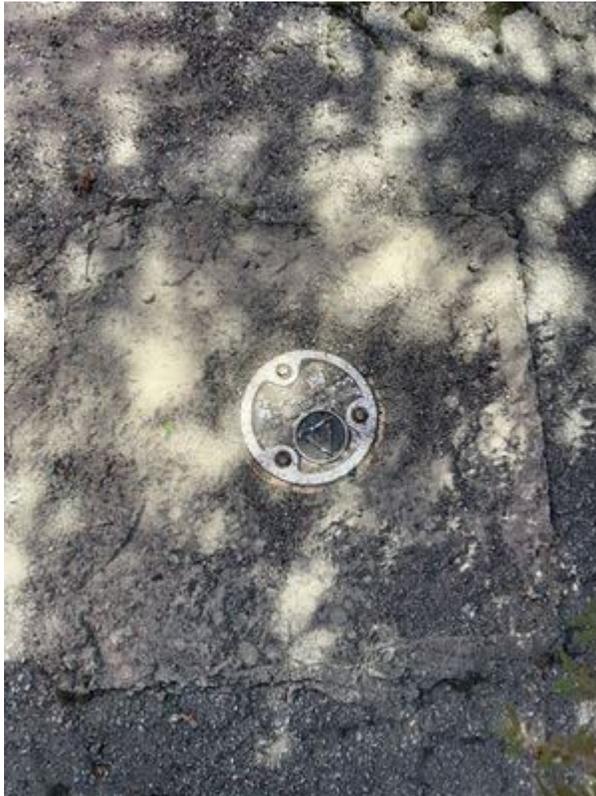
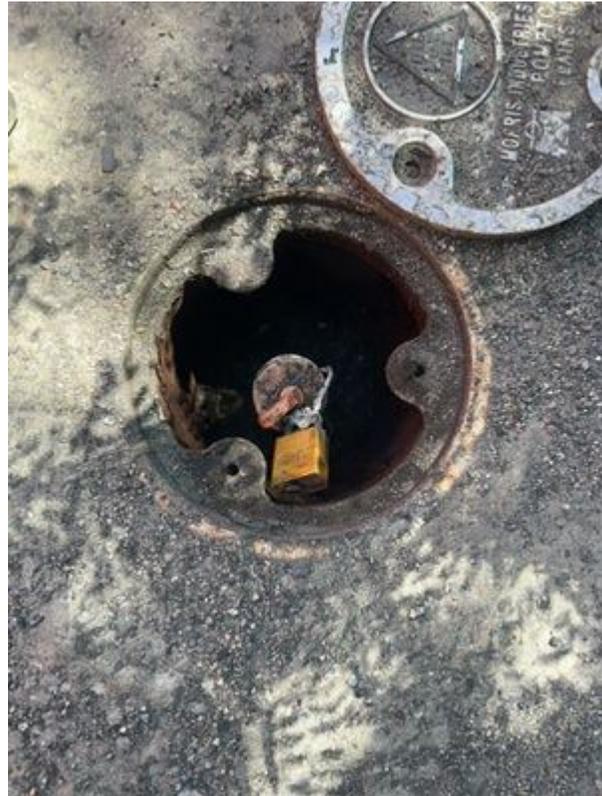
Client: Navy CLEAN	Facility: NWIRP Bethpage
Project Number: 112G08005-WE13	Location: Bethpage, New York
Date: July 19, 2024 11:39	Personnel: Jake Marlow
Well ID: BPS1-TT-MW307S	Well Location: 213361.572717347 1124903.93309059
Well Status: In Use (Confirmed)	Screen Interval: 40.5-50.5
WELL INVENTORY CONDITION	
Concrete pad in acceptable condition i.e. no cracks?	YES
Manhole cover present and in working condition?	YES
All bolts on manhole present and not stripped?	YES
Well plug present, locked and in good working condition?	YES
OVERALL CONDITION:	GOOD
Notes (Explain if answered No to any of the above)

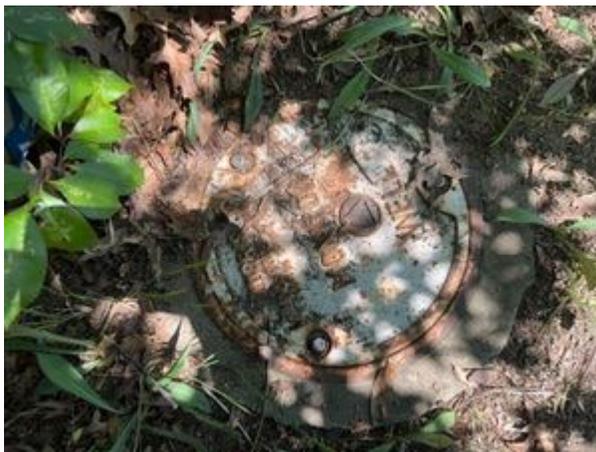
Client: Navy CLEAN	Facility: NWIRP Bethpage
Project Number: 112G08005-WE13	Location: Bethpage, New York
Date: July 19, 2024 11:20	Personnel: Jake Marlow
Well ID: GM38-RW1-MW3	Well Location: 206547.576946869 1130007.43985835
Well Status: In Use (Confirmed)	Screen Interval: 395-435
WELL INVENTORY CONDITION	
Concrete pad in acceptable condition i.e. no cracks?	YES
Manhole cover present and in working condition?	YES
All bolts on manhole present and not stripped?	YES
Well plug present, locked and in good working condition?	YES
OVERALL CONDITION:	GOOD
Notes (Explain if answered No to any of the above)

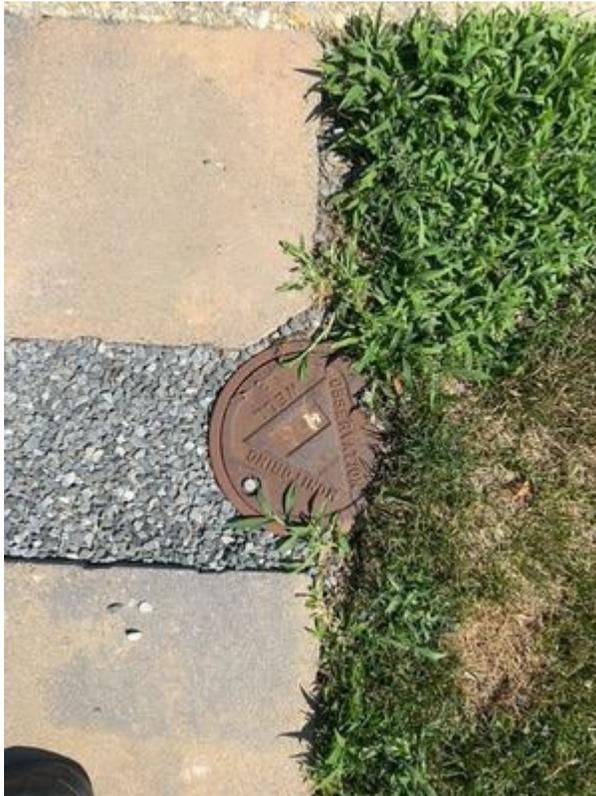
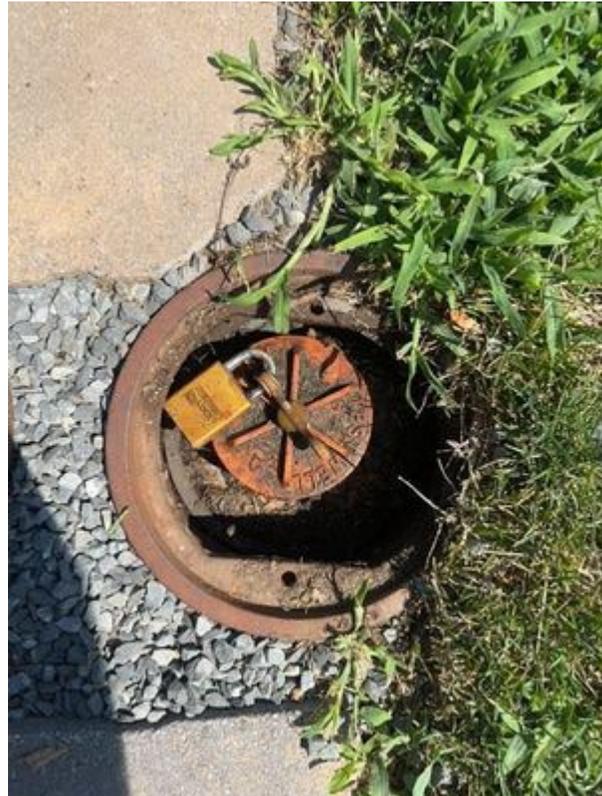
Client: Navy CLEAN	Facility: NWIRP Bethpage
Project Number: 112G08005-WE13	Location: Bethpage, New York
Date: July 19, 2024 10:58	Personnel: Jake Marlow
Well ID: BPHNMW42E	Well Location: 213790.027434996 1126052.10688273
Well Status: In Use (Confirmed)	Screen Interval: 50-60
WELL INVENTORY CONDITION	
Concrete pad in acceptable condition i.e. no cracks?	YES
Manhole cover present and in working condition?	NO
All bolts on manhole present and not stripped?	YES
Well plug present, locked and in good working condition?	YES
OVERALL CONDITION:	FAIR
Notes (Explain if answered No to any of the above) Threads where bolts attach to manhole are stripped
