Memorandum

To: Scott Sokolowski, NAVFAC MIDLANT
From: Richard Moore, Tetra Tech
Date: September 27, 2024
Re: Annual LUC Inspection and Operation Summary Report: Sites 1, 2, 3, and 4 –
NWIRP Bethpage
Contract/CTO Number: N6247016D9008/WE16

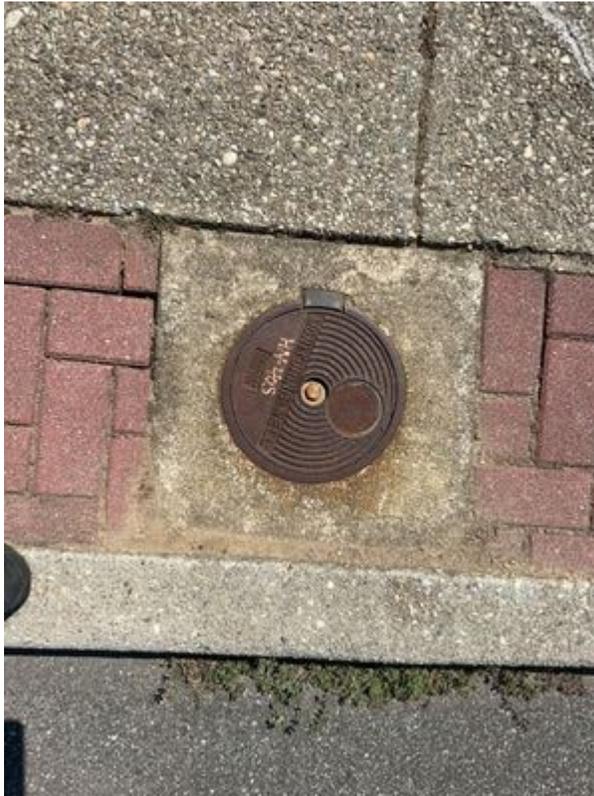
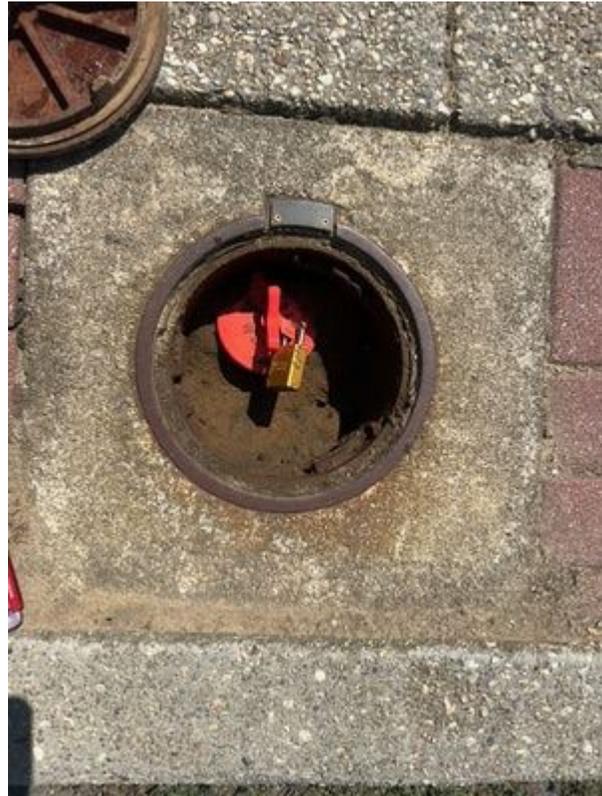
Client: Navy CLEAN	Facility: NWIRP Bethpage
Project Number: 112G08005-WE13	Location: Bethpage, New York
Date: July 19, 2024 10:53	Personnel: Jake Marlow
Well ID: BPHNMW40S	Well Location: 212384.984688246 1126001.30344932
Well Status: In Use (Confirmed)	Screen Interval: 49-59
WELL INVENTORY CONDITION	
Concrete pad in acceptable condition i.e. no cracks?	YES
Manhole cover present and in working condition?	YES
All bolts on manhole present and not stripped?	YES
Well plug present, locked and in good working condition?	YES
OVERALL CONDITION:	GOOD
Notes (Explain if answered No to any of the above)

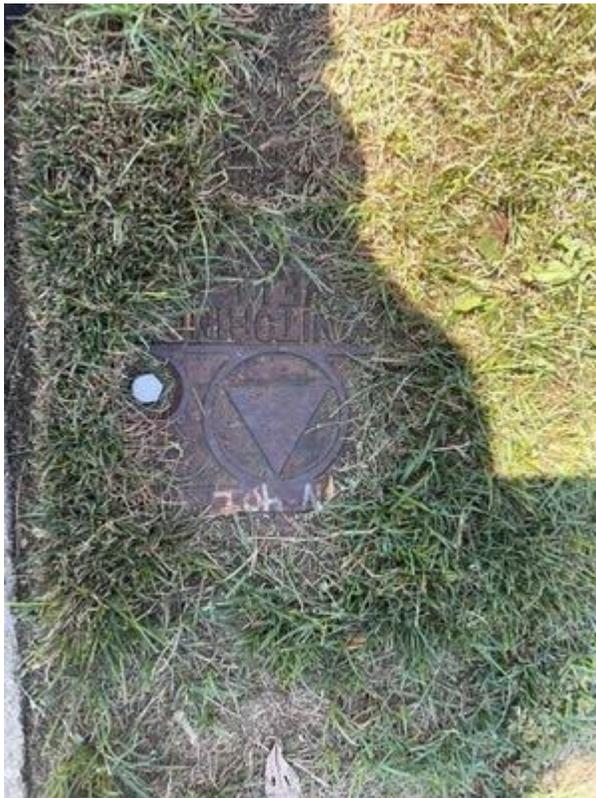
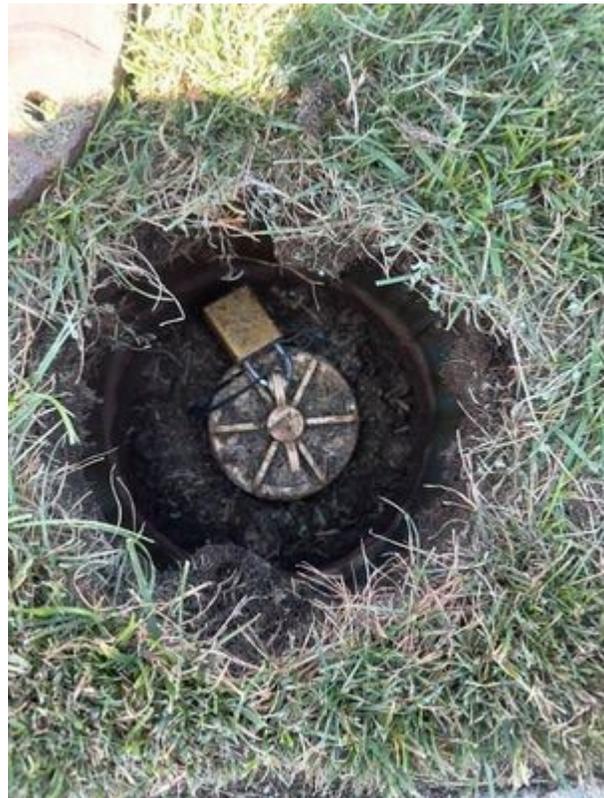
Client: Navy CLEAN	Facility: NWIRP Bethpage
Project Number: 112G08005-WE13	Location: Bethpage, New York
Date: July 19, 2024 10:50	Personnel: Jake Marlow
Well ID: BPHNMW40I	Well Location: 212420.345334125 1125996.52699535
Well Status: In Use (Confirmed)	Screen Interval: 108-118
WELL INVENTORY CONDITION	
Concrete pad in acceptable condition i.e. no cracks?	YES
Manhole cover present and in working condition?	NO
All bolts on manhole present and not stripped?	YES
Well plug present, locked and in good working condition?	YES
OVERALL CONDITION:	FAIR
Notes (Explain if answered No to any of the above) Threads on manhole where bolts go are stripped

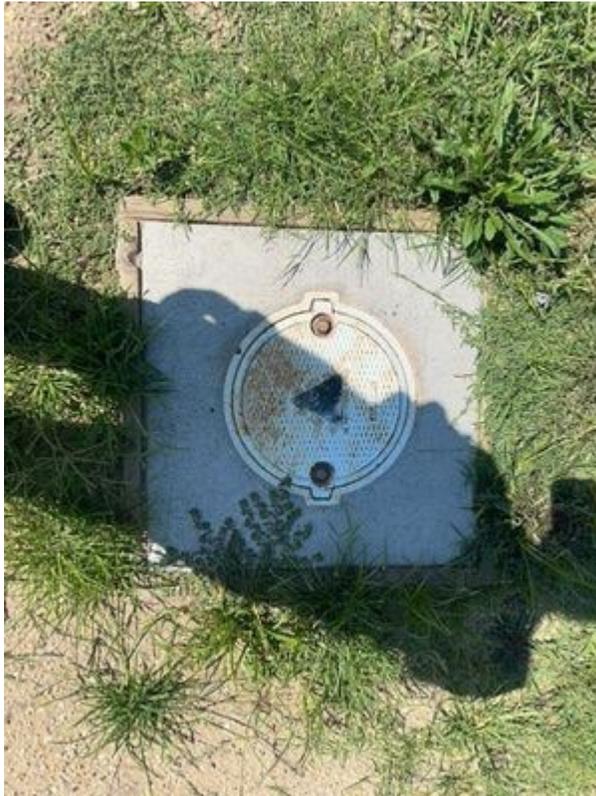
Client: Navy CLEAN	Facility: NWIRP Bethpage
Project Number: 112G08005-WE13	Location: Bethpage, New York
Date: July 19, 2024 10:28	Personnel: Jake Marlow
Well ID: RW4	Well Location: 206445.521258675 1125191.86860252
Well Status: In Use (Confirmed)	Screen Interval: 570-670
WELL INVENTORY CONDITION	
Concrete pad in acceptable condition i.e. no cracks?	YES
Manhole cover present and in working condition?	YES
All bolts on manhole present and not stripped?	YES
Well plug present, locked and in good working condition?	YES
OVERALL CONDITION:	GOOD
Notes (Explain if answered No to any of the above)

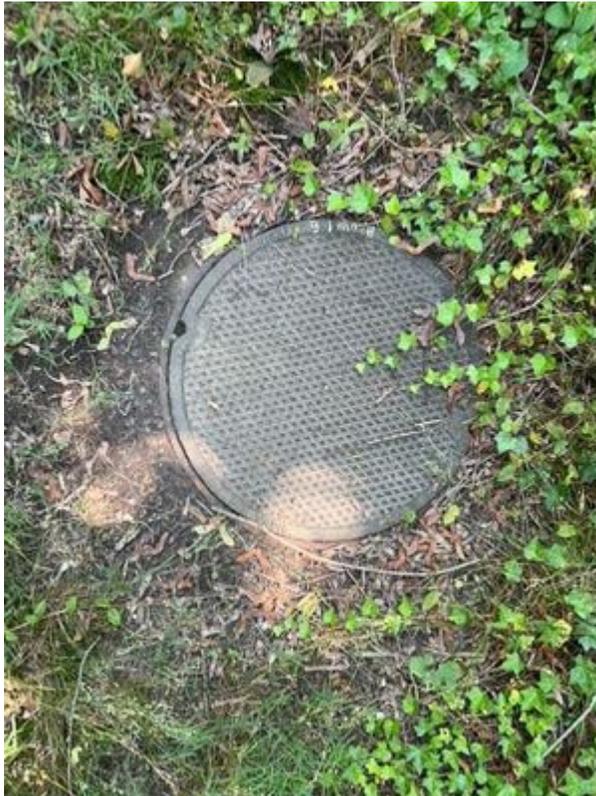
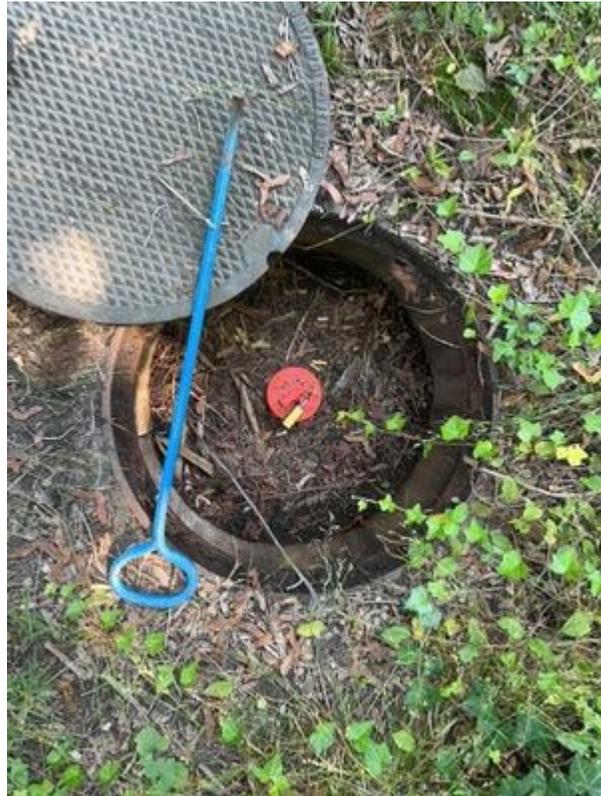
Client: Navy CLEAN	Facility: NWIRP Bethpage
Project Number: 112G08005-WE13	Location: Bethpage, New York
Date: July 19, 2024 10:14	Personnel: Jake Marlow
Well ID: BPOW1-6	Well Location: 203300.285789316 1132145.35545938
Well Status: In Use (Confirmed)	Screen Interval: 700-750
WELL INVENTORY CONDITION	
Concrete pad in acceptable condition i.e. no cracks?	YES
Manhole cover present and in working condition?	YES
All bolts on manhole present and not stripped?	YES
Well plug present, locked and in good working condition?	YES
OVERALL CONDITION:	GOOD
Notes (Explain if answered No to any of the above)

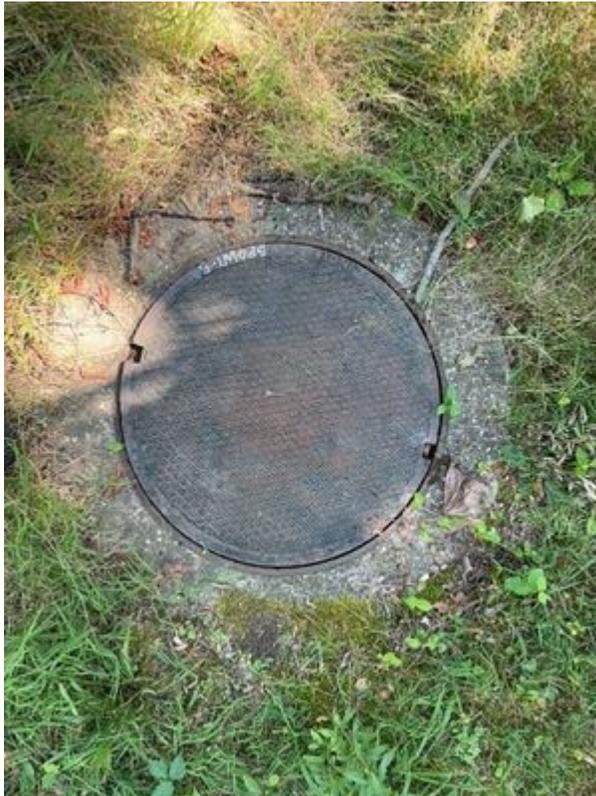
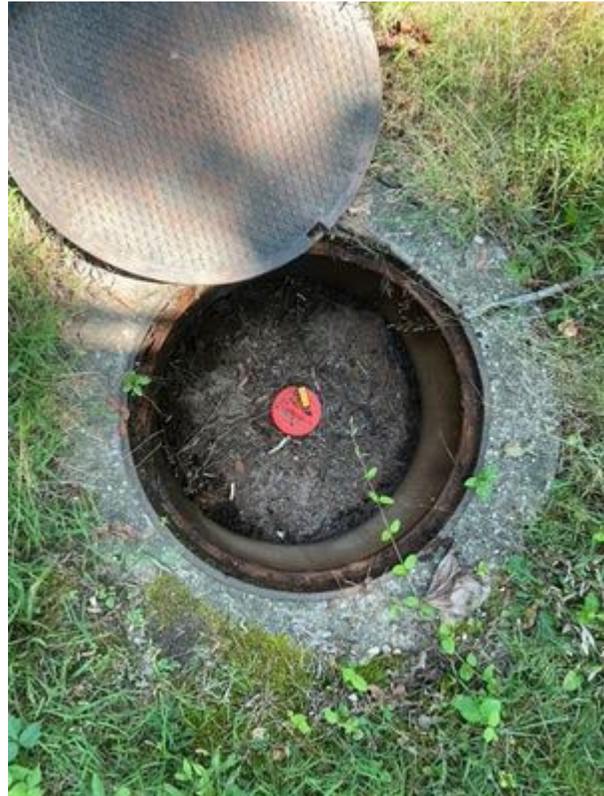
Client: Navy CLEAN	Facility: NWIRP Bethpage
Project Number: 112G08005-WE13	Location: Bethpage, New York
Date: July 19, 2024 10:13	Personnel: Jake Marlow
Well ID: BPOW1-5	Well Location: 203314.823590984 1132138.47745983
Well Status: In Use (Confirmed)	Screen Interval: 600-650
WELL INVENTORY CONDITION	
Concrete pad in acceptable condition i.e. no cracks?	YES
Manhole cover present and in working condition?	YES
All bolts on manhole present and not stripped?	YES
Well plug present, locked and in good working condition?	YES
OVERALL CONDITION:	GOOD
Notes (Explain if answered No to any of the above)

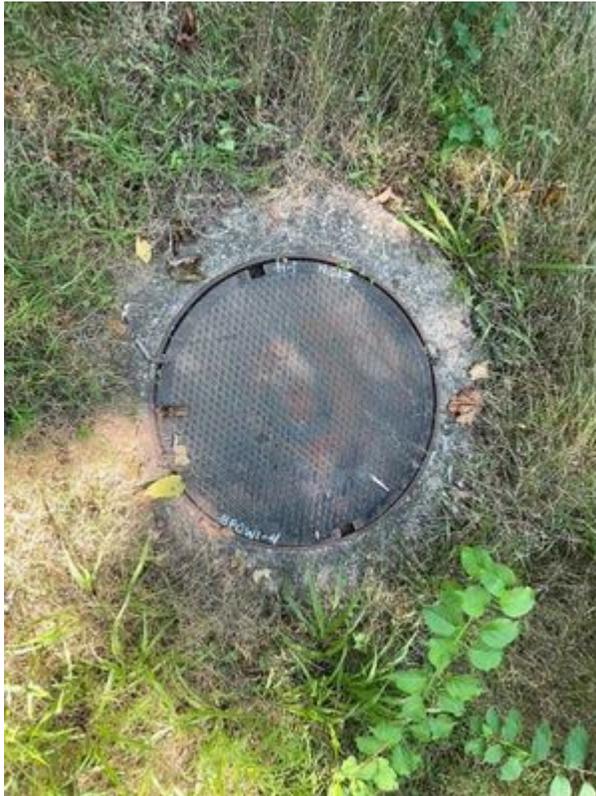
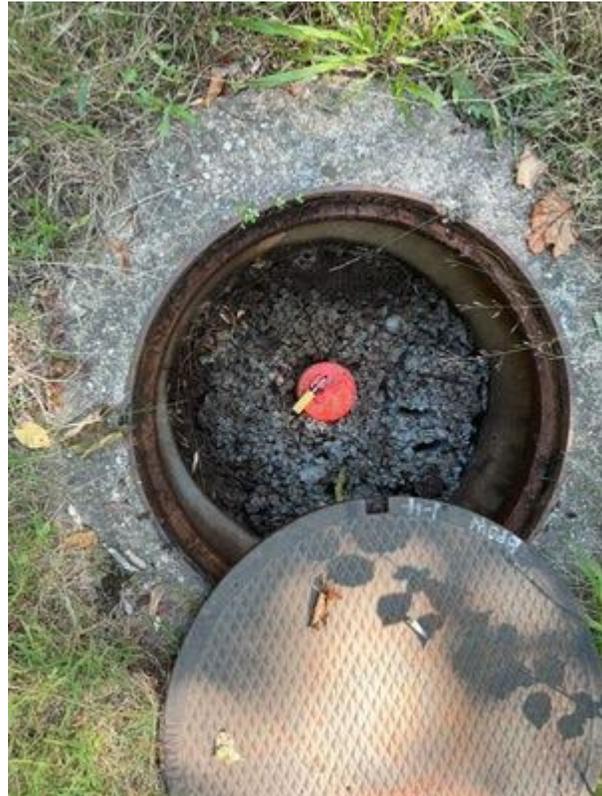
Client: Navy CLEAN	Facility: NWIRP Bethpage
Project Number: 112G08005-WE13	Location: Bethpage, New York
Date: July 19, 2024 10:08	Personnel: Jake Marlow
Well ID: BPOW1-4	Well Location: 203327.252593576 1132133.63079557
Well Status: In Use (Confirmed)	Screen Interval: 340-400
WELL INVENTORY CONDITION	
Concrete pad in acceptable condition i.e. no cracks?	YES
Manhole cover present and in working condition?	YES
All bolts on manhole present and not stripped?	YES
Well plug present, locked and in good working condition?	YES
OVERALL CONDITION:	GOOD
Notes (Explain if answered No to any of the above)

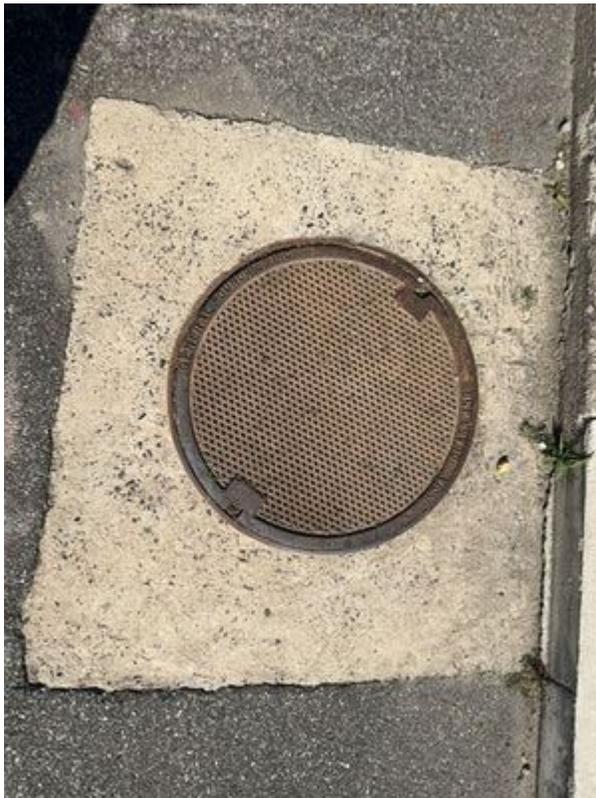
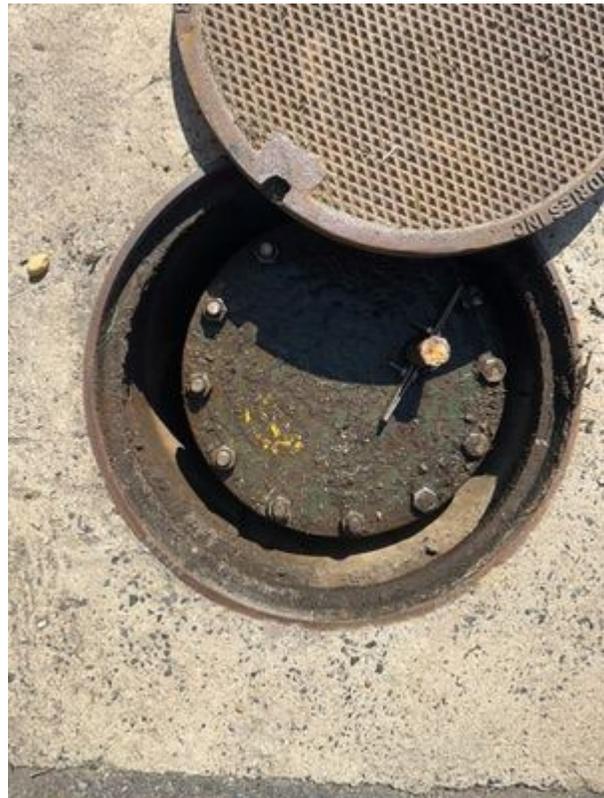
Client: Navy CLEAN	Facility: NWIRP Bethpage
Project Number: 112G08005-WE13	Location: Bethpage, New York
Date: July 19, 2024 09:51	Personnel: Jake Marlow
Well ID: RW6A	Well Location: 201984.350021087 1127022.07782932
Well Status: In Use (Confirmed)	Screen Interval:
WELL INVENTORY CONDITION	
Concrete pad in acceptable condition i.e. no cracks?	YES
Manhole cover present and in working condition?	YES
All bolts on manhole present and not stripped?	YES
Well plug present, locked and in good working condition?	YES
OVERALL CONDITION:	GOOD
Notes (Explain if answered No to any of the above)

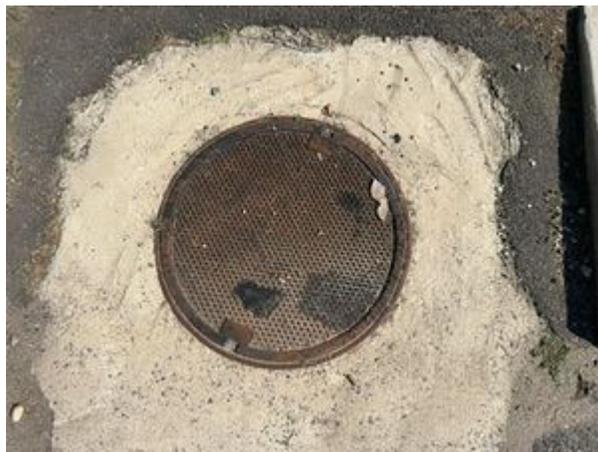
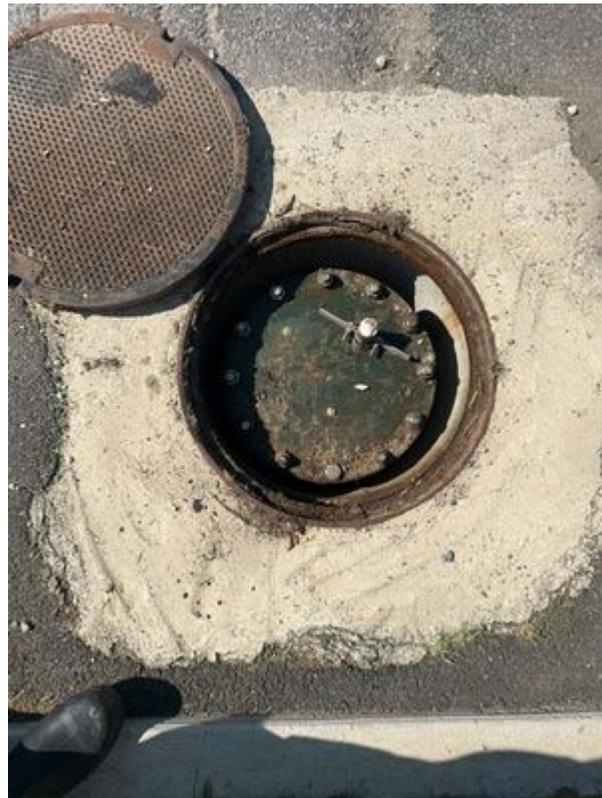
Client: Navy CLEAN	Facility: NWIRP Bethpage
Project Number: 112G08005-WE13	Location: Bethpage, New York
Date: July 19, 2024 09:47	Personnel: Jake Marlow
Well ID: RW6B	Well Location: 201989.276486196 1126940.92773973
Well Status: In Use (Confirmed)	Screen Interval:
WELL INVENTORY CONDITION	
Concrete pad in acceptable condition i.e. no cracks?	YES
Manhole cover present and in working condition?	YES
All bolts on manhole present and not stripped?	YES
Well plug present, locked and in good working condition?	YES
OVERALL CONDITION:	GOOD
Notes (Explain if answered No to any of the above)

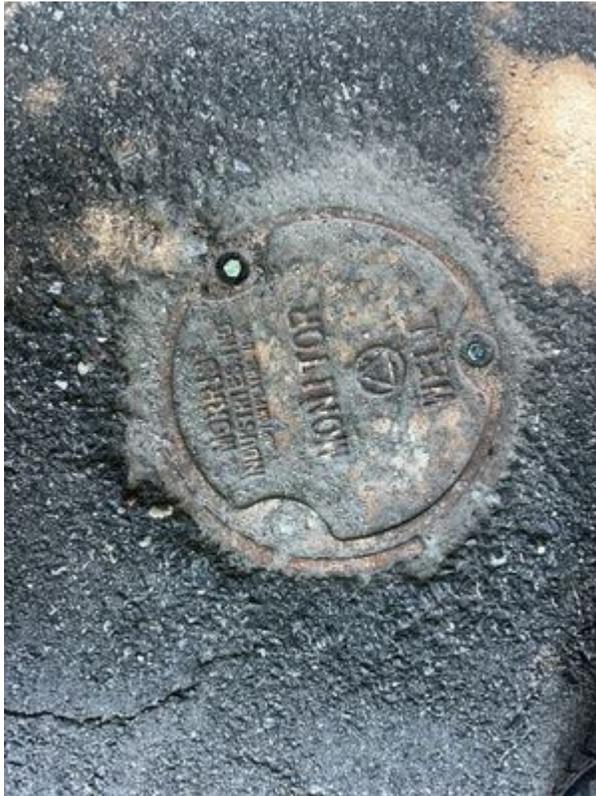
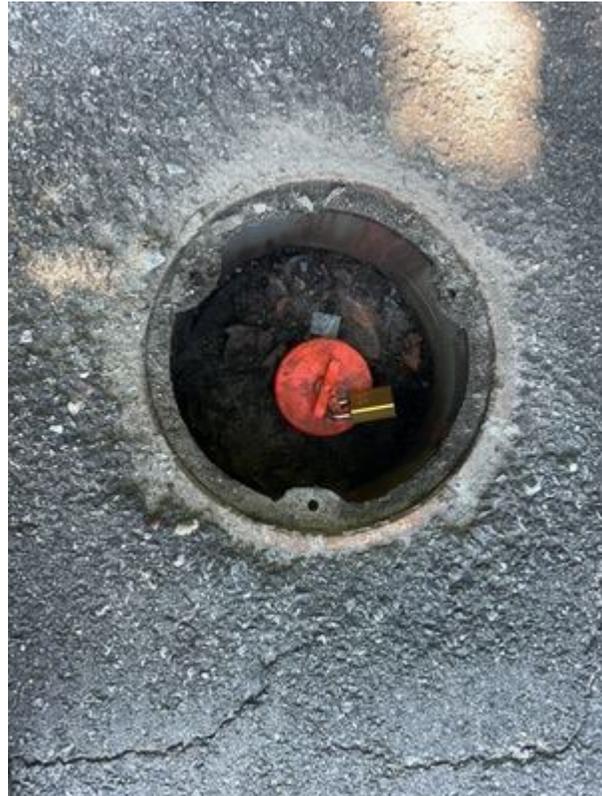
Client: Navy CLEAN	Facility: NWIRP Bethpage
Project Number: 112G08005-WE13	Location: Bethpage, New York
Date: July 19, 2024 09:38	Personnel: Jake Marlow
Well ID: BPOW5-3	Well Location: 198394.445971971 1127159.46223025
Well Status: In Use (Confirmed)	Screen Interval: 620-660
WELL INVENTORY CONDITION	
Concrete pad in acceptable condition i.e. no cracks?	YES
Manhole cover present and in working condition?	NO
All bolts on manhole present and not stripped?	YES
Well plug present, locked and in good working condition?	YES
OVERALL CONDITION:	FAIR
Notes (Explain if answered No to any of the above) Threads where bolts attach to manhole are stripped

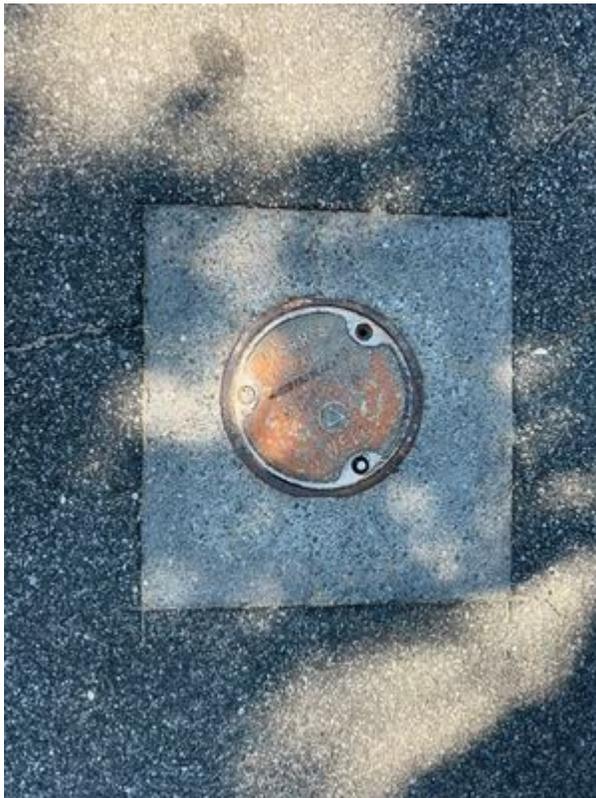
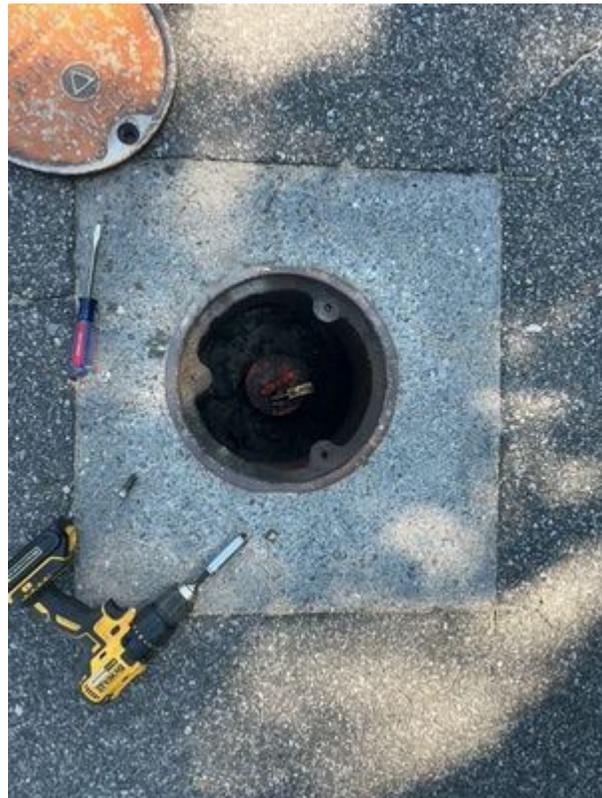
Client: Navy CLEAN	Facility: NWIRP Bethpage
Project Number: 112G08005-WE13	Location: Bethpage, New York
Date: July 19, 2024 09:35	Personnel: Jake Marlow
Well ID: BPOW5-1	Well Location: 198404.72823099 1127144.3471213
Well Status: In Use (Confirmed)	Screen Interval: 480-510
WELL INVENTORY CONDITION	
Concrete pad in acceptable condition i.e. no cracks?	YES
Manhole cover present and in working condition?	YES
All bolts on manhole present and not stripped?	NO
Well plug present, locked and in good working condition?	YES
OVERALL CONDITION:	FAIR
Notes (Explain if answered No to any of the above) Bolts sheared off in manhole

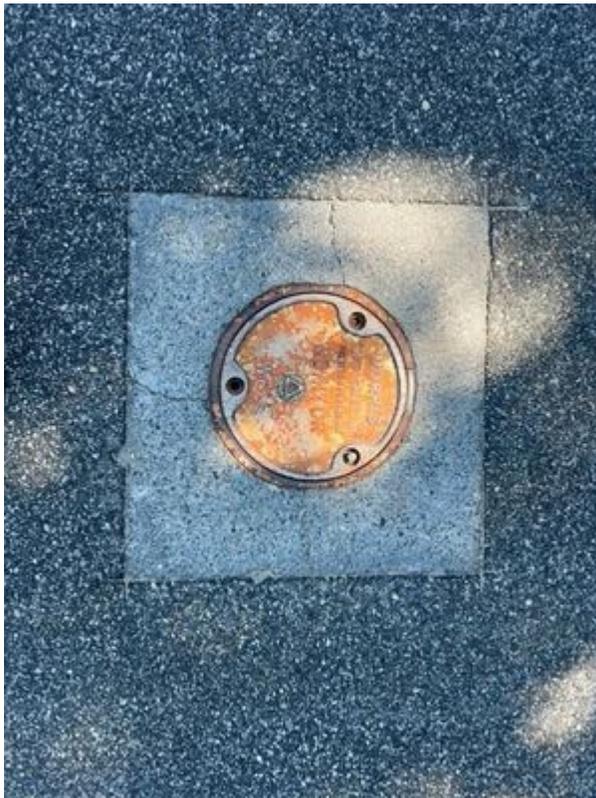
Client: Navy CLEAN	Facility: NWIRP Bethpage
Project Number: 112G08005-WE13	Location: Bethpage, New York
Date: July 19, 2024 09:32	Personnel: Jake Marlow
Well ID: BPOW5-2	Well Location: 198410.124010887 1127154.18468571
Well Status: In Use (Confirmed)	Screen Interval: 540-580
WELL INVENTORY CONDITION	
Concrete pad in acceptable condition i.e. no cracks?	NO
Manhole cover present and in working condition?	YES
All bolts on manhole present and not stripped?	NO
Well plug present, locked and in good working condition?	YES
OVERALL CONDITION:	FAIR
Notes (Explain if answered No to any of the above) Cracks in pad, bolts sheared off in manhole

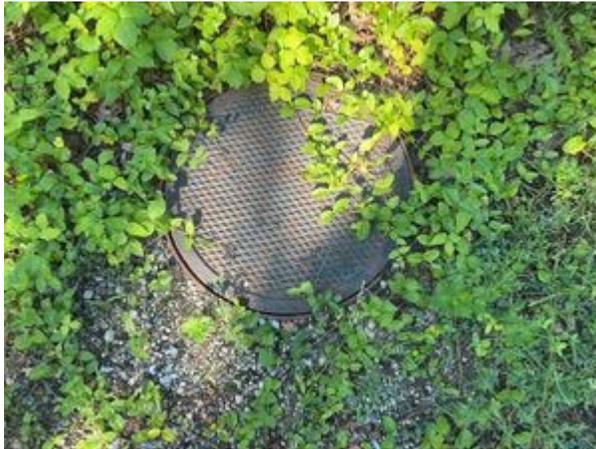
Client: Navy CLEAN	Facility: NWIRP Bethpage
Project Number: 112G08005-WE13	Location: Bethpage, New York
Date: July 19, 2024 09:16	Personnel: Jake Marlow
Well ID: TT102D2	Well Location: 195343.800684829 1127135.82049346
Well Status: In Use (Confirmed)	Screen Interval: 740-770
WELL INVENTORY CONDITION	
Concrete pad in acceptable condition i.e. no cracks?	YES
Manhole cover present and in working condition?	YES
All bolts on manhole present and not stripped?	YES
Well plug present, locked and in good working condition?	YES
OVERALL CONDITION:	GOOD
Notes (Explain if answered No to any of the above)

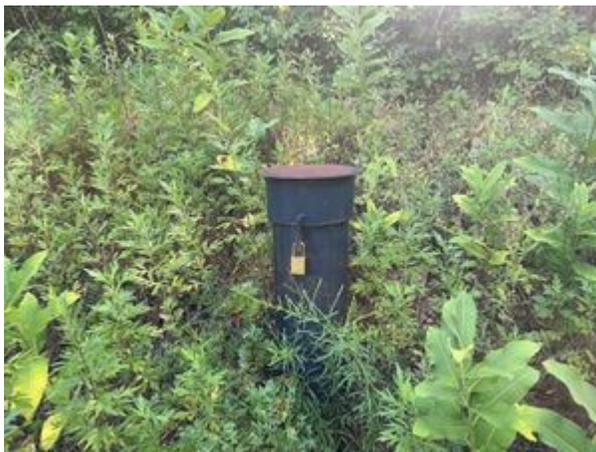
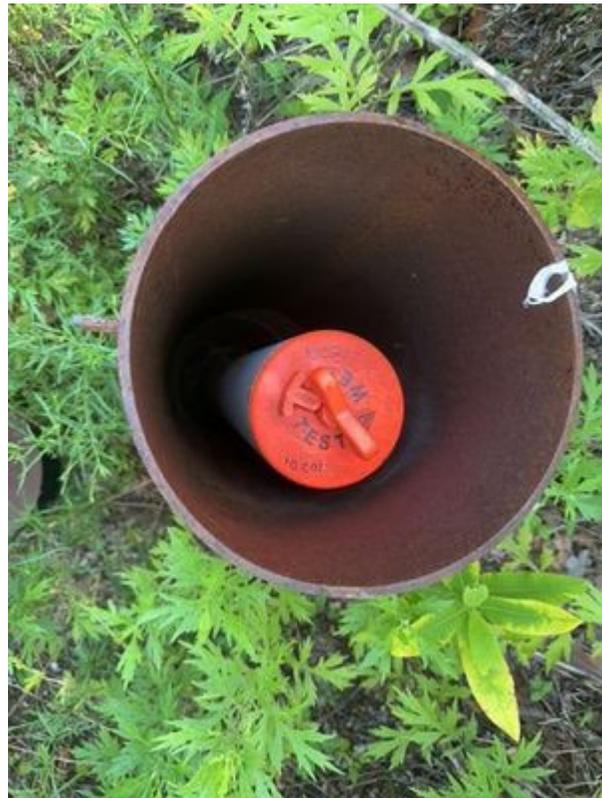
Client: Navy CLEAN	Facility: NWIRP Bethpage
Project Number: 112G08005-WE13	Location: Bethpage, New York
Date: July 19, 2024 09:14	Personnel: Jake Marlow
Well ID: TT102D1	Well Location: 195358.800740113 1127139.47023797
Well Status: In Use (Confirmed)	Screen Interval: 560-600
WELL INVENTORY CONDITION	
Concrete pad in acceptable condition i.e. no cracks?	YES
Manhole cover present and in working condition?	YES
All bolts on manhole present and not stripped?	YES
Well plug present, locked and in good working condition?	YES
OVERALL CONDITION:	GOOD
Notes (Explain if answered No to any of the above)

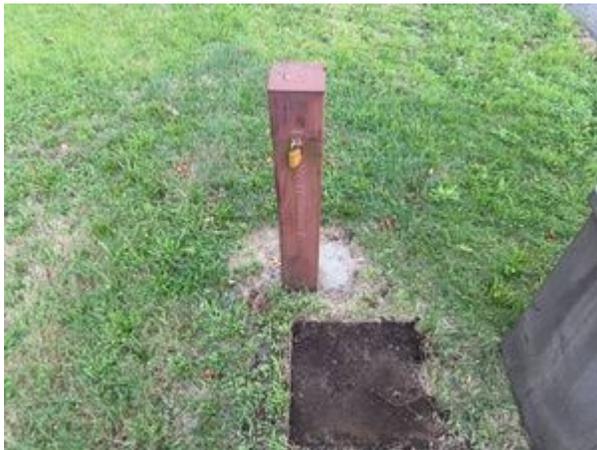
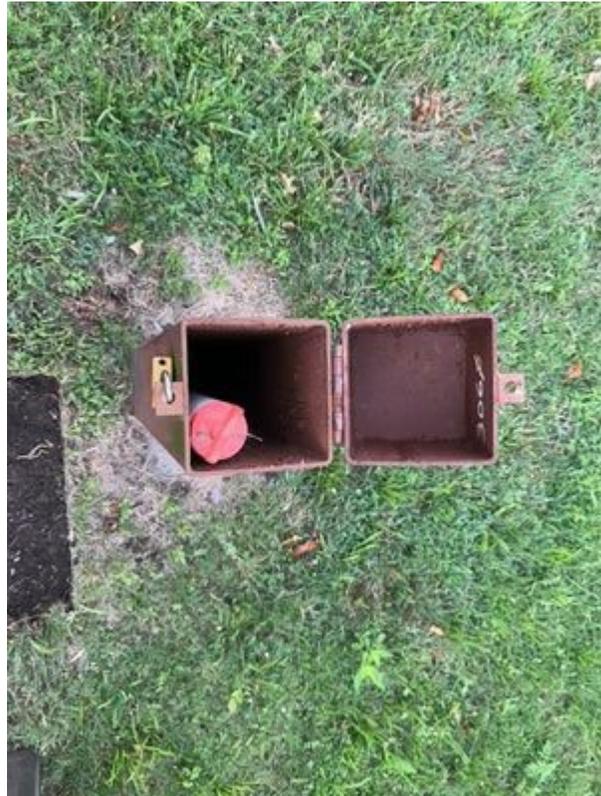
Client: Navy CLEAN	Facility: NWIRP Bethpage
Project Number: 112G08005-WE13	Location: Bethpage, New York
Date: July 18, 2024 16:45	Personnel: Jake Marlow
Well ID: BPS1-TT-MW306S	Well Location: 213380.855488704 1124389.14163271
Well Status: In Use (Confirmed)	Screen Interval: 50-60
WELL INVENTORY CONDITION	
Concrete pad in acceptable condition i.e. no cracks?	YES
Manhole cover present and in working condition?	YES
All bolts on manhole present and not stripped?	YES
Well plug present, locked and in good working condition?	YES
OVERALL CONDITION:	GOOD
Notes (Explain if answered No to any of the above)

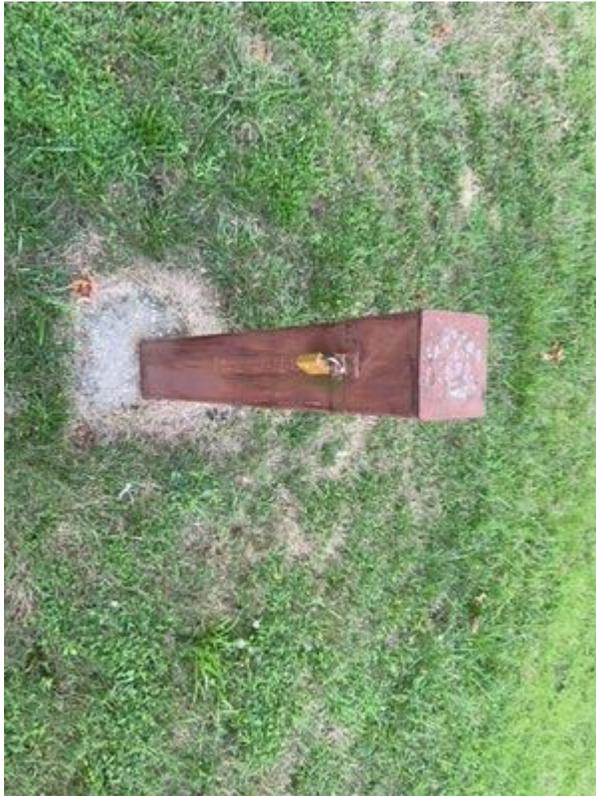
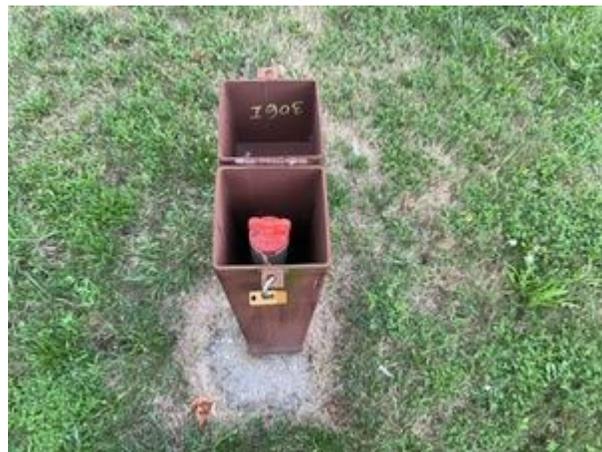
Client: Navy CLEAN	Facility: NWIRP Bethpage
Project Number: 112G08005-WE13	Location: Bethpage, New York
Date: July 18, 2024 16:44	Personnel: Jake Marlow
Well ID: BPS1-TT-MW306I	Well Location: 213378.515138964 1124400.52646802
Well Status: In Use (Confirmed)	Screen Interval: 189-199
WELL INVENTORY CONDITION	
Concrete pad in acceptable condition i.e. no cracks?	YES
Manhole cover present and in working condition?	YES
All bolts on manhole present and not stripped?	YES
Well plug present, locked and in good working condition?	YES
OVERALL CONDITION:	GOOD
Notes (Explain if answered No to any of the above)

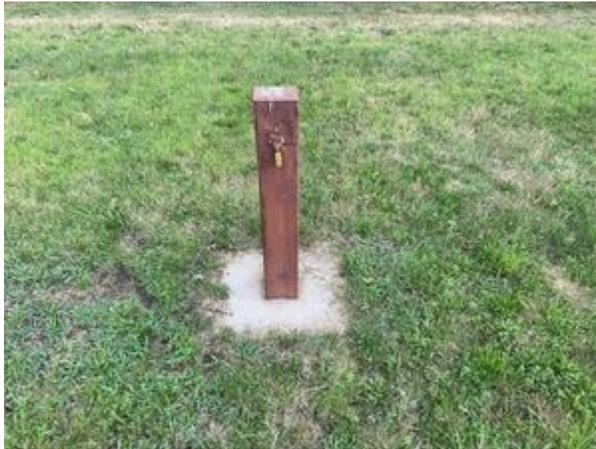
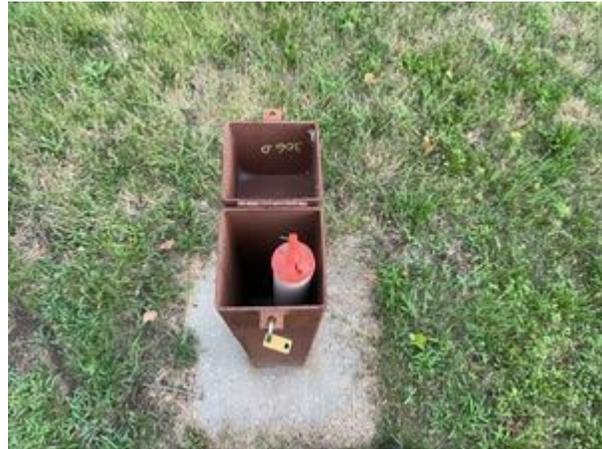
Client: Navy CLEAN	Facility: NWIRP Bethpage
Project Number: 112G08005-WE13	Location: Bethpage, New York
Date: July 18, 2024 16:42	Personnel: Jake Marlow
Well ID: BPS1-TT-MW306D	Well Location: 213381.050320401 1124414.36322241
Well Status: In Use (Confirmed)	Screen Interval: 284-294
WELL INVENTORY CONDITION	
Concrete pad in acceptable condition i.e. no cracks?	YES
Manhole cover present and in working condition?	YES
All bolts on manhole present and not stripped?	YES
Well plug present, locked and in good working condition?	YES
OVERALL CONDITION:	GOOD
Notes (Explain if answered No to any of the above)

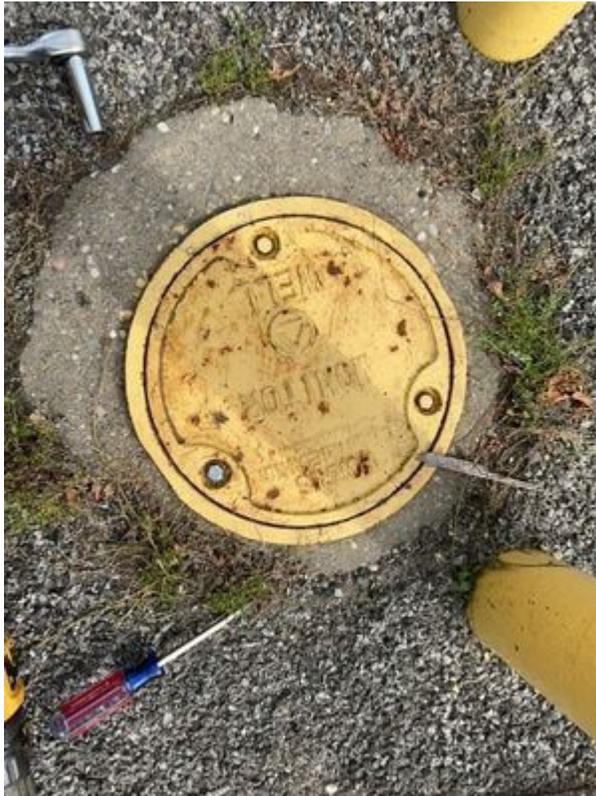
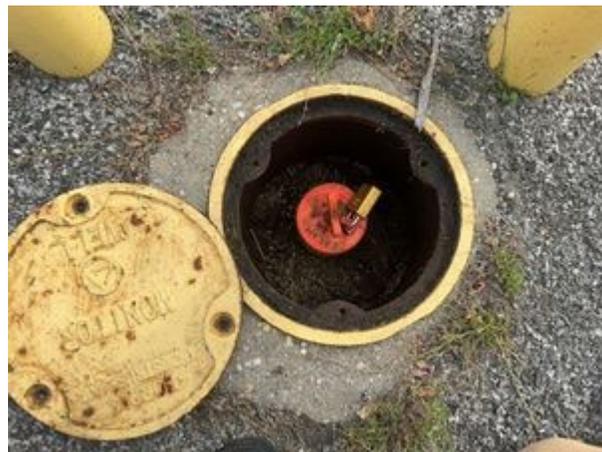
Client: Navy CLEAN	Facility: NWIRP Bethpage
Project Number: 112G08005-WE13	Location: Bethpage, New York
Date: July 18, 2024 16:36	Personnel: Jake Marlow
Well ID: BPHNMW24IR	Well Location: 214061.344236774 1123251.47081668
Well Status: In Use (Confirmed)	Screen Interval: 148-158
WELL INVENTORY CONDITION	
Concrete pad in acceptable condition i.e. no cracks?	YES
Manhole cover present and in working condition?	YES
All bolts on manhole present and not stripped?	YES
Well plug present, locked and in good working condition?	YES
OVERALL CONDITION:	GOOD
Notes (Explain if answered No to any of the above)

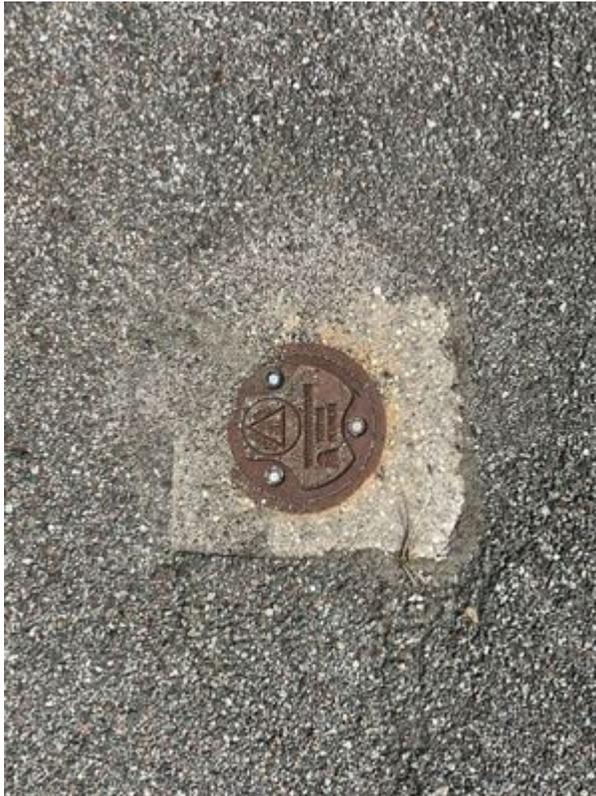
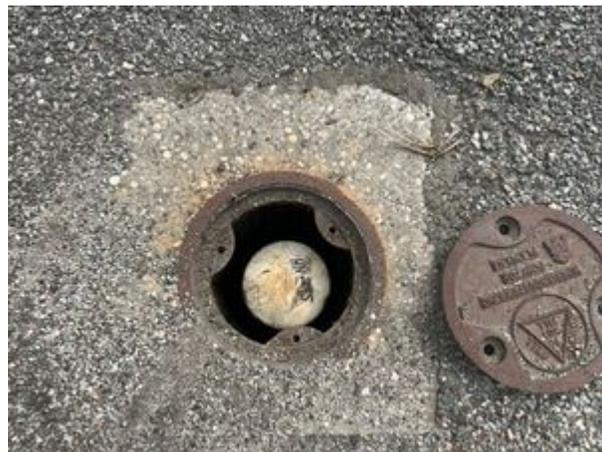
Client: Navy CLEAN	Facility: NWIRP Bethpage
Project Number: 112G08005-WE13	Location: Bethpage, New York
Date: July 18, 2024 16:34	Personnel: Jake Marlow
Well ID: BPHNMW24S	Well Location: 214053.916680239 1123262.38453252
Well Status: In Use (Confirmed)	Screen Interval: 48.6-58.6
WELL INVENTORY CONDITION	
Concrete pad in acceptable condition i.e. no cracks?	YES
Manhole cover present and in working condition?	YES
All bolts on manhole present and not stripped?	YES
Well plug present, locked and in good working condition?	YES
OVERALL CONDITION:	GOOD
Notes (Explain if answered No to any of the above)

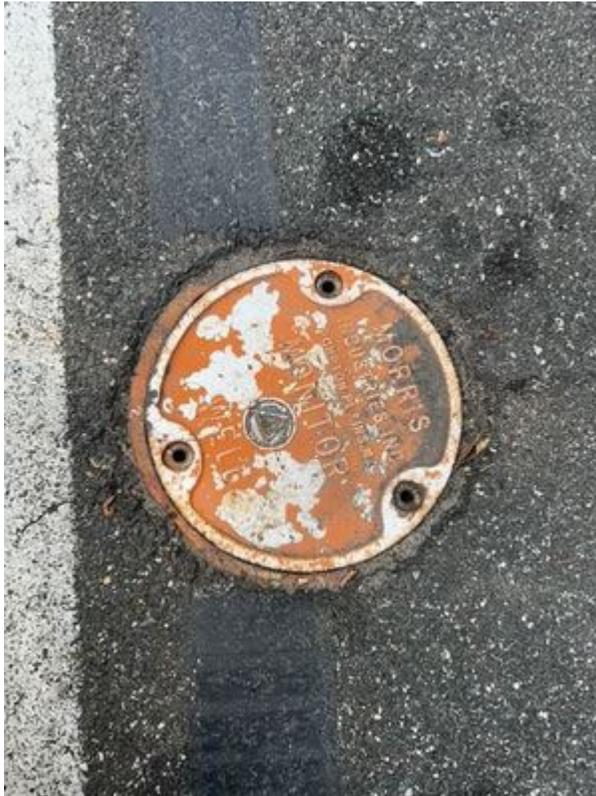
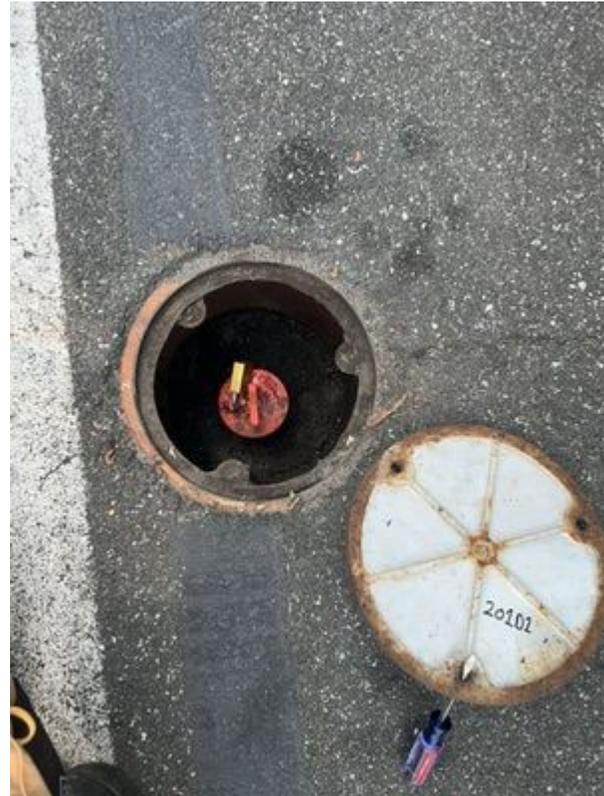
Client: Navy CLEAN	Facility: NWIRP Bethpage
Project Number: 112G08005-WE13	Location: Bethpage, New York
Date: July 18, 2024 16:28	Personnel: Jake Marlow
Well ID: BP-TT-MW201D1	Well Location: 214070.309412246 1123160.20301247
Well Status: In Use (Confirmed)	Screen Interval: 480-500
WELL INVENTORY CONDITION	
Concrete pad in acceptable condition i.e. no cracks?	YES
Manhole cover present and in working condition?	YES
All bolts on manhole present and not stripped?	NO
Well plug present, locked and in good working condition?	YES
OVERALL CONDITION:	FAIR
Notes (Explain if answered No to any of the above) Bolts sheared off in manhole

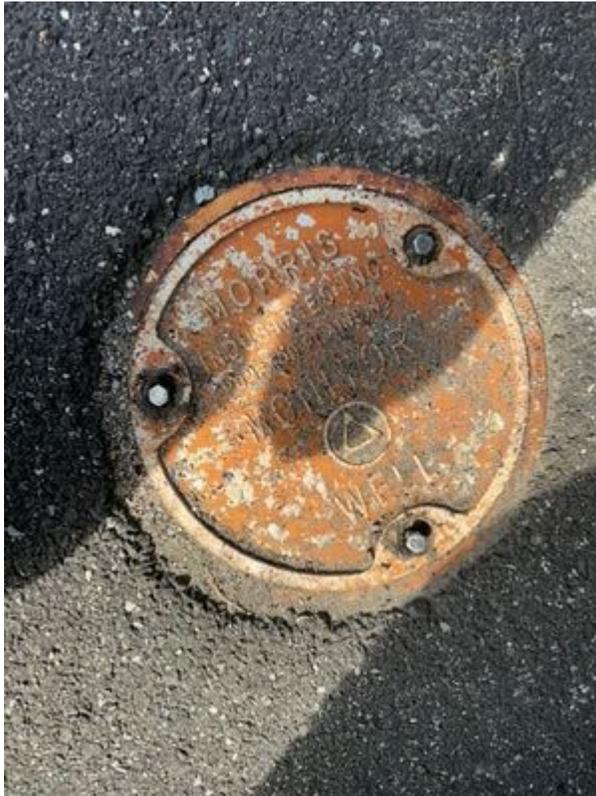
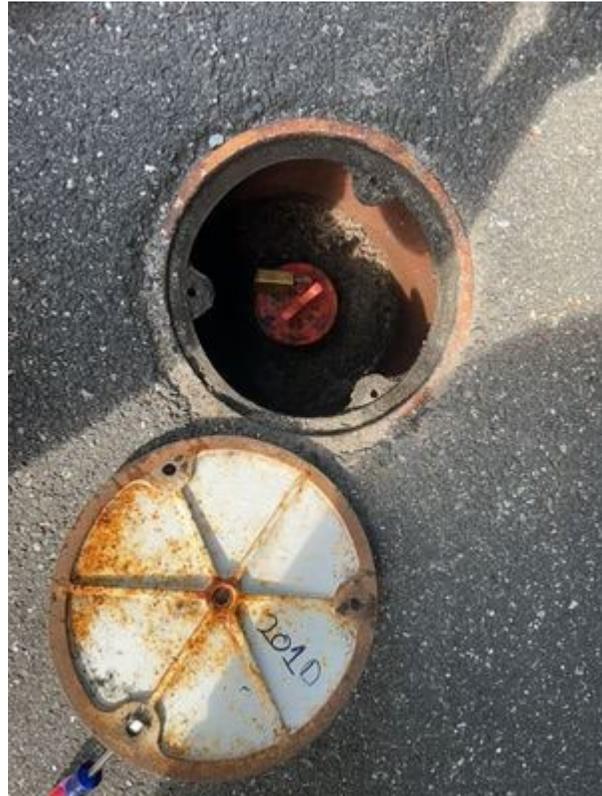
Client: Navy CLEAN	Facility: NWIRP Bethpage
Project Number: 112G08005-WE13	Location: Bethpage, New York
Date: July 18, 2024 16:21	Personnel: Jake Marlow
Well ID: BP-TT-MW201D	Well Location: 214082.600973821 1123120.83805253
Well Status: In Use (Confirmed)	Screen Interval: 335-350
WELL INVENTORY CONDITION	
Concrete pad in acceptable condition i.e. no cracks?	YES
Manhole cover present and in working condition?	YES
All bolts on manhole present and not stripped?	YES
Well plug present, locked and in good working condition?	YES
OVERALL CONDITION:	GOOD
Notes (Explain if answered No to any of the above)

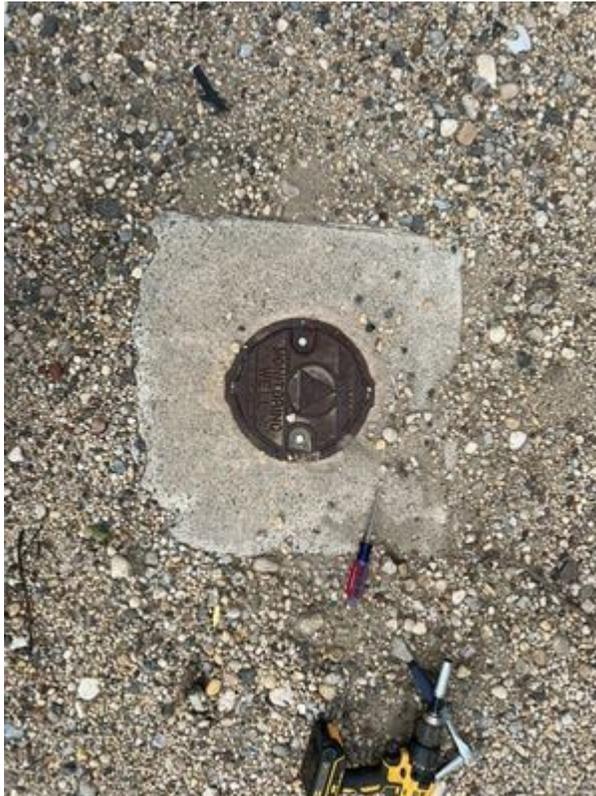
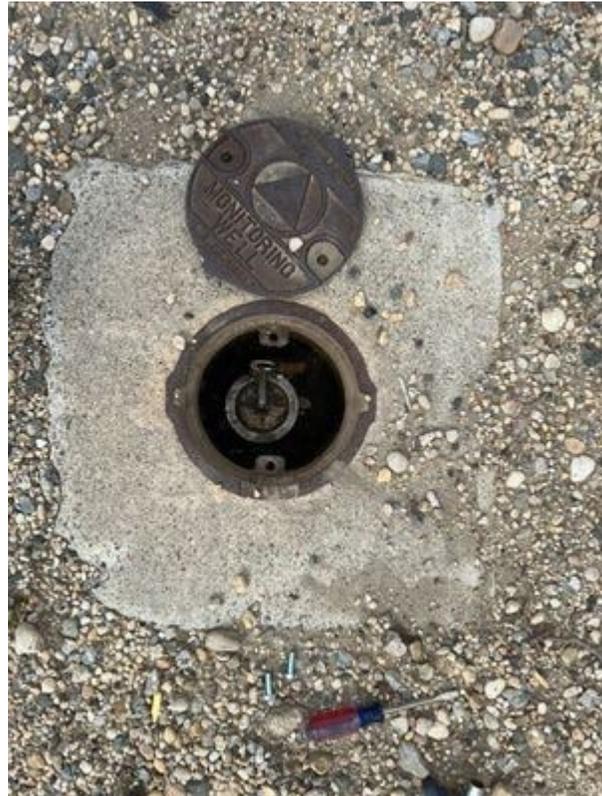
Client: Navy CLEAN	Facility: NWIRP Bethpage
Project Number: 112G08005-WE13	Location: Bethpage, New York
Date: July 18, 2024 16:12	Personnel: Jake Marlow
Well ID: BPGMMW17D	Well Location: 211396.053704106 1122842.04576608
Well Status: In Use (Confirmed)	Screen Interval: 278-298
WELL INVENTORY CONDITION	
Concrete pad in acceptable condition i.e. no cracks?	YES
Manhole cover present and in working condition?	YES
All bolts on manhole present and not stripped?	NO
Well plug present, locked and in good working condition?	YES
OVERALL CONDITION:	GOOD
Notes (Explain if answered No to any of the above) Threads are stripped where bolts go into manhole

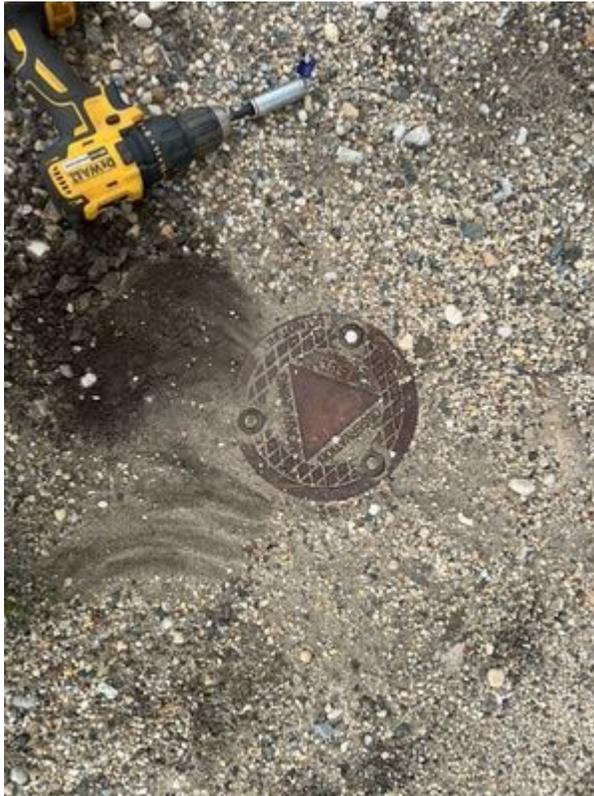
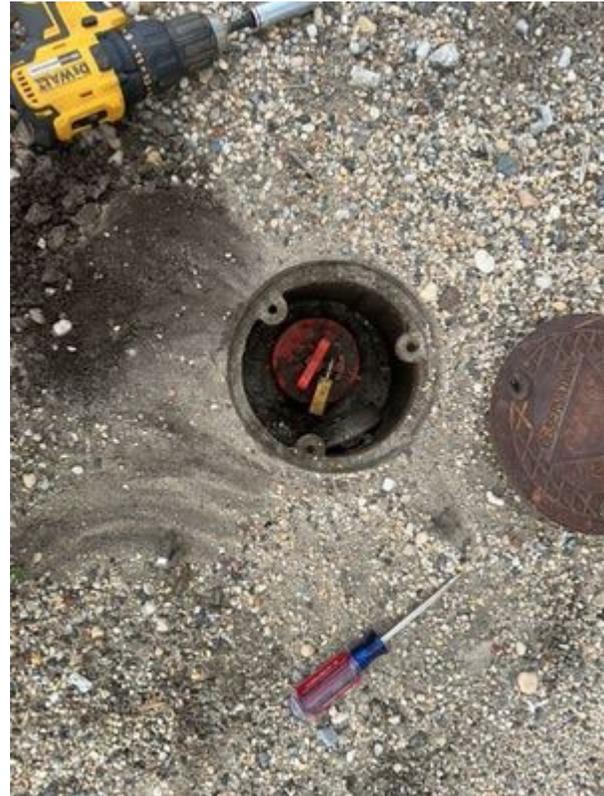
Client: Navy CLEAN	Facility: NWIRP Bethpage
Project Number: 112G08005-WE13	Location: Bethpage, New York
Date: July 18, 2024 16:09	Personnel: Jake Marlow
Well ID: GM-17SR	Well Location: 211383.35979424 1122842.42609968
Well Status: In Use (Confirmed)	Screen Interval:
WELL INVENTORY CONDITION	
Concrete pad in acceptable condition i.e. no cracks?	YES
Manhole cover present and in working condition?	YES
All bolts on manhole present and not stripped?	YES
Well plug present, locked and in good working condition?	YES
OVERALL CONDITION:	GOOD
Notes (Explain if answered No to any of the above)

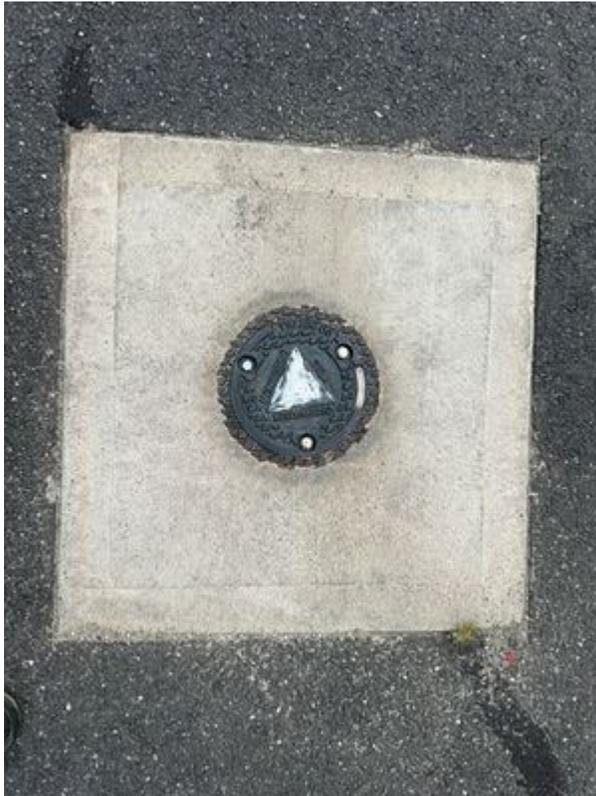
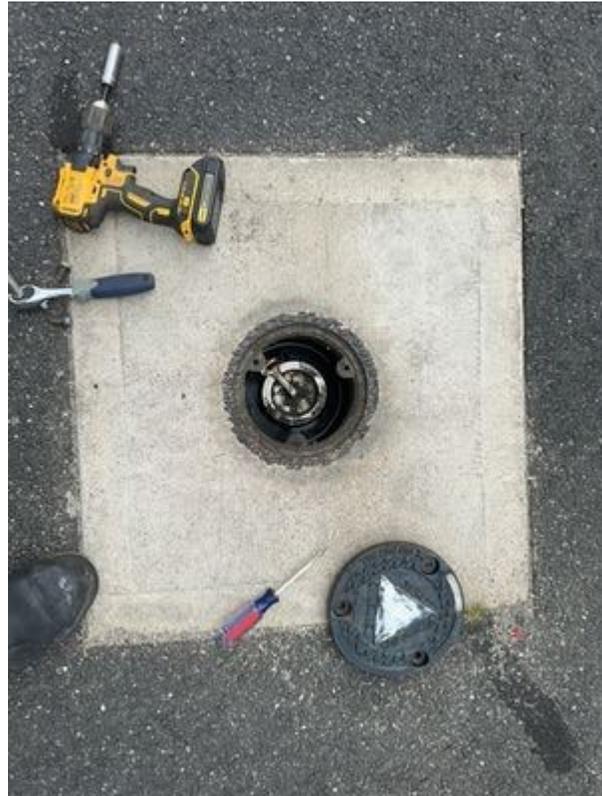
Client: Navy CLEAN	Facility: NWIRP Bethpage
Project Number: 112G08005-WE13	Location: Bethpage, New York
Date: July 18, 2024 16:02	Personnel: Jake Marlow
Well ID: PBGMMW39D2	Well Location: 209878.620637317 1124179.30908554
Well Status: In Use (Confirmed)	Screen Interval:
WELL INVENTORY CONDITION	
Concrete pad in acceptable condition i.e. no cracks?	YES
Manhole cover present and in working condition?	YES
All bolts on manhole present and not stripped?	YES
Well plug present, locked and in good working condition?	YES
OVERALL CONDITION:	GOOD
Notes (Explain if answered No to any of the above)
