Memorandum

To: Scott Sokolowski, NAVFAC MIDLANT
From: Richard Moore, Tetra Tech
Date: September 27, 2024
Re: Annual LUC Inspection and Operation Summary Report: Sites 1, 2, 3, and 4 –
NWIRP Bethpage
Contract/CTO Number: N6247016D9008/WE16

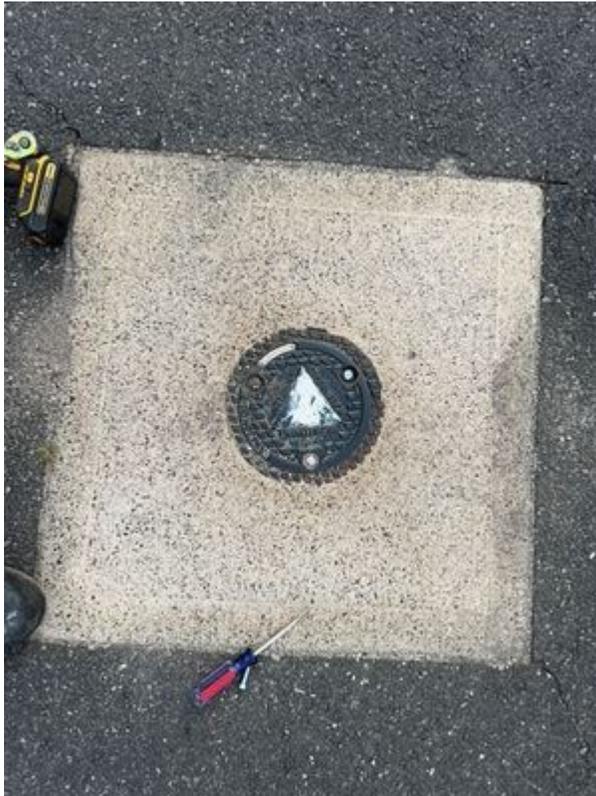
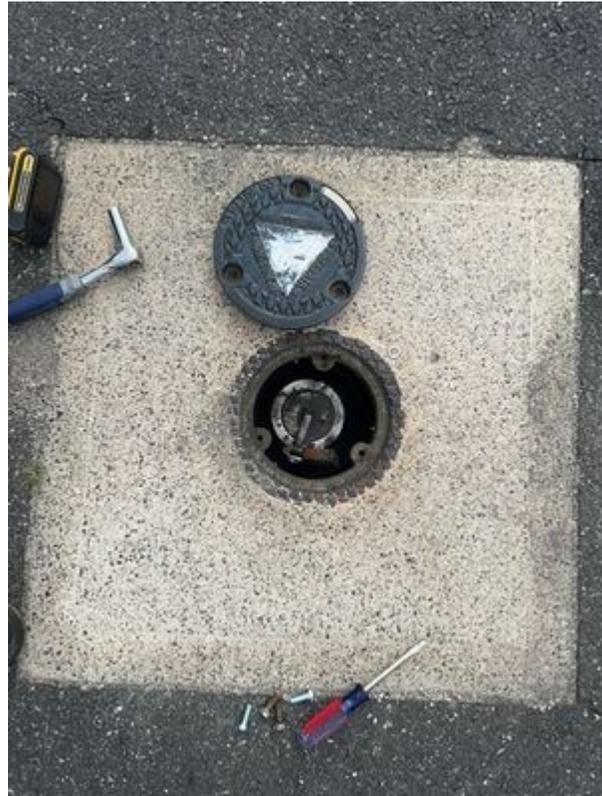
Client: Navy CLEAN	Facility: NWIRP Bethpage
Project Number: 112G08005-WE13	Location: Bethpage, New York
Date: July 18, 2024 15:59	Personnel: Jake Marlow
Well ID: BPGMMW39D	Well Location: 209876.837409604 1124172.45557354
Well Status: In Use (Confirmed)	Screen Interval: 262-282
WELL INVENTORY CONDITION	
Concrete pad in acceptable condition i.e. no cracks?	YES
Manhole cover present and in working condition?	YES
All bolts on manhole present and not stripped?	YES
Well plug present, locked and in good working condition?	YES
OVERALL CONDITION:	GOOD
Notes (Explain if answered No to any of the above)

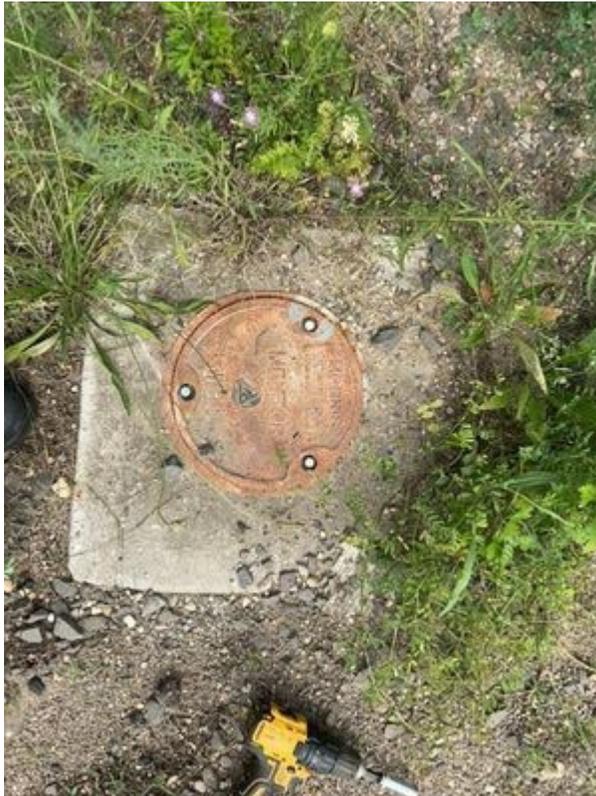
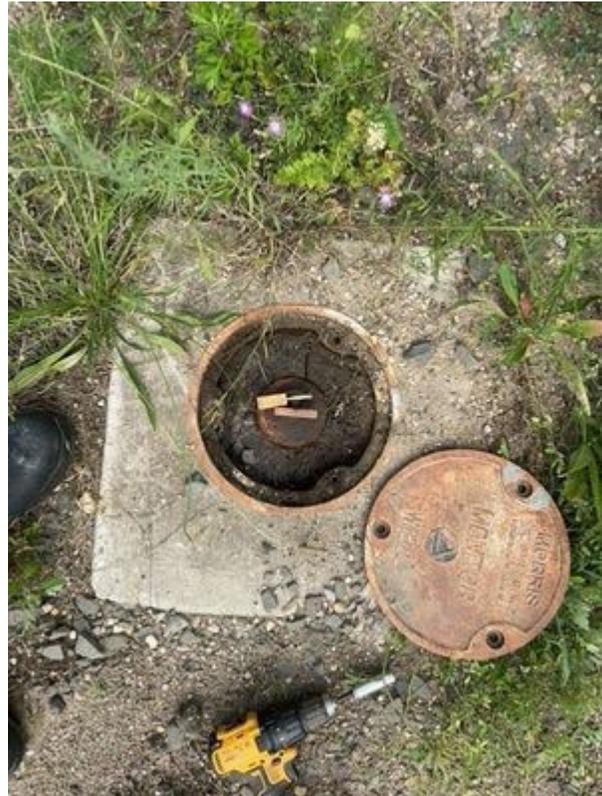
Client: Navy CLEAN	Facility: NWIRP Bethpage
Project Number: 112G08005-WE13	Location: Bethpage, New York
Date: July 18, 2024 15:47	Personnel: Jake Marlow
Well ID: RE123D2	Well Location: 209882.662151949 1124884.4317763
Well Status: In Use (Confirmed)	Screen Interval: 635-655
WELL INVENTORY CONDITION	
Concrete pad in acceptable condition i.e. no cracks?	YES
Manhole cover present and in working condition?	YES
All bolts on manhole present and not stripped?	YES
Well plug present, locked and in good working condition?	YES
OVERALL CONDITION:	GOOD
Notes (Explain if answered No to any of the above)

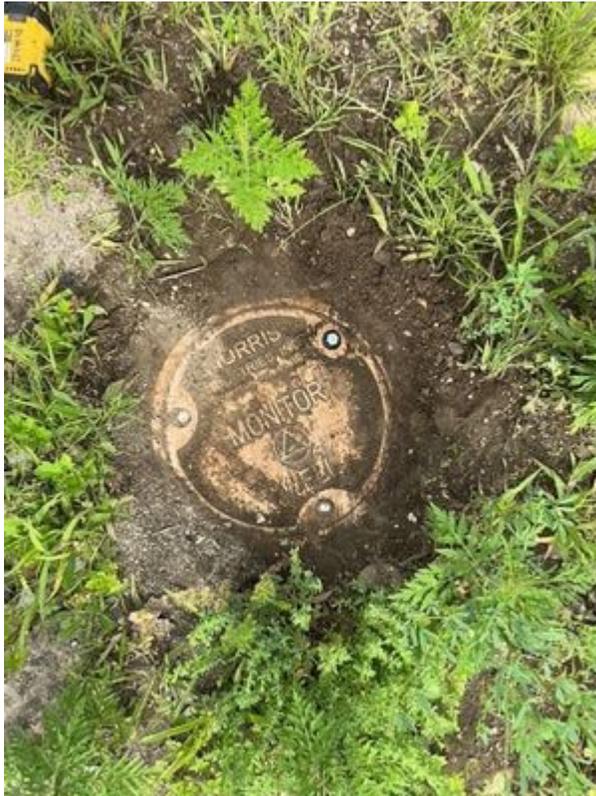
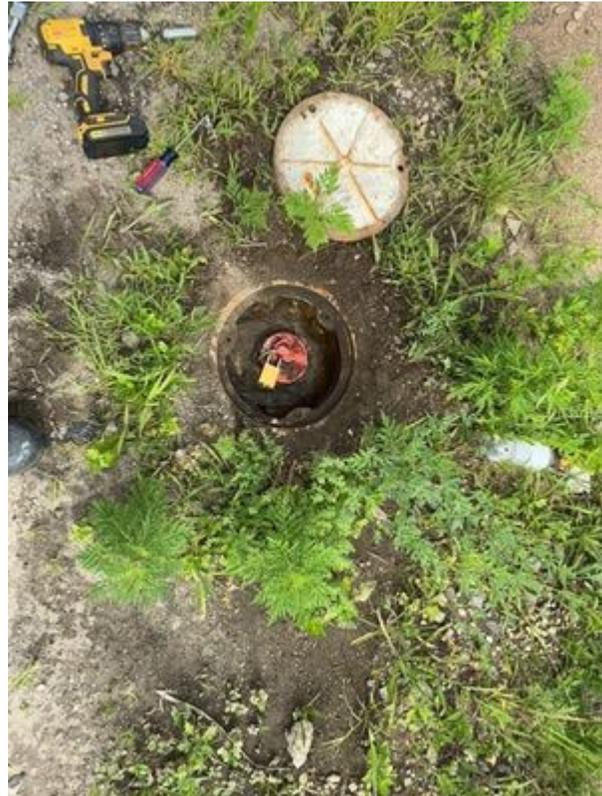
Client: Navy CLEAN	Facility: NWIRP Bethpage
Project Number: 112G08005-WE13	Location: Bethpage, New York
Date: July 18, 2024 15:42	Personnel: Jake Marlow
Well ID: RE132D1	Well Location: 209889.070173034 1124878.15131361
Well Status: In Use (Confirmed)	Screen Interval: 220-240
WELL INVENTORY CONDITION	
Concrete pad in acceptable condition i.e. no cracks?	YES
Manhole cover present and in working condition?	YES
All bolts on manhole present and not stripped?	YES
Well plug present, locked and in good working condition?	YES
OVERALL CONDITION:	GOOD
Notes (Explain if answered No to any of the above)

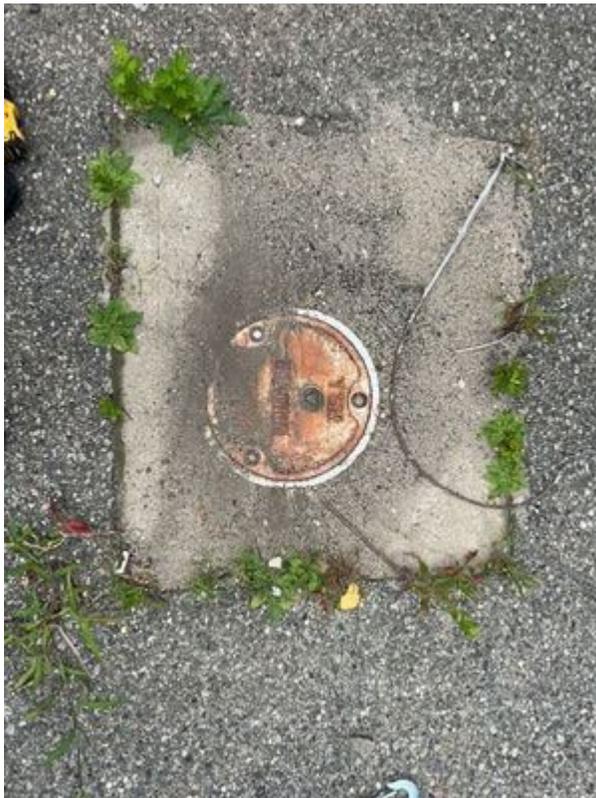
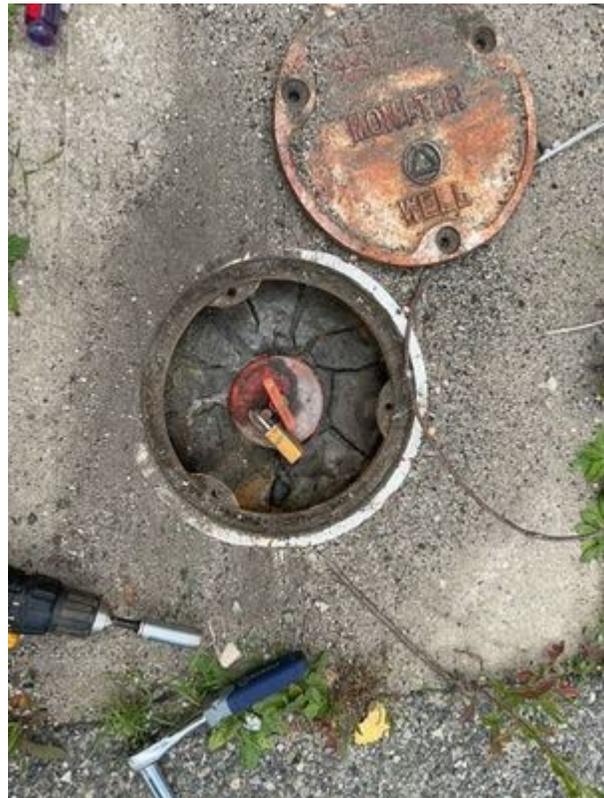
Client: Navy CLEAN	Facility: NWIRP Bethpage
Project Number: 112G08005-WE13	Location: Bethpage, New York
Date: July 18, 2024 15:37	Personnel: Jake Marlow
Well ID: RE123D3	Well Location: 209913.83590791 1124861.02254056
Well Status: In Use (Confirmed)	Screen Interval: 815-835
WELL INVENTORY CONDITION	
Concrete pad in acceptable condition i.e. no cracks?	YES
Manhole cover present and in working condition?	YES
All bolts on manhole present and not stripped?	YES
Well plug present, locked and in good working condition?	YES
OVERALL CONDITION:	GOOD
Notes (Explain if answered No to any of the above)

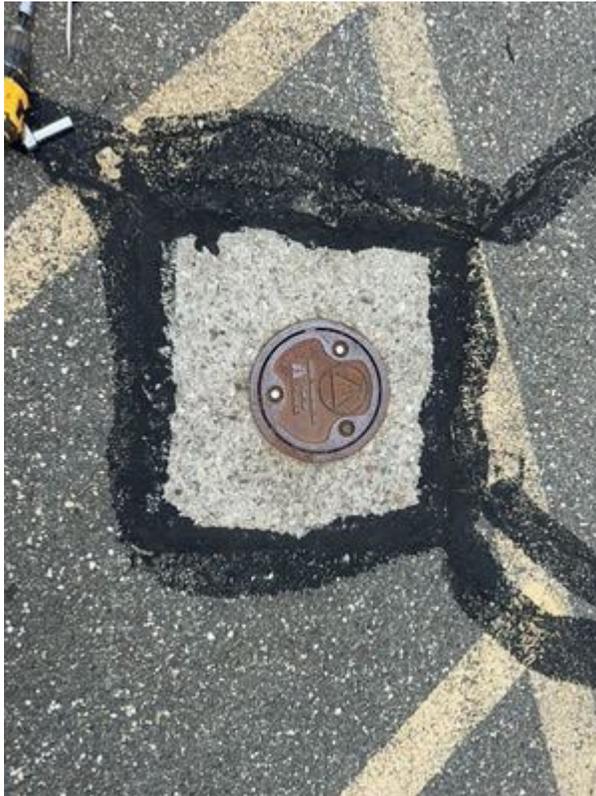
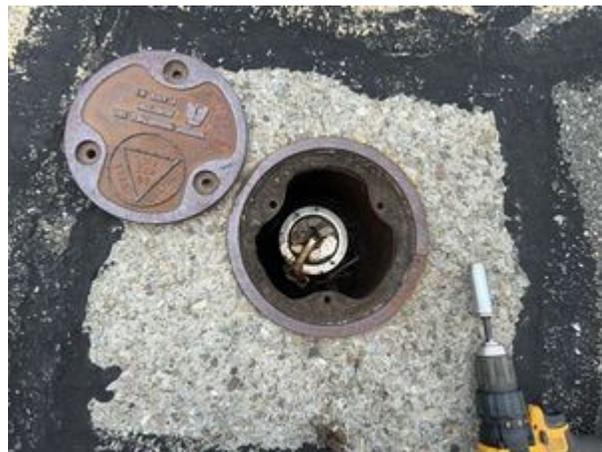
Client: Navy CLEAN	Facility: NWIRP Bethpage
Project Number: 112G08005-WE13	Location: Bethpage, New York
Date: July 18, 2024 15:31	Personnel: Jake Marlow
Well ID: BPGMMW18D	Well Location: 210356.113884895 1123714.03551827
Well Status: In Use (Confirmed)	Screen Interval: 290-300
WELL INVENTORY CONDITION	
Concrete pad in acceptable condition i.e. no cracks?	YES
Manhole cover present and in working condition?	YES
All bolts on manhole present and not stripped?	NO
Well plug present, locked and in good working condition?	YES
OVERALL CONDITION:	FAIR
Notes (Explain if answered No to any of the above) Threads on manhole are stripped

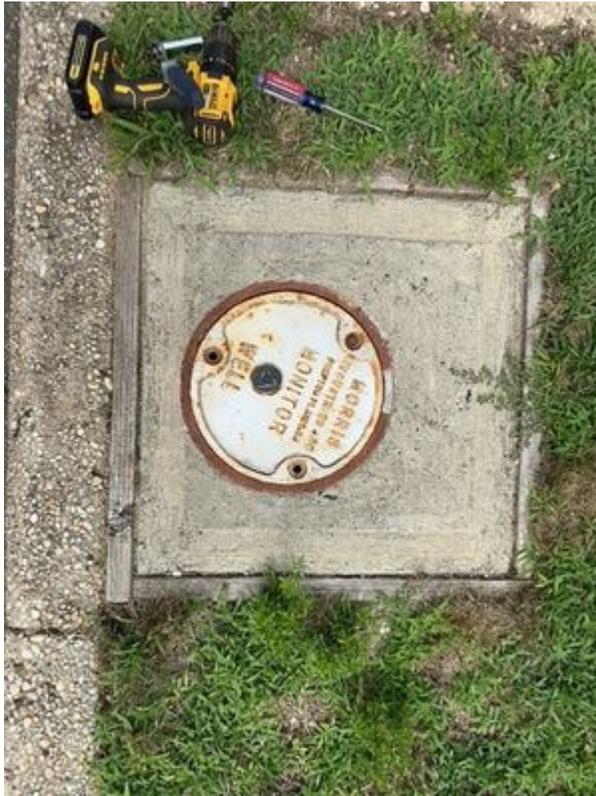
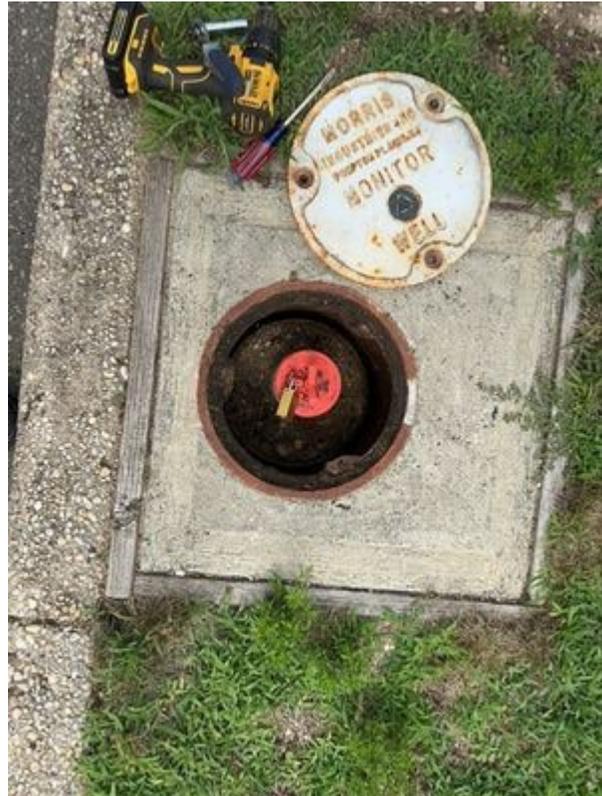
Client: Navy CLEAN	Facility: NWIRP Bethpage
Project Number: 112G08005-WE13	Location: Bethpage, New York
Date: July 18, 2024 14:53	Personnel: Jake Marlow
Well ID: BP-TT-MW179D1	Well Location: 213530.176858008 1120904.23952163
Well Status: In Use (Confirmed)	Screen Interval: 305-325
WELL INVENTORY CONDITION	
Concrete pad in acceptable condition i.e. no cracks?	YES
Manhole cover present and in working condition?	YES
All bolts on manhole present and not stripped?	NO
Well plug present, locked and in good working condition?	YES
OVERALL CONDITION:	FAIR
Notes (Explain if answered No to any of the above) One bolt is sheared off in manhole

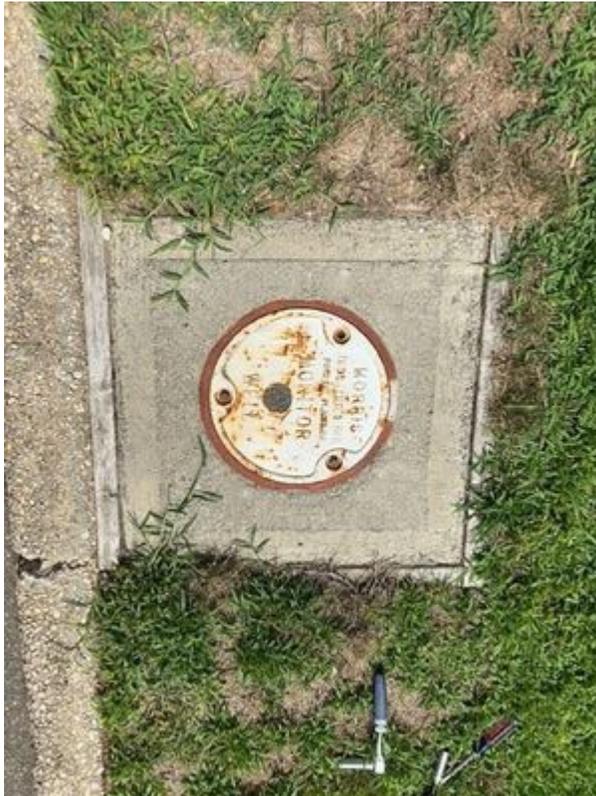
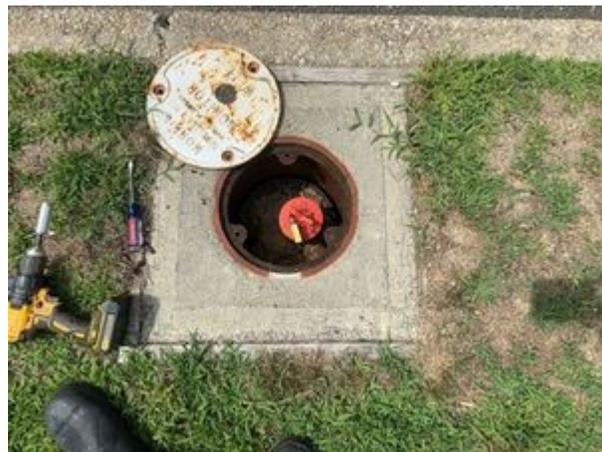
Client: Navy CLEAN	Facility: NWIRP Bethpage
Project Number: 112G08005-WE13	Location: Bethpage, New York
Date: July 18, 2024 14:50	Personnel: Jake Marlow
Well ID: BP-TT-MW179D2	Well Location: 213540.965583922 1120916.26539647
Well Status: In Use (Confirmed)	Screen Interval: 400-420
WELL INVENTORY CONDITION	
Concrete pad in acceptable condition i.e. no cracks?	YES
Manhole cover present and in working condition?	YES
All bolts on manhole present and not stripped?	NO
Well plug present, locked and in good working condition?	YES
OVERALL CONDITION:	FAIR
Notes (Explain if answered No to any of the above) One bolt is sheared off in manhole

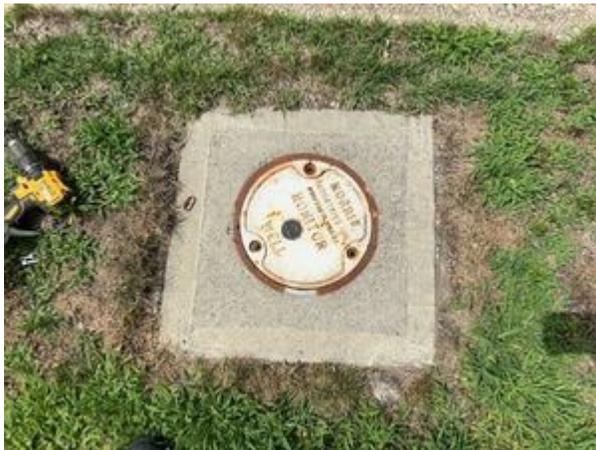
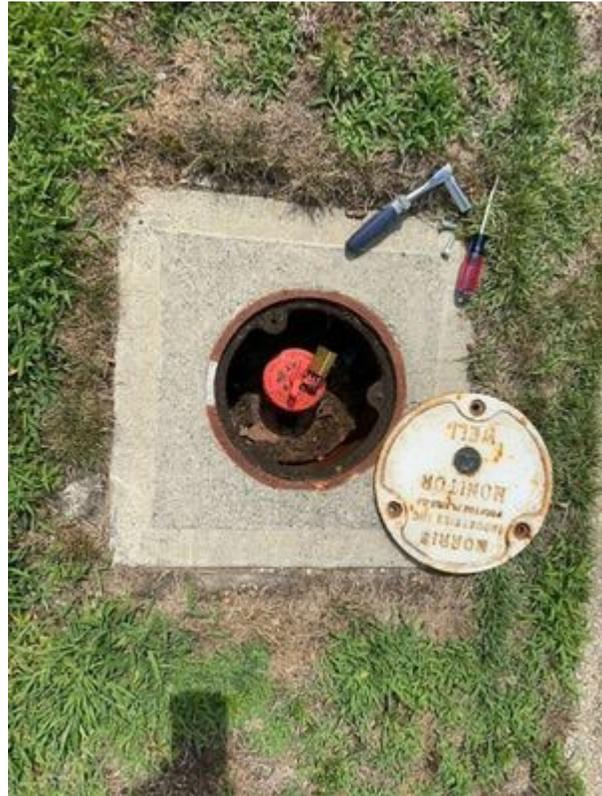
Client: Navy CLEAN	Facility: NWIRP Bethpage
Project Number: 112G08005-WE13	Location: Bethpage, New York
Date: July 18, 2024 14:45	Personnel: Jake Marlow
Well ID: BP-TT-MW179D	Well Location: 213543.613309868 1120913.04478814
Well Status: In Use (Confirmed)	Screen Interval: 212-232
WELL INVENTORY CONDITION	
Concrete pad in acceptable condition i.e. no cracks?	YES
Manhole cover present and in working condition?	YES
All bolts on manhole present and not stripped?	NO
Well plug present, locked and in good working condition?	YES
OVERALL CONDITION:	FAIR
Notes (Explain if answered No to any of the above) Two bolts sheared off

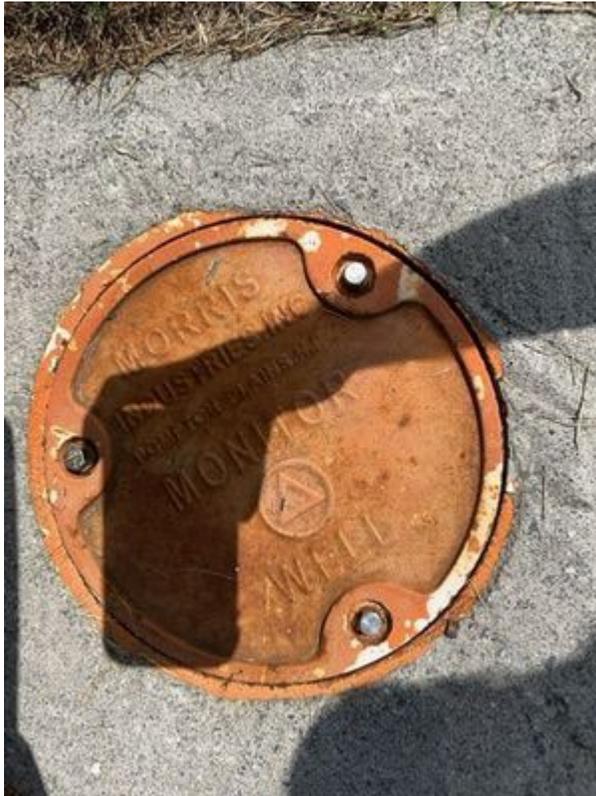
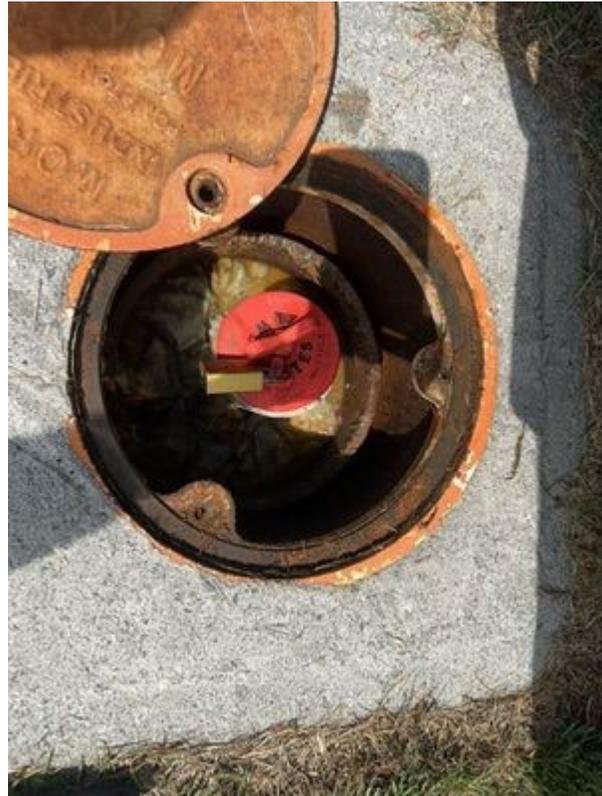
Client: Navy CLEAN	Facility: NWIRP Bethpage
Project Number: 112G08005-WE13	Location: Bethpage, New York
Date: July 18, 2024 14:38	Personnel: Jake Marlow
Well ID: BP-TT-MW17811	Well Location: 211953.320403693 1120868.60366834
Well Status: In Use (Confirmed)	Screen Interval: 420-440
WELL INVENTORY CONDITION	
Concrete pad in acceptable condition i.e. no cracks?	YES
Manhole cover present and in working condition?	YES
All bolts on manhole present and not stripped?	YES
Well plug present, locked and in good working condition?	YES
OVERALL CONDITION:	GOOD
Notes (Explain if answered No to any of the above)

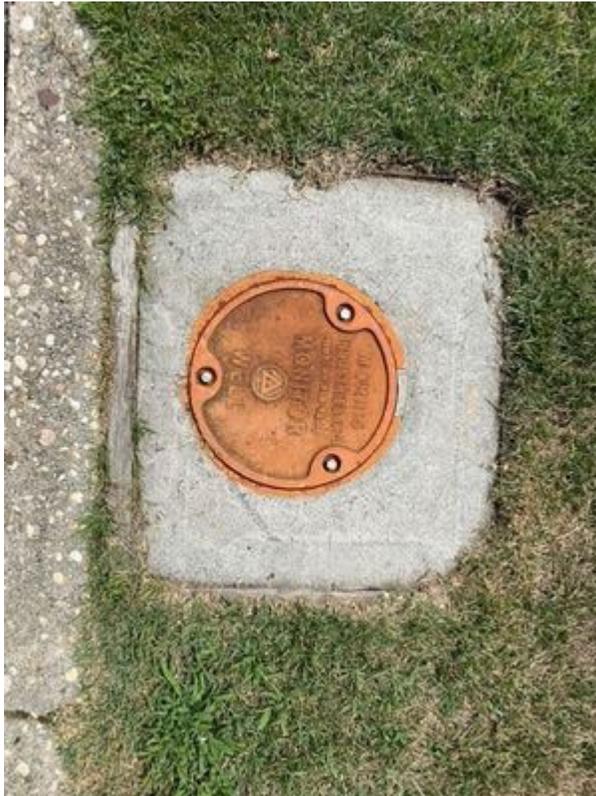
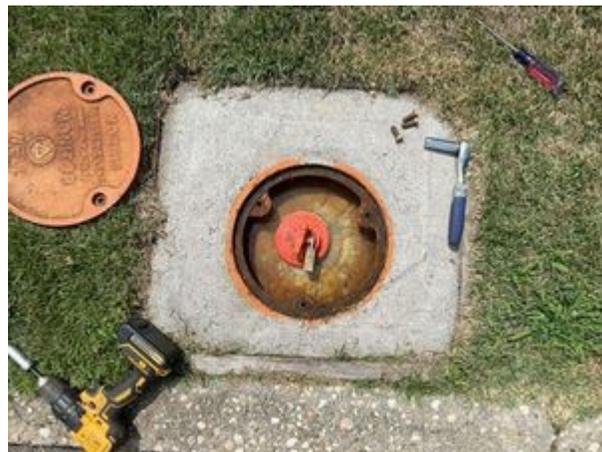
Client: Navy CLEAN	Facility: NWIRP Bethpage
Project Number: 112G08005-WE13	Location: Bethpage, New York
Date: July 18, 2024 14:34	Personnel: Jake Marlow
Well ID: BP-TT-MW178S	Well Location: 211956.573940319 1120864.7199772
Well Status: In Use (Confirmed)	Screen Interval: 190-210
WELL INVENTORY CONDITION	
Concrete pad in acceptable condition i.e. no cracks?	NO
Manhole cover present and in working condition?	YES
All bolts on manhole present and not stripped?	YES
Well plug present, locked and in good working condition?	YES
OVERALL CONDITION:	GOOD
Notes (Explain if answered No to any of the above) Crack in pad

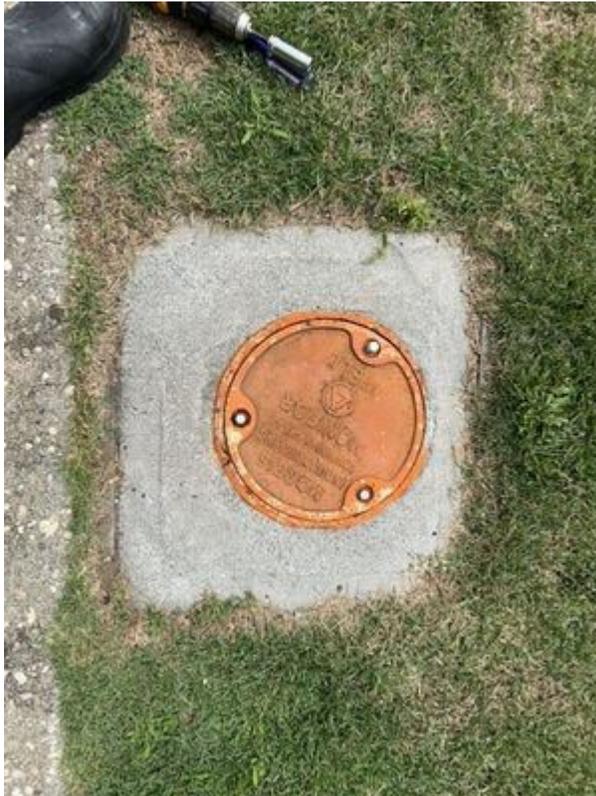
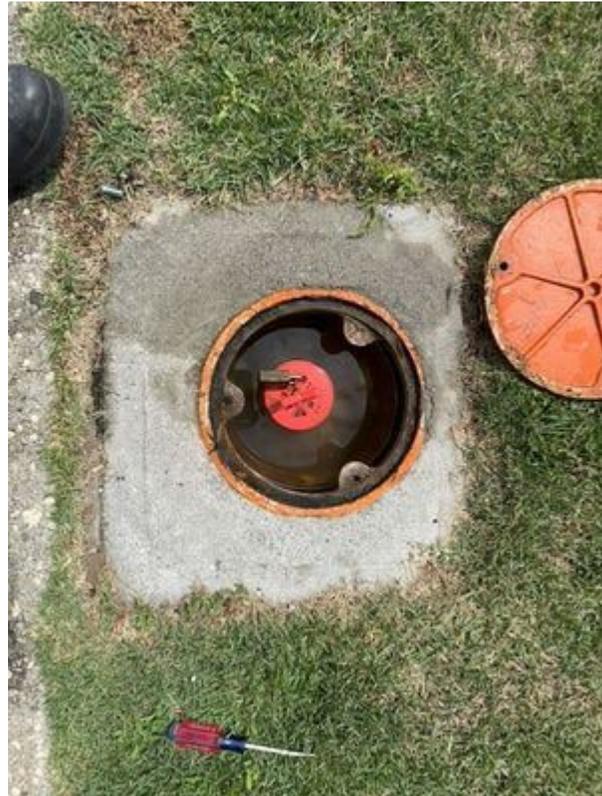
Client: Navy CLEAN	Facility: NWIRP Bethpage
Project Number: 112G08005-WE13	Location: Bethpage, New York
Date: July 18, 2024 14:24	Personnel: Jake Marlow
Well ID: BP-TT-MW178I	Well Location: 211960.871261502 1120867.62516331
Well Status: In Use (Confirmed)	Screen Interval: 290-310
WELL INVENTORY CONDITION	
Concrete pad in acceptable condition i.e. no cracks?	YES
Manhole cover present and in working condition?	YES
All bolts on manhole present and not stripped?	YES
Well plug present, locked and in good working condition?	YES
OVERALL CONDITION:	GOOD
Notes (Explain if answered No to any of the above)

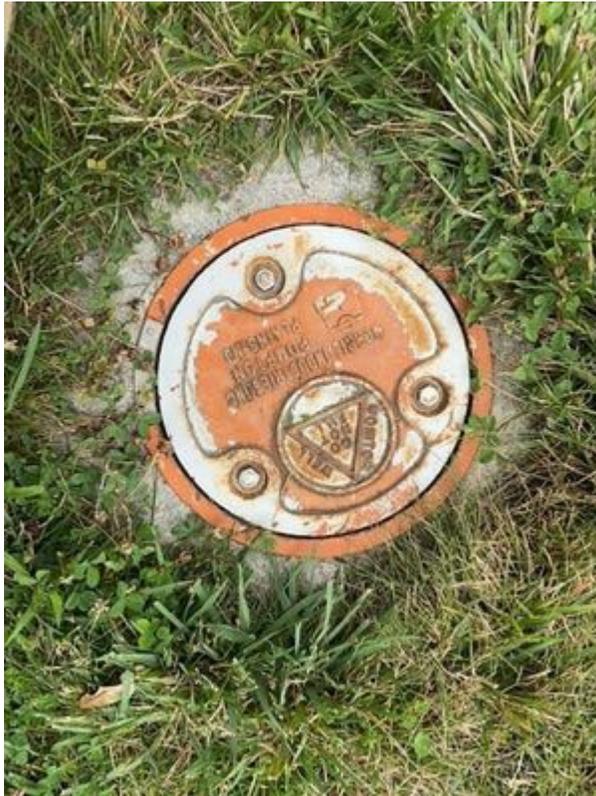
Client: Navy CLEAN	Facility: NWIRP Bethpage
Project Number: 112G08005-WE13	Location: Bethpage, New York
Date: July 18, 2024 14:10	Personnel: Jake Marlow
Well ID: BPGMMW21D2	Well Location: 209451.791258072 1125457.30425138
Well Status: In Use (Confirmed)	Screen Interval:
WELL INVENTORY CONDITION	
Concrete pad in acceptable condition i.e. no cracks?	YES
Manhole cover present and in working condition?	YES
All bolts on manhole present and not stripped?	YES
Well plug present, locked and in good working condition?	YES
OVERALL CONDITION:	GOOD
Notes (Explain if answered No to any of the above) Labeled as GM-21S

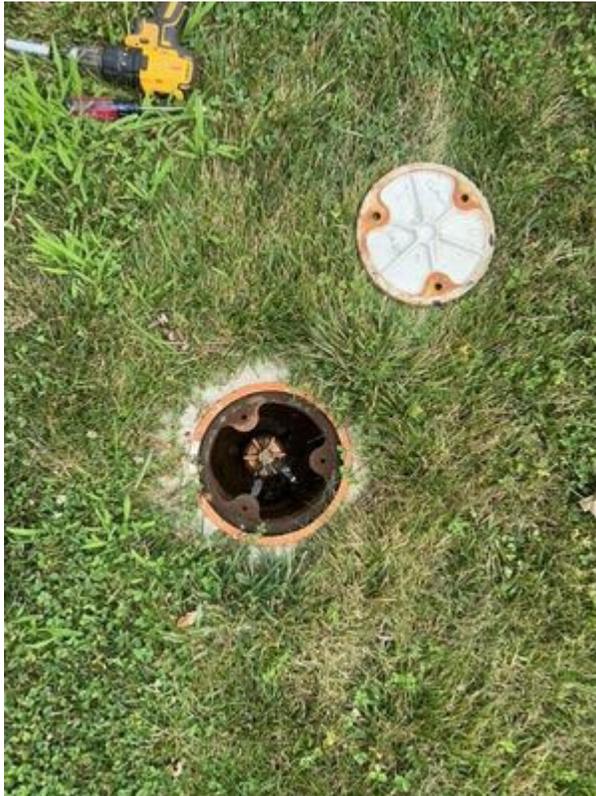
Client: Navy CLEAN	Facility: NWIRP Bethpage
Project Number: 112G08005-WE13	Location: Bethpage, New York
Date: July 18, 2024 14:10	Personnel: Jake Marlow
Well ID: BPGMMW21D2	Well Location: 209451.791258072 1125457.30425138
Well Status: In Use (Confirmed)	Screen Interval:
WELL INVENTORY CONDITION	
Concrete pad in acceptable condition i.e. no cracks?	YES
Manhole cover present and in working condition?	YES
All bolts on manhole present and not stripped?	YES
Well plug present, locked and in good working condition?	YES
OVERALL CONDITION:	GOOD
Notes (Explain if answered No to any of the above) Labeled as GM-21S

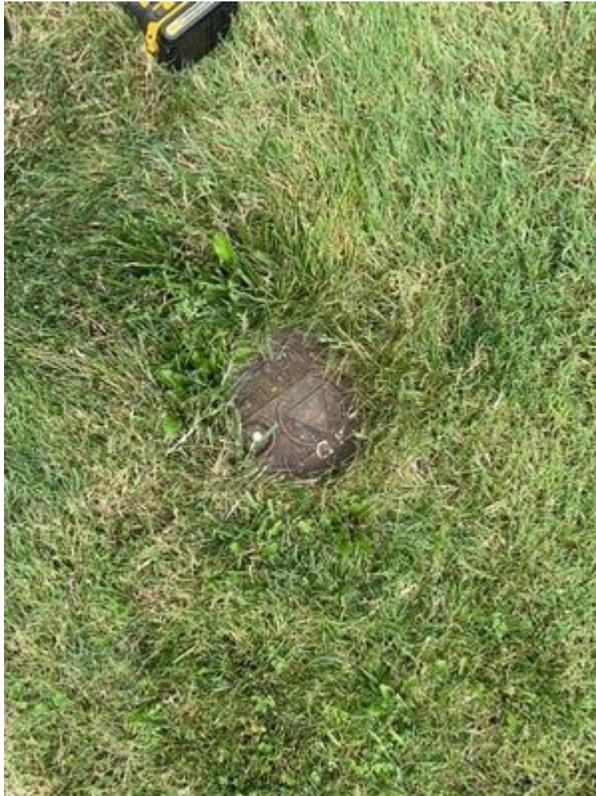
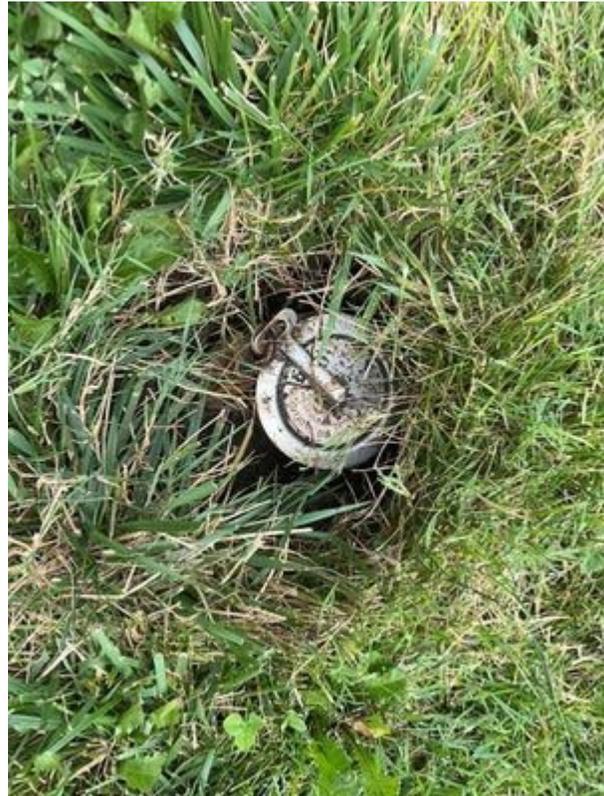
Client: Navy CLEAN	Facility: NWIRP Bethpage
Project Number: 112G08005-WE13	Location: Bethpage, New York
Date: July 18, 2024 14:08	Personnel: Jake Marlow
Well ID: BPGMMW21D	Well Location: 209440.079937607 1125453.60108869
Well Status: In Use (Confirmed)	Screen Interval: 278-288
WELL INVENTORY CONDITION	
Concrete pad in acceptable condition i.e. no cracks?	YES
Manhole cover present and in working condition?	YES
All bolts on manhole present and not stripped?	YES
Well plug present, locked and in good working condition?	YES
OVERALL CONDITION:	GOOD
Notes (Explain if answered No to any of the above)

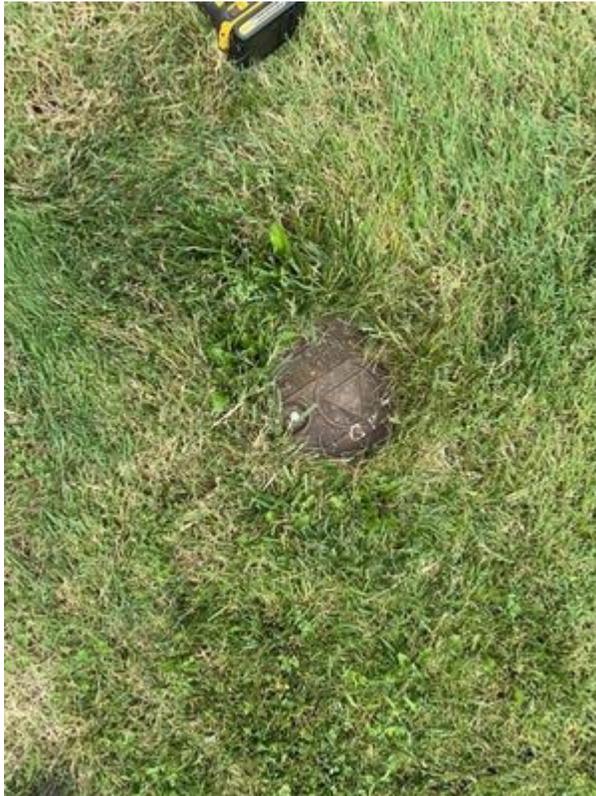
Client: Navy CLEAN	Facility: NWIRP Bethpage
Project Number: 112G08005-WE13	Location: Bethpage, New York
Date: July 18, 2024 14:08	Personnel: Jake Marlow
Well ID: BPGMMW21D	Well Location: 209440.079937607 1125453.60108869
Well Status: In Use (Confirmed)	Screen Interval: 278-288
WELL INVENTORY CONDITION	
Concrete pad in acceptable condition i.e. no cracks?	YES
Manhole cover present and in working condition?	YES
All bolts on manhole present and not stripped?	YES
Well plug present, locked and in good working condition?	YES
OVERALL CONDITION:	GOOD
Notes (Explain if answered No to any of the above)

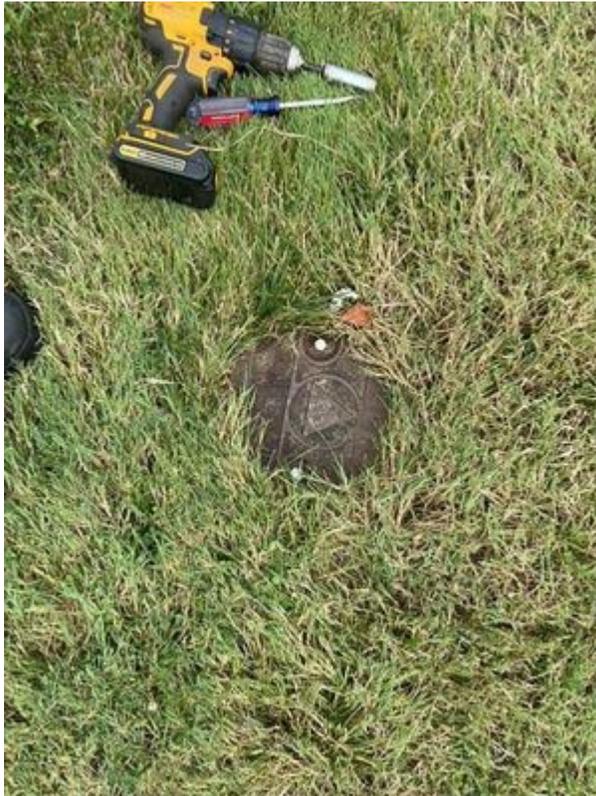
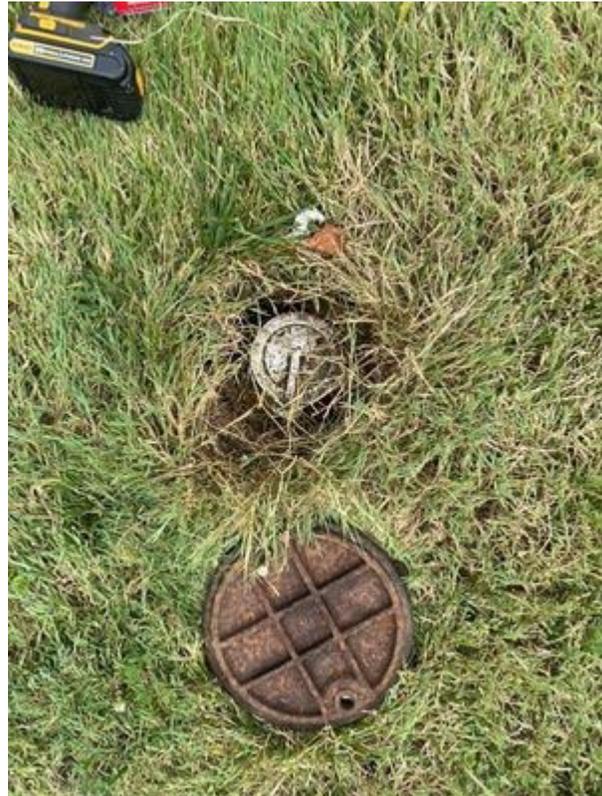
Client: Navy CLEAN	Facility: NWIRP Bethpage
Project Number: 112G08005-WE13	Location: Bethpage, New York
Date: July 18, 2024 14:06	Personnel: Jake Marlow
Well ID: BPGMMW21I	Well Location: 209446.128632242 1125453.21812094
Well Status: In Use (Confirmed)	Screen Interval: 130-140
WELL INVENTORY CONDITION	
Concrete pad in acceptable condition i.e. no cracks?	YES
Manhole cover present and in working condition?	YES
All bolts on manhole present and not stripped?	YES
Well plug present, locked and in good working condition?	YES
OVERALL CONDITION:	GOOD
Notes (Explain if answered No to any of the above)

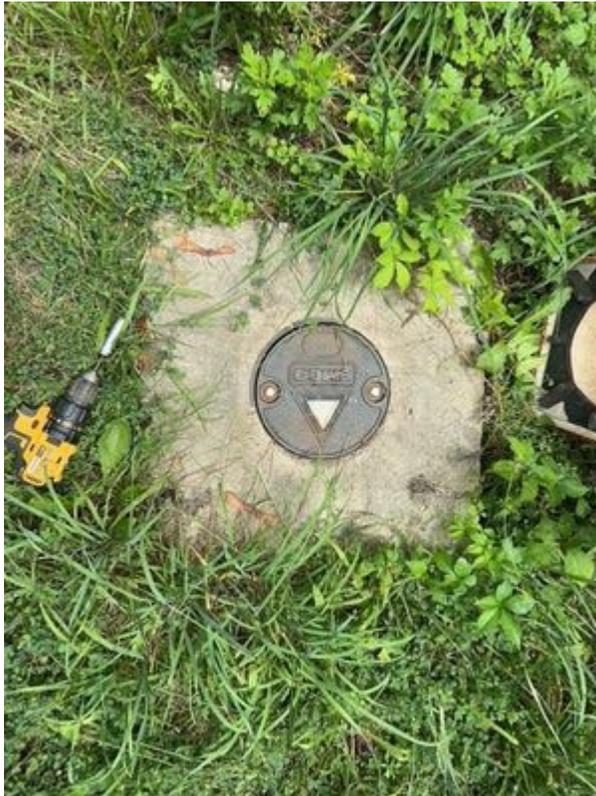
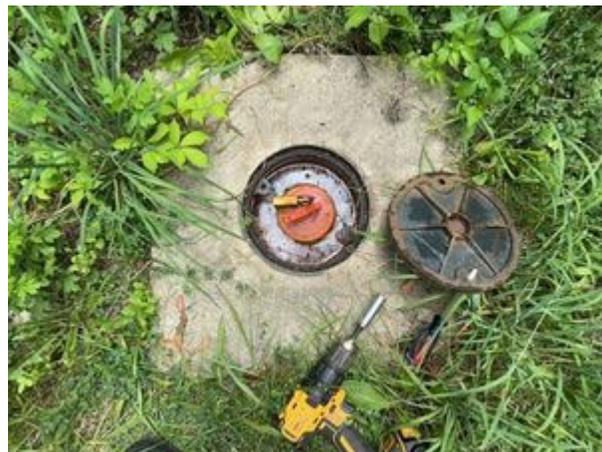
Client: Navy CLEAN	Facility: NWIRP Bethpage
Project Number: 112G08005-WE13	Location: Bethpage, New York
Date: July 18, 2024 13:48	Personnel: Jake Marlow
Well ID: GM38-RW03	Well Location: 206378.647294604 1128833.3898839
Well Status: In Use (Confirmed)	Screen Interval: 392-504
WELL INVENTORY CONDITION	
Concrete pad in acceptable condition i.e. no cracks?	YES
Manhole cover present and in working condition?	YES
All bolts on manhole present and not stripped?	YES
Well plug present, locked and in good working condition?	YES
OVERALL CONDITION:	GOOD
Notes (Explain if answered No to any of the above)

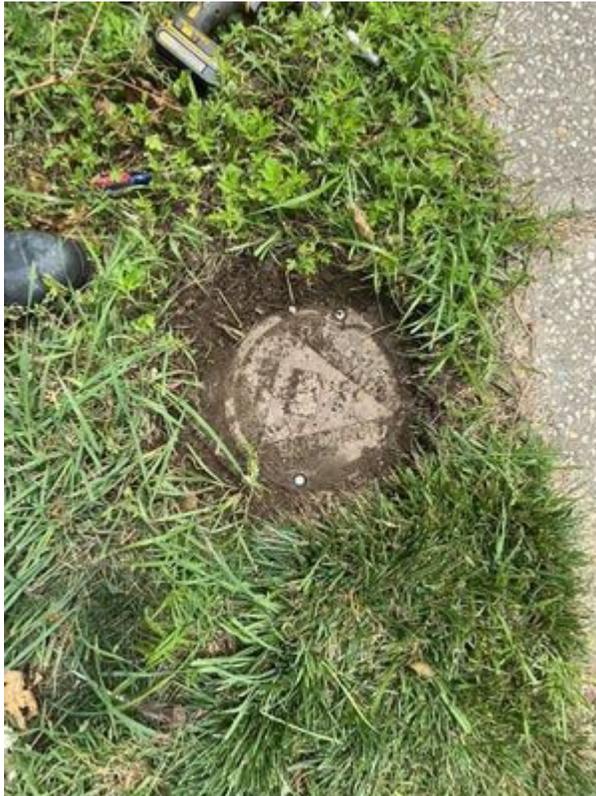
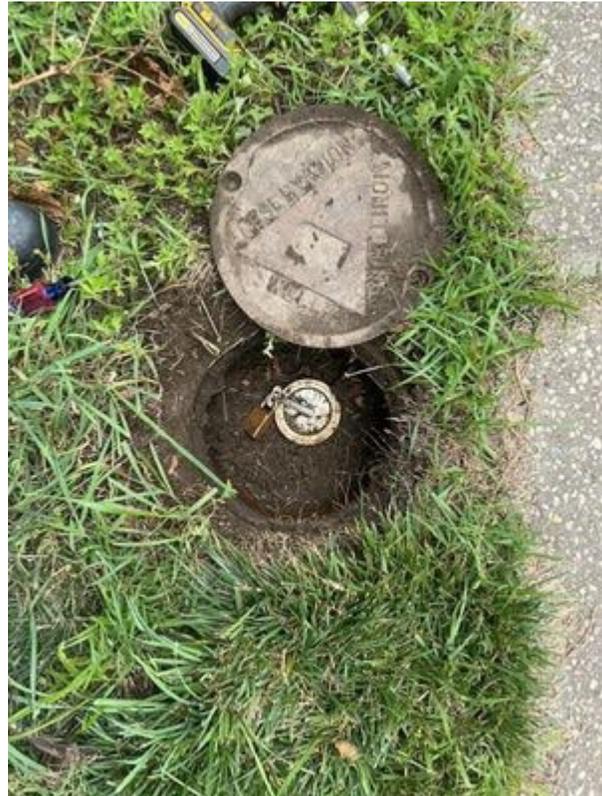
Client: Navy CLEAN	Facility: NWIRP Bethpage
Project Number: 112G08005-WE13	Location: Bethpage, New York
Date: July 18, 2024 13:43	Personnel: Jake Marlow
Well ID: GM38D	Well Location: 206347.904070638 1128949.08151949
Well Status: In Use (Confirmed)	Screen Interval: 320-340
WELL INVENTORY CONDITION	
Concrete pad in acceptable condition i.e. no cracks?	YES
Manhole cover present and in working condition?	NO
All bolts on manhole present and not stripped?	YES
Well plug present, locked and in good working condition?	YES
OVERALL CONDITION:	GOOD
Notes (Explain if answered No to any of the above) Threads on manhole for bolts are stripped

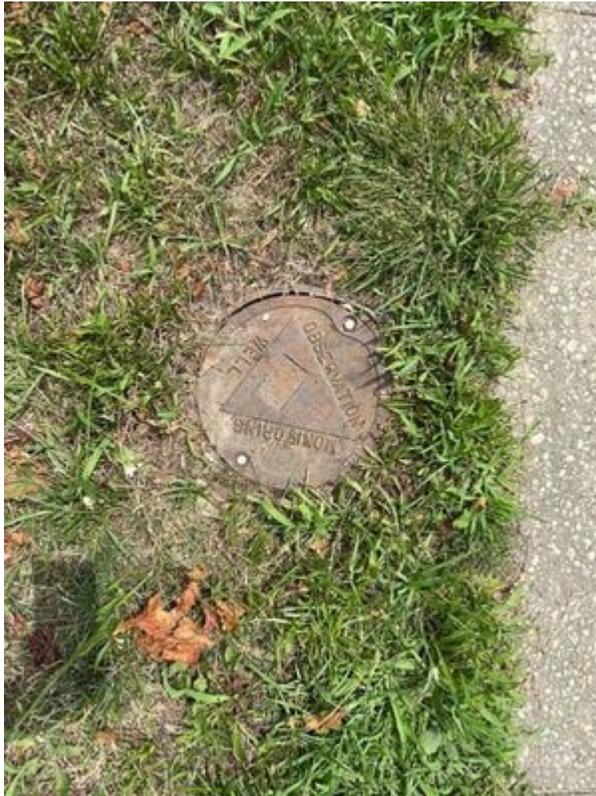
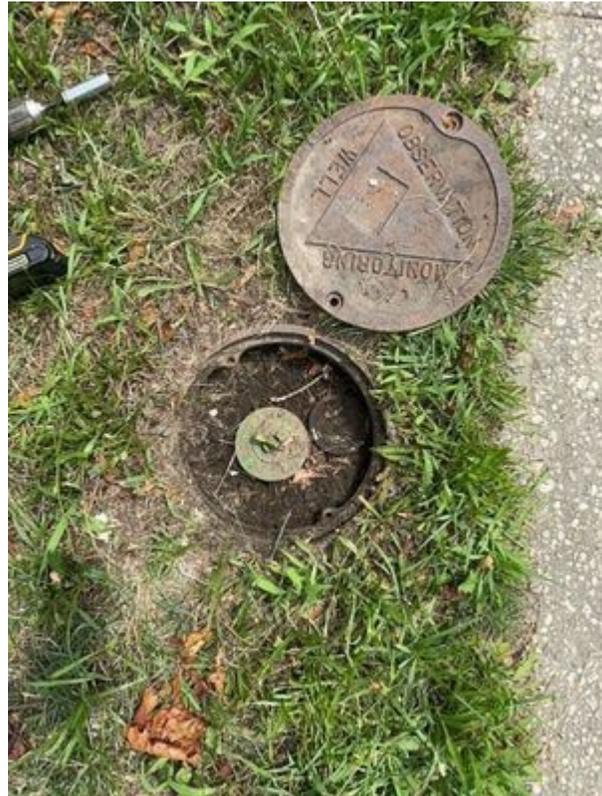
Client: Navy CLEAN	Facility: NWIRP Bethpage
Project Number: 112G08005-WE13	Location: Bethpage, New York
Date: July 18, 2024 13:40	Personnel: Jake Marlow
Well ID: GM38D2	Well Location: 206341.407117872 1128952.06277858
Well Status: In Use (Confirmed)	Screen Interval: 475-495
WELL INVENTORY CONDITION	
Concrete pad in acceptable condition i.e. no cracks?	YES
Manhole cover present and in working condition?	NO
All bolts on manhole present and not stripped?	YES
Well plug present, locked and in good working condition?	YES
OVERALL CONDITION:	GOOD
Notes (Explain if answered No to any of the above) Threads on manhole for bolts is stripped

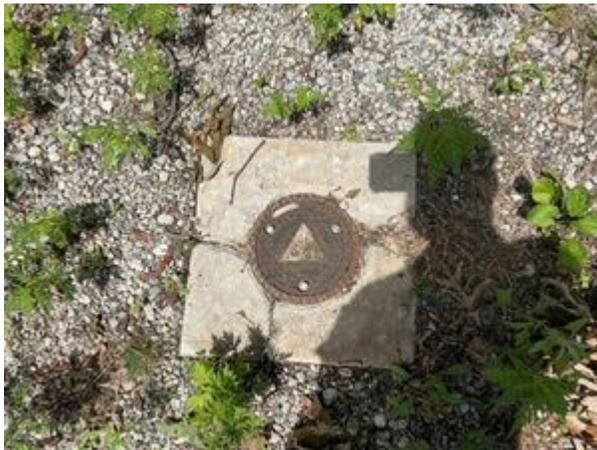
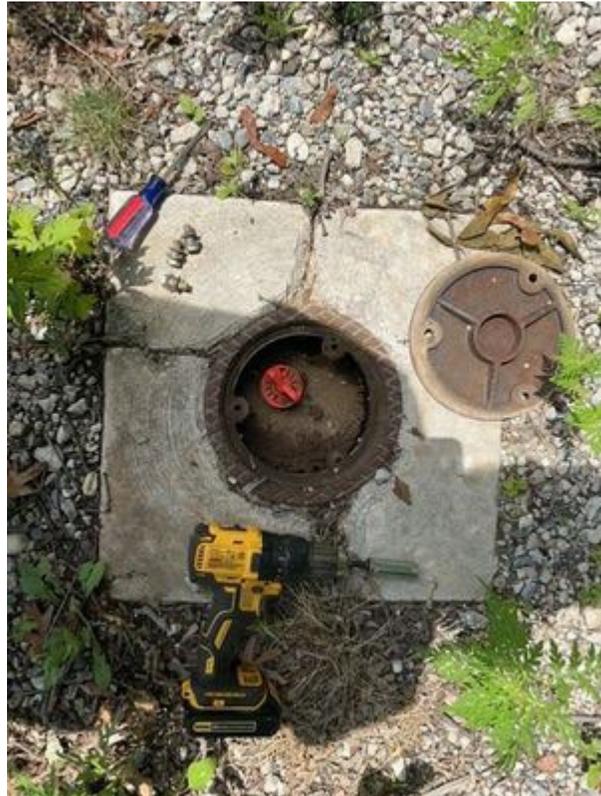
Client: Navy CLEAN	Facility: NWIRP Bethpage
Project Number: 112G08005-WE13	Location: Bethpage, New York
Date: July 18, 2024 13:34	Personnel: Jake Marlow
Well ID: GM38-RW2-MW2	Well Location: 206366.959002403 1129159.76850584
Well Status: In Use (Confirmed)	Screen Interval: 470-510
WELL INVENTORY CONDITION	
Concrete pad in acceptable condition i.e. no cracks?	NO
Manhole cover present and in working condition?	YES
All bolts on manhole present and not stripped?	YES
Well plug present, locked and in good working condition?	YES
OVERALL CONDITION:	GOOD
Notes (Explain if answered No to any of the above) Cracked pad

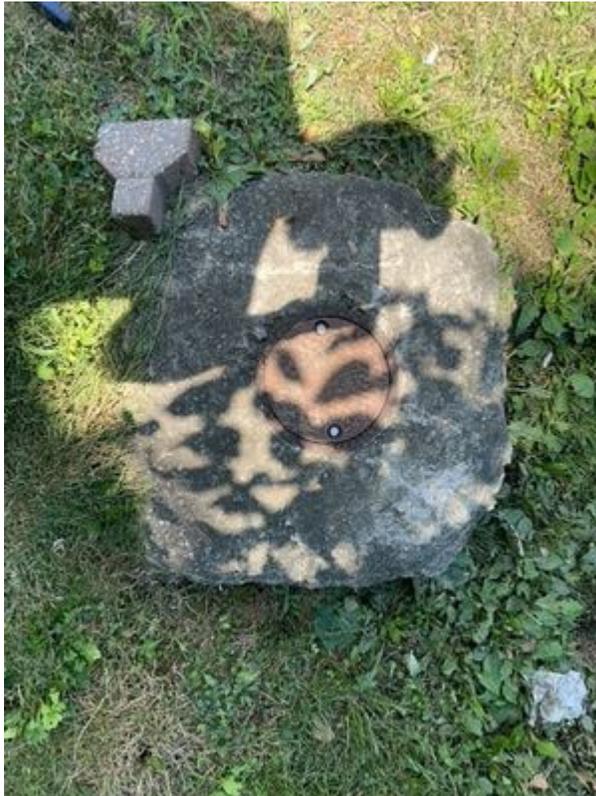
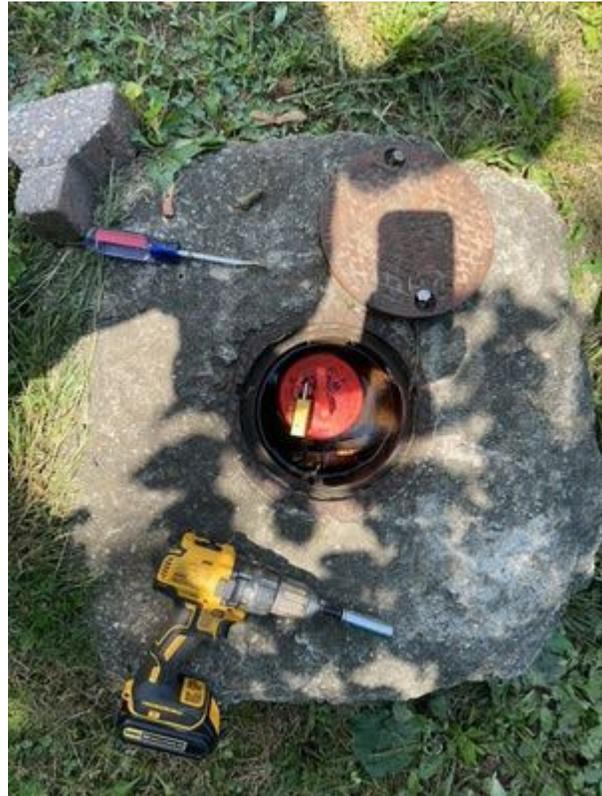
Client: Navy CLEAN	Facility: NWIRP Bethpage
Project Number: 112G08005-WE13	Location: Bethpage, New York
Date: July 18, 2024 13:29	Personnel: Jake Marlow
Well ID: GM38-RW2-MW1	Well Location: 206439.398825626 1129248.005385
Well Status: In Use (Confirmed)	Screen Interval: 470-510
WELL INVENTORY CONDITION	
Concrete pad in acceptable condition i.e. no cracks?	NO
Manhole cover present and in working condition?	NO
All bolts on manhole present and not stripped?	NO
Well plug present, locked and in good working condition?	YES
OVERALL CONDITION:	FAIR
Notes (Explain if answered No to any of the above) Cracked pad, part of manhole where bolts screw in is broken off

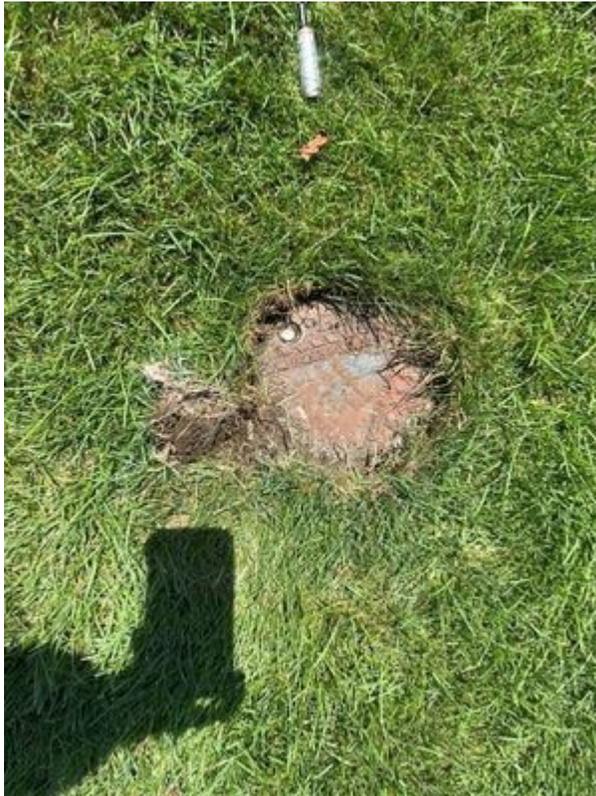
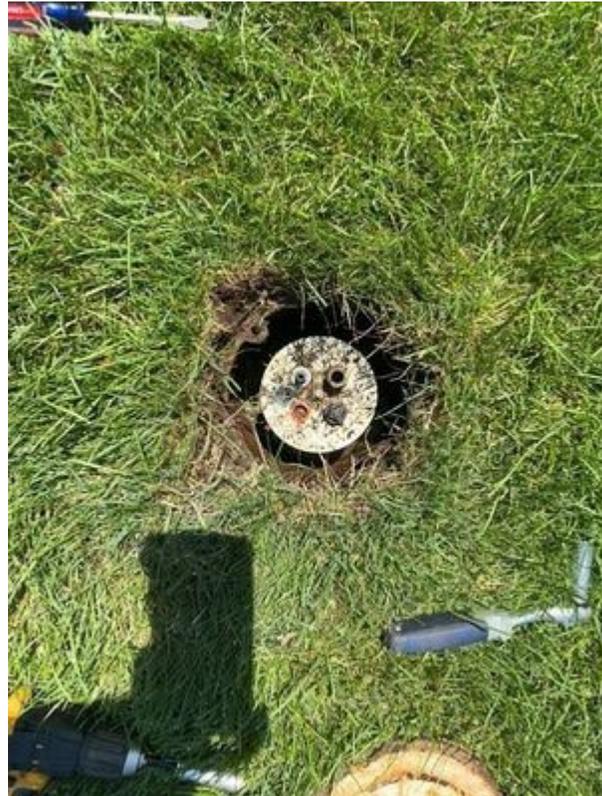
Client: Navy CLEAN	Facility: NWIRP Bethpage
Project Number: 112G08005-WE13	Location: Bethpage, New York
Date: July 18, 2024 13:15	Personnel: Jake Marlow
Well ID: GM38-RW1-MW1	Well Location: 206063.348515851 1129603.17157195
Well Status: In Use (Confirmed)	Screen Interval: 395-435
WELL INVENTORY CONDITION	
Concrete pad in acceptable condition i.e. no cracks?	YES
Manhole cover present and in working condition?	YES
All bolts on manhole present and not stripped?	YES
Well plug present, locked and in good working condition?	YES
OVERALL CONDITION:	GOOD
Notes (Explain if answered No to any of the above)
