Memorandum

To: Scott Sokolowski, NAVFAC MIDLANT
From: Richard Moore, Tetra Tech
Date: September 27, 2024
Re: Annual LUC Inspection and Operation Summary Report: Sites 1, 2, 3, and 4 –
NWIRP Bethpage
Contract/CTO Number: N6247016D9008/WE16

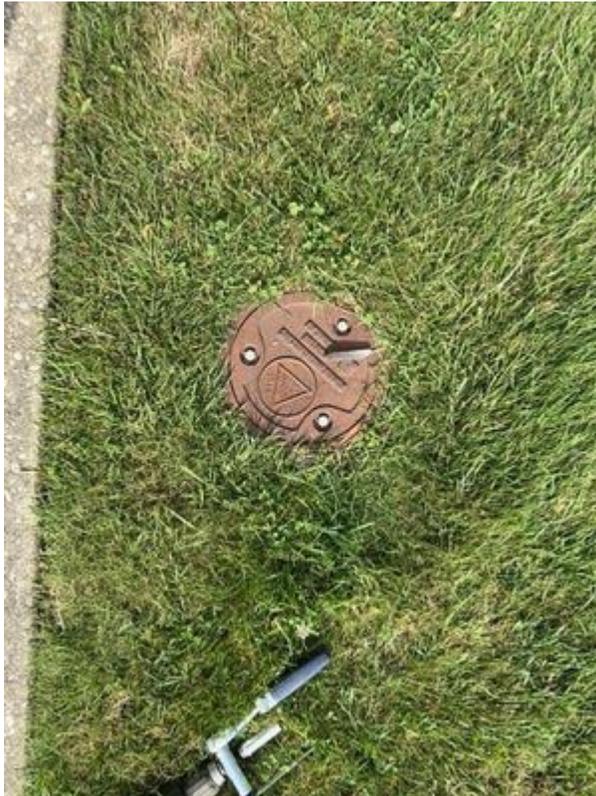
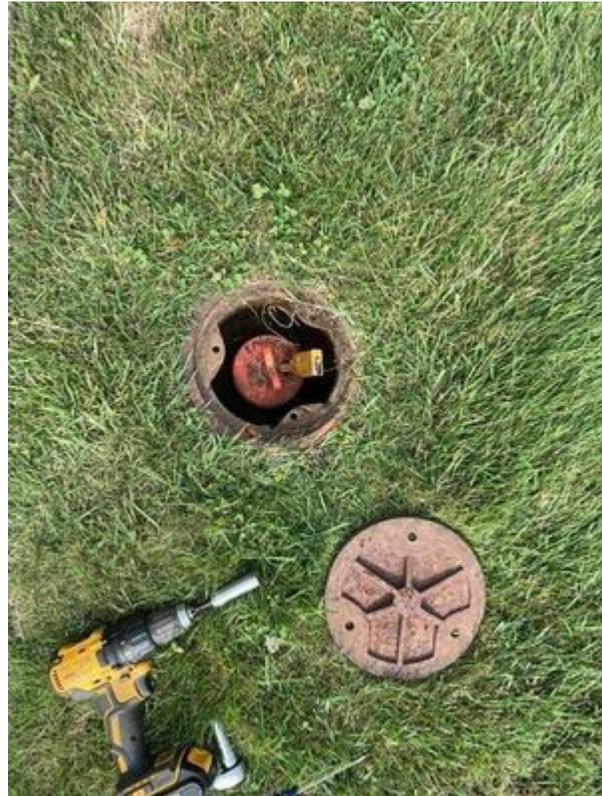
Client: Navy CLEAN	Facility: NWIRP Bethpage
Project Number: 112G08005-WE13	Location: Bethpage, New York
Date: July 9, 2024 16:40	Personnel: Jake Marlow
Well ID: GM38-RW3-MW3	Well Location: 206752.990095133 1128991.2004153
Well Status: In Use (Confirmed)	Screen Interval: 320-340
WELL INVENTORY CONDITION	
Concrete pad in acceptable condition i.e. no cracks?	YES
Manhole cover present and in working condition?	YES
All bolts on manhole present and not stripped?	YES
Well plug present, locked and in good working condition?	YES
OVERALL CONDITION:	GOOD
Notes (Explain if answered No to any of the above) Replaced lock

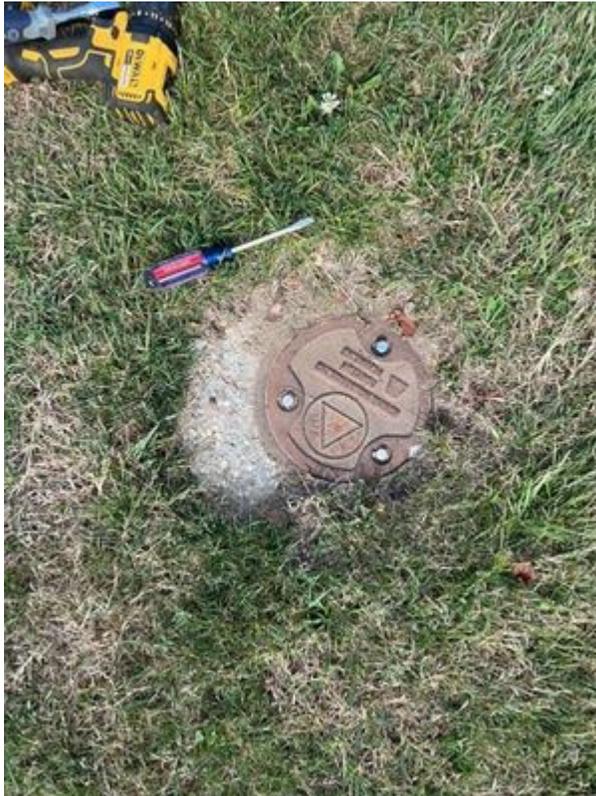
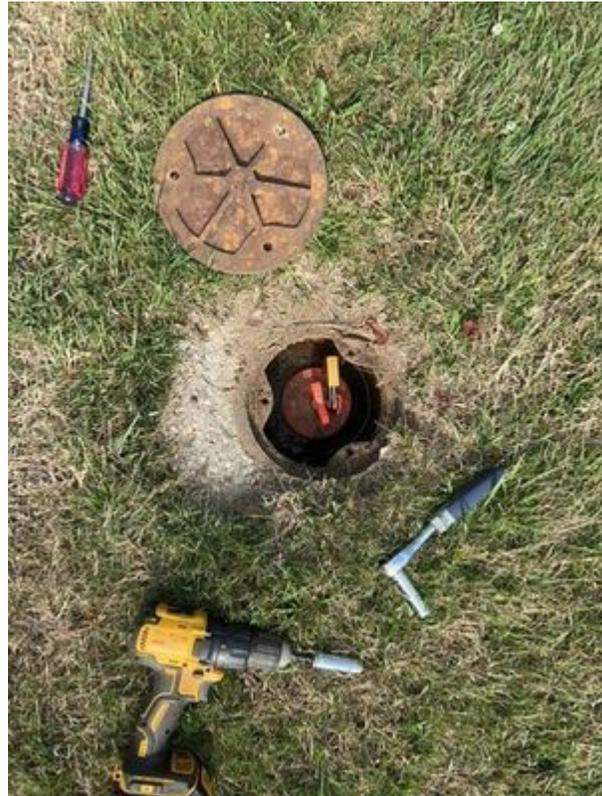
Client: Navy CLEAN	Facility: NWIRP Bethpage
Project Number: 112G08005-WE13	Location: Bethpage, New York
Date: July 9, 2024 16:36	Personnel: Jake Marlow
Well ID: GM38-RW3-MW4	Well Location: 206752.554911676 1128973.3280407
Well Status: In Use (Confirmed)	Screen Interval: 475-495
WELL INVENTORY CONDITION	
Concrete pad in acceptable condition i.e. no cracks?	YES
Manhole cover present and in working condition?	NO
All bolts on manhole present and not stripped?	YES
Well plug present, locked and in good working condition?	YES
OVERALL CONDITION:	FAIR
Notes (Explain if answered No to any of the above) Threads for bolts in manhole are stripped

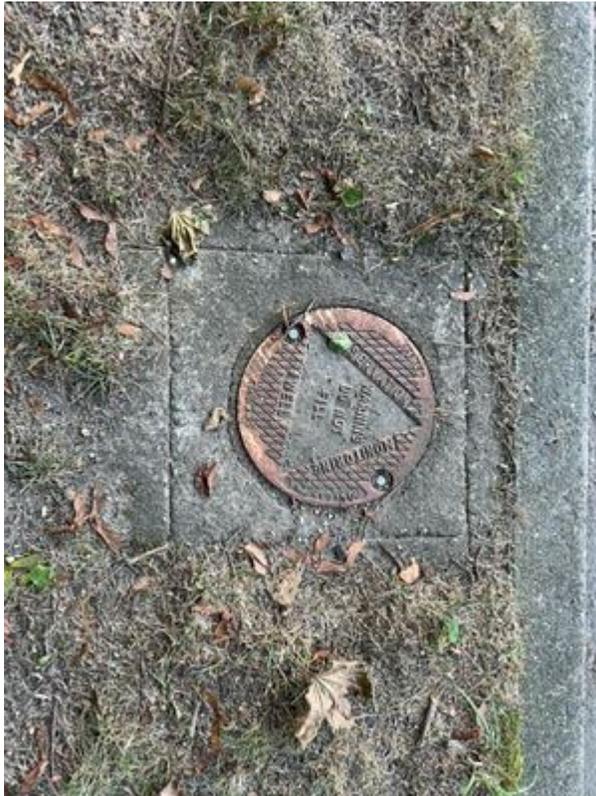
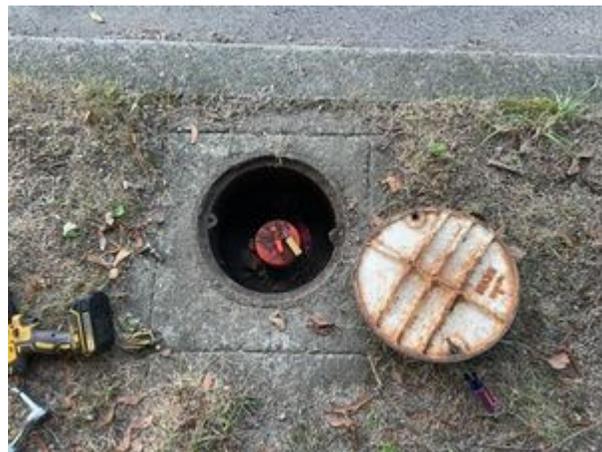
Client: Navy CLEAN	Facility: NWIRP Bethpage
Project Number: 112G08005-WE13	Location: Bethpage, New York
Date: July 9, 2024 16:31	Personnel: Jake Marlow
Well ID: RE104D3	Well Location: 206996.459254936 1127689.5040623
Well Status: In Use (Confirmed)	Screen Interval: 760-780
WELL INVENTORY CONDITION	
Concrete pad in acceptable condition i.e. no cracks?	YES
Manhole cover present and in working condition?	YES
All bolts on manhole present and not stripped?	YES
Well plug present, locked and in good working condition?	YES
OVERALL CONDITION:	GOOD
Notes (Explain if answered No to any of the above)

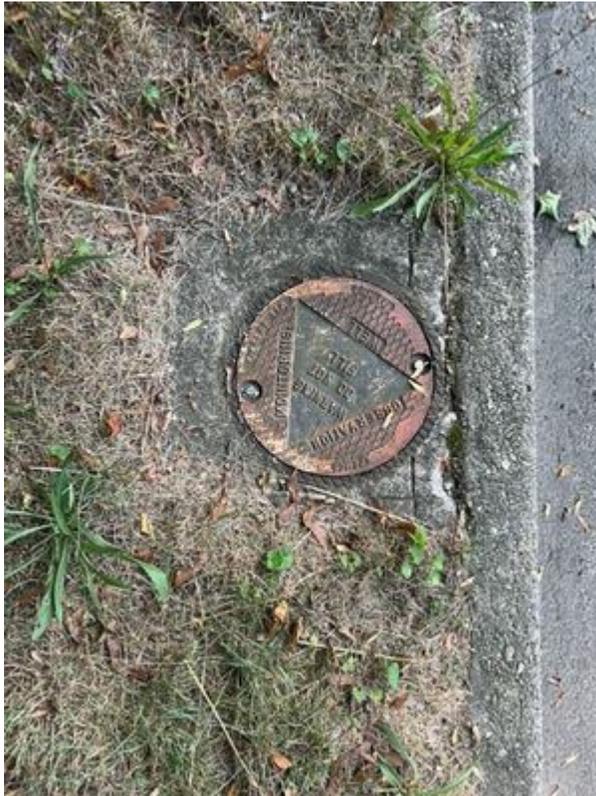
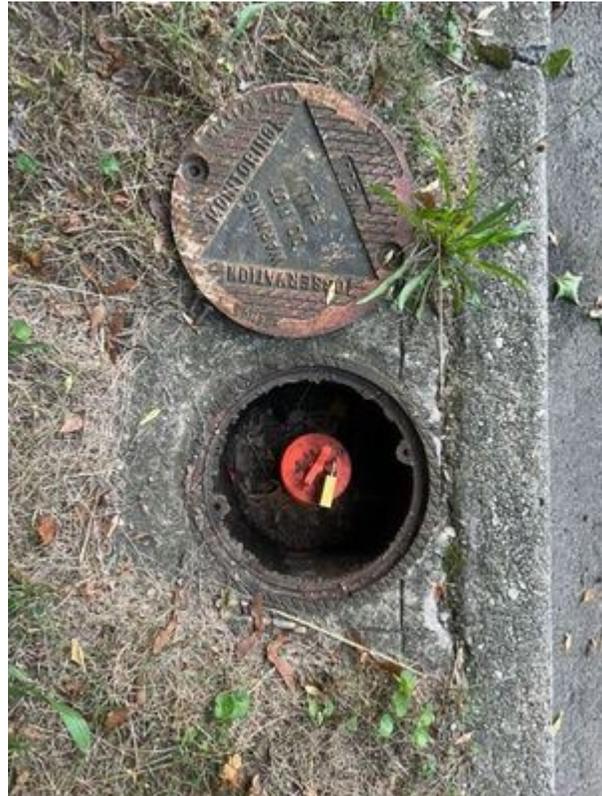
Client: Navy CLEAN	Facility: NWIRP Bethpage
Project Number: 112G08005-WE13	Location: Bethpage, New York
Date: July 9, 2024 16:29	Personnel: Jake Marlow
Well ID: RE104D2	Well Location: 206999.608428117 1127702.73356432
Well Status: In Use (Confirmed)	Screen Interval: 710-730
WELL INVENTORY CONDITION	
Concrete pad in acceptable condition i.e. no cracks?	YES
Manhole cover present and in working condition?	YES
All bolts on manhole present and not stripped?	YES
Well plug present, locked and in good working condition?	YES
OVERALL CONDITION:	GOOD
Notes (Explain if answered No to any of the above)

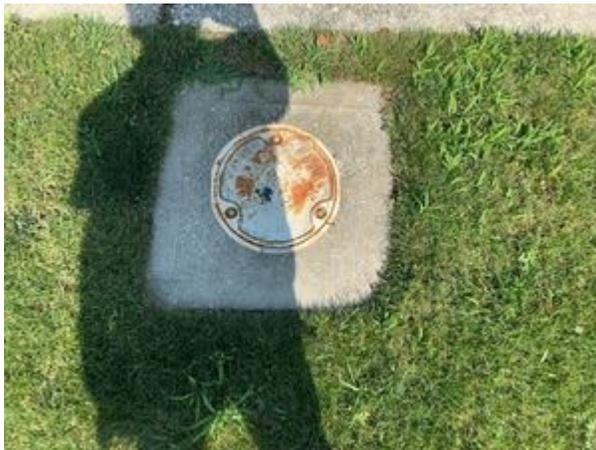
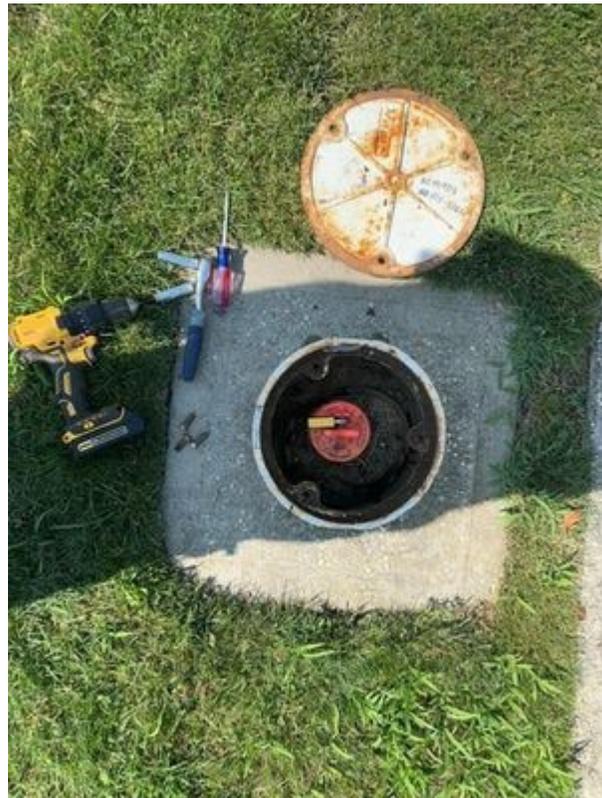
Client: Navy CLEAN	Facility: NWIRP Bethpage
Project Number: 112G08005-WE13	Location: Bethpage, New York
Date: July 9, 2024 15:35	Personnel: Jake Marlow
Well ID: RE109D1	Well Location: 208532.846490949 1126648.12996107
Well Status: In Use (Confirmed)	Screen Interval: 515-535
WELL INVENTORY CONDITION	
Concrete pad in acceptable condition i.e. no cracks?	YES
Manhole cover present and in working condition?	YES
All bolts on manhole present and not stripped?	YES
Well plug present, locked and in good working condition?	YES
OVERALL CONDITION:	GOOD
Notes (Explain if answered No to any of the above)

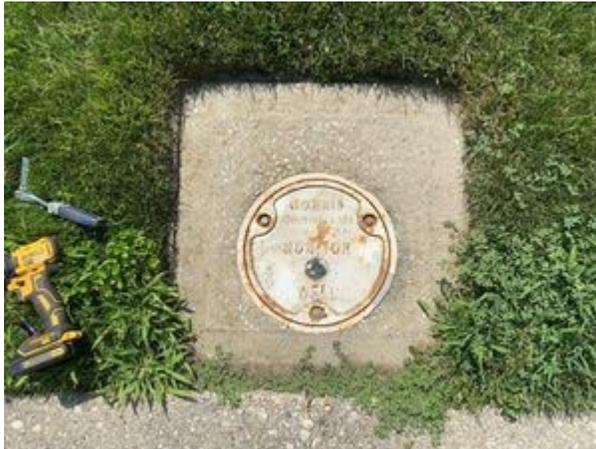
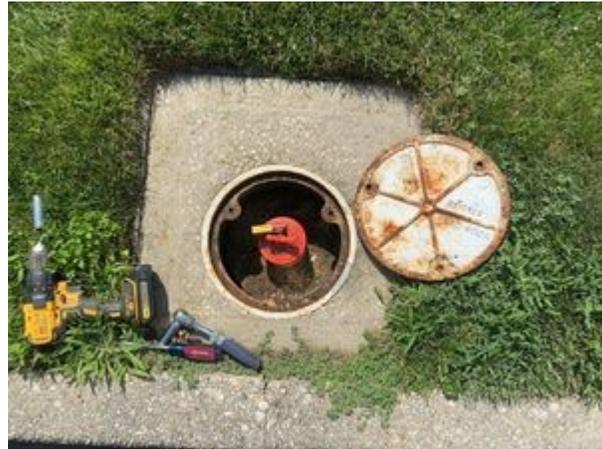
Client: Navy CLEAN	Facility: NWIRP Bethpage
Project Number: 112G08005-WE13	Location: Bethpage, New York
Date: July 9, 2024 15:32	Personnel: Jake Marlow
Well ID: RE109D3	Well Location: 208553.939840864 1126646.64165022
Well Status: In Use (Confirmed)	Screen Interval: 580-600
WELL INVENTORY CONDITION	
Concrete pad in acceptable condition i.e. no cracks?	YES
Manhole cover present and in working condition?	YES
All bolts on manhole present and not stripped?	YES
Well plug present, locked and in good working condition?	YES
OVERALL CONDITION:	GOOD
Notes (Explain if answered No to any of the above)

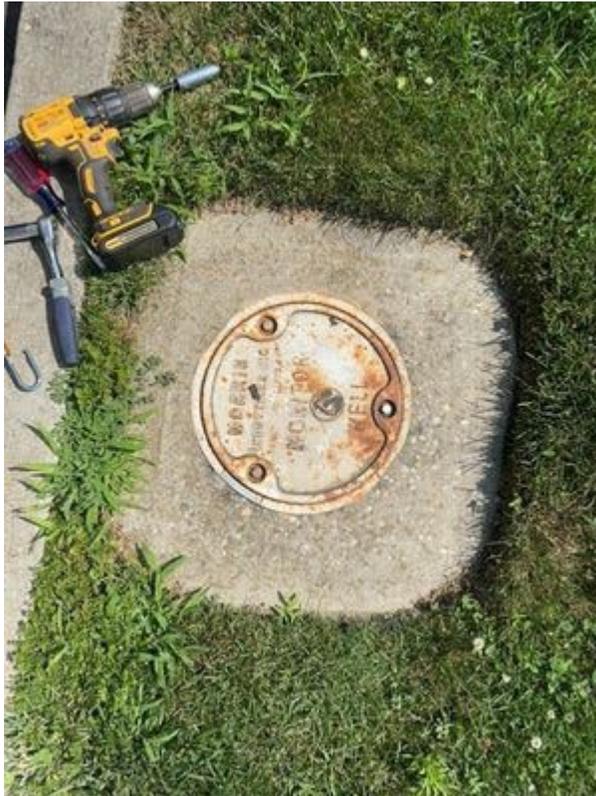
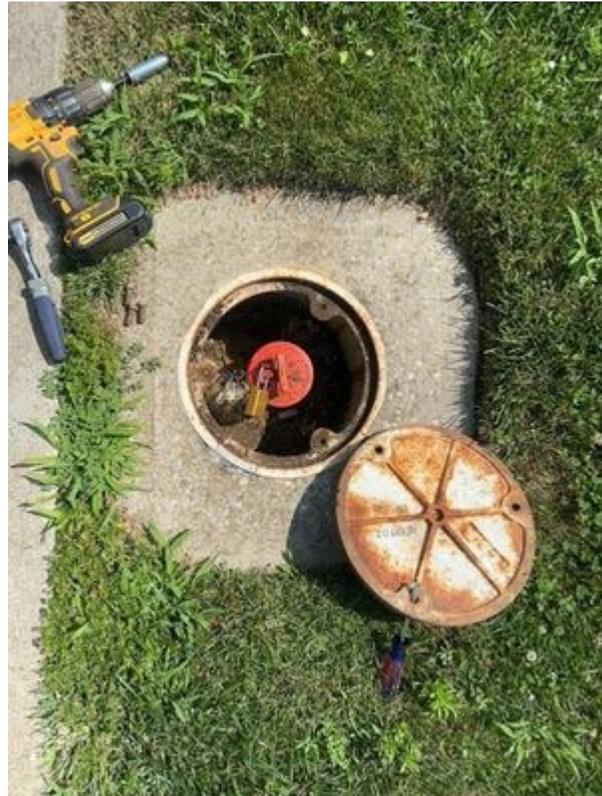
Client: Navy CLEAN	Facility: NWIRP Bethpage
Project Number: 112G08005-WE13	Location: Bethpage, New York
Date: July 9, 2024 15:29	Personnel: Jake Marlow
Well ID: RE109D2	Well Location: 208578.59440718 1126654.12745086
Well Status: In Use (Confirmed)	Screen Interval: 550-570
WELL INVENTORY CONDITION	
Concrete pad in acceptable condition i.e. no cracks?	YES
Manhole cover present and in working condition?	YES
All bolts on manhole present and not stripped?	YES
Well plug present, locked and in good working condition?	YES
OVERALL CONDITION:	GOOD
Notes (Explain if answered No to any of the above) Replaced lock

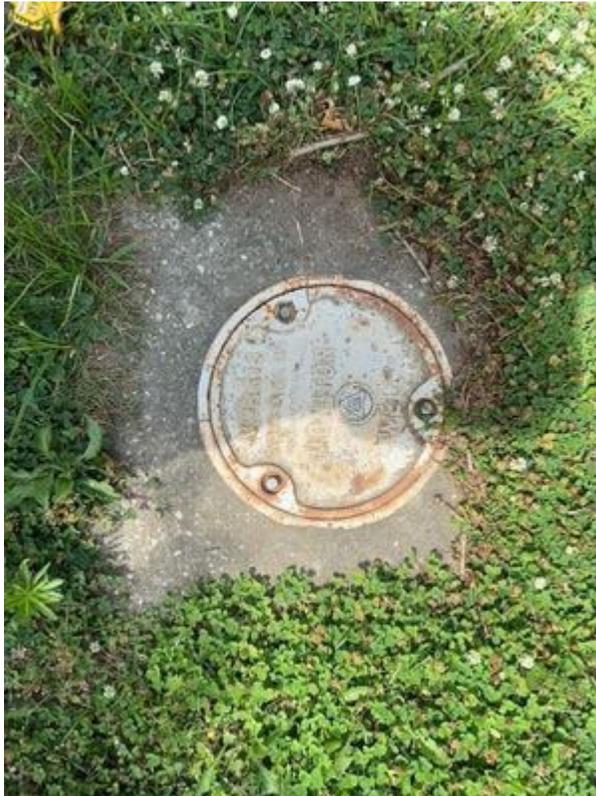
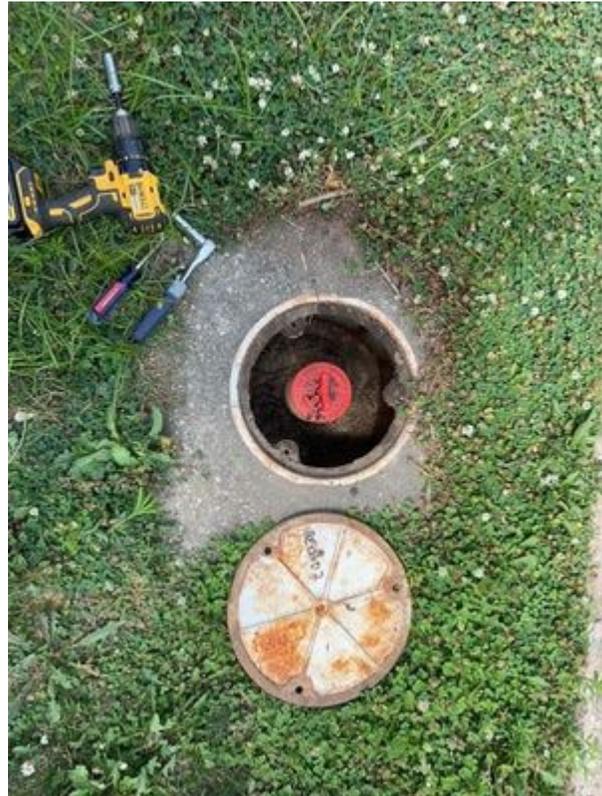
Client: Navy CLEAN	Facility: NWIRP Bethpage
Project Number: 112G08005-WE13	Location: Bethpage, New York
Date: July 9, 2024 14:44	Personnel: Jake Marlow
Well ID: RE126D2	Well Location: 208590.033145561 1125645.3527688
Well Status: In Use (Confirmed)	Screen Interval: 555-575
WELL INVENTORY CONDITION	
Concrete pad in acceptable condition i.e. no cracks?	YES
Manhole cover present and in working condition?	YES
All bolts on manhole present and not stripped?	YES
Well plug present, locked and in good working condition?	YES
OVERALL CONDITION:	GOOD
Notes (Explain if answered No to any of the above)

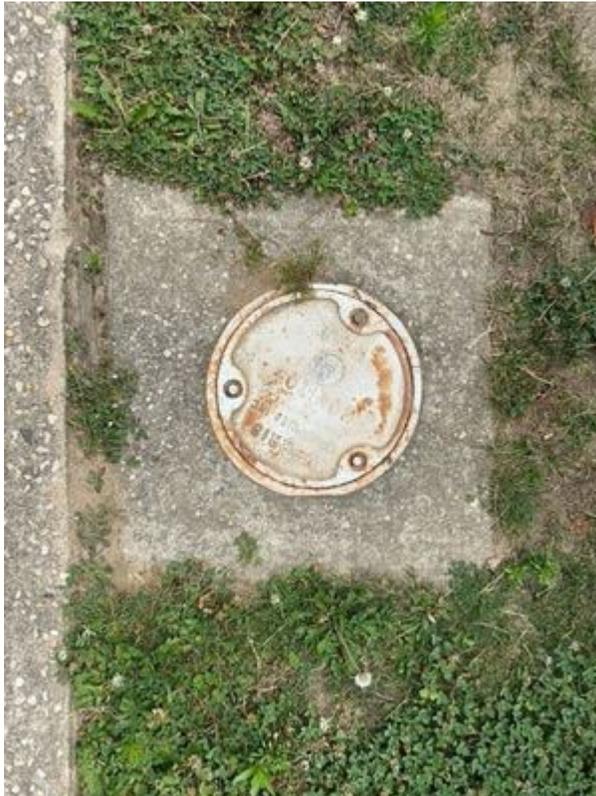
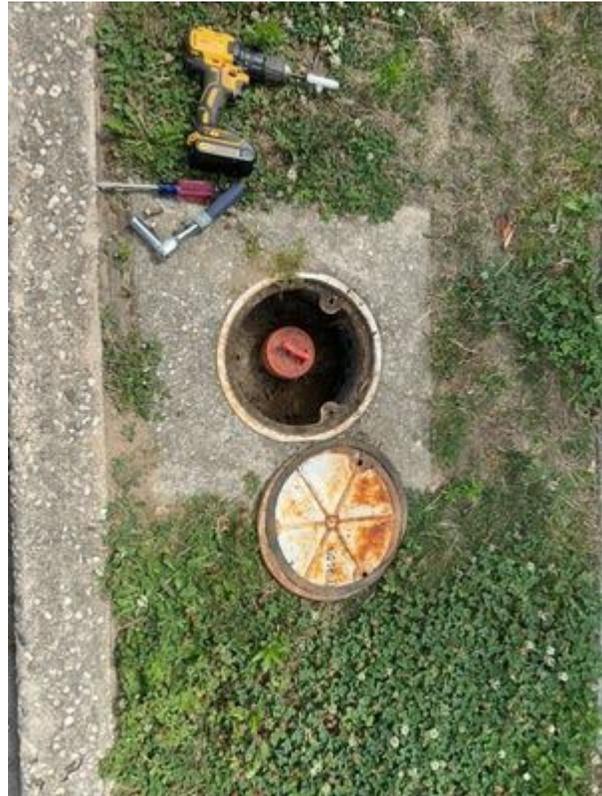
Client: Navy CLEAN	Facility: NWIRP Bethpage
Project Number: 112G08005-WE13	Location: Bethpage, New York
Date: July 9, 2024 14:40	Personnel: Jake Marlow
Well ID: RE126D3	Well Location: 208566.159938417 1125640.85271251
Well Status: In Use (Confirmed)	Screen Interval: 640-660
WELL INVENTORY CONDITION	
Concrete pad in acceptable condition i.e. no cracks?	NO
Manhole cover present and in working condition?	YES
All bolts on manhole present and not stripped?	YES
Well plug present, locked and in good working condition?	YES
OVERALL CONDITION:	FAIR
Notes (Explain if answered No to any of the above) Cracks in pad

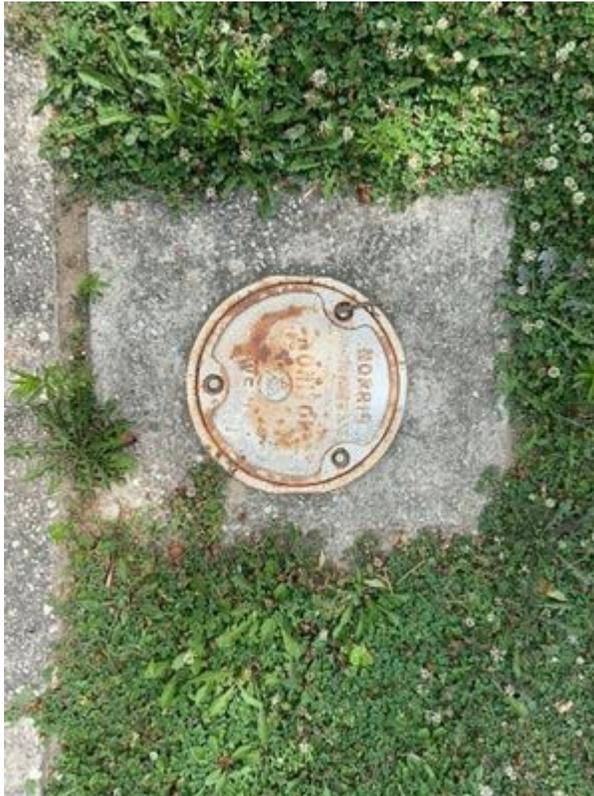
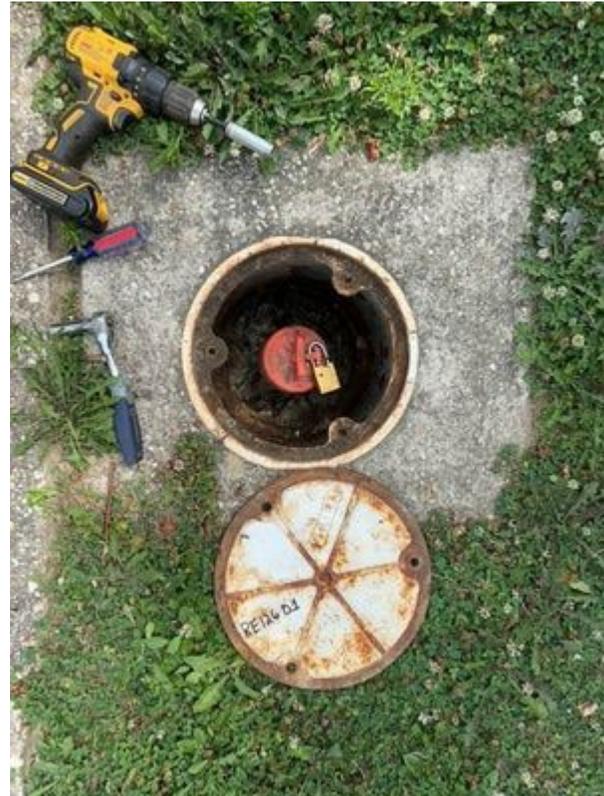
Client: Navy CLEAN	Facility: NWIRP Bethpage
Project Number: 112G08005-WE13	Location: Bethpage, New York
Date: July 9, 2024 14:37	Personnel: Jake Marlow
Well ID: RE126D1	Well Location: 208551.087950683 1125642.717996
Well Status: In Use (Confirmed)	Screen Interval: 500-520
WELL INVENTORY CONDITION	
Concrete pad in acceptable condition i.e. no cracks?	YES
Manhole cover present and in working condition?	YES
All bolts on manhole present and not stripped?	YES
Well plug present, locked and in good working condition?	YES
OVERALL CONDITION:	GOOD
Notes (Explain if answered No to any of the above)

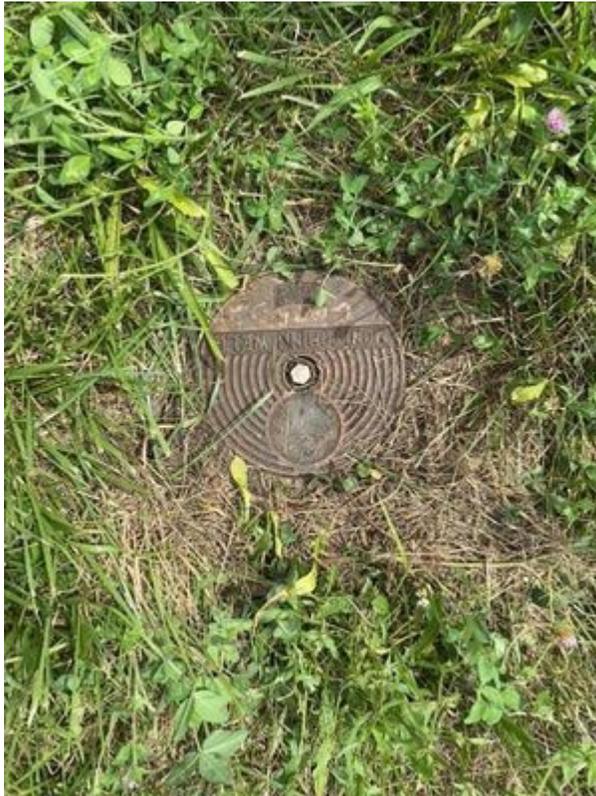
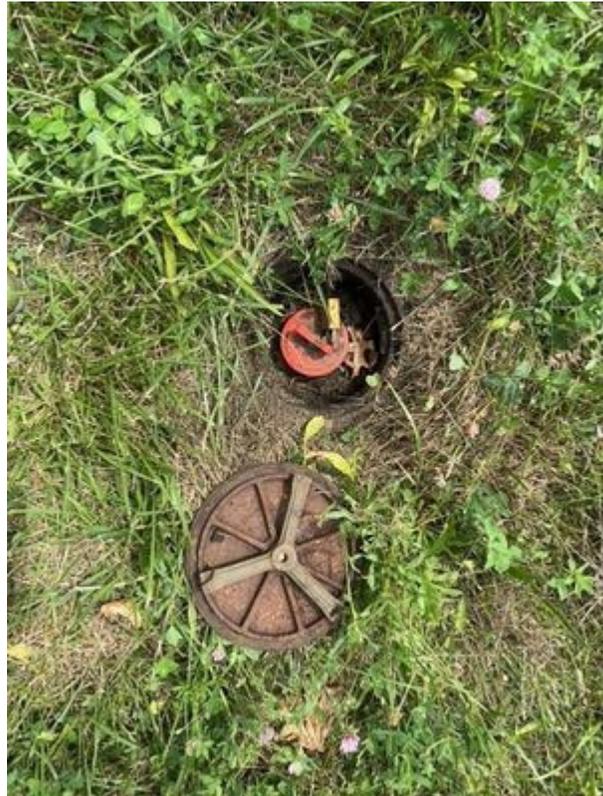
Client: Navy CLEAN	Facility: NWIRP Bethpage
Project Number: 112G08005-WE13	Location: Bethpage, New York
Date: July 9, 2024 14:26	Personnel: Jake Marlow
Well ID: BPGMMW75D2	Well Location: 208490.903585835 1124240.21530947
Well Status: In Use (Confirmed)	Screen Interval: 505-525
WELL INVENTORY CONDITION	
Concrete pad in acceptable condition i.e. no cracks?	YES
Manhole cover present and in working condition?	YES
All bolts on manhole present and not stripped?	YES
Well plug present, locked and in good working condition?	YES
OVERALL CONDITION:	GOOD
Notes (Explain if answered No to any of the above)

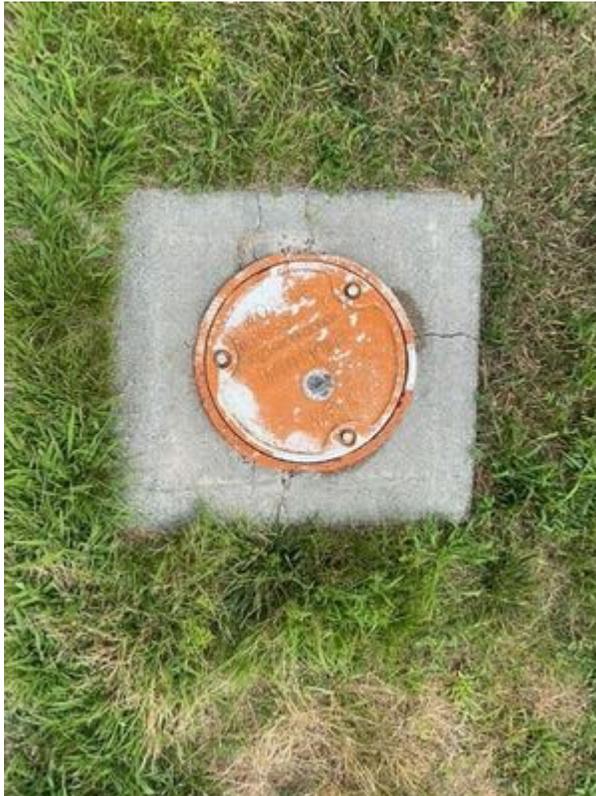
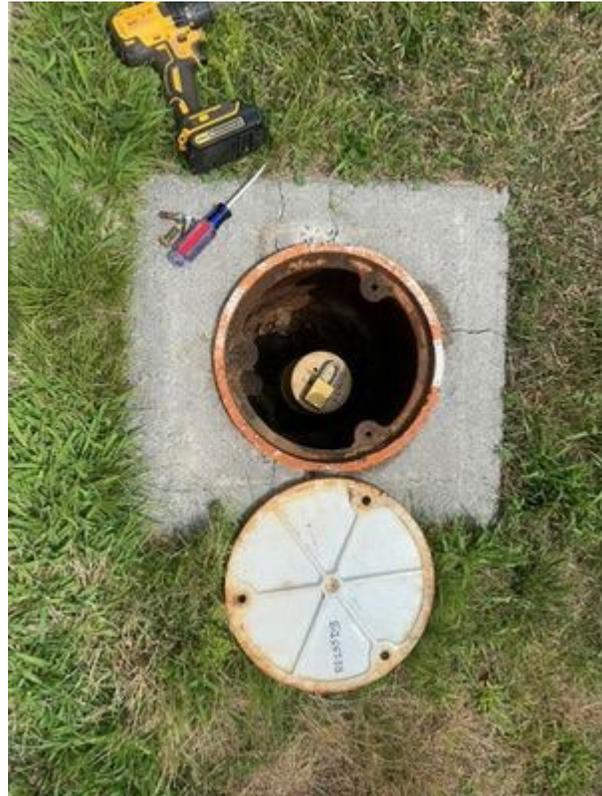
Client: Navy CLEAN	Facility: NWIRP Bethpage
Project Number: 112G08005-WE13	Location: Bethpage, New York
Date: July 9, 2024 14:13	Personnel: Jake Marlow
Well ID: RE135D3	Well Location: 204567.065070889 1120810.99290632
Well Status: In Use (Confirmed)	Screen Interval: 640-660
WELL INVENTORY CONDITION	
Concrete pad in acceptable condition i.e. no cracks?	NO
Manhole cover present and in working condition?	YES
All bolts on manhole present and not stripped?	YES
Well plug present, locked and in good working condition?	YES
OVERALL CONDITION:	FAIR
Notes (Explain if answered No to any of the above) Cracks in pad

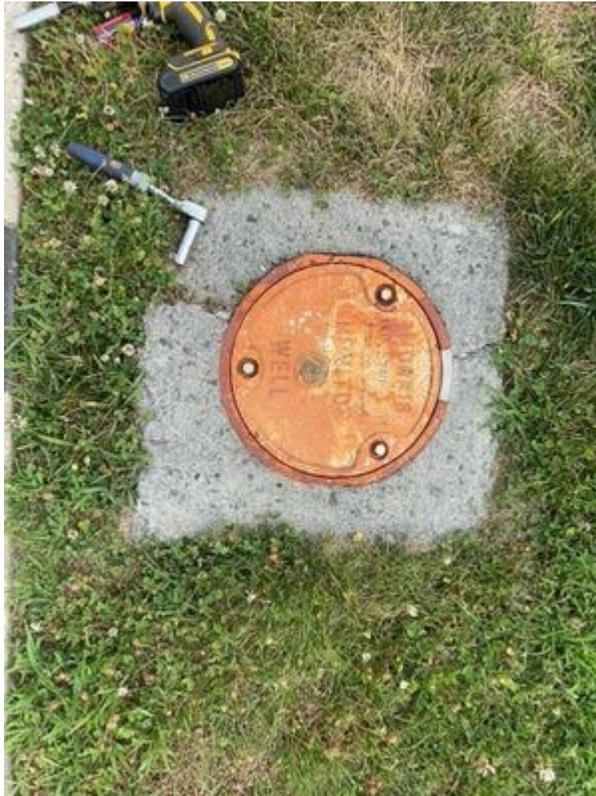
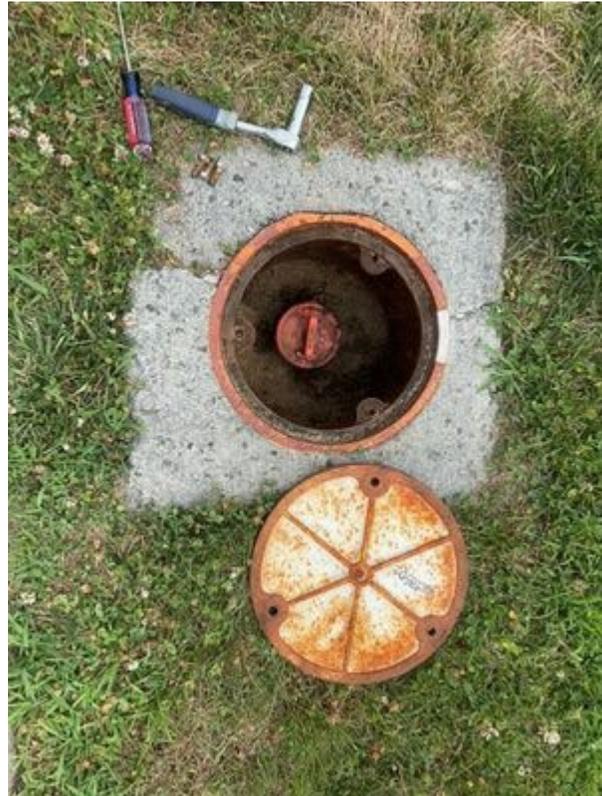
Client: Navy CLEAN	Facility: NWIRP Bethpage
Project Number: 112G08005-WE13	Location: Bethpage, New York
Date: July 9, 2024 14:08	Personnel: Jake Marlow
Well ID: RE135D2	Well Location: 204573.746809087 1120787.89597569
Well Status: In Use (Confirmed)	Screen Interval: 545-565
WELL INVENTORY CONDITION	
Concrete pad in acceptable condition i.e. no cracks?	NO
Manhole cover present and in working condition?	YES
All bolts on manhole present and not stripped?	YES
Well plug present, locked and in good working condition?	NO
OVERALL CONDITION:	FAIR
Notes (Explain if answered No to any of the above) Cracks in pad, missing lock

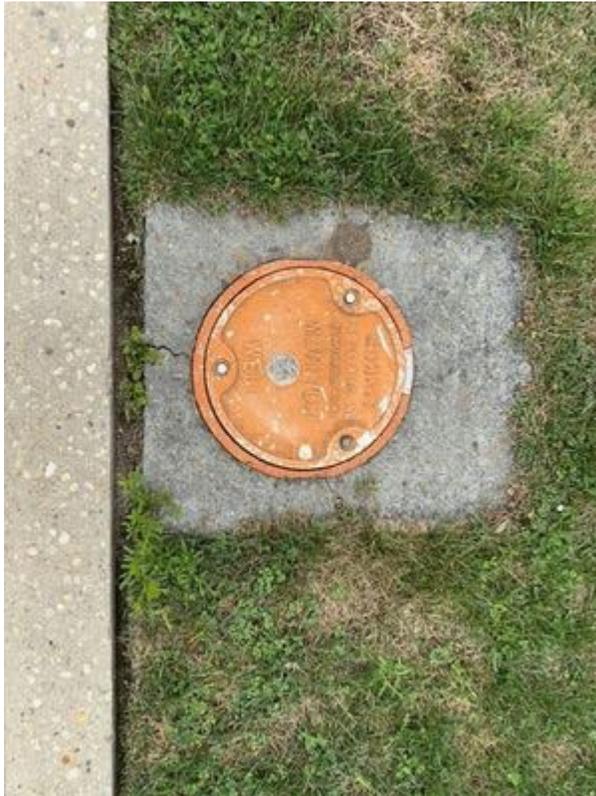
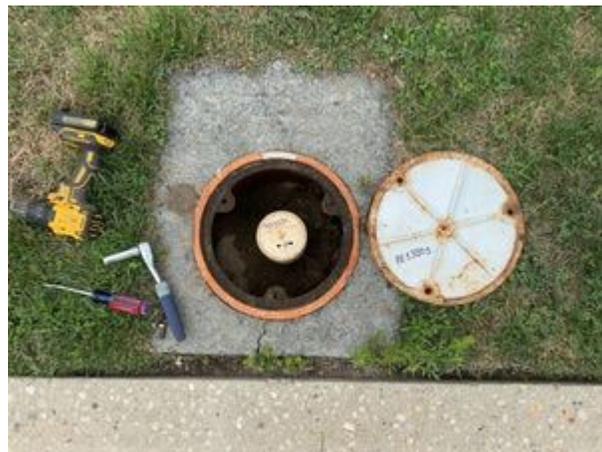
Client: Navy CLEAN	Facility: NWIRP Bethpage
Project Number: 112G08005-WE13	Location: Bethpage, New York
Date: July 9, 2024 14:05	Personnel: Jake Marlow
Well ID: RE135D1	Well Location: 204605.535373306 1120805.22532459
Well Status: In Use (Confirmed)	Screen Interval: 410-430
WELL INVENTORY CONDITION	
Concrete pad in acceptable condition i.e. no cracks?	NO
Manhole cover present and in working condition?	YES
All bolts on manhole present and not stripped?	YES
Well plug present, locked and in good working condition?	YES
OVERALL CONDITION:	FAIR
Notes (Explain if answered No to any of the above) Cracks in pad

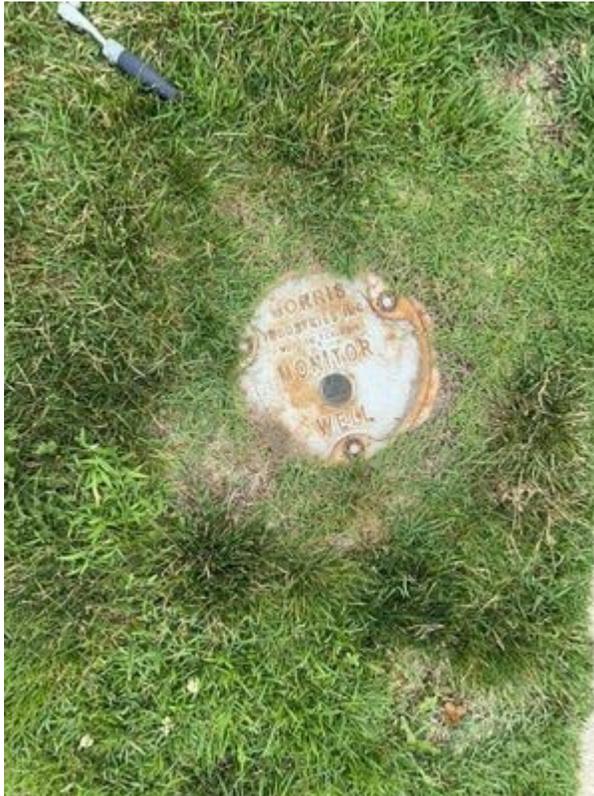
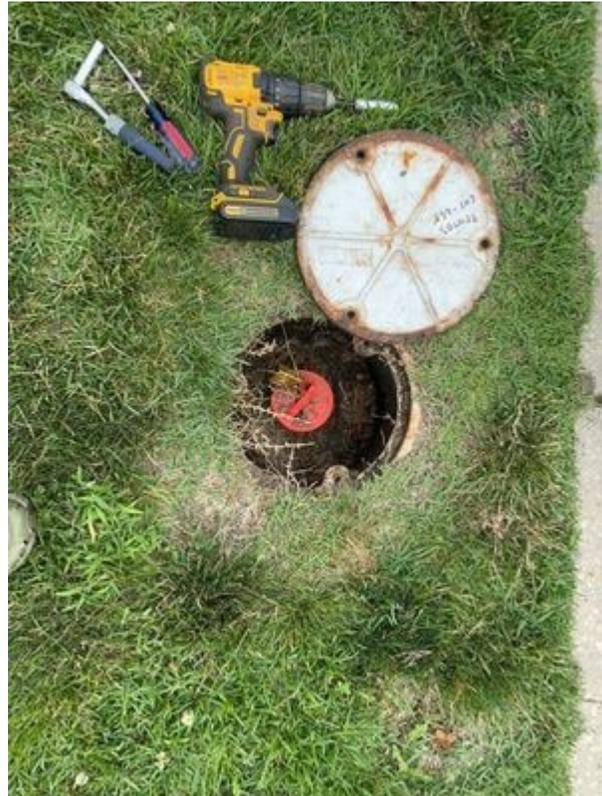
Client: Navy CLEAN	Facility: NWIRP Bethpage
Project Number: 112G08005-WE13	Location: Bethpage, New York
Date: July 9, 2024 13:52	Personnel: Jake Marlow
Well ID: RE107D3	Well Location: 208496.689847734 1123764.91587742
Well Status: In Use (Confirmed)	Screen Interval: 645-665
WELL INVENTORY CONDITION	
Concrete pad in acceptable condition i.e. no cracks?	YES
Manhole cover present and in working condition?	YES
All bolts on manhole present and not stripped?	YES
Well plug present, locked and in good working condition?	YES
OVERALL CONDITION:	GOOD
Notes (Explain if answered No to any of the above)

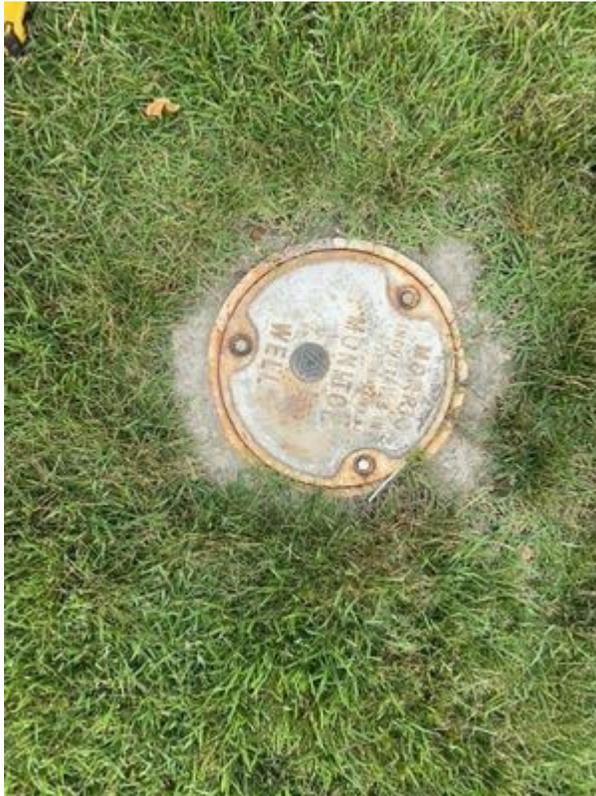
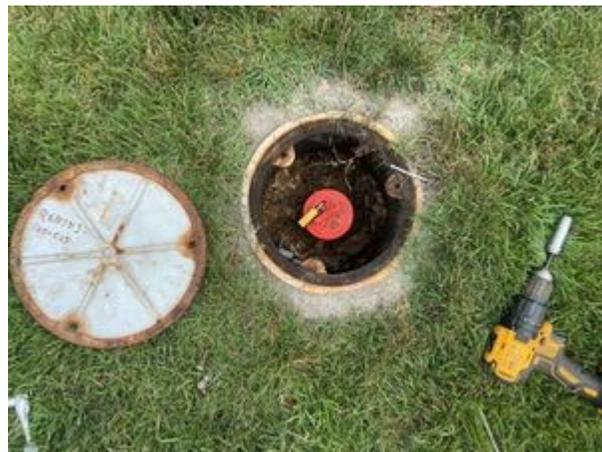
Client: Navy CLEAN	Facility: NWIRP Bethpage
Project Number: 112G08005-WE13	Location: Bethpage, New York
Date: July 9, 2024 13:49	Personnel: Jake Marlow
Well ID: RE107D1	Well Location: 208548.597440475 1123825.20007228
Well Status: In Use (Confirmed)	Screen Interval: 505-525
WELL INVENTORY CONDITION	
Concrete pad in acceptable condition i.e. no cracks?	YES
Manhole cover present and in working condition?	YES
All bolts on manhole present and not stripped?	YES
Well plug present, locked and in good working condition?	YES
OVERALL CONDITION:	GOOD
Notes (Explain if answered No to any of the above)

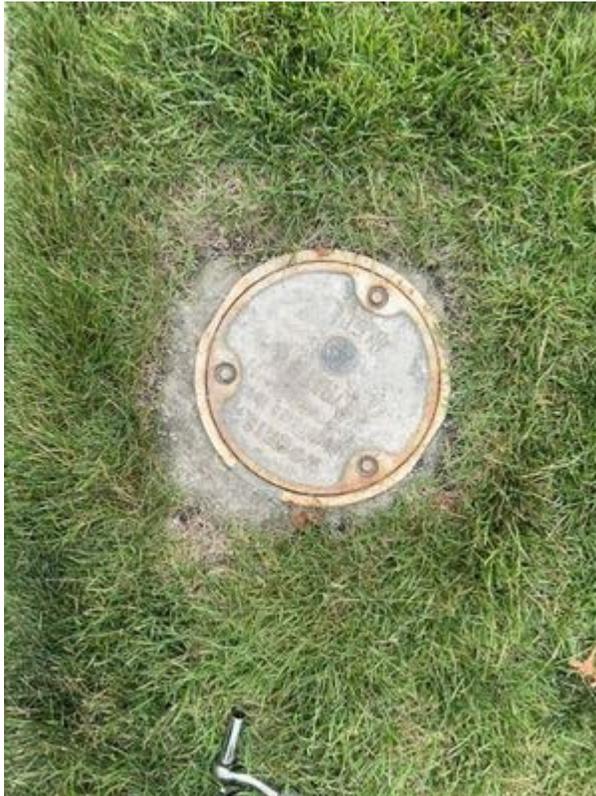
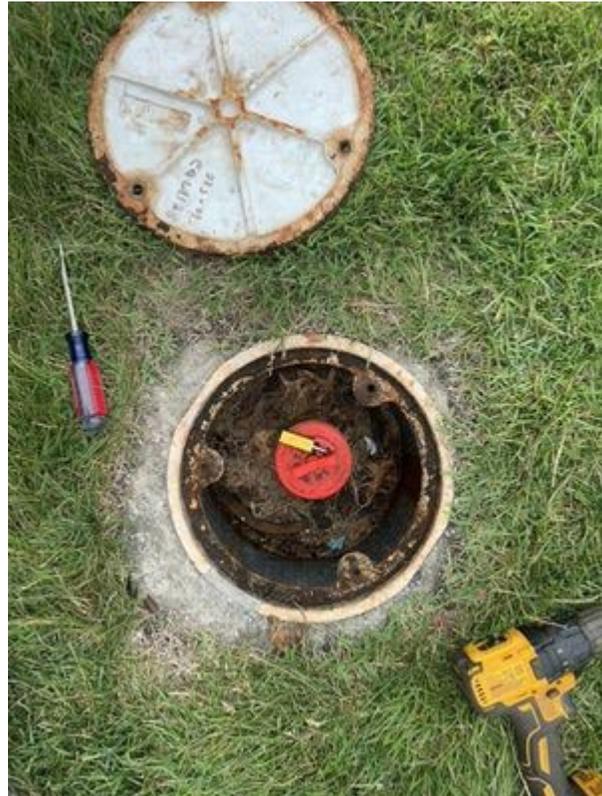
Client: Navy CLEAN	Facility: NWIRP Bethpage
Project Number: 112G08005-WE13	Location: Bethpage, New York
Date: July 9, 2024 13:47	Personnel: Jake Marlow
Well ID: RE107D2	Well Location: 208560.2593782 1123834.67977281
Well Status: In Use (Confirmed)	Screen Interval: 560-580
WELL INVENTORY CONDITION	
Concrete pad in acceptable condition i.e. no cracks?	YES
Manhole cover present and in working condition?	YES
All bolts on manhole present and not stripped?	YES
Well plug present, locked and in good working condition?	YES
OVERALL CONDITION:	GOOD
Notes (Explain if answered No to any of the above)

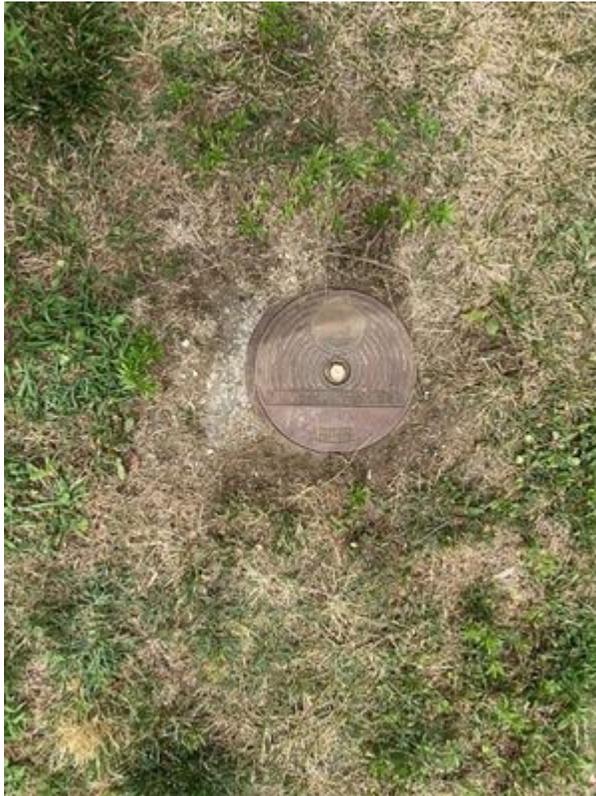
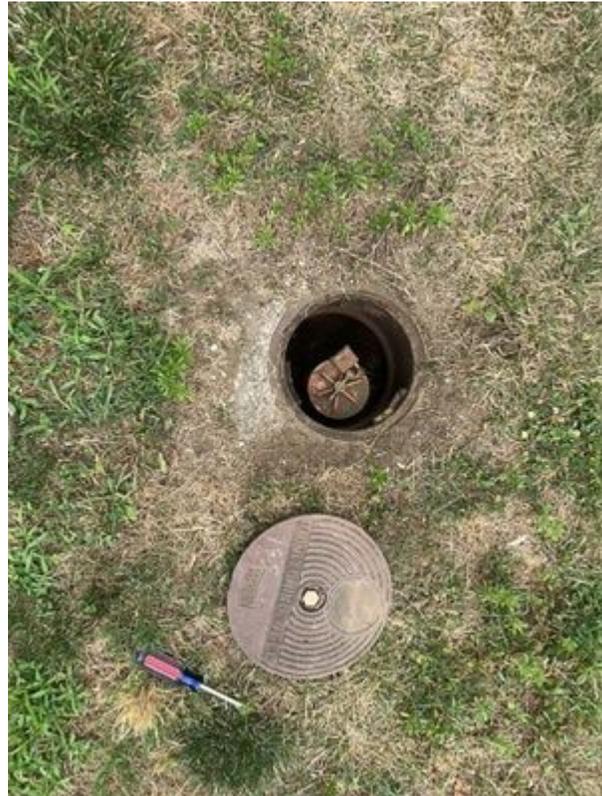
Client: Navy CLEAN	Facility: NWIRP Bethpage
Project Number: 112G08005-WE13	Location: Bethpage, New York
Date: July 9, 2024 13:42	Personnel: Jake Marlow
Well ID: BPGMMW78S	Well Location: 209353.113074399 1123626.46194022
Well Status: In Use (Confirmed)	Screen Interval: 60-70
WELL INVENTORY CONDITION	
Concrete pad in acceptable condition i.e. no cracks?	YES
Manhole cover present and in working condition?	YES
All bolts on manhole present and not stripped?	NO
Well plug present, locked and in good working condition?	YES
OVERALL CONDITION:	FAIR
Notes (Explain if answered No to any of the above) Bolt is stripped

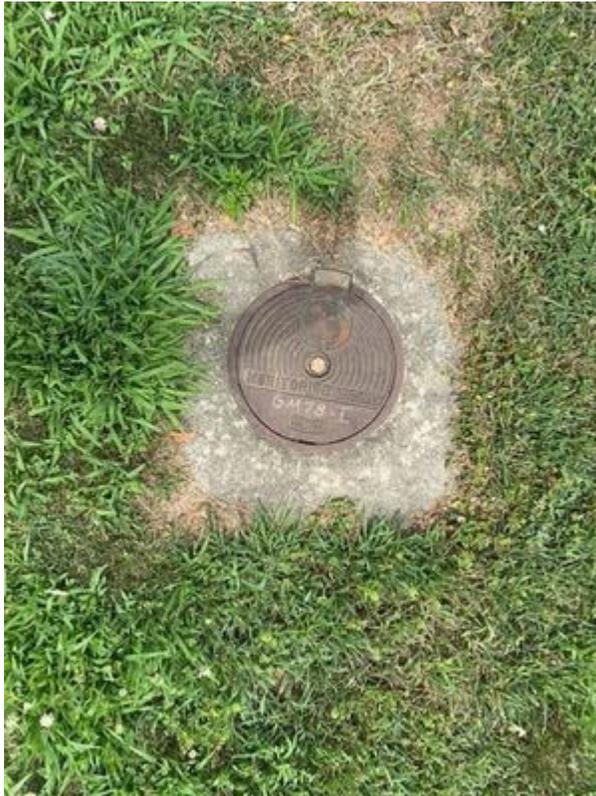
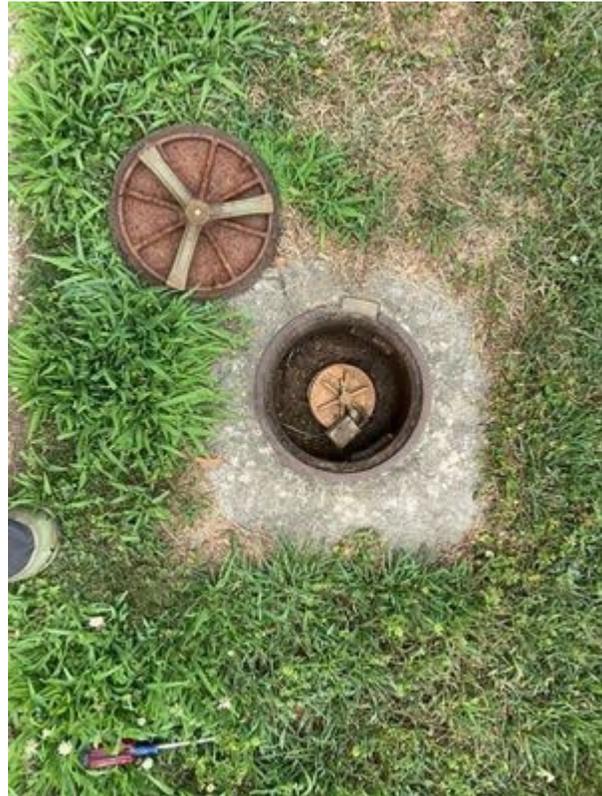
Client: Navy CLEAN	Facility: NWIRP Bethpage
Project Number: 112G08005-WE13	Location: Bethpage, New York
Date: July 9, 2024 13:38	Personnel: Jake Marlow
Well ID: BPGMMW78I	Well Location: 209331.673890096 1123622.38337063
Well Status: In Use (Confirmed)	Screen Interval: 90-100
WELL INVENTORY CONDITION	
Concrete pad in acceptable condition i.e. no cracks?	YES
Manhole cover present and in working condition?	YES
All bolts on manhole present and not stripped?	NO
Well plug present, locked and in good working condition?	YES
OVERALL CONDITION:	FAIR
Notes (Explain if answered No to any of the above) Bolt is stripped

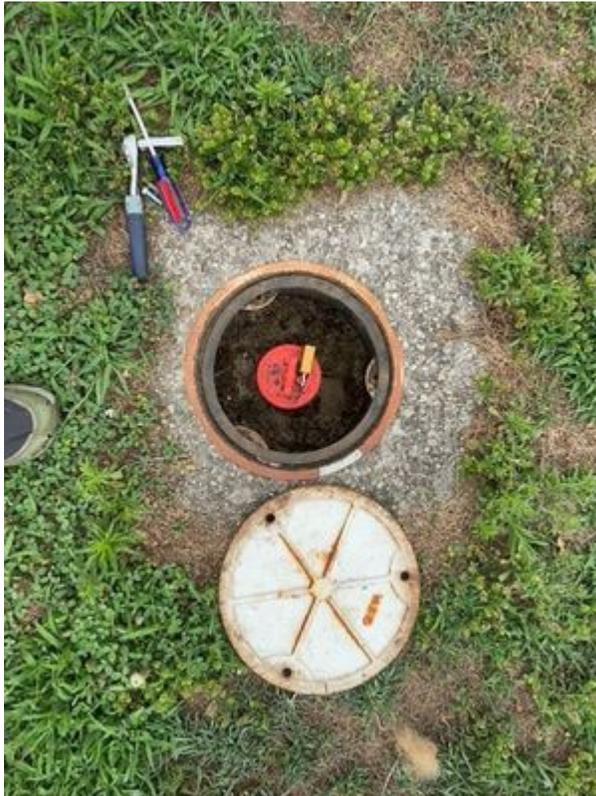
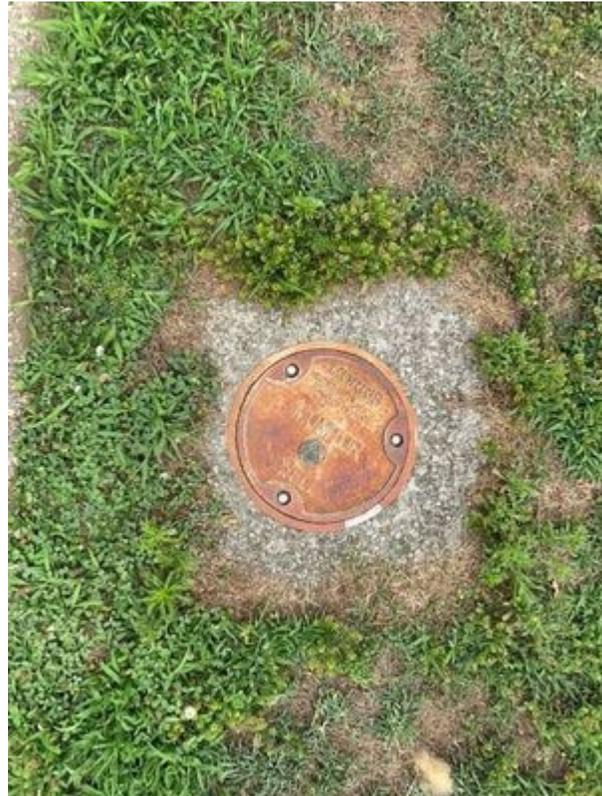
Client: Navy CLEAN	Facility: NWIRP Bethpage
Project Number: 112G08005-WE13	Location: Bethpage, New York
Date: July 9, 2024 13:31	Personnel: Jake Marlow
Well ID: RE106D3	Well Location: 209341.874777547 1122876.33100144
Well Status: In Use (Confirmed)	Screen Interval: 510-530
WELL INVENTORY CONDITION	
Concrete pad in acceptable condition i.e. no cracks?	YES
Manhole cover present and in working condition?	YES
All bolts on manhole present and not stripped?	YES
Well plug present, locked and in good working condition?	YES
OVERALL CONDITION:	GOOD
Notes (Explain if answered No to any of the above) Replaced missing bolt

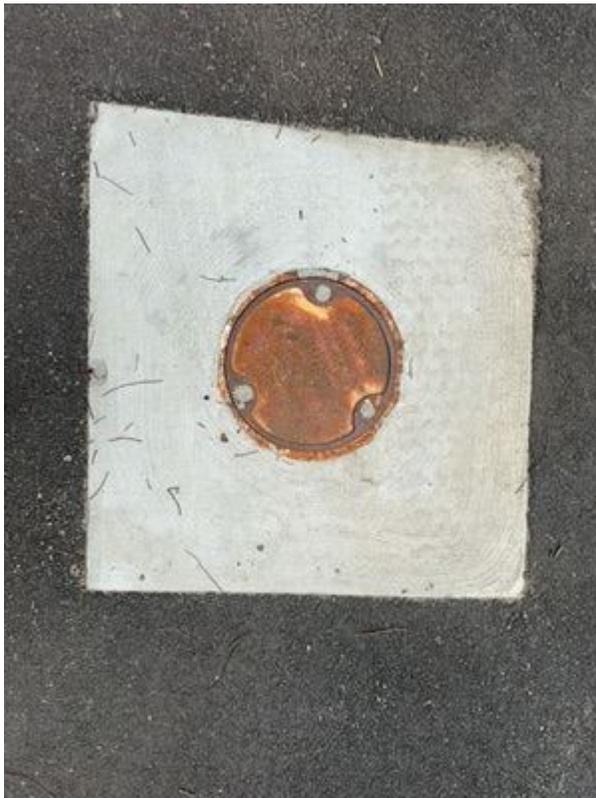
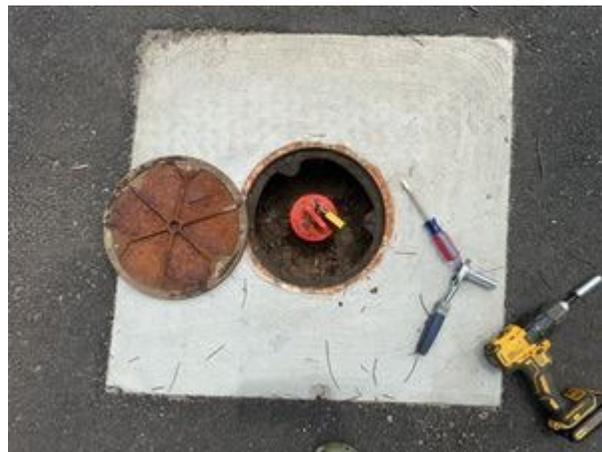
Client: Navy CLEAN	Facility: NWIRP Bethpage
Project Number: 112G08005-WE13	Location: Bethpage, New York
Date: July 9, 2024 12:57	Personnel: Jake Marlow
Well ID: RE131D1	Well Location: 204362.250184186 1123120.38637669
Well Status: In Use (Confirmed)	Screen Interval: 430-450
WELL INVENTORY CONDITION	
Concrete pad in acceptable condition i.e. no cracks?	YES
Manhole cover present and in working condition?	NO
All bolts on manhole present and not stripped?	NO
Well plug present, locked and in good working condition?	YES
OVERALL CONDITION:	FAIR
Notes (Explain if answered No to any of the above) Manhole cover has cement in bolt holes
