Memorandum

To: Scott Sokolowski, NAVFAC MIDLANT
From: Richard Moore, Tetra Tech
Date: September 27, 2024
Re: Annual LUC Inspection and Operation Summary Report: Sites 1, 2, 3, and 4 –
NWIRP Bethpage
Contract/CTO Number: N6247016D9008/WE16

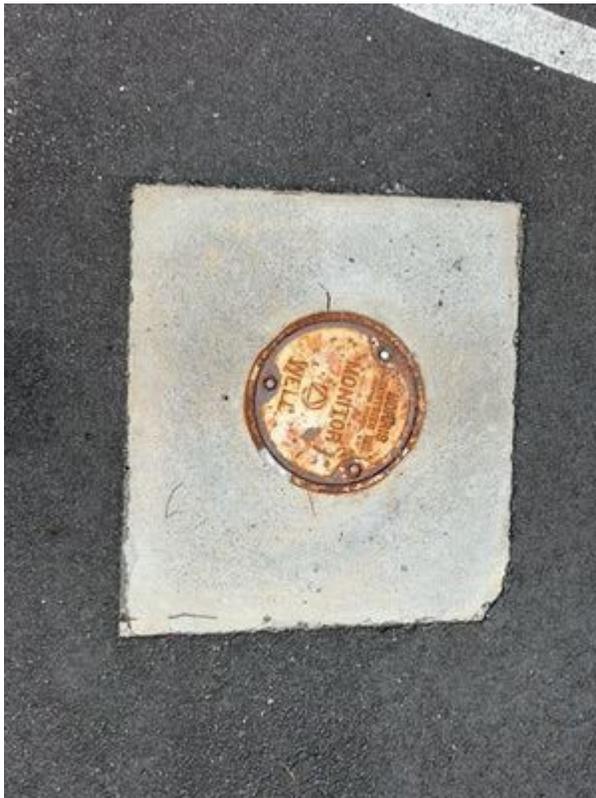
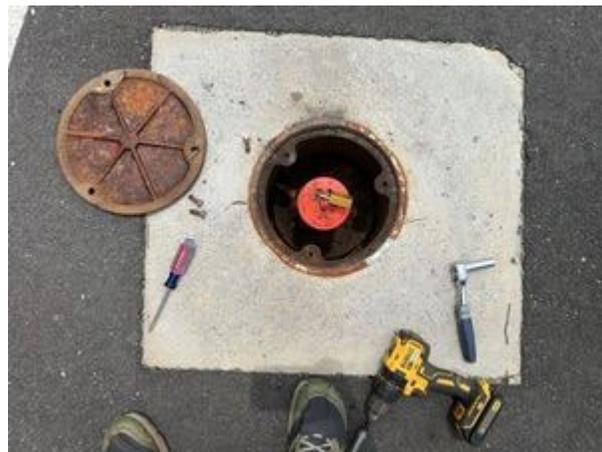
Client: Navy CLEAN	Facility: NWIRP Bethpage
Project Number: 112G08005-WE13	Location: Bethpage, New York
Date: July 9, 2024 12:52	Personnel: Jake Marlow
Well ID: RE131D3	Well Location: 204349.764091008 1123120.21221665
Well Status: In Use (Confirmed)	Screen Interval: 660-680
WELL INVENTORY CONDITION	
Concrete pad in acceptable condition i.e. no cracks?	YES
Manhole cover present and in working condition?	YES
All bolts on manhole present and not stripped?	YES
Well plug present, locked and in good working condition?	NO
OVERALL CONDITION:	FAIR
Notes (Explain if answered No to any of the above) Can not fully close manhole cover with JPlug on

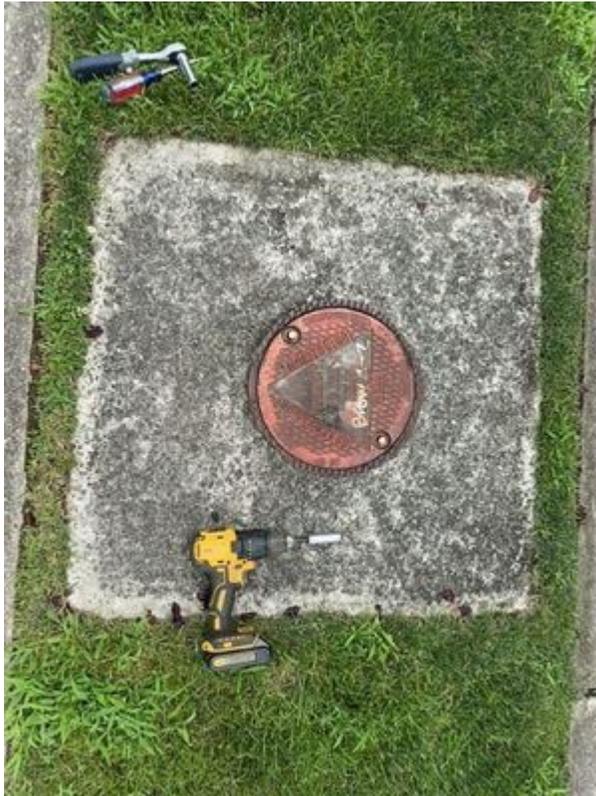
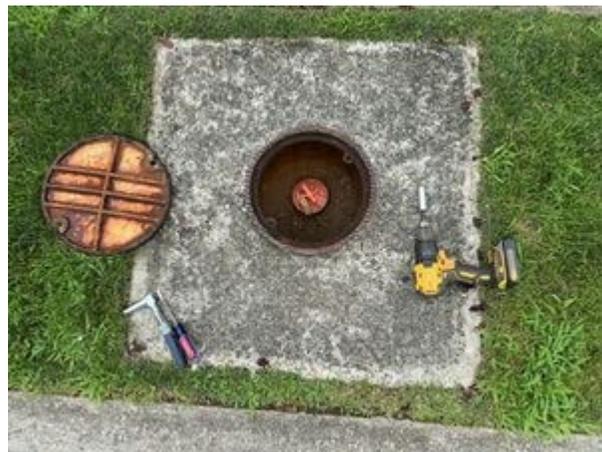
Client: Navy CLEAN	Facility: NWIRP Bethpage
Project Number: 112G08005-WE13	Location: Bethpage, New York
Date: July 9, 2024 12:04	Personnel: Jake Marlow
Well ID: BPOW1-1	Well Location: 202000.913579254 1132153.10385717
Well Status: In Use (Confirmed)	Screen Interval: 196-241
WELL INVENTORY CONDITION	
Concrete pad in acceptable condition i.e. no cracks?	YES
Manhole cover present and in working condition?	YES
All bolts on manhole present and not stripped?	NO
Well plug present, locked and in good working condition?	YES
OVERALL CONDITION:	GOOD
Notes (Explain if answered No to any of the above) Threads for bolts on manhole are stripped

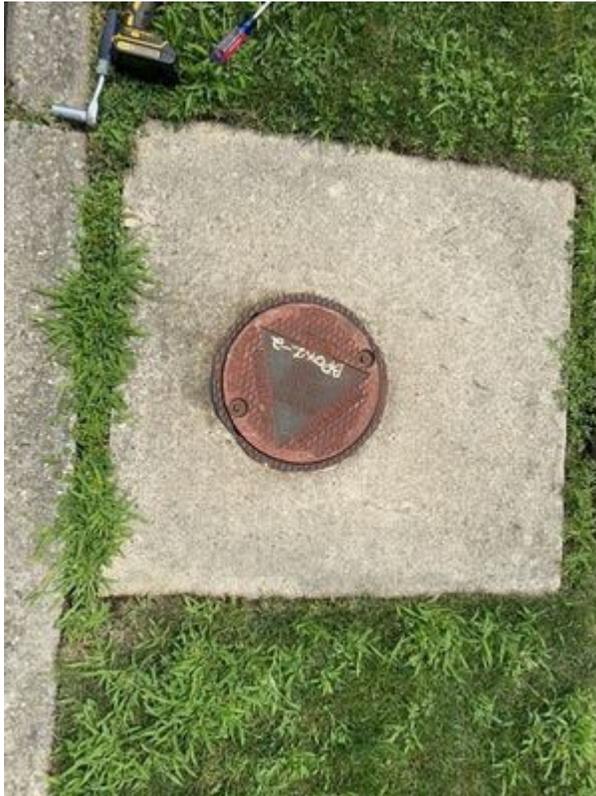
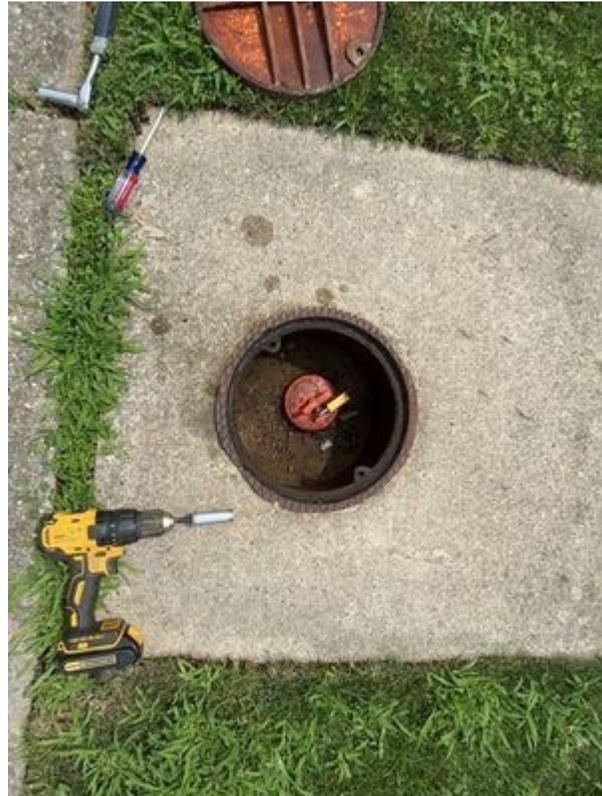
Client: Navy CLEAN	Facility: NWIRP Bethpage
Project Number: 112G08005-WE13	Location: Bethpage, New York
Date: July 9, 2024 12:00	Personnel: Jake Marlow
Well ID: BPOW1-2	Well Location: 202005.066672264 1132177.14893897
Well Status: In Use (Confirmed)	Screen Interval: 310-335
WELL INVENTORY CONDITION	
Concrete pad in acceptable condition i.e. no cracks?	YES
Manhole cover present and in working condition?	YES
All bolts on manhole present and not stripped?	NO
Well plug present, locked and in good working condition?	YES
OVERALL CONDITION:	FAIR
Notes (Explain if answered No to any of the above) Threads for bolts on manhole are stripped

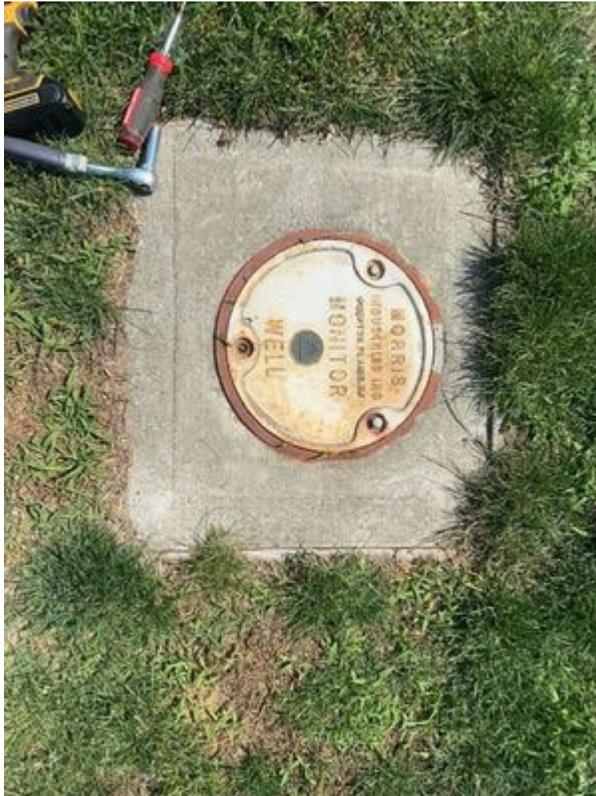
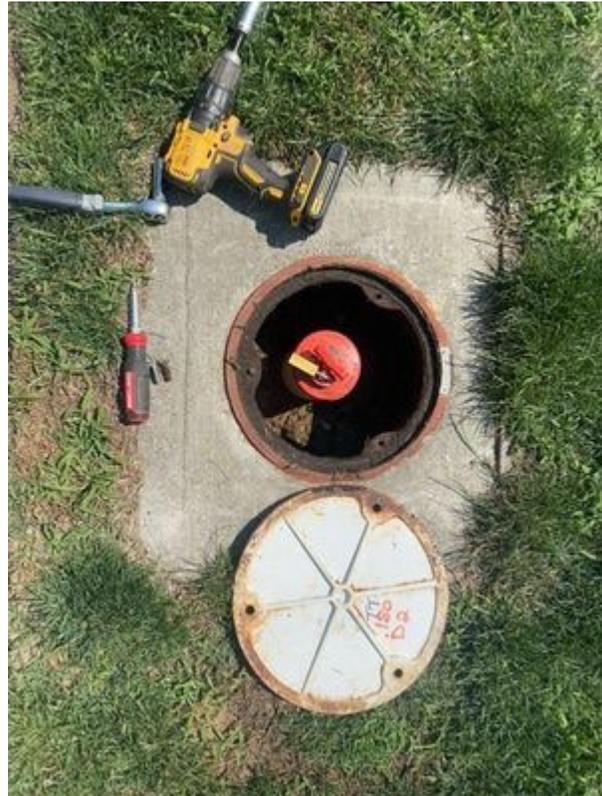
Client: Navy CLEAN	Facility: NWIRP Bethpage
Project Number: 112G08005-WE13	Location: Bethpage, New York
Date: June 13, 2024 14:58	Personnel: Jake Marlow
Well ID: BP-TT-MW180D2	Well Location: 200967.776074546 1124943.3832937
Well Status: In Use (Confirmed)	Screen Interval: 710-730
WELL INVENTORY CONDITION	
Concrete pad in acceptable condition i.e. no cracks?	YES
Manhole cover present and in working condition?	YES
All bolts on manhole present and not stripped?	NO
Well plug present, locked and in good working condition?	YES
OVERALL CONDITION:	FAIR
Notes (Explain if answered No to any of the above) Replaced one bolt, another bolt is sheared off

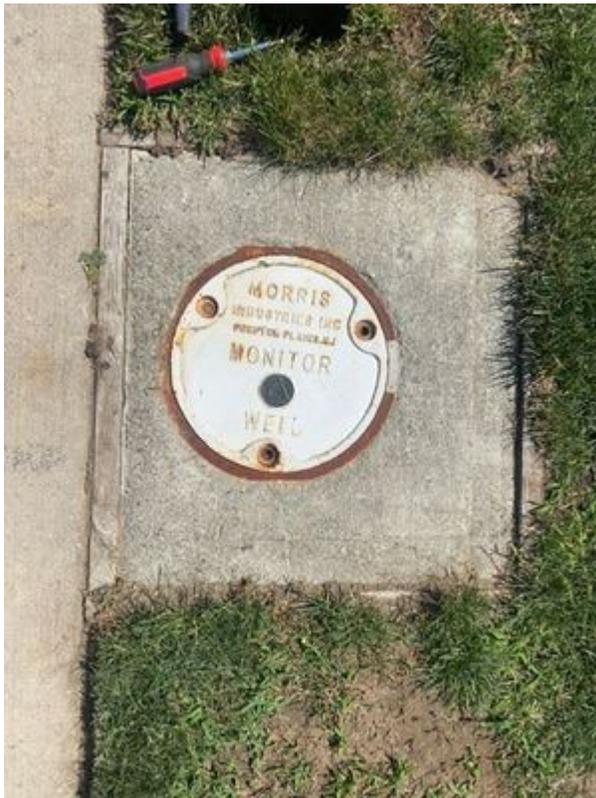
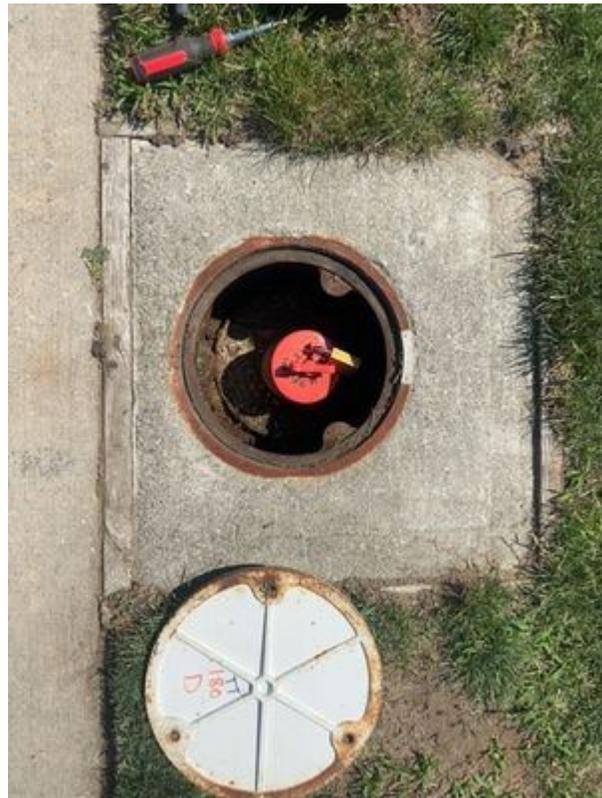
Client: Navy CLEAN	Facility: NWIRP Bethpage
Project Number: 112G08005-WE13	Location: Bethpage, New York
Date: June 13, 2024 14:56	Personnel: Jake Marlow
Well ID: BP-TT-MW180D	Well Location: 200994.723257421 1124938.87629276
Well Status: In Use (Confirmed)	Screen Interval: 220-240
WELL INVENTORY CONDITION	
Concrete pad in acceptable condition i.e. no cracks?	YES
Manhole cover present and in working condition?	YES
All bolts on manhole present and not stripped?	NO
Well plug present, locked and in good working condition?	YES
OVERALL CONDITION:	FAIR
Notes (Explain if answered No to any of the above) Three bolts are sheared off

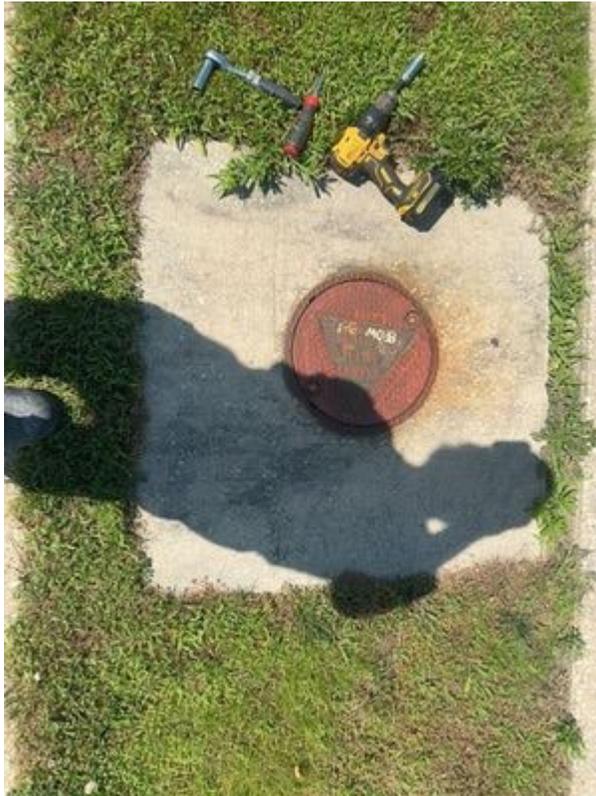
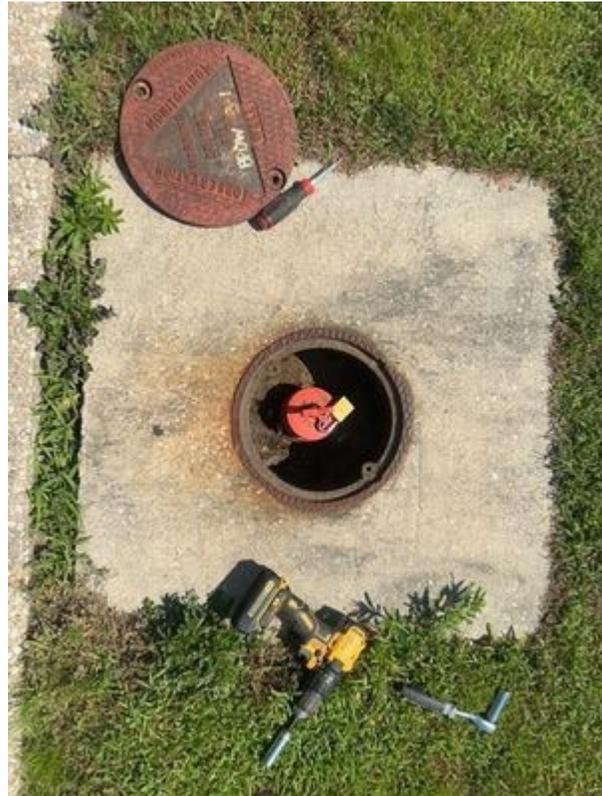
Client: Navy CLEAN	Facility: NWIRP Bethpage
Project Number: 112G08005-WE13	Location: Bethpage, New York
Date: June 13, 2024 14:40	Personnel: Jake Marlow
Well ID: BPOW3-1	Well Location: 198632.856349871 1124805.08461245
Well Status: In Use (Confirmed)	Screen Interval: 426-516
WELL INVENTORY CONDITION	
Concrete pad in acceptable condition i.e. no cracks?	YES
Manhole cover present and in working condition?	YES
All bolts on manhole present and not stripped?	NO
Well plug present, locked and in good working condition?	YES
OVERALL CONDITION:	FAIR
Notes (Explain if answered No to any of the above) Bolt threads on manhole are stripped

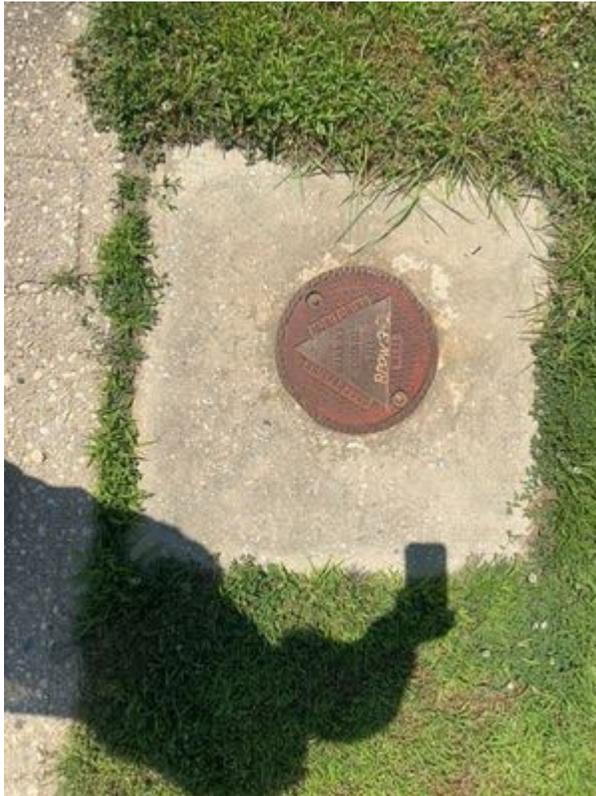
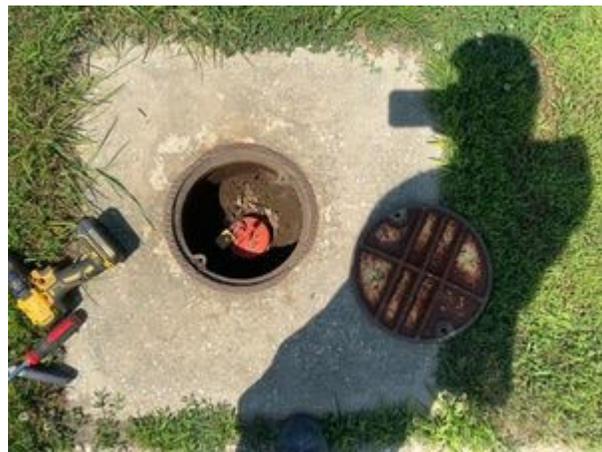
Client: Navy CLEAN	Facility: NWIRP Bethpage
Project Number: 112G08005-WE13	Location: Bethpage, New York
Date: June 13, 2024 14:37	Personnel: Jake Marlow
Well ID: BPOW3-2	Well Location: 198624.117239113 1124806.38222109
Well Status: In Use (Confirmed)	Screen Interval: 612-647
WELL INVENTORY CONDITION	
Concrete pad in acceptable condition i.e. no cracks?	YES
Manhole cover present and in working condition?	YES
All bolts on manhole present and not stripped?	NO
Well plug present, locked and in good working condition?	YES
OVERALL CONDITION:	FAIR
Notes (Explain if answered No to any of the above) Bolt threads on manhole are stripped

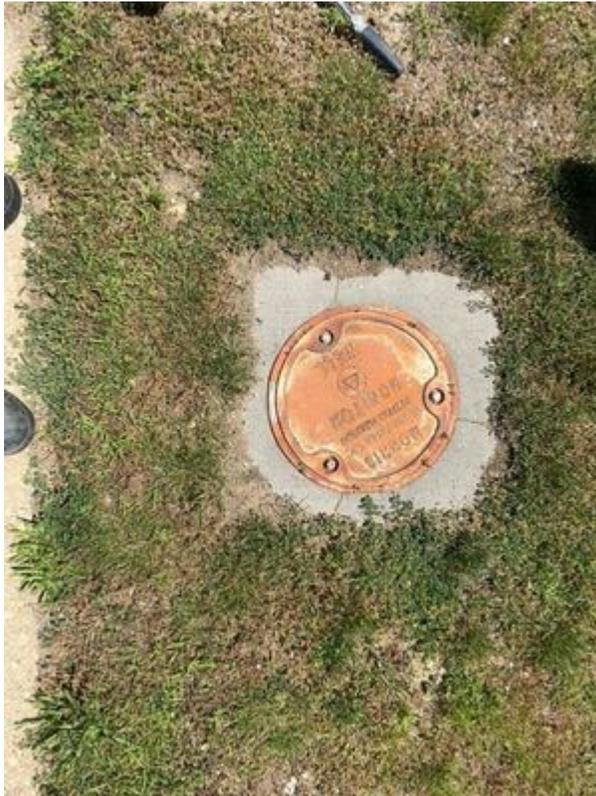
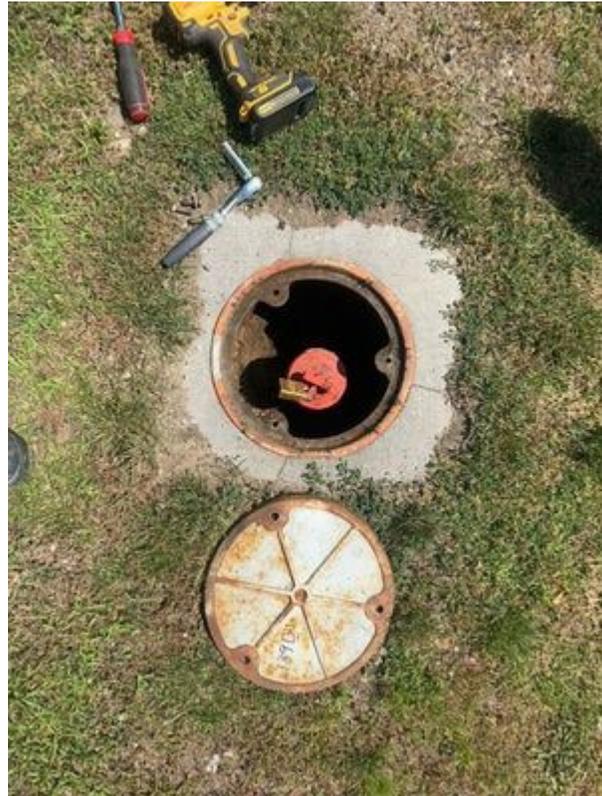
Client: Navy CLEAN	Facility: NWIRP Bethpage
Project Number: 112G08005-WE13	Location: Bethpage, New York
Date: June 13, 2024 14:34	Personnel: Jake Marlow
Well ID: RE139D1	Well Location: 198617.132005766 1124858.21178739
Well Status: In Use (Confirmed)	Screen Interval: 650-670
WELL INVENTORY CONDITION	
Concrete pad in acceptable condition i.e. no cracks?	NO
Manhole cover present and in working condition?	YES
All bolts on manhole present and not stripped?	YES
Well plug present, locked and in good working condition?	YES
OVERALL CONDITION:	FAIR
Notes (Explain if answered No to any of the above) Cracked pad

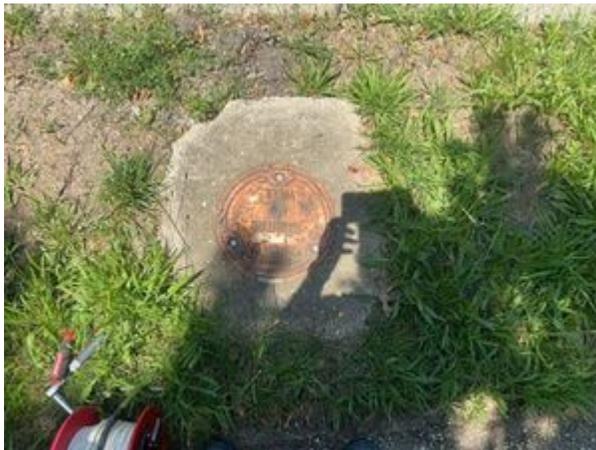
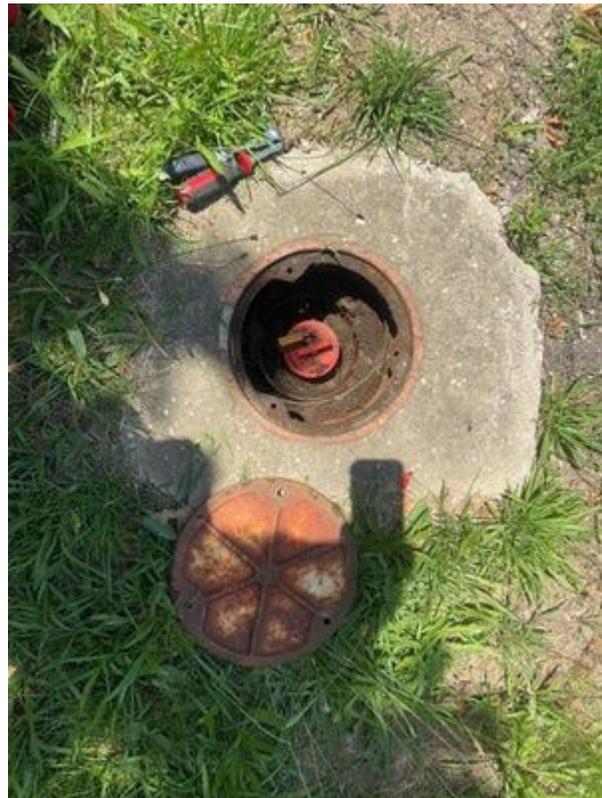
Client: Navy CLEAN	Facility: NWIRP Bethpage
Project Number: 112G08005-WE13	Location: Bethpage, New York
Date: June 13, 2024 13:24	Personnel: Jake Marlow
Well ID: BPOW2-3	Well Location: 199716.628183534 1127374.40432031
Well Status: In Use (Confirmed)	Screen Interval: 564-594
WELL INVENTORY CONDITION	
Concrete pad in acceptable condition i.e. no cracks?	NO
Manhole cover present and in working condition?	YES
All bolts on manhole present and not stripped?	NO
Well plug present, locked and in good working condition?	YES
OVERALL CONDITION:	FAIR
Notes (Explain if answered No to any of the above) Cracked pad, bolt threads on manhole are stripped

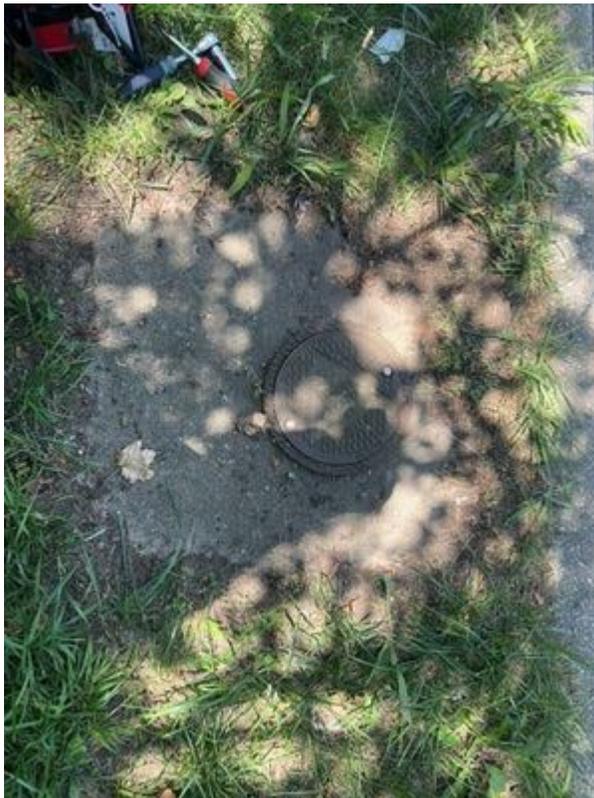
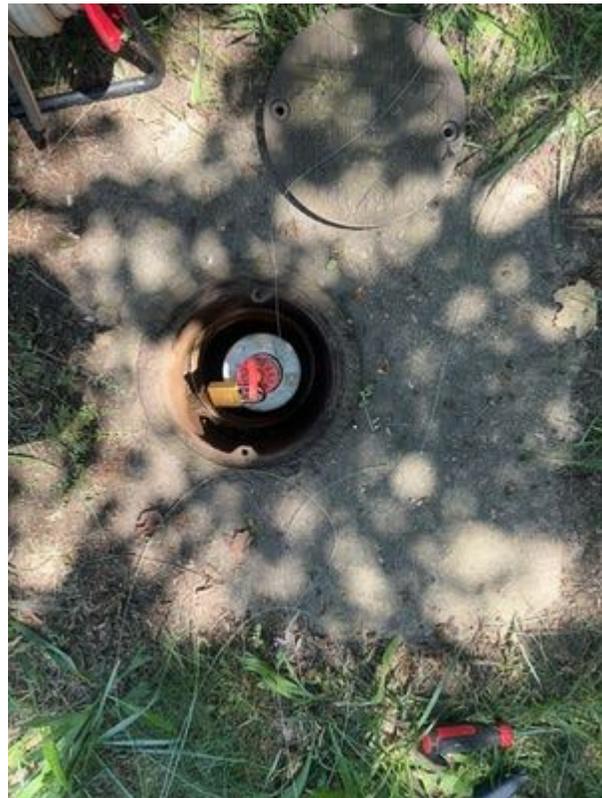
Client: Navy CLEAN	Facility: NWIRP Bethpage
Project Number: 112G08005-WE13	Location: Bethpage, New York
Date: June 13, 2024 13:13	Personnel: Jake Marlow
Well ID: BPOW2-2	Well Location: 199716.459313838 1127408.49223513
Well Status: In Use (Confirmed)	Screen Interval: 455-495
WELL INVENTORY CONDITION	
Concrete pad in acceptable condition i.e. no cracks?	YES
Manhole cover present and in working condition?	YES
All bolts on manhole present and not stripped?	NO
Well plug present, locked and in good working condition?	YES
OVERALL CONDITION:	FAIR
Notes (Explain if answered No to any of the above) Bolt threads on manhole are stripped, added lock

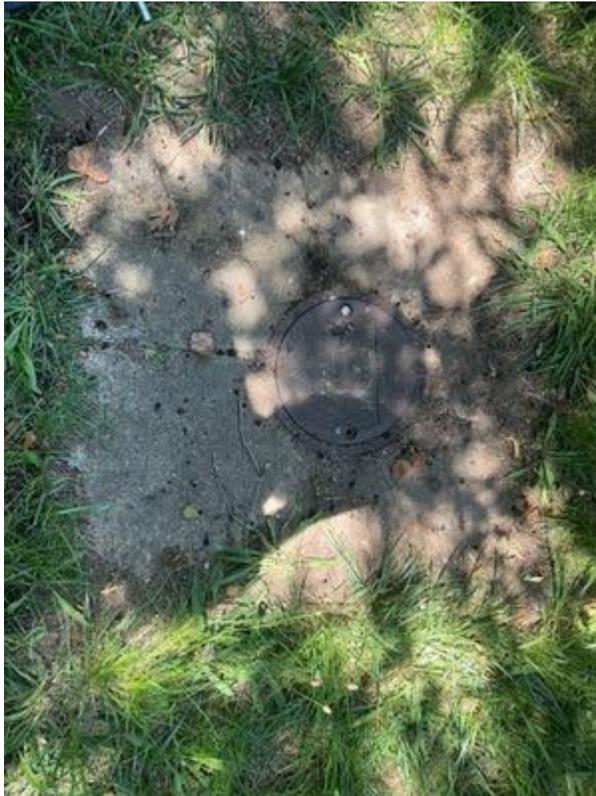
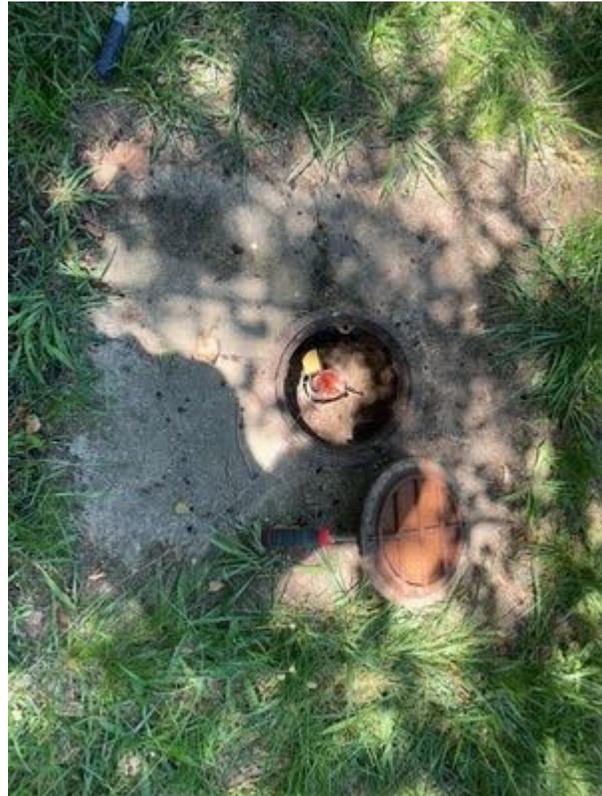
Client: Navy CLEAN	Facility: NWIRP Bethpage
Project Number: 112G08005-WE13	Location: Bethpage, New York
Date: June 13, 2024 13:06	Personnel: Jake Marlow
Well ID: BPOW2-1	Well Location: 199714.204134264 1127418.82370218
Well Status: In Use (Confirmed)	Screen Interval: 356-396
WELL INVENTORY CONDITION	
Concrete pad in acceptable condition i.e. no cracks?	NO
Manhole cover present and in working condition?	YES
All bolts on manhole present and not stripped?	NO
Well plug present, locked and in good working condition?	YES
OVERALL CONDITION:	FAIR
Notes (Explain if answered No to any of the above) Crack in pad, one bolt is sheared off

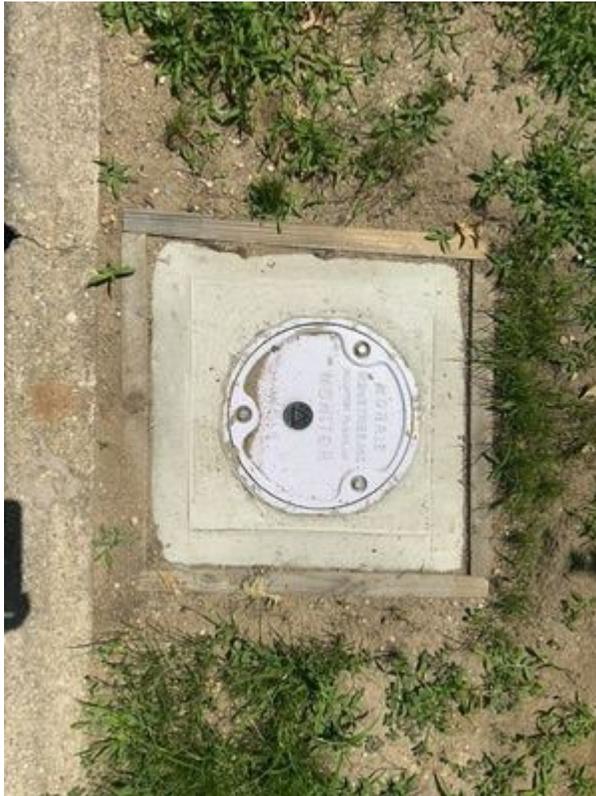
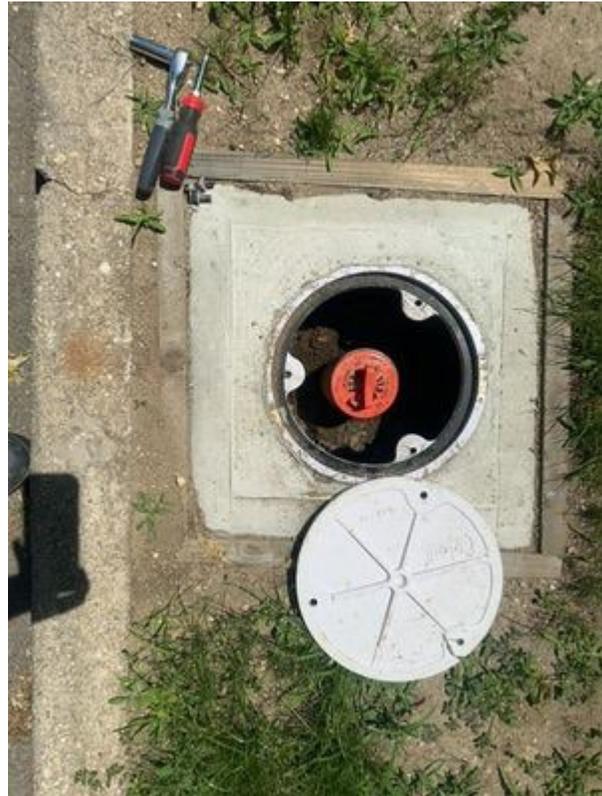
Client: Navy CLEAN	Facility: NWIRP Bethpage
Project Number: 112G08005-WE13	Location: Bethpage, New York
Date: June 13, 2024 12:04	Personnel: Jake Marlow
Well ID: TT-191D2	Well Location: 199593.901414838 1125980.13478504
Well Status: In Use (Confirmed)	Screen Interval:
WELL INVENTORY CONDITION	
Concrete pad in acceptable condition i.e. no cracks?	YES
Manhole cover present and in working condition?	YES
All bolts on manhole present and not stripped?	YES
Well plug present, locked and in good working condition?	NO
OVERALL CONDITION:	FAIR
Notes (Explain if answered No to any of the above) Missing lock

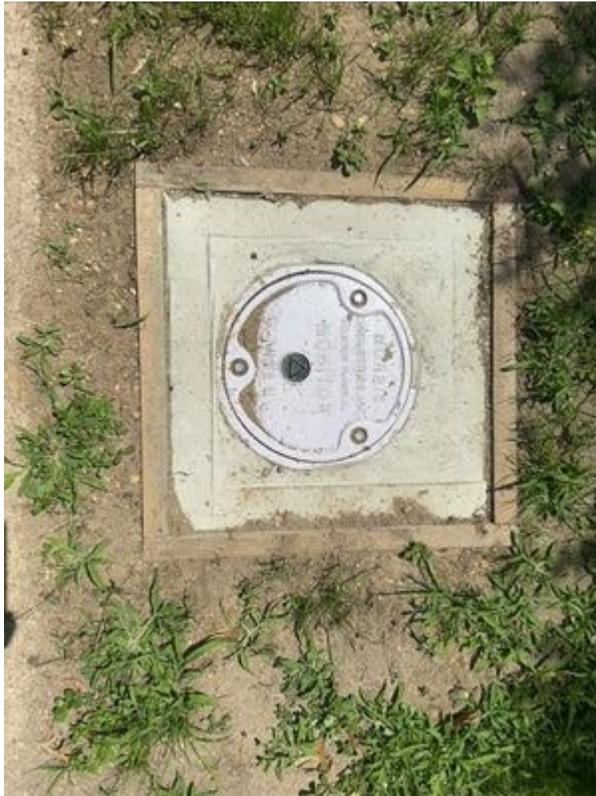
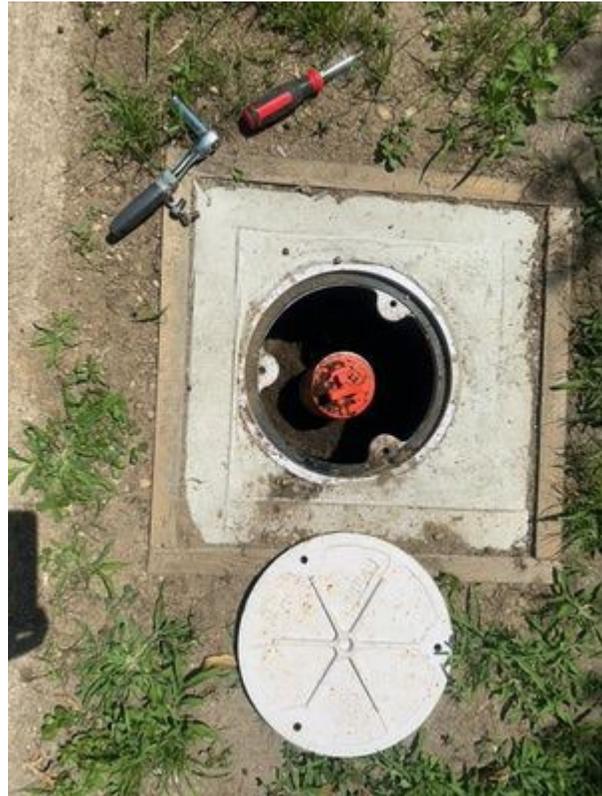
Client: Navy CLEAN	Facility: NWIRP Bethpage
Project Number: 112G08005-WE13	Location: Bethpage, New York
Date: June 13, 2024 12:01	Personnel: Jake Marlow
Well ID: TT-191D1	Well Location: 199594.324069455 1125996.80547318
Well Status: In Use (Confirmed)	Screen Interval:
WELL INVENTORY CONDITION	
Concrete pad in acceptable condition i.e. no cracks?	YES
Manhole cover present and in working condition?	YES
All bolts on manhole present and not stripped?	YES
Well plug present, locked and in good working condition?	NO
OVERALL CONDITION:	FAIR
Notes (Explain if answered No to any of the above) Missing lock

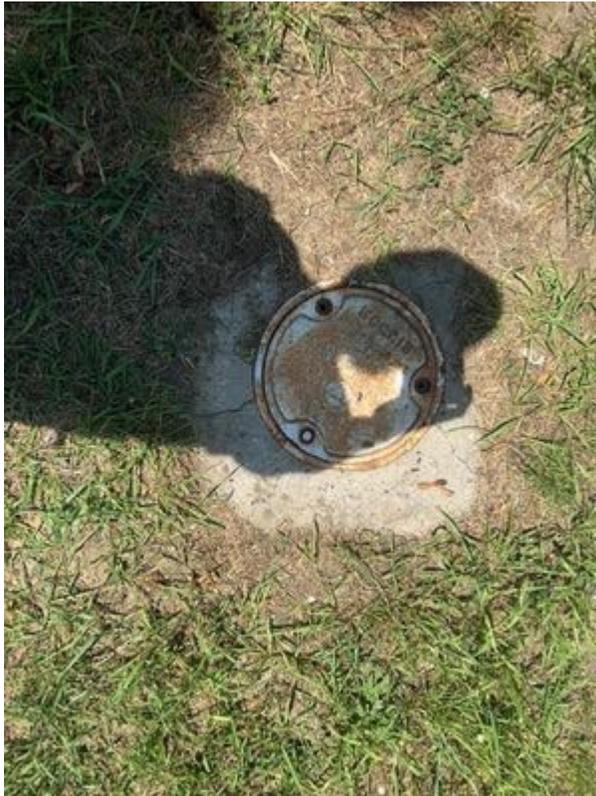
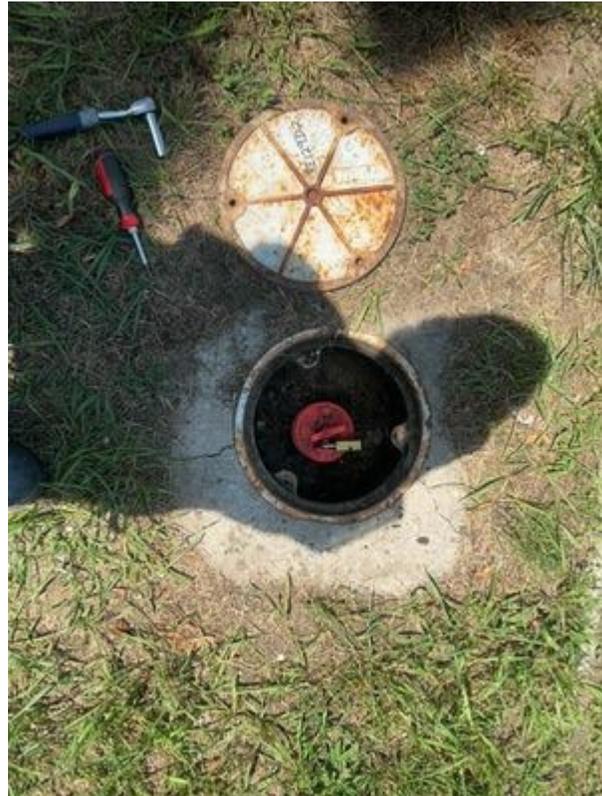
Client: Navy CLEAN	Facility: NWIRP Bethpage
Project Number: 112G08005-WE13	Location: Bethpage, New York
Date: June 13, 2024 11:46	Personnel: Jake Marlow
Well ID: RE129D2	Well Location: 196069.829074387 1124070.67664321
Well Status: In Use (Confirmed)	Screen Interval: 805-825
WELL INVENTORY CONDITION	
Concrete pad in acceptable condition i.e. no cracks?	NO
Manhole cover present and in working condition?	YES
All bolts on manhole present and not stripped?	NO
Well plug present, locked and in good working condition?	YES
OVERALL CONDITION:	FAIR
Notes (Explain if answered No to any of the above) Two bolts sheared off, cracks on pad

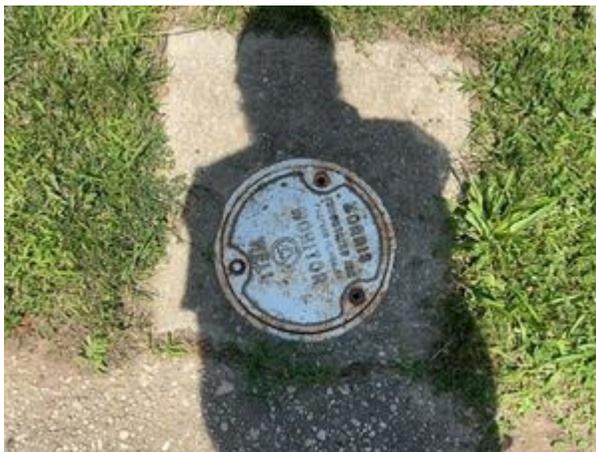
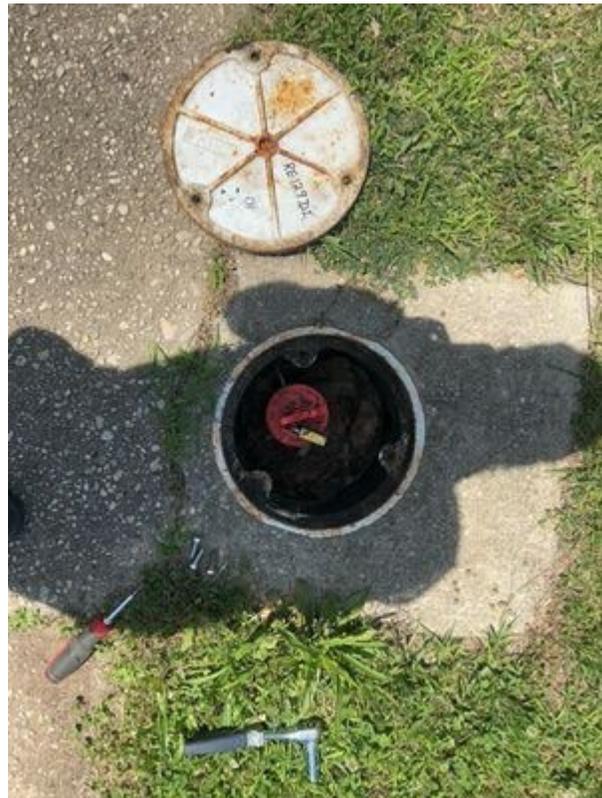
Client: Navy CLEAN	Facility: NWIRP Bethpage
Project Number: 112G08005-WE13	Location: Bethpage, New York
Date: June 13, 2024 11:40	Personnel: Jake Marlow
Well ID: RE129D1	Well Location: 196086.231491048 1124099.15540276
Well Status: In Use (Confirmed)	Screen Interval: 690-710
WELL INVENTORY CONDITION	
Concrete pad in acceptable condition i.e. no cracks?	YES
Manhole cover present and in working condition?	YES
All bolts on manhole present and not stripped?	NO
Well plug present, locked and in good working condition?	YES
OVERALL CONDITION:	FAIR
Notes (Explain if answered No to any of the above) Two bolts are sheared off

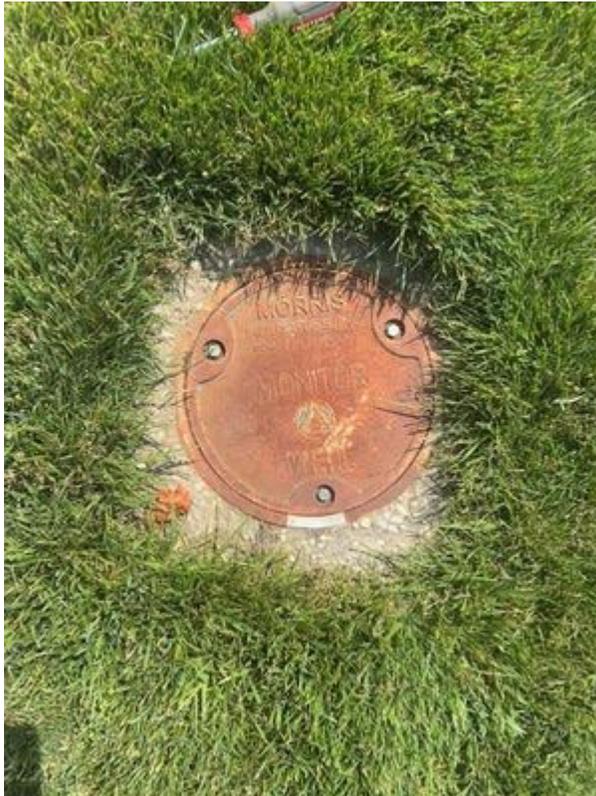
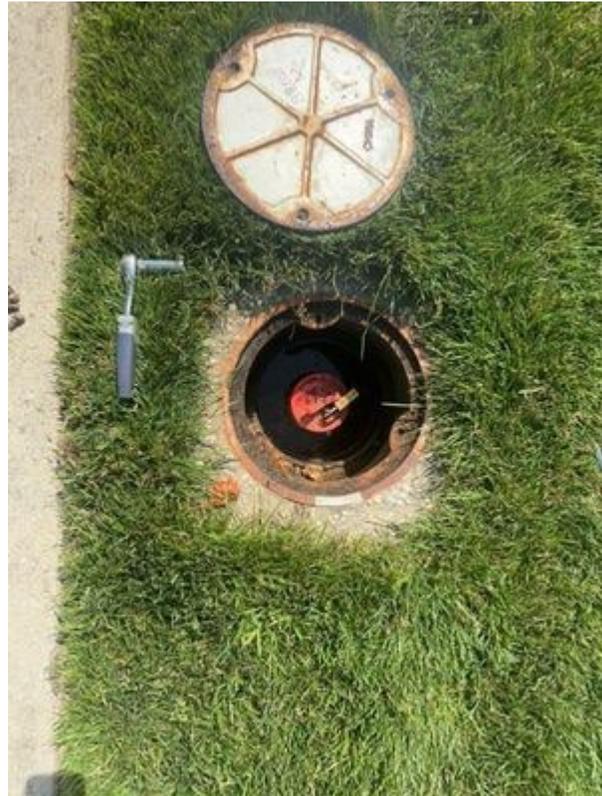
Client: Navy CLEAN	Facility: NWIRP Bethpage
Project Number: 112G08005-WE13	Location: Bethpage, New York
Date: June 13, 2024 10:19	Personnel: Jake Marlow
Well ID: BPOW6-5	Well Location: 194042.45026981 1128176.26081481
Well Status: In Use (Confirmed)	Screen Interval: 525-550
WELL INVENTORY CONDITION	
Concrete pad in acceptable condition i.e. no cracks?	YES
Manhole cover present and in working condition?	YES
All bolts on manhole present and not stripped?	NO
Well plug present, locked and in good working condition?	YES
OVERALL CONDITION:	FAIR
Notes (Explain if answered No to any of the above) Bolt threads on manhole are stripped

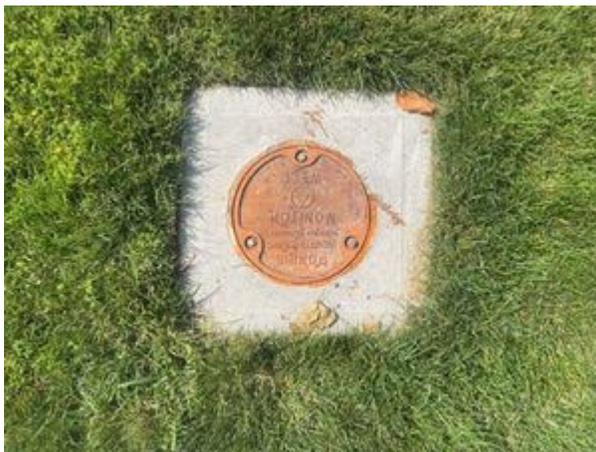
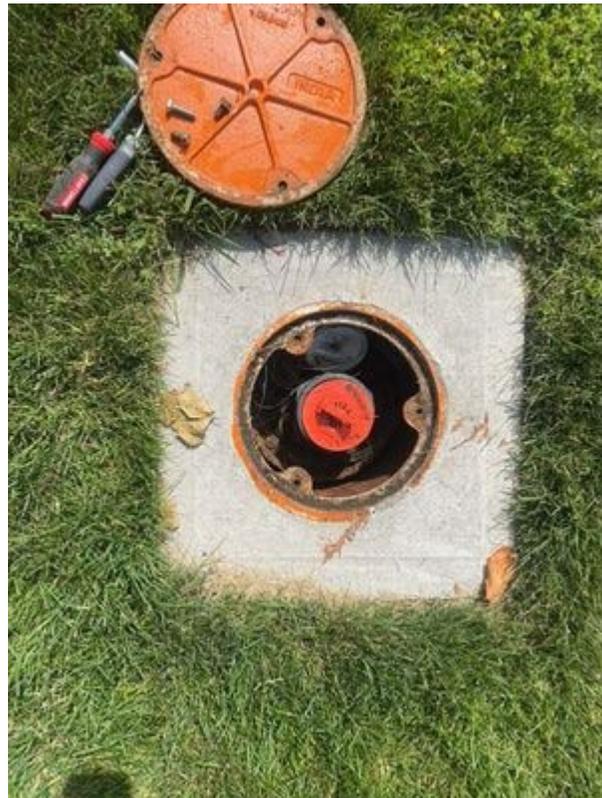
Client: Navy CLEAN	Facility: NWIRP Bethpage
Project Number: 112G08005-WE13	Location: Bethpage, New York
Date: June 13, 2024 10:10	Personnel: Jake Marlow
Well ID: DECHC05-MW-01	Well Location: 194120.830624535 1126587.48116766
Well Status: In Use (Confirmed)	Screen Interval: 950-970
WELL INVENTORY CONDITION	
Concrete pad in acceptable condition i.e. no cracks?	YES
Manhole cover present and in working condition?	YES
All bolts on manhole present and not stripped?	YES
Well plug present, locked and in good working condition?	YES
OVERALL CONDITION:	GOOD
Notes (Explain if answered No to any of the above) Replaced one missing bolt

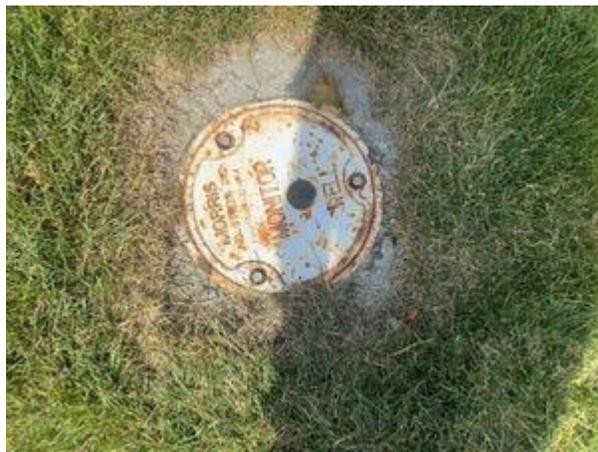
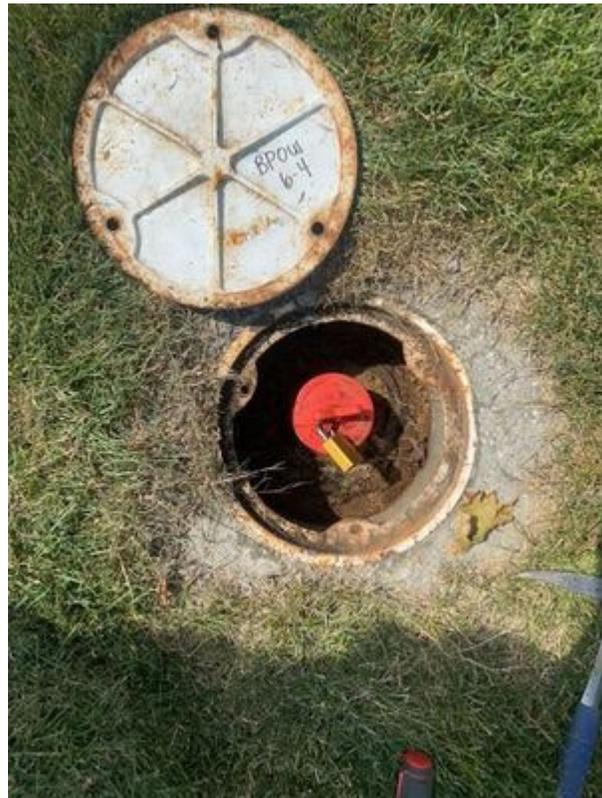
Client: Navy CLEAN	Facility: NWIRP Bethpage
Project Number: 112G08005-WE13	Location: Bethpage, New York
Date: June 13, 2024 10:01	Personnel: Jake Marlow
Well ID: BPOW6-4	Well Location: 194119.697041507 1127578.76920924
Well Status: In Use (Confirmed)	Screen Interval: 545-570
WELL INVENTORY CONDITION	
Concrete pad in acceptable condition i.e. no cracks?	YES
Manhole cover present and in working condition?	YES
All bolts on manhole present and not stripped?	YES
Well plug present, locked and in good working condition?	YES
OVERALL CONDITION:	GOOD
Notes (Explain if answered No to any of the above) Replaced three missing bolts

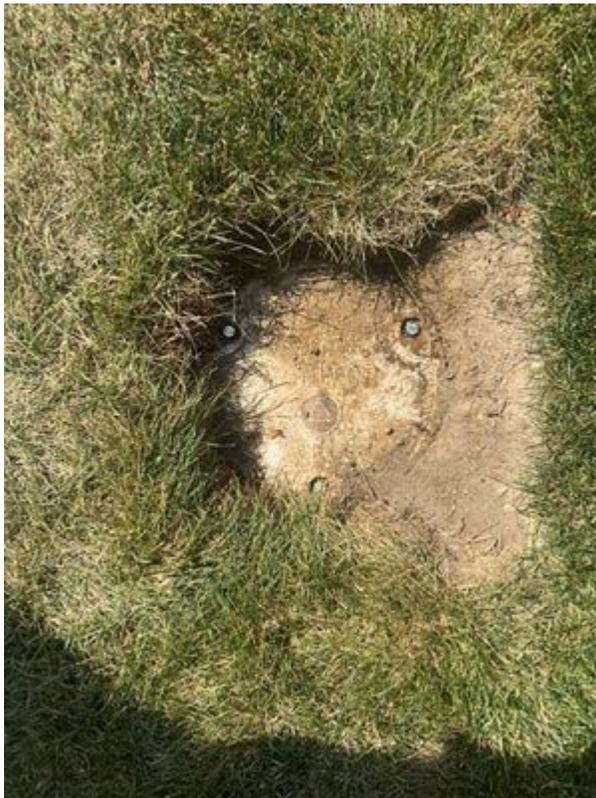
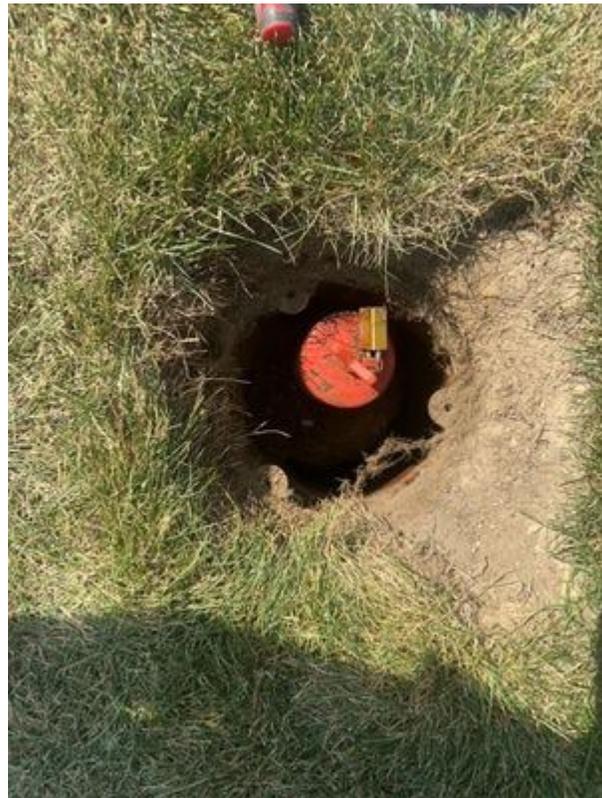
Client: Navy CLEAN	Facility: NWIRP Bethpage
Project Number: 112G08005-WE13	Location: Bethpage, New York
Date: June 13, 2024 09:46	Personnel: Claire Starke
Well ID: BPOW6-2	Well Location: 193246.152419429 1126785.4692475
Well Status: In Use (Confirmed)	Screen Interval: 755-780
WELL INVENTORY CONDITION	
Concrete pad in acceptable condition i.e. no cracks?	YES
Manhole cover present and in working condition?	NO
All bolts on manhole present and not stripped?	YES
Well plug present, locked and in good working condition?	YES
OVERALL CONDITION:	FAIR
Notes (Explain if answered No to any of the above) Replaced three missing bolts, J-Plug/PVC sits too high can not secure manhole

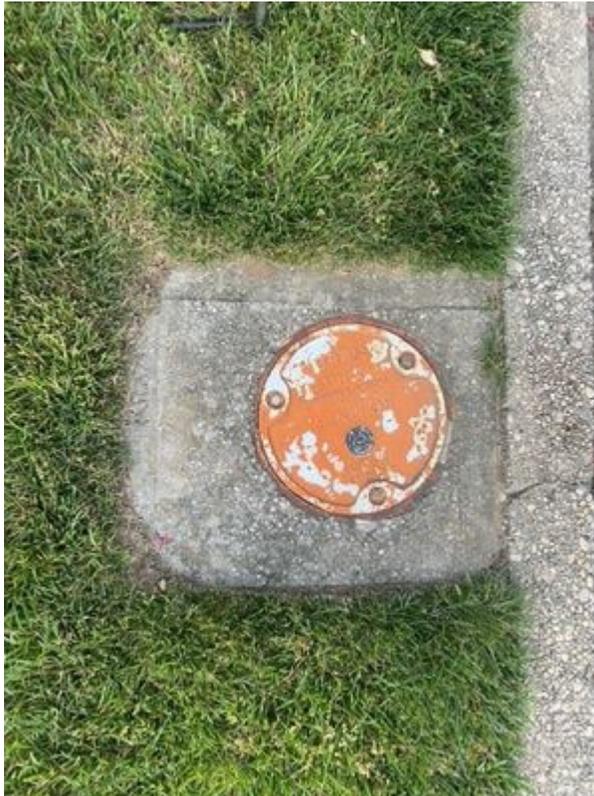
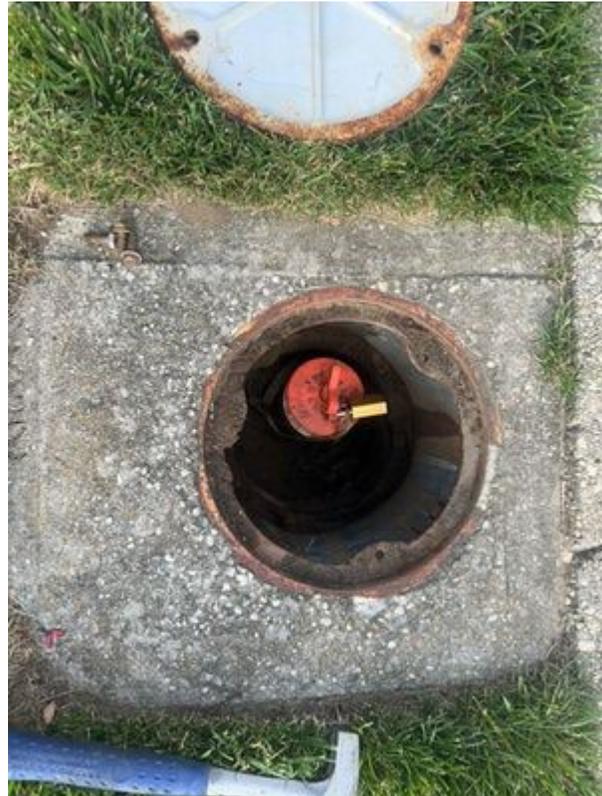
Client: Navy CLEAN	Facility: NWIRP Bethpage
Project Number: 112G08005-WE13	Location: Bethpage, New York
Date: June 12, 2024 18:02	Personnel: Jake Marlow
Well ID: RE103D1	Well Location: 206697.423641753 1125114.88760867
Well Status: In Use (Confirmed)	Screen Interval: 625-640
WELL INVENTORY CONDITION	
Concrete pad in acceptable condition i.e. no cracks?	YES
Manhole cover present and in working condition?	YES
All bolts on manhole present and not stripped?	NO
Well plug present, locked and in good working condition?	YES
OVERALL CONDITION:	FAIR
Notes (Explain if answered No to any of the above) Bolt threads on manhole are stripped

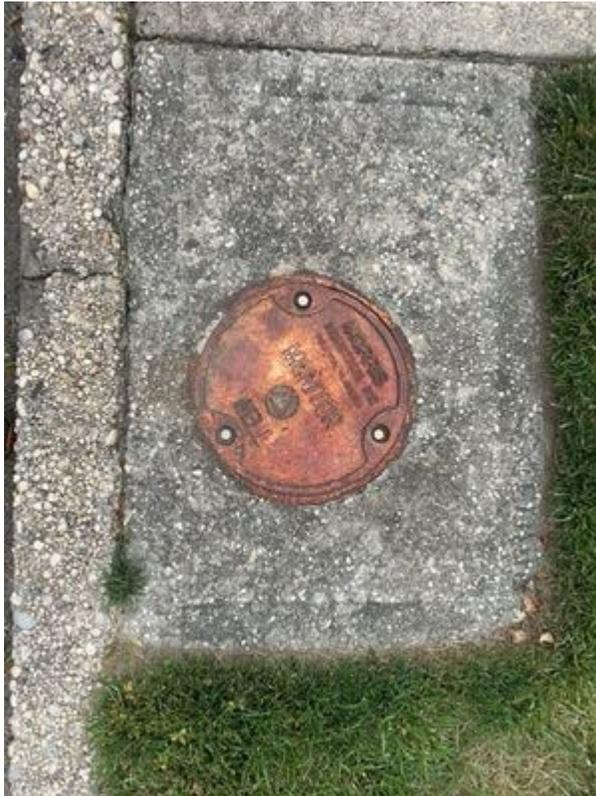
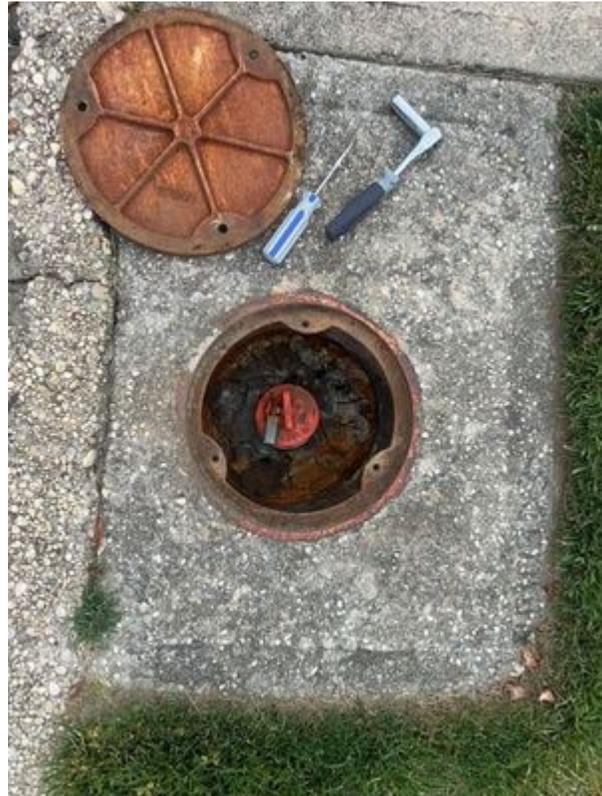
Client: Navy CLEAN	Facility: NWIRP Bethpage
Project Number: 112G08005-WE13	Location: Bethpage, New York
Date: June 12, 2024 17:45	Personnel: Jake Marlow
Well ID: RE103D3	Well Location: 206691.075809102 1125144.33629072
Well Status: In Use (Confirmed)	Screen Interval: 715-730
WELL INVENTORY CONDITION	
Concrete pad in acceptable condition i.e. no cracks?	YES
Manhole cover present and in working condition?	YES
All bolts on manhole present and not stripped?	NO
Well plug present, locked and in good working condition?	YES
OVERALL CONDITION:	FAIR
Notes (Explain if answered No to any of the above) Bolt threads on manhole are stripped
