Memorandum

To: Scott Sokolowski, NAVFAC MIDLANT
From: Richard Moore, Tetra Tech
Date: September 27, 2024
Re: Annual LUC Inspection and Operation Summary Report: Sites 1, 2, 3, and 4 –
NWIRP Bethpage
Contract/CTO Number: N6247016D9008/WE16

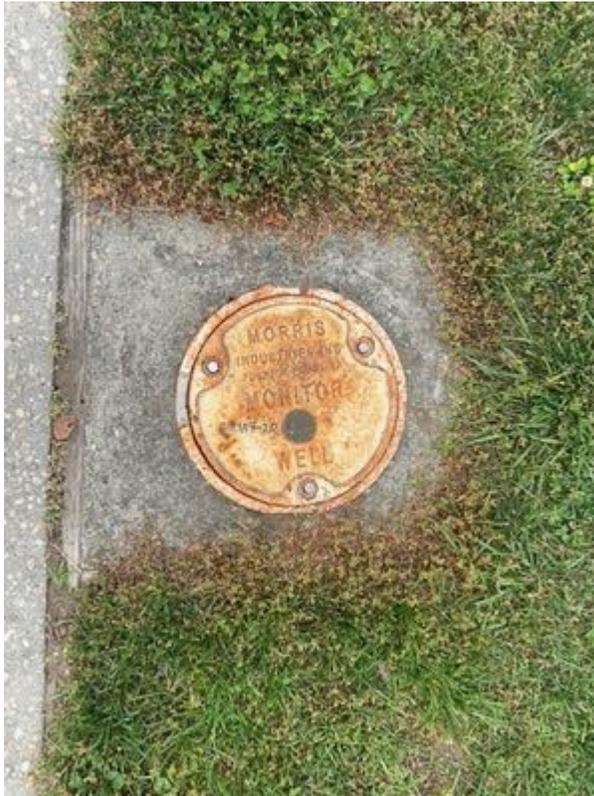
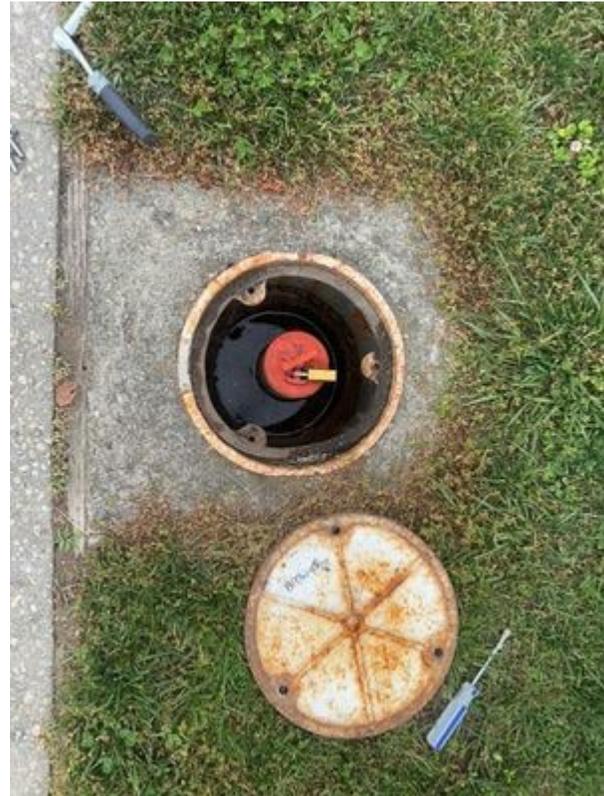
Client: Navy CLEAN	Facility: NWIRP Bethpage
Project Number: 112G08005-WE13	Location: Bethpage, New York
Date: June 12, 2024 17:27	Personnel: Jake Marlow
Well ID: BPOW4-2R	Well Location: 200679.672666752 1123198.03140341
Well Status: In Use (Confirmed)	Screen Interval: 725-765
WELL INVENTORY CONDITION	
Concrete pad in acceptable condition i.e. no cracks?	YES
Manhole cover present and in working condition?	YES
All bolts on manhole present and not stripped?	YES
Well plug present, locked and in good working condition?	YES
OVERALL CONDITION:	GOOD
Notes (Explain if answered No to any of the above) Replaced three bolts

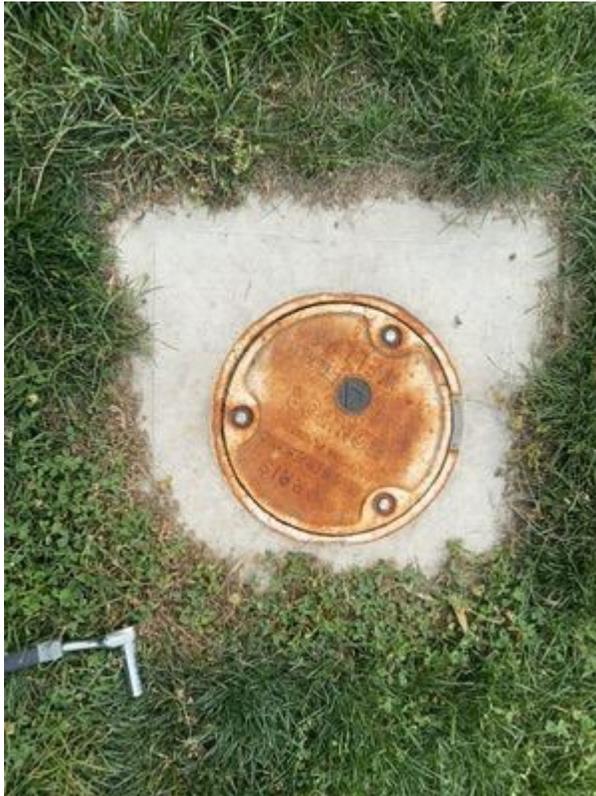
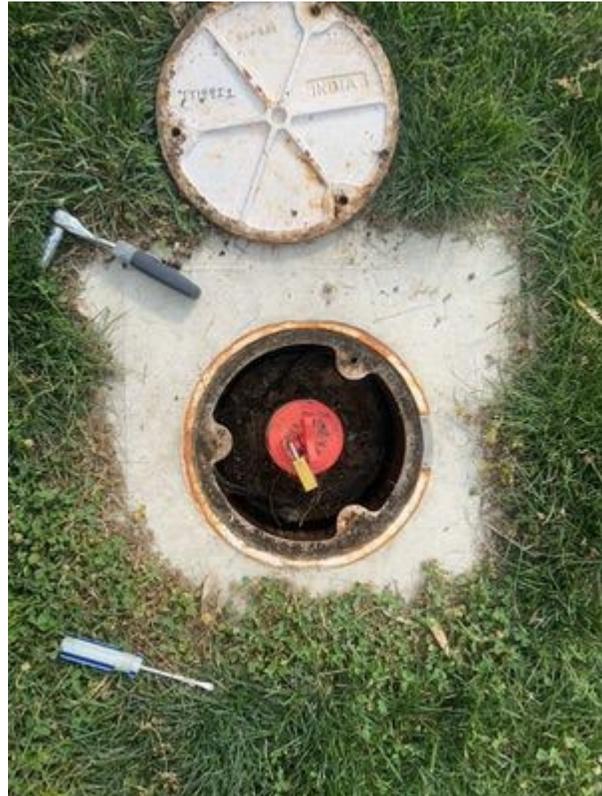
Client: Navy CLEAN	Facility: NWIRP Bethpage
Project Number: 112G08005-WE13	Location: Bethpage, New York
Date: June 12, 2024 16:59	Personnel: Jake Marlow
Well ID: TT-MW14911	Well Location: 201000.391799197 1125731.0868444
Well Status: In Use (Confirmed)	Screen Interval:
WELL INVENTORY CONDITION	
Concrete pad in acceptable condition i.e. no cracks?	YES
Manhole cover present and in working condition?	YES
All bolts on manhole present and not stripped?	YES
Well plug present, locked and in good working condition?	YES
OVERALL CONDITION:	GOOD
Notes (Explain if answered No to any of the above)

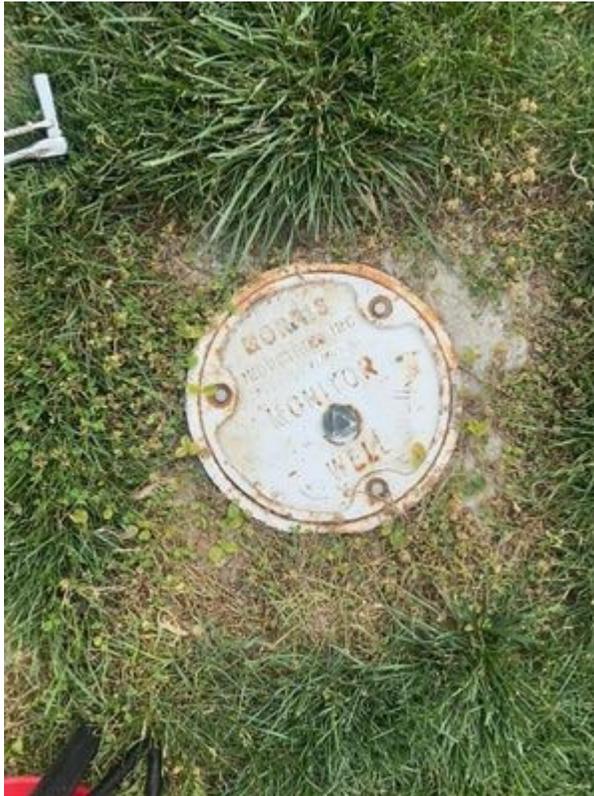
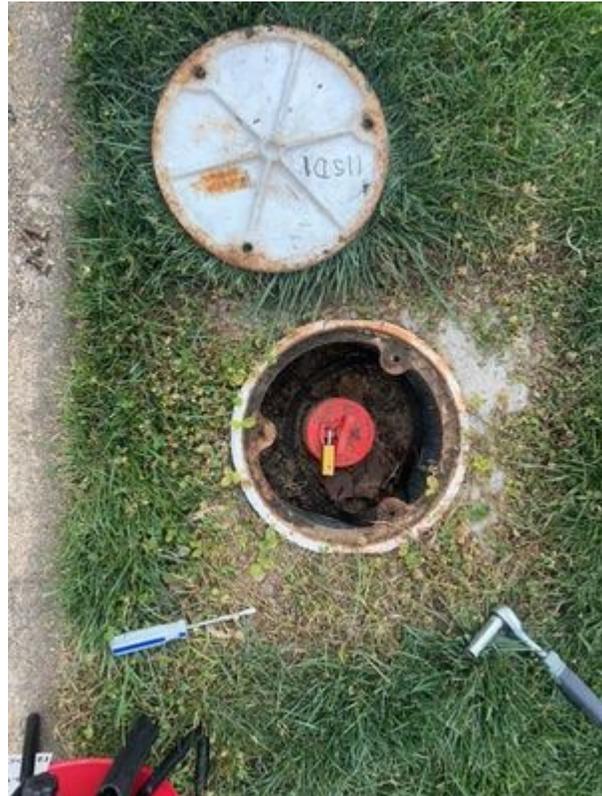
Client: Navy CLEAN	Facility: NWIRP Bethpage
Project Number: 112G08005-WE13	Location: Bethpage, New York
Date: June 12, 2024 16:51	Personnel: Jake Marlow
Well ID: RE115D1	Well Location: 200995.086303388 1125726.95539175
Well Status: In Use (Confirmed)	Screen Interval: 640-655
WELL INVENTORY CONDITION	
Concrete pad in acceptable condition i.e. no cracks?	YES
Manhole cover present and in working condition?	YES
All bolts on manhole present and not stripped?	YES
Well plug present, locked and in good working condition?	YES
OVERALL CONDITION:	GOOD
Notes (Explain if answered No to any of the above)

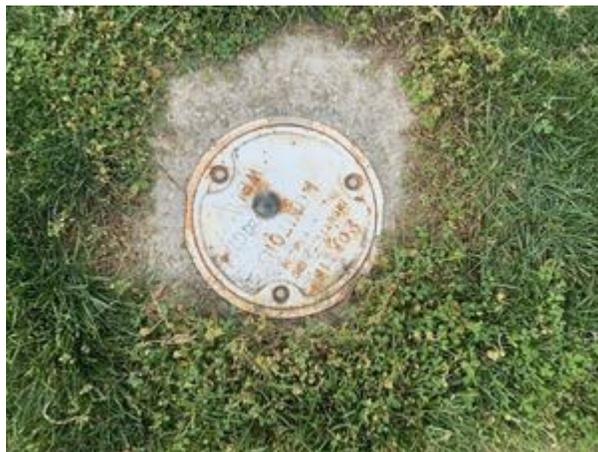
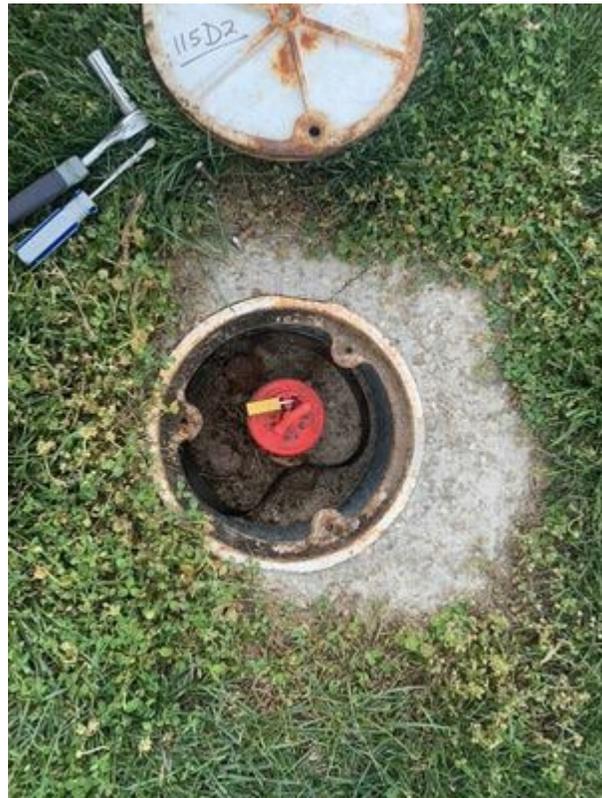
Client: Navy CLEAN	Facility: NWIRP Bethpage
Project Number: 112G08005-WE13	Location: Bethpage, New York
Date: June 12, 2024 16:44	Personnel: Jake Marlow
Well ID: RE115D2	Well Location: 201004.769656106 1125740.15145047
Well Status: In Use (Confirmed)	Screen Interval: 730-750
WELL INVENTORY CONDITION	
Concrete pad in acceptable condition i.e. no cracks?	YES
Manhole cover present and in working condition?	YES
All bolts on manhole present and not stripped?	YES
Well plug present, locked and in good working condition?	YES
OVERALL CONDITION:	GOOD
Notes (Explain if answered No to any of the above)

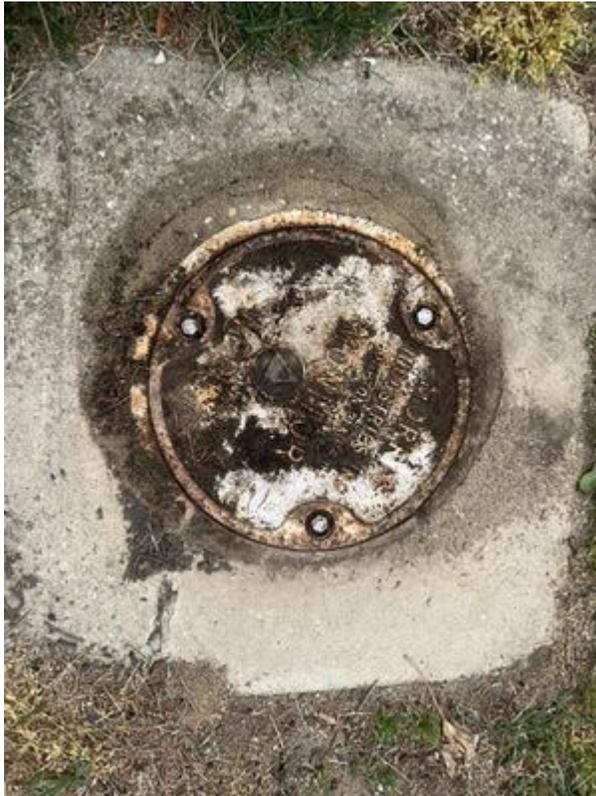
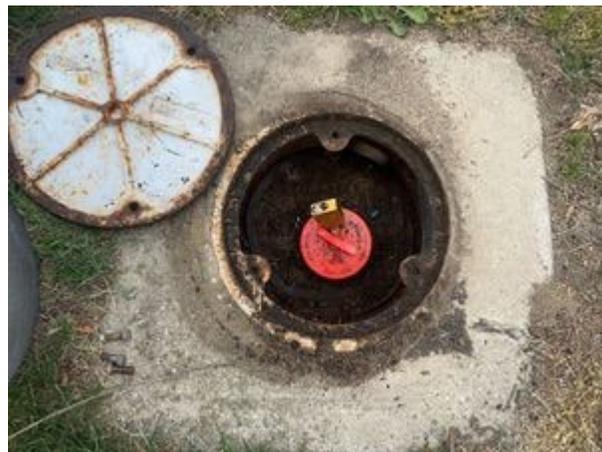
Client: Navy CLEAN	Facility: NWIRP Bethpage
Project Number: 112G08005-WE13	Location: Bethpage, New York
Date: June 12, 2024 15:21	Personnel: Jake Marlow
Well ID: BPOW5-5	Well Location: 197281.001753998 1126290.89871852
Well Status: In Use (Confirmed)	Screen Interval: 515-540
WELL INVENTORY CONDITION	
Concrete pad in acceptable condition i.e. no cracks?	YES
Manhole cover present and in working condition?	YES
All bolts on manhole present and not stripped?	YES
Well plug present, locked and in good working condition?	YES
OVERALL CONDITION:	GOOD
Notes (Explain if answered No to any of the above)

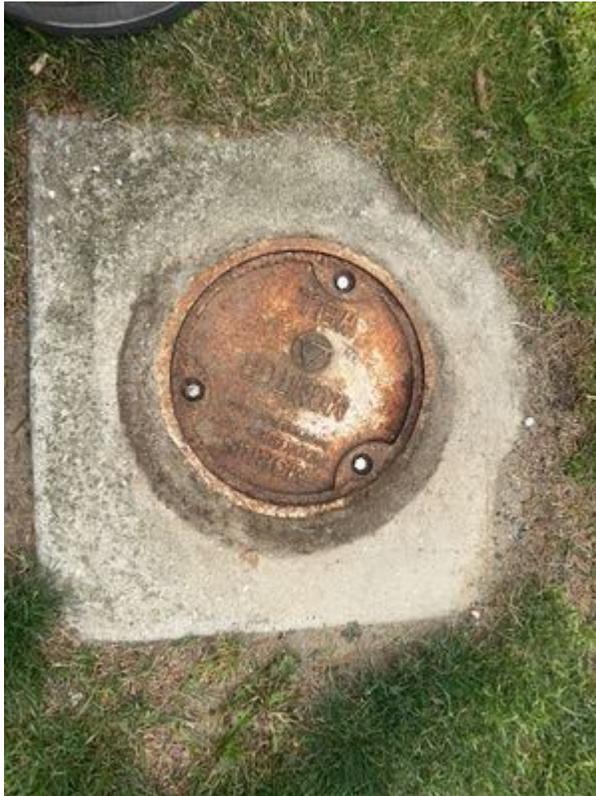
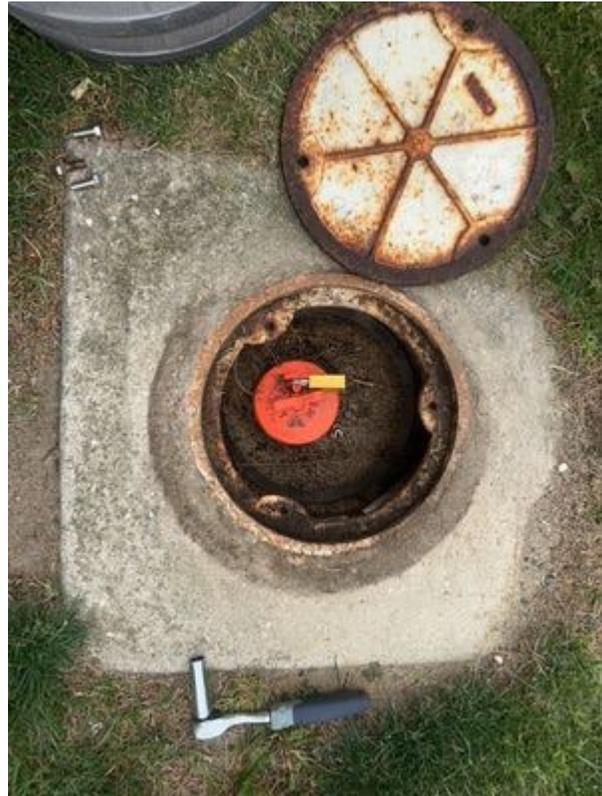
Client: Navy CLEAN	Facility: NWIRP Bethpage
Project Number: 112G08005-WE13	Location: Bethpage, New York
Date: June 12, 2024 15:16	Personnel: Jake Marlow
Well ID: RE118D1	Well Location: 197295.30525013 1126287.16443194
Well Status: In Use (Confirmed)	Screen Interval: 765-790
WELL INVENTORY CONDITION	
Concrete pad in acceptable condition i.e. no cracks?	YES
Manhole cover present and in working condition?	YES
All bolts on manhole present and not stripped?	YES
Well plug present, locked and in good working condition?	YES
OVERALL CONDITION:	GOOD
Notes (Explain if answered No to any of the above) Replaced two bolts

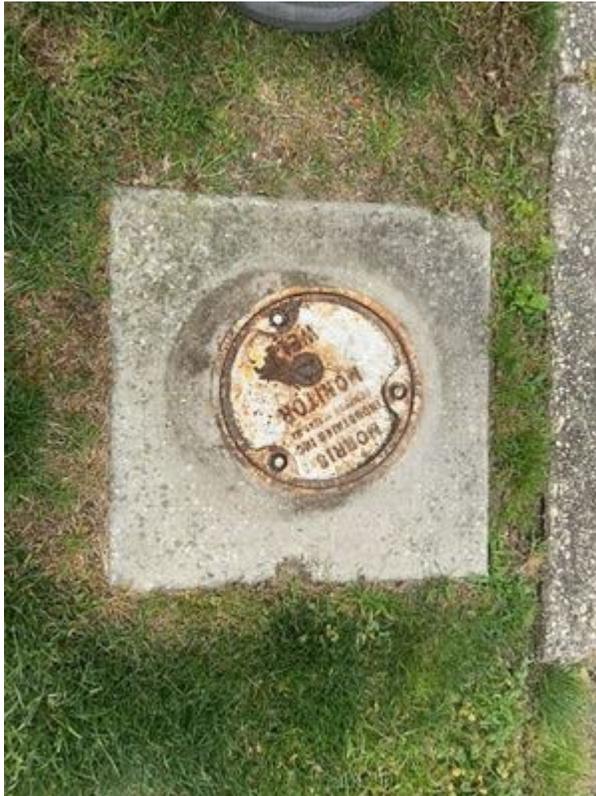
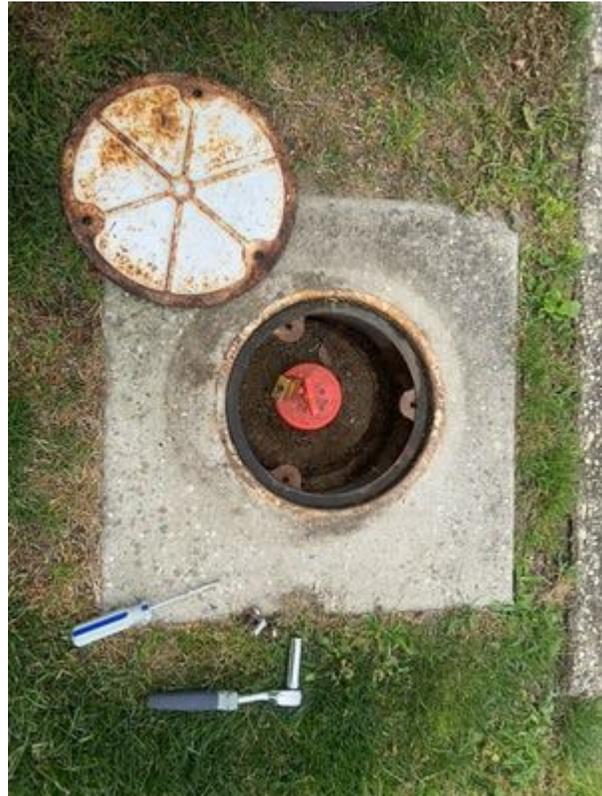
Client: Navy CLEAN	Facility: NWIRP Bethpage
Project Number: 112G08005-WE13	Location: Bethpage, New York
Date: June 12, 2024 15:12	Personnel: Jake Marlow
Well ID: BPOW5-6	Well Location: 197325.200430074 1126287.21555447
Well Status: In Use (Confirmed)	Screen Interval: 585-610
WELL INVENTORY CONDITION	
Concrete pad in acceptable condition i.e. no cracks?	YES
Manhole cover present and in working condition?	YES
All bolts on manhole present and not stripped?	YES
Well plug present, locked and in good working condition?	YES
OVERALL CONDITION:	GOOD
Notes (Explain if answered No to any of the above) Replaced one bolt

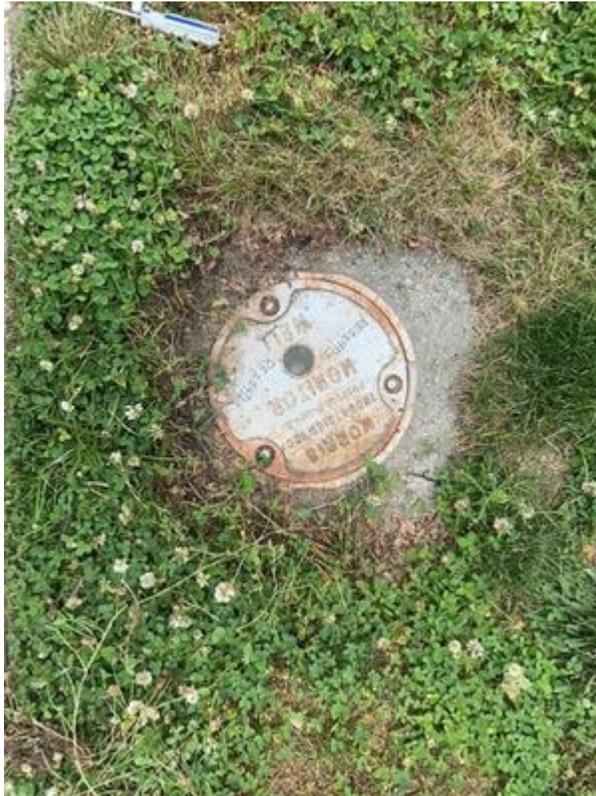
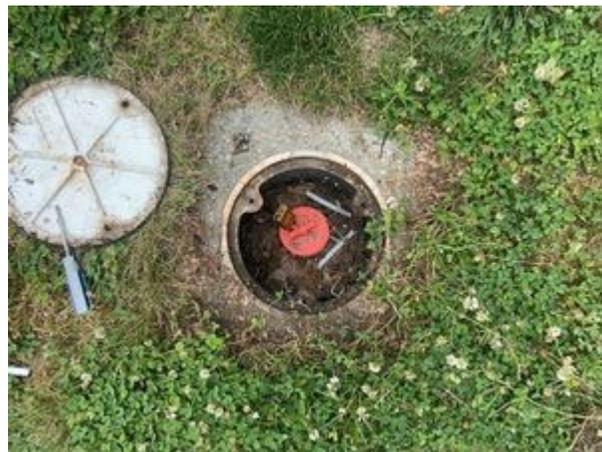
Client: Navy CLEAN	Facility: NWIRP Bethpage
Project Number: 112G08005-WE13	Location: Bethpage, New York
Date: June 12, 2024 12:26	Personnel: Jake Marlow
Well ID: RE114D1	Well Location: 201720.849360959 1124286.70617876
Well Status: In Use (Confirmed)	Screen Interval: 535-550
WELL INVENTORY CONDITION	
Concrete pad in acceptable condition i.e. no cracks?	YES
Manhole cover present and in working condition?	YES
All bolts on manhole present and not stripped?	YES
Well plug present, locked and in good working condition?	YES
OVERALL CONDITION:	GOOD
Notes (Explain if answered No to any of the above)

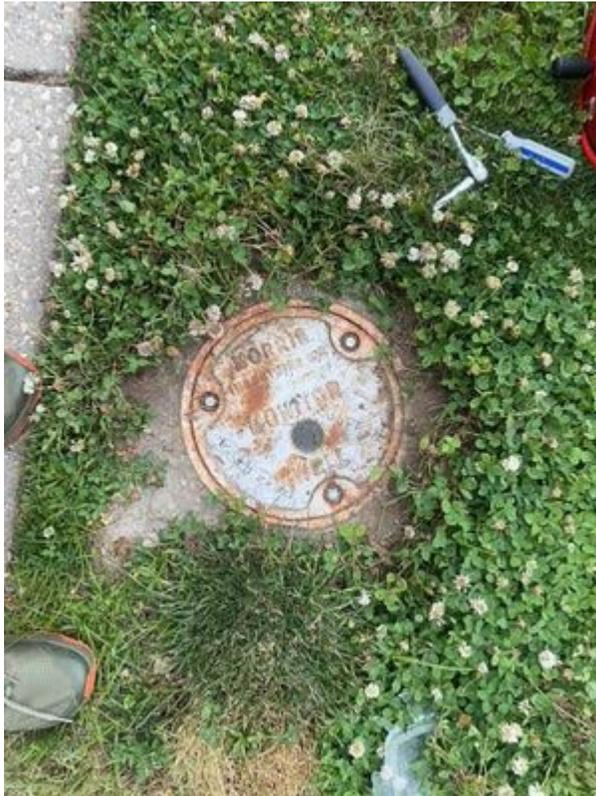
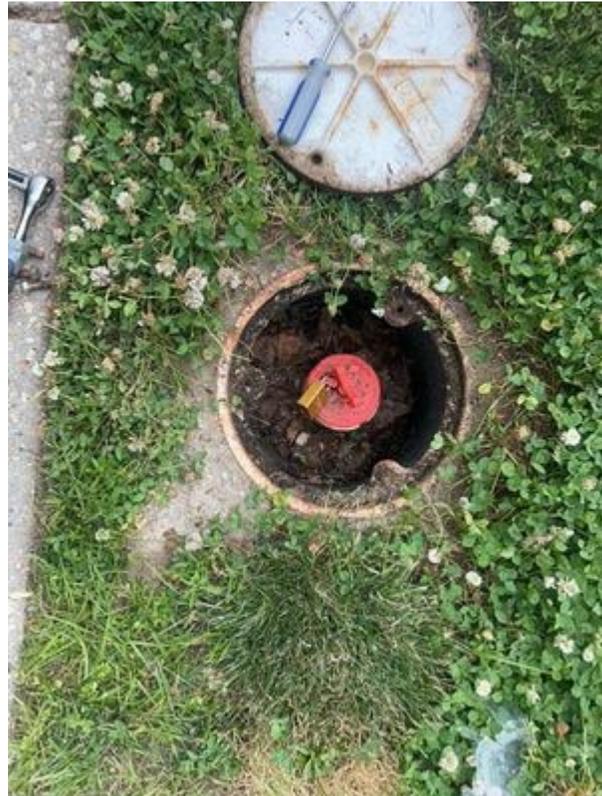
Client: Navy CLEAN	Facility: NWIRP Bethpage
Project Number: 112G08005-WE13	Location: Bethpage, New York
Date: June 12, 2024 12:14	Personnel: Jake Marlow
Well ID: RE114D3	Well Location: 201711.874207803 1124280.56350778
Well Status: In Use (Confirmed)	Screen Interval: 700-720
WELL INVENTORY CONDITION	
Concrete pad in acceptable condition i.e. no cracks?	YES
Manhole cover present and in working condition?	YES
All bolts on manhole present and not stripped?	YES
Well plug present, locked and in good working condition?	YES
OVERALL CONDITION:	GOOD
Notes (Explain if answered No to any of the above)

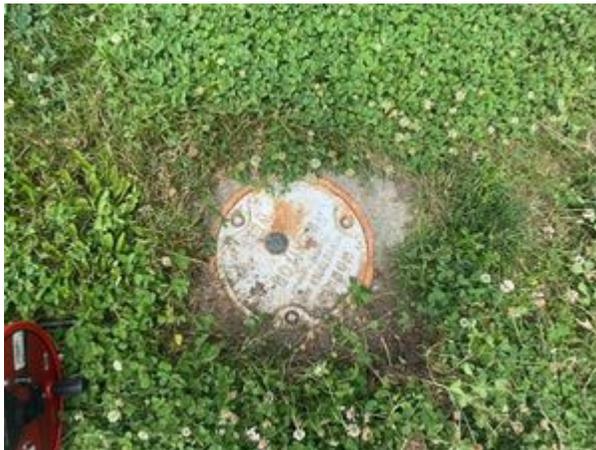
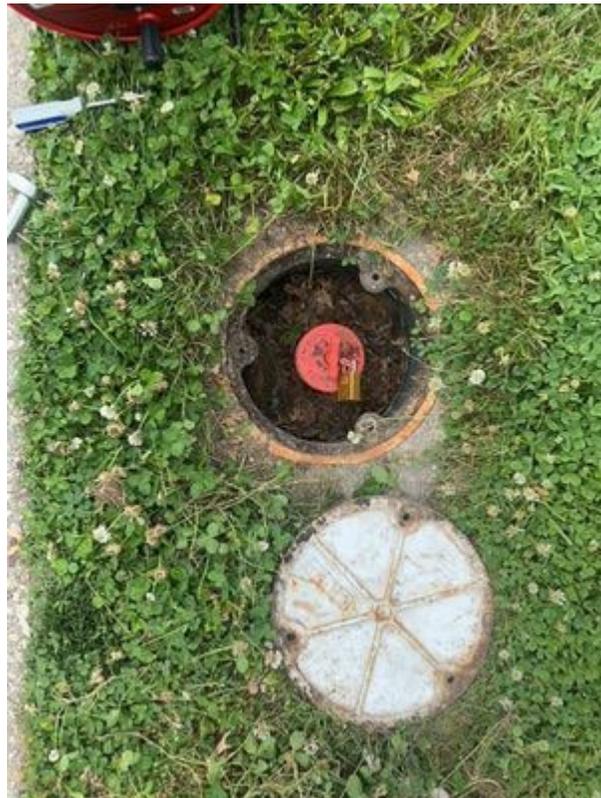
Client: Navy CLEAN	Facility: NWIRP Bethpage
Project Number: 112G08005-WE13	Location: Bethpage, New York
Date: June 12, 2024 12:06	Personnel: Jake Marlow
Well ID: RE114D2	Well Location: 201702.305377091 1124271.48421406
Well Status: In Use (Confirmed)	Screen Interval: 610-630
WELL INVENTORY CONDITION	
Concrete pad in acceptable condition i.e. no cracks?	YES
Manhole cover present and in working condition?	YES
All bolts on manhole present and not stripped?	YES
Well plug present, locked and in good working condition?	YES
OVERALL CONDITION:	GOOD
Notes (Explain if answered No to any of the above)

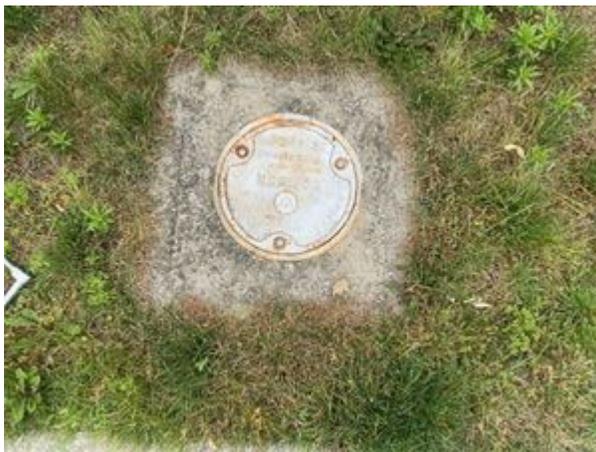
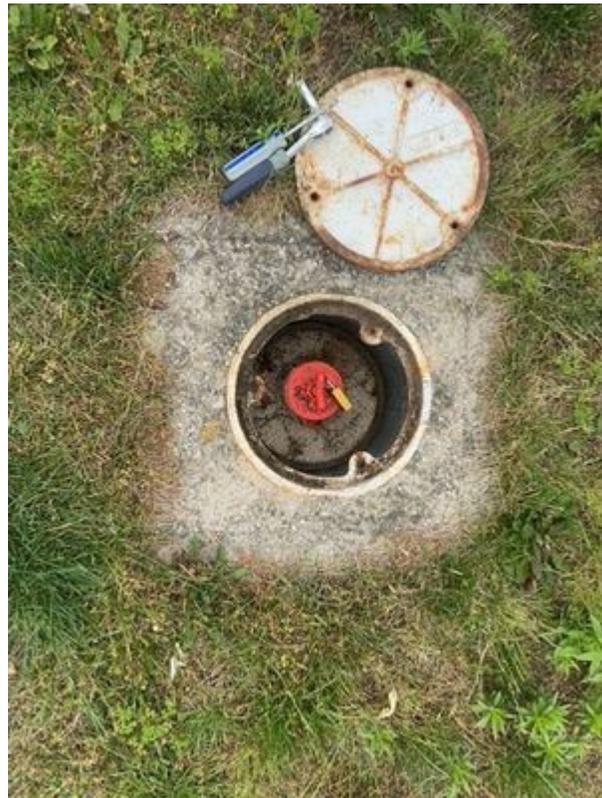
Client: Navy CLEAN	Facility: NWIRP Bethpage
Project Number: 112G08005-WE13	Location: Bethpage, New York
Date: June 12, 2024 11:44	Personnel: Jake Marlow
Well ID: RE124D1	Well Location: 202695.323419694 1122969.5914579
Well Status: In Use (Confirmed)	Screen Interval: 660-680
WELL INVENTORY CONDITION	
Concrete pad in acceptable condition i.e. no cracks?	YES
Manhole cover present and in working condition?	YES
All bolts on manhole present and not stripped?	YES
Well plug present, locked and in good working condition?	YES
OVERALL CONDITION:	GOOD
Notes (Explain if answered No to any of the above)

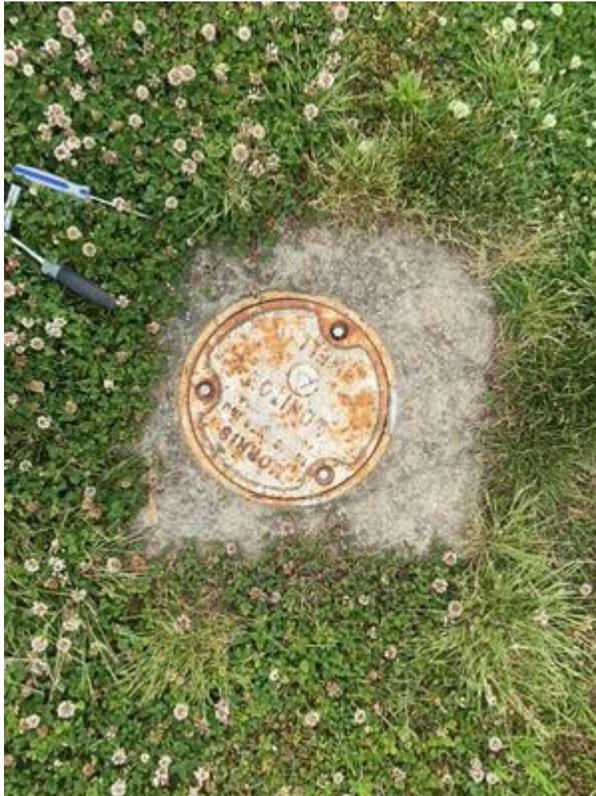
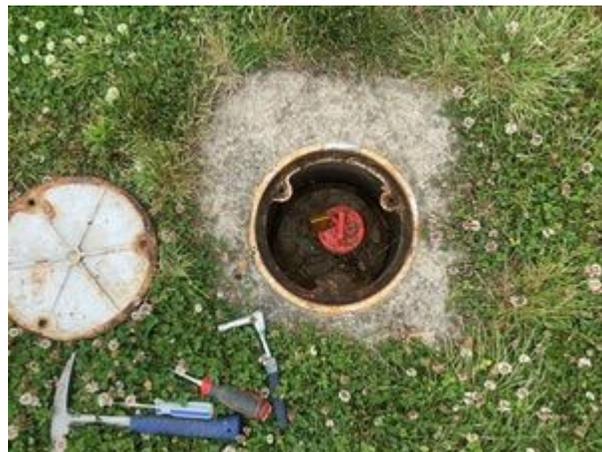
Client: Navy CLEAN	Facility: NWIRP Bethpage
Project Number: 112G08005-WE13	Location: Bethpage, New York
Date: June 12, 2024 11:33	Personnel: Jake Marlow
Well ID: RE124D2	Well Location: 202683.064081202 1122969.63100574
Well Status: In Use (Confirmed)	Screen Interval: 730-750
WELL INVENTORY CONDITION	
Concrete pad in acceptable condition i.e. no cracks?	YES
Manhole cover present and in working condition?	YES
All bolts on manhole present and not stripped?	YES
Well plug present, locked and in good working condition?	YES
OVERALL CONDITION:	GOOD
Notes (Explain if answered No to any of the above)

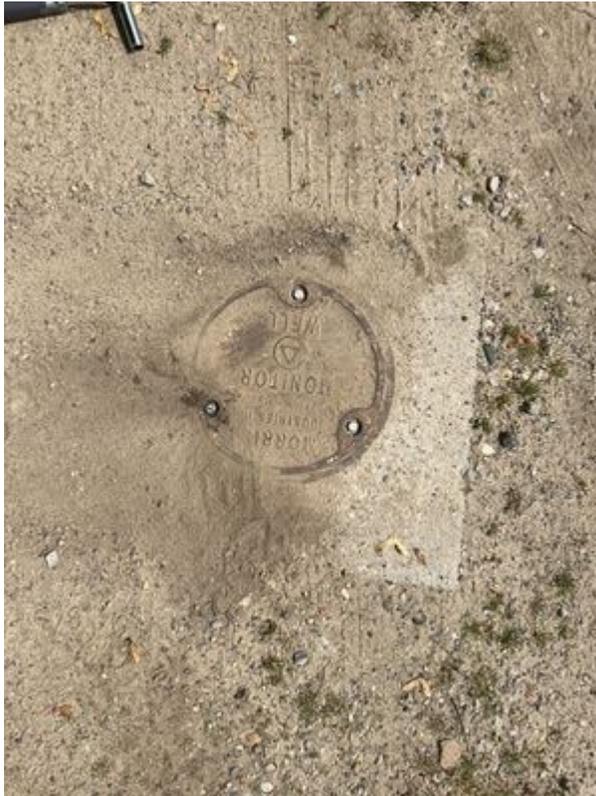
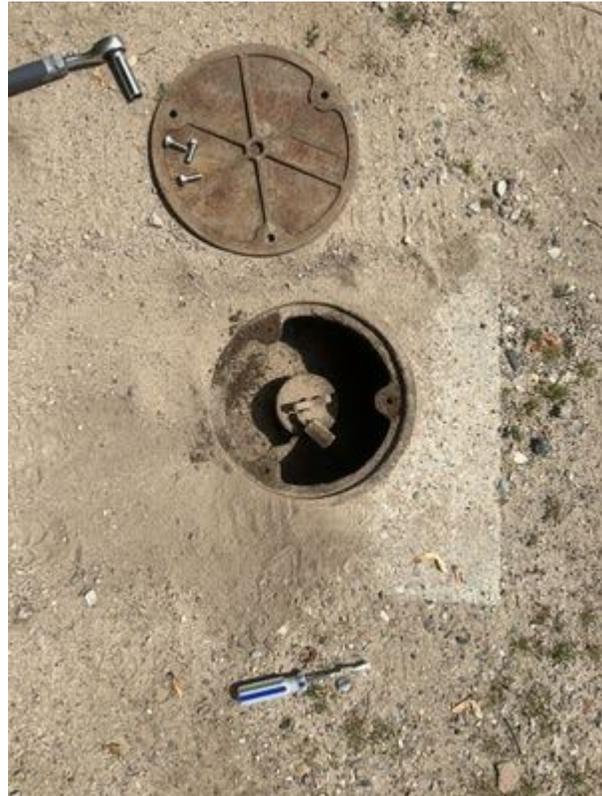
Client: Navy CLEAN	Facility: NWIRP Bethpage
Project Number: 112G08005-WE13	Location: Bethpage, New York
Date: June 12, 2024 10:59	Personnel: Jake Marlow
Well ID: RE128D2	Well Location: 200541.786767183 1129198.44234961
Well Status: In Use (Confirmed)	Screen Interval: 735-755
WELL INVENTORY CONDITION	
Concrete pad in acceptable condition i.e. no cracks?	YES
Manhole cover present and in working condition?	YES
All bolts on manhole present and not stripped?	NO
Well plug present, locked and in good working condition?	YES
OVERALL CONDITION:	FAIR
Notes (Explain if answered No to any of the above) Bolt threads on manhole are stripped

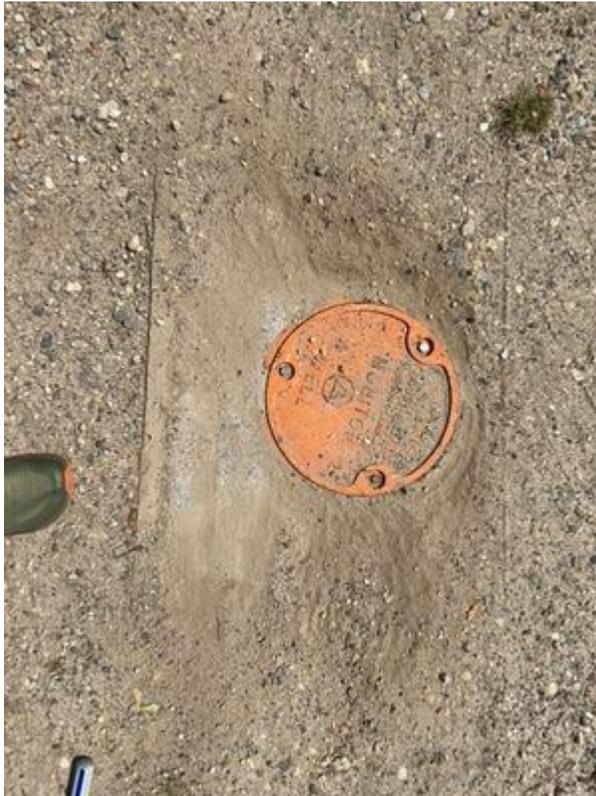
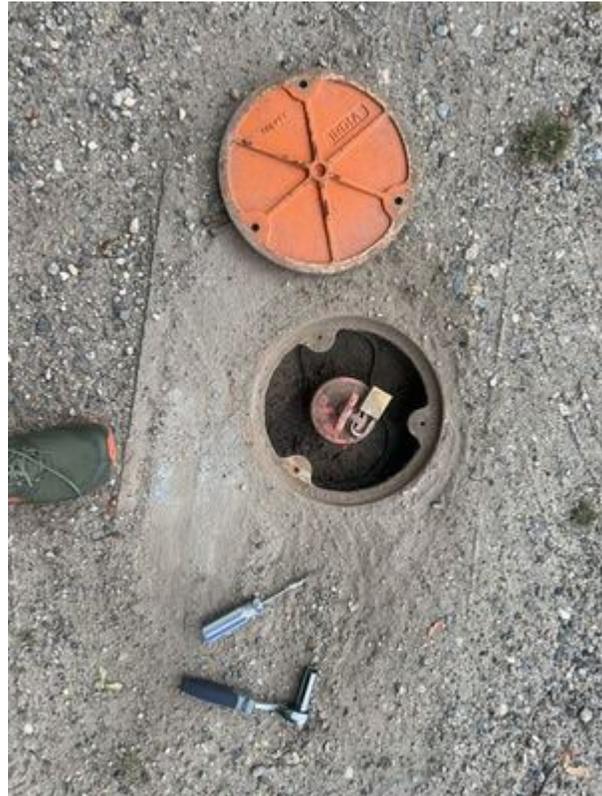
Client: Navy CLEAN	Facility: NWIRP Bethpage
Project Number: 112G08005-WE13	Location: Bethpage, New York
Date: June 12, 2024 10:53	Personnel: Jake Marlow
Well ID: TT-MW162S1	Well Location: 200516.13849843 1129192.39237933
Well Status: In Use (Confirmed)	Screen Interval:
WELL INVENTORY CONDITION	
Concrete pad in acceptable condition i.e. no cracks?	YES
Manhole cover present and in working condition?	YES
All bolts on manhole present and not stripped?	YES
Well plug present, locked and in good working condition?	NO
OVERALL CONDITION:	GOOD
Notes (Explain if answered No to any of the above) J-Plug sits too high, can not screw in bolts due to J-Plug

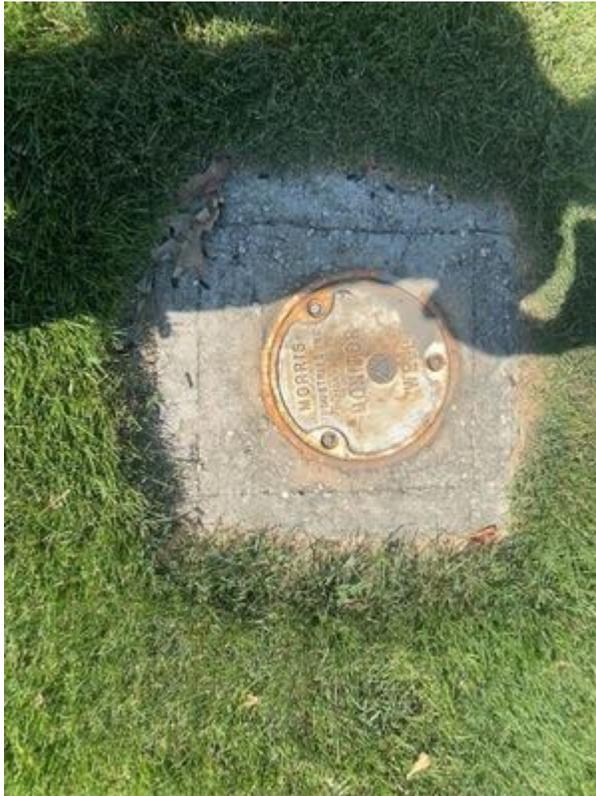
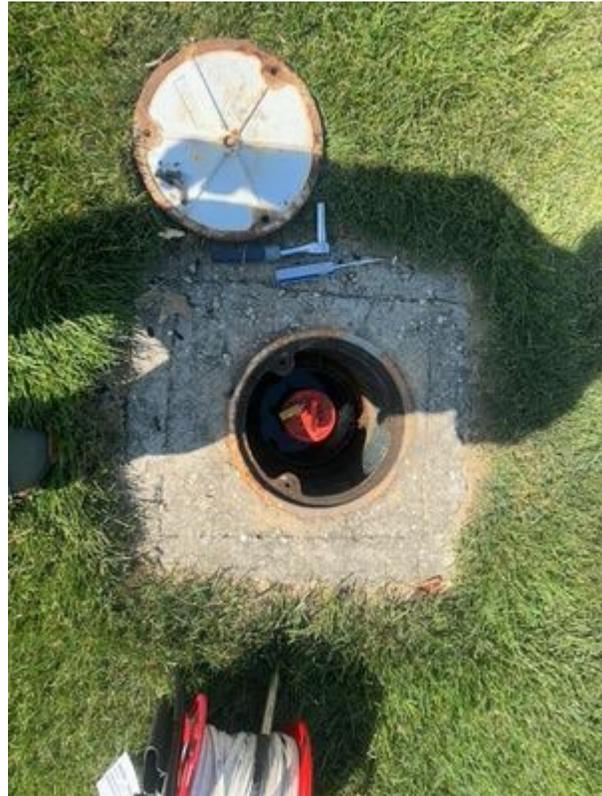
Client: Navy CLEAN	Facility: NWIRP Bethpage
Project Number: 112G08005-WE13	Location: Bethpage, New York
Date: June 12, 2024 10:31	Personnel: Jake Marlow
Well ID: RE121D1	Well Location: 203054.270357242 1126705.46994904
Well Status: In Use (Confirmed)	Screen Interval: 550-570
WELL INVENTORY CONDITION	
Concrete pad in acceptable condition i.e. no cracks?	NO
Manhole cover present and in working condition?	YES
All bolts on manhole present and not stripped?	YES
Well plug present, locked and in good working condition?	YES
OVERALL CONDITION:	GOOD
Notes (Explain if answered No to any of the above) Not on Field Maps, cracks in pad

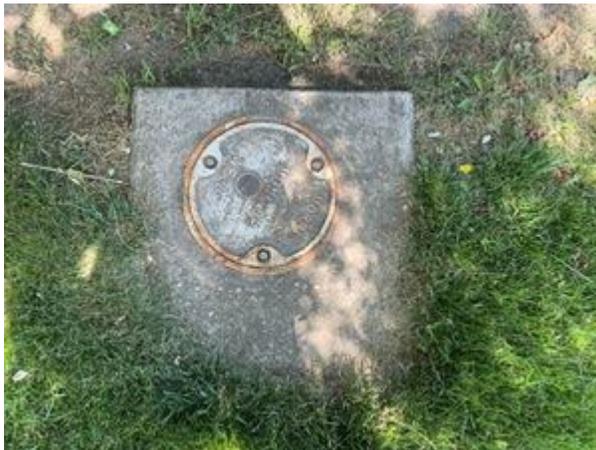
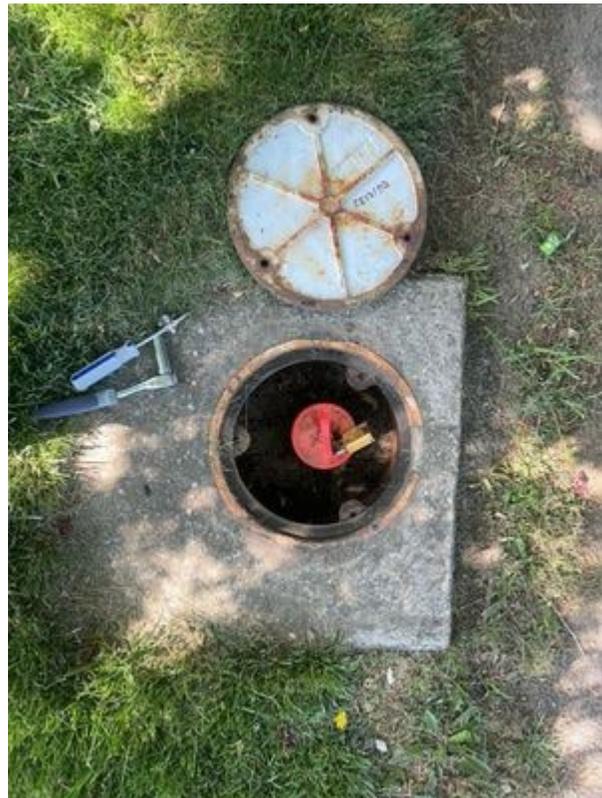
Client: Navy CLEAN	Facility: NWIRP Bethpage
Project Number: 112G08005-WE13	Location: Bethpage, New York
Date: June 12, 2024 10:25	Personnel: Jake Marlow
Well ID: RE121D2	Well Location: 202997.425940297 1126662.70745856
Well Status: In Use (Confirmed)	Screen Interval: 730-750
WELL INVENTORY CONDITION	
Concrete pad in acceptable condition i.e. no cracks?	YES
Manhole cover present and in working condition?	YES
All bolts on manhole present and not stripped?	YES
Well plug present, locked and in good working condition?	YES
OVERALL CONDITION:	GOOD
Notes (Explain if answered No to any of the above)

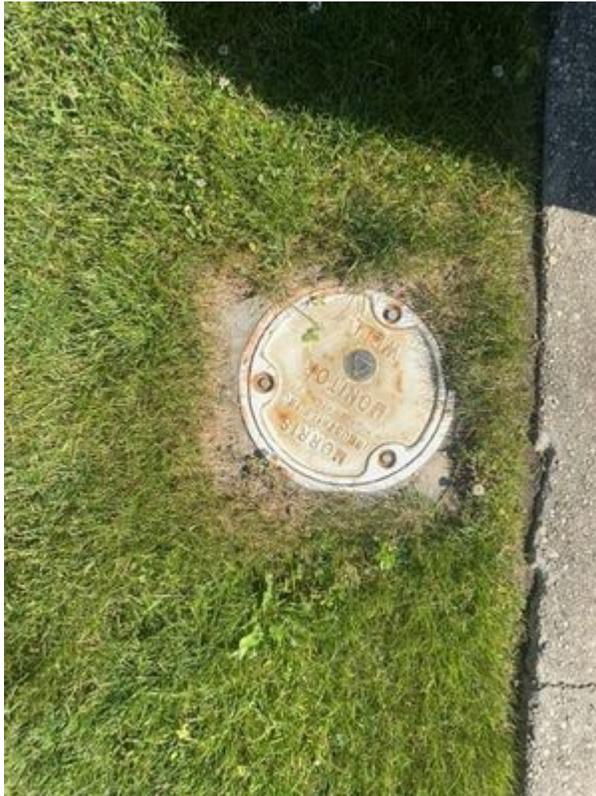
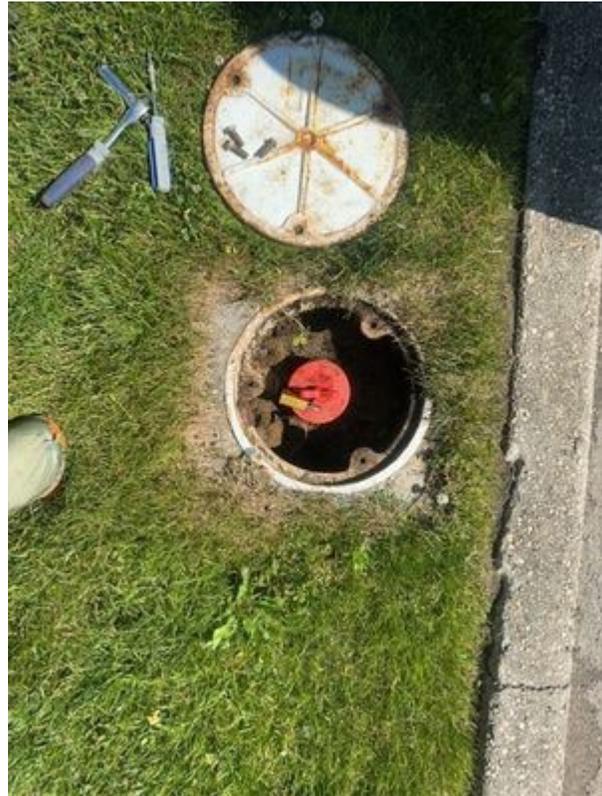
Client: Navy CLEAN	Facility: NWIRP Bethpage
Project Number: 112G08005-WE13	Location: Bethpage, New York
Date: June 12, 2024 09:42	Personnel: Jake Marlow
Well ID: RE120D2	Well Location: 204575.230177362 1125059.61291886
Well Status: In Use (Confirmed)	Screen Interval: 690-710
WELL INVENTORY CONDITION	
Concrete pad in acceptable condition i.e. no cracks?	YES
Manhole cover present and in working condition?	YES
All bolts on manhole present and not stripped?	YES
Well plug present, locked and in good working condition?	YES
OVERALL CONDITION:	GOOD
Notes (Explain if answered No to any of the above)

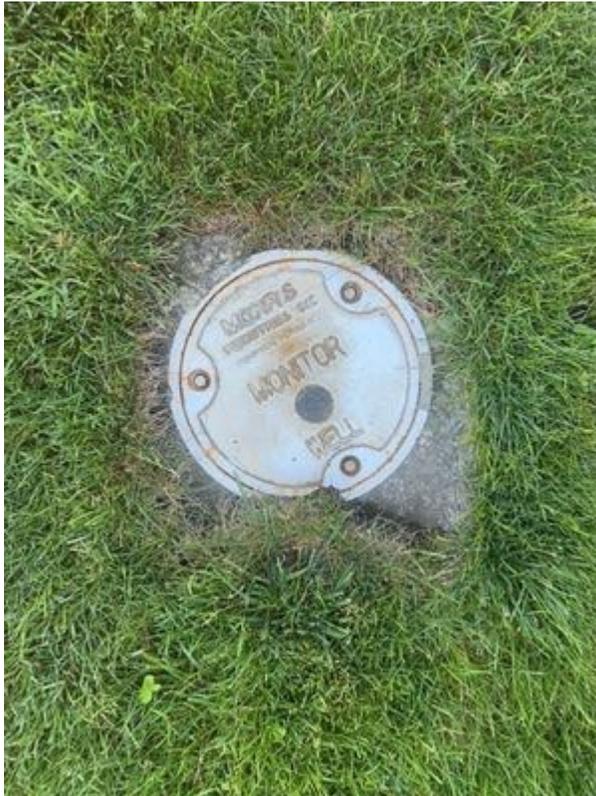
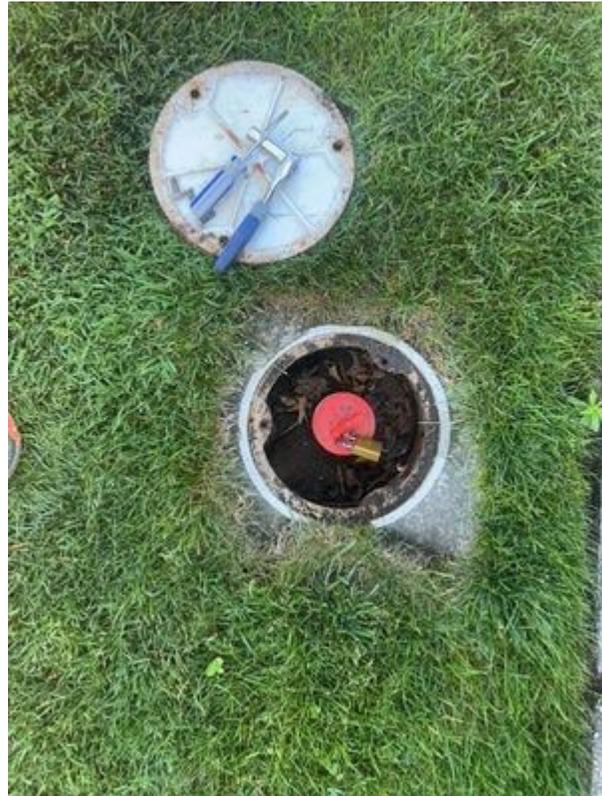
Client: Navy CLEAN	Facility: NWIRP Bethpage
Project Number: 112G08005-WE13	Location: Bethpage, New York
Date: June 12, 2024 09:32	Personnel: Jake Marlow
Well ID: RE120D1	Well Location: 204592.611028444 1125057.62845072
Well Status: In Use (Confirmed)	Screen Interval: 630-650
WELL INVENTORY CONDITION	
Concrete pad in acceptable condition i.e. no cracks?	YES
Manhole cover present and in working condition?	YES
All bolts on manhole present and not stripped?	YES
Well plug present, locked and in good working condition?	YES
OVERALL CONDITION:	GOOD
Notes (Explain if answered No to any of the above)

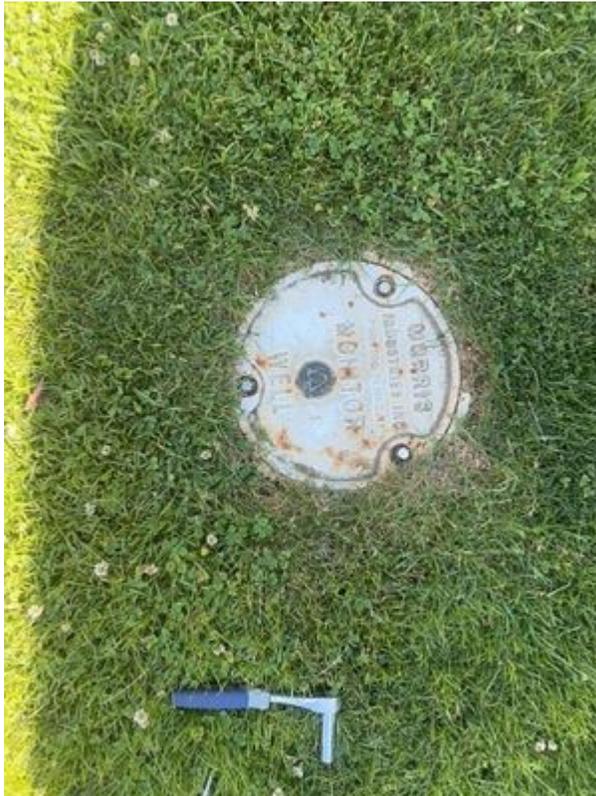
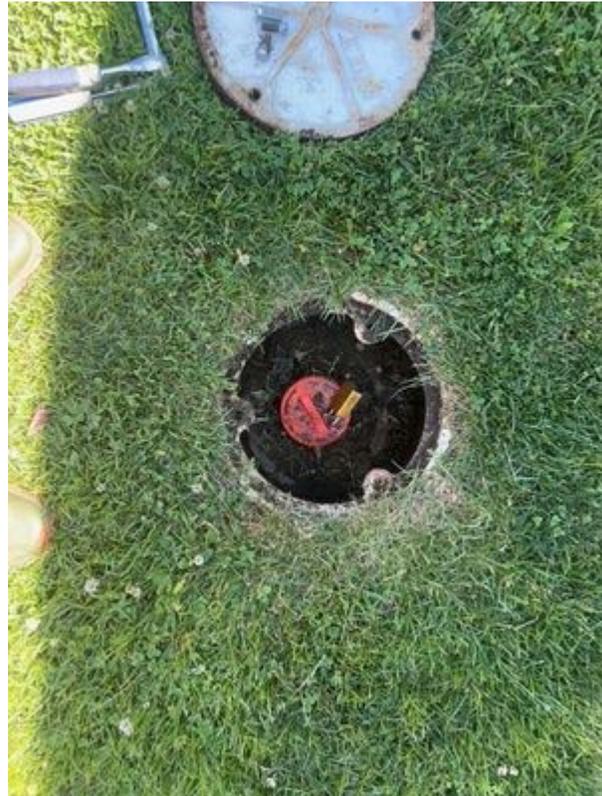
Client: Navy CLEAN	Facility: NWIRP Bethpage
Project Number: 112G08005-WE13	Location: Bethpage, New York
Date: June 12, 2024 09:27	Personnel: Jake Marlow
Well ID: RE120D3	Well Location: 204619.410218227 1125061.3365316
Well Status: In Use (Confirmed)	Screen Interval: 740-760
WELL INVENTORY CONDITION	
Concrete pad in acceptable condition i.e. no cracks?	YES
Manhole cover present and in working condition?	YES
All bolts on manhole present and not stripped?	YES
Well plug present, locked and in good working condition?	YES
OVERALL CONDITION:	GOOD
Notes (Explain if answered No to any of the above)

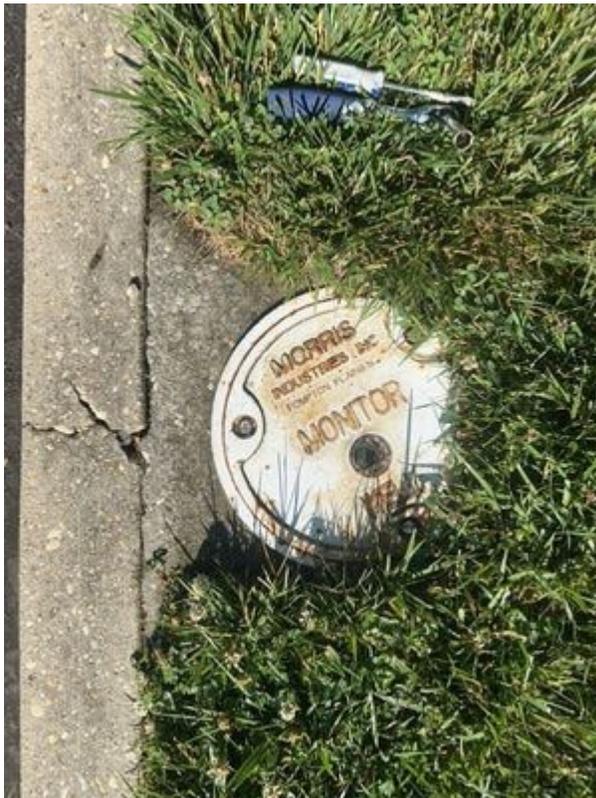
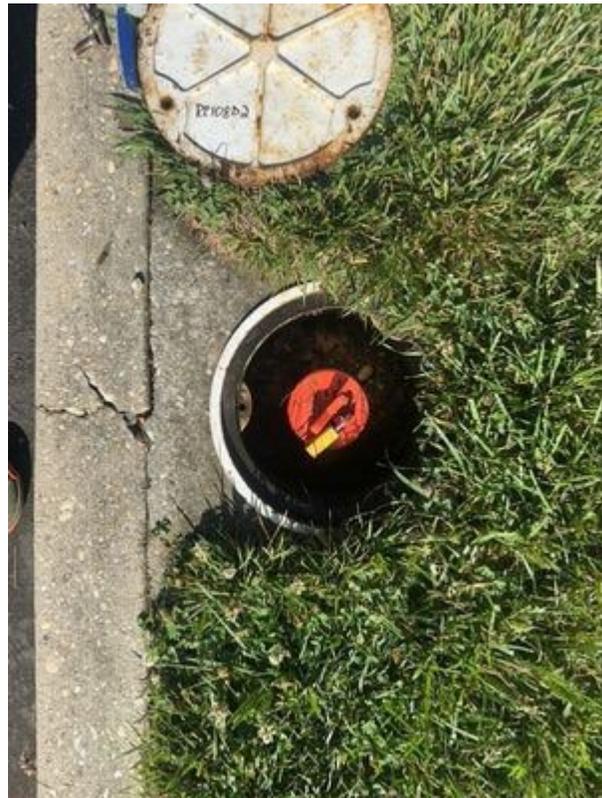
Client: Navy CLEAN	Facility: NWIRP Bethpage
Project Number: 112G08005-WE13	Location: Bethpage, New York
Date: June 12, 2024 09:01	Personnel: Jake Marlow
Well ID: RE122D2	Well Location: 207661.425640095 1125486.11003209
Well Status: In Use (Confirmed)	Screen Interval: 590-610
WELL INVENTORY CONDITION	
Concrete pad in acceptable condition i.e. no cracks?	YES
Manhole cover present and in working condition?	YES
All bolts on manhole present and not stripped?	YES
Well plug present, locked and in good working condition?	YES
OVERALL CONDITION:	GOOD
Notes (Explain if answered No to any of the above)

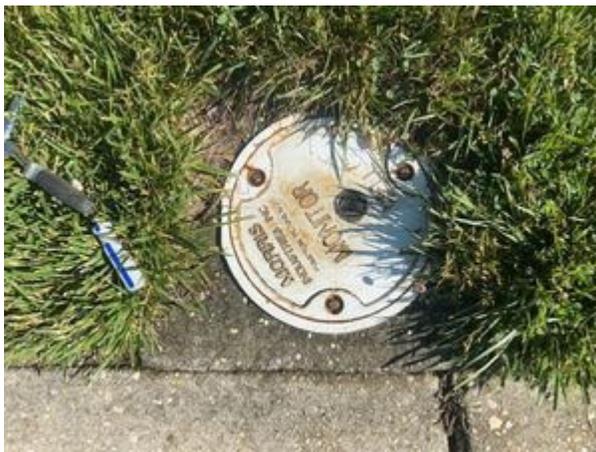
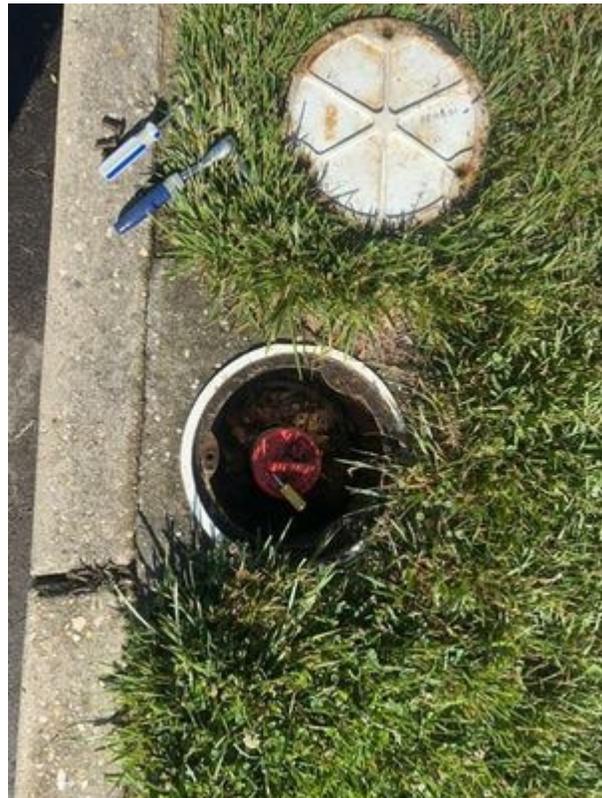
Client: Navy CLEAN	Facility: NWIRP Bethpage
Project Number: 112G08005-WE13	Location: Bethpage, New York
Date: June 12, 2024 08:52	Personnel: Jake Marlow
Well ID: RE108D1	Well Location: 207660.513948131 1125485.77639693
Well Status: In Use (Confirmed)	Screen Interval: 530-550
WELL INVENTORY CONDITION	
Concrete pad in acceptable condition i.e. no cracks?	YES
Manhole cover present and in working condition?	YES
All bolts on manhole present and not stripped?	YES
Well plug present, locked and in good working condition?	YES
OVERALL CONDITION:	GOOD
Notes (Explain if answered No to any of the above)
