Memorandum

To: Scott Sokolowski, NAVFAC MIDLANT
From: Richard Moore, Tetra Tech
Date: September 27, 2024
Re: Annual LUC Inspection and Operation Summary Report: Sites 1, 2, 3, and 4 –
NWIRP Bethpage
Contract/CTO Number: N6247016D9008/WE16

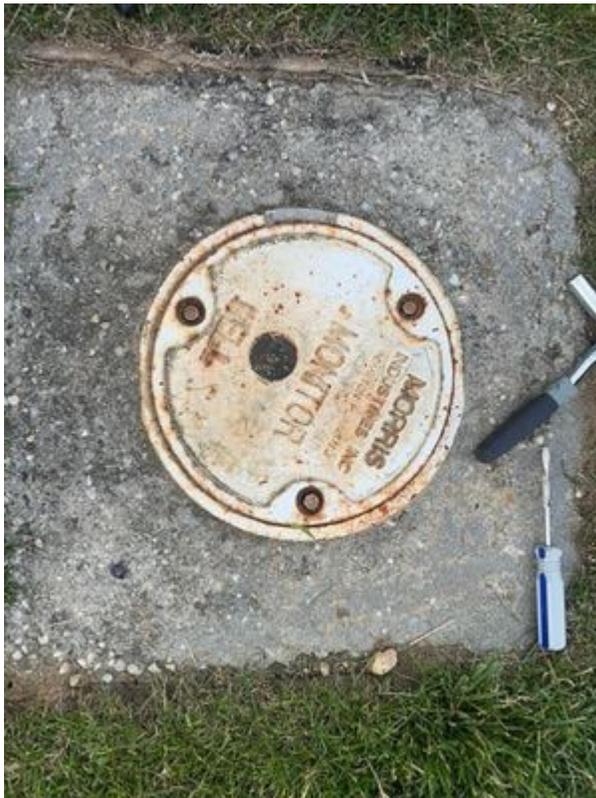
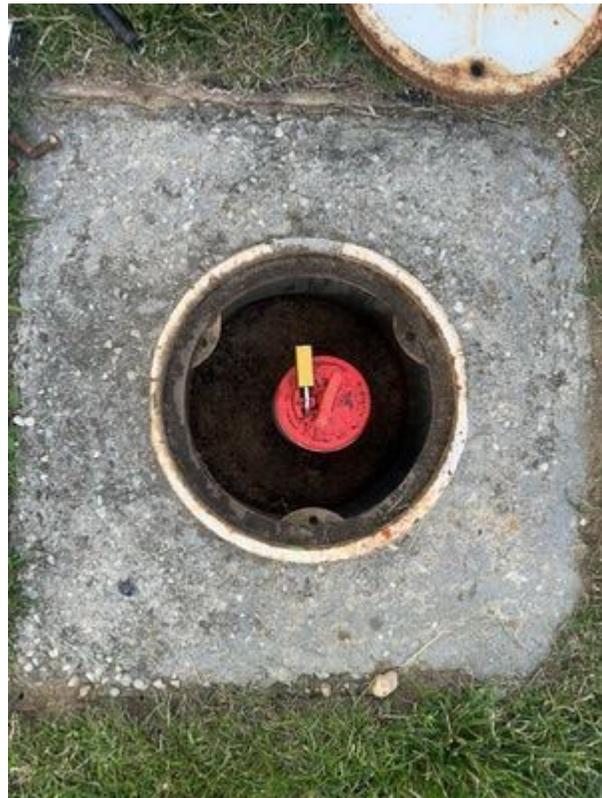
Client: Navy CLEAN	Facility: NWIRP Bethpage
Project Number: 112G08005-WE13	Location: Bethpage, New York
Date: June 11, 2024 19:03	Personnel: Jake Marlow
Well ID: RE122D1	Well Location: 207818.056374455 1124982.32305491
Well Status: In Use (Confirmed)	Screen Interval: 520-540
WELL INVENTORY CONDITION	
Concrete pad in acceptable condition i.e. no cracks?	YES
Manhole cover present and in working condition?	YES
All bolts on manhole present and not stripped?	YES
Well plug present, locked and in good working condition?	YES
OVERALL CONDITION:	GOOD
Notes (Explain if answered No to any of the above)

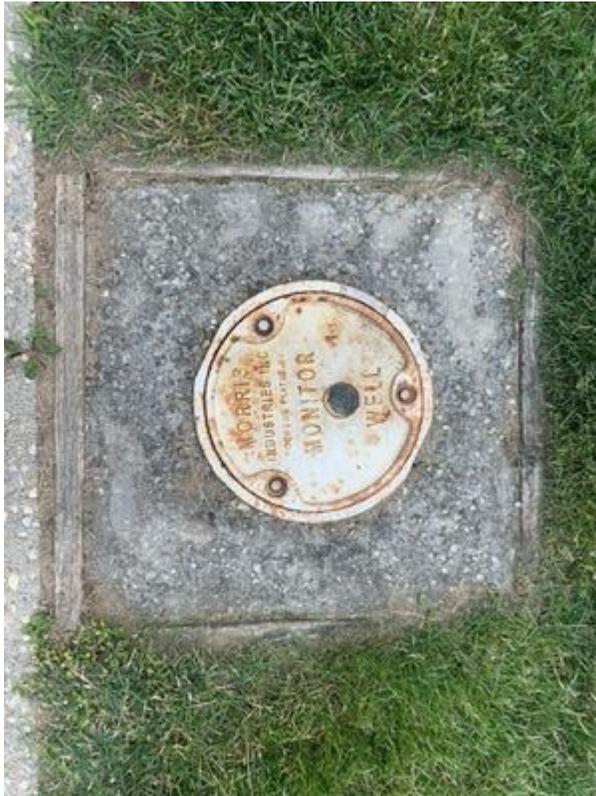
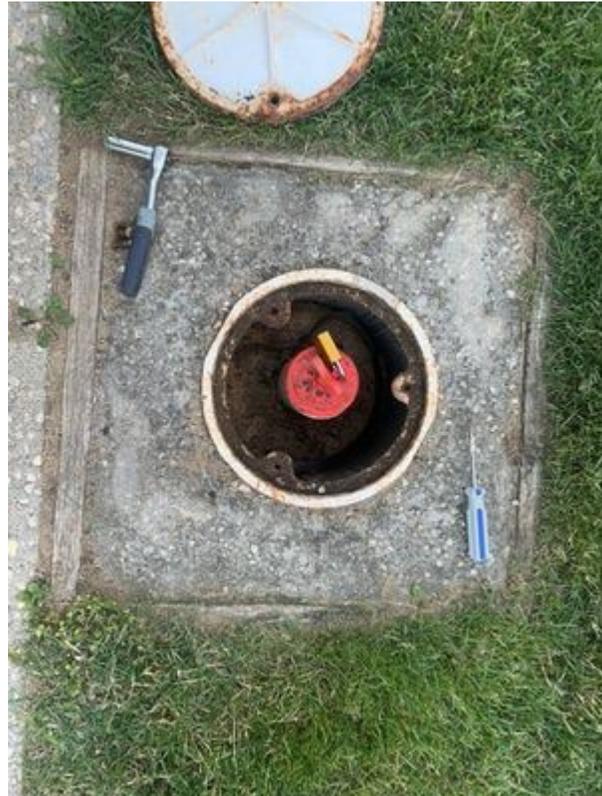
Client: Navy CLEAN	Facility: NWIRP Bethpage
Project Number: 112G08005-WE13	Location: Bethpage, New York
Date: June 11, 2024 18:50	Personnel: Jake Marlow
Well ID: RE125D2	Well Location: 207787.198594866 1124990.01649174
Well Status: In Use (Confirmed)	Screen Interval: 580-600
WELL INVENTORY CONDITION	
Concrete pad in acceptable condition i.e. no cracks?	YES
Manhole cover present and in working condition?	YES
All bolts on manhole present and not stripped?	YES
Well plug present, locked and in good working condition?	YES
OVERALL CONDITION:	GOOD
Notes (Explain if answered No to any of the above)

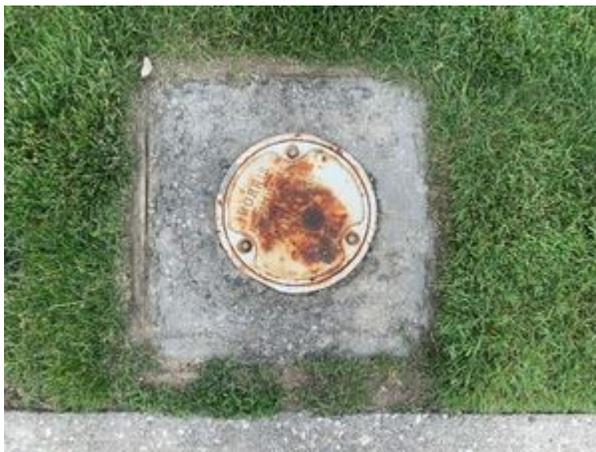
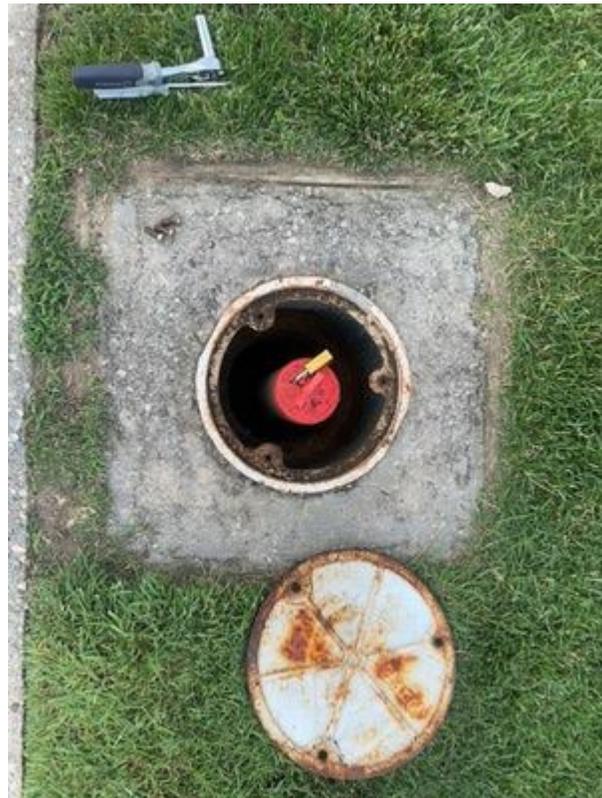
Client: Navy CLEAN	Facility: NWIRP Bethpage
Project Number: 112G08005-WE13	Location: Bethpage, New York
Date: June 11, 2024 18:39	Personnel: Jake Marlow
Well ID: RE122D3	Well Location: 207769.783942217 1124980.95865228
Well Status: In Use (Confirmed)	Screen Interval: 715-735
WELL INVENTORY CONDITION	
Concrete pad in acceptable condition i.e. no cracks?	YES
Manhole cover present and in working condition?	YES
All bolts on manhole present and not stripped?	YES
Well plug present, locked and in good working condition?	YES
OVERALL CONDITION:	GOOD
Notes (Explain if answered No to any of the above)

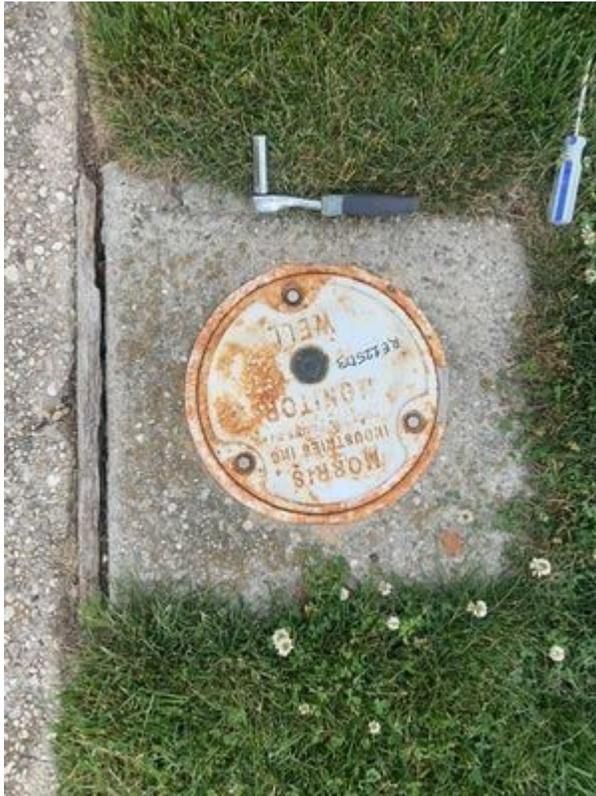
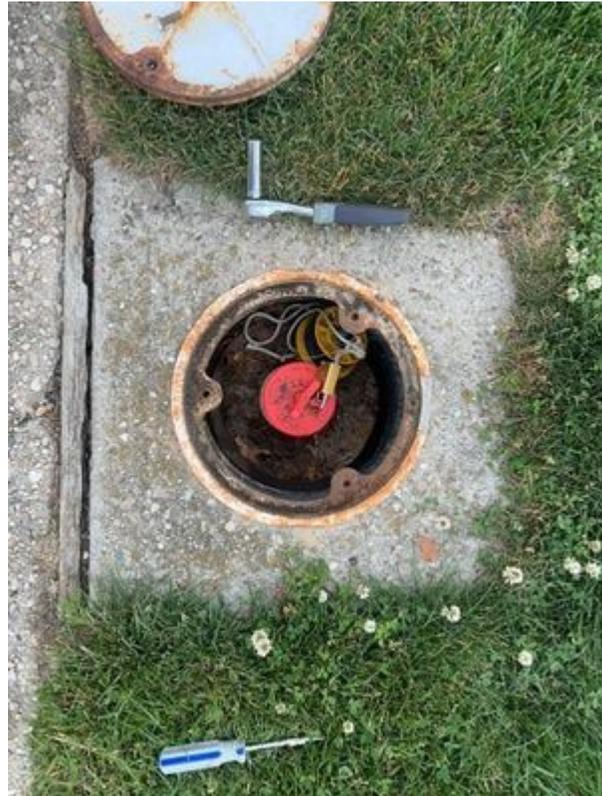
Client: Navy CLEAN	Facility: NWIRP Bethpage
Project Number: 112G08005-WE13	Location: Bethpage, New York
Date: June 11, 2024 18:14	Personnel: Jake Marlow
Well ID: RE125D3	Well Location: 204713.55364632 1124514.7200082
Well Status: In Use (Confirmed)	Screen Interval: 670-690
WELL INVENTORY CONDITION	
Concrete pad in acceptable condition i.e. no cracks?	YES
Manhole cover present and in working condition?	YES
All bolts on manhole present and not stripped?	YES
Well plug present, locked and in good working condition?	YES
OVERALL CONDITION:	GOOD
Notes (Explain if answered No to any of the above)

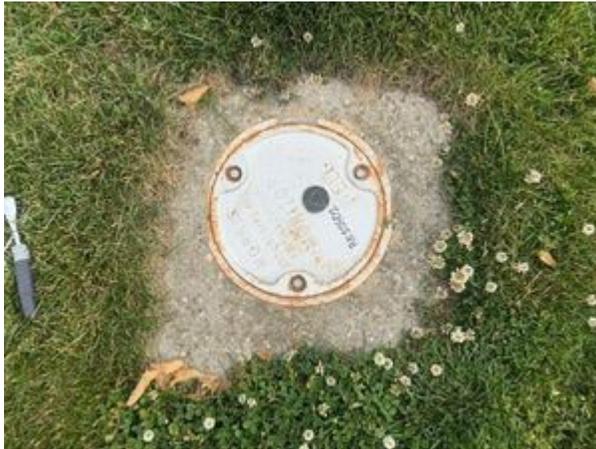
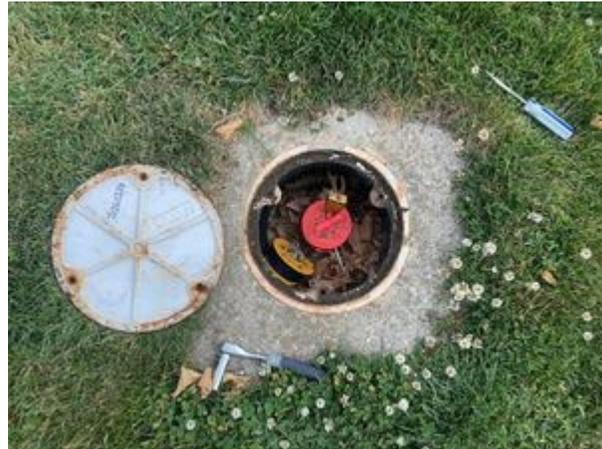
Client: Navy CLEAN	Facility: NWIRP Bethpage
Project Number: 112G08005-WE13	Location: Bethpage, New York
Date: June 11, 2024 18:05	Personnel: Jake Marlow
Well ID: RE125D2	Well Location: 204710.639683281 1124485.51911778
Well Status: In Use (Confirmed)	Screen Interval: 580-600
WELL INVENTORY CONDITION	
Concrete pad in acceptable condition i.e. no cracks?	YES
Manhole cover present and in working condition?	YES
All bolts on manhole present and not stripped?	YES
Well plug present, locked and in good working condition?	YES
OVERALL CONDITION:	GOOD
Notes (Explain if answered No to any of the above)

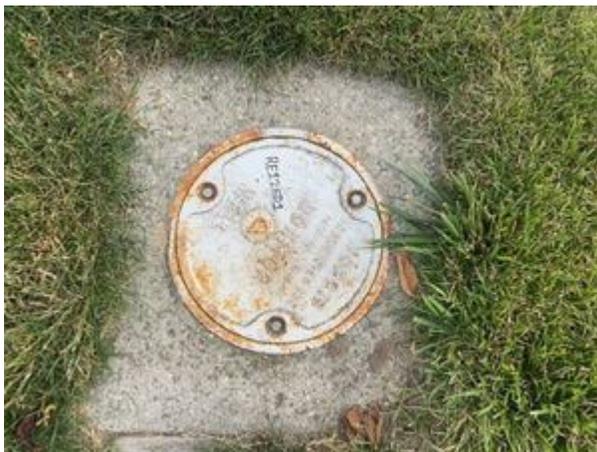
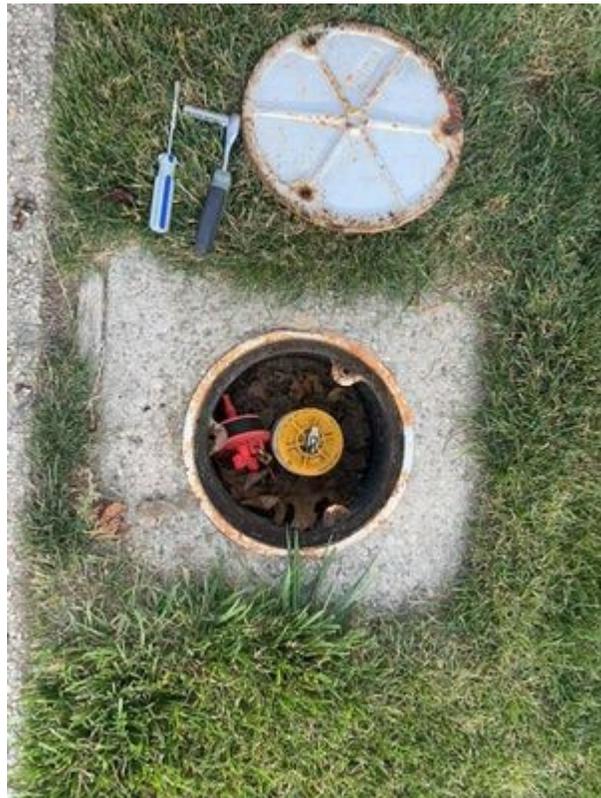
Client: Navy CLEAN	Facility: NWIRP Bethpage
Project Number: 112G08005-WE13	Location: Bethpage, New York
Date: June 11, 2024 17:59	Personnel: Jake Marlow
Well ID: RE125D1	Well Location: 204725.72830539 1124479.14240028
Well Status: In Use (Confirmed)	Screen Interval: 320-340
WELL INVENTORY CONDITION	
Concrete pad in acceptable condition i.e. no cracks?	YES
Manhole cover present and in working condition?	YES
All bolts on manhole present and not stripped?	YES
Well plug present, locked and in good working condition?	YES
OVERALL CONDITION:	GOOD
Notes (Explain if answered No to any of the above)

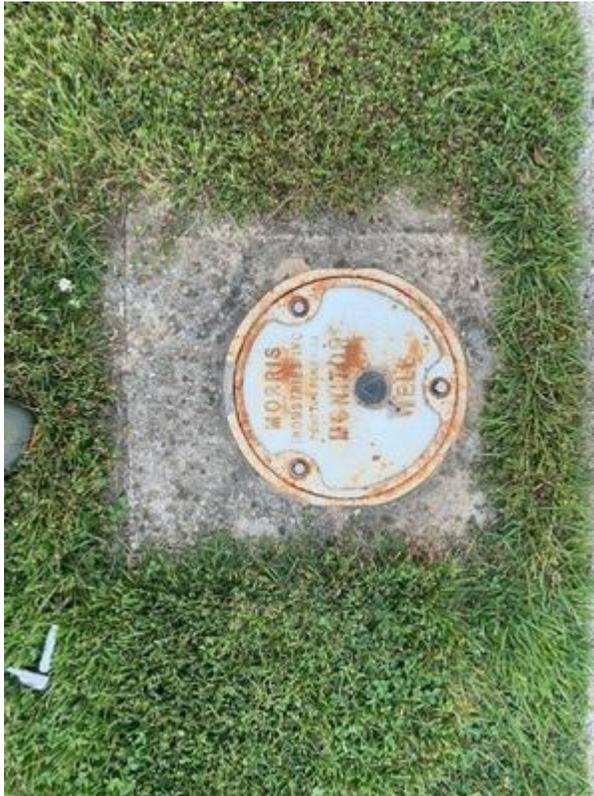
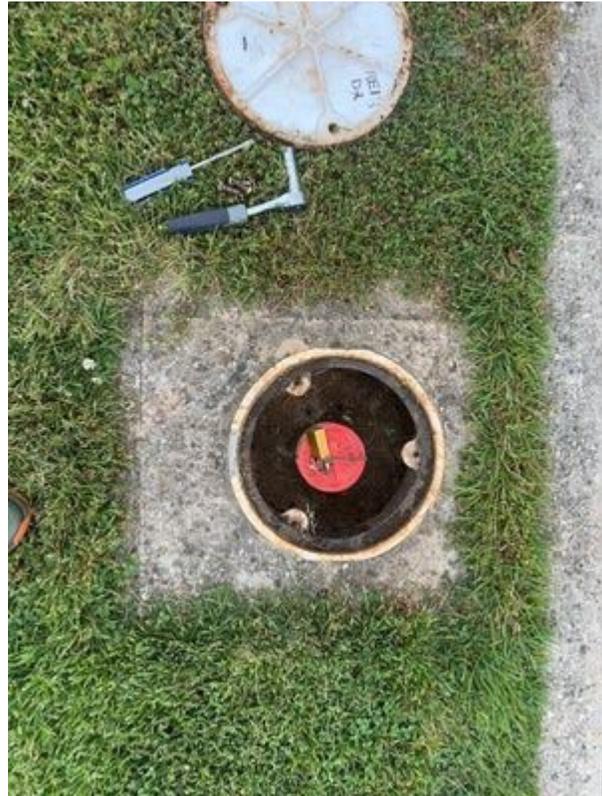
Client: Navy CLEAN	Facility: NWIRP Bethpage
Project Number: 112G08005-WE13	Location: Bethpage, New York
Date: June 11, 2024 17:31	Personnel: Jake Marlow
Well ID: RE132D2	Well Location: 193985.4383175 1126225.23392932
Well Status: In Use (Confirmed)	Screen Interval: 330-350
WELL INVENTORY CONDITION	
Concrete pad in acceptable condition i.e. no cracks?	YES
Manhole cover present and in working condition?	YES
All bolts on manhole present and not stripped?	YES
Well plug present, locked and in good working condition?	YES
OVERALL CONDITION:	GOOD
Notes (Explain if answered No to any of the above) Replaced one missing bolt

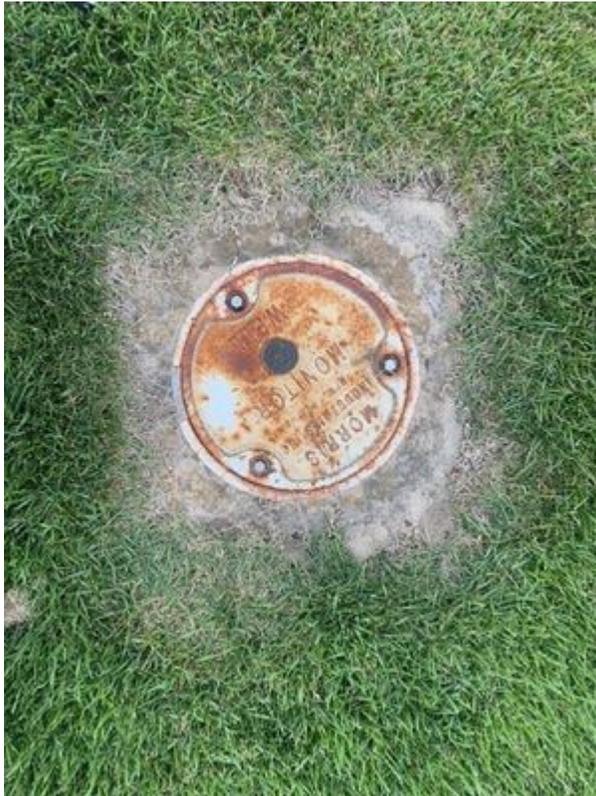
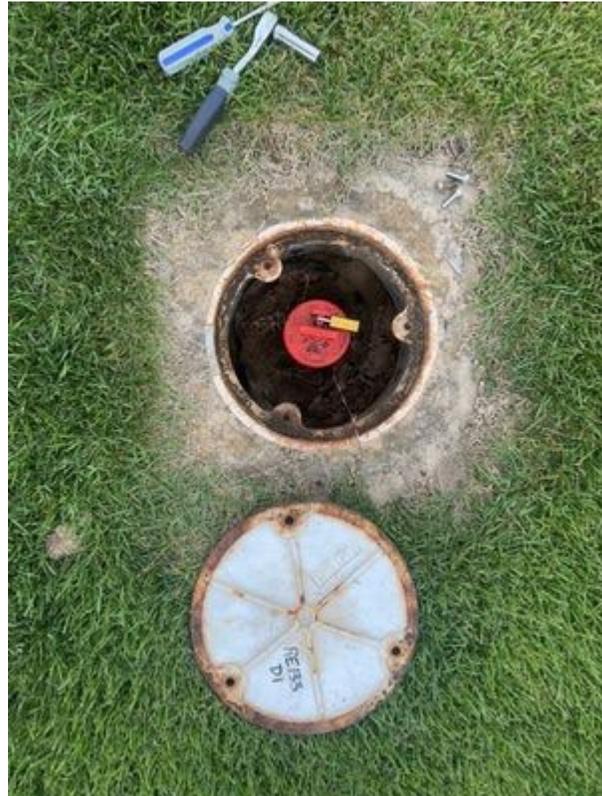
Client: Navy CLEAN	Facility: NWIRP Bethpage
Project Number: 112G08005-WE13	Location: Bethpage, New York
Date: June 11, 2024 17:27	Personnel: Jake Marlow
Well ID: RE133D1	Well Location: 193966.638348905 1126227.12487723
Well Status: In Use (Confirmed)	Screen Interval: 560-580
WELL INVENTORY CONDITION	
Concrete pad in acceptable condition i.e. no cracks?	YES
Manhole cover present and in working condition?	YES
All bolts on manhole present and not stripped?	YES
Well plug present, locked and in good working condition?	YES
OVERALL CONDITION:	GOOD
Notes (Explain if answered No to any of the above)

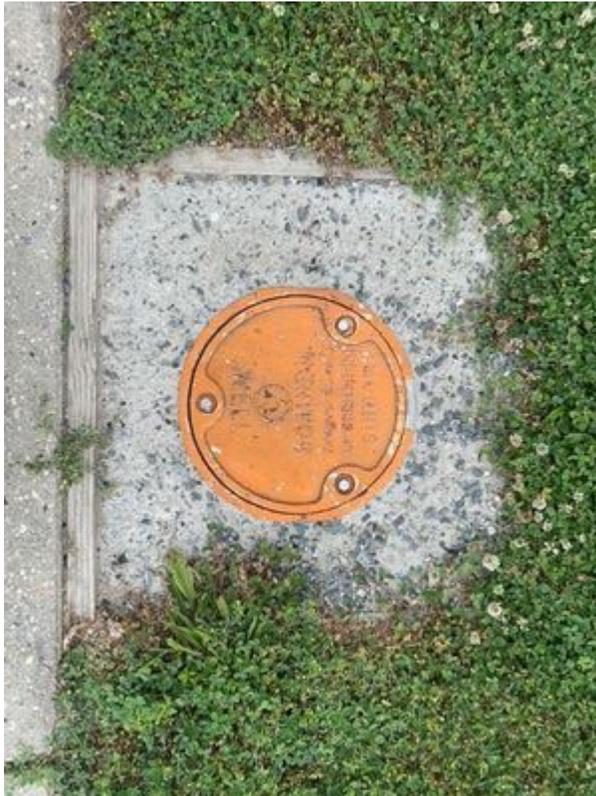
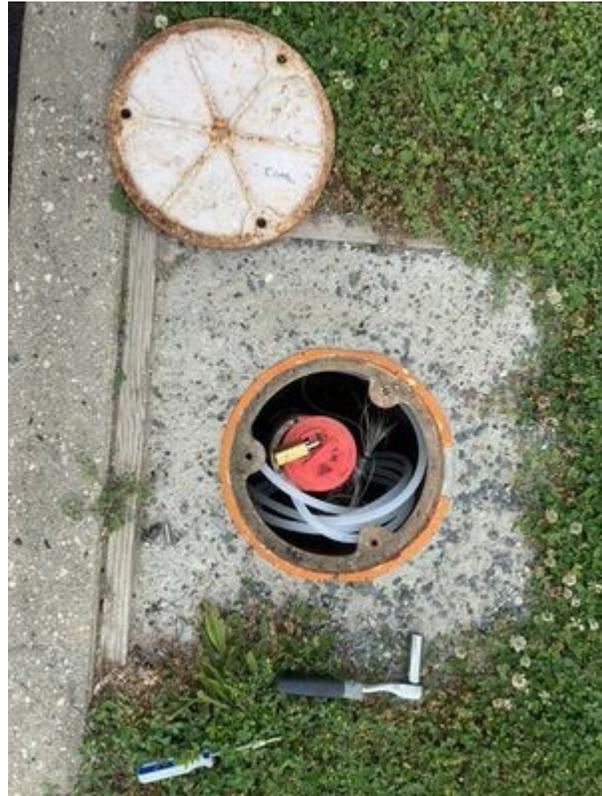
Client: Navy CLEAN	Facility: NWIRP Bethpage
Project Number: 112G08005-WE13	Location: Bethpage, New York
Date: June 11, 2024 17:21	Personnel: Jake Marlow
Well ID: DECHC05-MW-03	Well Location: 193938.793050461 1126196.6064
Well Status: In Use (Confirmed)	Screen Interval: 950-970
WELL INVENTORY CONDITION	
Concrete pad in acceptable condition i.e. no cracks?	YES
Manhole cover present and in working condition?	YES
All bolts on manhole present and not stripped?	YES
Well plug present, locked and in good working condition?	YES
OVERALL CONDITION:	GOOD
Notes (Explain if answered No to any of the above) One bolt is sheared off

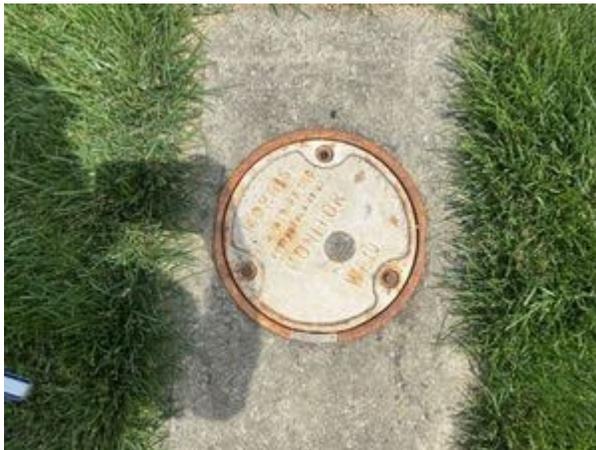
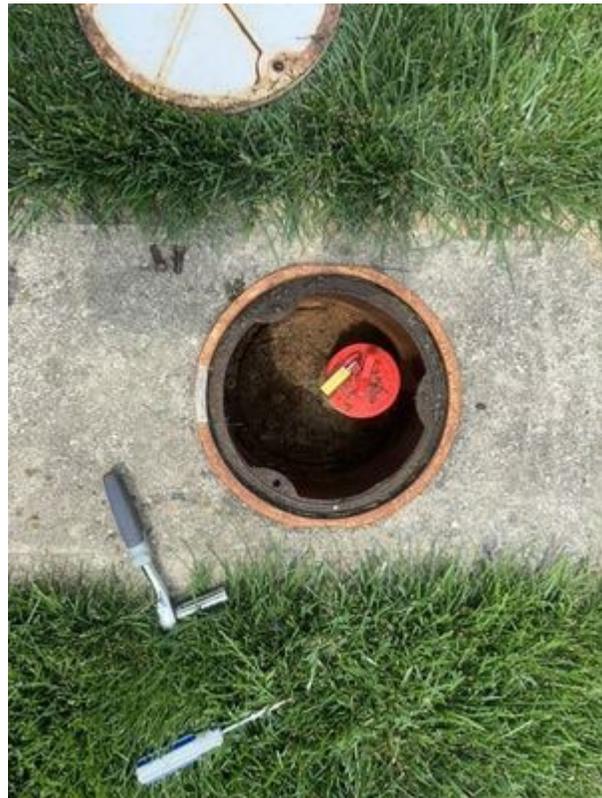
Client: Navy CLEAN	Facility: NWIRP Bethpage
Project Number: 112G08005-WE13	Location: Bethpage, New York
Date: June 11, 2024 14:00	Personnel: Jake Marlow
Well ID: RE134D1	Well Location: 206191.546218349 1123310.80543247
Well Status: In Use (Confirmed)	Screen Interval: 325-345
WELL INVENTORY CONDITION	
Concrete pad in acceptable condition i.e. no cracks?	YES
Manhole cover present and in working condition?	YES
All bolts on manhole present and not stripped?	NO
Well plug present, locked and in good working condition?	YES
OVERALL CONDITION:	GOOD
Notes (Explain if answered No to any of the above) One bolt sheared off

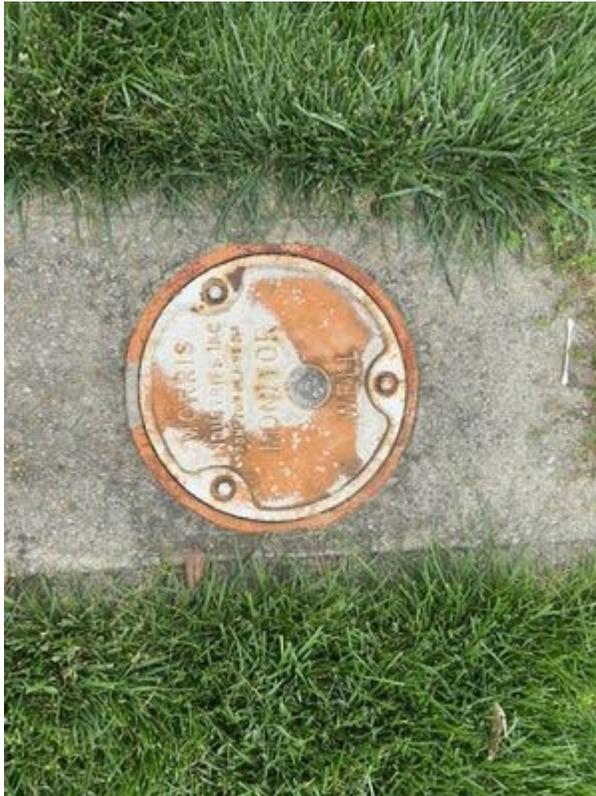
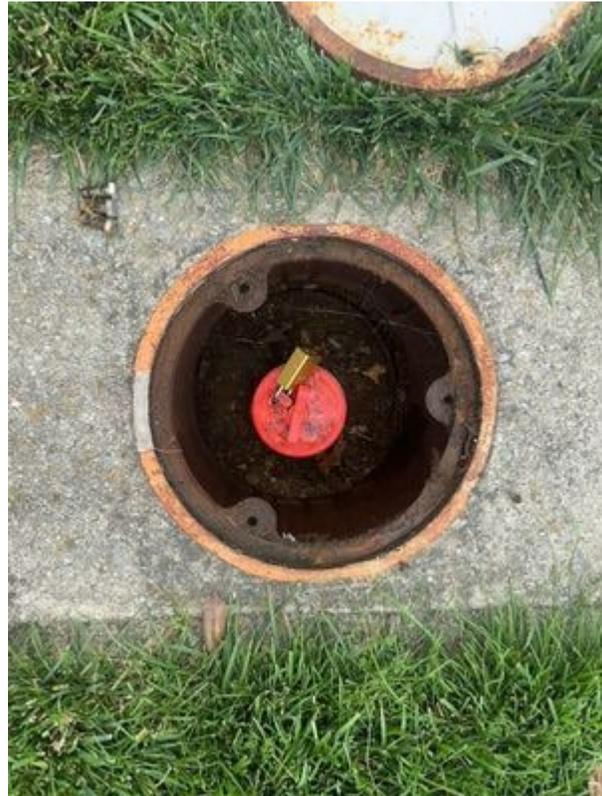
Client: Navy CLEAN	Facility: NWIRP Bethpage
Project Number: 112G08005-WE13	Location: Bethpage, New York
Date: June 11, 2024 13:45	Personnel: Jake Marlow
Well ID: RE134D2	Well Location: 206176.82889245 1123307.0655583
Well Status: In Use (Confirmed)	Screen Interval: 510-530
WELL INVENTORY CONDITION	
Concrete pad in acceptable condition i.e. no cracks?	YES
Manhole cover present and in working condition?	YES
All bolts on manhole present and not stripped?	YES
Well plug present, locked and in good working condition?	YES
OVERALL CONDITION:	GOOD
Notes (Explain if answered No to any of the above)

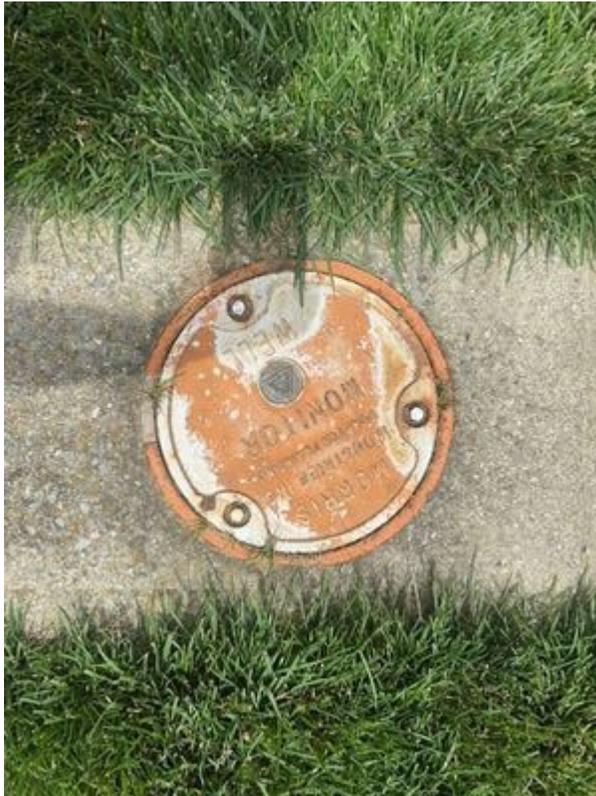
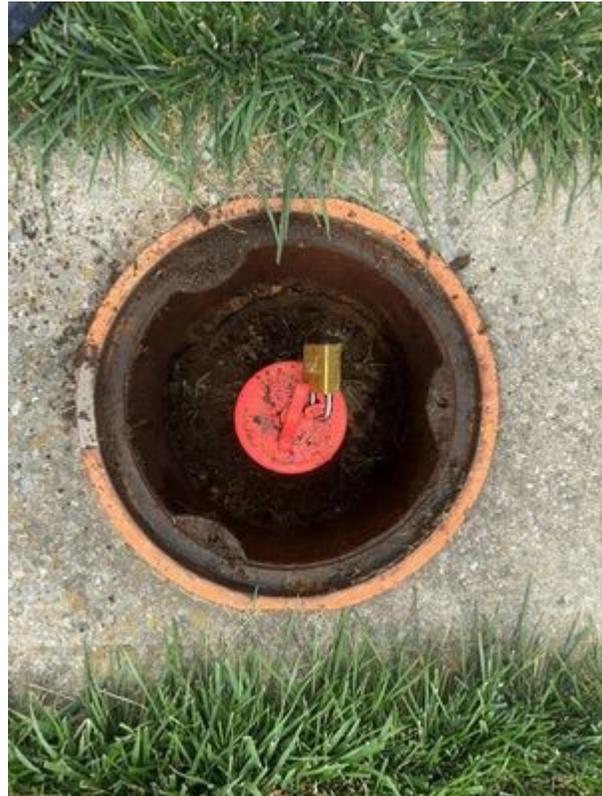
Client: Navy CLEAN	Facility: NWIRP Bethpage
Project Number: 112G08005-WE13	Location: Bethpage, New York
Date: June 11, 2024 13:39	Personnel: Jake Marlow
Well ID: RE134D3	Well Location: 206161.224883457 1123299.401539
Well Status: In Use (Confirmed)	Screen Interval: 600-620
WELL INVENTORY CONDITION	
Concrete pad in acceptable condition i.e. no cracks?	YES
Manhole cover present and in working condition?	YES
All bolts on manhole present and not stripped?	YES
Well plug present, locked and in good working condition?	YES
OVERALL CONDITION:	GOOD
Notes (Explain if answered No to any of the above)

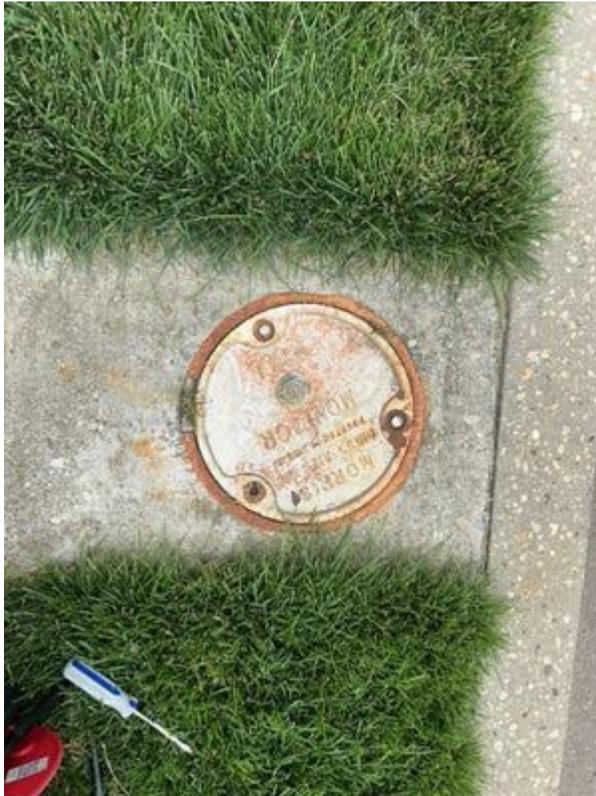
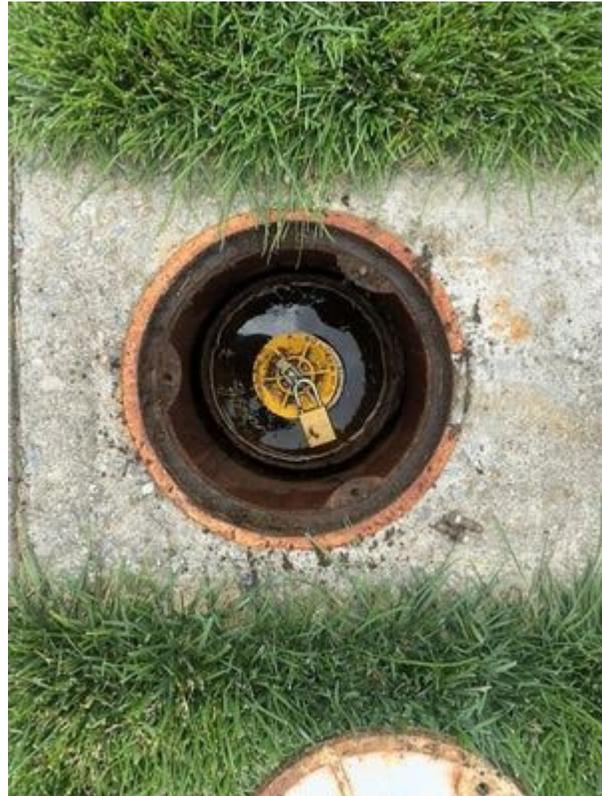
Client: Navy CLEAN	Facility: NWIRP Bethpage
Project Number: 112G08005-WE13	Location: Bethpage, New York
Date: June 11, 2024 13:35	Personnel: Jake Marlow
Well ID: RE134D4	Well Location: 206145.871196284 1123284.42501337
Well Status: In Use (Confirmed)	Screen Interval: 665-685
WELL INVENTORY CONDITION	
Concrete pad in acceptable condition i.e. no cracks?	YES
Manhole cover present and in working condition?	YES
All bolts on manhole present and not stripped?	NO
Well plug present, locked and in good working condition?	YES
OVERALL CONDITION:	GOOD
Notes (Explain if answered No to any of the above) One bolt is sheared off

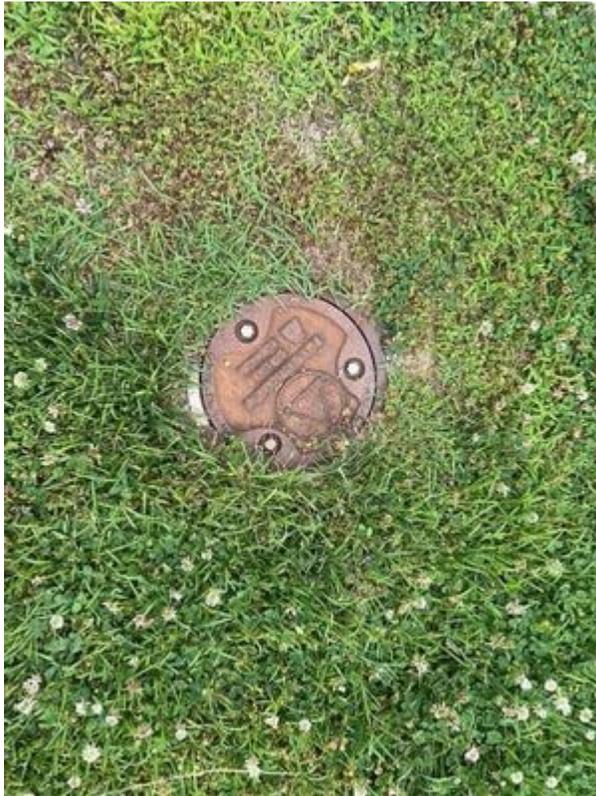
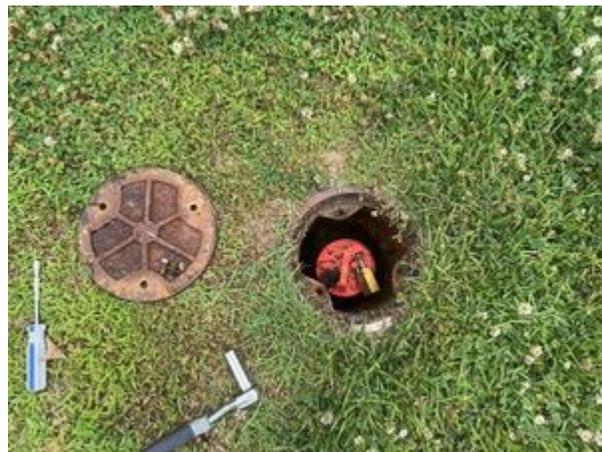
Client: Navy CLEAN	Facility: NWIRP Bethpage
Project Number: 112G08005-WE13	Location: Bethpage, New York
Date: June 11, 2024 13:14	Personnel: Jake Marlow
Well ID: GM38-RW3-MW2	Well Location: 206535.379745349 1128459.09397316
Well Status: In Use (Confirmed)	Screen Interval: 330-350
WELL INVENTORY CONDITION	
Concrete pad in acceptable condition i.e. no cracks?	YES
Manhole cover present and in working condition?	YES
All bolts on manhole present and not stripped?	YES
Well plug present, locked and in good working condition?	YES
OVERALL CONDITION:	GOOD
Notes (Explain if answered No to any of the above)

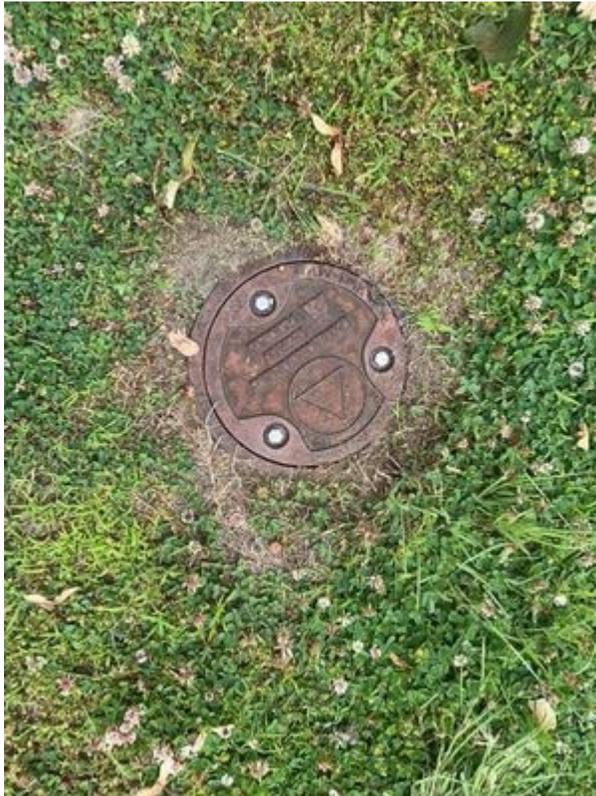
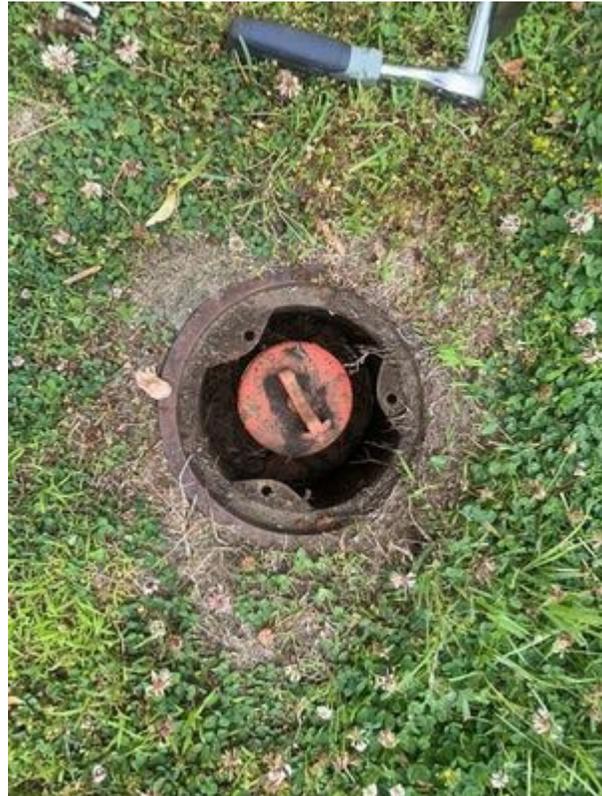
Client: Navy CLEAN	Facility: NWIRP Bethpage
Project Number: 112G08005-WE13	Location: Bethpage, New York
Date: June 11, 2024 13:07	Personnel: Jake Marlow
Well ID: GM38-RW3-MW1	Well Location: 206551.411853861 1128460.40860564
Well Status: In Use (Confirmed)	Screen Interval: 475-495
WELL INVENTORY CONDITION	
Concrete pad in acceptable condition i.e. no cracks?	YES
Manhole cover present and in working condition?	YES
All bolts on manhole present and not stripped?	YES
Well plug present, locked and in good working condition?	YES
OVERALL CONDITION:	GOOD
Notes (Explain if answered No to any of the above) Replaced one bolt

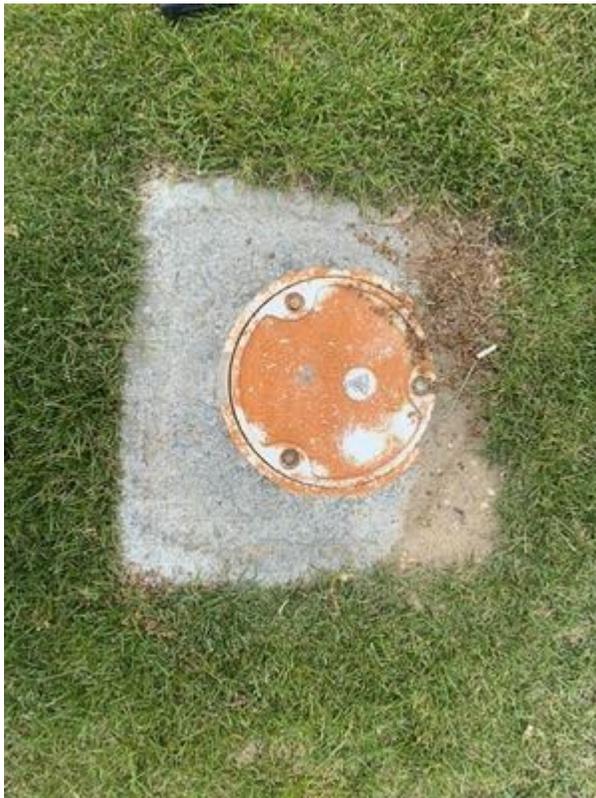
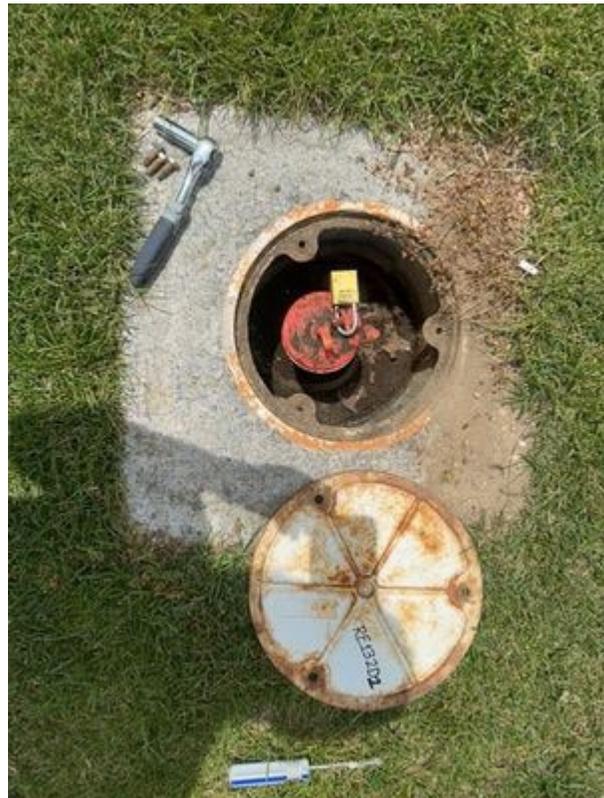
Client: Navy CLEAN	Facility: NWIRP Bethpage
Project Number: 112G08005-WE13	Location: Bethpage, New York
Date: June 11, 2024 12:31	Personnel: Jake Marlow
Well ID: RE132D1	Well Location: 203052.40436827 1125663.20829529
Well Status: In Use (Confirmed)	Screen Interval: 220-240
WELL INVENTORY CONDITION	
Concrete pad in acceptable condition i.e. no cracks?	YES
Manhole cover present and in working condition?	YES
All bolts on manhole present and not stripped?	YES
Well plug present, locked and in good working condition?	YES
OVERALL CONDITION:	GOOD
Notes (Explain if answered No to any of the above)

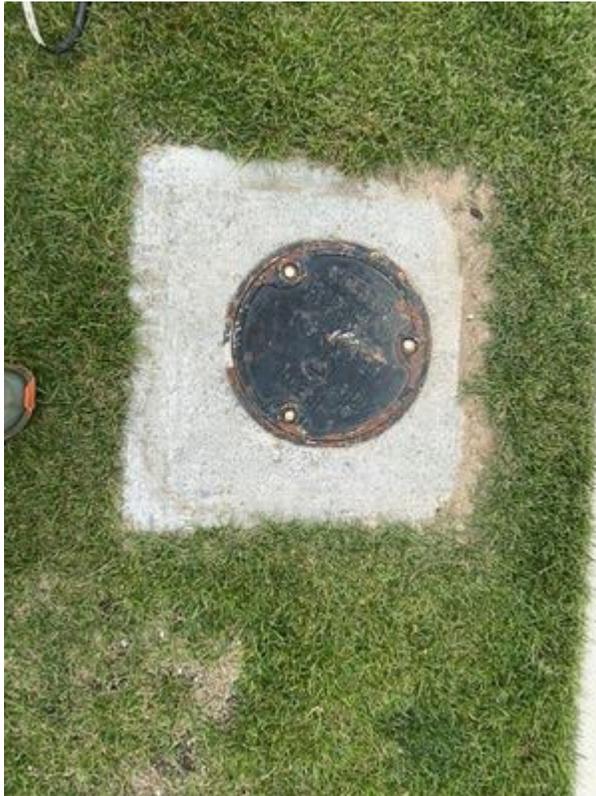
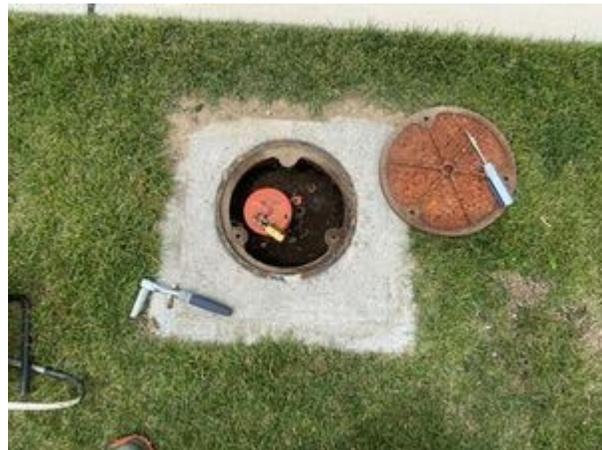
Client: Navy CLEAN	Facility: NWIRP Bethpage
Project Number: 112G08005-WE13	Location: Bethpage, New York
Date: June 11, 2024 12:23	Personnel: Jake Marlow
Well ID: RE132D7	Well Location: 203040.021443608 1125658.60643037
Well Status: In Use (Confirmed)	Screen Interval: 743-758
WELL INVENTORY CONDITION	
Concrete pad in acceptable condition i.e. no cracks?	YES
Manhole cover present and in working condition?	YES
All bolts on manhole present and not stripped?	YES
Well plug present, locked and in good working condition?	YES
OVERALL CONDITION:	GOOD
Notes (Explain if answered No to any of the above)

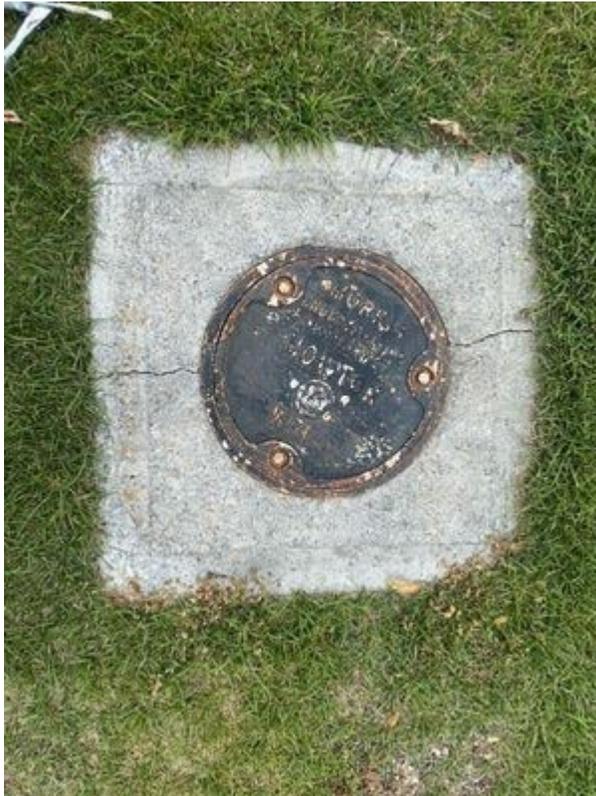
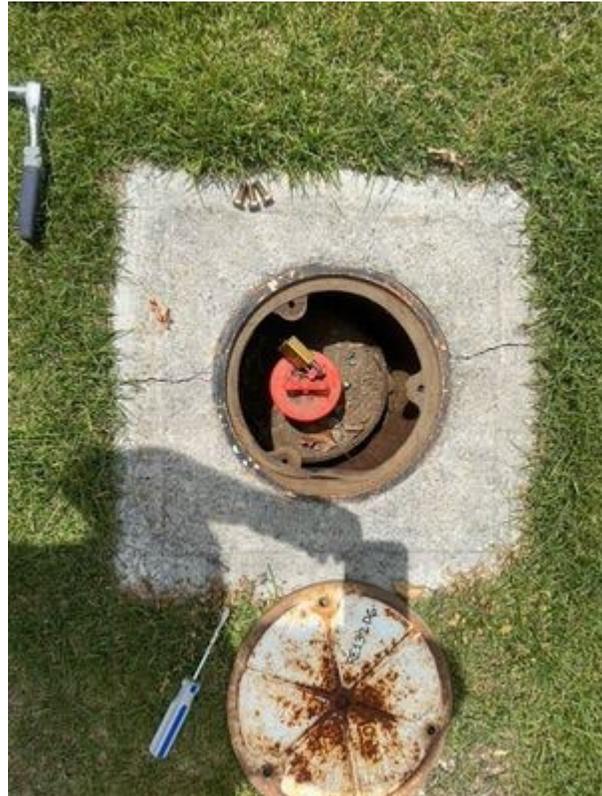
Client: Navy CLEAN	Facility: NWIRP Bethpage
Project Number: 112G08005-WE13	Location: Bethpage, New York
Date: June 11, 2024 12:12	Personnel: Jake Marlow
Well ID: RE132D6	Well Location: 203019.897629784 1125660.85384088
Well Status: In Use (Confirmed)	Screen Interval: 685-705
WELL INVENTORY CONDITION	
Concrete pad in acceptable condition i.e. no cracks?	YES
Manhole cover present and in working condition?	YES
All bolts on manhole present and not stripped?	YES
Well plug present, locked and in good working condition?	YES
OVERALL CONDITION:	GOOD
Notes (Explain if answered No to any of the above)

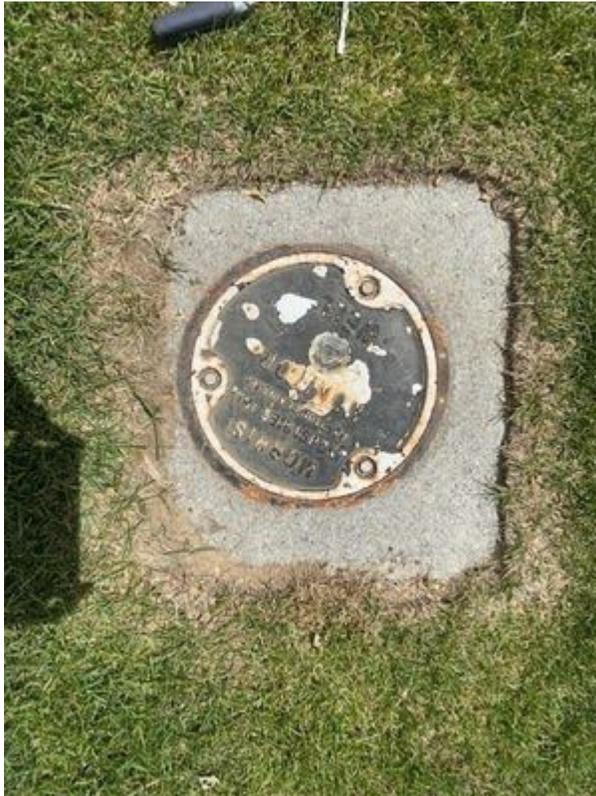
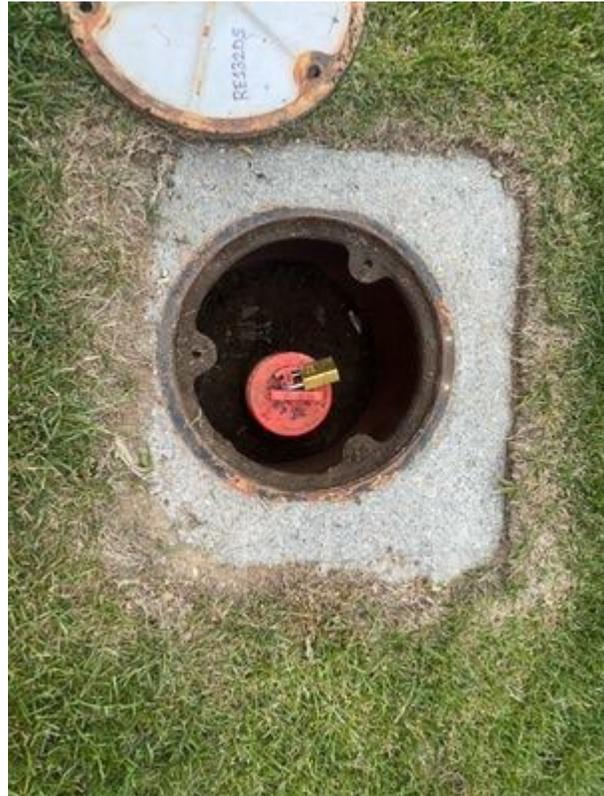
Client: Navy CLEAN	Facility: NWIRP Bethpage
Project Number: 112G08005-WE13	Location: Bethpage, New York
Date: June 11, 2024 12:05	Personnel: Jake Marlow
Well ID: RE132D5	Well Location: 203073.055132445 1125718.08446904
Well Status: In Use (Confirmed)	Screen Interval: 610-630
WELL INVENTORY CONDITION	
Concrete pad in acceptable condition i.e. no cracks?	YES
Manhole cover present and in working condition?	YES
All bolts on manhole present and not stripped?	YES
Well plug present, locked and in good working condition?	YES
OVERALL CONDITION:	GOOD
Notes (Explain if answered No to any of the above)

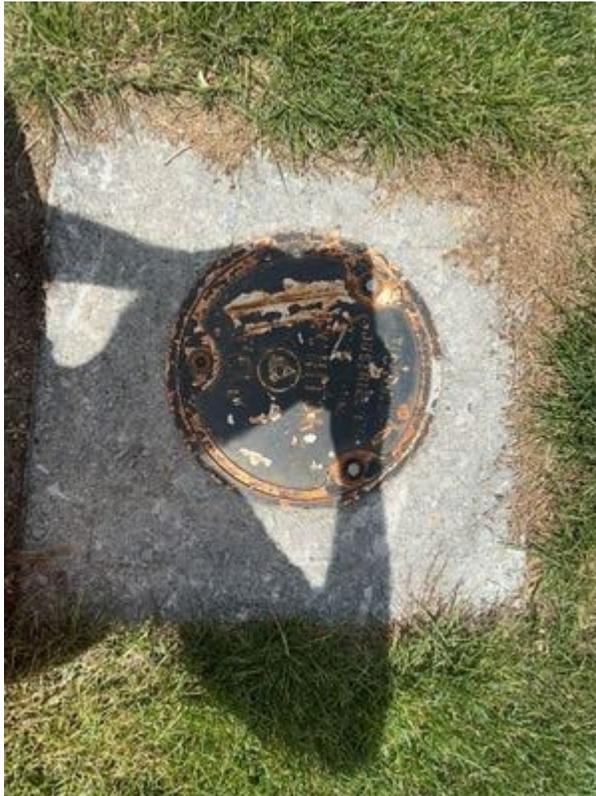
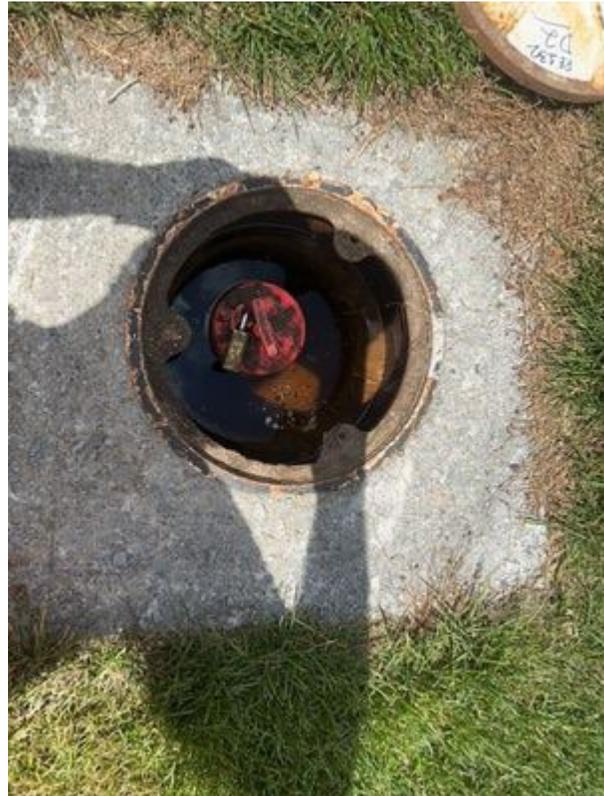
Client: Navy CLEAN	Facility: NWIRP Bethpage now
Project Number: 112G08005-WE13	Location: Bethpage, New York
Date: June 11, 2024 12:00	Personnel: Jake Marlow
Well ID: RE132D2	Well Location: 203105.517396297 1125692.72955598
Well Status: In Use (Confirmed)	Screen Interval: 330-350
WELL INVENTORY CONDITION	
Concrete pad in acceptable condition i.e. no cracks?	YES
Manhole cover present and in working condition?	YES
All bolts on manhole present and not stripped?	NO
Well plug present, locked and in good working condition?	YES
OVERALL CONDITION:	GOOD
Notes (Explain if answered No to any of the above) One bolt is sheared off

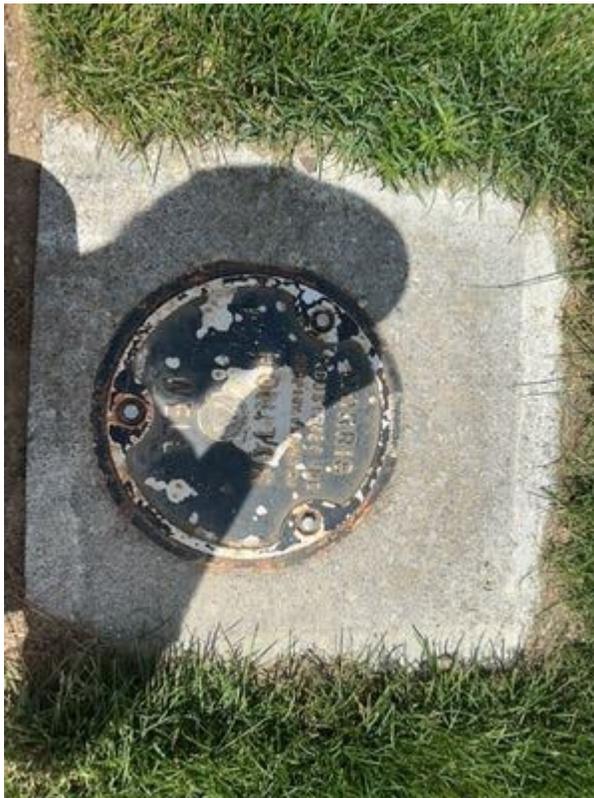
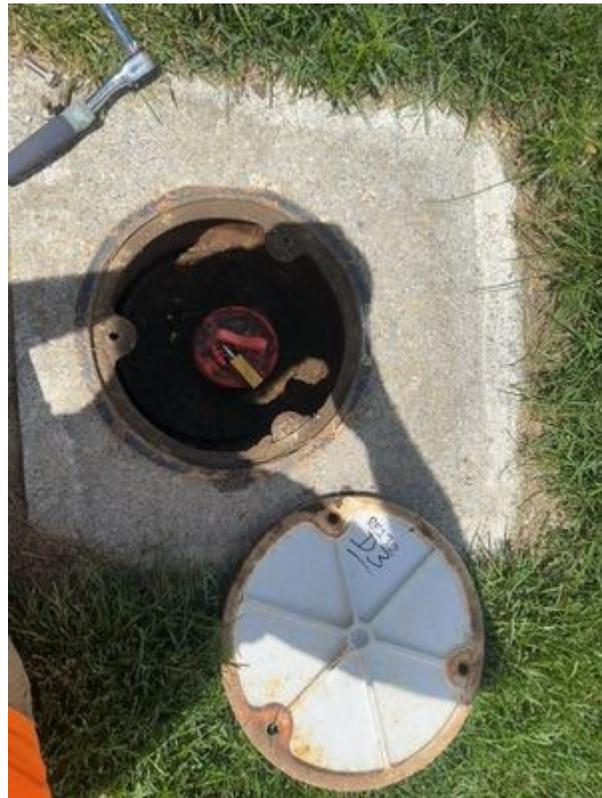
Client: Navy CLEAN	Facility: NWIRP Bethpage
Project Number: 112G08005-WE13	Location: Bethpage, New York
Date: June 11, 2024 11:54	Personnel: Jake Marlow
Well ID: RE132D3	Well Location: 203111.837627801 1125711.12945089
Well Status: In Use (Confirmed)	Screen Interval: 500-520
WELL INVENTORY CONDITION	
Concrete pad in acceptable condition i.e. no cracks?	YES
Manhole cover present and in working condition?	YES
All bolts on manhole present and not stripped?	YES
Well plug present, locked and in good working condition?	YES
OVERALL CONDITION:	GOOD
Notes (Explain if answered No to any of the above) Replaced one bolt
