Memorandum

To: Scott Sokolowski, NAVFAC MIDLANT
From: Richard Moore, Tetra Tech
Date: September 27, 2024
Re: Annual LUC Inspection and Operation Summary Report: Sites 1, 2, 3, and 4 –
NWIRP Bethpage
Contract/CTO Number: N6247016D9008/WE16

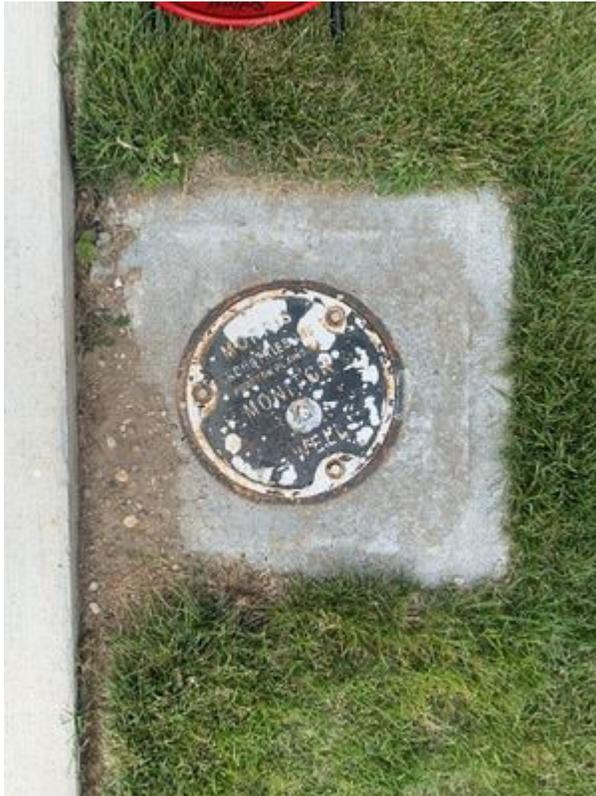
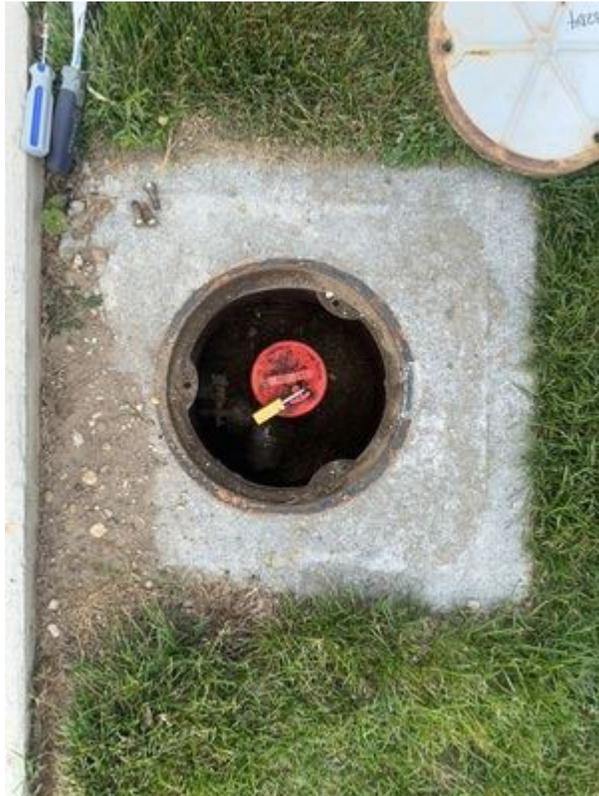
Client: Navy CLEAN	Facility: NWIRP Bethpage
Project Number: 112G08005-WE13	Location: Bethpage, New York
Date: June 11, 2024 11:48	Personnel: Jake Marlow
Well ID: RE132D4	Well Location: 203104.619845995 1125712.83464091
Well Status: In Use (Confirmed)	Screen Interval: 560-580
WELL INVENTORY CONDITION	
Concrete pad in acceptable condition i.e. no cracks?	YES
Manhole cover present and in working condition?	YES
All bolts on manhole present and not stripped?	YES
Well plug present, locked and in good working condition?	YES
OVERALL CONDITION:	GOOD
Notes (Explain if answered No to any of the above)

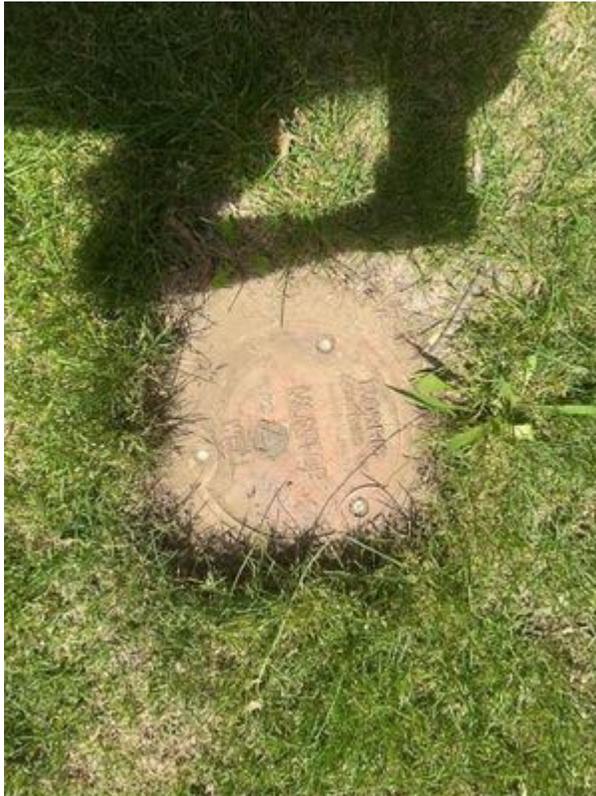
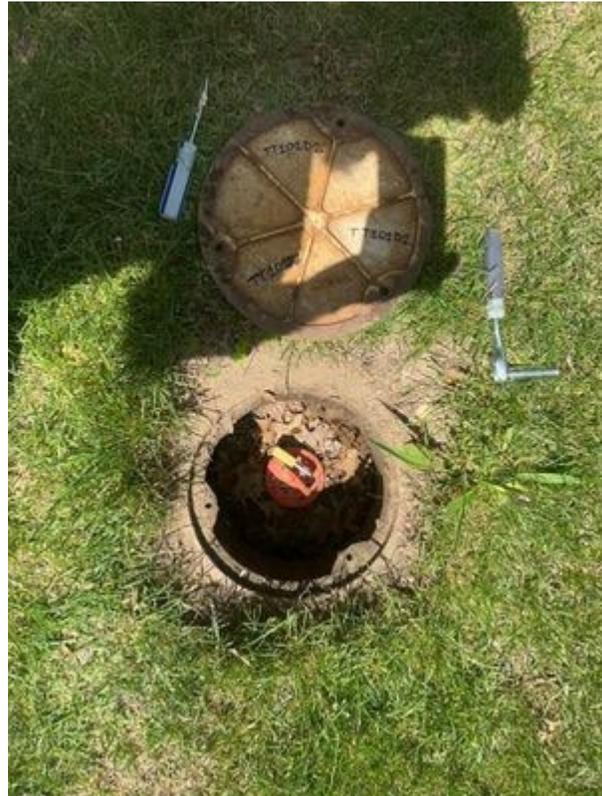
Client: Navy CLEAN	Facility: NWIRP Bethpage
Project Number: 112G08005-WE13	Location: Bethpage, New York
Date: June 11, 2024 11:02	Personnel: Jake Marlow
Well ID: TT101D2	Well Location: 203542.528667964 1125450.85894362
Well Status: In Use (Confirmed)	Screen Interval: 740-760
WELL INVENTORY CONDITION	
Concrete pad in acceptable condition i.e. no cracks?	YES
Manhole cover present and in working condition?	YES
All bolts on manhole present and not stripped?	YES
Well plug present, locked and in good working condition?	YES
OVERALL CONDITION:	GOOD
Notes (Explain if answered No to any of the above)

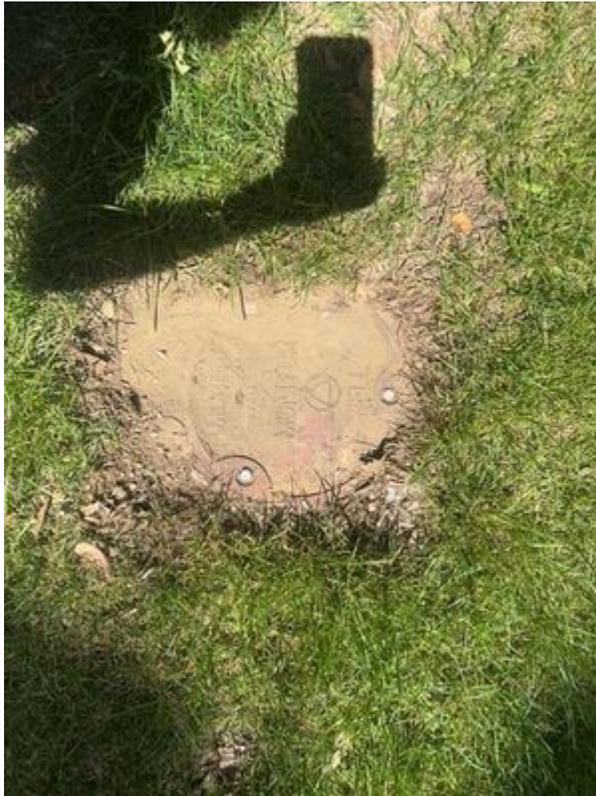
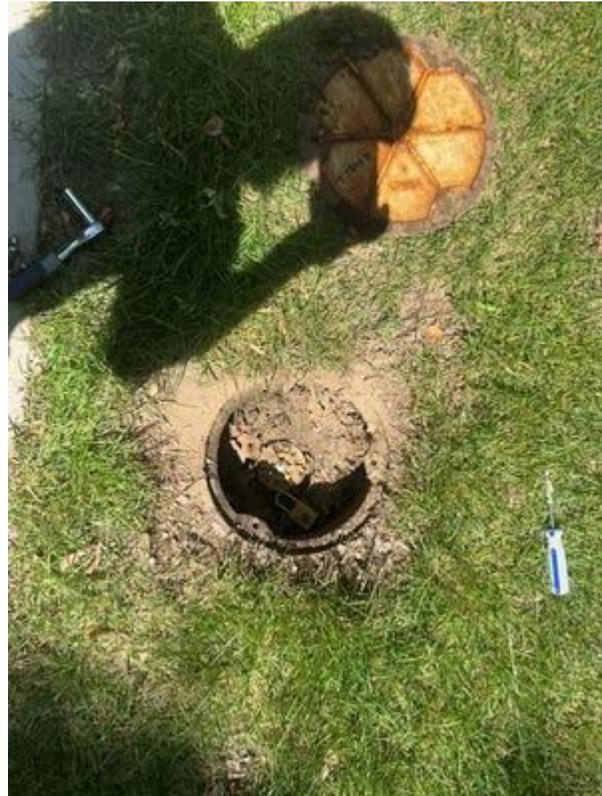
Client: Navy CLEAN	Facility: NWIRP Bethpage
Project Number: 112G08005-WE13	Location: Bethpage, New York
Date: June 11, 2024 10:54	Personnel: Jake Marlow
Well ID: TT101D	Well Location: 203539.461528487 1125463.55021942
Well Status: In Use (Confirmed)	Screen Interval: 325-345
WELL INVENTORY CONDITION	
Concrete pad in acceptable condition i.e. no cracks?	YES
Manhole cover present and in working condition?	YES
All bolts on manhole present and not stripped?	YES
Well plug present, locked and in good working condition?	YES
OVERALL CONDITION:	GOOD
Notes (Explain if answered No to any of the above)

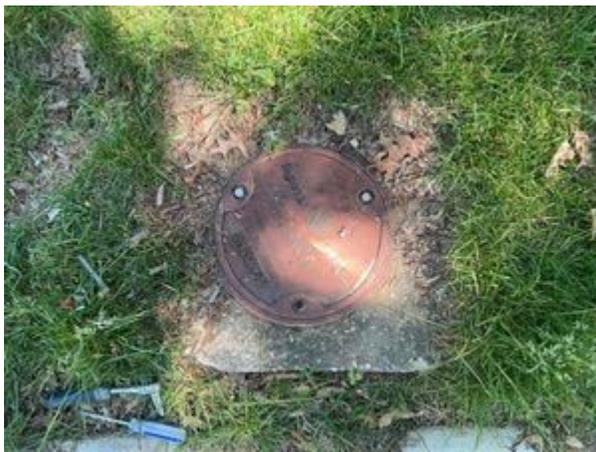
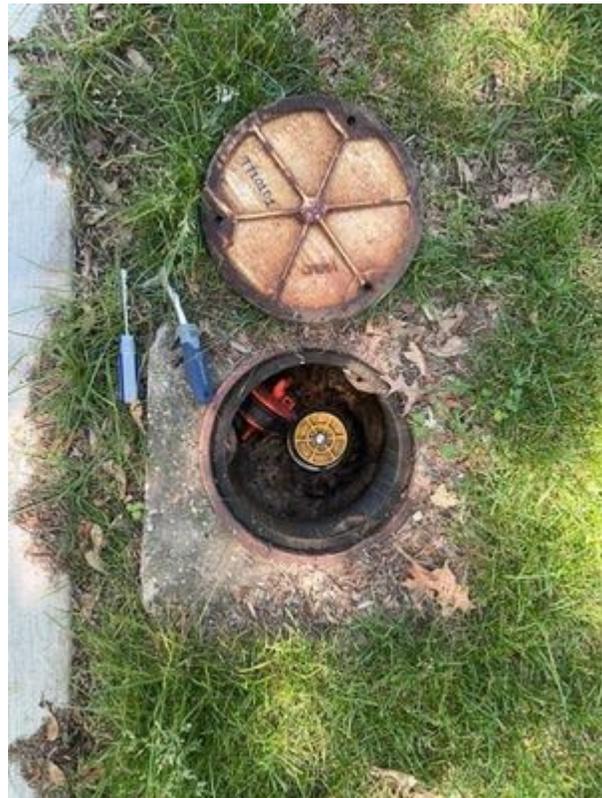
Client: Navy CLEAN	Facility: NWIRP Bethpage
Project Number: 112G08005-WE13	Location: Bethpage, New York
Date: June 11, 2024 10:46	Personnel: Noah Sprouse
Well ID: TT101D1	Well Location: 203536.2431745 1125486.07162606
Well Status: In Use (Confirmed)	Screen Interval: 570-590
WELL INVENTORY CONDITION	
Concrete pad in acceptable condition i.e. no cracks?	YES
Manhole cover present and in working condition?	YES
All bolts on manhole present and not stripped?	NO
Well plug present, locked and in good working condition?	YES
OVERALL CONDITION:	GOOD
Notes (Explain if answered No to any of the above) One bolt sheared off

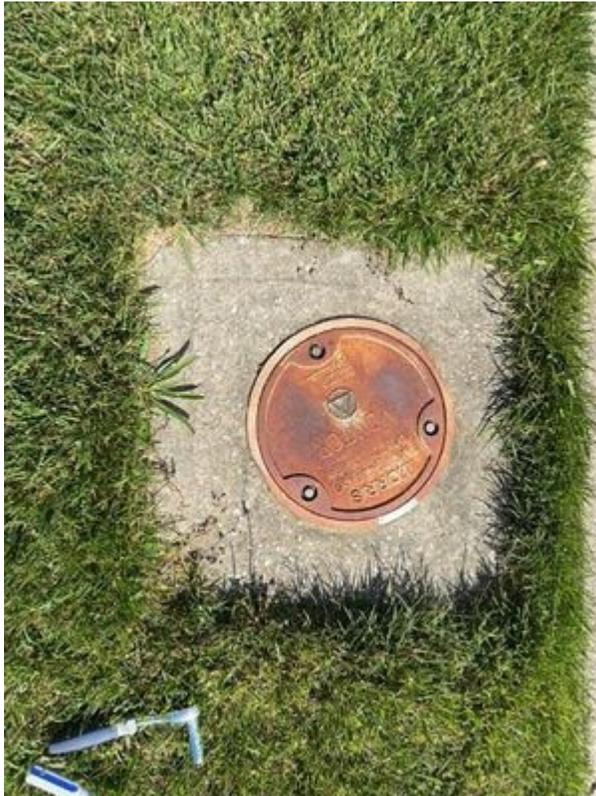
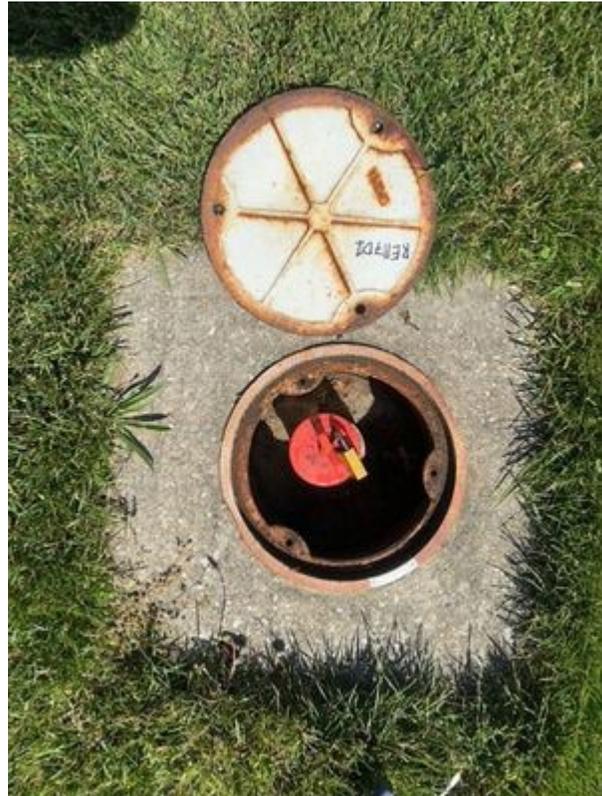
Client: Navy CLEAN	Facility: NWIRP Bethpage
Project Number: 112G08005-WE13	Location: Bethpage, New York
Date: June 11, 2024 09:31	Personnel: Jake Marlow
Well ID: RE117D1	Well Location: 196456.17474962 1125316.26543246
Well Status: In Use (Confirmed)	Screen Interval: 730-755
WELL INVENTORY CONDITION	
Concrete pad in acceptable condition i.e. no cracks?	YES
Manhole cover present and in working condition?	YES
All bolts on manhole present and not stripped?	YES
Well plug present, locked and in good working condition?	YES
OVERALL CONDITION:	GOOD
Notes (Explain if answered No to any of the above)

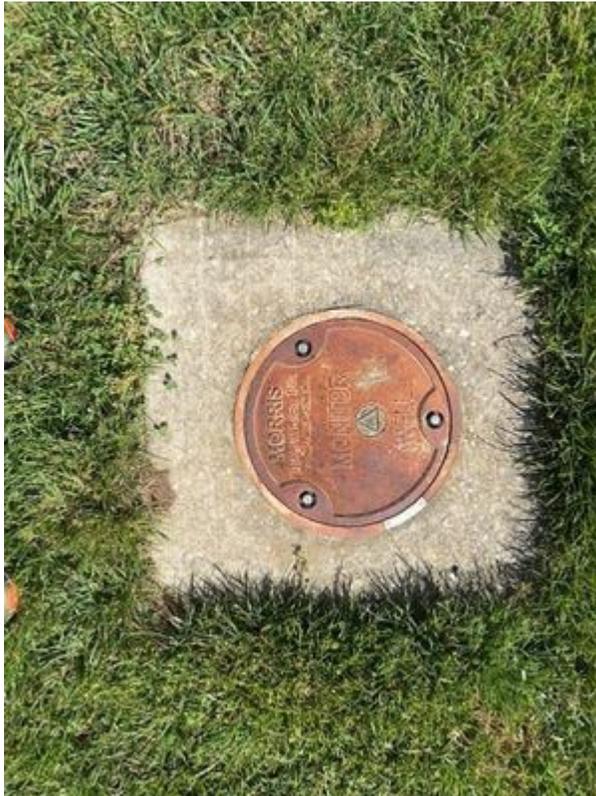
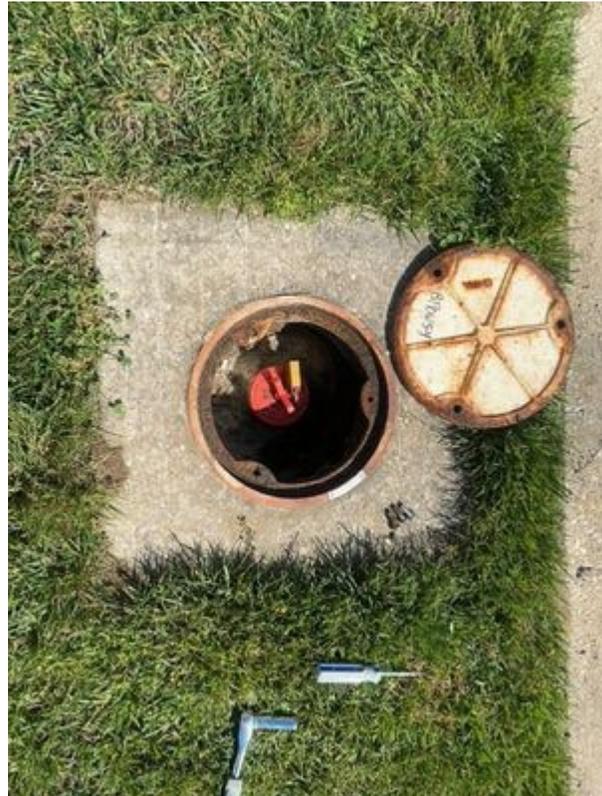
Client: Navy CLEAN	Facility: NWIRP Bethpage
Project Number: 112G08005-WE13	Location: Bethpage, New York
Date: June 11, 2024 09:25	Personnel: Jake Marlow
Well ID: BPOW5-4	Well Location: 196469.939132629 1125297.84521184
Well Status: In Use (Confirmed)	Screen Interval: 545-570
WELL INVENTORY CONDITION	
Concrete pad in acceptable condition i.e. no cracks?	YES
Manhole cover present and in working condition?	YES
All bolts on manhole present and not stripped?	YES
Well plug present, locked and in good working condition?	YES
OVERALL CONDITION:	GOOD
Notes (Explain if answered No to any of the above)

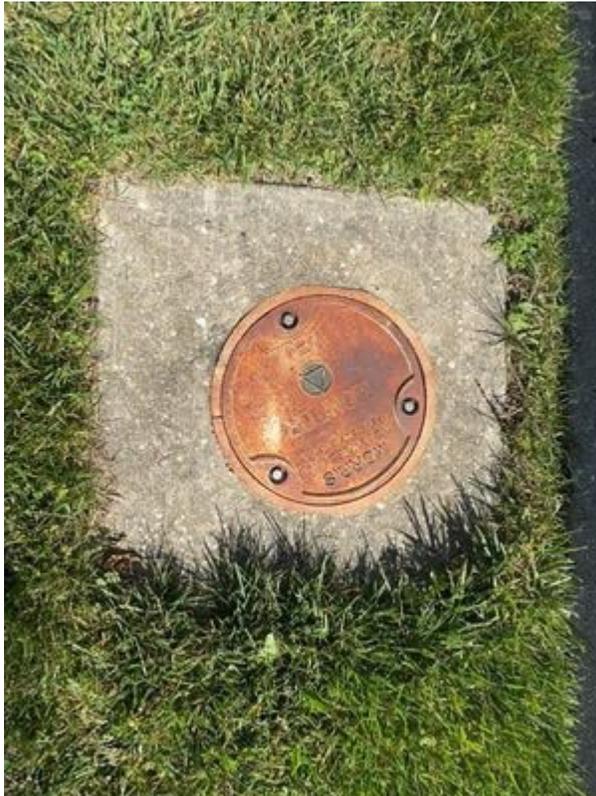
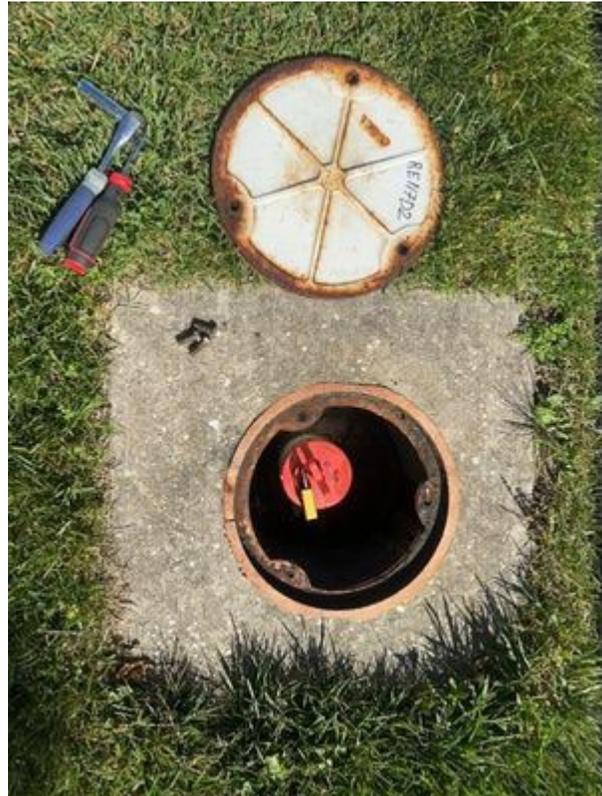
Client: Navy CLEAN	Facility: NWIRP Bethpage
Project Number: 112G08005-WE13	Location: Bethpage, New York
Date: June 11, 2024 09:18	Personnel: Jake Marlow
Well ID: RE117D2	Well Location: 196473.402477222 1125380.12382993
Well Status: In Use (Confirmed)	Screen Interval: 780-805
WELL INVENTORY CONDITION	
Concrete pad in acceptable condition i.e. no cracks?	YES
Manhole cover present and in working condition?	YES
All bolts on manhole present and not stripped?	YES
Well plug present, locked and in good working condition?	YES
OVERALL CONDITION:	GOOD
Notes (Explain if answered No to any of the above)
