SYOSSET LANDFILL

2014 ANNUAL POST-CLOSURE SUMMARY REPORT

TOWN OF OYSTER BAY

**DEPARTMENT OF PUBLIC WORKS
SYOSSET, NEW YORK 11791**

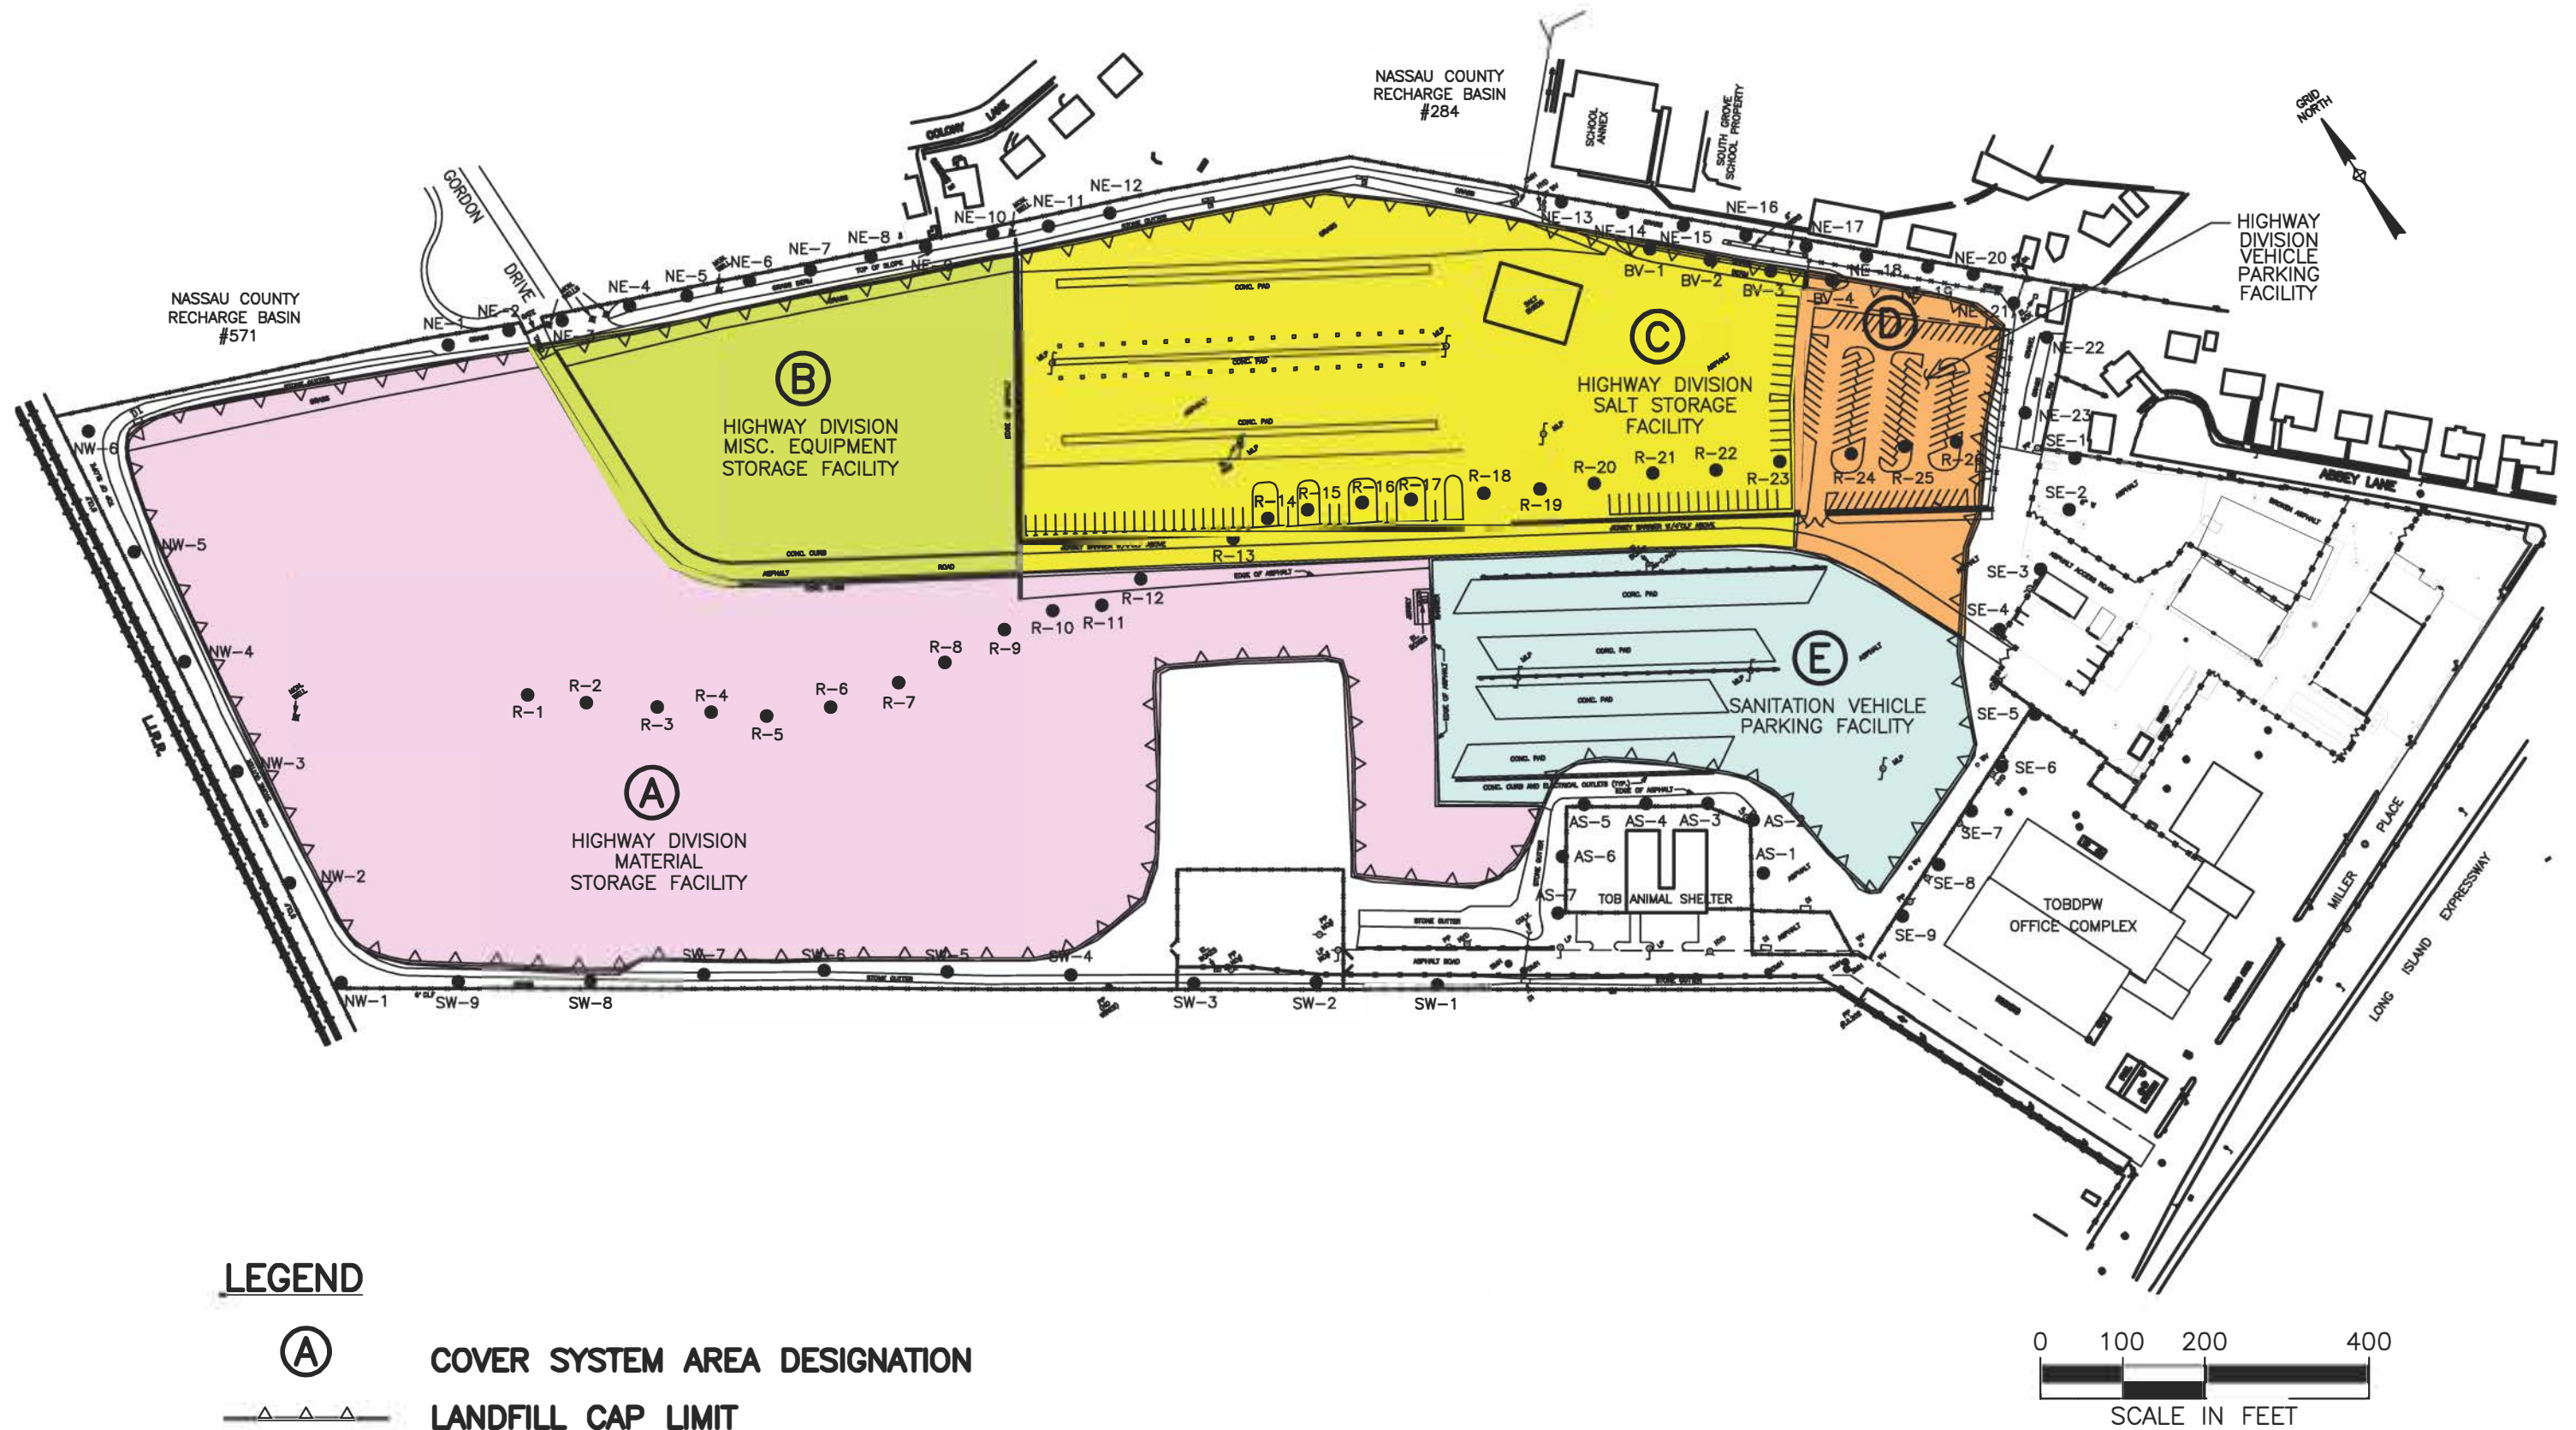
FIGURE 1
SYOSSET LANDFILL
COVER SYSTEM LOCATION PLAN

Areas of surface material erosion (i.e., ruts) in the recycled concrete aggregate (RCA) were noticeable in the Highway Department Material Storage Facility and the Miscellaneous Equipment Storage Facility. This area is designated as Area A and Area B, respectively, on Figure 1. Erosion within Area A and B was evident along the perimeter.

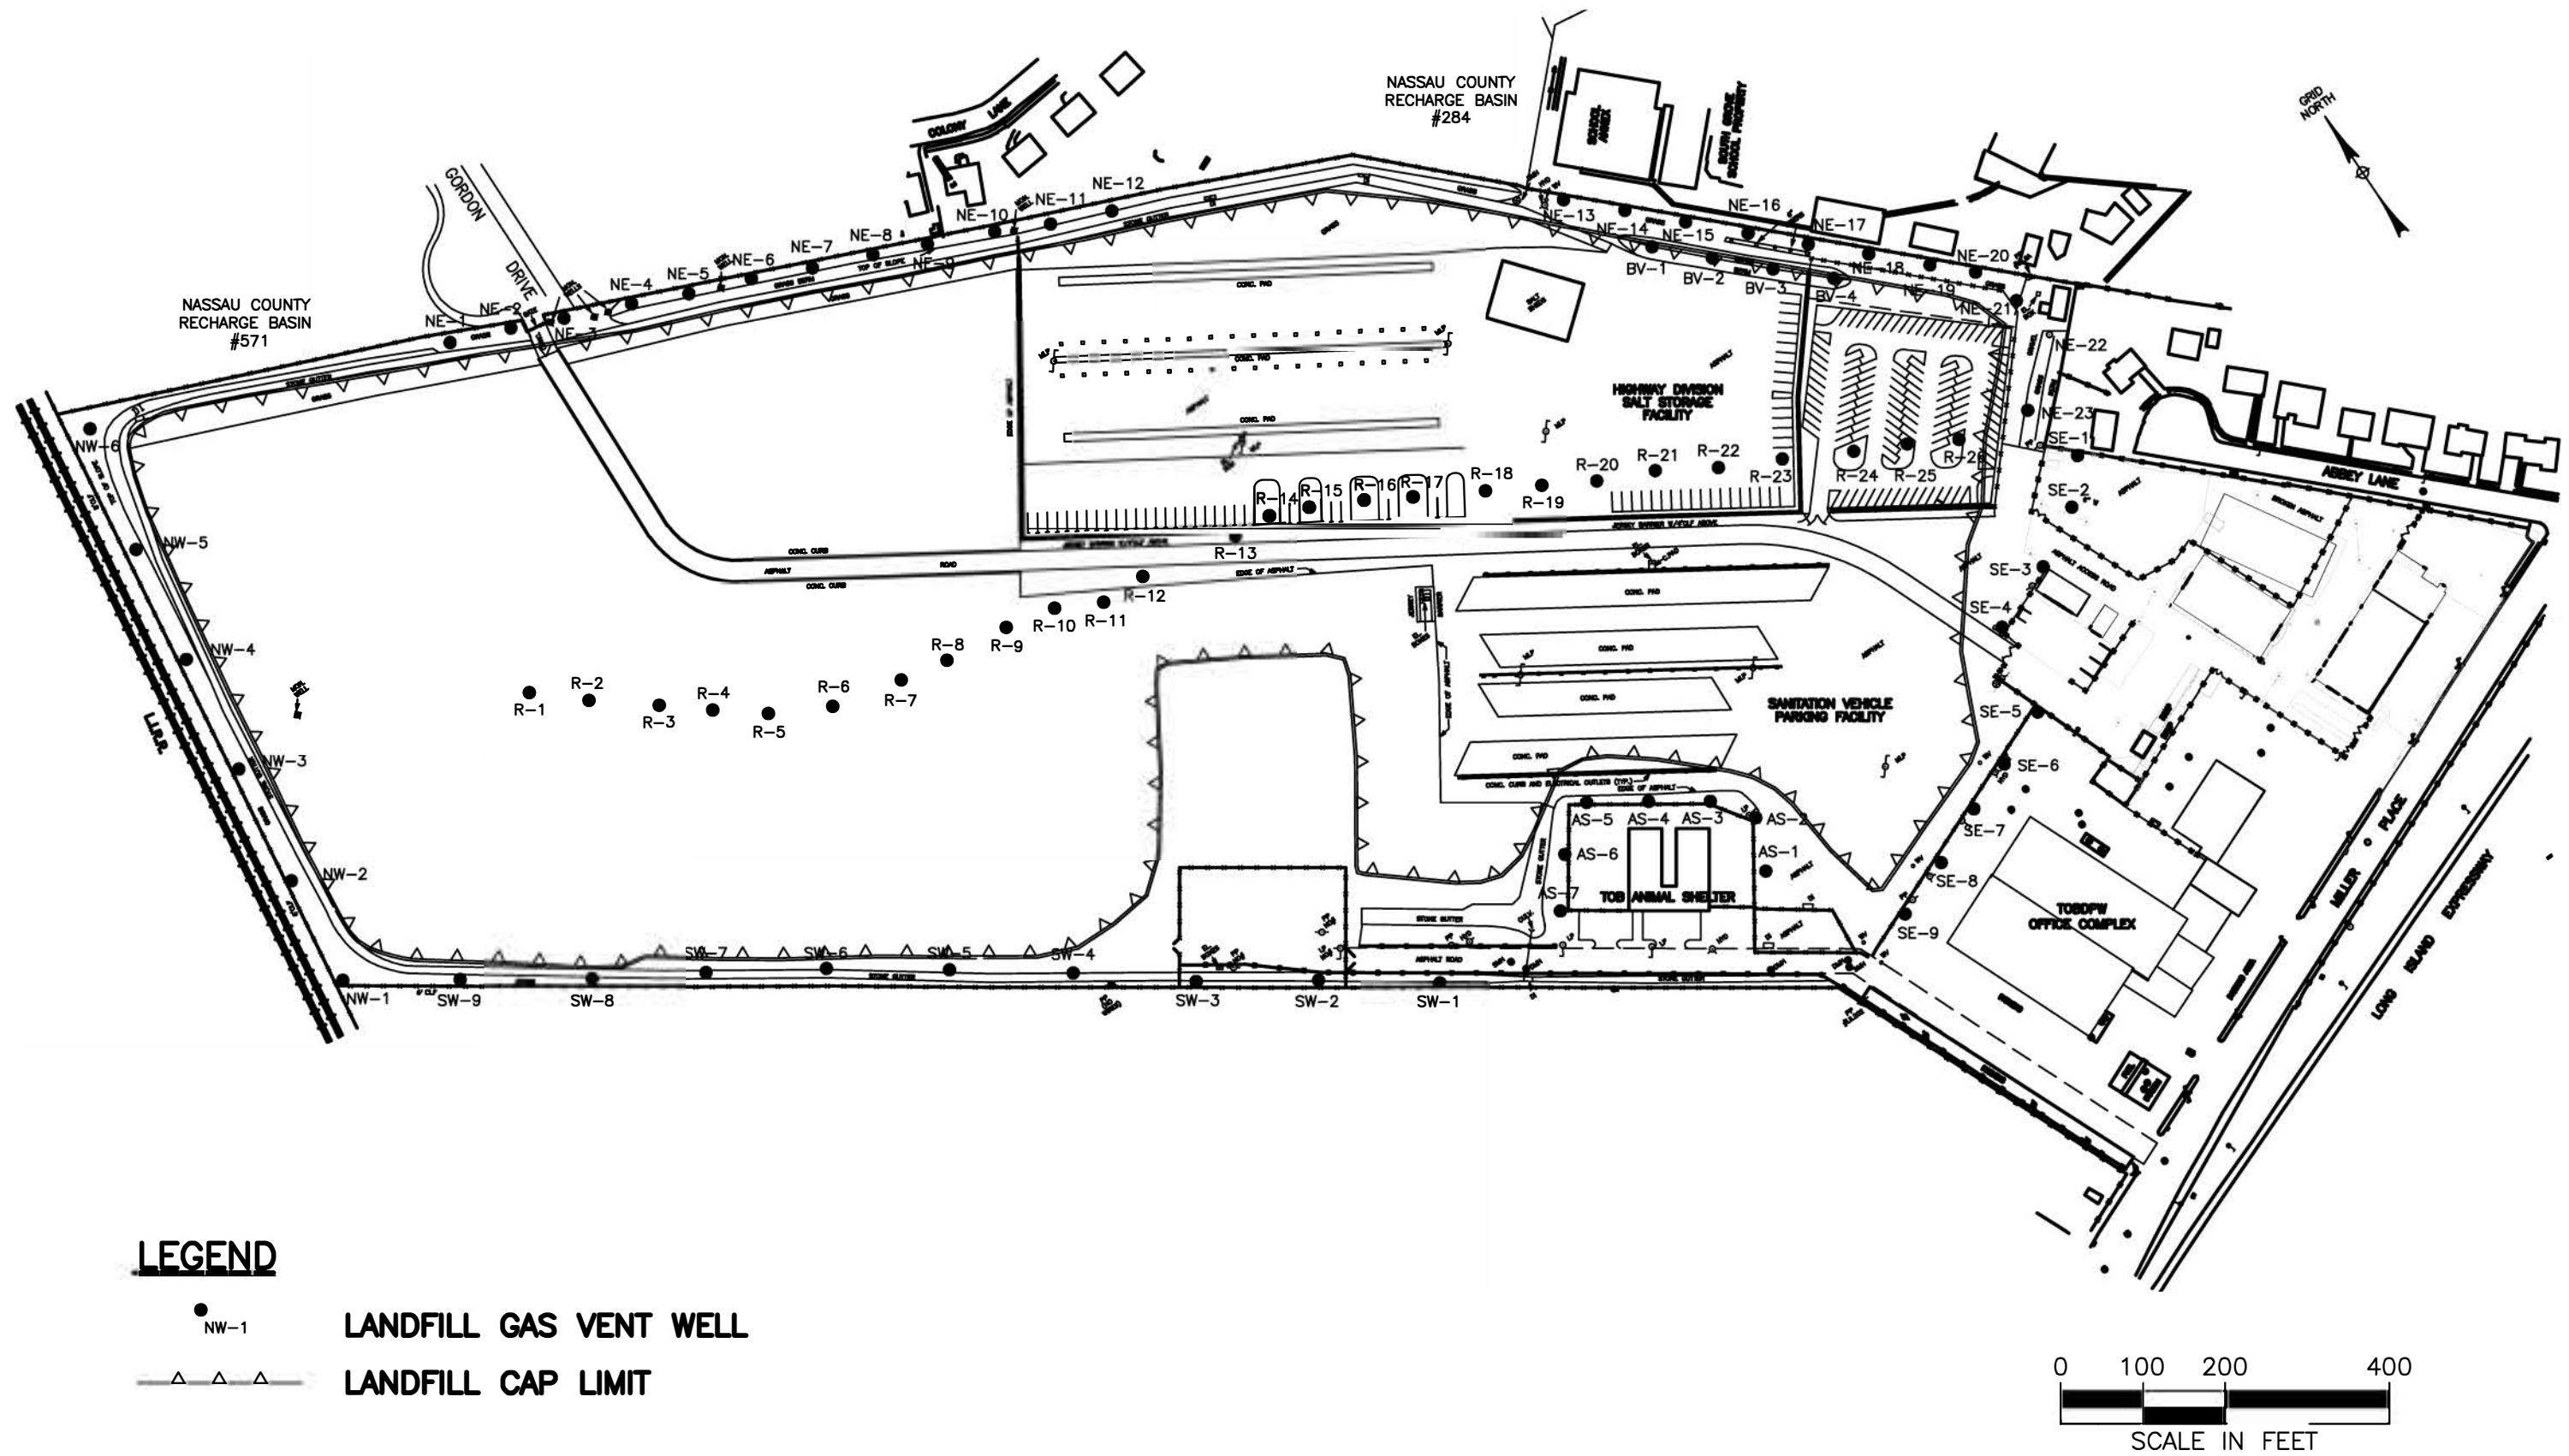
FIGURE 3
SYOSSET LANDFILL
GAS VENTING SYSTEM LOCATION PLAN

Section 3.1 discusses the gas vent well defects found during the four rounds of inspections performed in 2014. The defects are identified by gas vent well number. Gas vent well locations are shown on Figure 3. The defect descriptions and observed causes are identified in Appendix C in the "Gas Venting System Inspection Report" Table's C1-1, C2-1, C-3-1 and C4-1 for the first, second, third and fourth round inspections, respectively. When defects are noted, pictures are included in Appendix C following the Inspection Report Tables. Where defects are the same as those identified in previous inspection reports, they are so noted. Pictures of these defects can be found in those reports.

Gas Venting System: Recommended that stockpiles not be placed within 25 feet of the ridge vent wells to prevent trucks from damaging the wells in the future.
