# *SYOSSET LANDFILL*

## *2015 ANNUAL POST-CLOSURE SUMMARY REPORT*

**DEPARTMENT OF PUBLIC WORKS  
SYOSSET, NEW YORK 11791**

**June 2016**

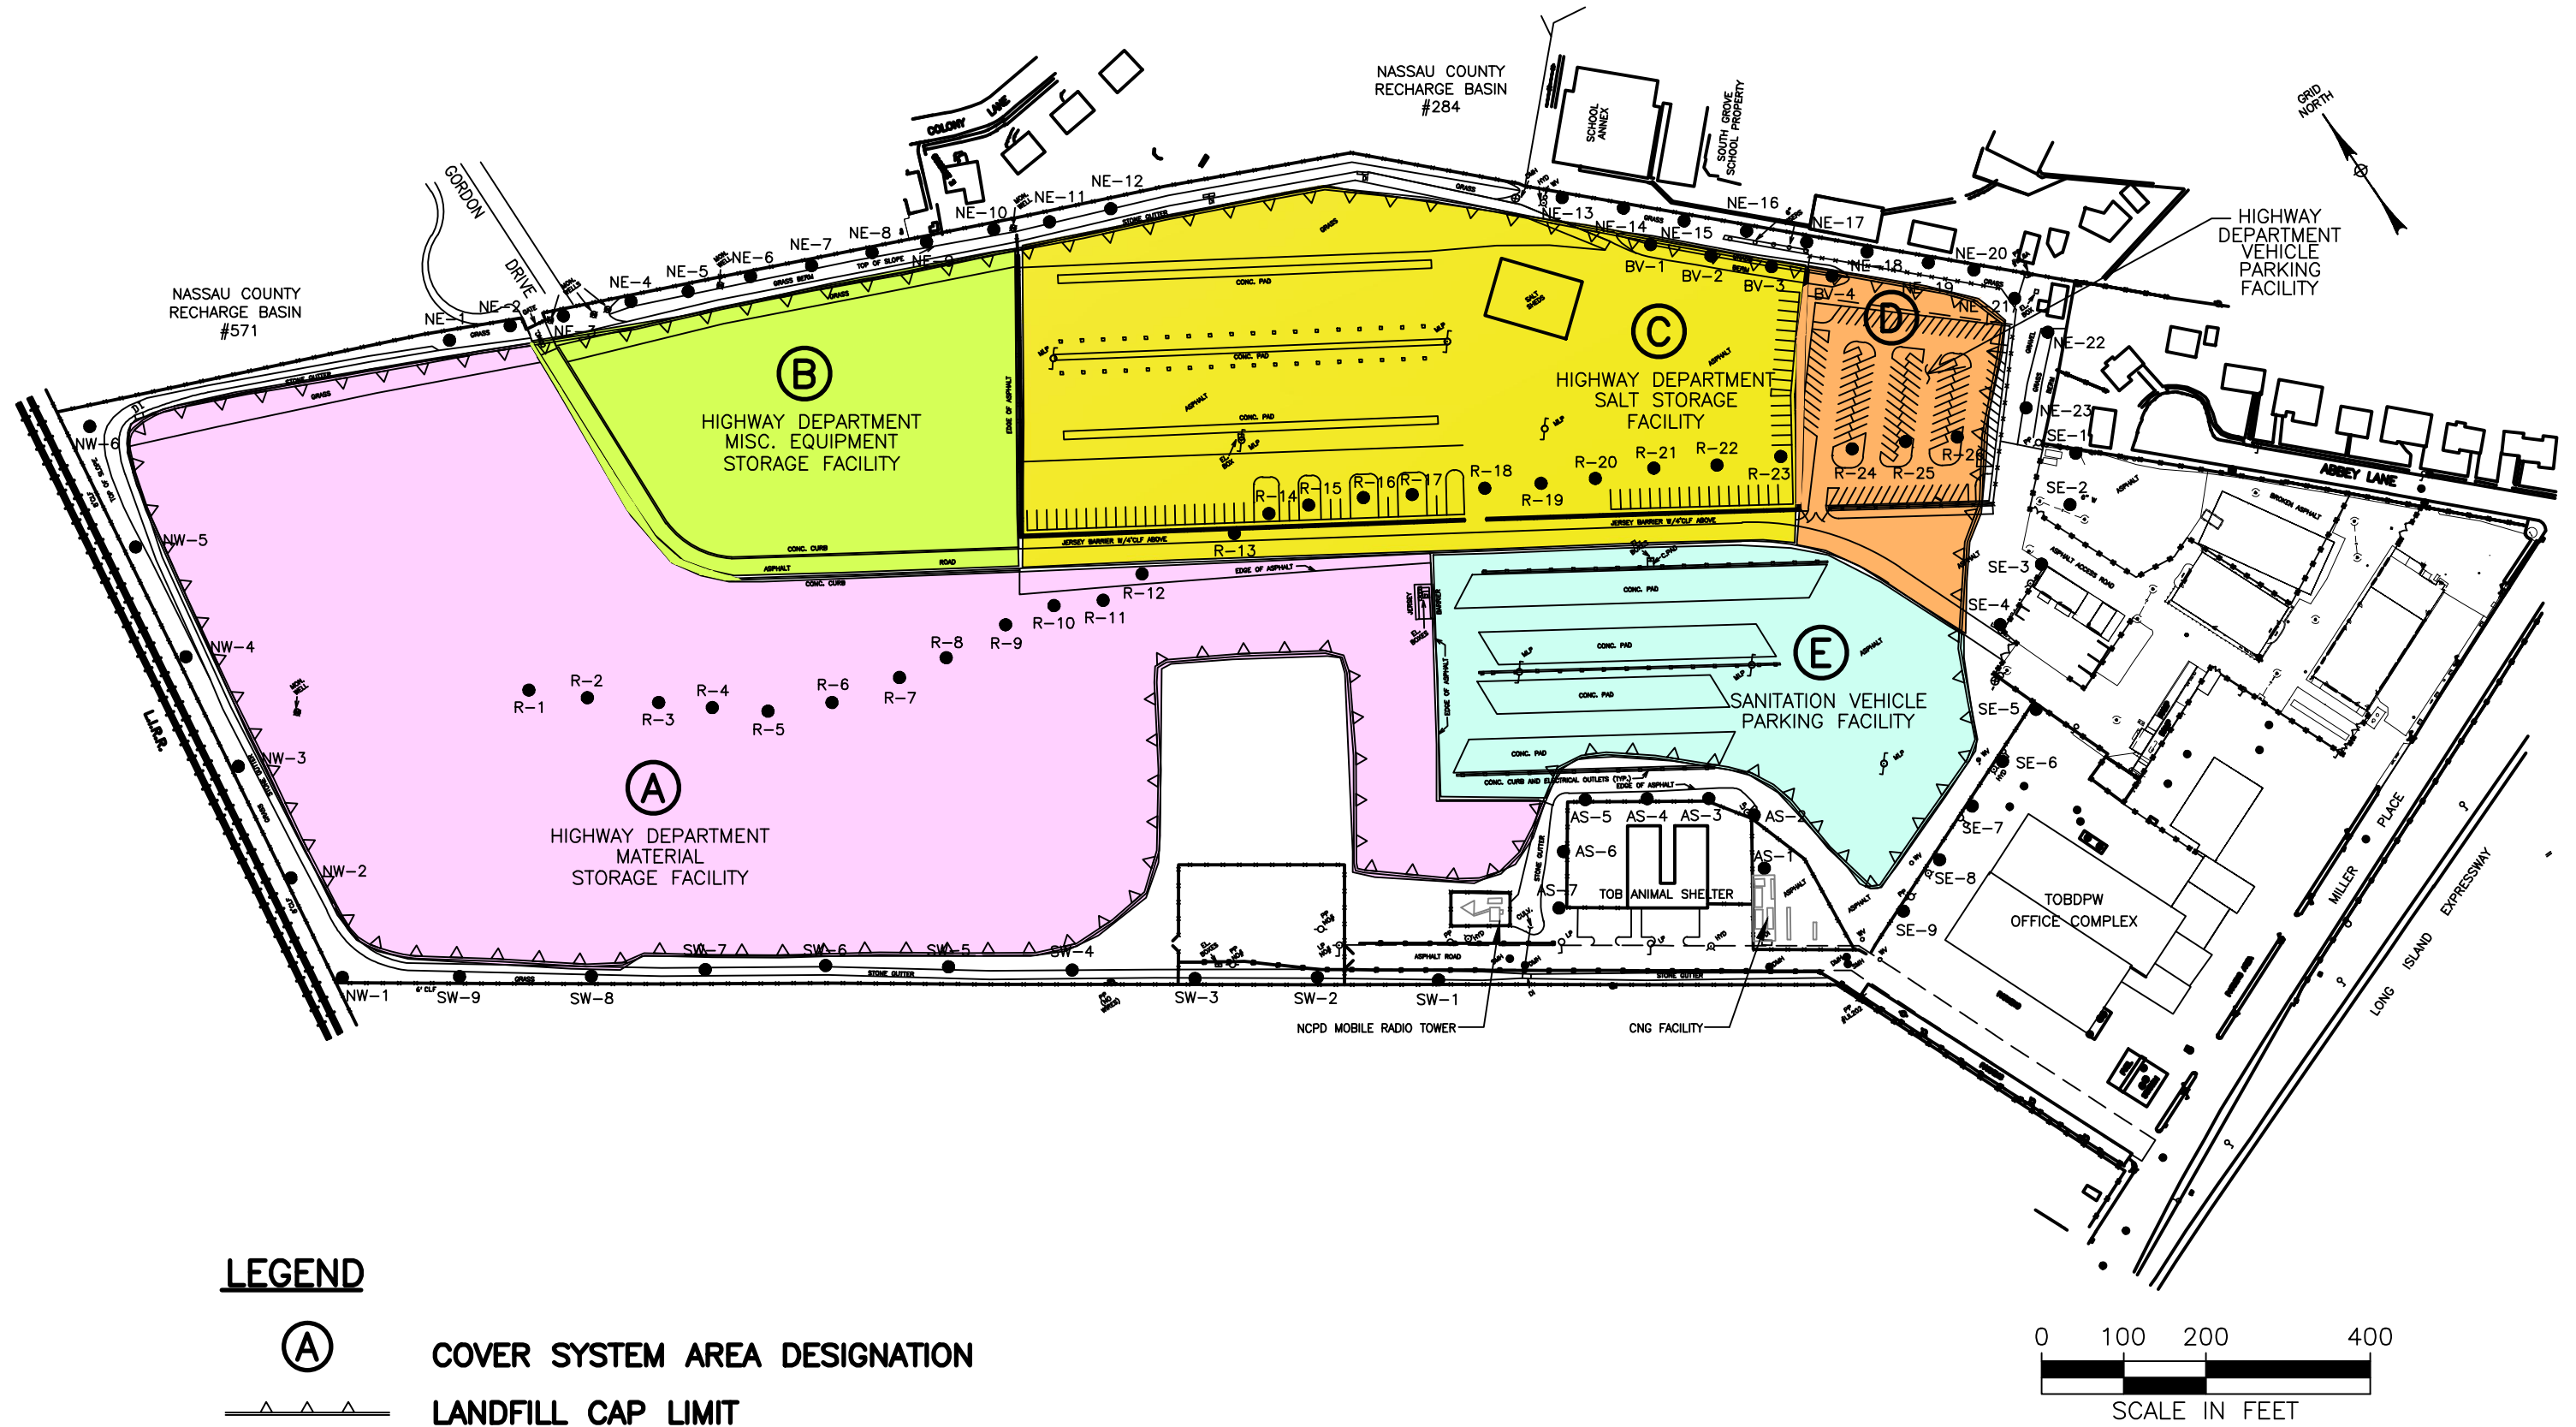
**FIGURE 1**  
**SYOSSET LANDFILL**  
**COVER SYSTEM LOCATION PLAN**

Areas of surface material erosion (i.e., ruts) in the recycled concrete aggregate (RCA) were noticeable in the Highway Department Material Storage Facility and the Miscellaneous Equipment Storage Facility. This area is designated as Area A and Area B, respectively, on Figure 1. Erosion within Area A and B was evident along the perimeter.
