SYOSSET LANDFILL

2016 ANNUAL POST-CLOSURE SUMMARY REPORT

TOWN OF OYSTER BAY

LOCKWOOD
KESSLER &
BARTLETT, INC.
SYOSSET, NEW YORK 11791

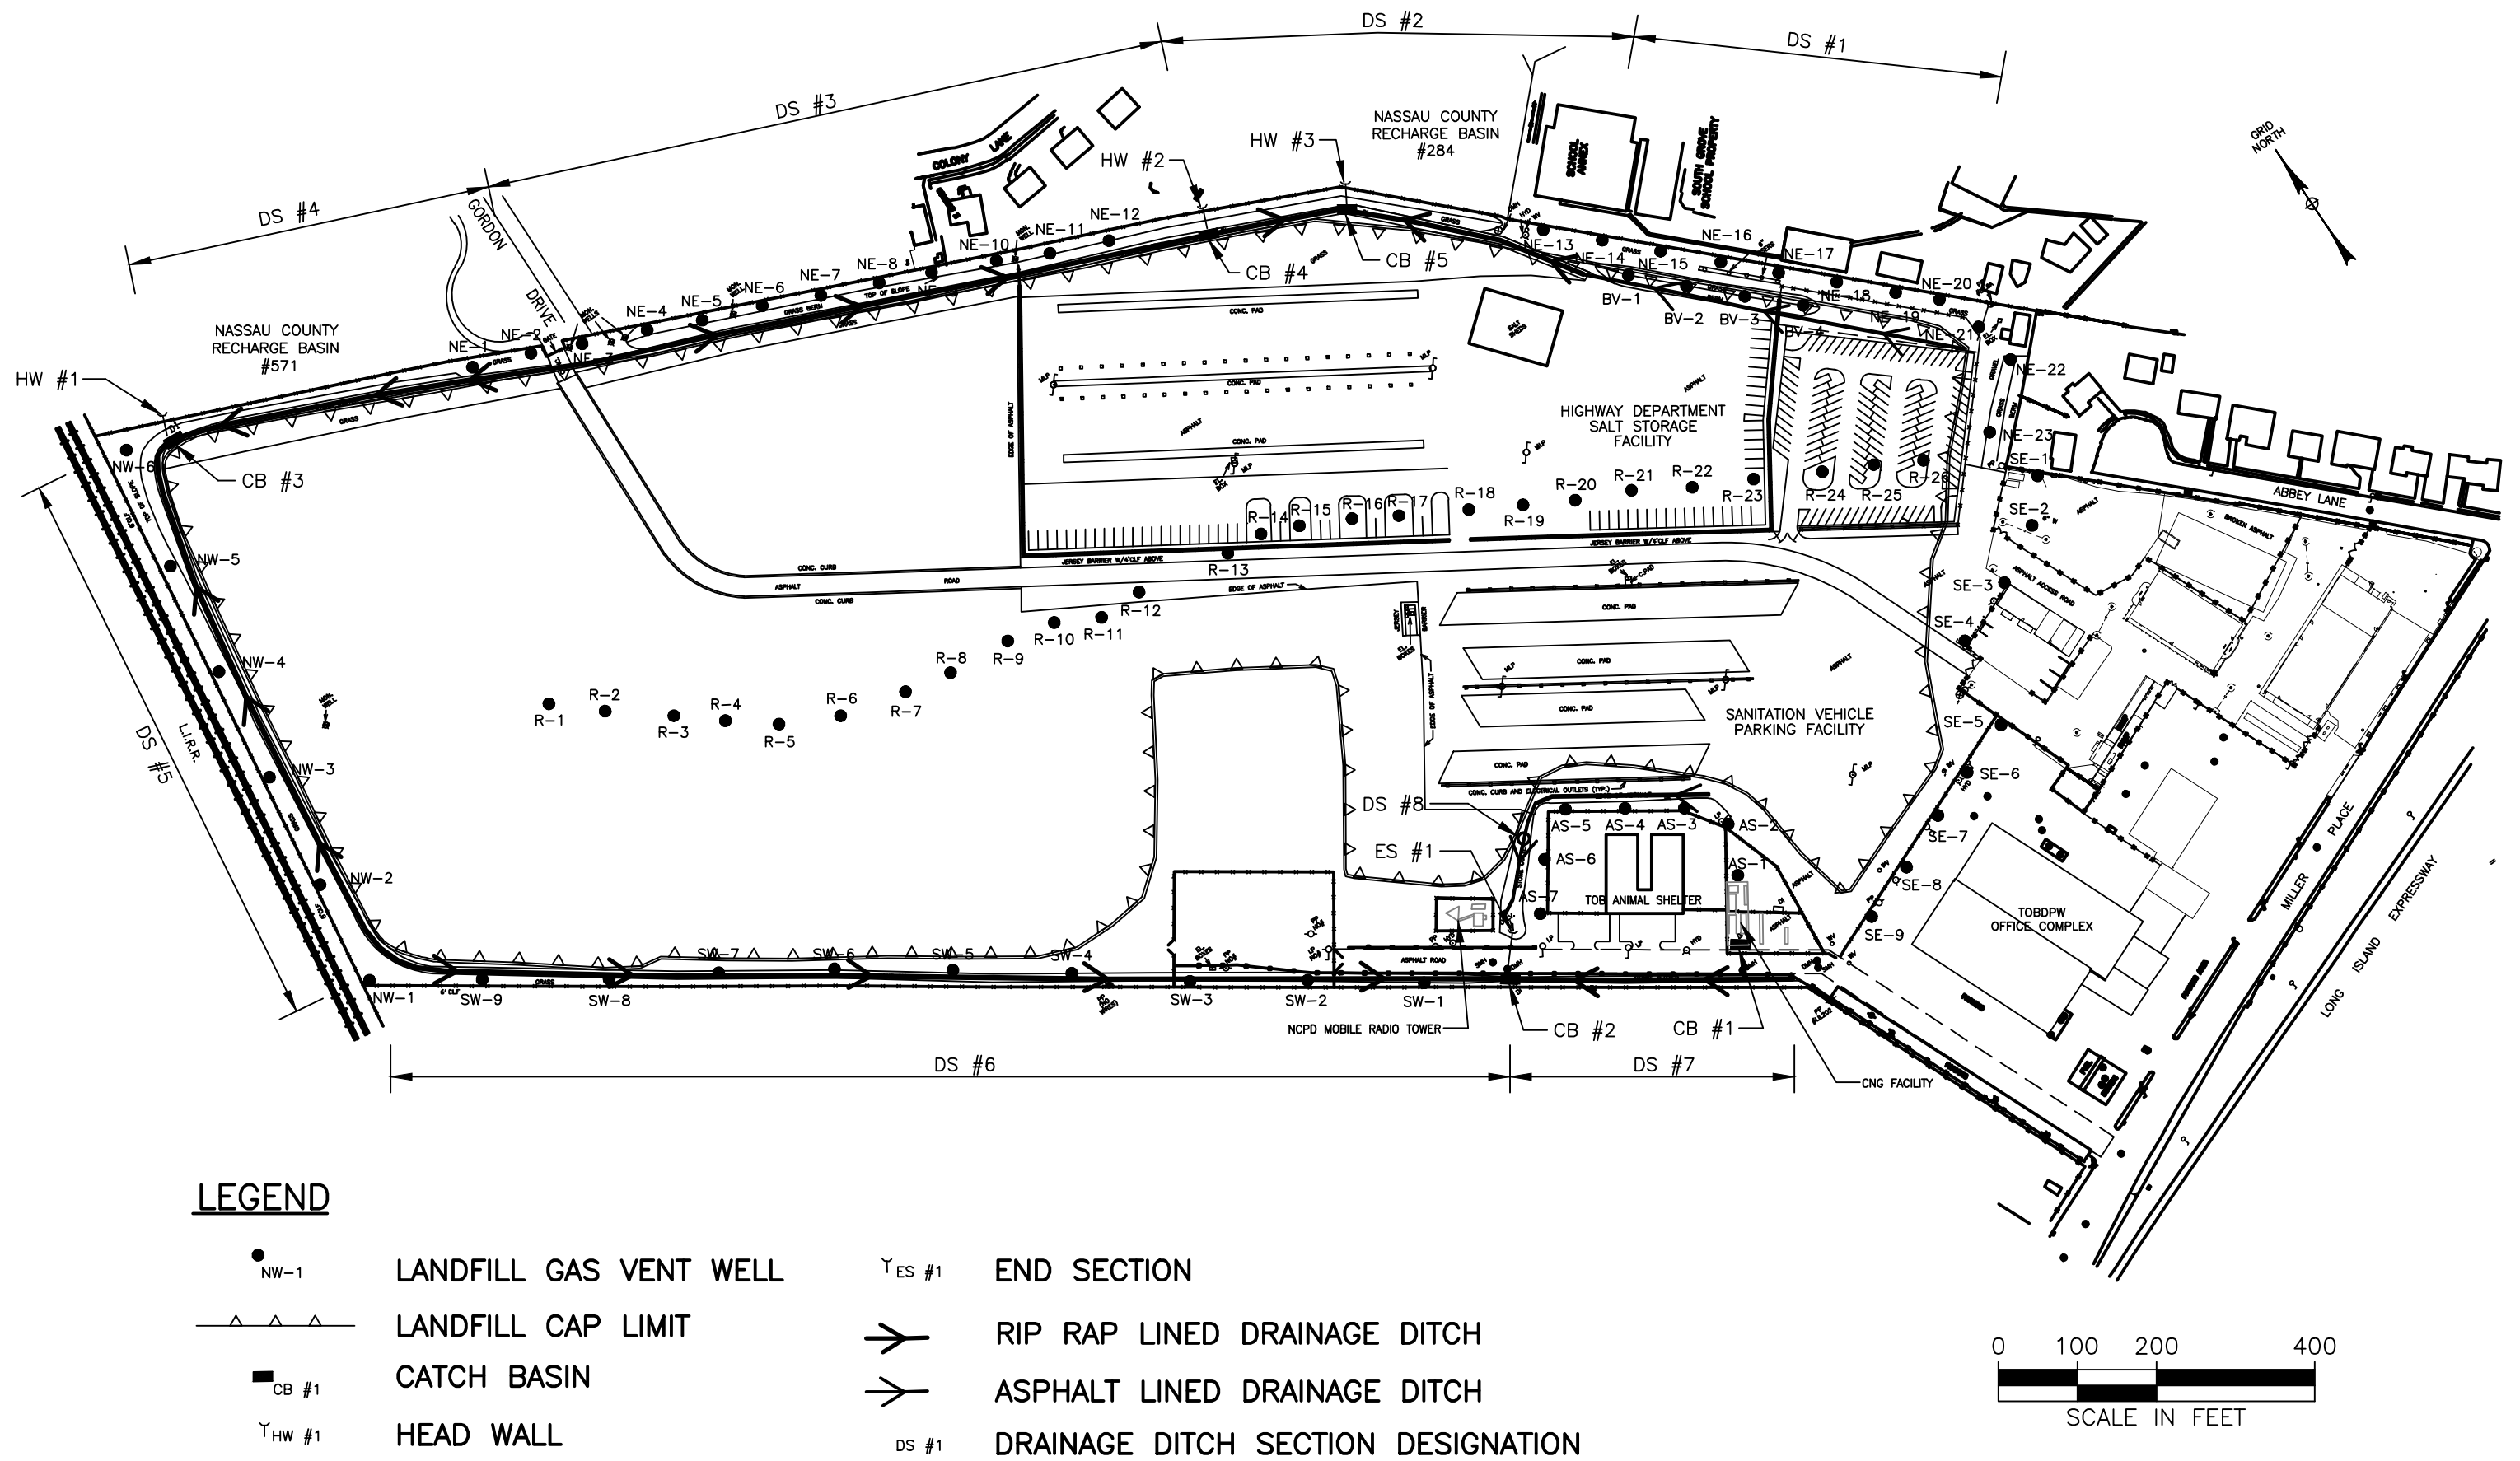
FIGURE 2
SYOSSET LANDFILL
DRAINAGE SYSTEM LOCATION PLAN

The drainage system throughout the landfill was inspected. The ditch sections, catch basins, storm drainage pipes, manholes and recharge basin headwalls were inspected for defects. The defects encountered are identified on Tables B1-1, B2-1, B3-1 and B4-2, in Appendix B and their locations are identified by drainage ditch section number or drainage structure number on Figure 2, Drainage System Location Plan. Pictures of the defects follow the tables for each round of inspections. Repairs were performed prior to the fourth inspection round and a copy of the "Drainage System Repair Report" (e.g., Table B4-1) is also included in Appendix B.

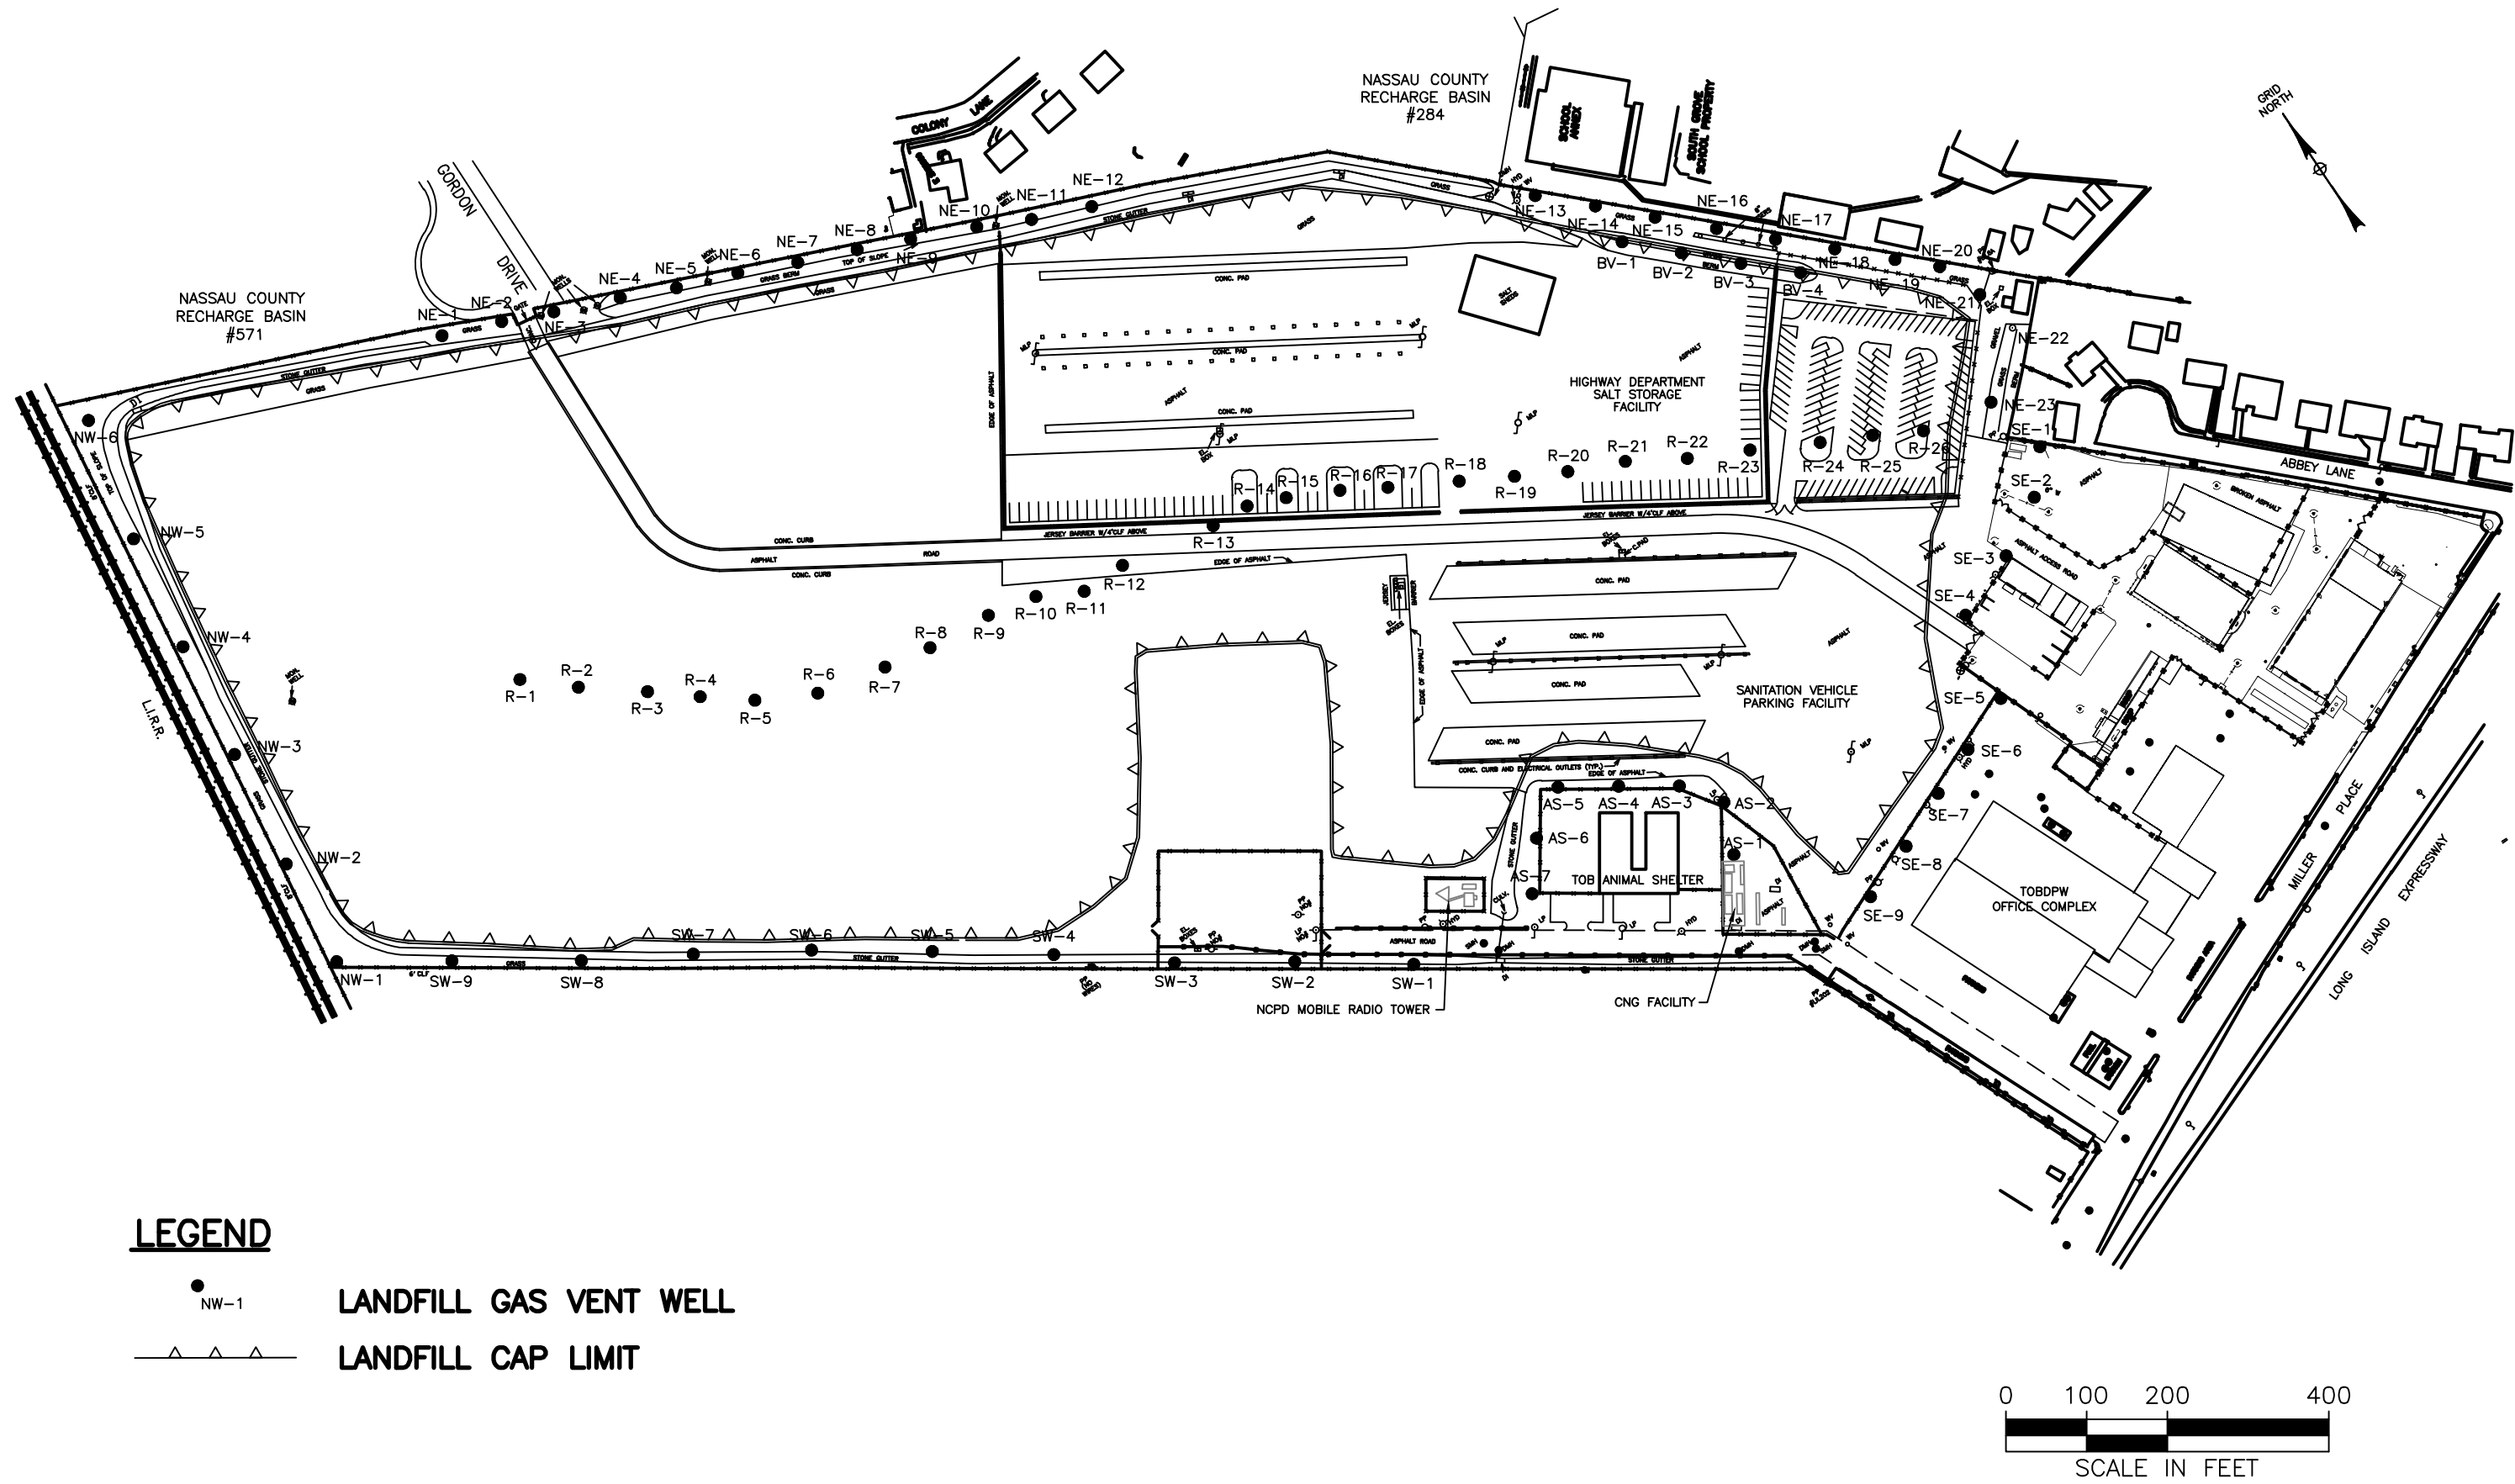
FIGURE 3
SYOSSET LANDFILL
GAS VENTING SYSTEM LOCATION PLAN

The landfill gas venting system consists of 38 property line gas vent wells, 16 perimeter gas vent wells and 26 landfill ridge gas vent wells as shown on Figure 3. Eight gas monitoring cluster wells and a gas venting trench located along the property line adjacent to the South Grove Elementary School were installed during previous work performed at the site. In addition, four six inch diameter PVC gas vent wells were installed over a gas venting trench during the Preload Program within the landfill limits in an area northeast of the Salt Storage Sheds. The vent wells were installed to allow the trench to continue venting, if necessary, following the placement of the cap and an earthen berm over the trench.

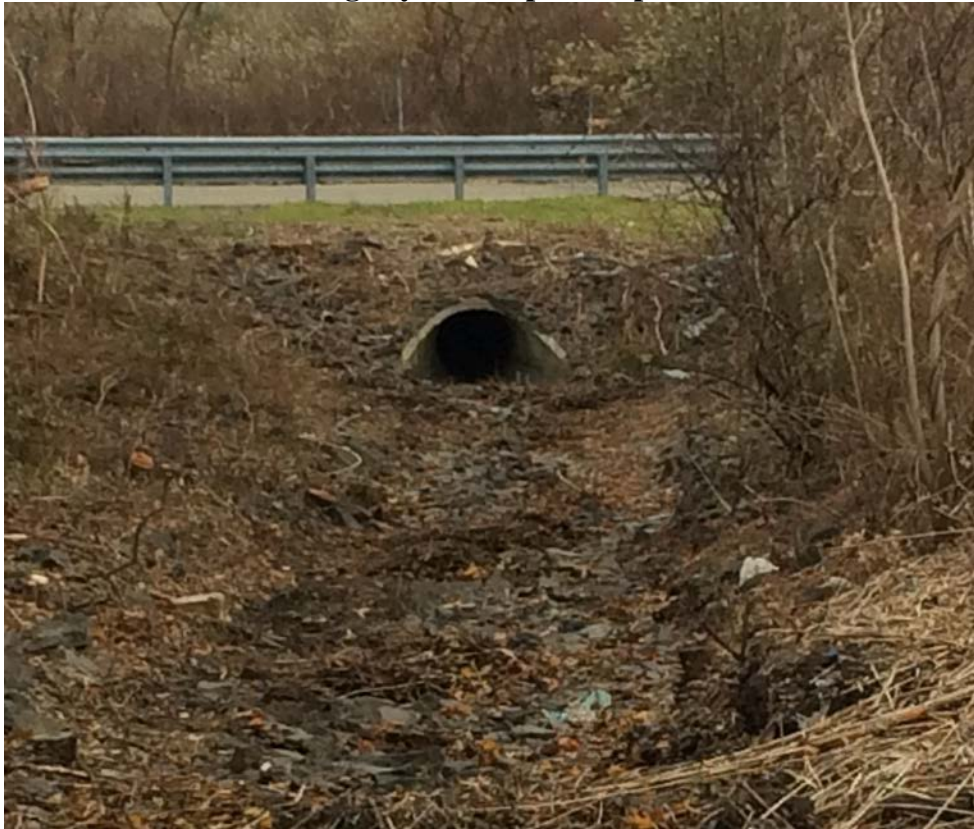
Storm Drainage Pipe ES #1

The storm drainage pipes were inspected at the drainage structure locations and only minimal sedimentation and heavy vegetative growth was noted at the entrance to the end section located adjacent to the Animal Shelter (ES #1, see Figure 2) during the first three rounds of inspections. The vegetative growth was cleared prior to the fourth inspection round.
