# *SYOSSET LANDFILL*

## *2023 ANNUAL POST-CLOSURE SUMMARY REPORT*

**TOWN OF OYSTER BAY**

Lockwood, Kessler and Bartlett, Inc.  
One Aerial Way  
Syosset, NY 11791

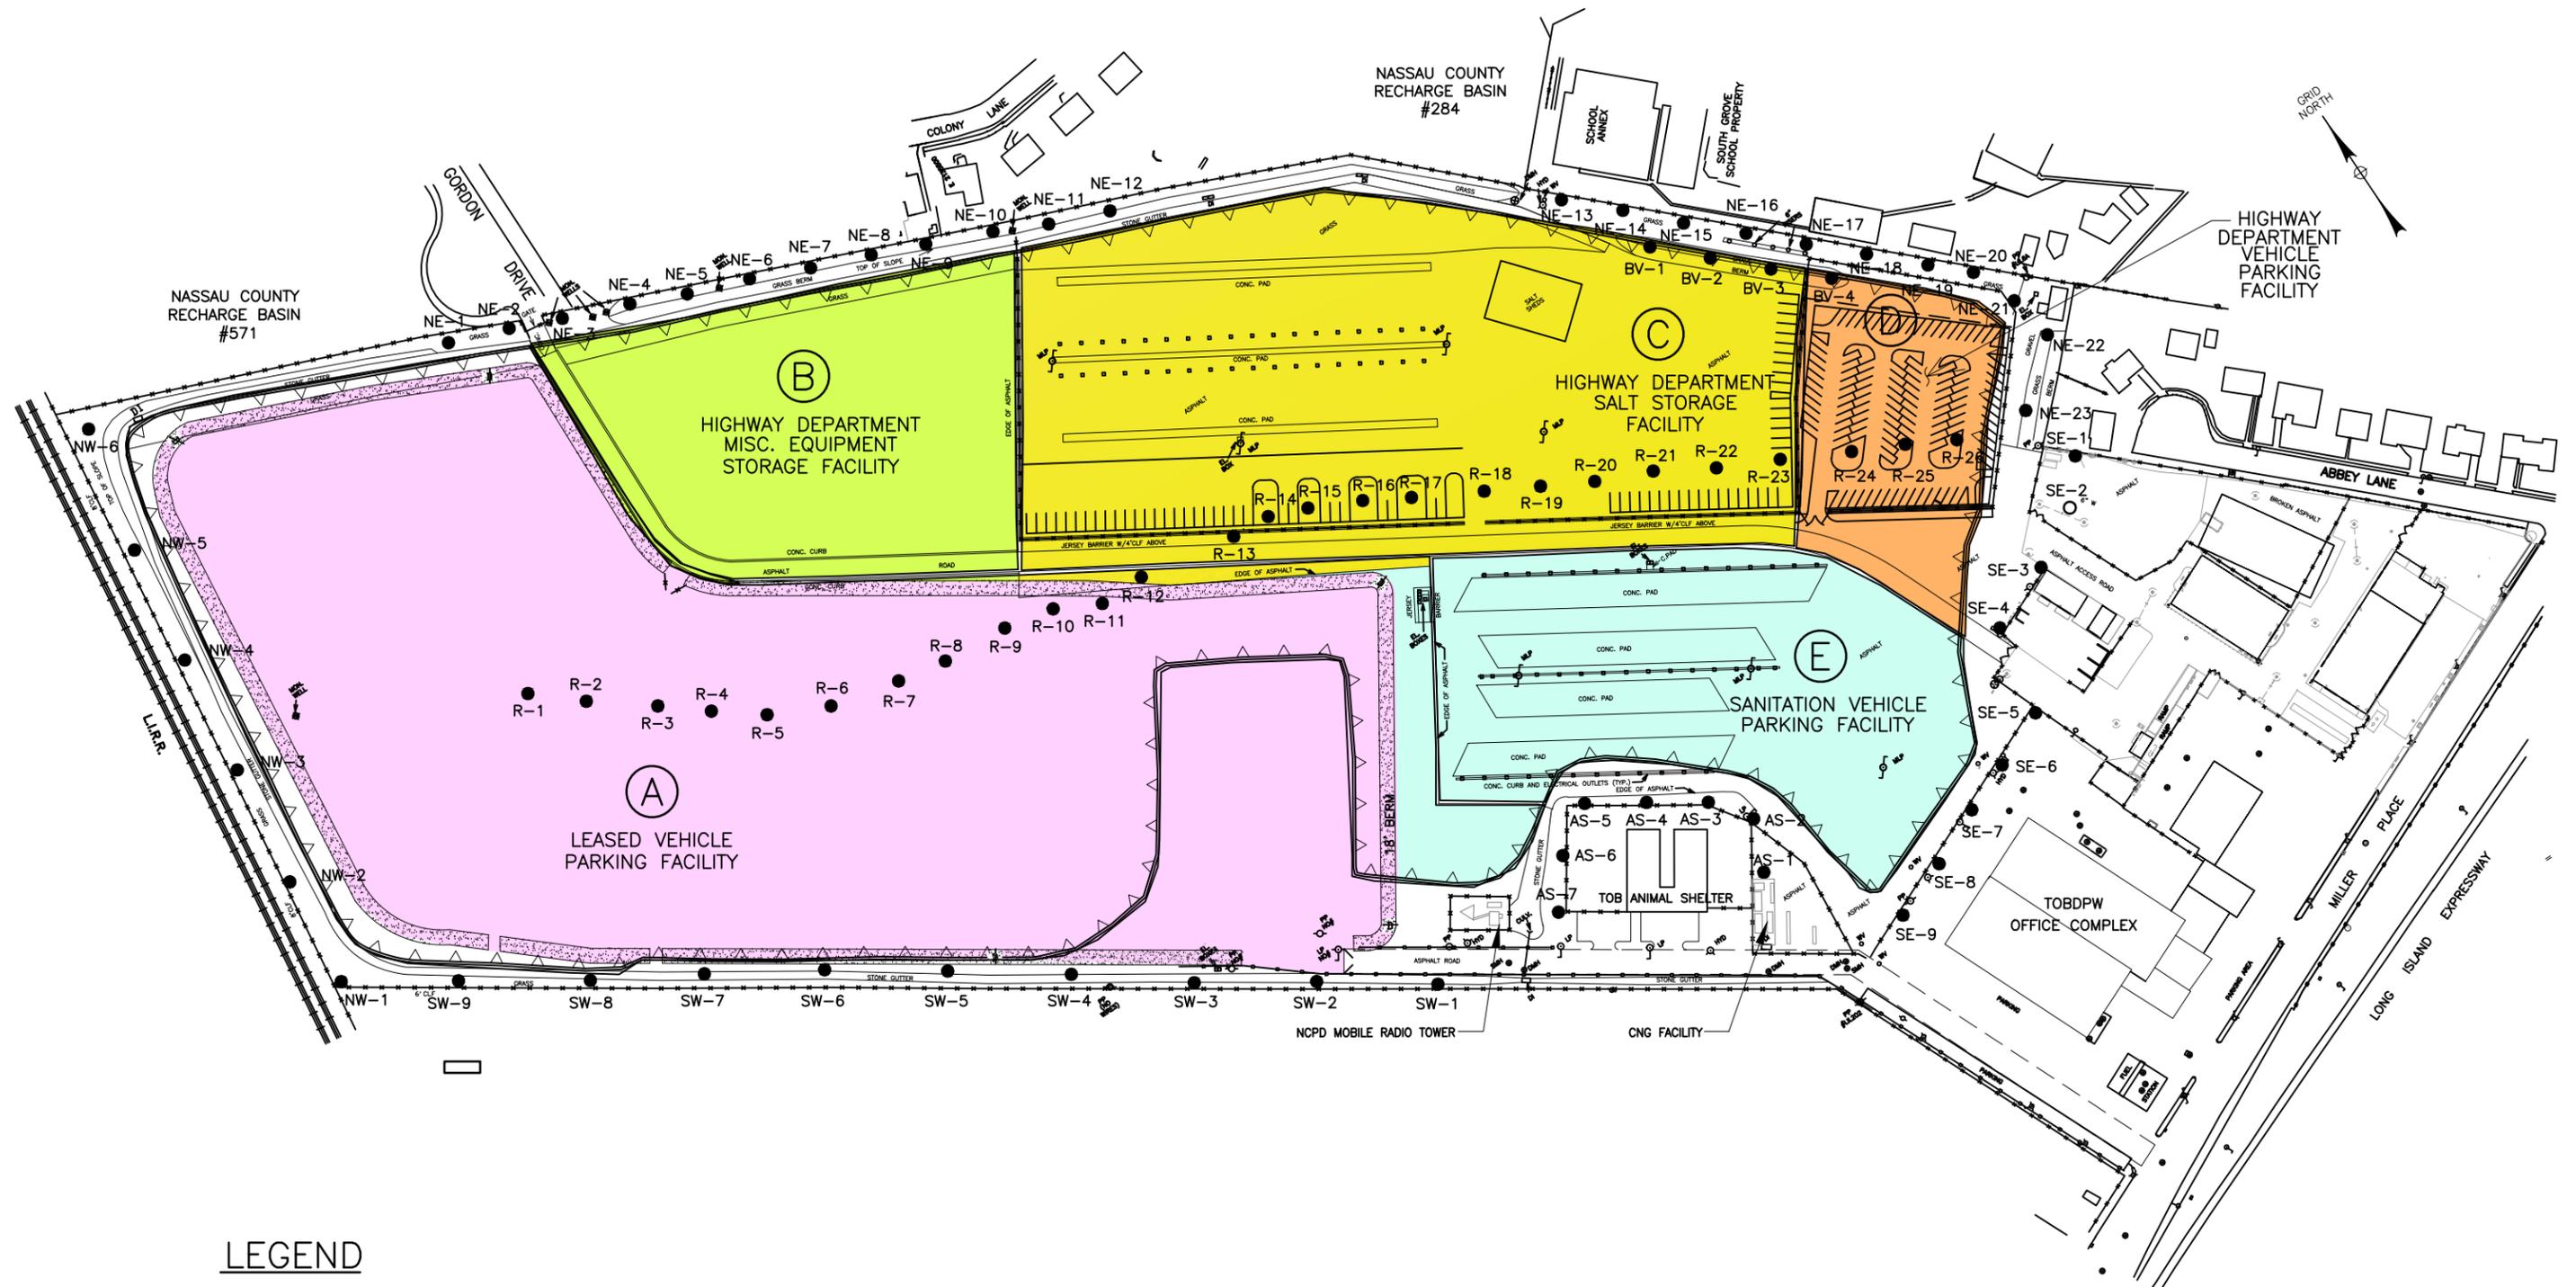
FIGURE 1  
SYOSSET LANDFILL  
COVER SYSTEM LOCATION PLAN

Three types of surface treatments were designated for use in particular areas of the site based on the anticipated future site uses. The site was divided into five different facilities as shown on Figure 1, Syosset Landfill Cover System Location Plan. The recycled concrete surface treatment was utilized in both the Highway Division's Material Storage Facility (now the Leased Vehicle Parking Facility) and the Miscellaneous Equipment Storage Facility (Areas A and B, respectively, on Figure 1). The asphalt concrete surface treatment was utilized in the Highway Division's Salt Storage Facility and Vehicle Parking Facility as well as the Sanitation Department Vehicle Parking Facility (Areas C, D and E, respectively, on Figure 1). The vegetative cover surface treatment was utilized in a buffer area along the northern property line in Areas A, B and C.

identified in Appendix A, Tables A1-1 and A2-1, with their locations referenced to the areas designated on Figure 1. Pictures of typical defects are also included in Appendix A following each of the Inspection Report Tables. Where applicable, defects that may remain from the previous year have been identified and further information can be found in the previous Annual Report.

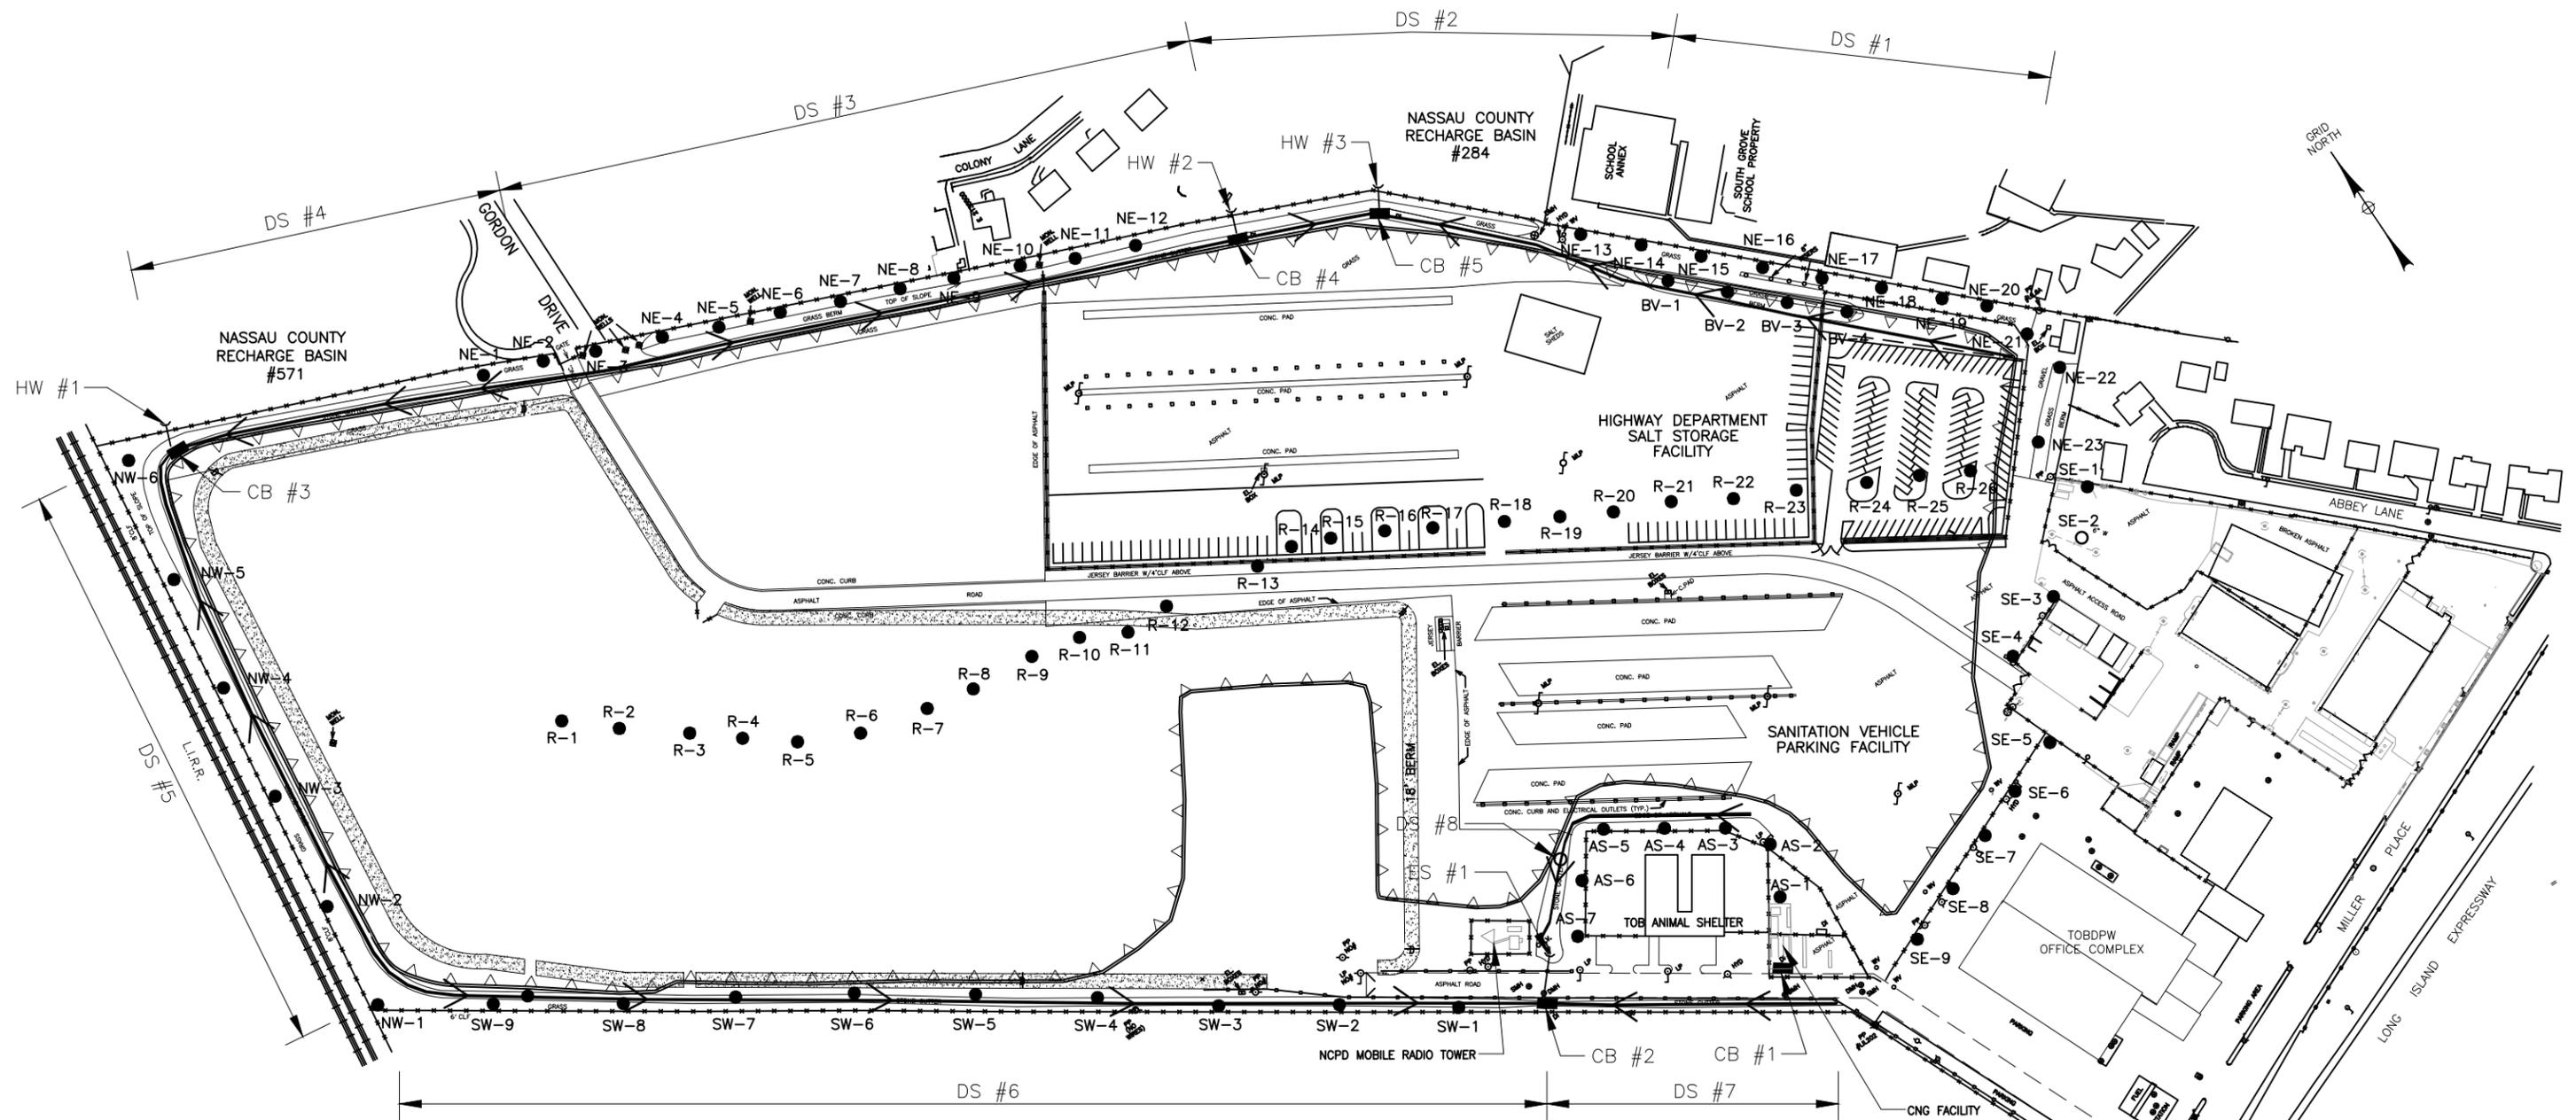
**FIGURE 2**  
**SYOSSET LANDFILL**  
**DRAINAGE SYSTEM LOCATION PLAN**

During this reporting period, the drainage system throughout the landfill was inspected semi-annually. There were no 5-year, 24-hour storm events during 2023. The ditch sections, catch basins, storm drainage pipes, manholes and recharge basin headwalls were inspected for defects. The defects encountered are identified on Tables B1-1 and B2-1, in Appendix B and their locations are identified by drainage ditch section number or drainage structure number on Figure 2, Drainage System Location Plan. Pictures of typical defects follow the tables for each round of inspections.

The storm drainage pipes were inspected; no defects were detected in the two rounds of inspections at the entrance to the end section located adjacent to the Animal Shelter (ES #1, see Figure 2) during the 2023 reporting period.
