# Monthly Report of the Operations & Maintenance Activities

Claremont Polychemical Operable Unit 5  
Groundwater Treatment System

*Old Bethpage, New York*  
June 2020

NYSDEC Standby Engineering Contract  
Work Assignment #D0076025-28

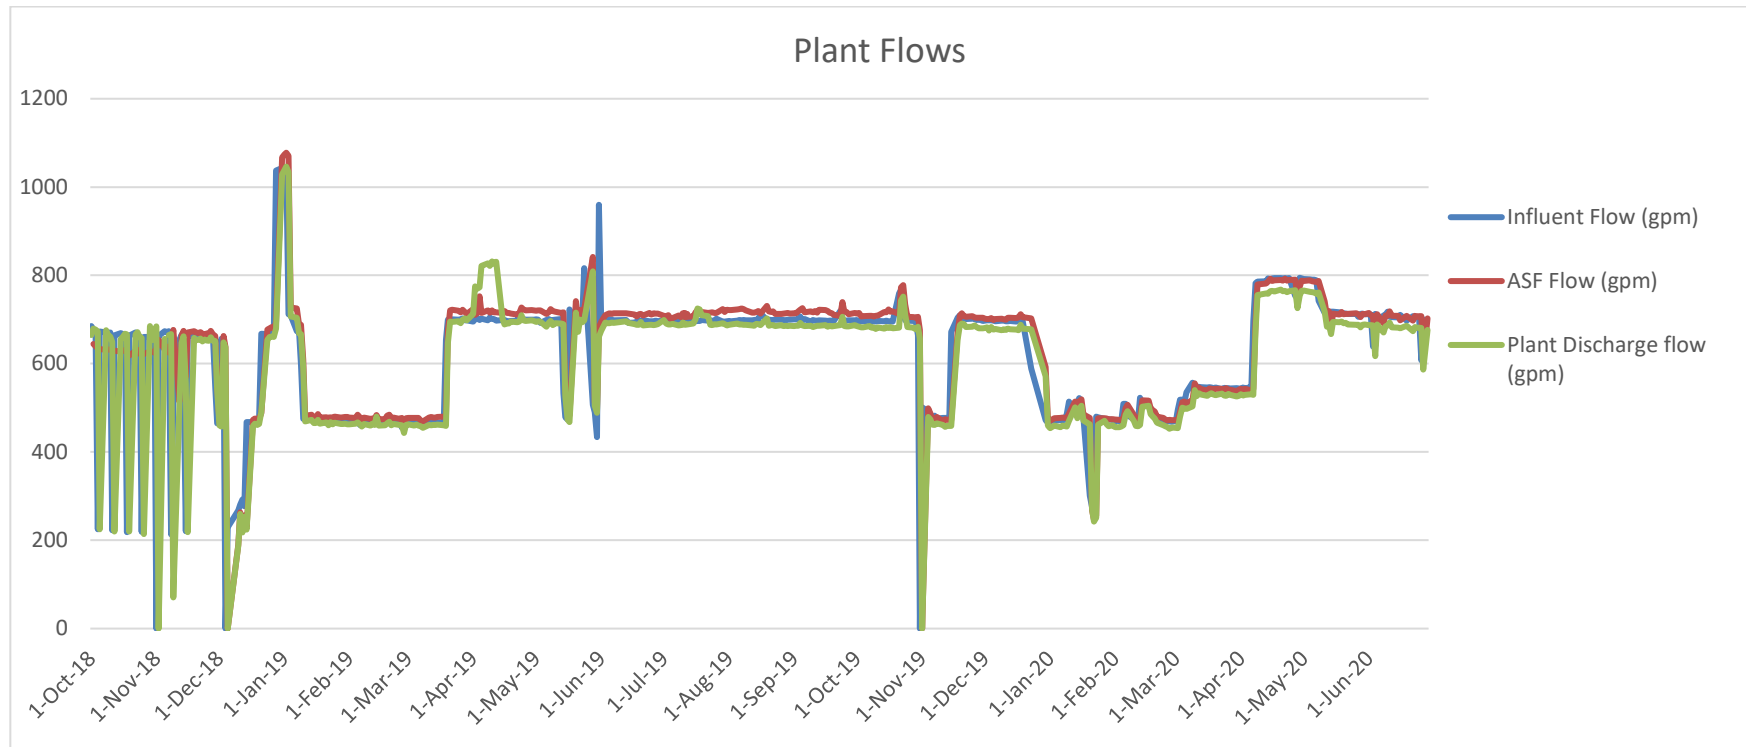
**Figure 1 – Plant Discharge Daily Flow**

During June, the plant continued to operate in the auto mode. The volume of treated water discharged by the treatment plant to the selected recharge basin is determined from readings of the plant effluent flow meter output, these HMI readings were recorded. The treatment system experienced process control problems and equipment failures and was shut down for a total of 3333 minutes to correct the problems.

A graphic representation of the system's daily plant discharge output is provided in **Figure 1** and the daily plant totalizer readings for June are provided in **Table 4**, both following the text of this report.
