Re: Report of Vapor Mitigation System Observation & Testing Services
COSTCO Wholesale (Oceanside, NY)
Daly Boulevard & Hampton Road
Town of Hempstead, Nassau County, New York
MC Project No. 12000271A

March & April 2017 Inspection of Liquid Boot Application and Smoke Testing

Attachment #1
Vapor Barrier Testing Log

Attachment #2
Site Photographs

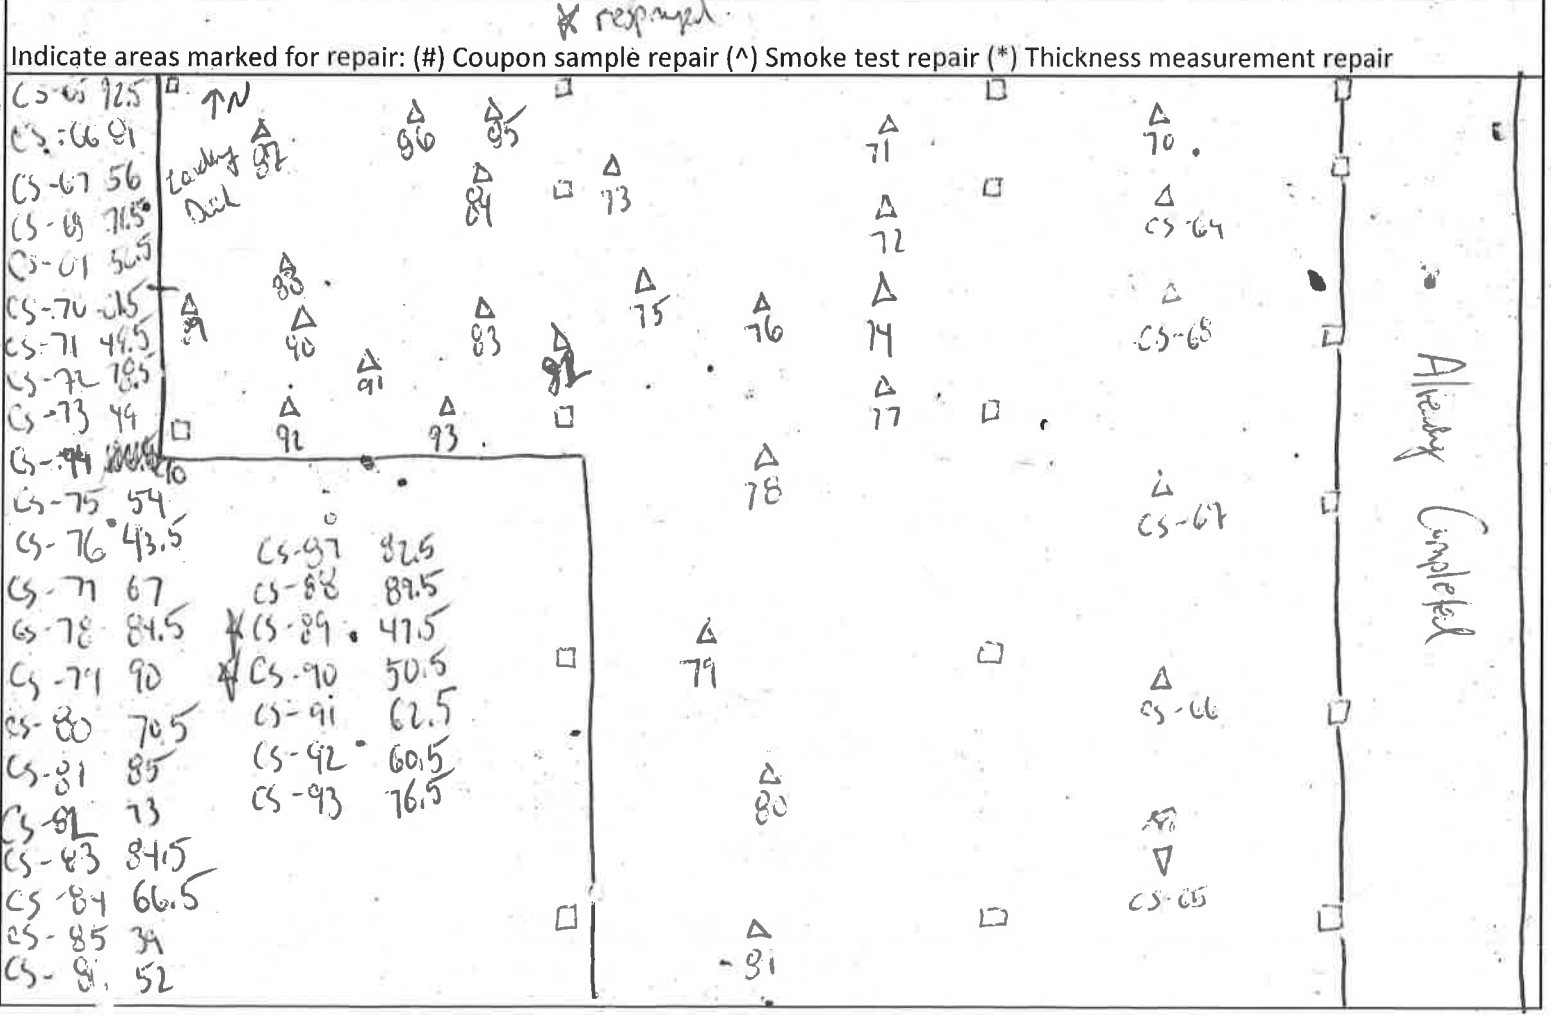
Coupon Samples Taken	29
Coupon Samples Under the Specified Thickness	10
Coupon Sample Marked for Repair	10

Smoke Test Conducted	3/20/17
Duration of Smoke Test	5 hrs
Number of Areas Needing Repair

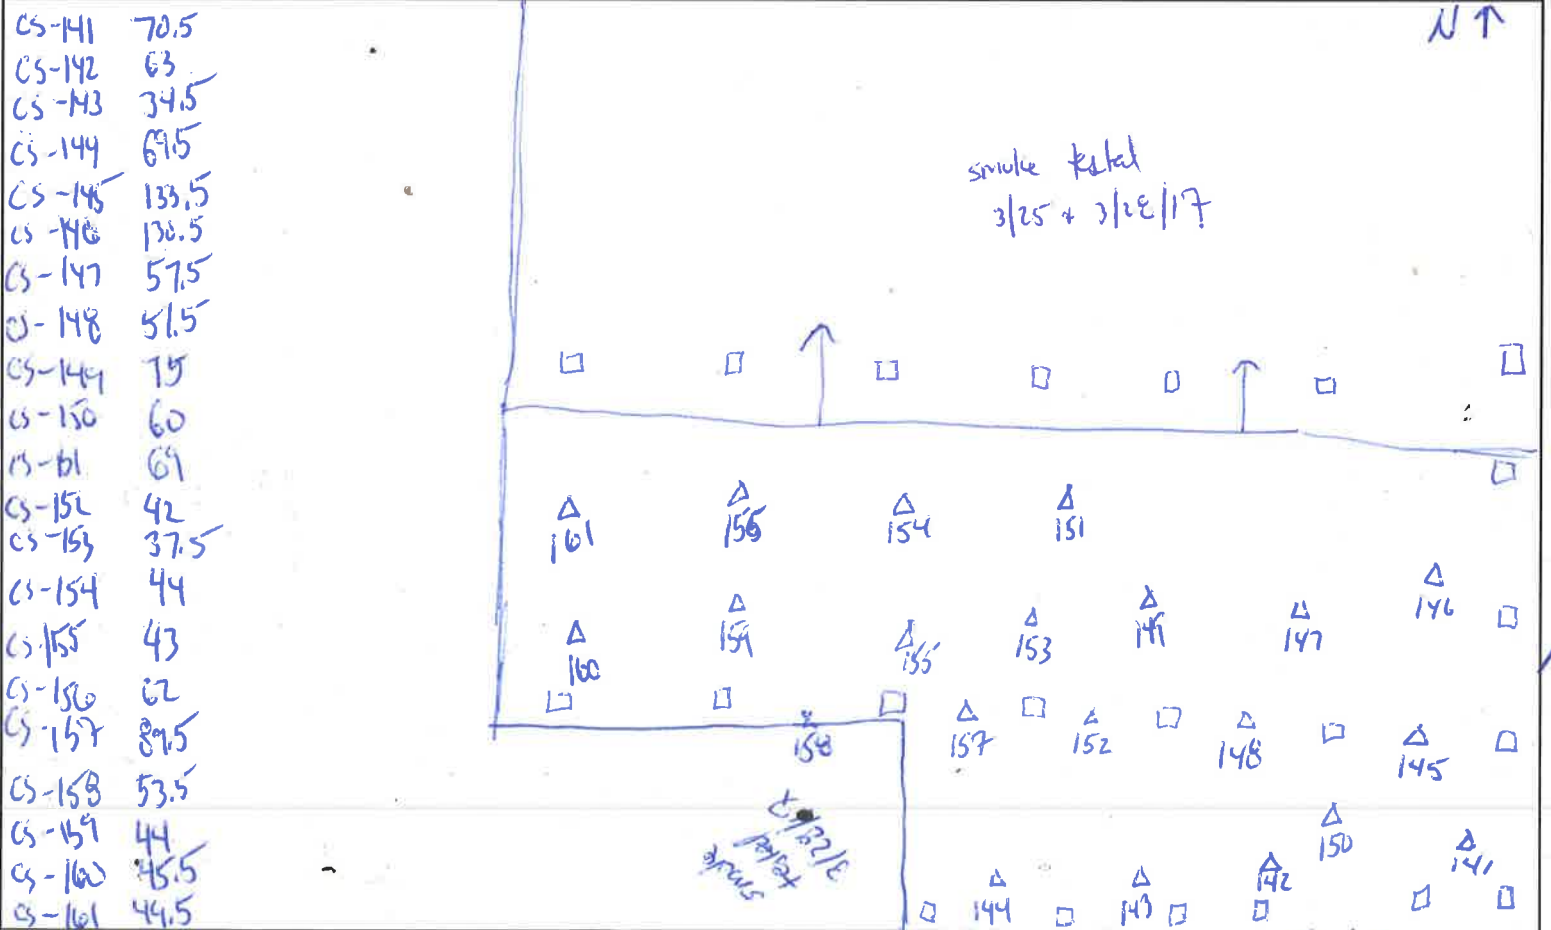
Coupon Samples Taken	<u>21</u>
Coupon Samples Under the Specified Thickness	<u>11</u>
Coupon Sample Marked for Repair	<u>11</u>

Smoke Test Conducted	<u>562 3/29/17</u>
Duration of Smoke Test	<u>520</u>
Number of Areas Needing Repair	<u>11</u>

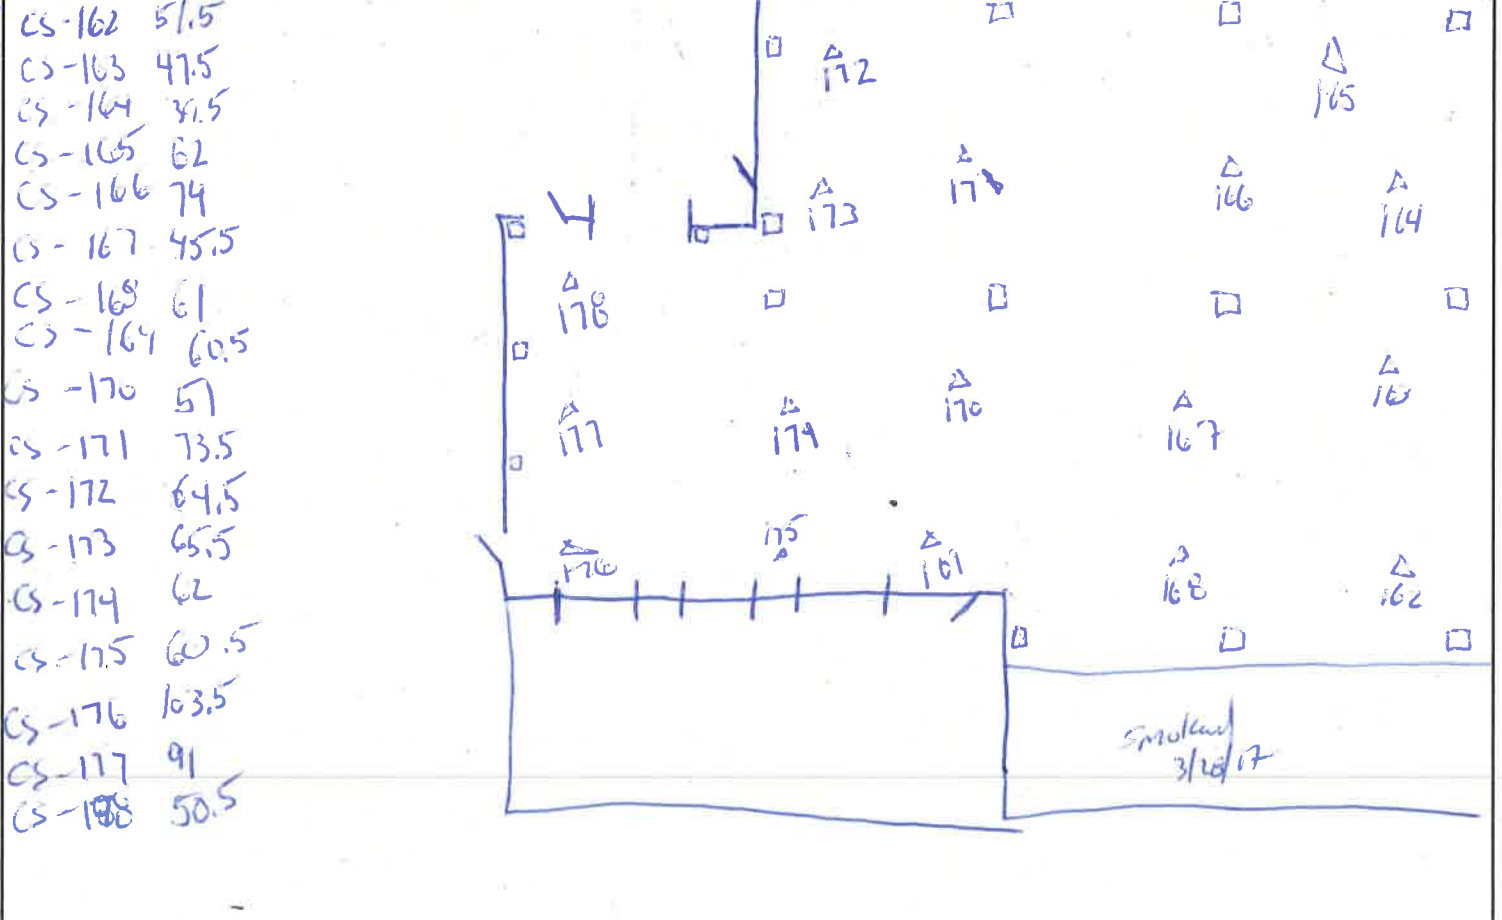
Coupon Samples Taken	<u>17</u>
Coupon Samples Under the Specified Thickness	<u>6</u>
Coupon Sample Marked for Repair	<u>5</u>

Smoke Test Conducted	<u>3/30/17</u>
Duration of Smoke Test	<u>4h</u>
Number of Areas Needing Repair	<u>5</u>
