# Advanced Cleanup Technologies, Inc.

### PHASE I/PHASE II ENVIRONMENTAL SITE ASSESSMENT

1-3 Manorhaven Boulevard  
Port Washington, New York 11050

October 30, 2006

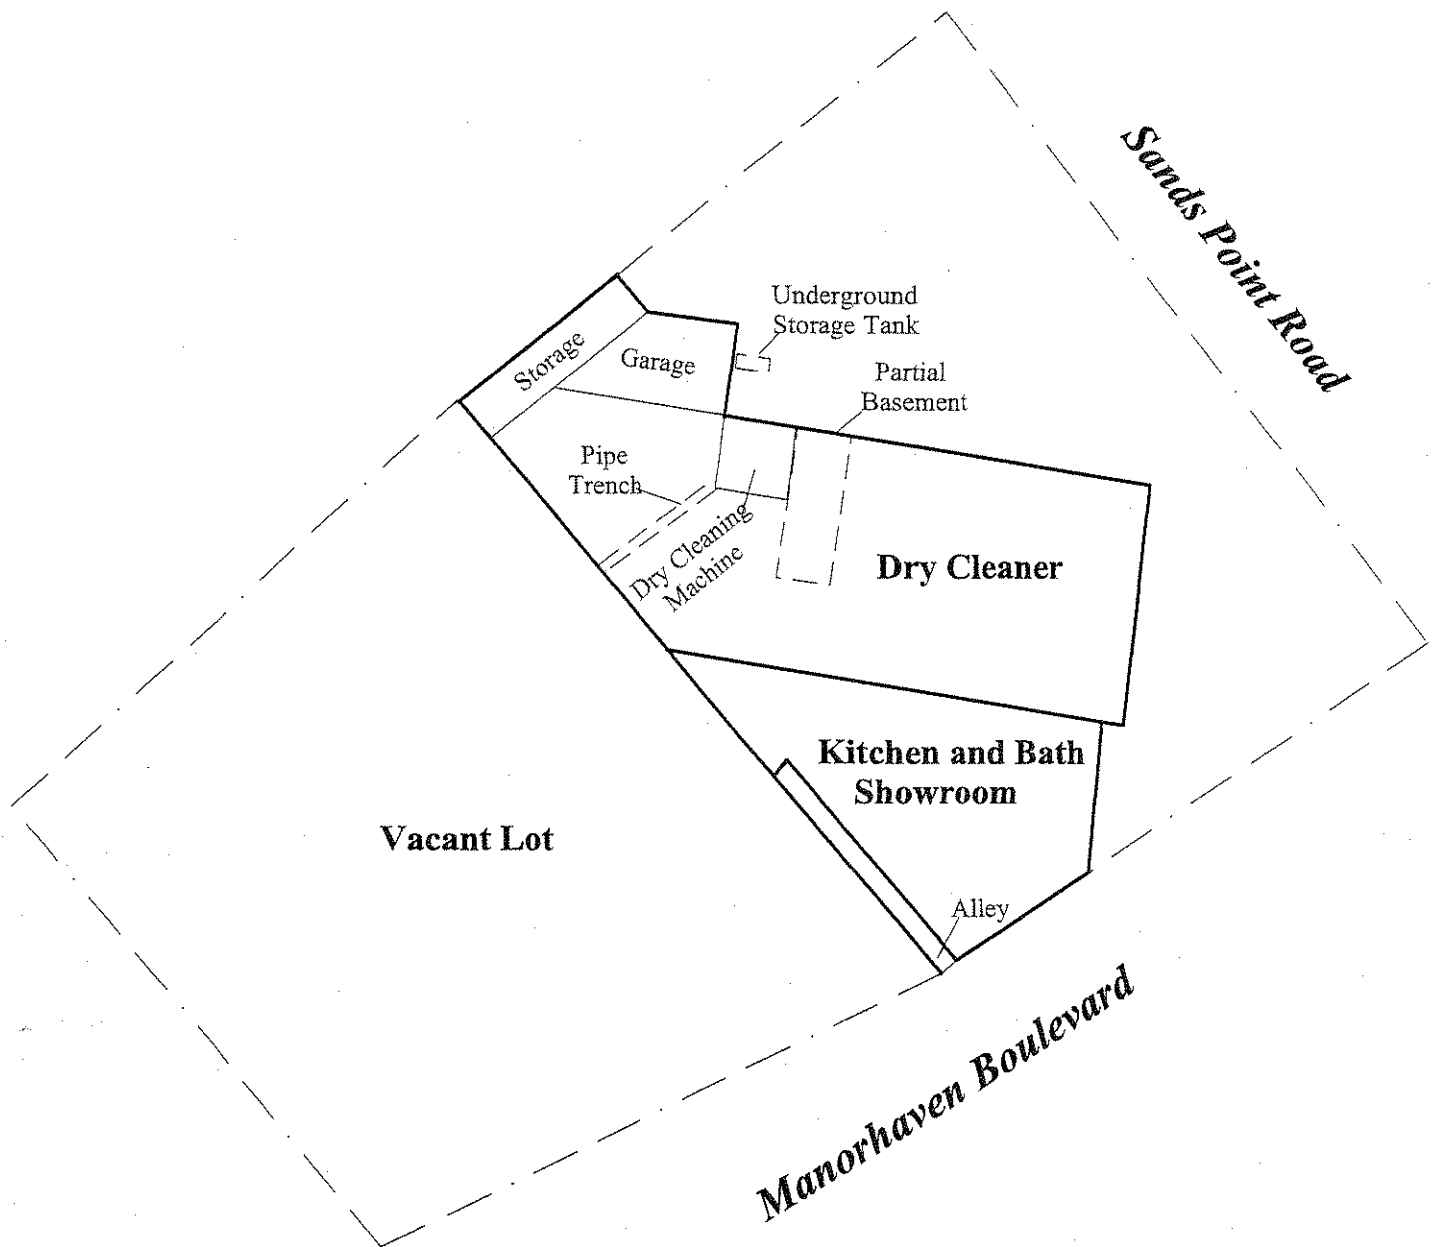
Figure 2	
Site Diagram	
Job No. 5621-PWNY	Date: 10/30/06
Drawing No. 5621-02	Scale: NTS
Drawn By: William K. Sisco	Approved By: Paul Stewart
<b>Advanced Cleanup Technologies, Inc.</b>

The subject property consists of two adjoining one-story commercial buildings. The buildings are constructed on concrete slabs. The northern building contains Chez Valet Dry Cleaners located at 1 Manorhaven Boulevard ("dry cleaner") and has a partial basement (Photograph 1). The southern building contains The Breakfast Room, a kitchen and bath showroom located at 3 Manorhaven Boulevard ("kitchen and bath showroom") with no basement (Photograph 2).

The combined footprint of both buildings is 6,560 square feet in area. The property is approximately 13,100 square feet in area. A Site Diagram is provided as Figure 2.

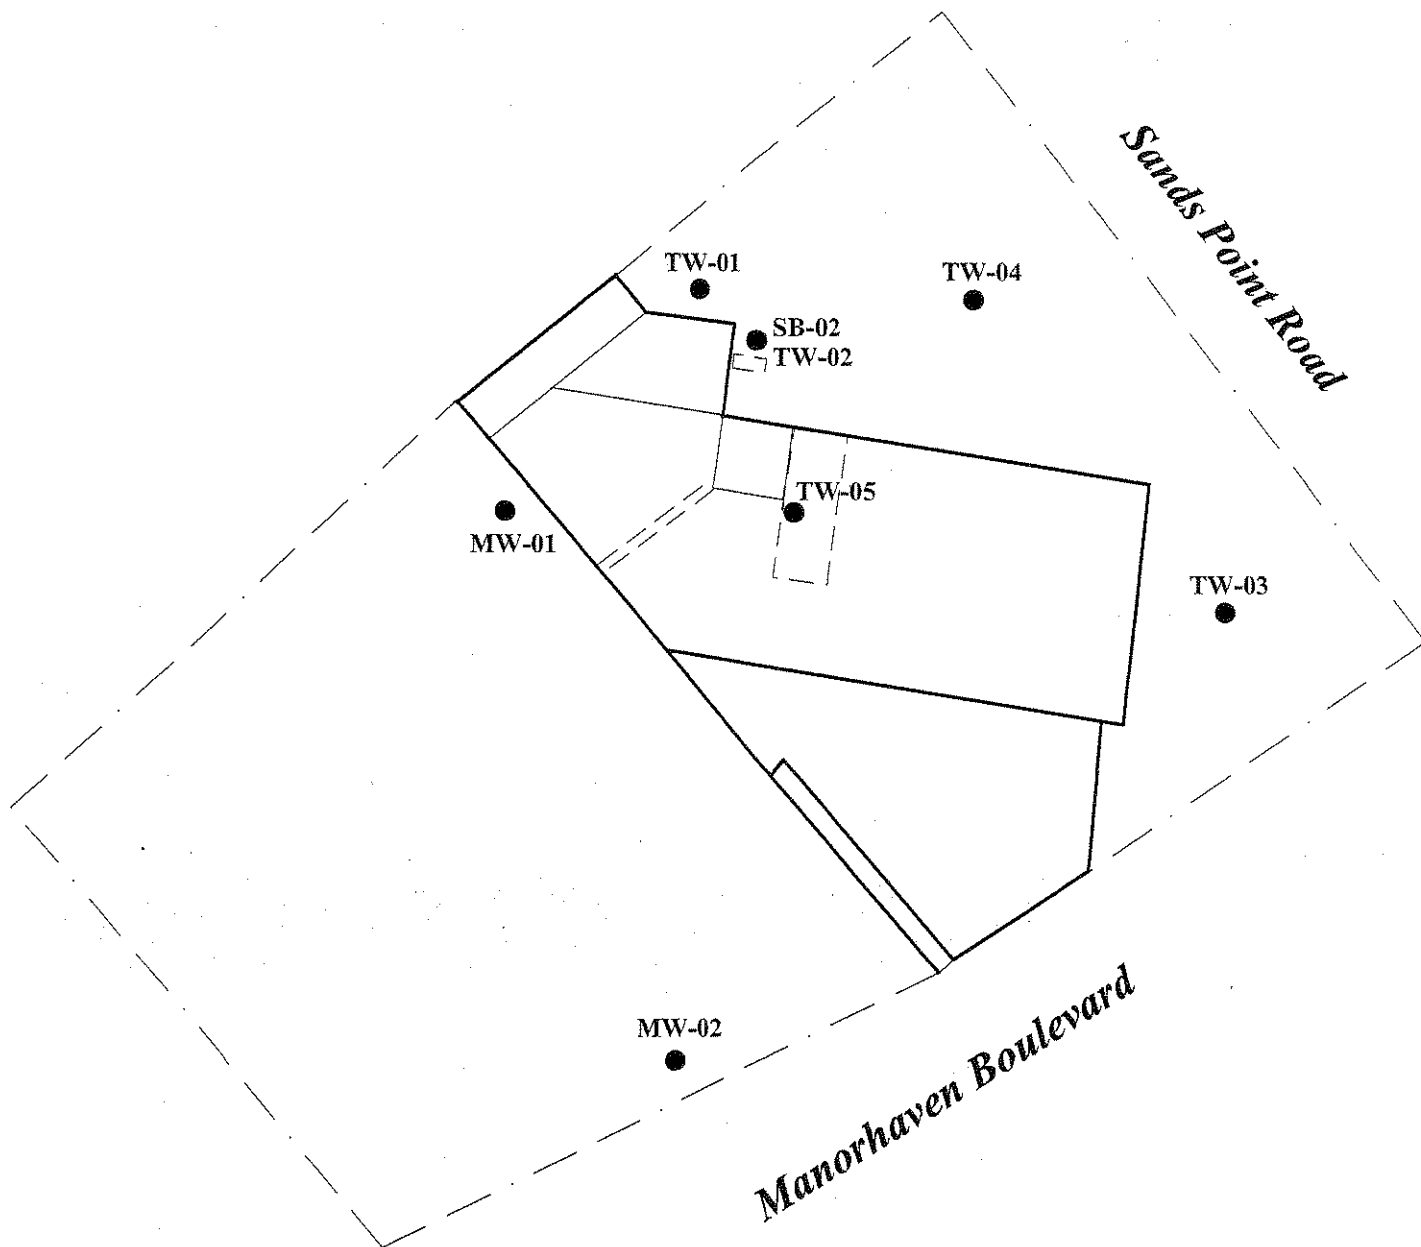
Figure 5	
Sampling Diagram	
Job No. 5621-PWNY	Date: 10/30/06
Drawing No. 5621-05	Scale: NTS
Drawn By: William K. Sisco	Approved By: Paul Stewart
Advanced Cleanup Technologies, Inc.

The scope of work for the Phase II portion of the Assessment included the installation and sampling of one soil boring and 5 temporary ground water monitoring wells. The scope of work also included the sampling of 2 conventional monitoring wells located on the adjacent vacant lot. Finally, the scope of work included the in-house screening of all ground water samples and the laboratory analysis of two ground water samples. A diagram of sampling locations is provided in Figure 5. Copies of field notes are included in Appendix E.

Soil quality adjacent to the active underground fuel oil storage tank was determined by installing one soil boring (SB-02) adjacent to the northern sidewall of the tank utilizing a truck-mounted Geoprobe style hydraulic unit in combination with five foot macro core soil samplers containing acetate liners. The location of soil boring SB-02 is shown in Figure 5.

Ground water quality was determined during the Phase II portion of the Assessment by installing and sampling 5 temporary ground water monitoring wells at the Site. In addition, 2 conventional monitoring wells located on the adjacent vacant lot were sampled. These ground water sampling locations are indicated in Figure 5.

The certified laboratory results indicate that concentrations of Tetrachloroethene were found above water quality standards in water samples from temporary well TW-01 (19 ug/l) and conventional well MW-01 (7.1 ug/l). No other VOCs were detected in ground water samples collected beneath or in the immediate vicinity of the subject property. Copies of the certified laboratory reports are included in Appendix G.

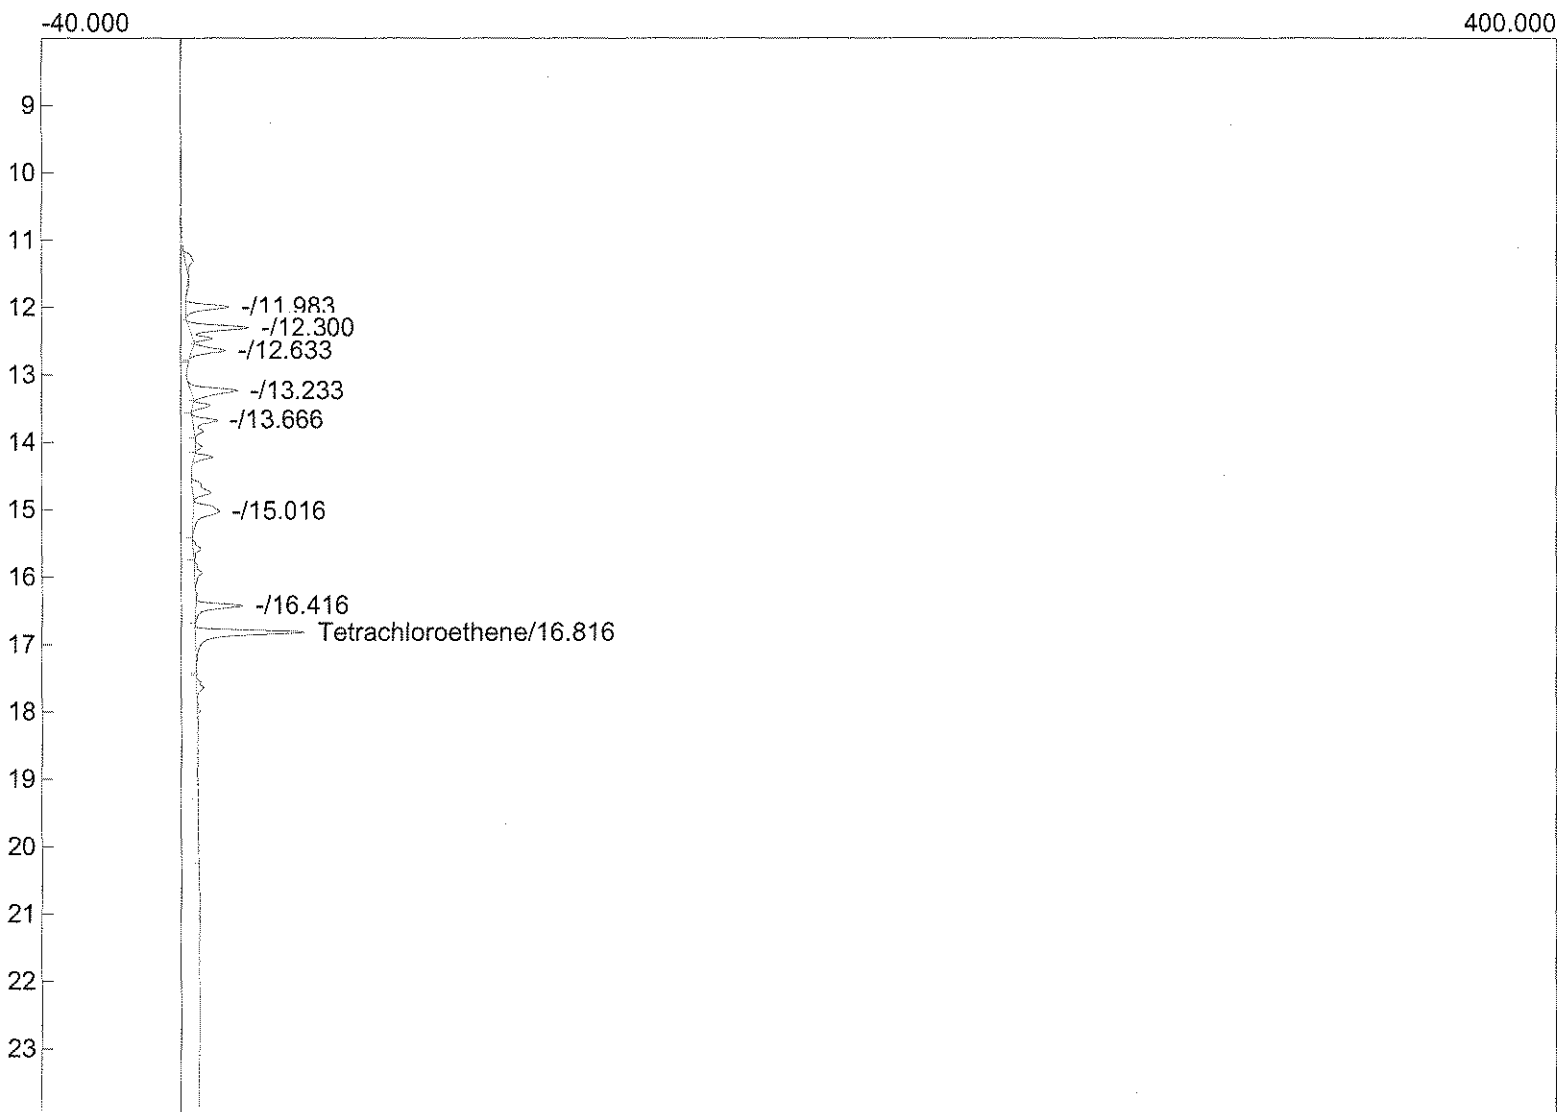
Client ID: 5621-PWNY  
Collected: 9/22/06  
Analysis date: 09/25/2006 11:12:29  
Method: purge and trap  
Lab ID: 70006563  
Description: fid  
Data file: A6563.CHR ()  
Sample: TW-1  
Comments: 10 ml. sample in sparge tube

Component	Retention	Area	External
Tetrachloroethene	16.816	181.5960	25.5495
		181.5960	25.5495

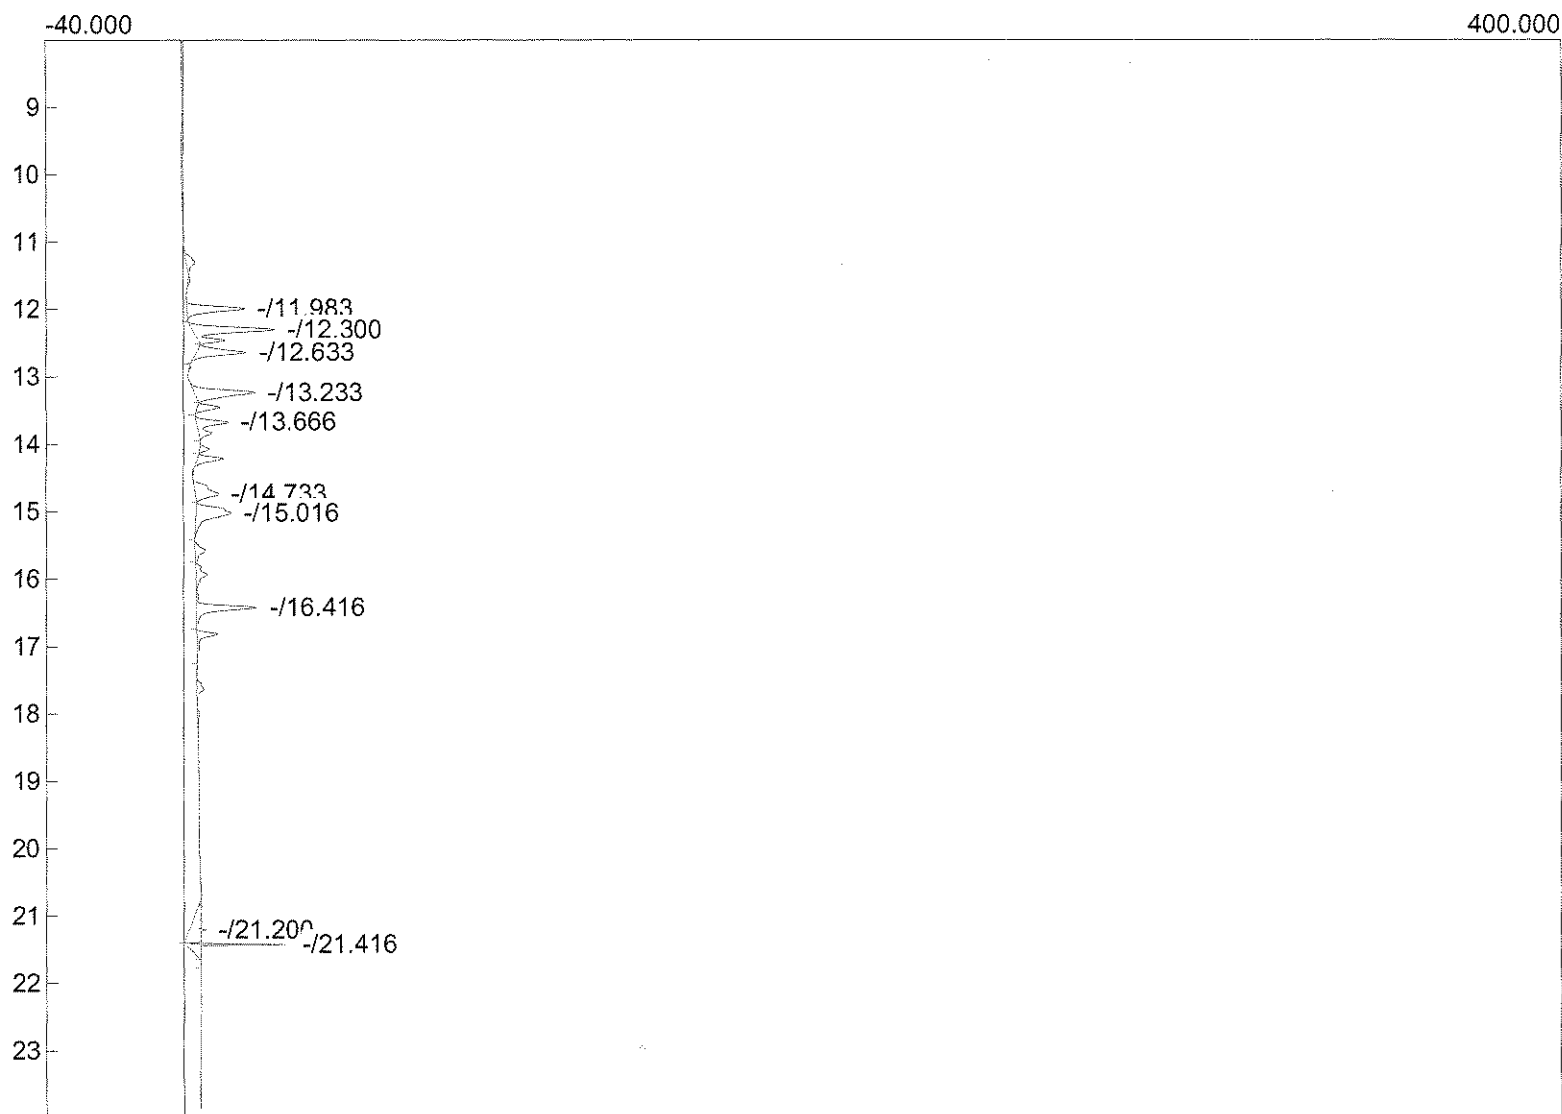
Client ID: 5621-PWNY  
Collected: 9/22/06  
Analysis date: 09/25/2006 10:35:48  
Method: purge and trap  
Lab ID: 70006562  
Description: fid  
Data file: A6562.CHR ()  
Sample: TW-2  
Comments: 10 ml. sample in sparge tube

Component	Retention	Area	External
		0.0000	0.0000

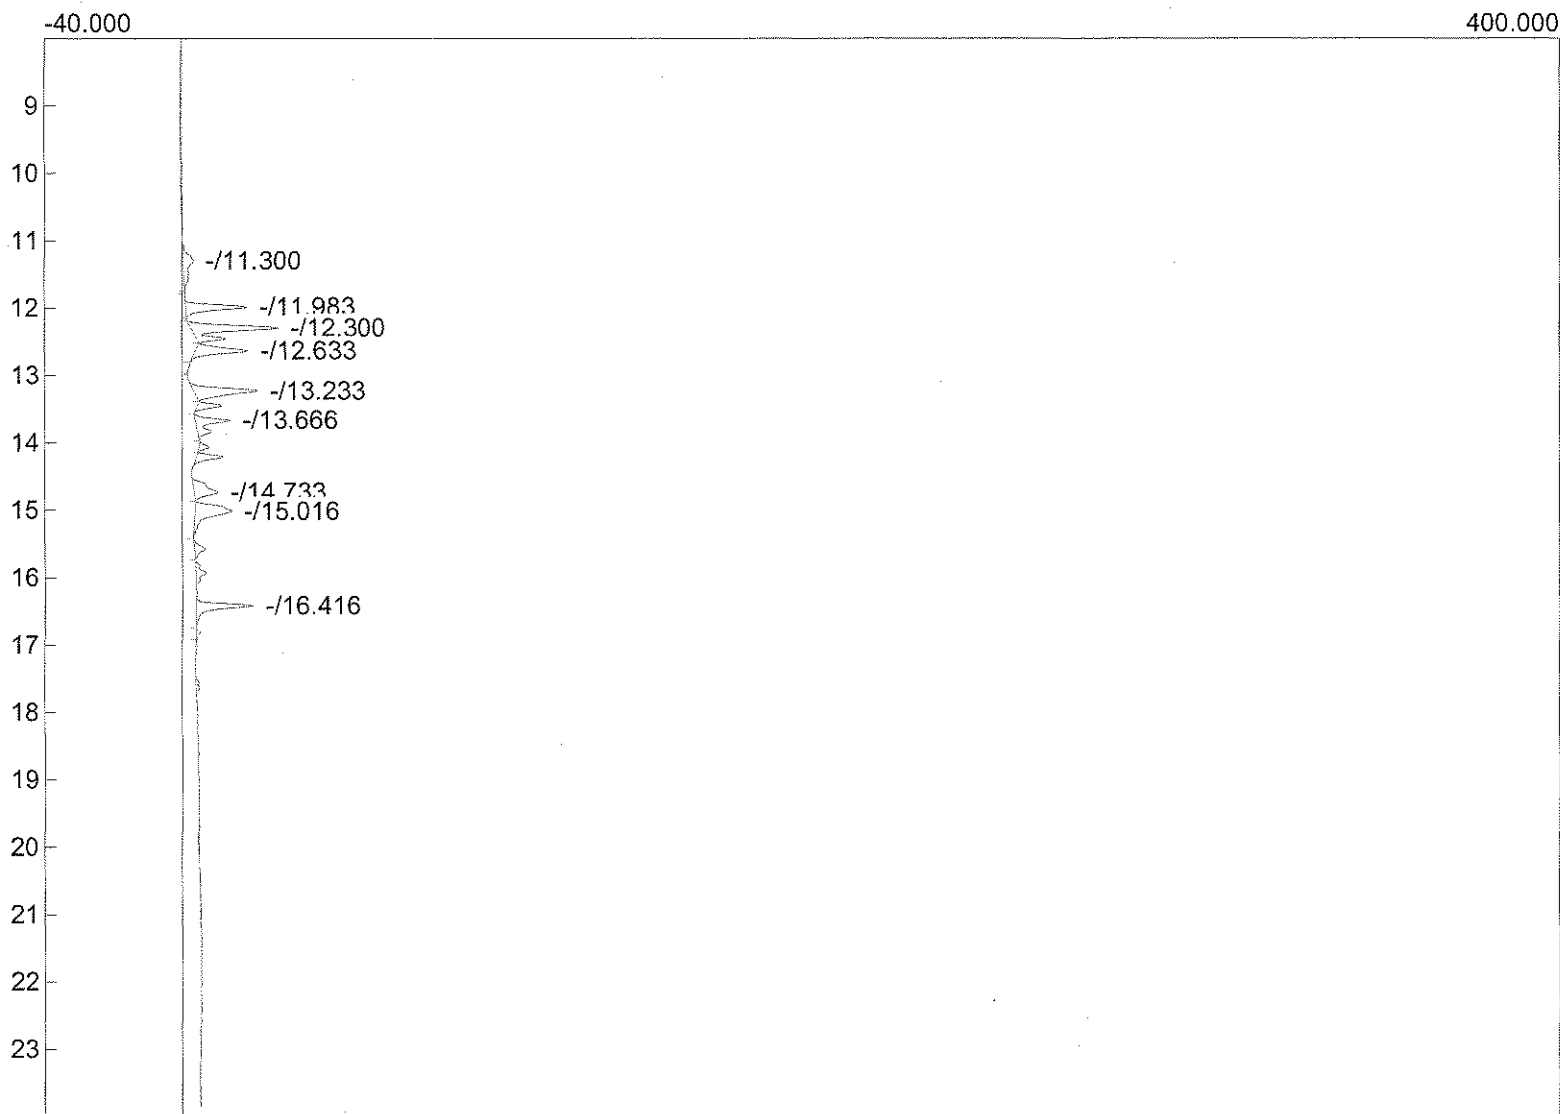
Client ID: 5621-PWNY  
Collected: 9/22/06  
Analysis date: 09/25/2006 10:06:42  
Method: purge and trap  
Lab ID: 70006561  
Description: fid  
Data file: A6561.CHR ()  
Sample: TW-3  
Comments: 10 ml. sample in sparge tube

Component	Retention	Area	External
		0.0000	0.0000

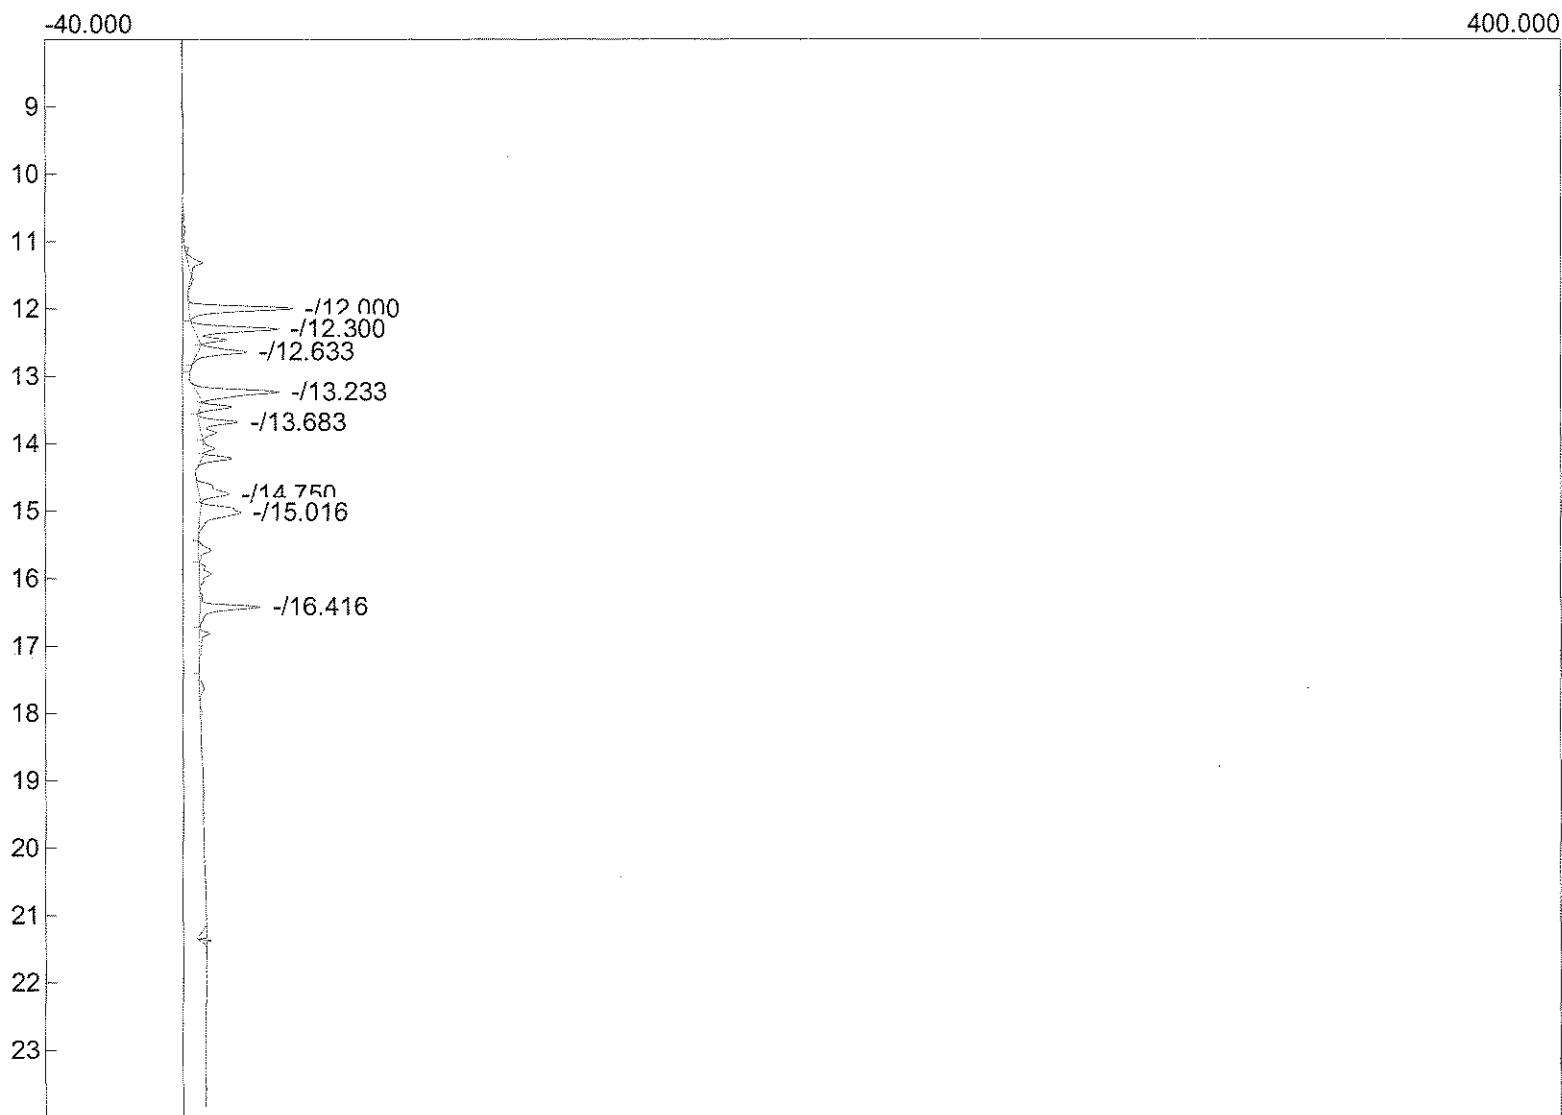
Sample: TW-4

Component	Retention	Area	External
		0.0000	0.0000

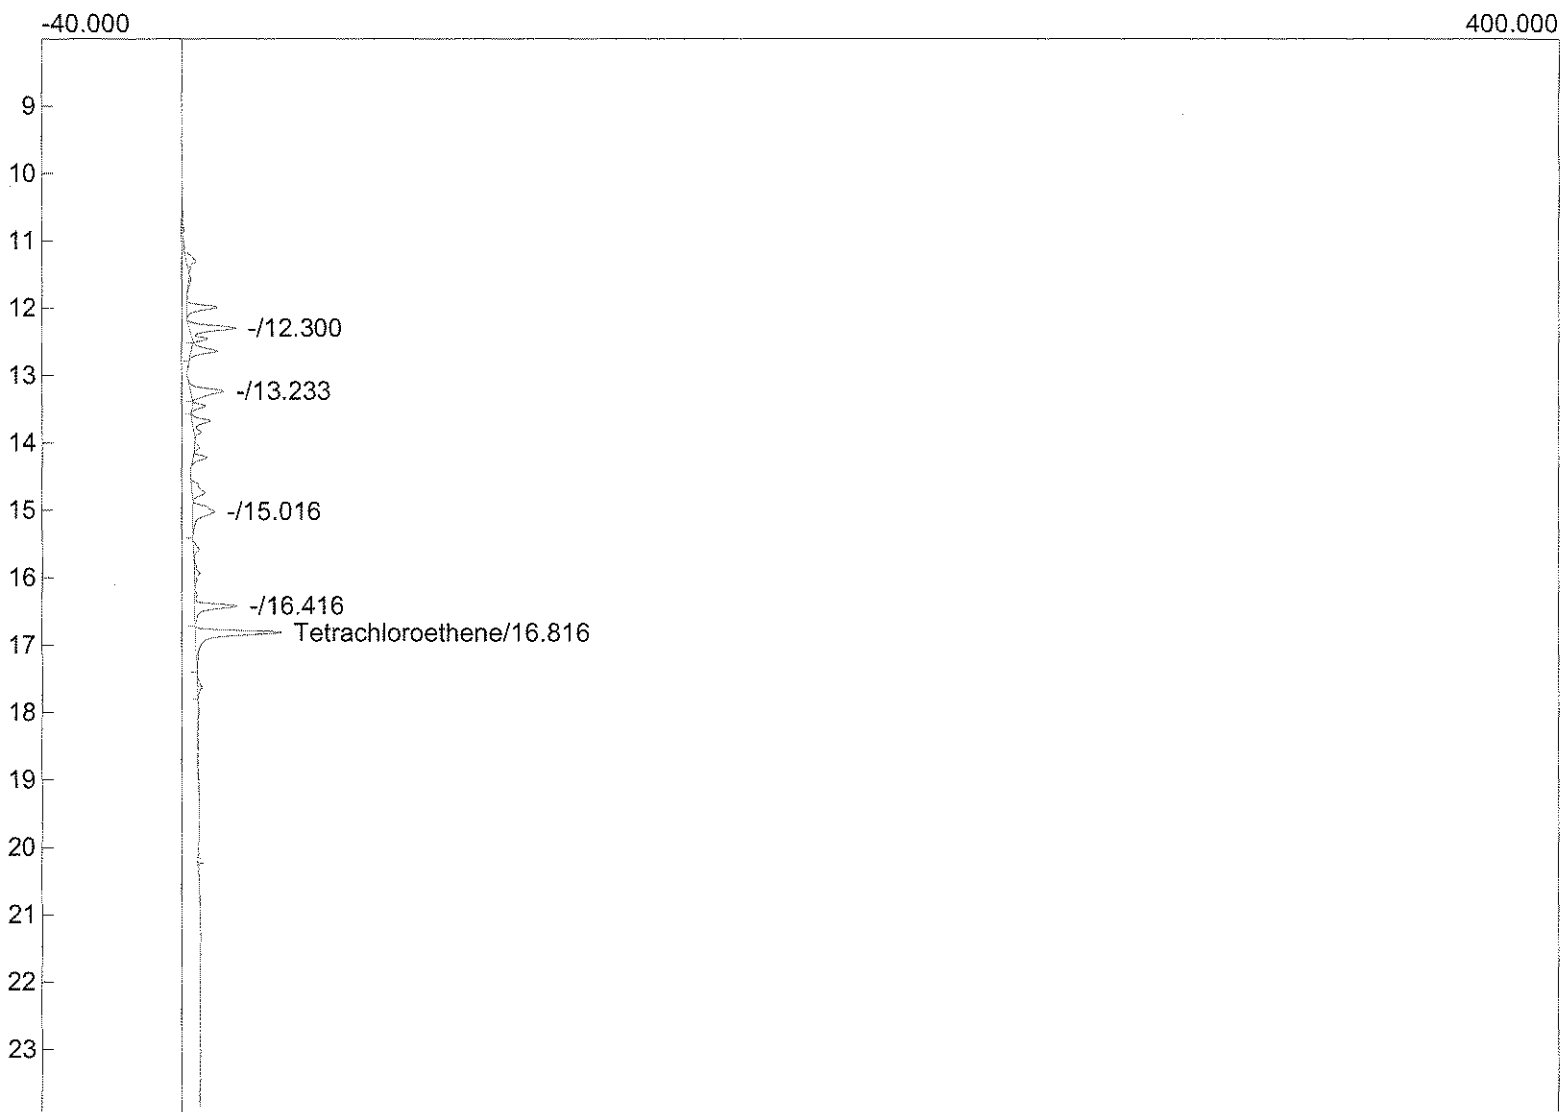
Client ID: 5621-PWNY  
Collected: 9/22/06  
Analysis date: 09/25/2006 11:42:23  
Method: purge and trap  
Lab ID: 70006564  
Description: fid  
Data file: A6564.CHR ()  
Sample: TW-5  
Comments: 10 ml. sample in sparge tube

Component	Retention	Area	External
Tetrachloroethene	16.816	145.3830	20.8393
		145.3830	20.8393

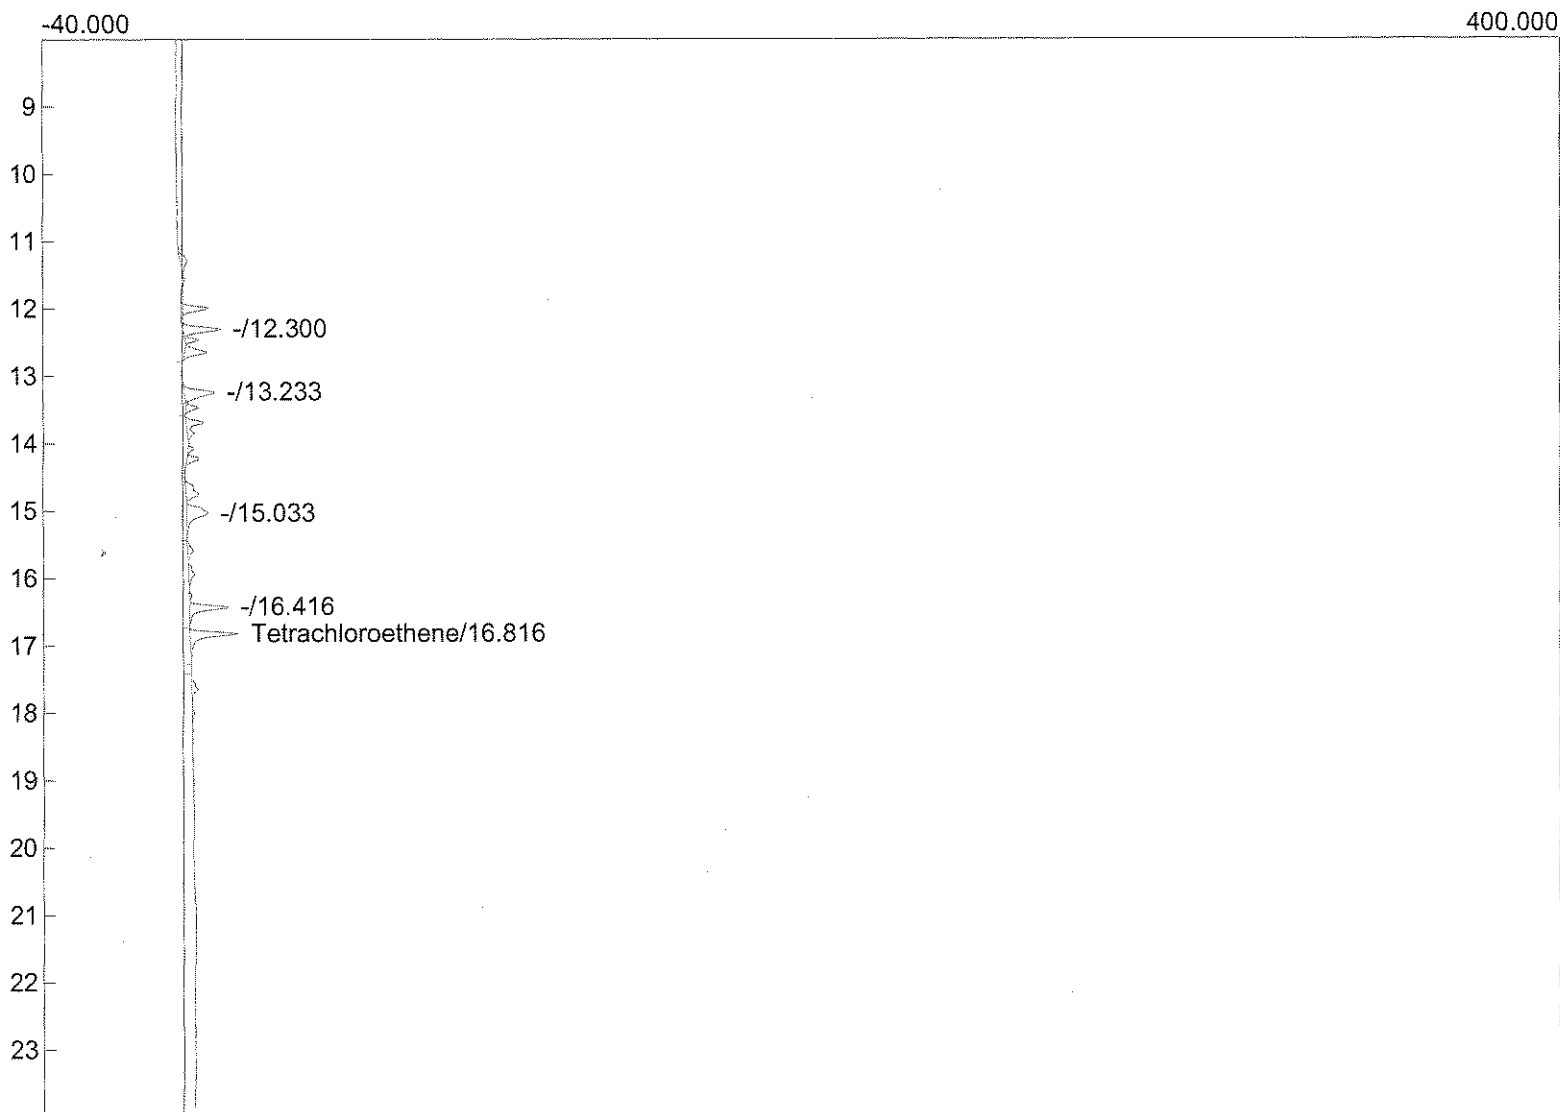
Client ID: 5621-PWNY  
Collected: 9/22/06  
Analysis date: 09/25/2006 12:07:55  
Method: purge and trap  
Lab ID: 70006565  
Description: fid  
Data file: A6565.CHR ()  
Sample: MW-01  
Comments: 10 ml. sample in sparge tube

Component	Retention	Area	External
Tetrachloroethene	16.816	76.7660	11.9144
		76.7660	11.9144

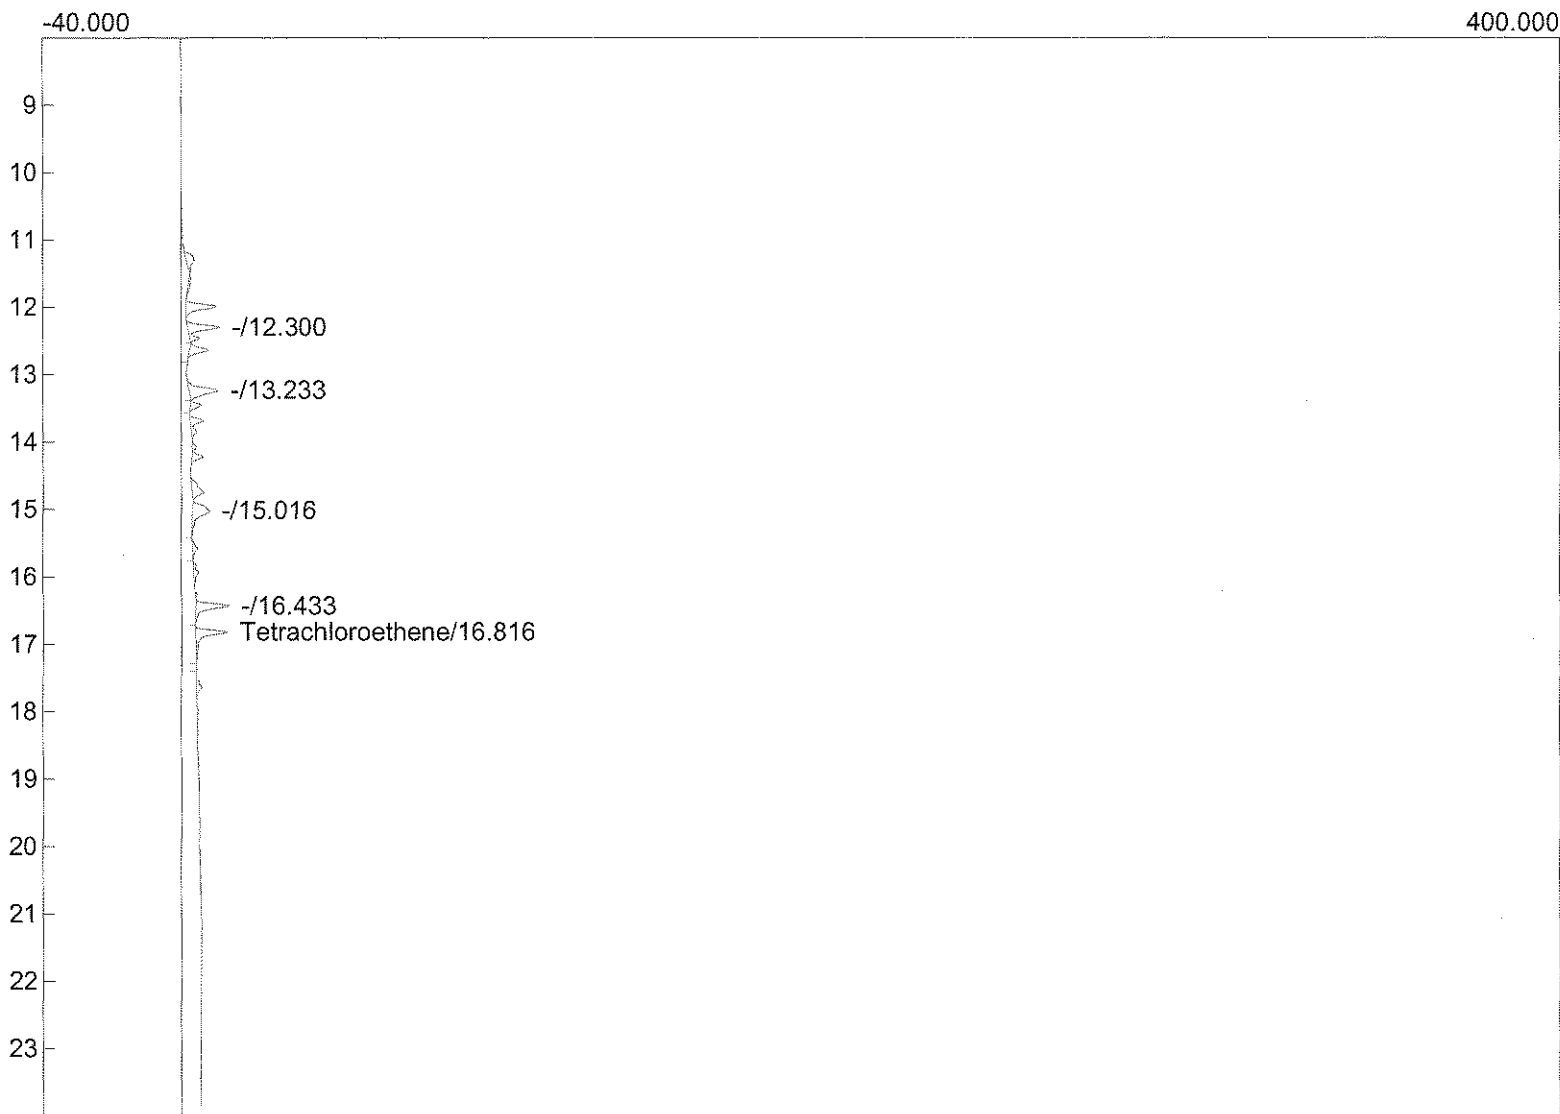
Client ID: 5621-PWNY  
 Collected: 9/22/06  
 Analysis date: 09/25/2006 13:20:38  
 Method: purge and trap  
 Lab ID: 70006566  
 Description: fid  
 Data file: A6566.CHR ()  
 Sample: MW-02  
 Comments: 10 ml. sample in sparge tube

Component	Retention	Area	External
Tetrachloroethene	16.816	53.1660	8.8448
		53.1660	8.8448
