Subject: Chez Valet Dry Cleaners – NYSDEC Site Number 1-03-169  
Revised Progress Report For Time Period 4/9/2013 through 1/29/2015

**SSD/SVE SYSTEM  
NYSDEC Site Number 1-03-169  
Former Chez Valet Dry Cleaners  
1-3 Manorhaven Boulevard  
Port Washington, NY 11050**

**Progress Report**

**Time Period  
4/9/2013 to 1/29/2015**

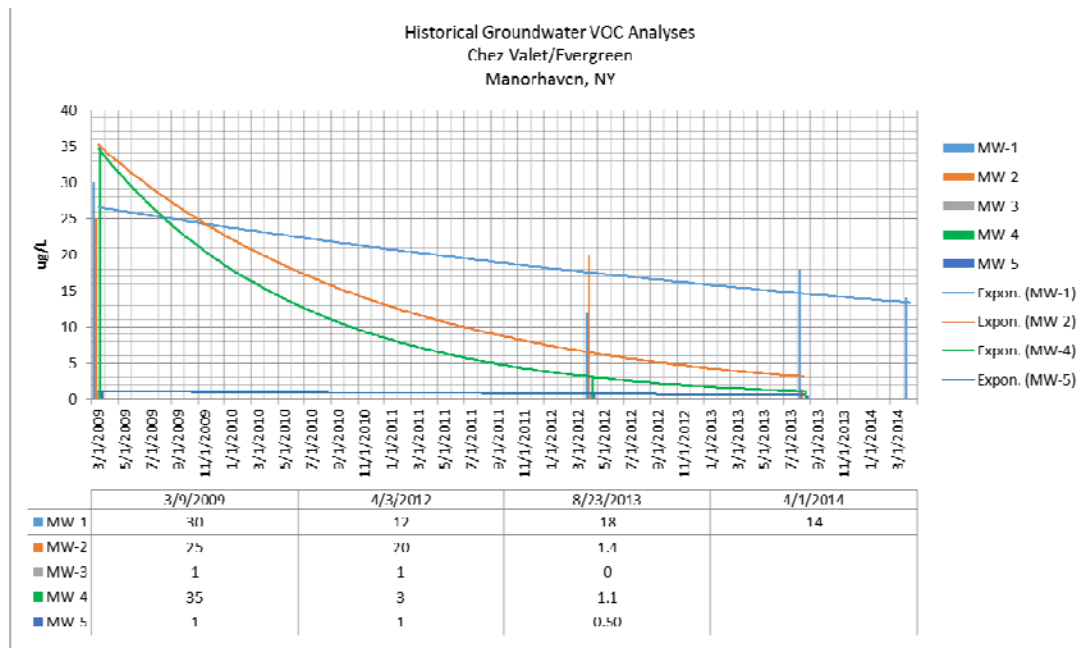
- Groundwater Sampling
  - o A groundwater sampling event was conducted on 4/1/14.
  - o In accordance with an NYSDEC approved protocol, only MW-1 was sampled.
  - o MW-1 showed a slight decrease in concentration from the previous sampling event as can be seen in the graphic below.
  - o Based on the letter dated February 26, 2015, "... Further groundwater sampling will not be required at this time. Groundwater sampling will be required prior to removal of the groundwater use restrictions."

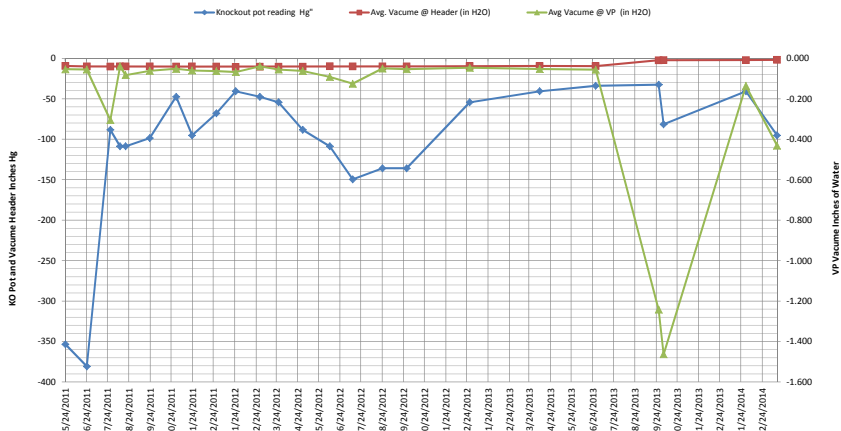
# Knockout Pot, Avg Vacuum Header and Avg Vapor Point Trends

<sup>1</sup> It should be noted that the SVE/SSD extraction system was focused on the North Room's westerly side, suspected hotspot location as of 9/27/13. This rebalancing of the SVE/SSD system showed much lower vacuums as a result in the vacuum system servicing the North Room's, easterly side and the salon areas. This phenomenon is represented on all the graphics discussed in this paragraph.
