**Re: Town of Islip
Blydenburgh Road Landfill 2020 2nd Half Semi-Annual Post Closure Monitoring
and Maintenance Report**

TO: Anthony J. Varrichio, P.E., Chief Engineer
FROM: Fazil Rahaman, Acting Ground Water Treatment Plant Operator
DATE: April 9th, 2021
RE: **Blydenburgh Rd. L.F. 2020 2nd Half Semi-Annual Post Closure
Monitoring and Maintenance Report**

POST CLOSURE MONITORING AND MAINTENANCE REPORT

FOR THE BLYDENBURGH ROAD M.S.W. LANDFILL

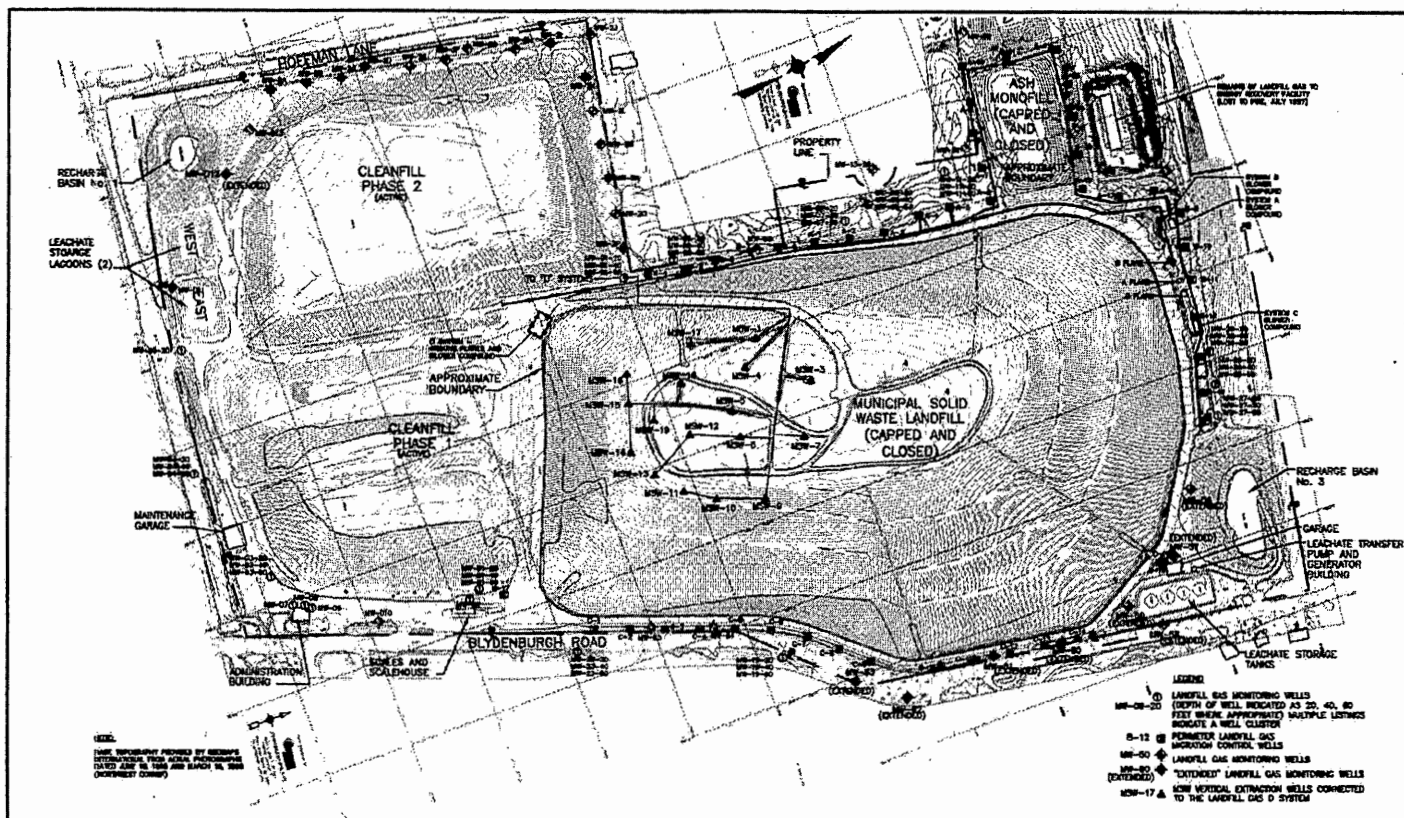
The landfill gas monitoring results are provided in Tables 1 through 11 and ambient air VOC monitoring results are provided in Table 12. Methane was not detected in any of the landfill monitoring wells this month and VOCs were not detected in the ambient air. A Site Plan depicting the locations of the landfill gas monitoring points is included in Figure 1.

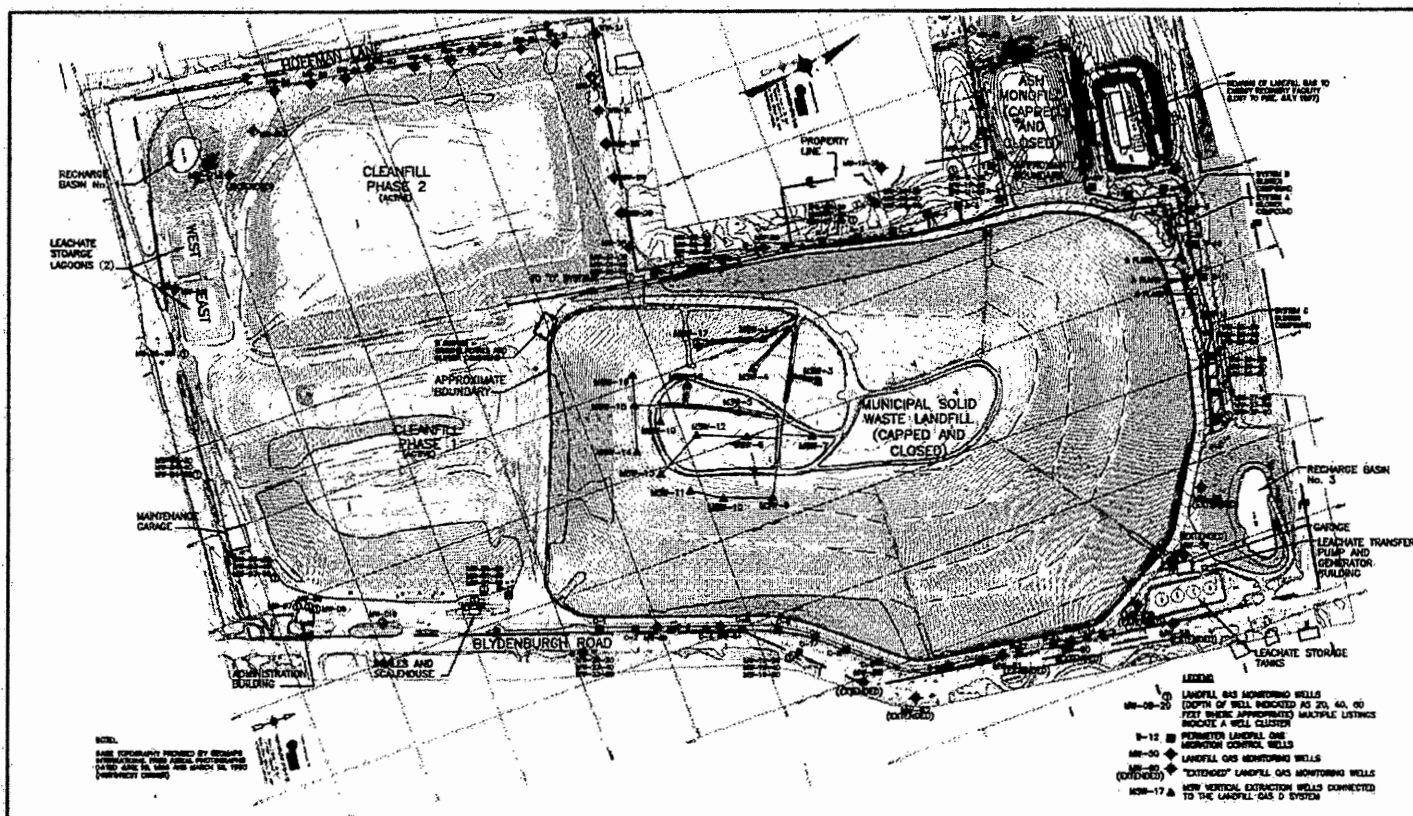
FIGURE 1

The landfill gas monitoring results are provided in Tables 1 through 11 and ambient air VOC monitoring results are provided in Table 12. Methane was not detected in any of the landfill monitoring wells this month and VOCs were not detected in the ambient air. A Site Plan depicting the locations of the landfill gas monitoring points is included in Figure 1.

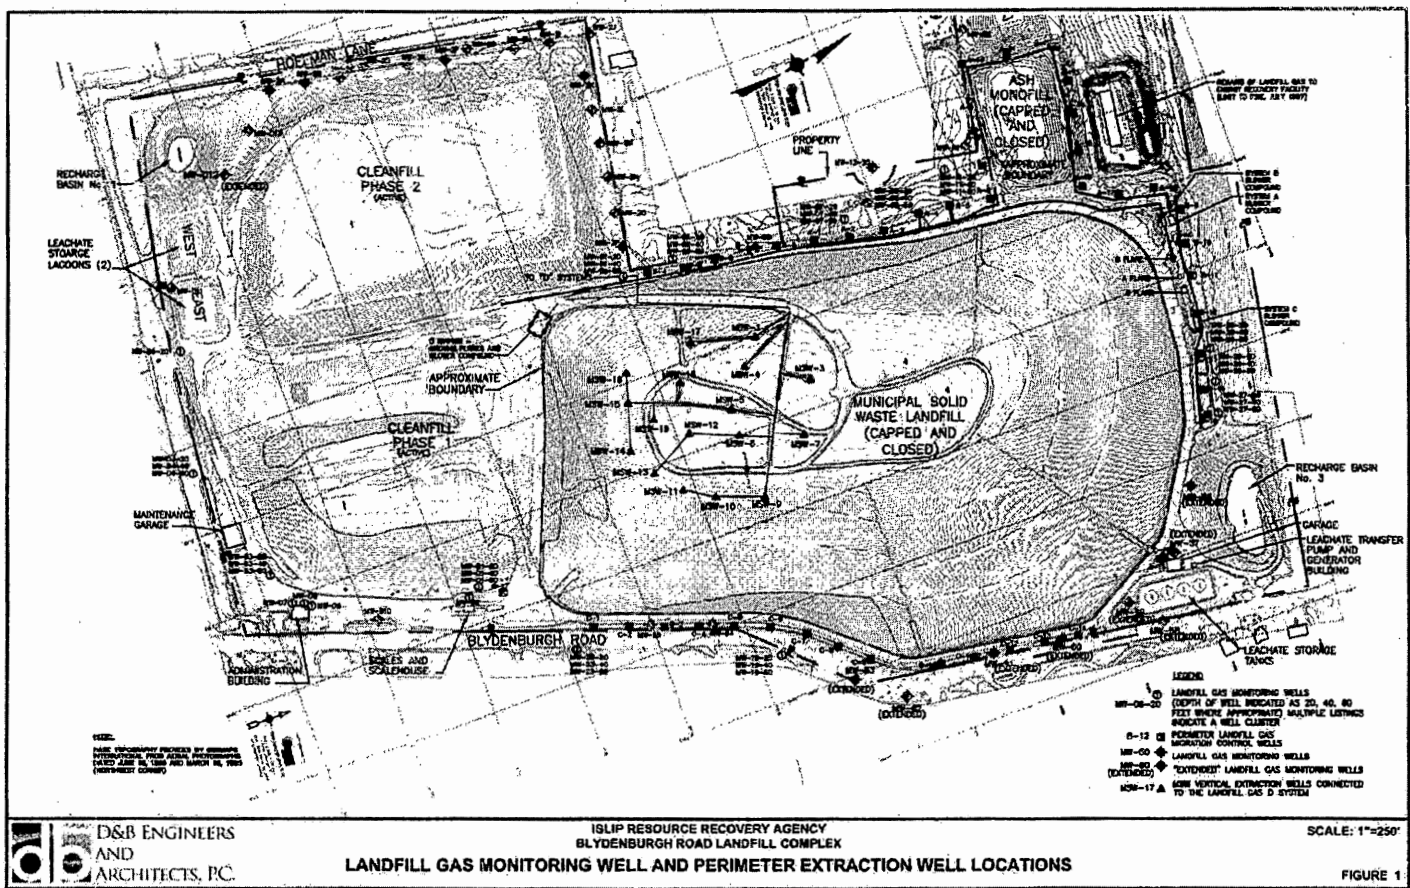
FIGURE 1

The landfill gas monitoring results are provided in Tables 1 through 11 and ambient air VOC monitoring results are provided in Table 12. Methane was not detected in any of the landfill monitoring wells this month and VOCs were not detected in the ambient air. A Site Plan depicting the locations of the landfill gas monitoring points is included in Figure 1.

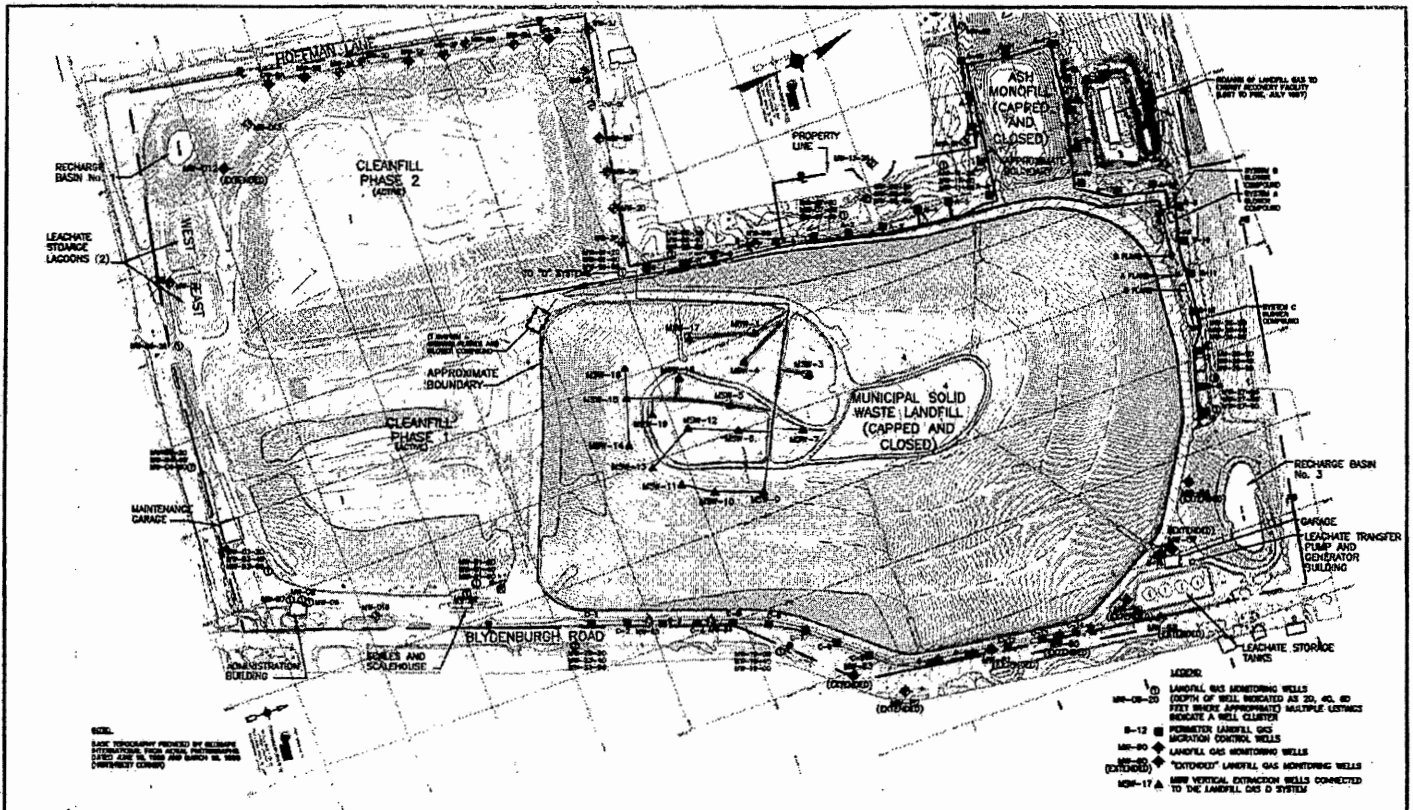
FIGURE 1

The landfill gas monitoring results are provided in Tables 1 through 11 and ambient air VOC monitoring results are provided in Table 12. Methane was not detected in any of the landfill monitoring wells this month and VOCs were not detected in the ambient air. A Site Plan depicting the locations of the landfill gas monitoring points is included in Figure 1.

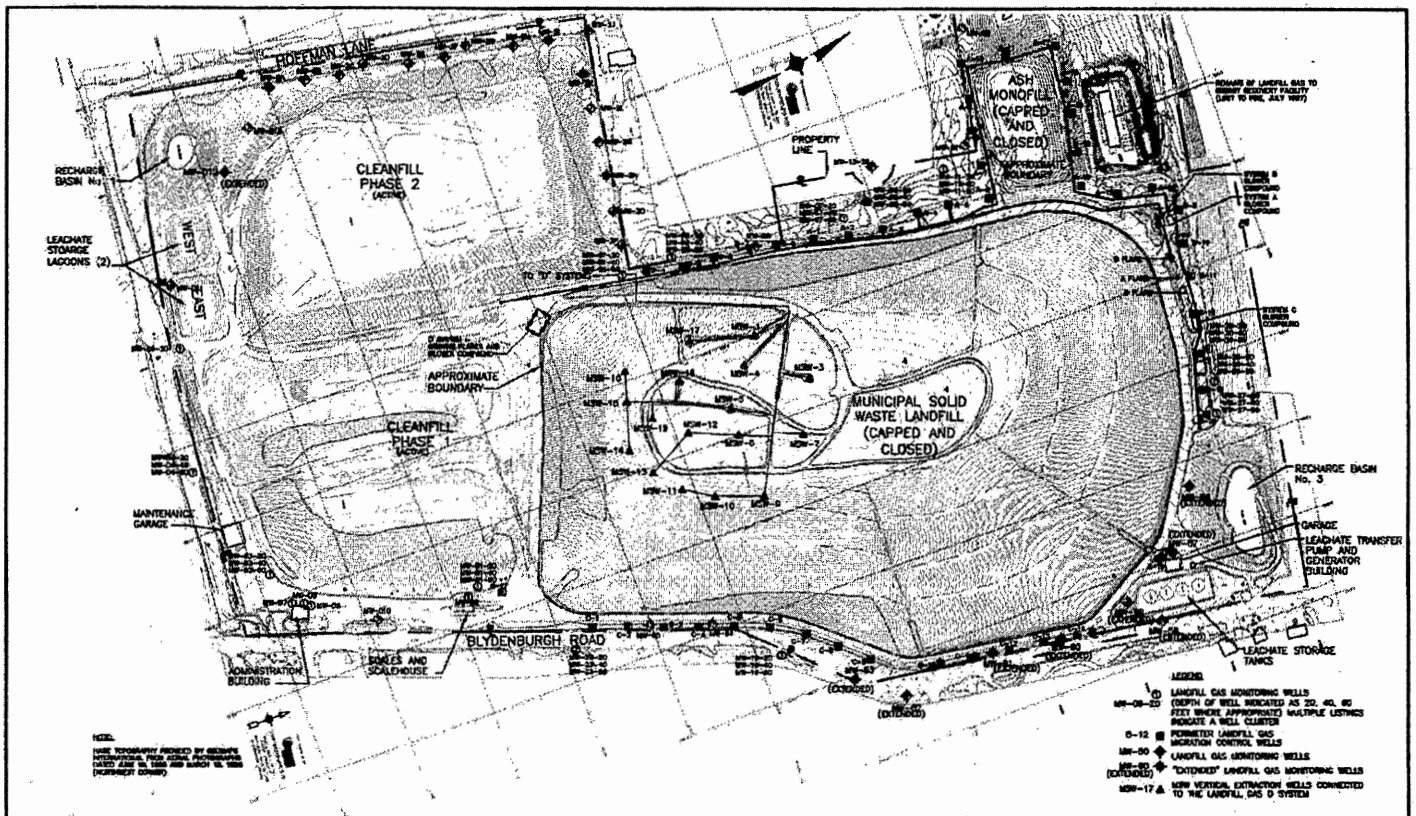
FIGURE 1

The landfill gas monitoring results are provided in Tables 1 through 11 and ambient air VOC monitoring results are provided in Table 12. Methane was not detected in any of the landfill monitoring wells this month and VOCs were not detected in the ambient air. A Site Plan depicting the locations of the landfill gas monitoring points is included in Figure 1.

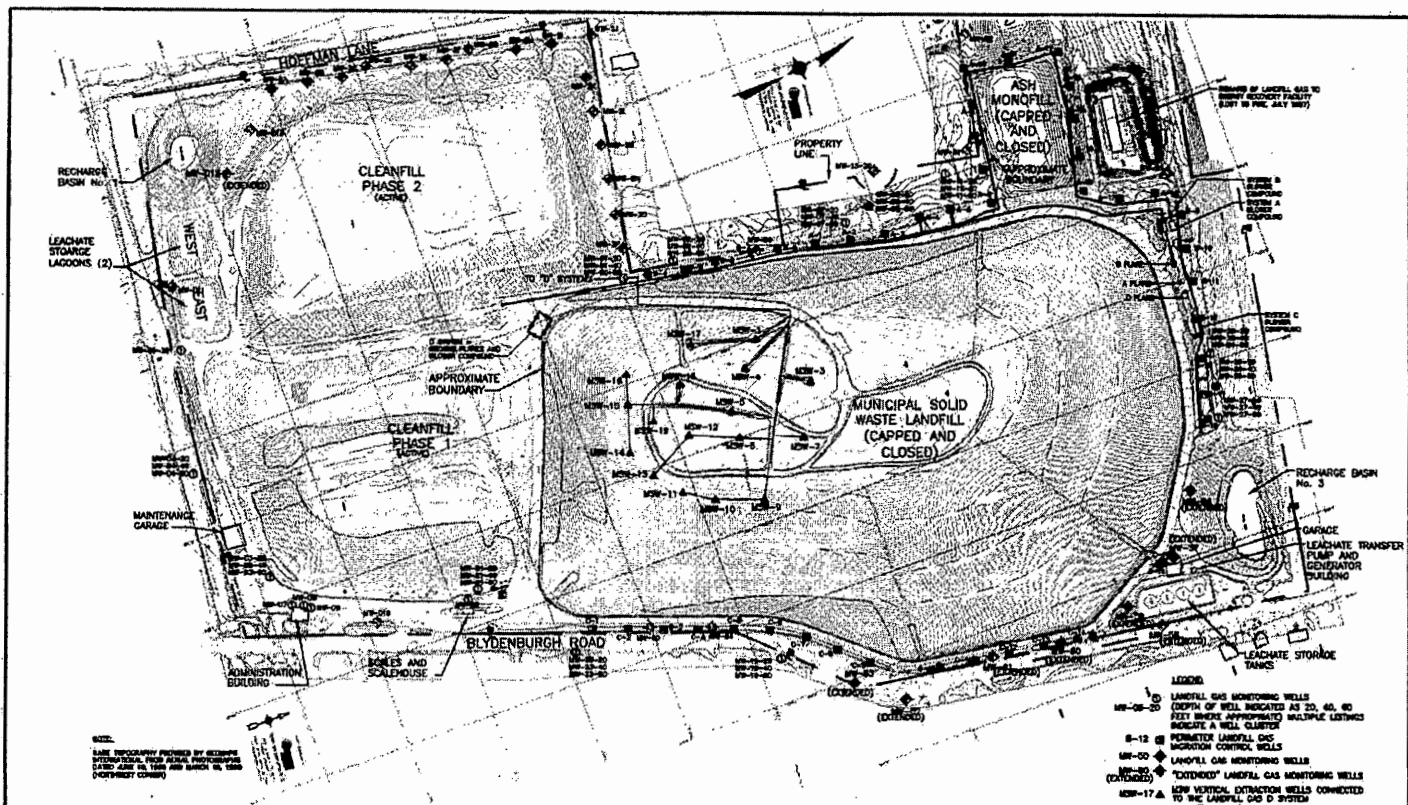
The landfill gas monitoring results are provided in Tables 1 through 11 and ambient air VOC monitoring results are provided in Table 12. Methane was not detected in any of the landfill monitoring wells this month and VOCs were not detected in the ambient air. A Site Plan depicting the locations of the landfill gas monitoring points is included in Figure 1.
