PROJECT:	Former Fulton MGP – Parcels III and IV (Site No.: 224051)
ADDRESS:	545 Sackett St., Brooklyn, NY
PREPARED BY:	Roux Environmental Engineering and Geology, D.P.C.
DATE:	February 14, 2024
WEATHER:	Temp: 31-39°F, Sunny, RH: 53% Pressure: 30.19" in Hg Wind: NW @ 9 mph
TIME:	07:00 – 15:30

DAILY STATUS REPORT

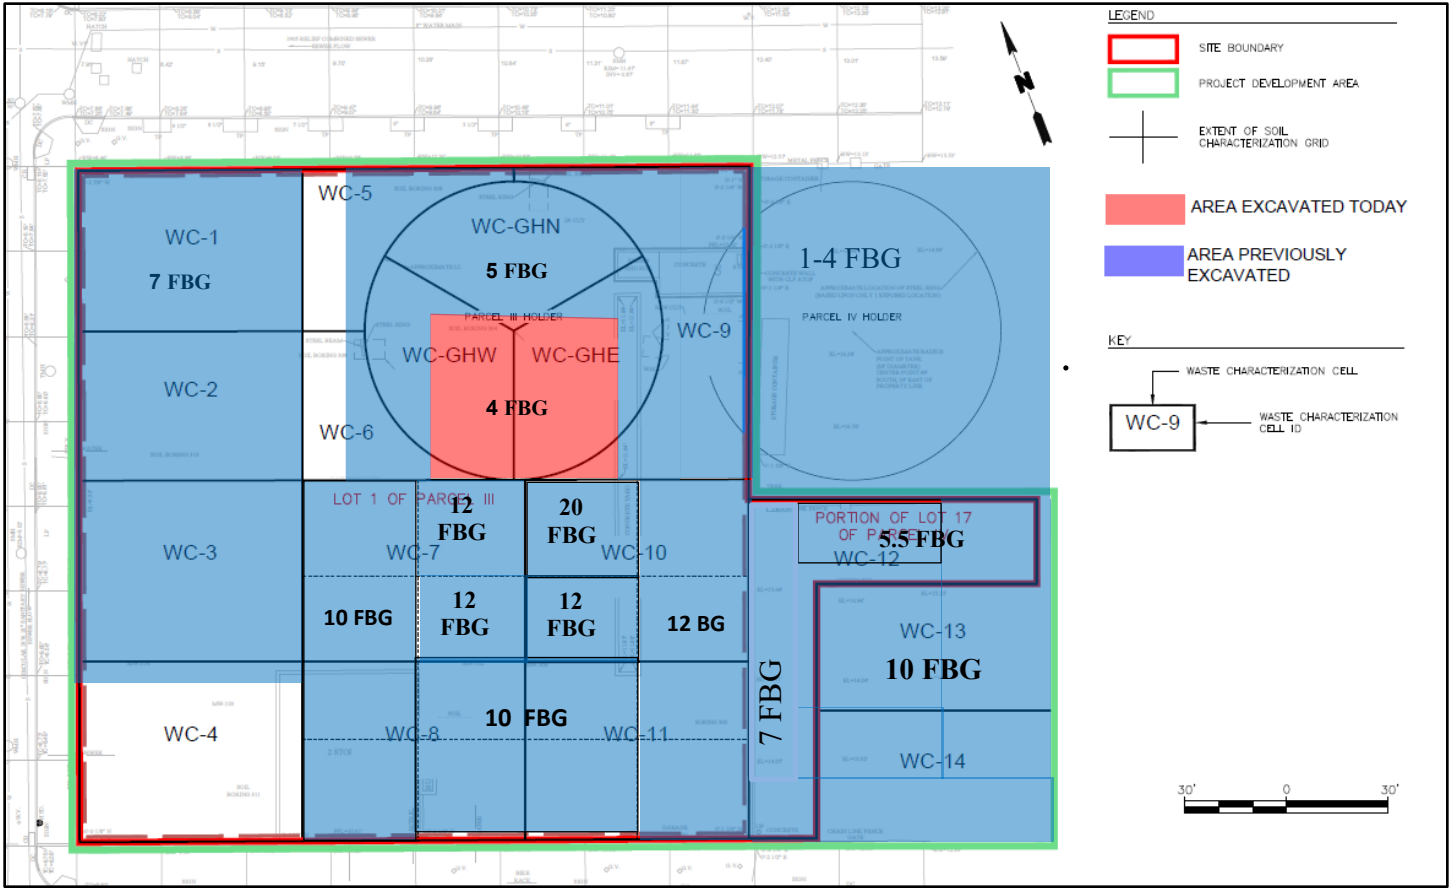
Excavation Diagram

- Excavated and exported material from waste characterization grids WC-GHW(0-5) and WC-GHE(0-5).
- Continued set up and installation of the dewatering system in Gas Holder 3 excavation area.
- Groundwater samples were collected from sentinel monitoring wells.
