18 June 2024

**Re: Annual Maintenance and Monitoring Report – 2022 and 2023
Former Acme Steel/Metal Works
95 Lombardy Street/46 Anthony Street
Brooklyn, New York
NYSDEC Site No. 224131
Langan Project No.: 170157201**

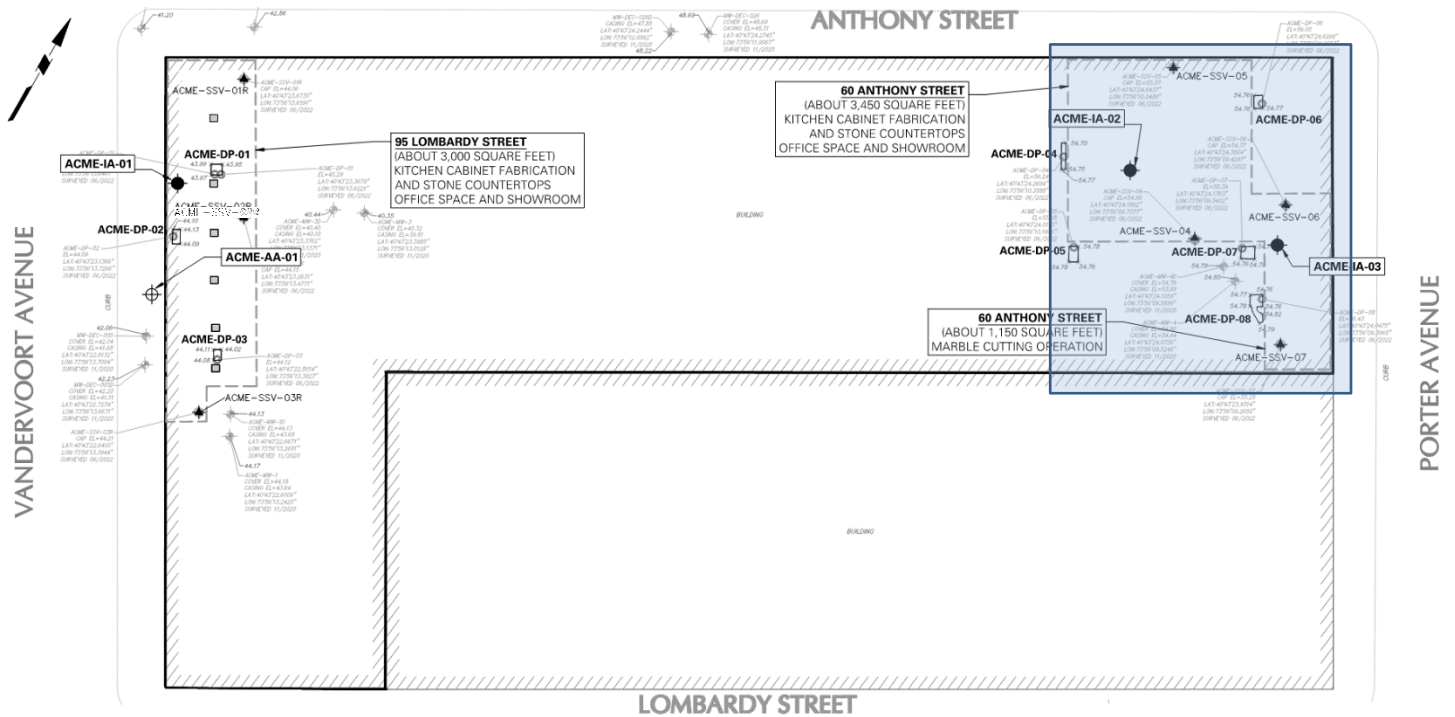
Photo 3:

- inspected the SSD system blower and the roof-mounted SSD system piping, and increased the speed of the blower
 - used concrete patch to patch surficial cracks in the slab surrounding vapor monitoring point ACME-SSV-05

View of the final condition of the slab surrounding vapor monitoring point ACME-SSV-05 at 60 Anthony Street (facing northwest).
