**FINAL
SUMMARY REPORT**

**ROCKAWAY PARK FORMER MANUFACTURED GAS PLANT SITE
BULKHEAD AREA
INTERIM REMEDIAL MEASURE (IRM)**

**KEYSPAN CORPORATION
1 METROTECH CENTER
BROOKLYN, NEW YORK**

**TETRA TECH FW, INC.
1000 THE AMERICAN ROAD
MORRIS PLAINS, NEW JERSEY**

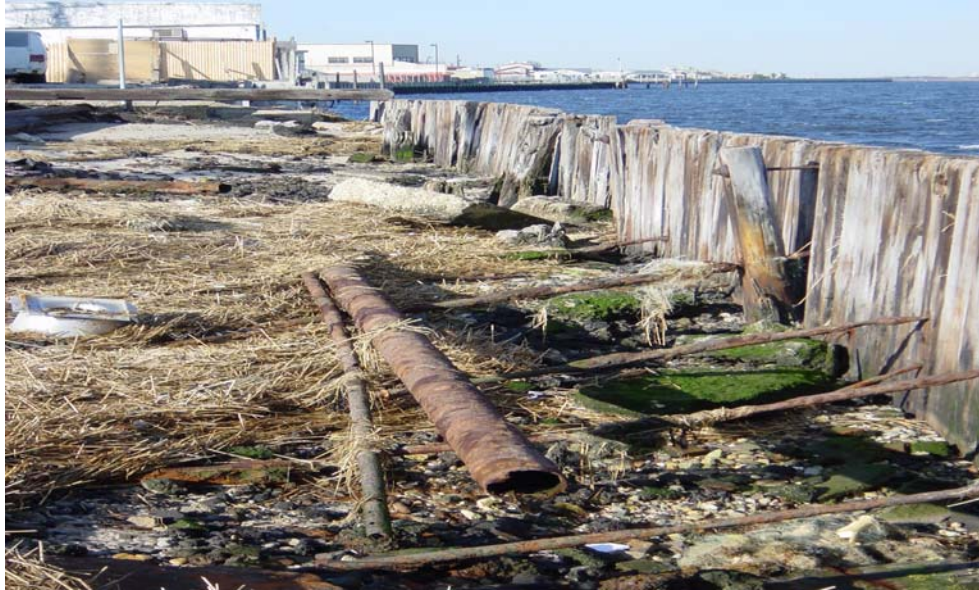
The Bulkhead IRM Area is located just behind the Bulkhead along Jamaica Bay. Beach Channel Drive (out of the picture to the left) forms the southern boundary of the area.
