TYLL ENGINEERING & CONSULTING PC

Re: Annual Certification and Corrective Actions Plan  
NYSDEC Site Number: 241128  
127-13 Merrick Blvd., Jamaica, NY

## Annual Site-wide Inspection Form

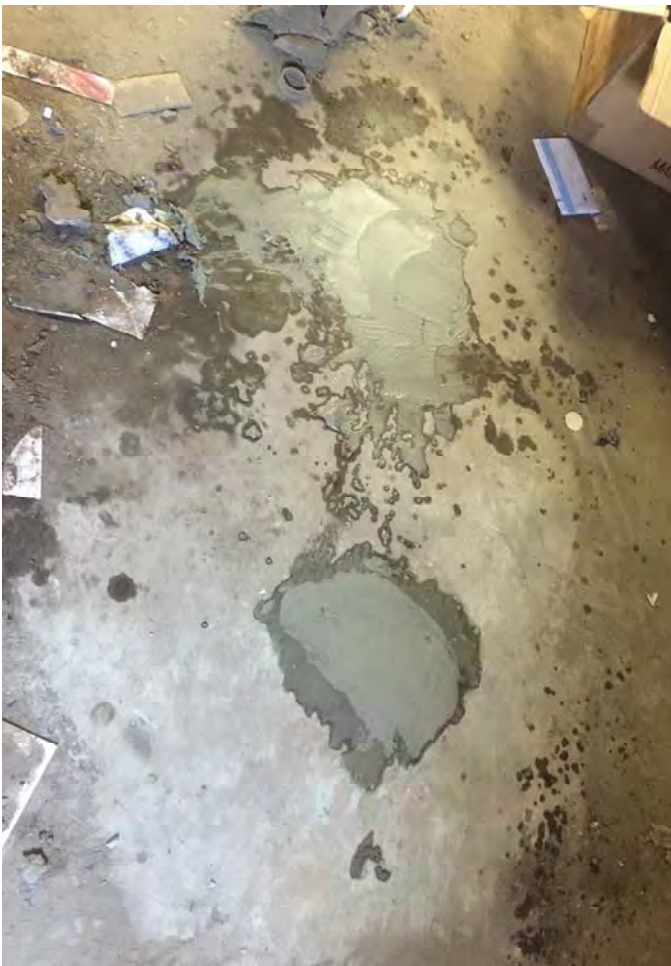
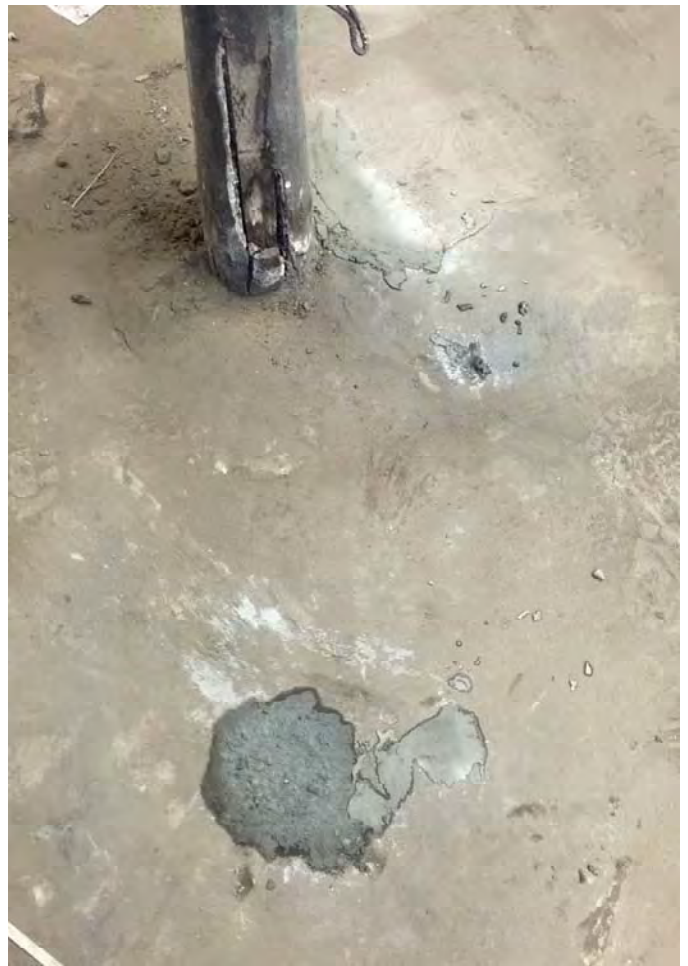
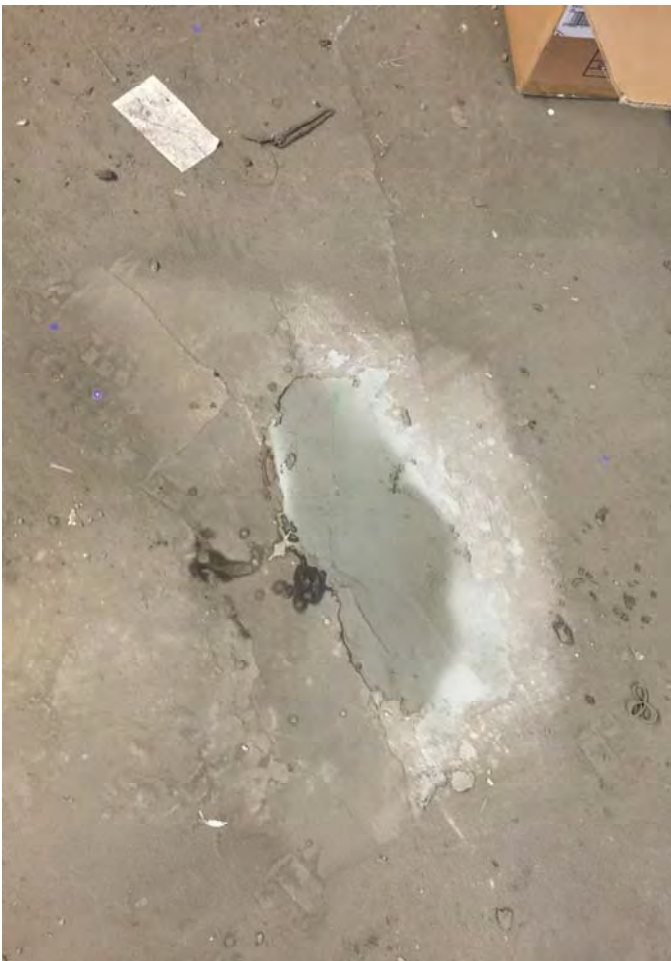
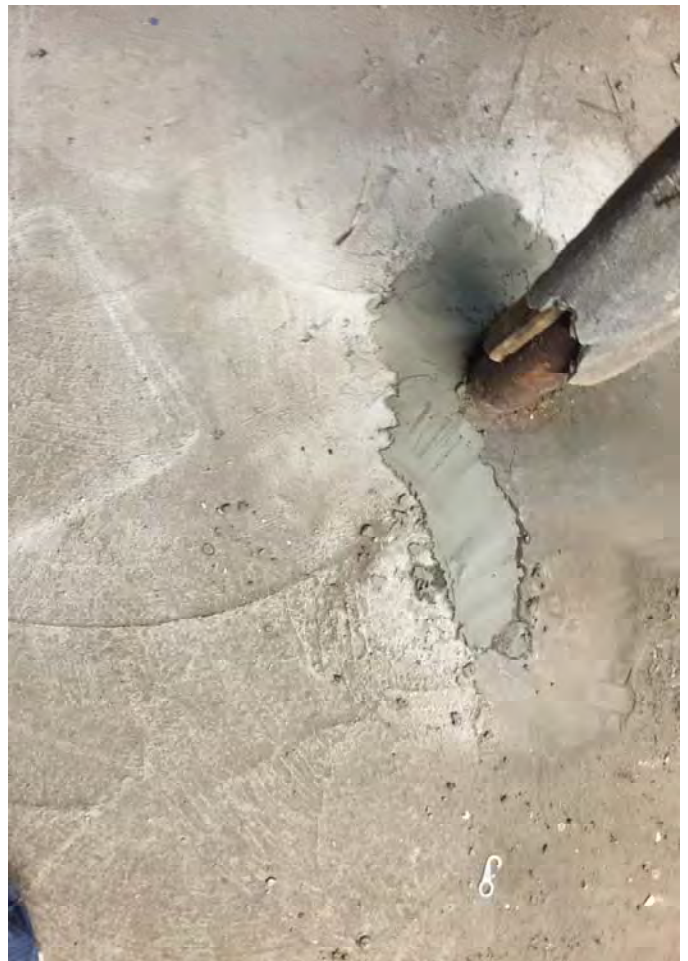
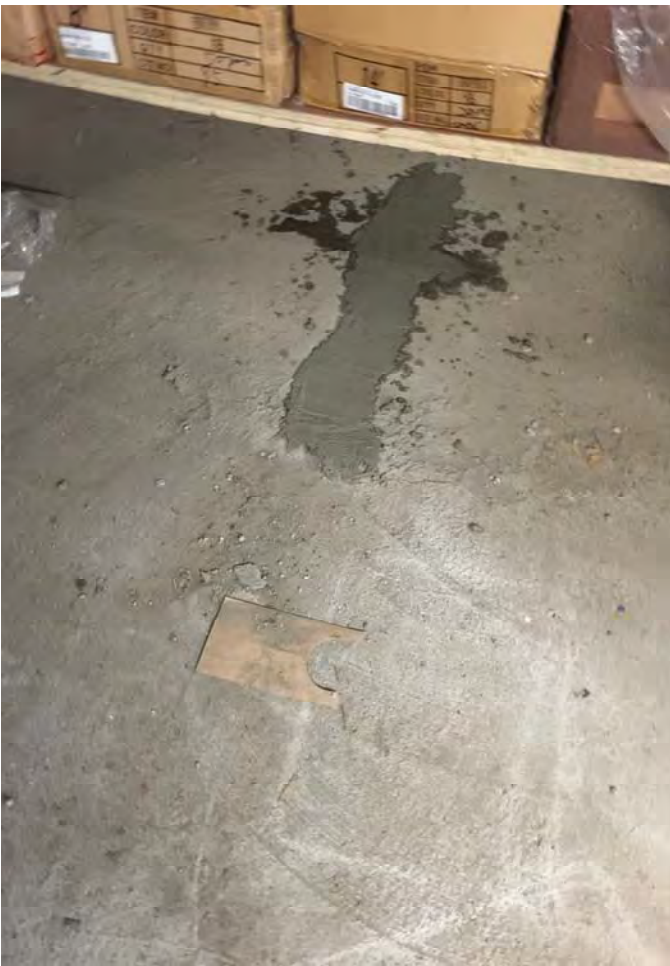
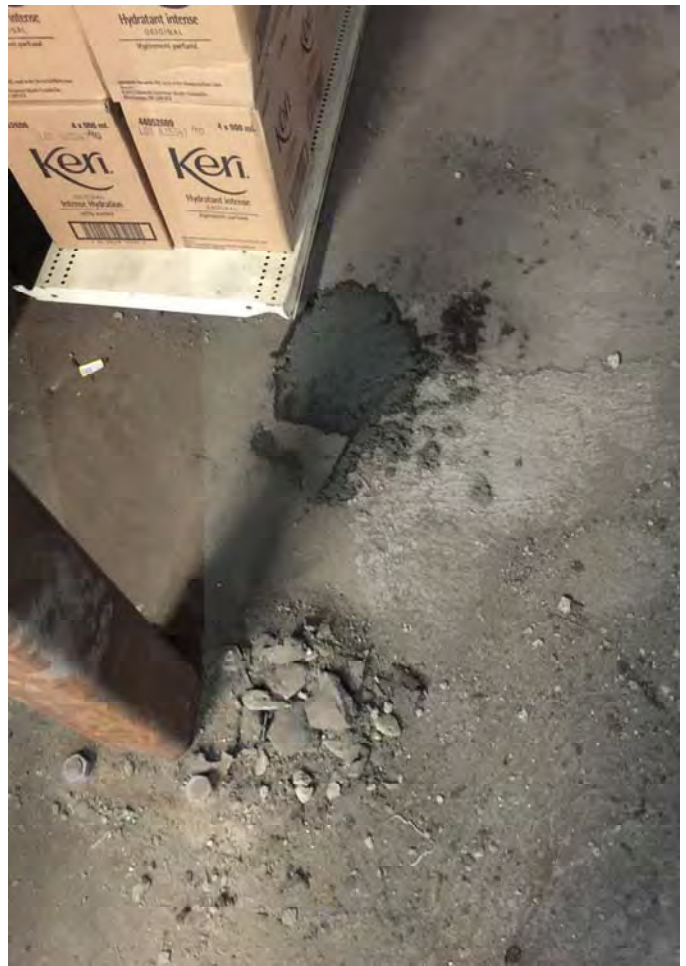
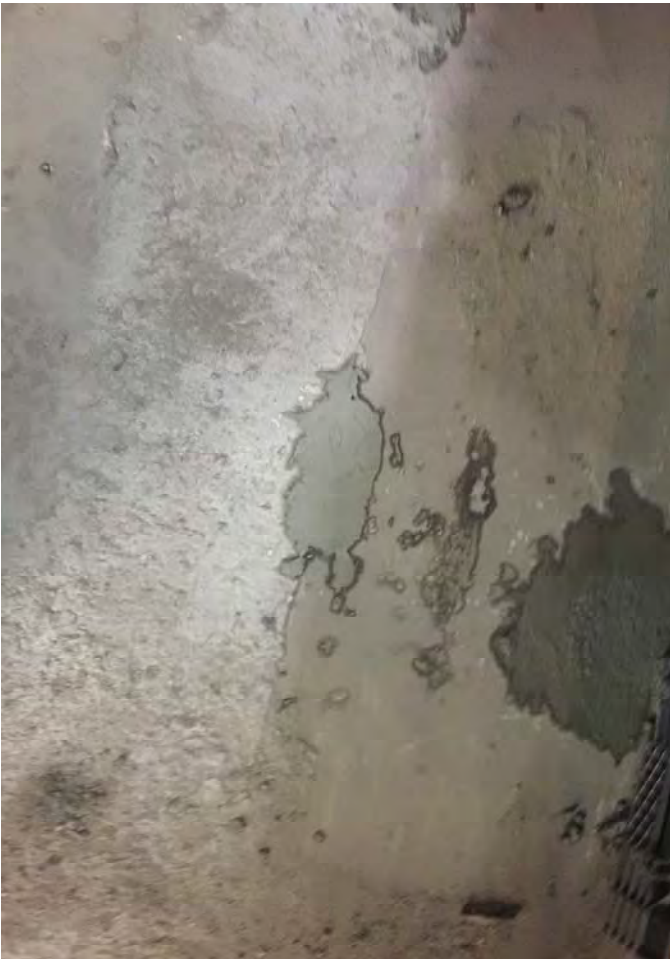
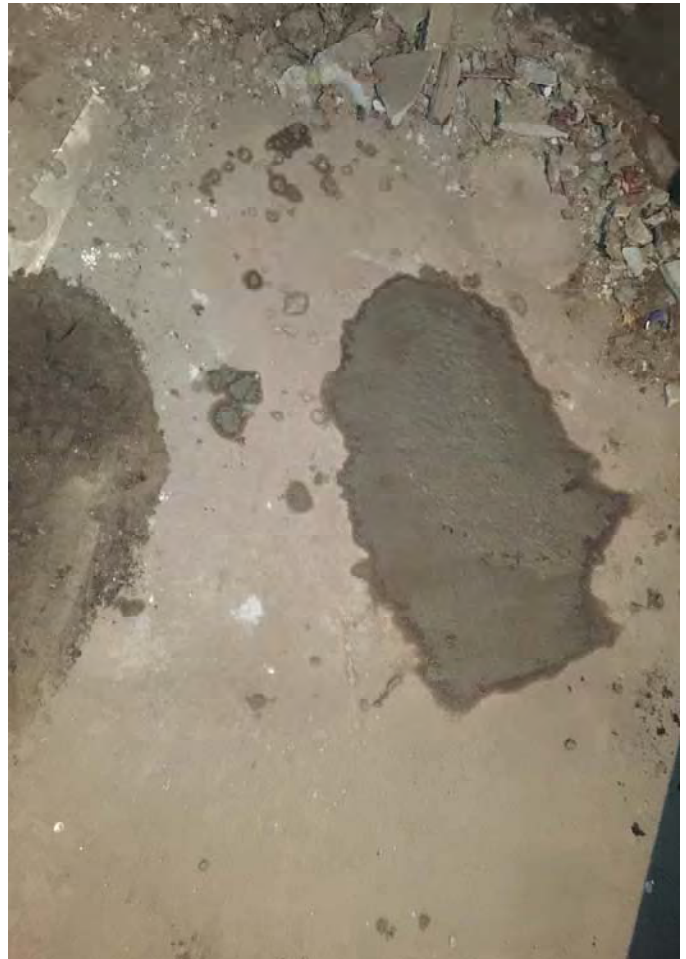
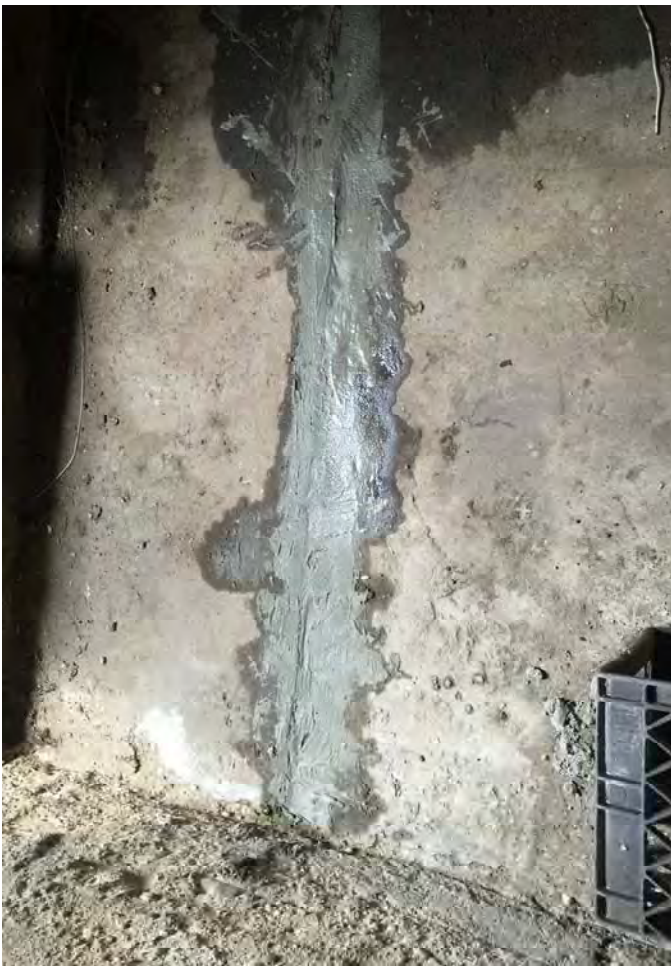
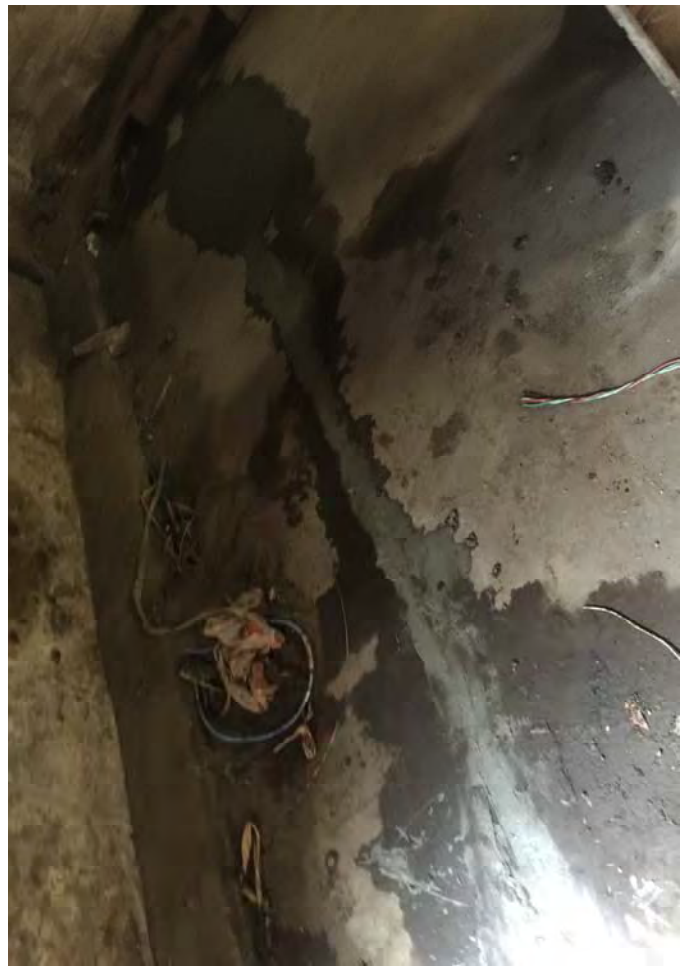
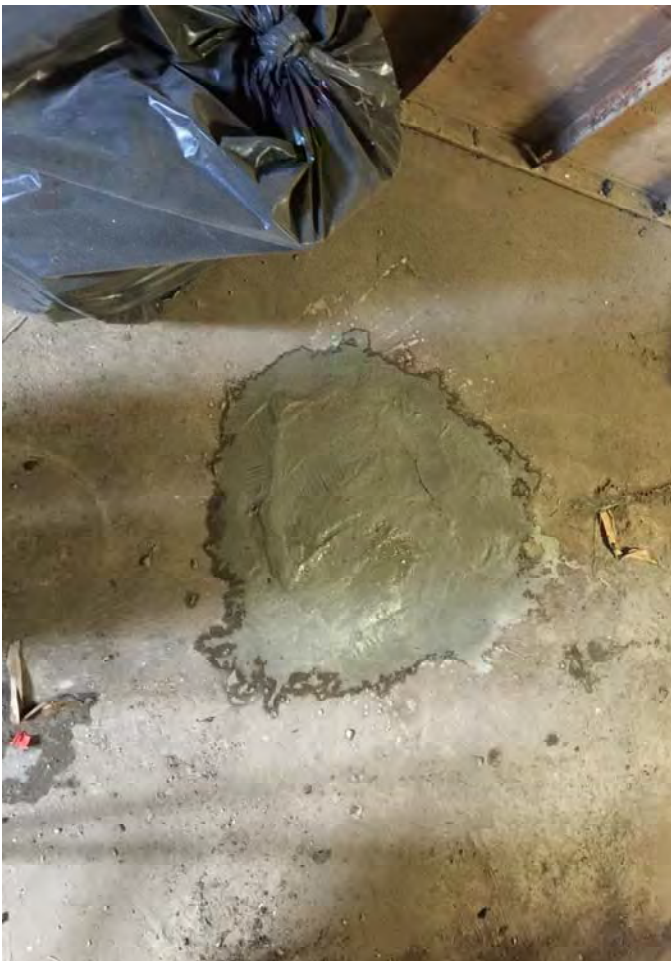
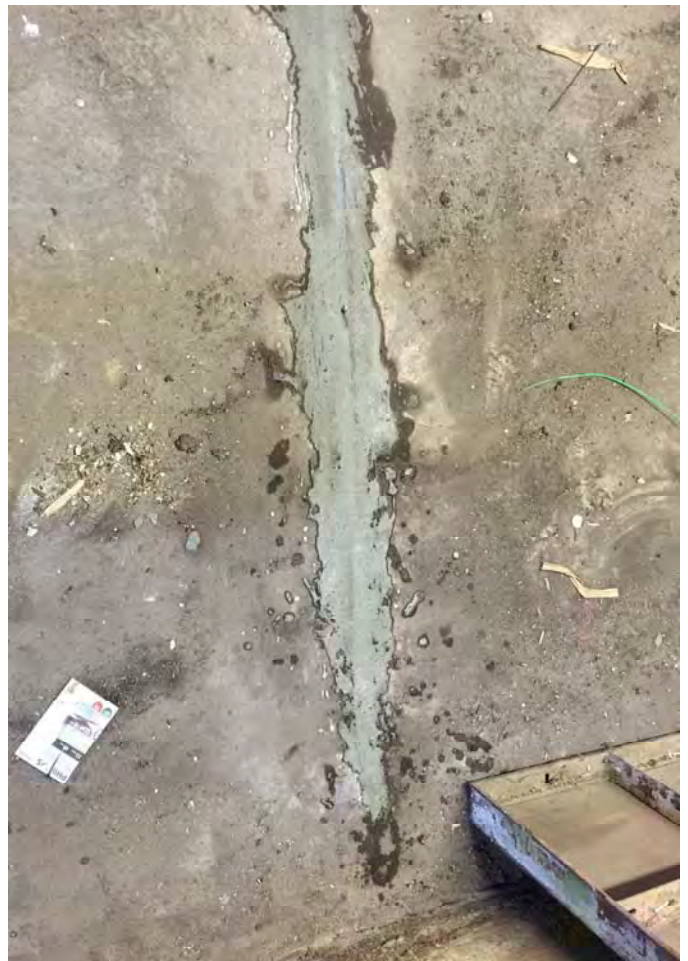
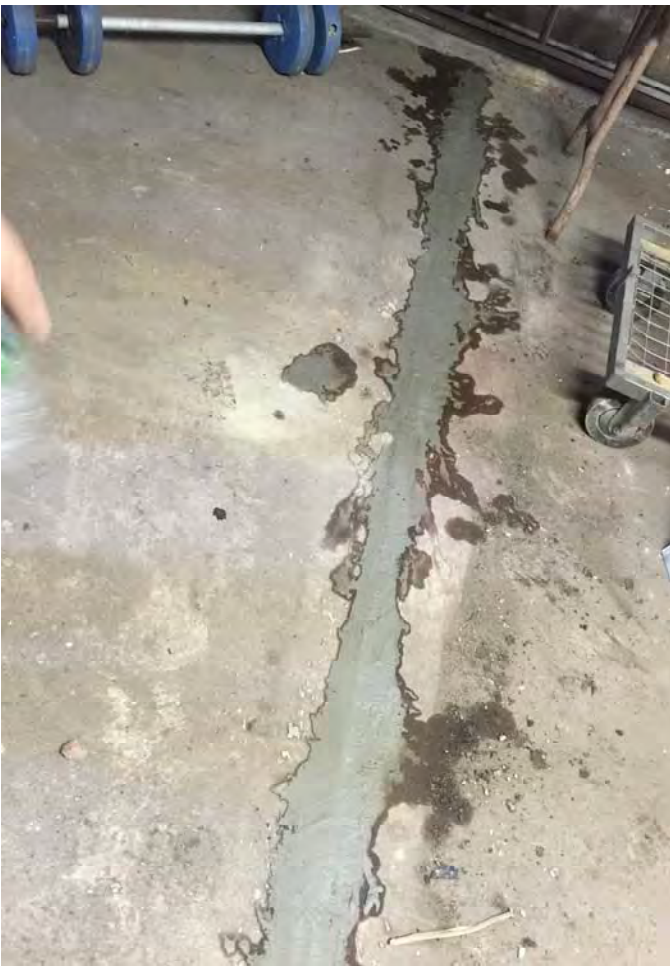
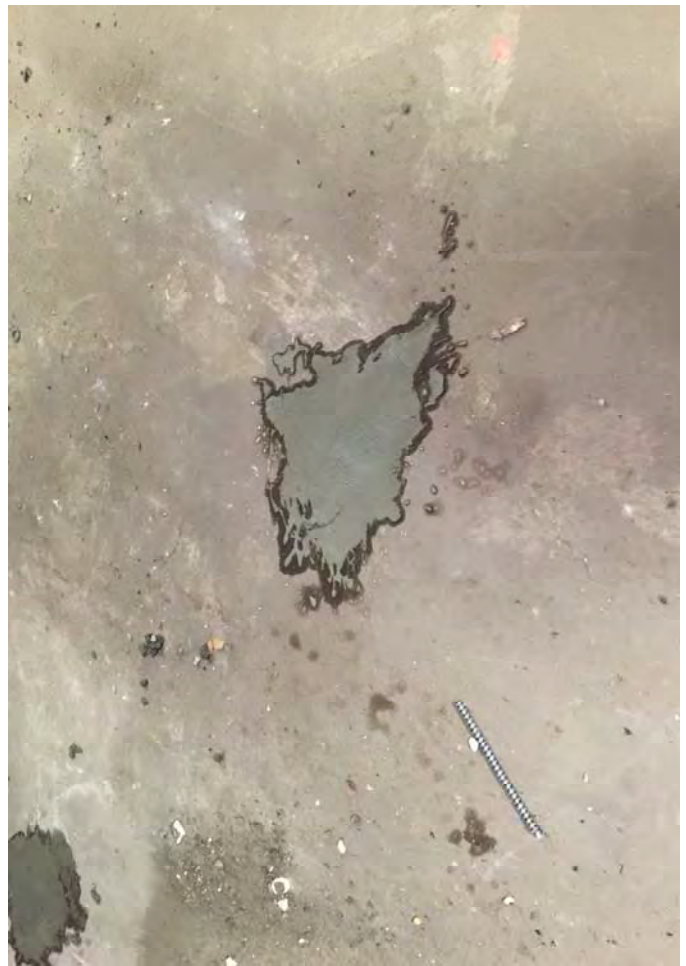
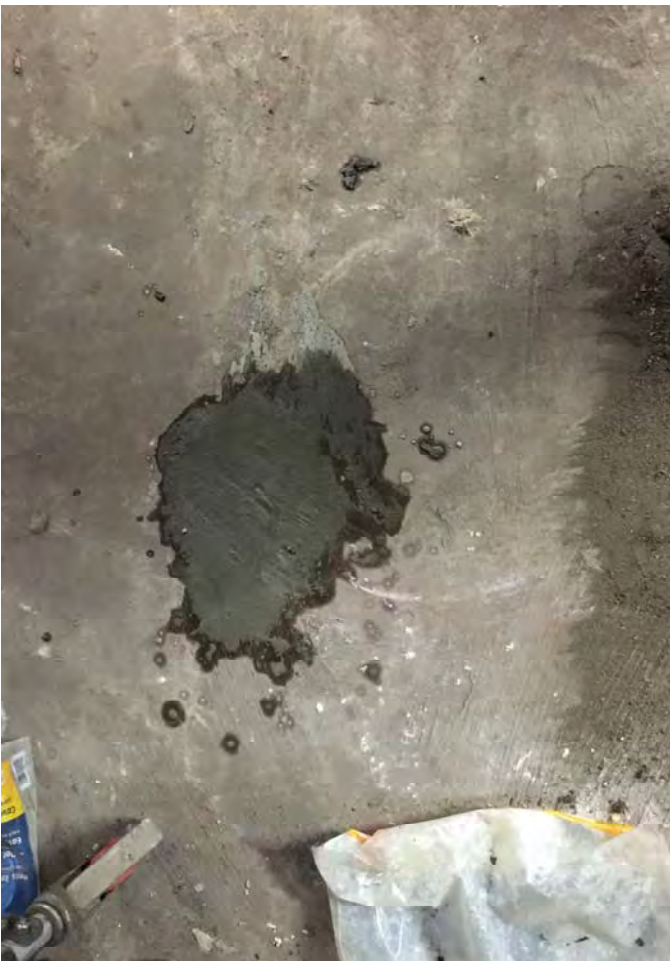
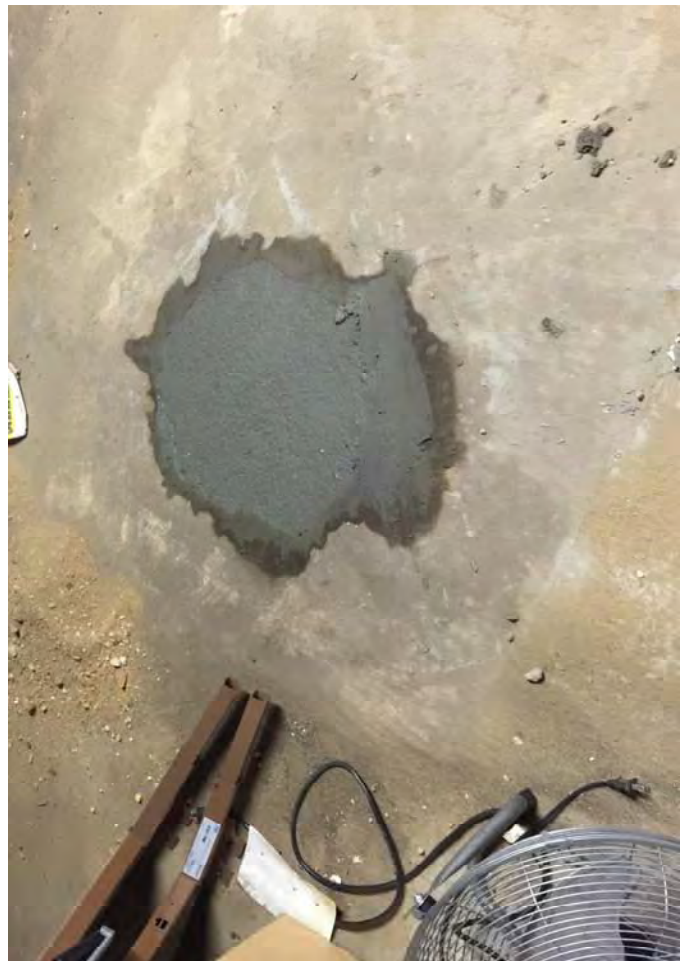
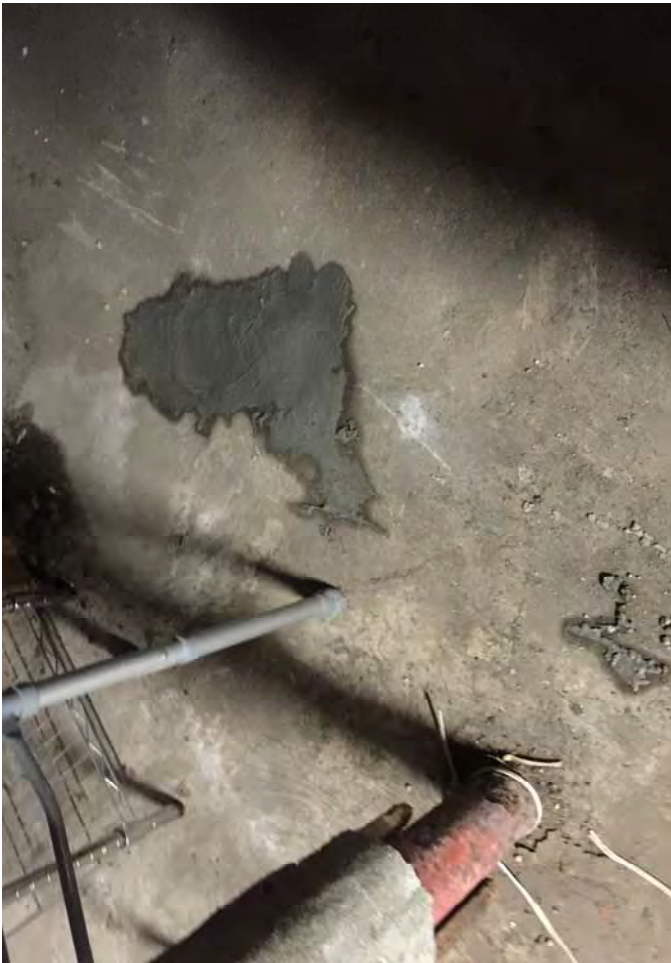
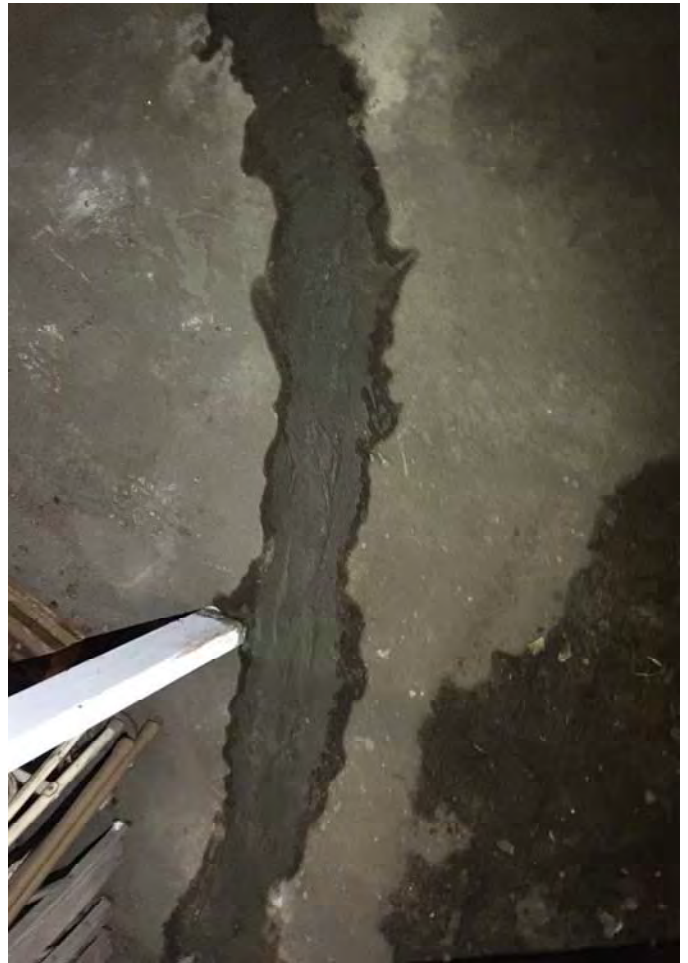
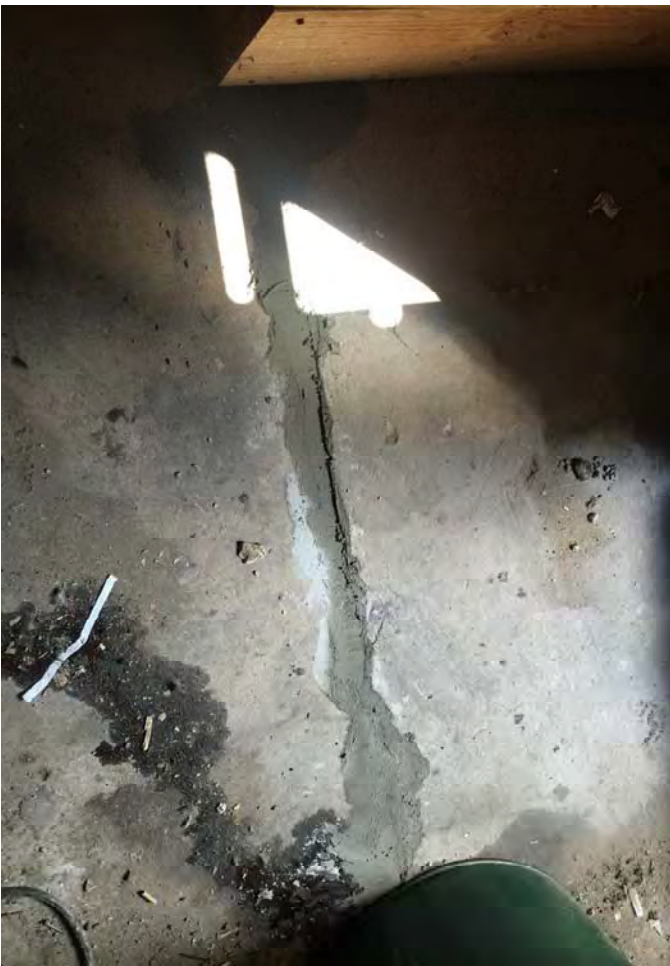
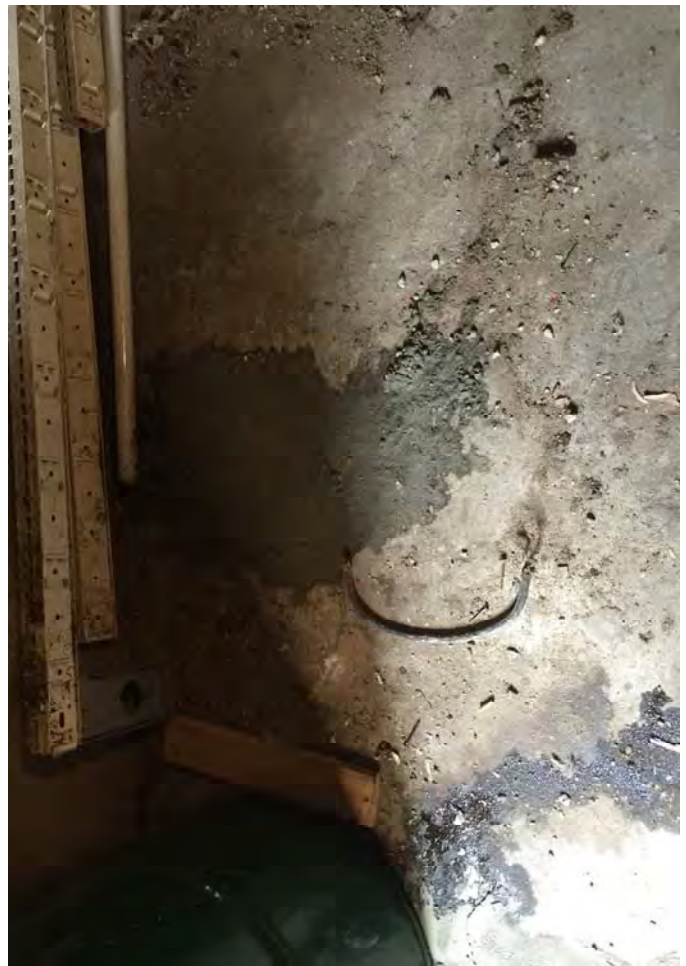
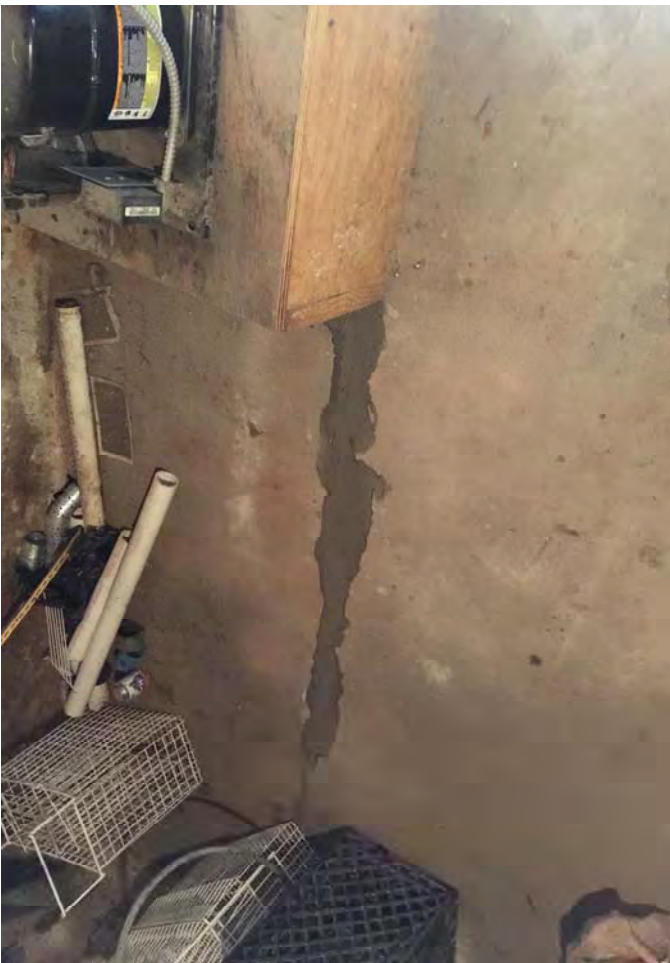
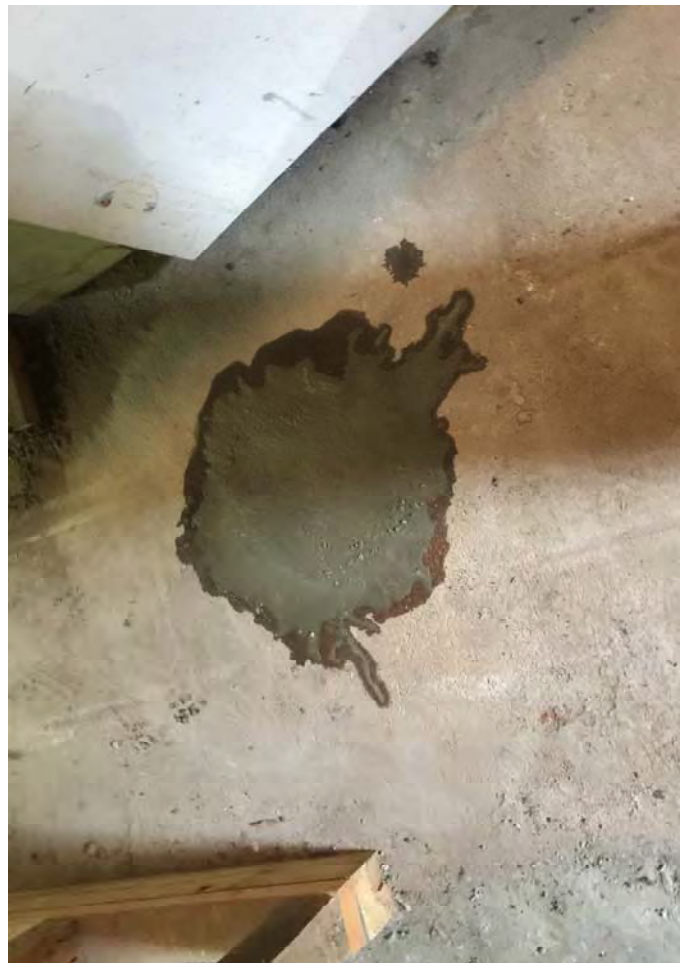
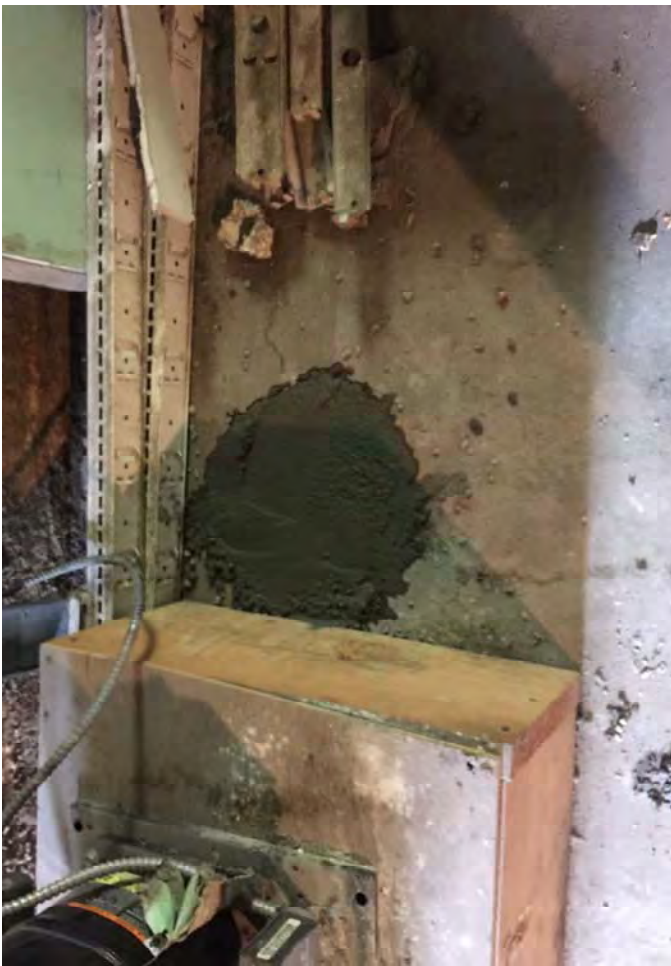
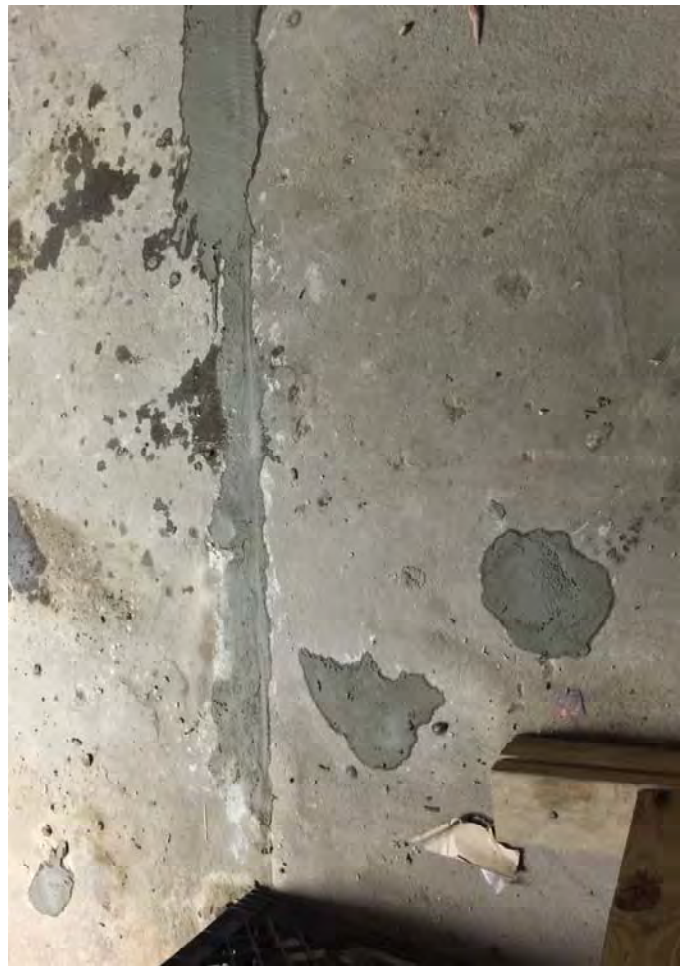
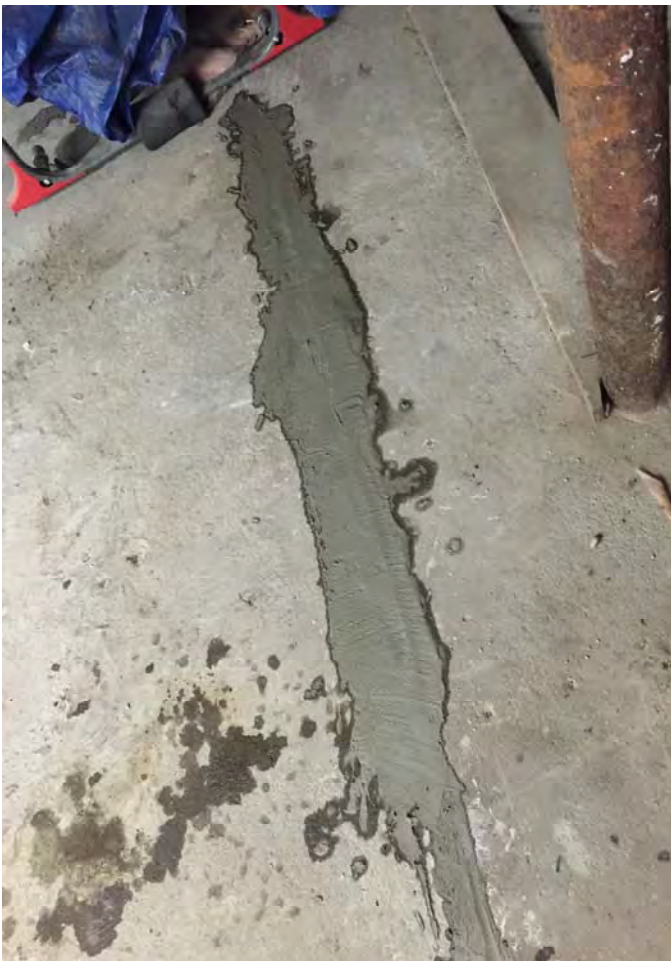
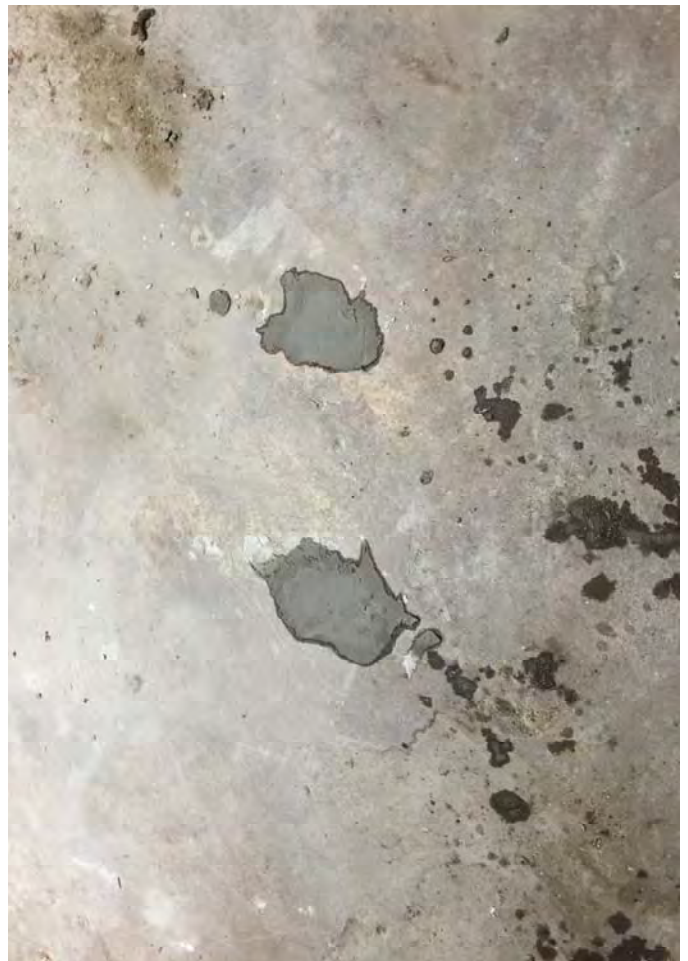
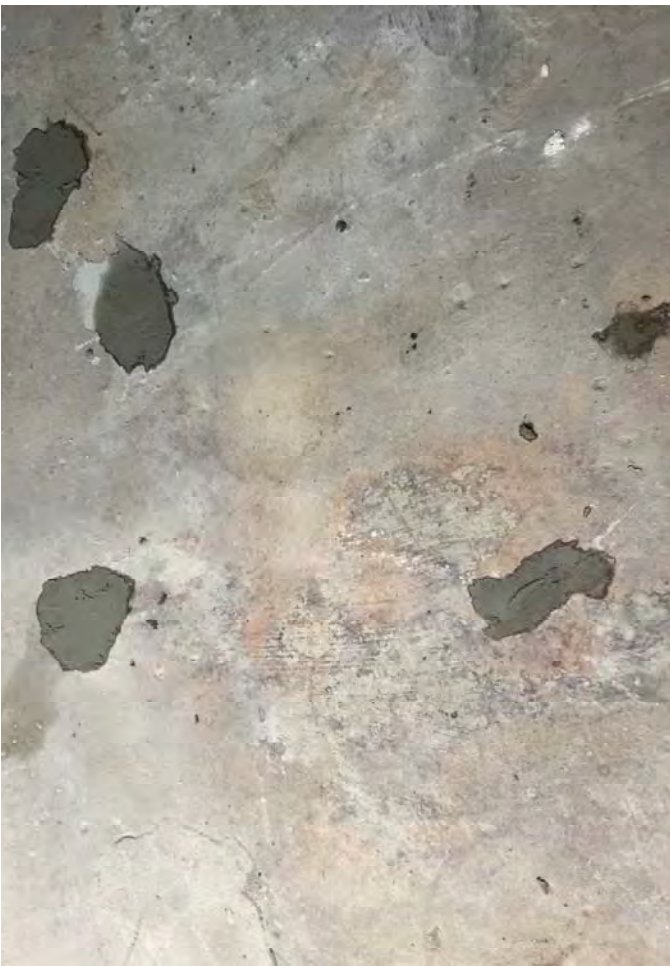
Many deficiencies (cracks, gaps, and holes) were found in the concrete slab within the basements of many units. Two monitoring points (one vapor and one groundwater) were also found in the basement of Unit 127-13. A plan to repair the deficiencies was developed.

On July 18 & 19, 2016, the Owners contracted with Jose K. Rogel Padilla Construction to repair the holes discovered in the eight (8) basement units for 127-1, 3, 5, 7, 9, 13, 15 and 17. Photographs of these concrete repairs can be found in Attachment 1. The remaining 3 units (127-19, 21, and 23) have finished basement and no deficiencies were observed at the time of the inspection.
