TYLL ENGINEERING & CONSULTING PC

Re: Annual Certification and Corrective Actions Report
Certification Period: 5/19/16 to 9/29/16
NYSDEC Site Number: 241128
127-13 Merrick Blvd., Jamaica, NY

Repair of Deficiencies of the Concrete Slab

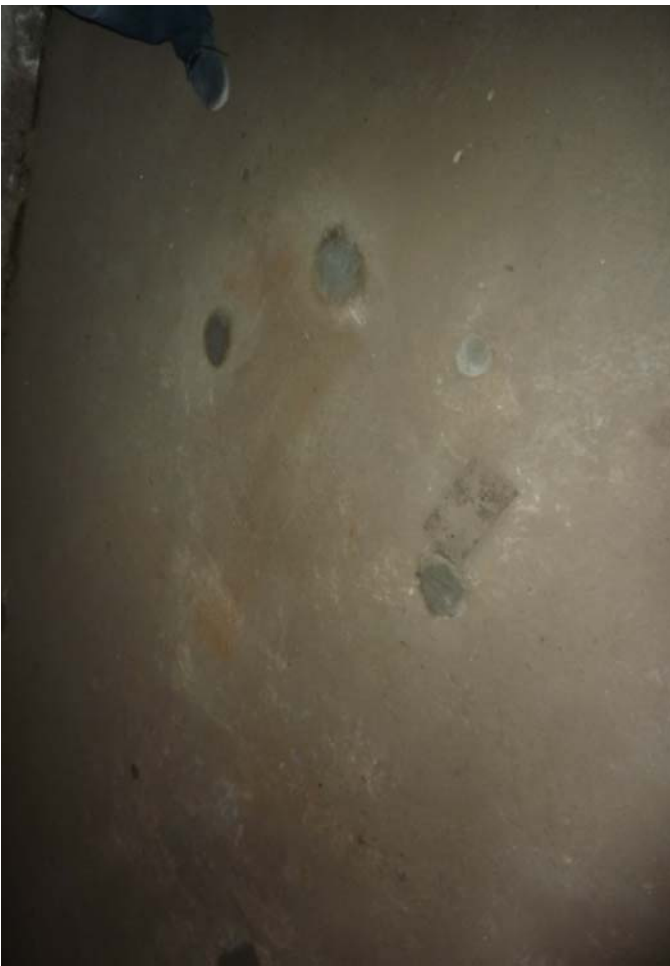
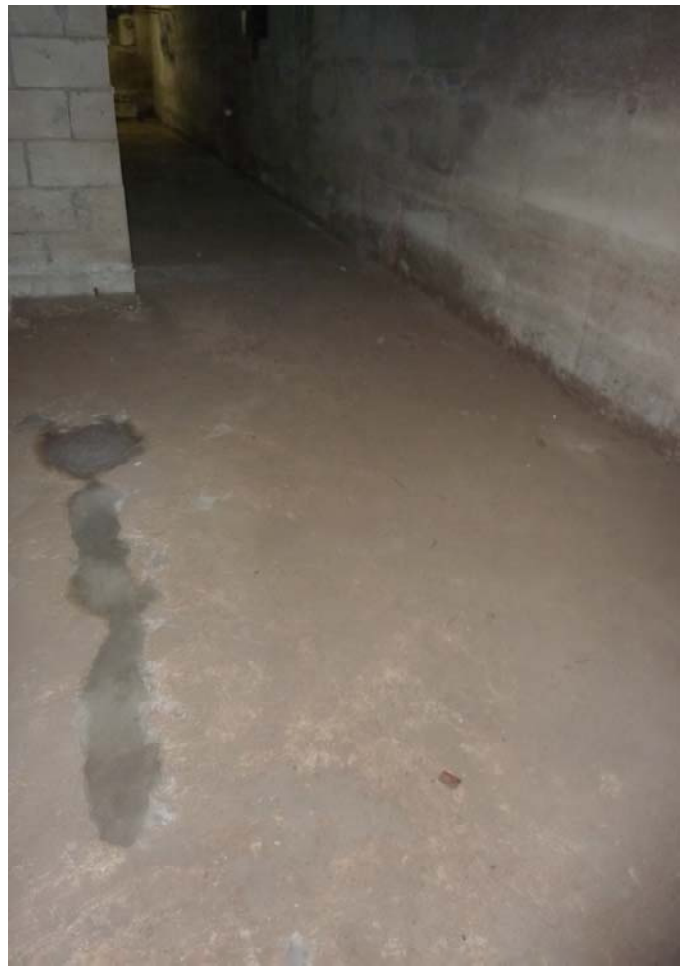
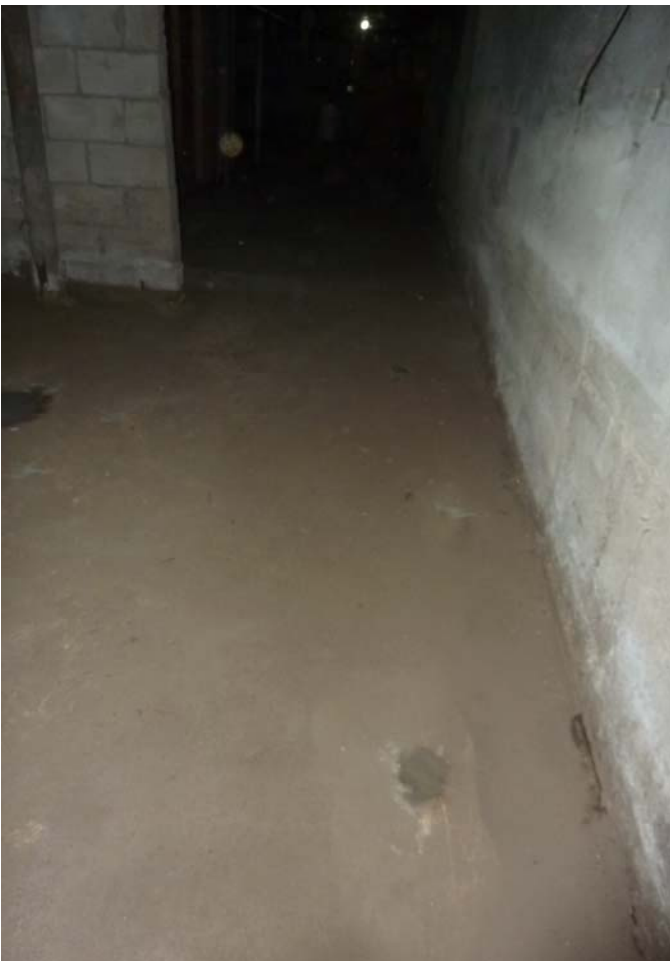
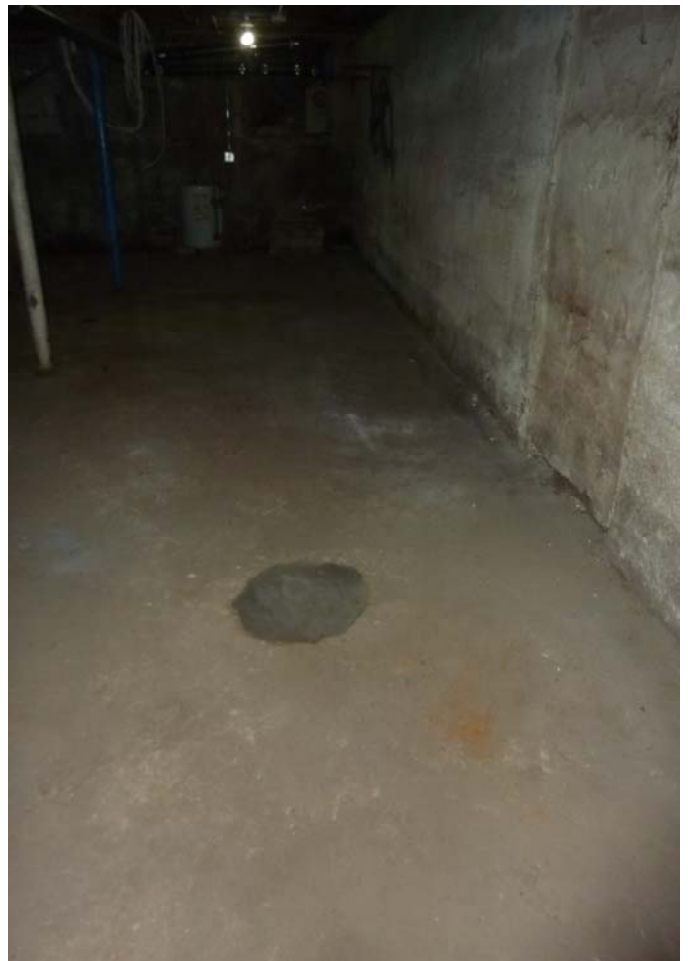
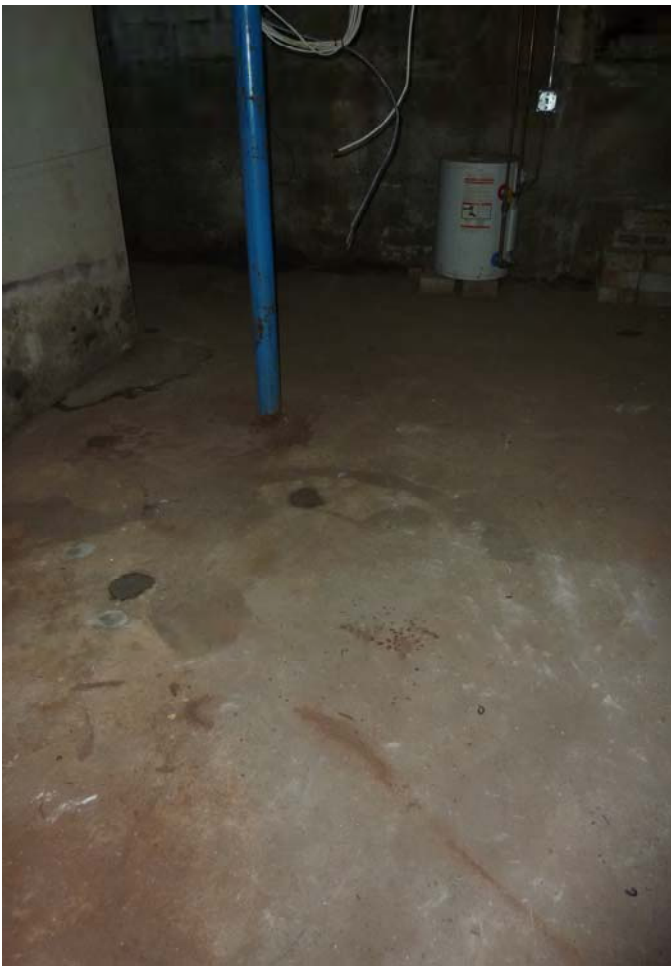
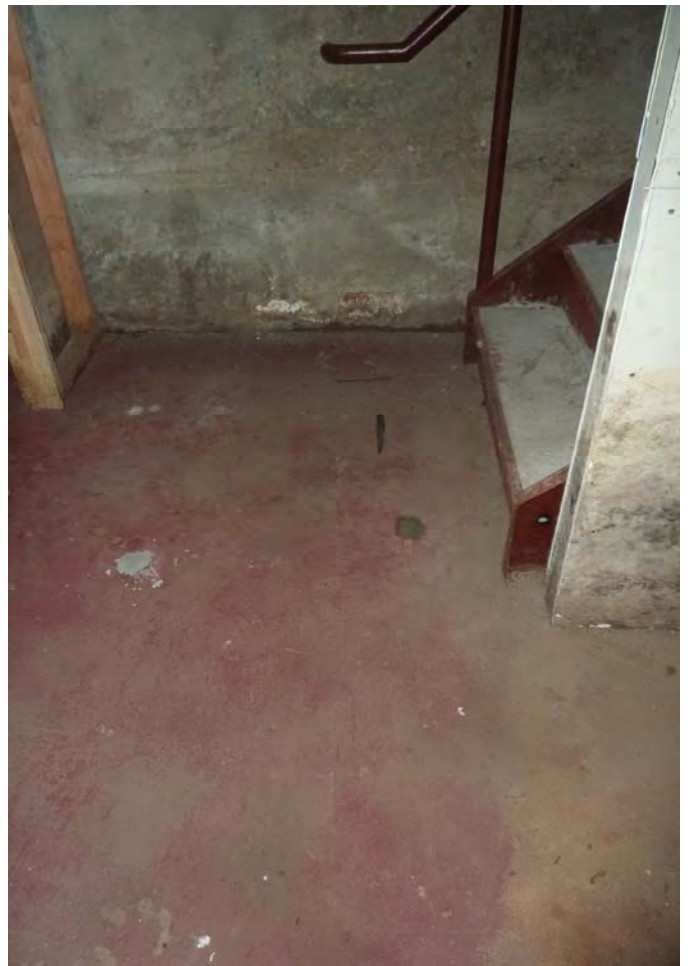
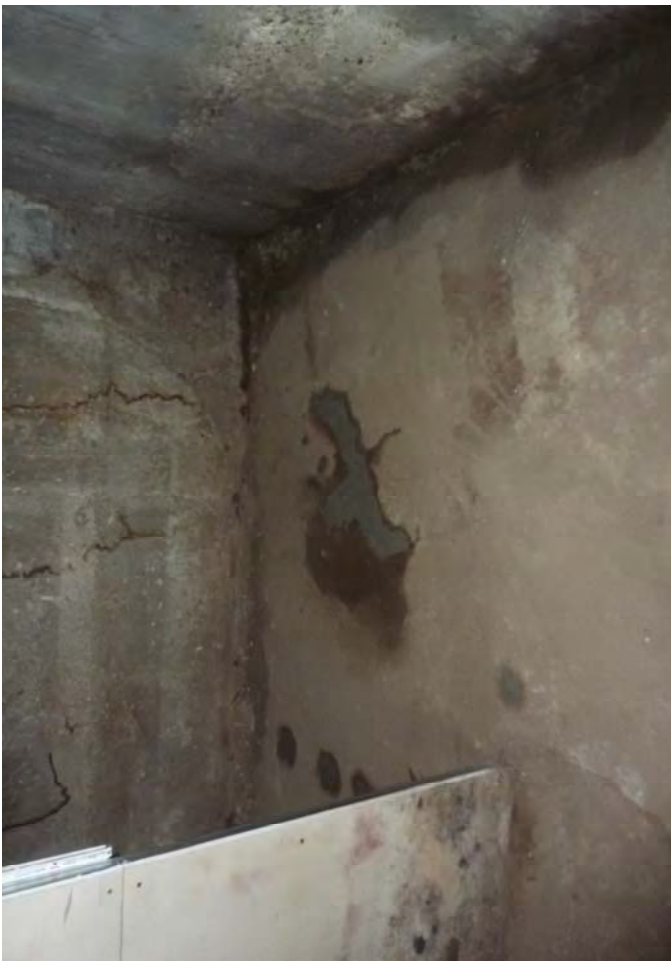
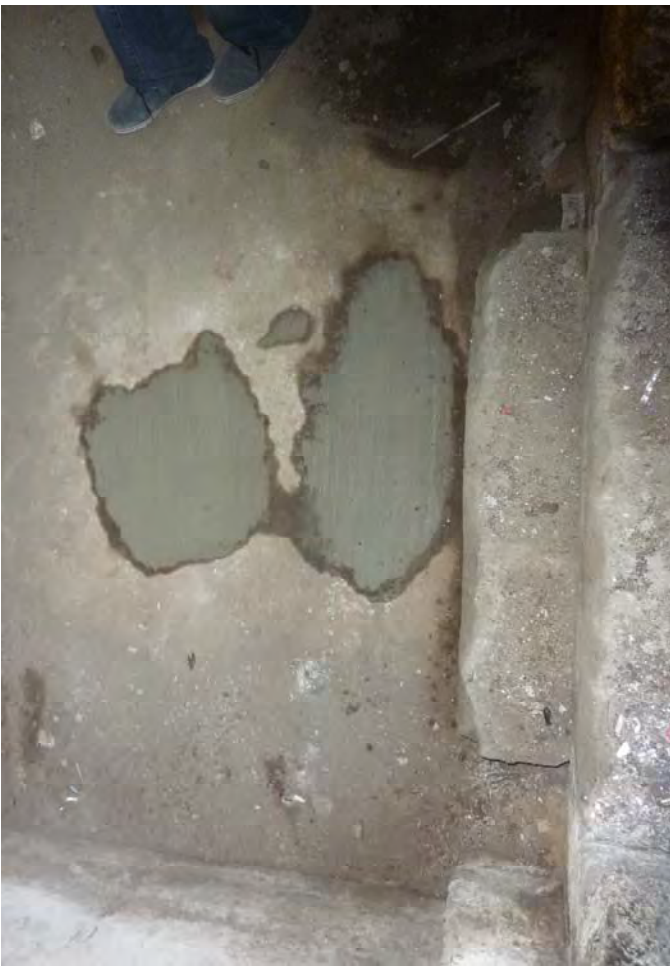
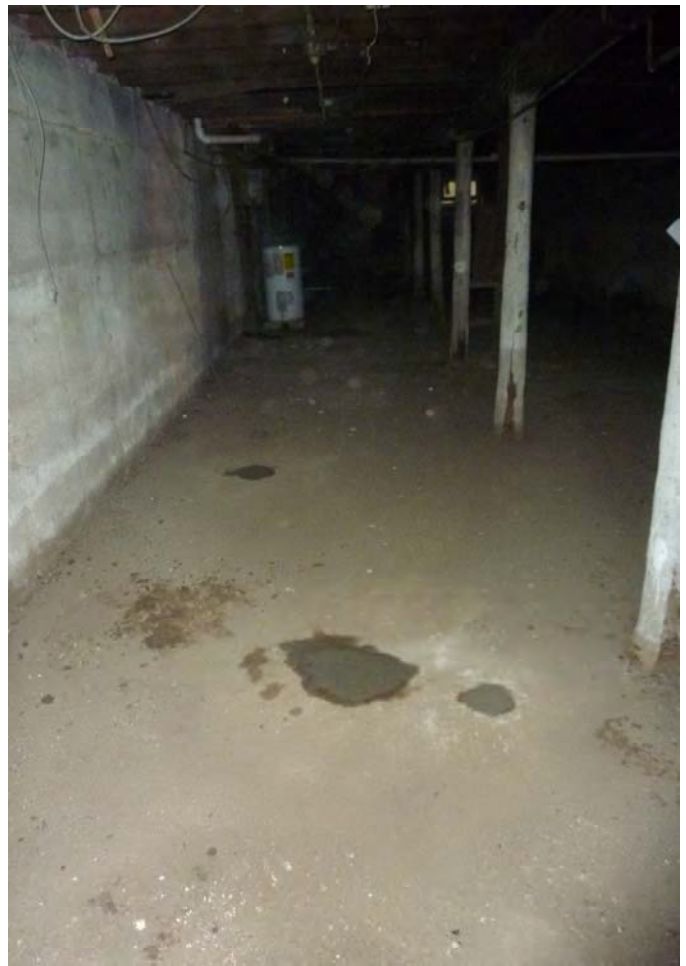
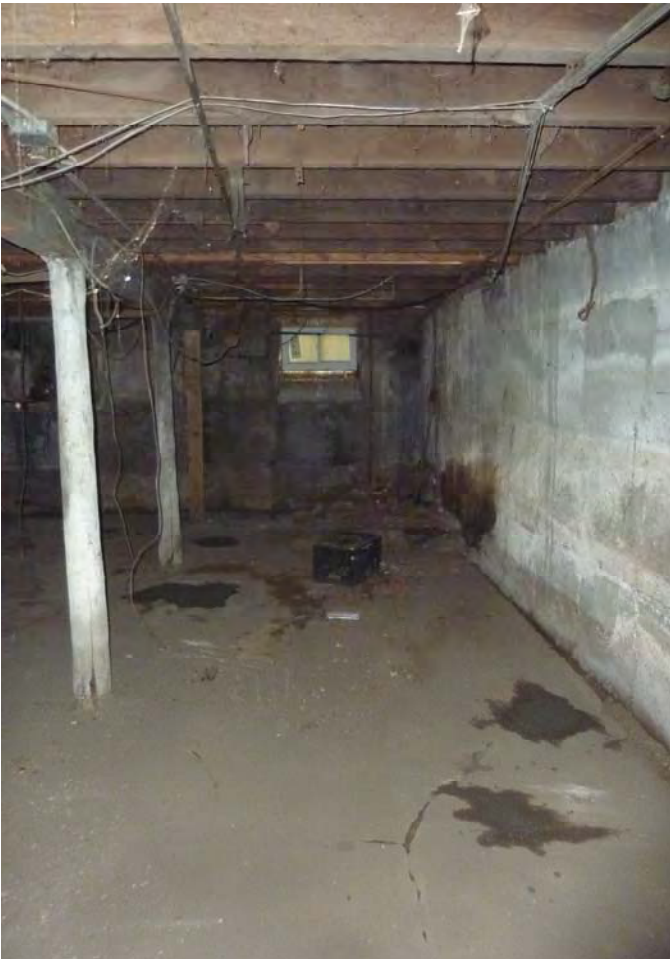
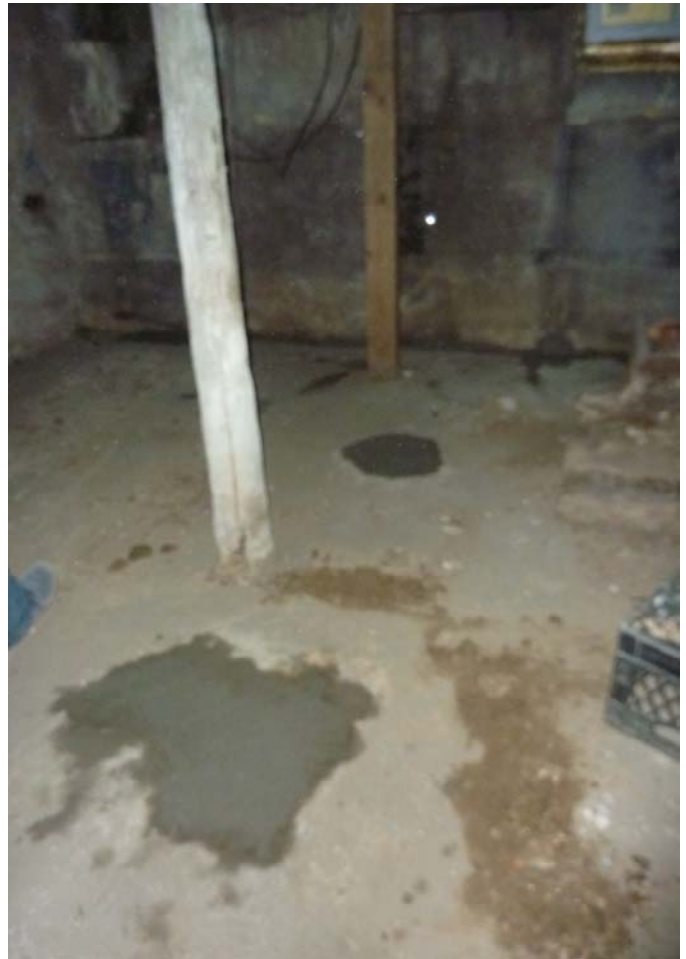
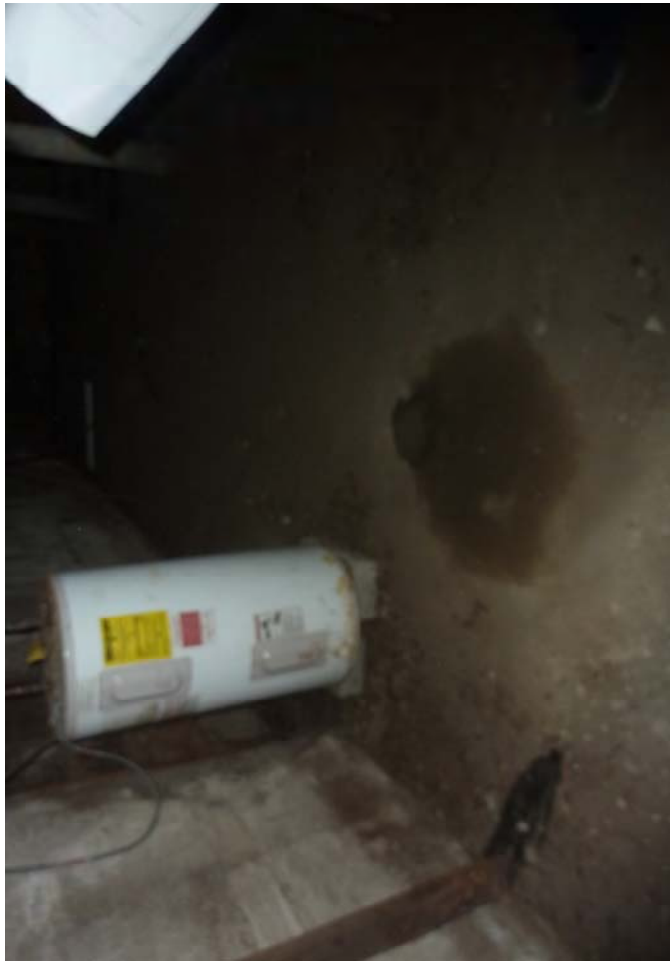
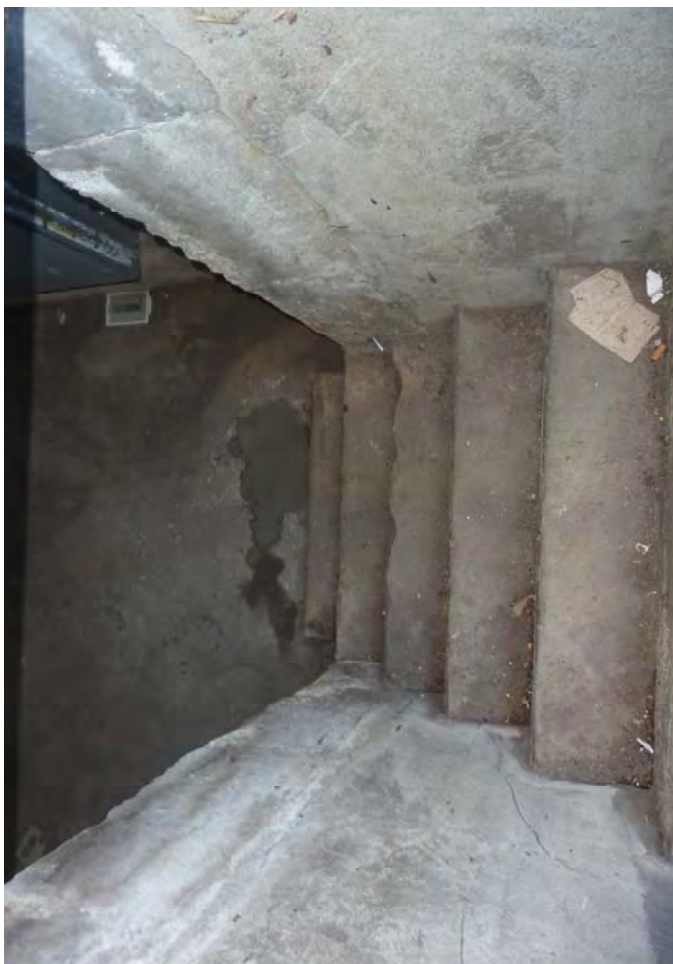
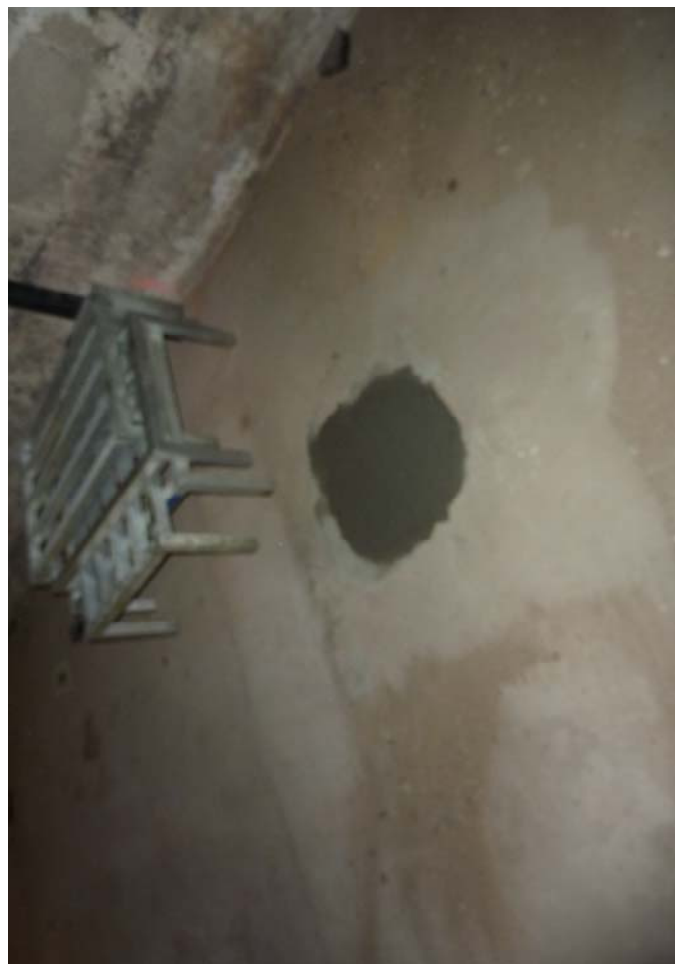
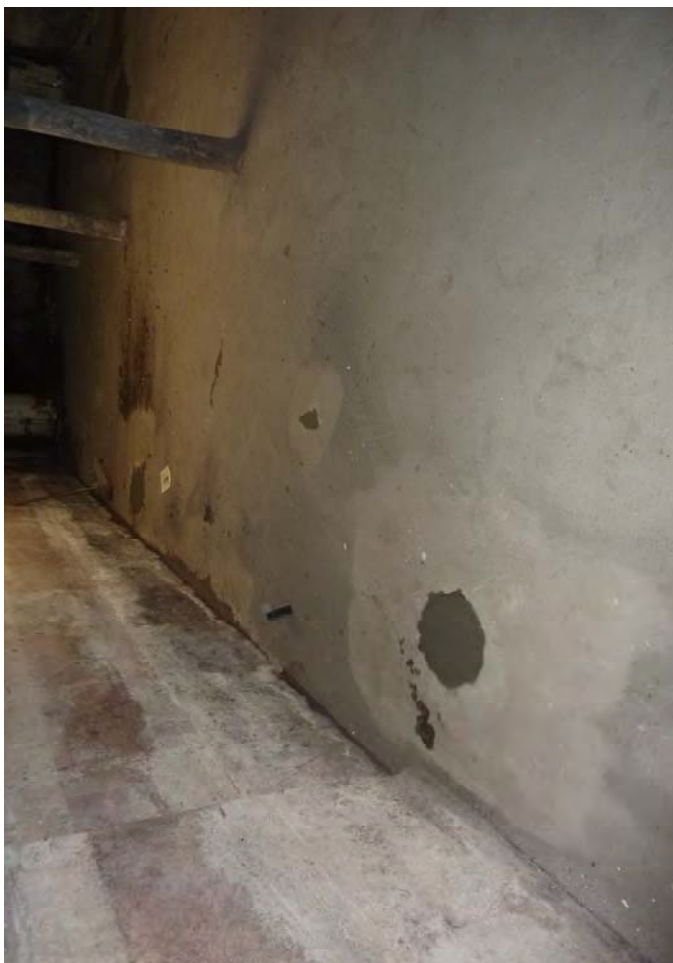
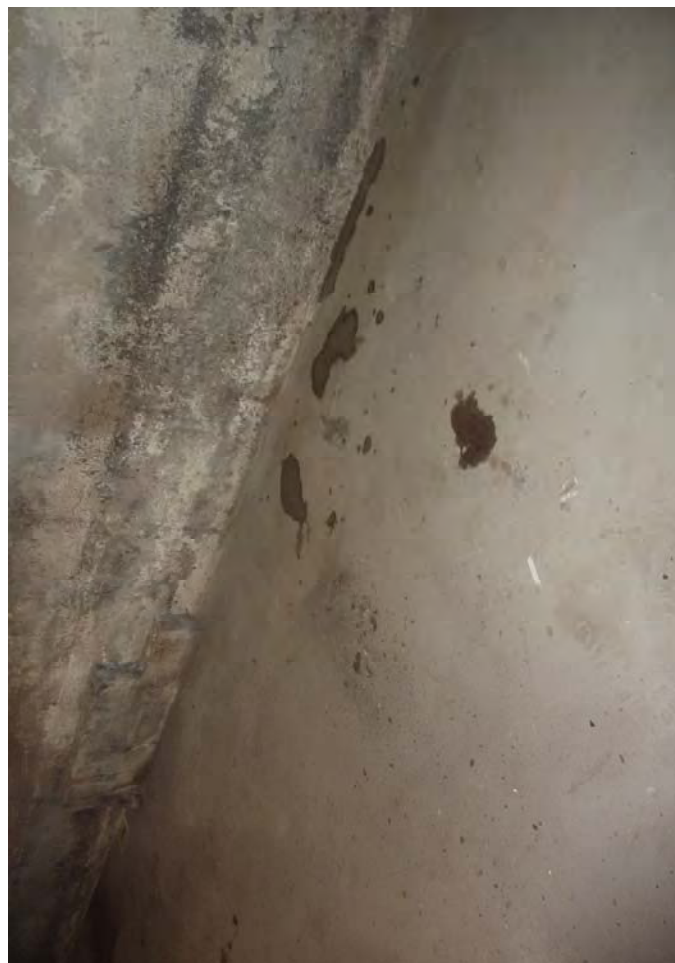
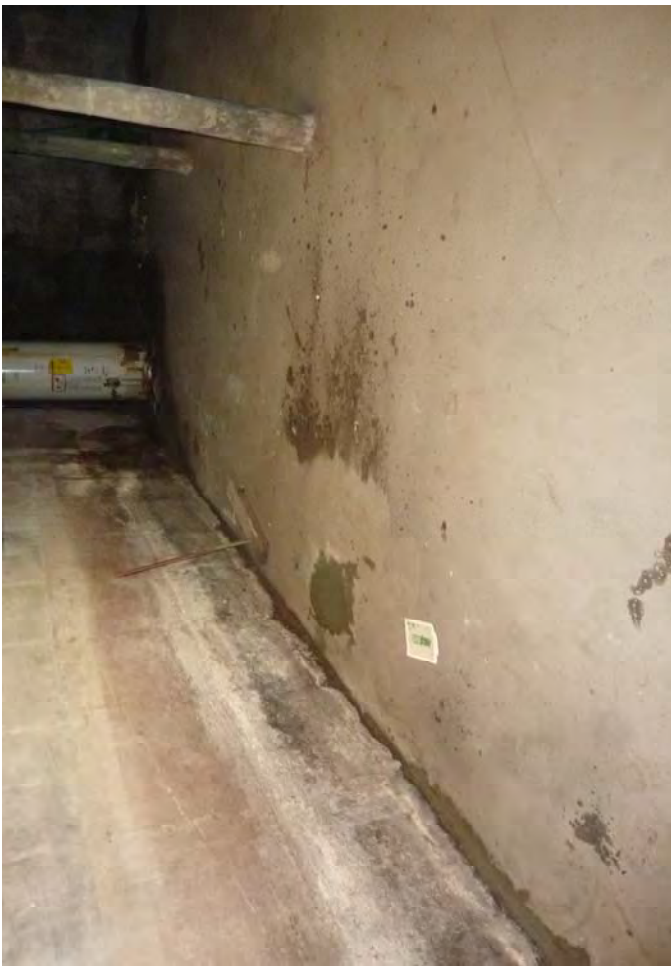
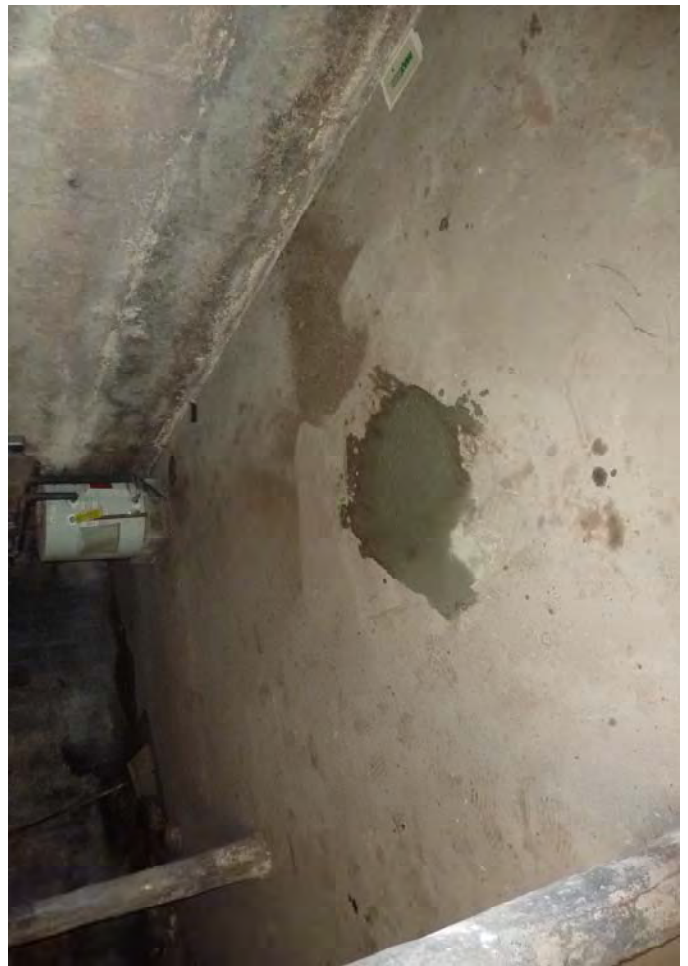
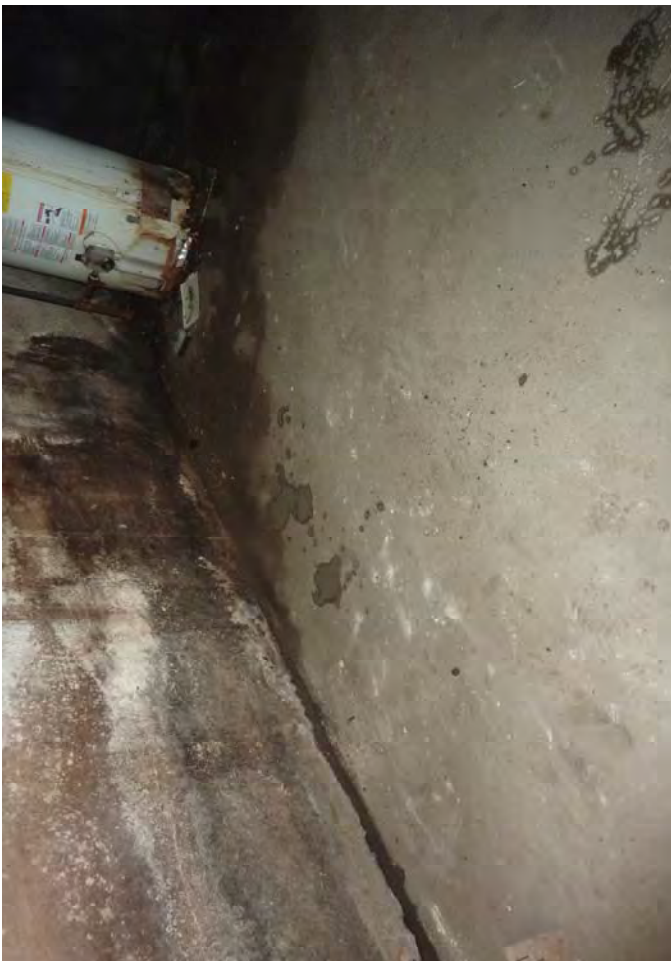
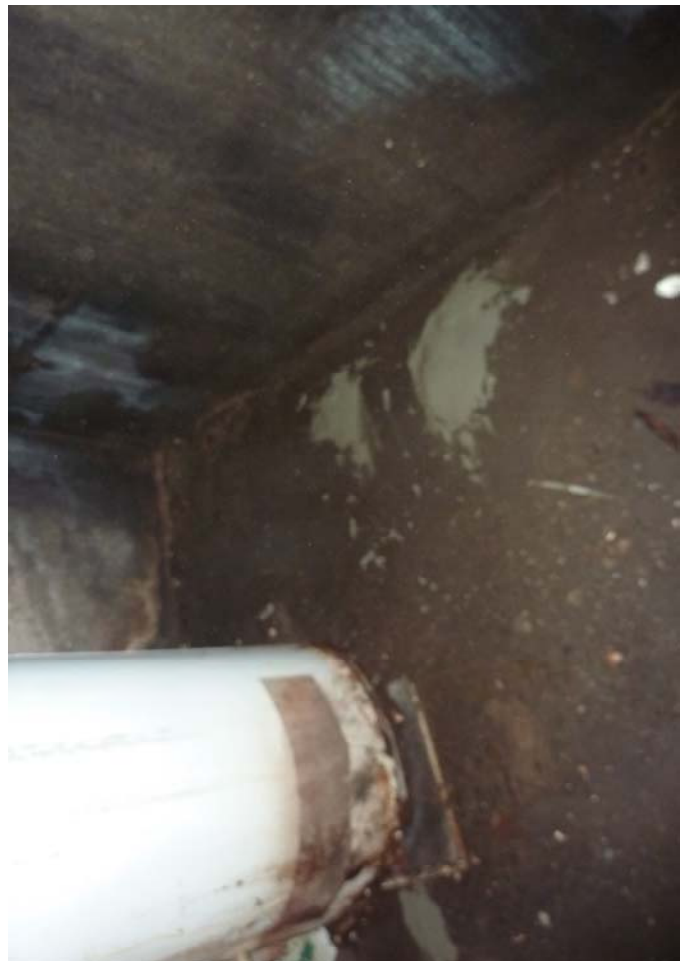
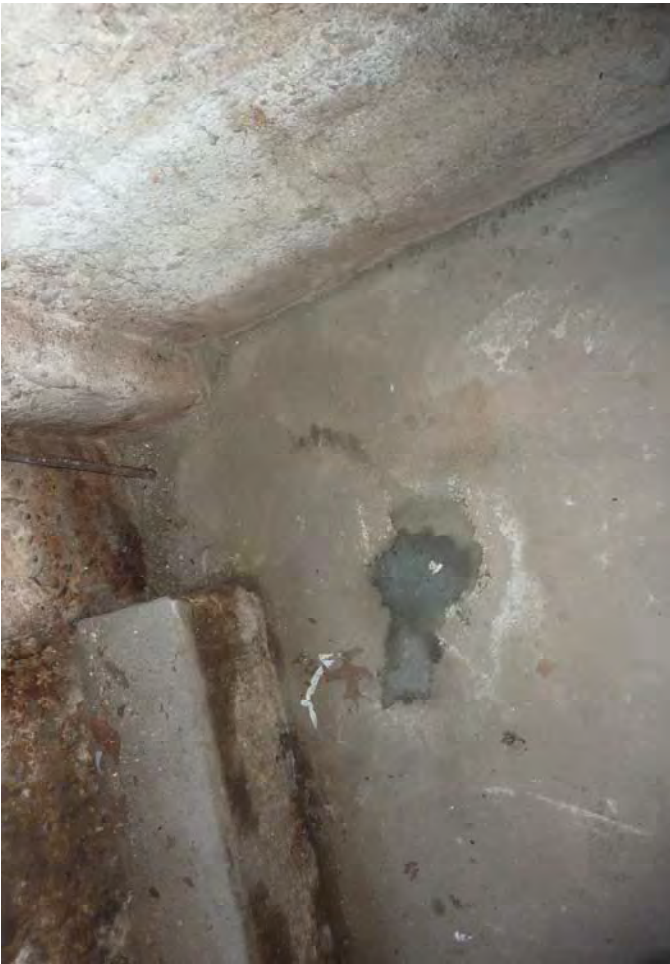
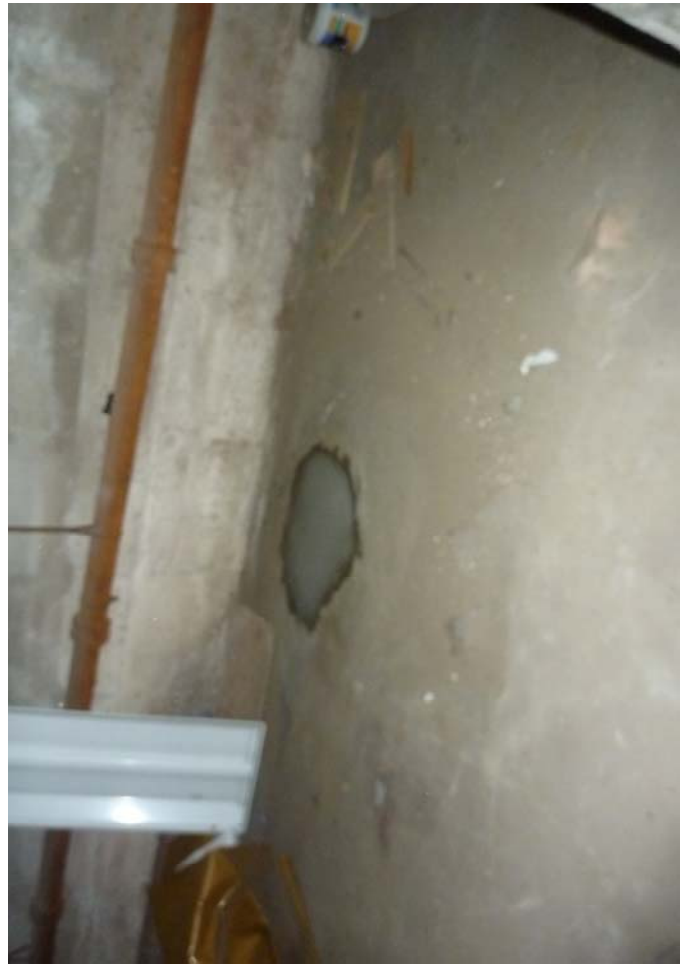
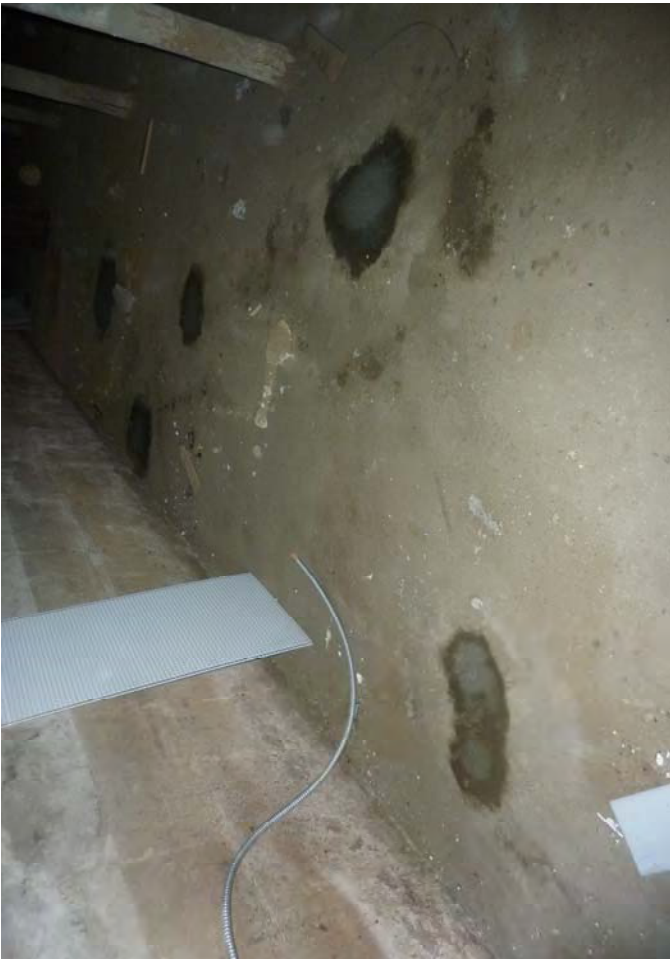
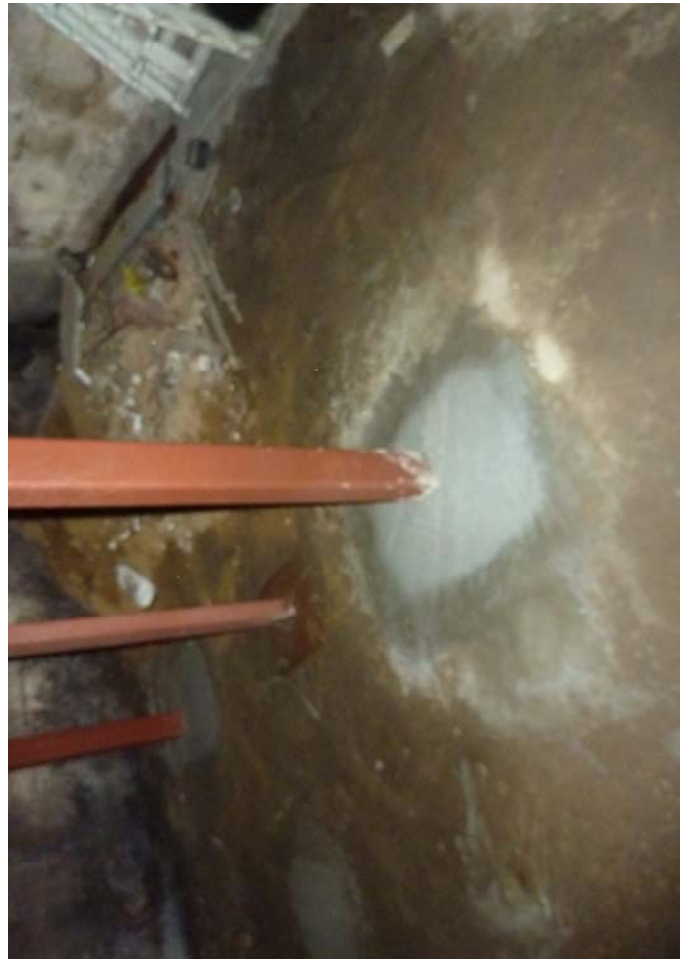
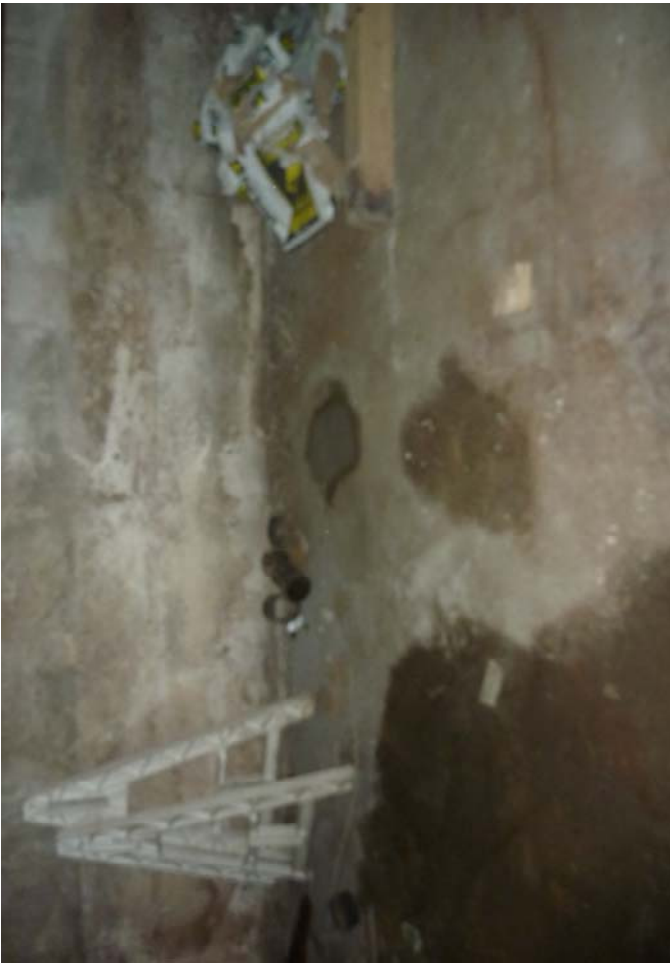
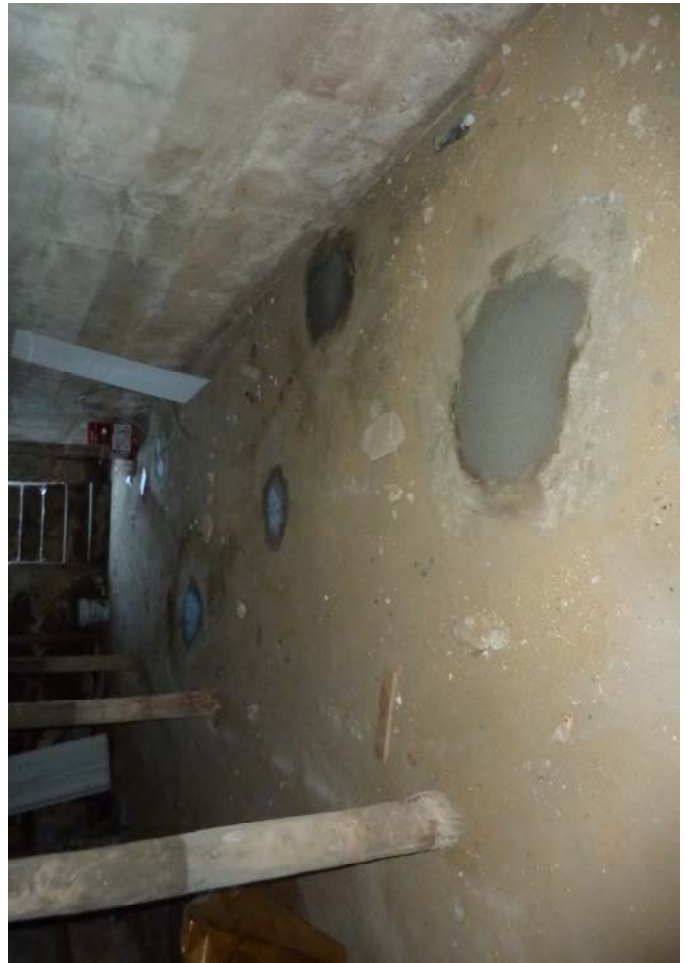
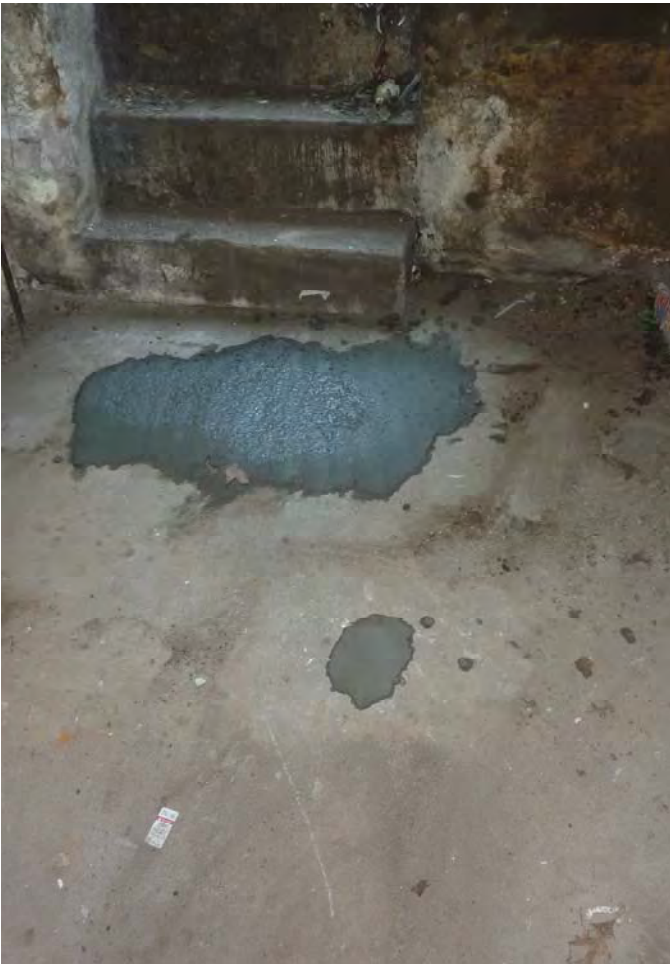
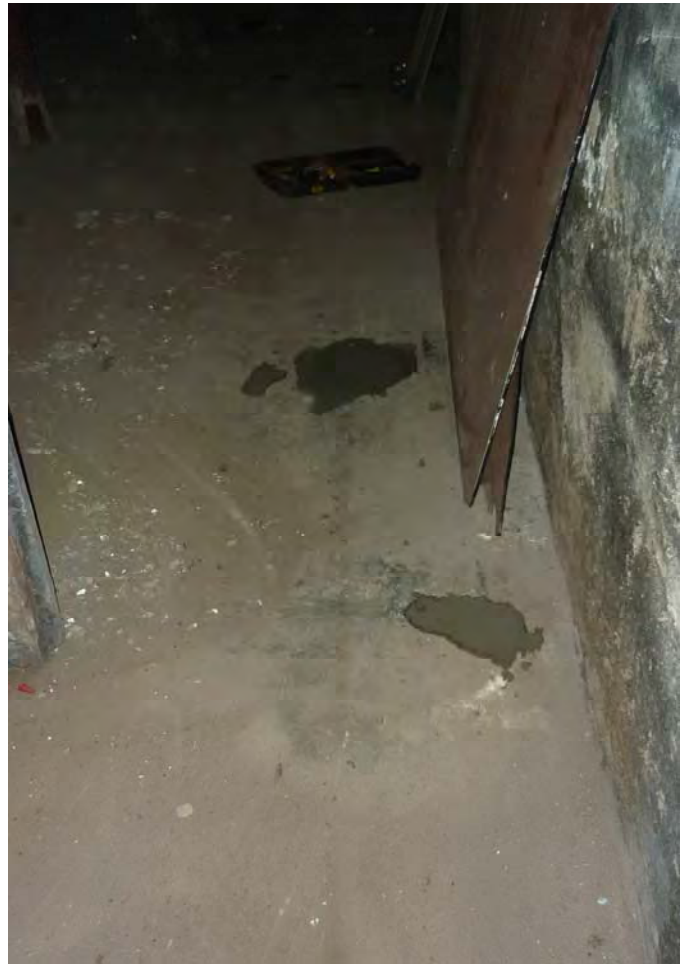
Many deficiencies (cracks, gaps, and holes) were found in the concrete slab within the basements of many units. Two monitoring points (one vapor and one groundwater) were also found in the basement of Unit 127-13. A plan to repair the deficiencies was developed.

On July 18 & 19, 2016, the Owners contracted with Jose K. Rogel Padilla Construction to repair the holes discovered in the eight (8) basement units for 127-1, 3, 5, 7, 9, 13, 15 and 17. Photographs of these concrete repairs can be found in Attachment 1. The remaining 3 units

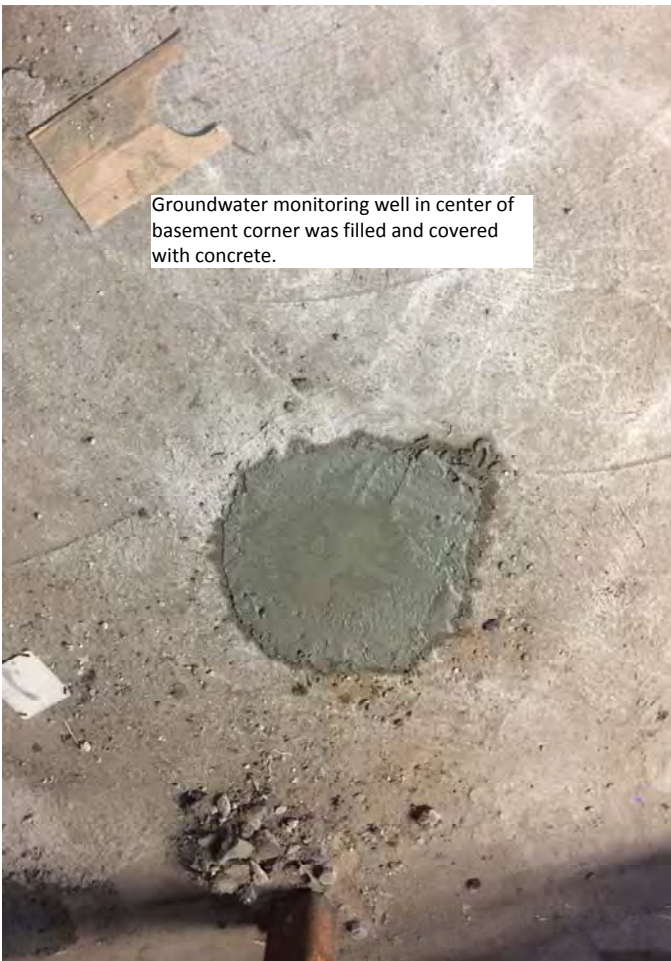
Groundwater monitoring well in center of basement corner was filled and covered with concrete.
