**PERFLUORINATED COMPOUNDS PRELIMINARY ASSESSMENT
SITE VISIT REPORT**

**NEW YORK AIR NATIONAL GUARD
STEWART AIR NATIONAL GUARD BASE
NEWBURGH, NEW YORK**

February 2016

**BB&E, Inc.
February 2016**

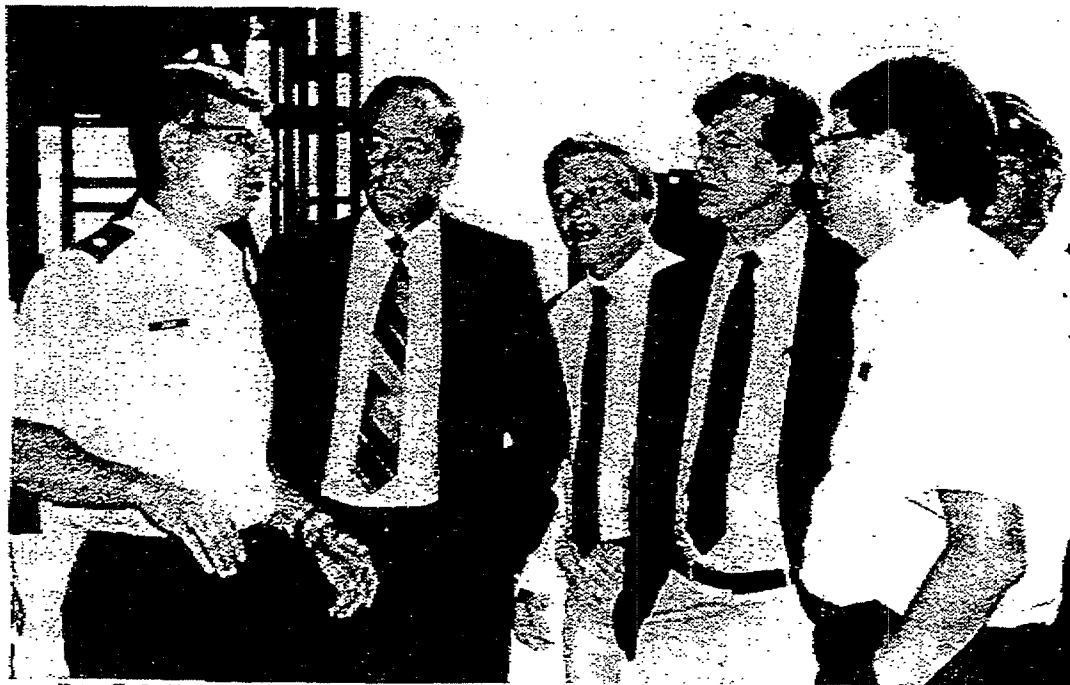
Lt. Col. William Steene, left, explains the process that the New York Air National Guard uses for diverting de-icing materials into a retention pond, with, from left, New Windsor Town Attorney Tad Seamon, Town Engineer Dick McGoe, Joe Marcogliese of the state DEC, and Mike Tremper, Director of Operations for CAMO Pollution Control, operators of the Town of New Windsor's sewerage treatment plant. Photo by J. Mecca.
