**From:** [Montroy, Brian](#)  
**To:** [Spellman, John \(DEC\)](#)  
**Cc:** [Christopher Wagner](#)  
**Subject:** 2021 Operation and Maintenance Report, Clarkstown Sanitary Landfill  
**Date:** Monday, March 7, 2022 10:49:31 PM  
**Attachments:** [Transmittal.pdf](#)  
[Operation and Maintenance Report 2021 DRAFT final.pdf](#)

Subject: 2021 Annual Landfill Gas Report

**PROJECT:**     **Clarkstown Sanitary Landfill; Landfill Gas Management**  
                  **Town of Clarkstown, Department of Engineering & Facilities Management**  
                  **West Nyack, New York**  
                  **NYSDEC Inactive Hazardous Waste Site No. 344001**

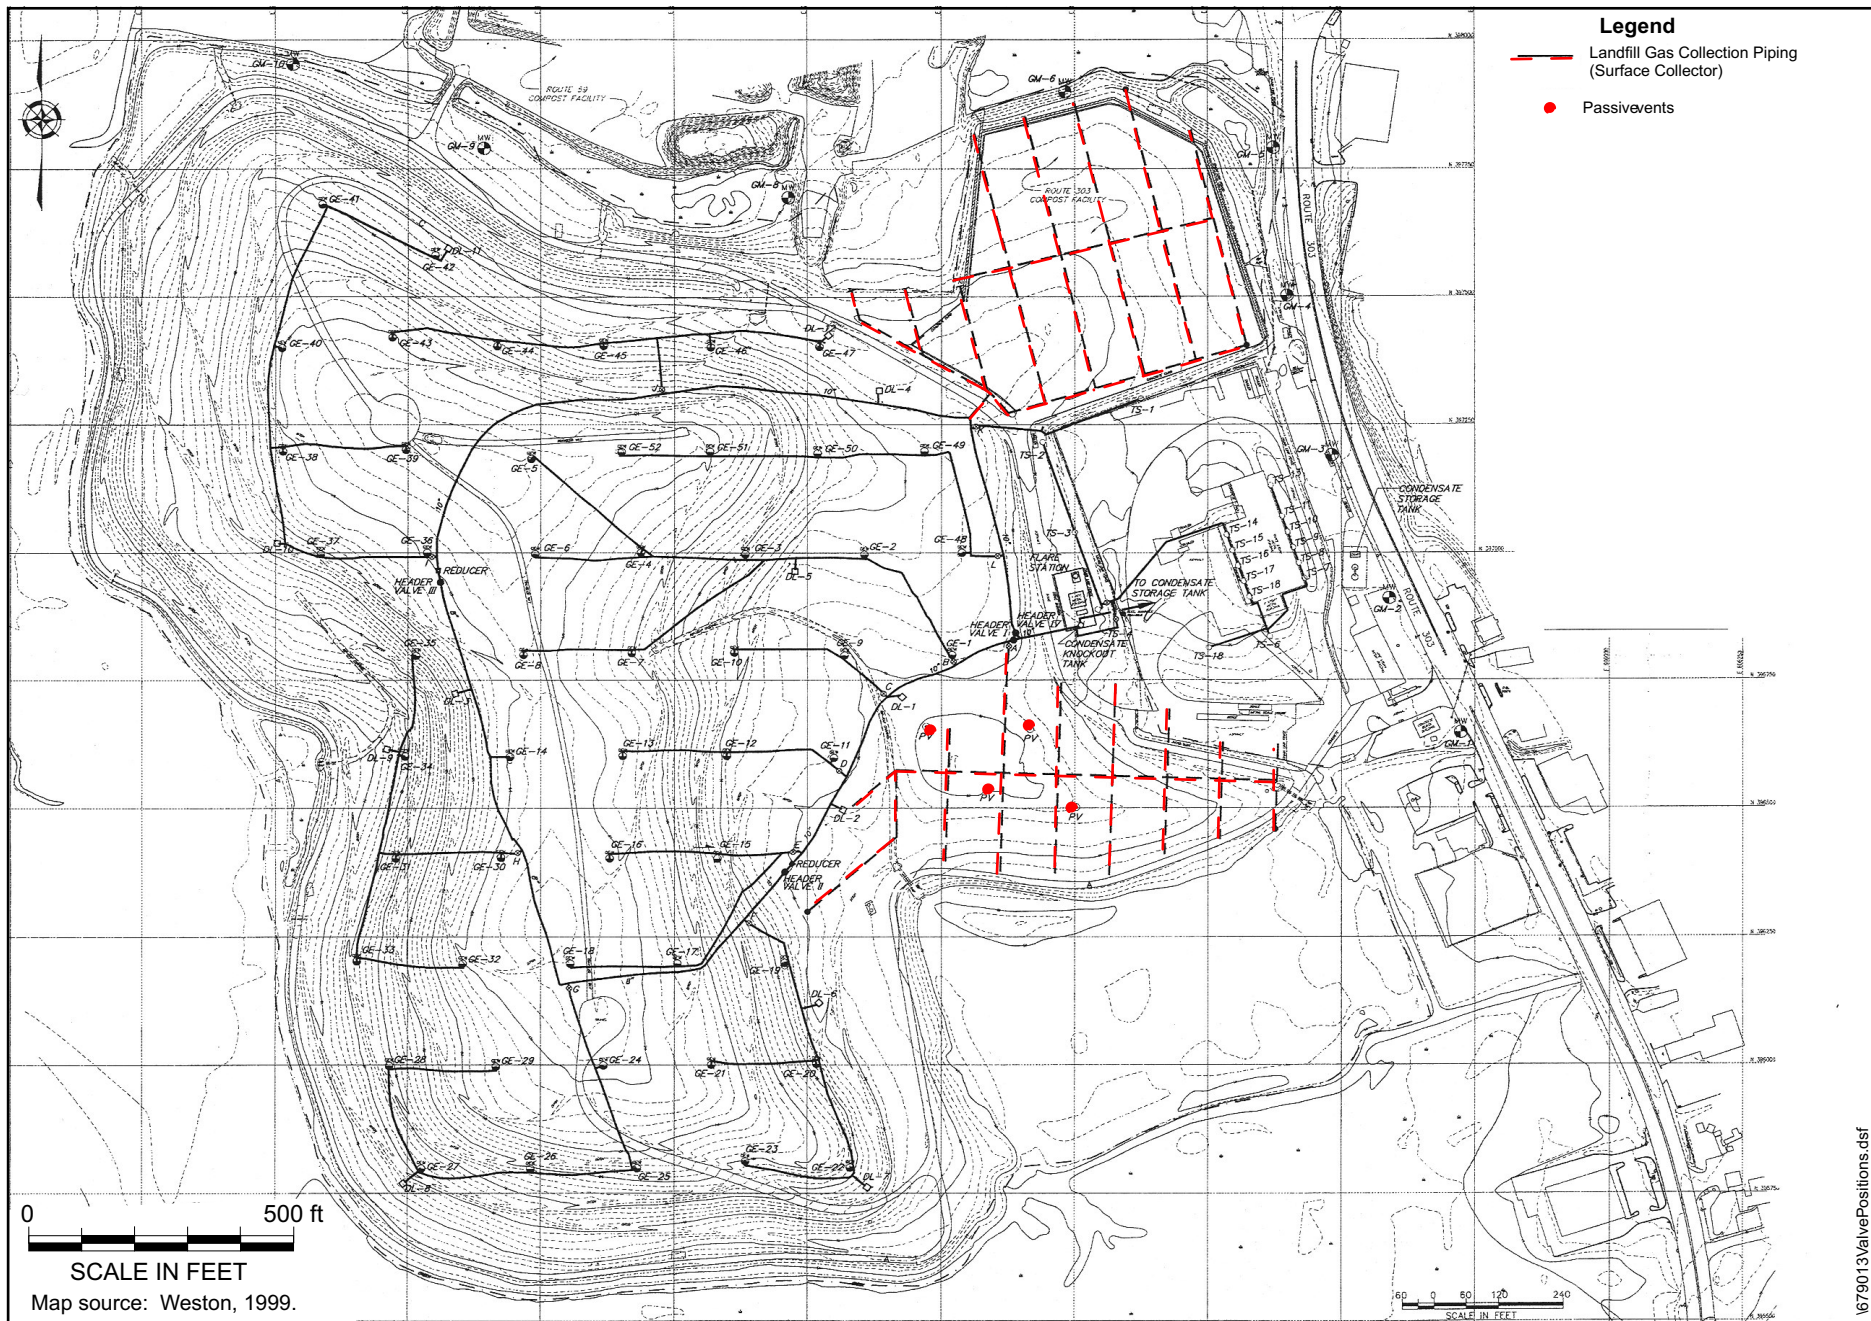
Figure 6

The 52 LFG extraction wells (Figure 6) were inspected during monthly site visits. Gas extraction well monitoring, and inspections of each well were conducted to identify potential leakage, liquid pooling, and hazardous methane conditions in the surrounding area. Deficiencies noted during the monthly inspections were reported on Form DP-1, which are included as Appendix B.

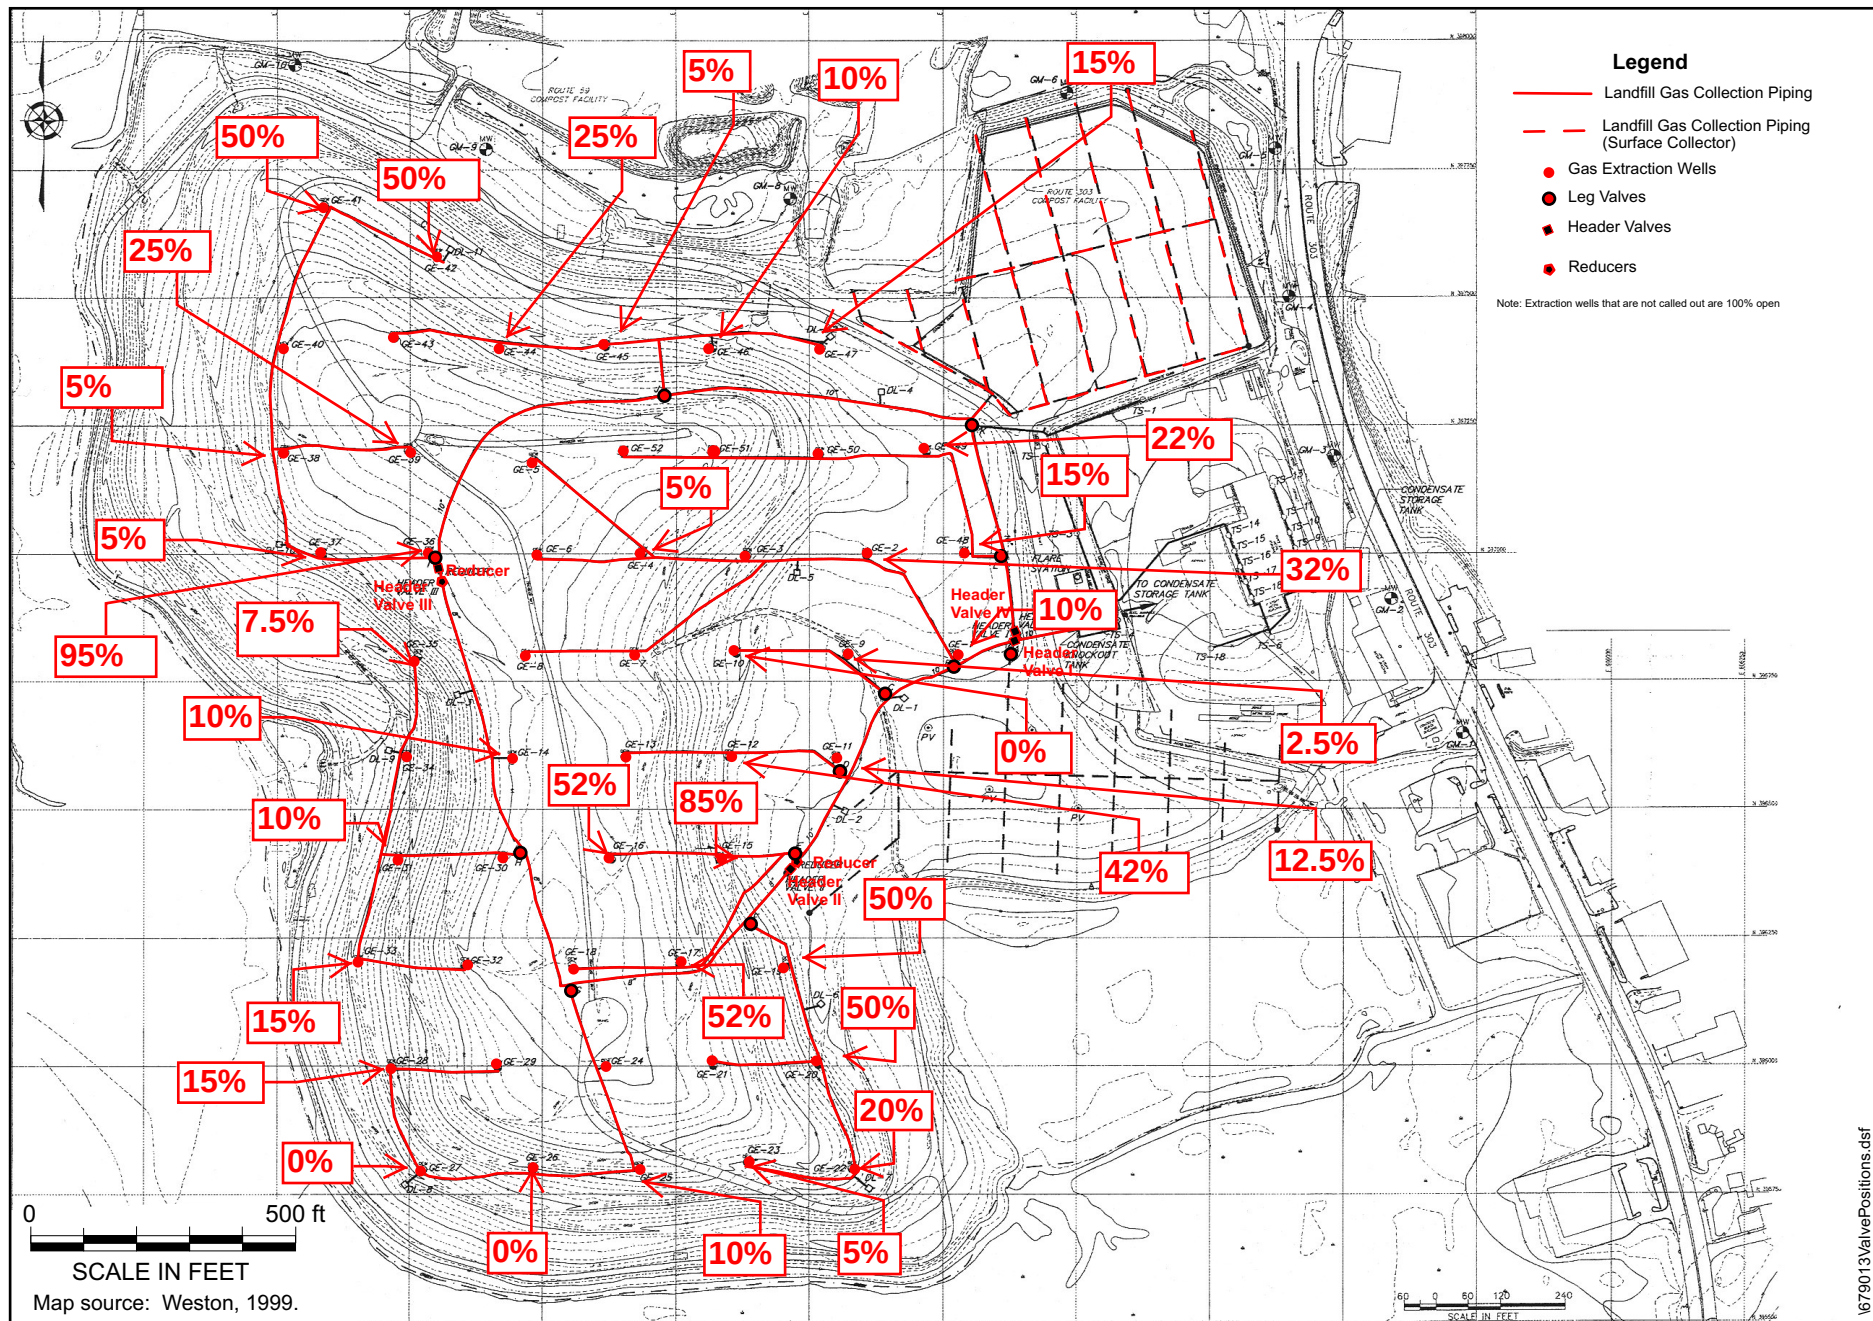
Figure 8

It was also observed during the reporting period that the historic area of low methane production located on the northwest side of the landfill (Figure 8) has now split forming two areas of low methane production. It was also reported that a small area along the east side and the southwest corner of the landfill also showed low methane production during the reporting period. It is not clear why methane production in this area have changed in 2021 operational year but monthly well balancing will continually be adjusted as necessary to account for these fluctuations.

Localized Area of Low Methane Readings  
Clarkstown Landfill  
West Nyack, NY 10994
