**Periodic Review Report August 2023**  
**NYSDEC Site No. 344014**  
**West Nyack Operating Center**

766 West Nyack Road, West Nyack, NY  
(Formerly 180 West Nyack Road)

August 2023  
Project 2101712

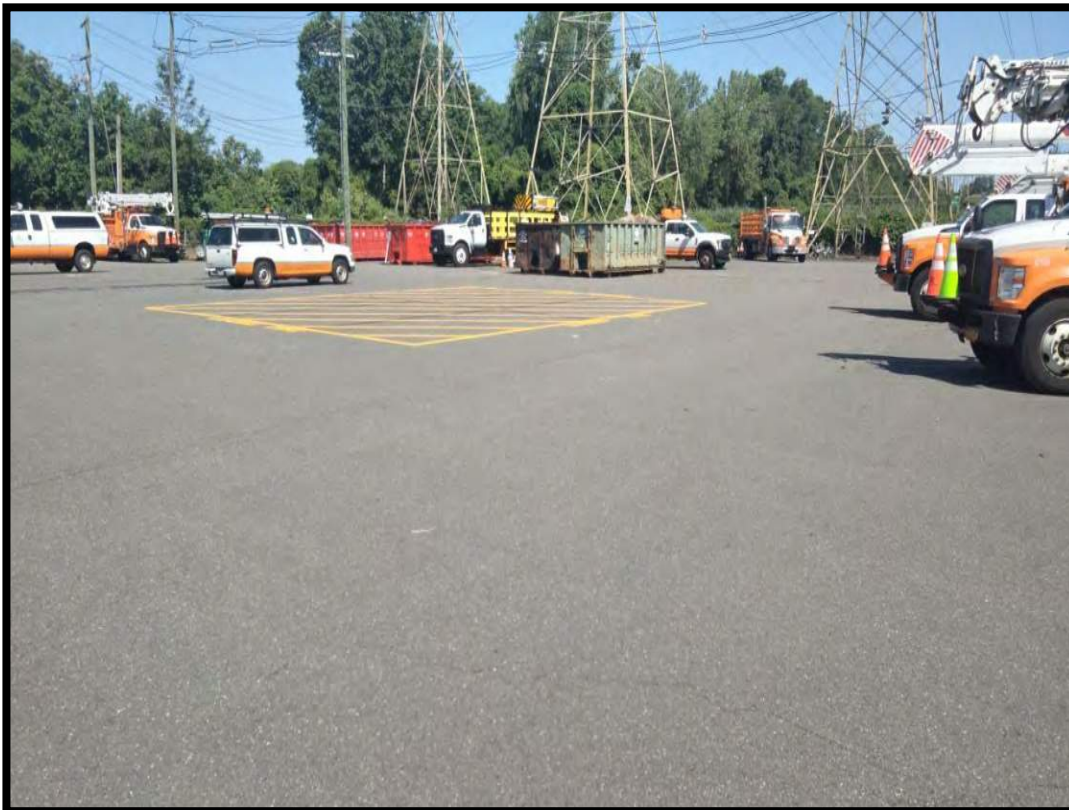
**PHOTOGRAPH 3**

Pavement in rear parking lot –View looking north behind buildings

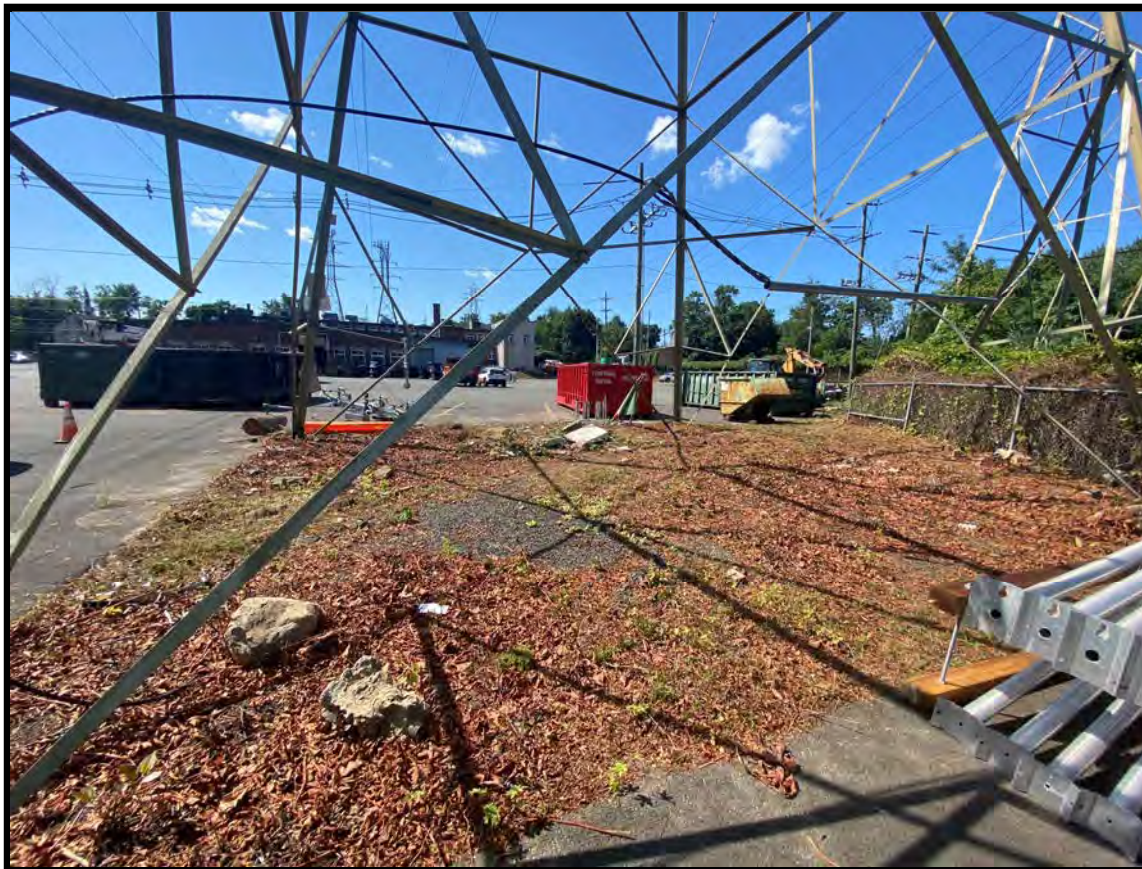
**PHOTOGRAPH 9**

Base of Northwestern Transmission Tower – Oil Stone Chips Present

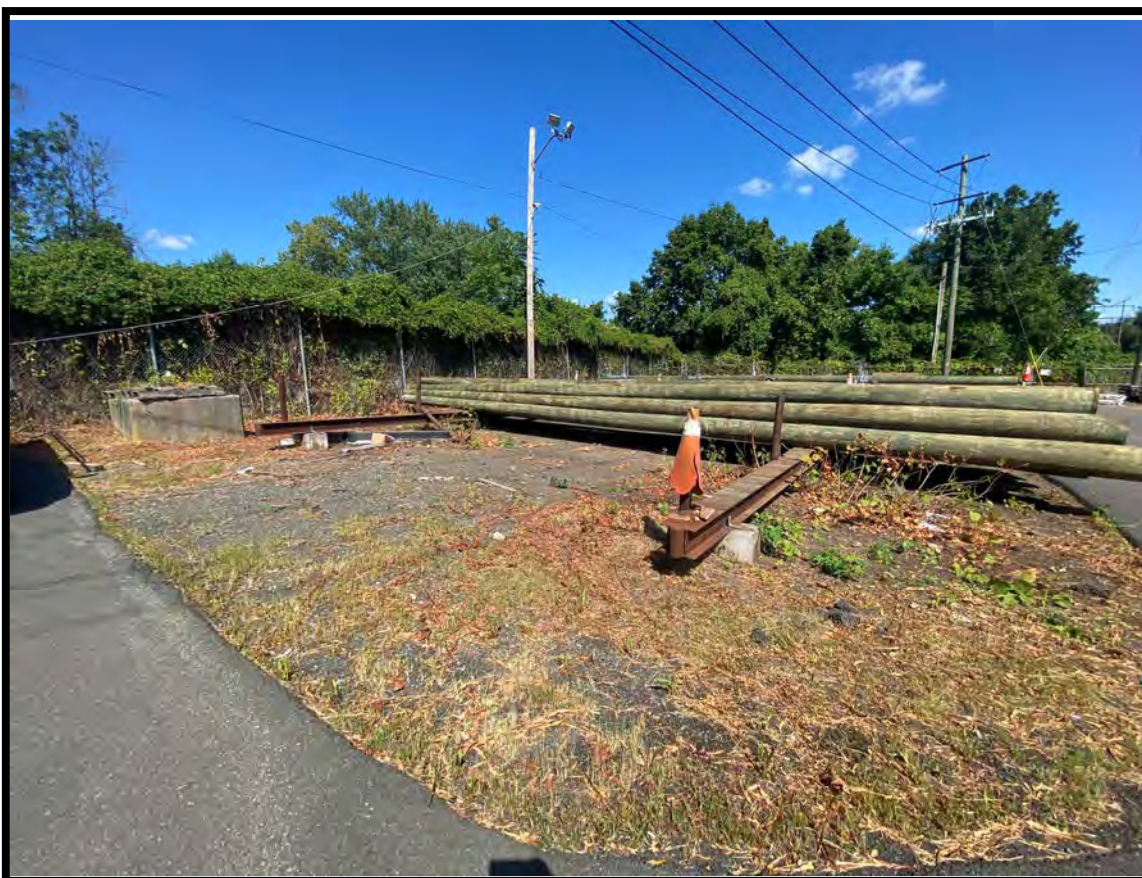
**PHOTOGRAPH 10**

Pole Rack Along Northwestern Fence Line

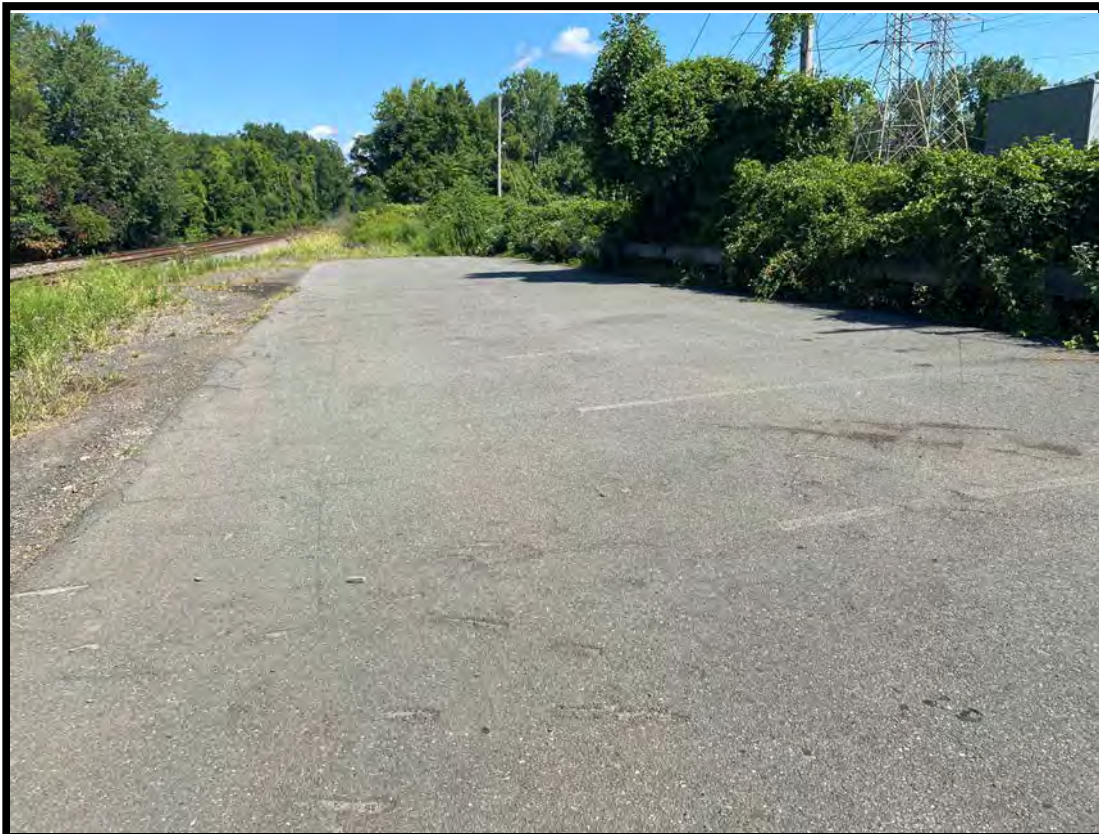
**PHOTOGRAPH 14**

Pavement on Lot 48 – West of Fence-line, East of RR, looking North

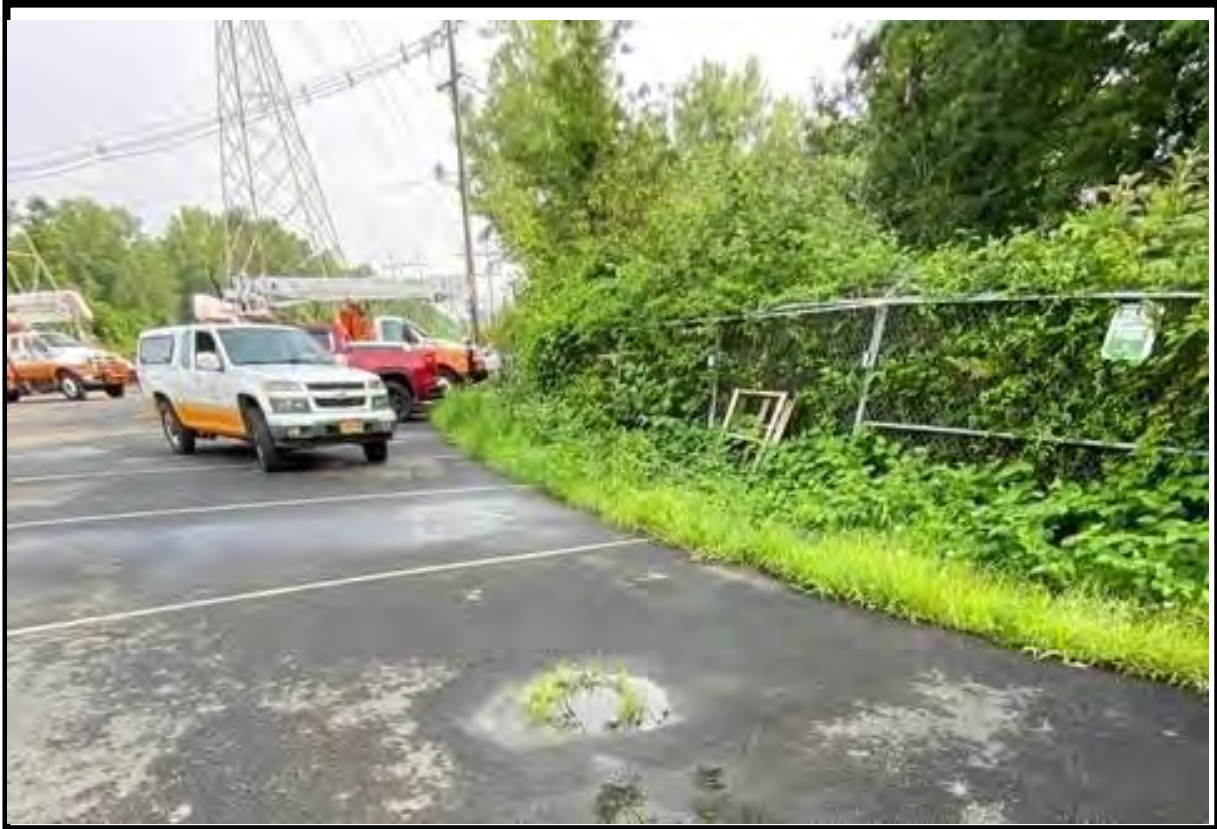
**PHOTOGRAPH 5**

issues impacted the effectiveness of the institutional or engineering controls. The fence surrounding the site was intact, however, significant vegetation was present all along the fence line (Photograph 5, Appendix B).

Pavement and Fence – Looking Northeast, North of WNOC Building

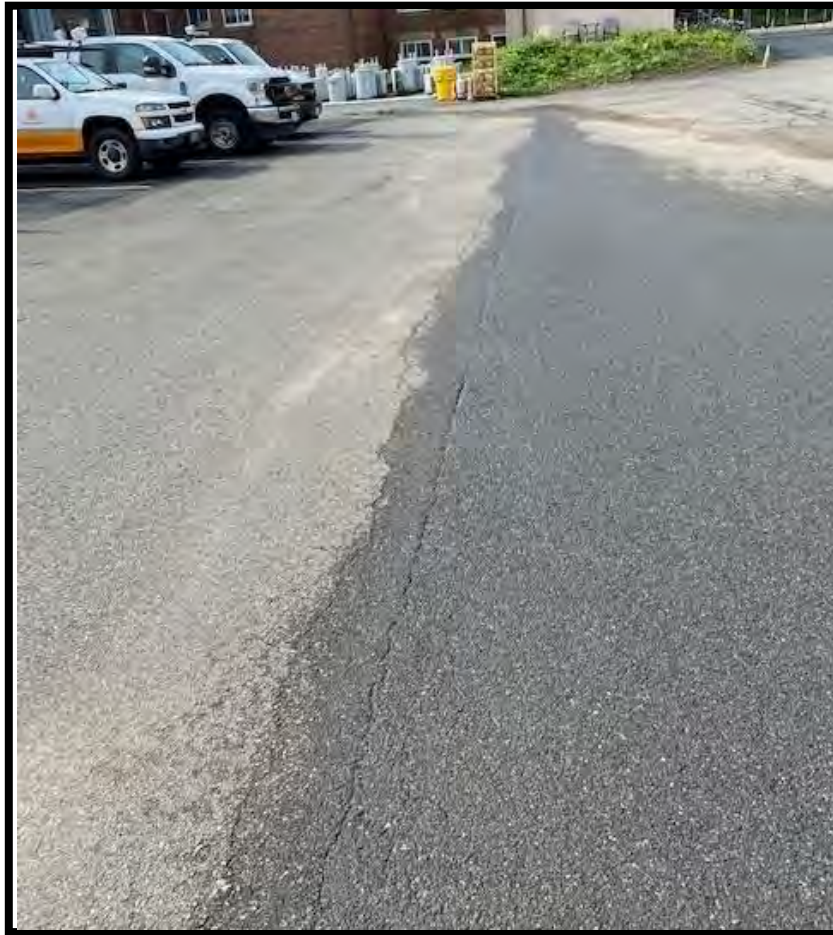
**PHOTOGRAPH 7**

- The condition of the asphalt cap in the parking and driveway areas throughout the site is improved subsequent to the 2016 re-paving. Some settlement cracks were identified within the asphalt during the 2020 inspection and have since then progressed. However, the cracks are surficial and there is no exposure to the sub-base or subsurface material. The overall integrity of the pavement is good (Photographs 5 through 10).

Pavement Northwest of Building Looking South Towards Exit

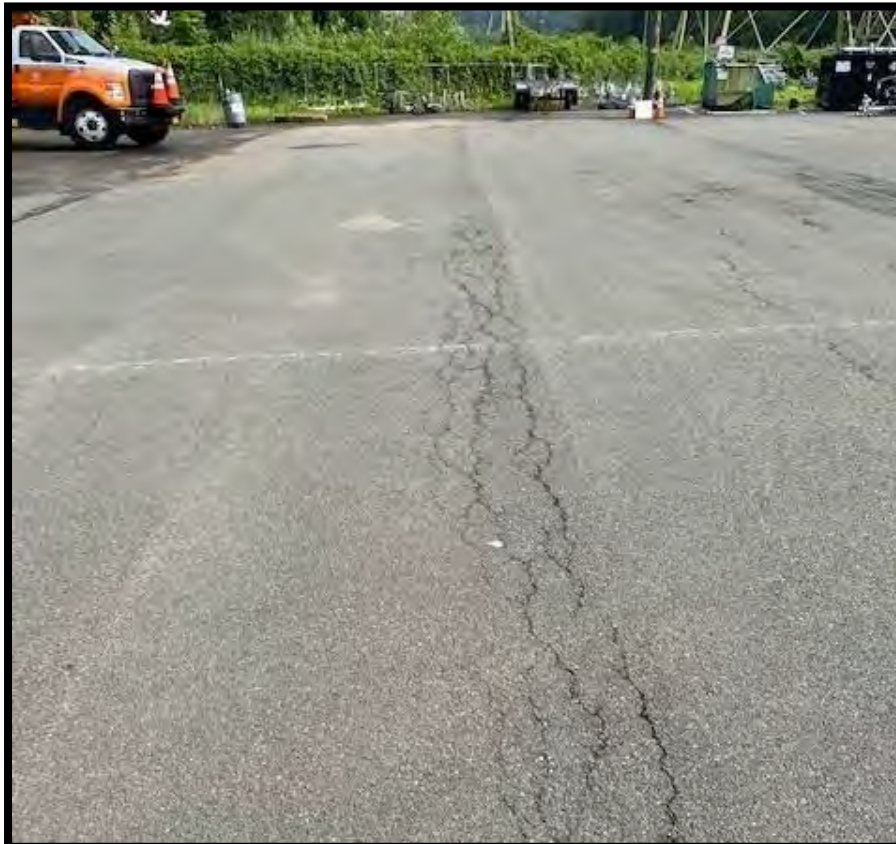
**PHOTOGRAPH 8**

Pavement Northwest of building looking North

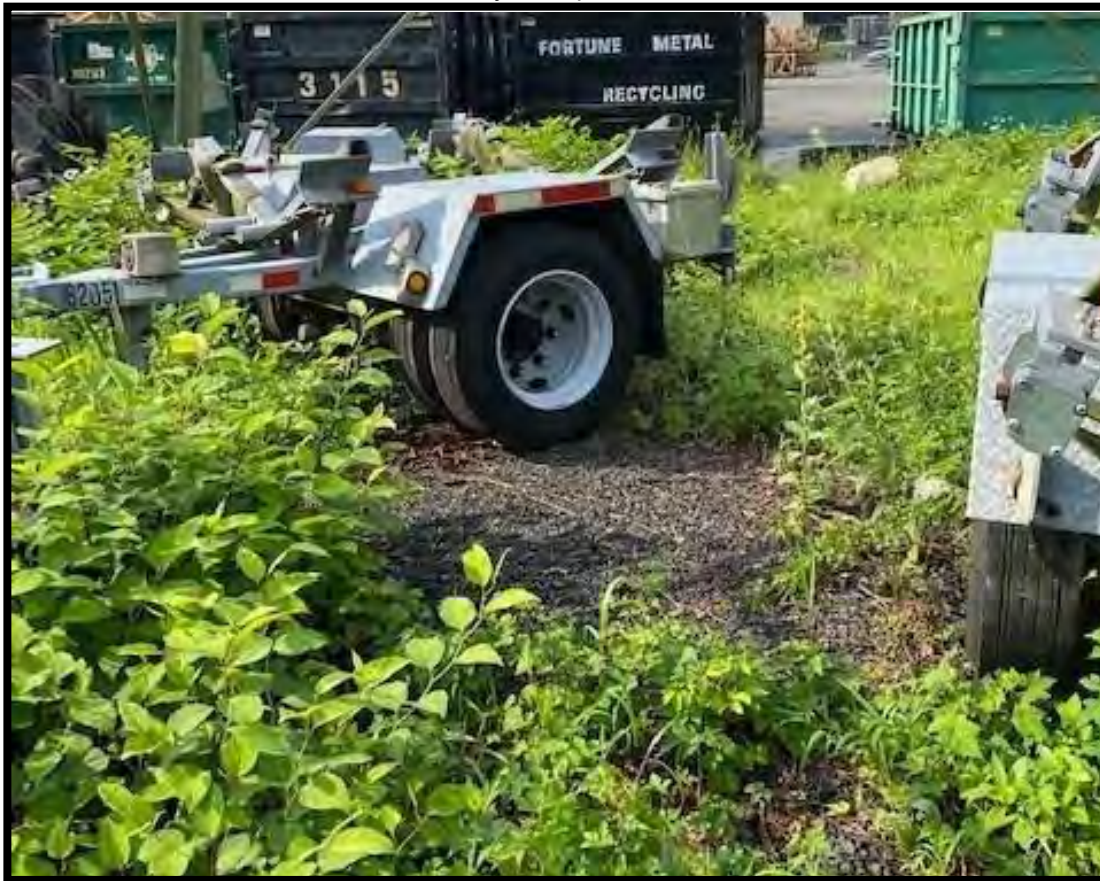
**PHOTOGRAPH 11**

- The oil stone chips are present beneath the transmission towers. The integrity of the cap preventing exposure to subsurface soil at these locations appears to be intact however the oil stone chips are starting to erode. There is vegetation and some equipment and debris in these areas. Replacement of oil chips in this area should be considered to prevent further erosion and exposure of soil (Photograph 11).

Base of Northwestern Transmission Tower – Oil Stone Chips Present

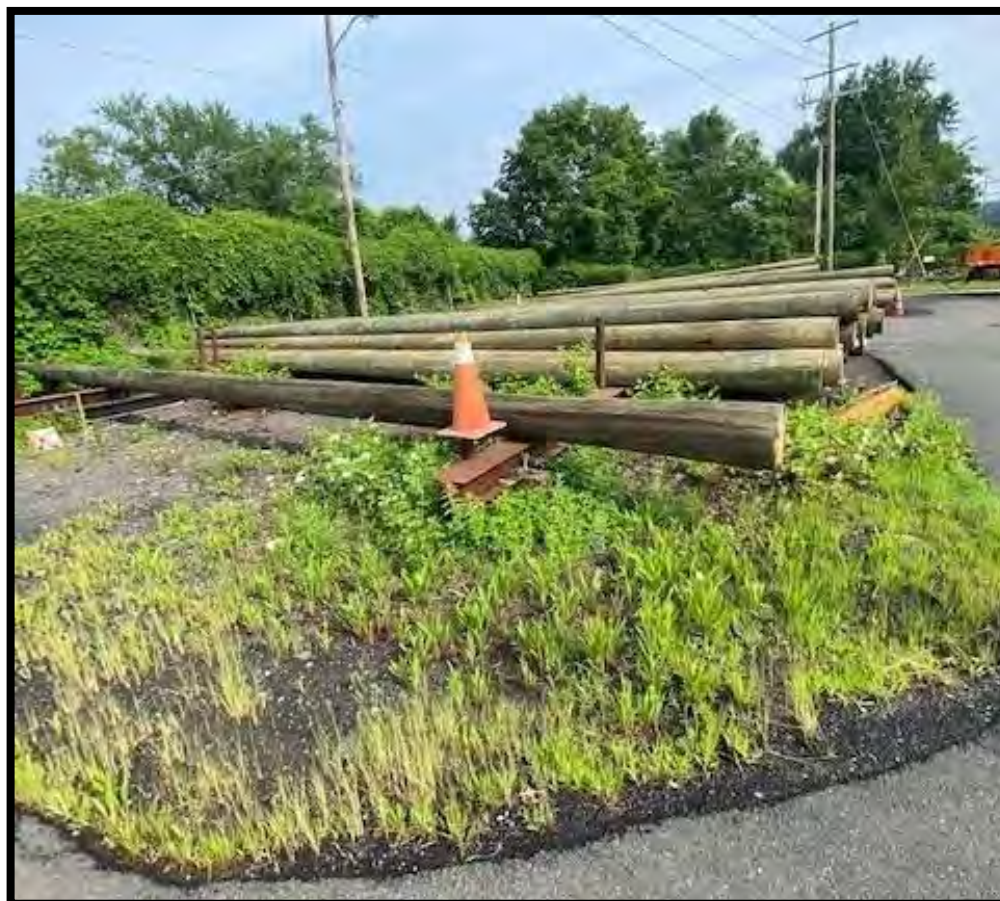
**PHOTOGRAPH 12**

- The oil stone chips are present beneath the pole rack along the northwestern fence line. There is vegetation present. (Photograph 12).

- Consistent with previous inspections, there is erosion of the oil stone chips on the sloped areas adjacent to the southwestern side of the building. Brown soil is exposed in this area where there appears to be further erosion of the concrete platform above the slope (Photograph 12). Vegetation was present during the 2021 inspection although not as overgrown as the 2020 inspection (Photographs 13 and 14). The oil stone chips, asphalt and concrete are still present and preventing exposure to the underlying soil at most locations. Since the oil chips were placed in the rear of the building to protect the integrity of the asphalt cap, future maintenance, and replacement of the oil chips in this area should be performed to prevent further erosion.

Pole Rack Along Northwestern Fence Line

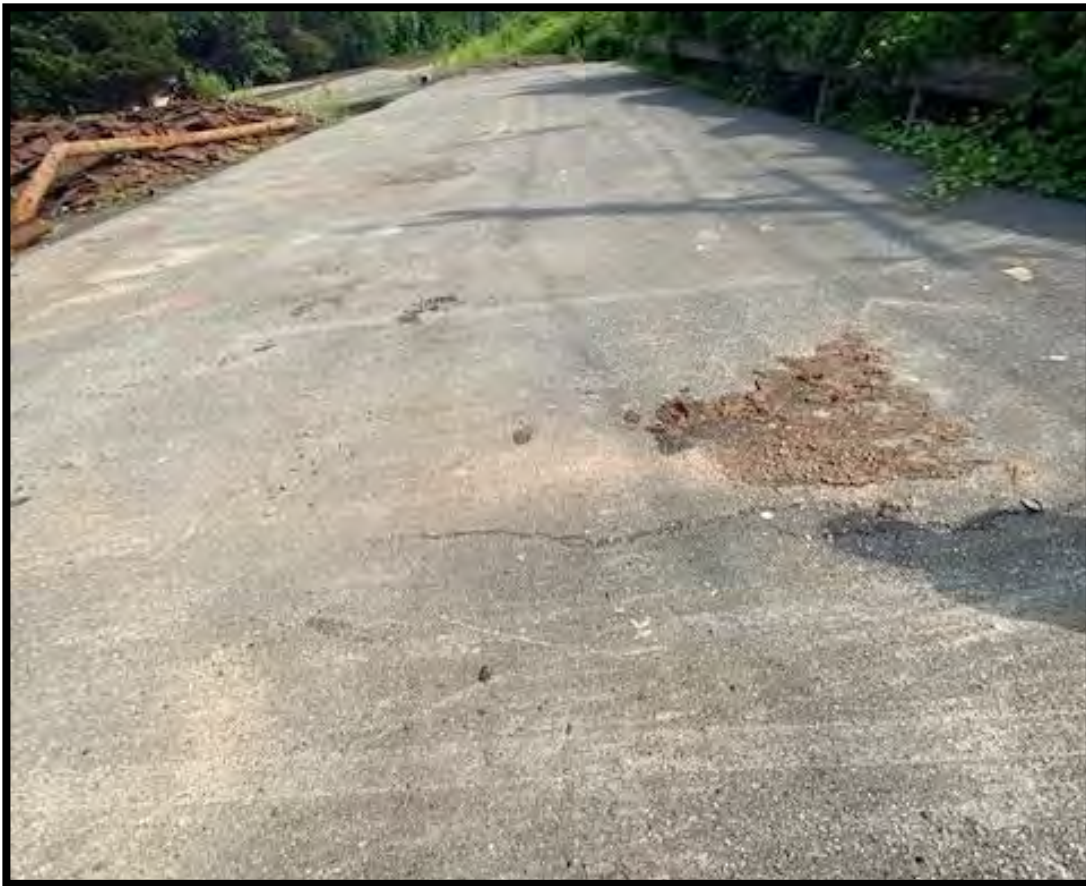
**PHOTOGRAPH 17**

- Minor cracks were observed within the pavement on Lot 48 west of the fence-line and east of the RR consistent with observations during the 2020 inspection (Photograph 17). There is no exposure to subsurface soil.

Pavement on Lot 48 – West of Fence-line, East of RR, looking North

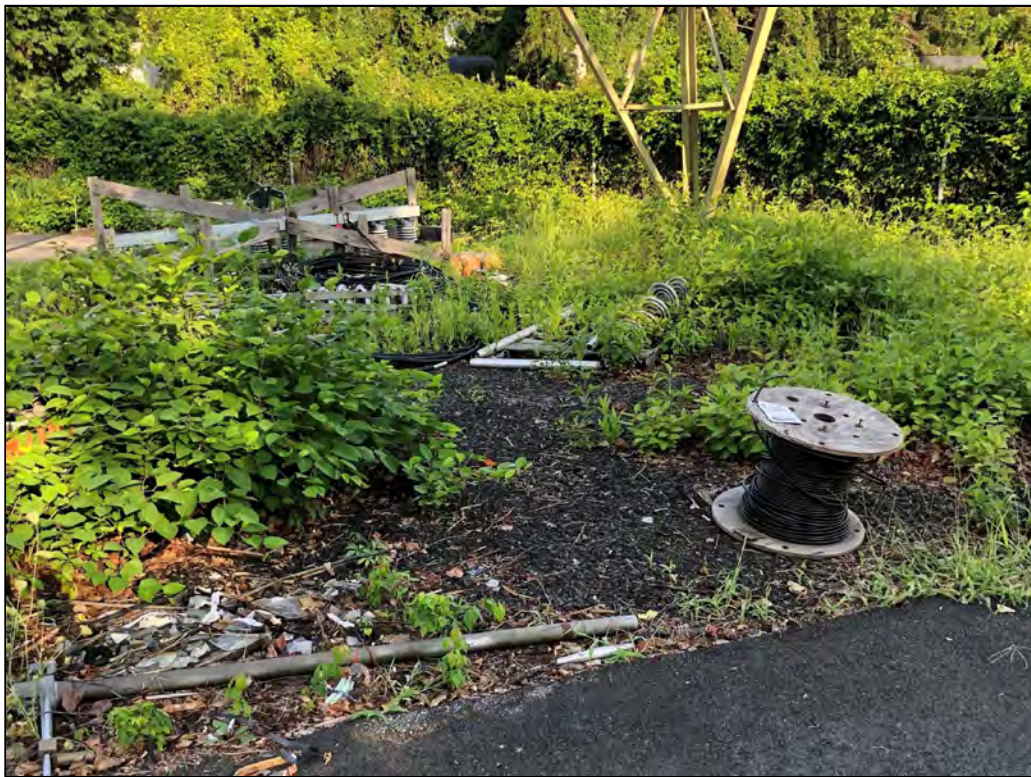
- The oil stone chips are present beneath the transmission towers. There is significant vegetation and debris in these areas. The integrity of the cap preventing exposure to subsurface soil at these locations appears to be intact (Photograph 4).

**PHOTOGRAPH 4**  
Base of Northwestern Transmission Tower – Oil Stone Chips Present

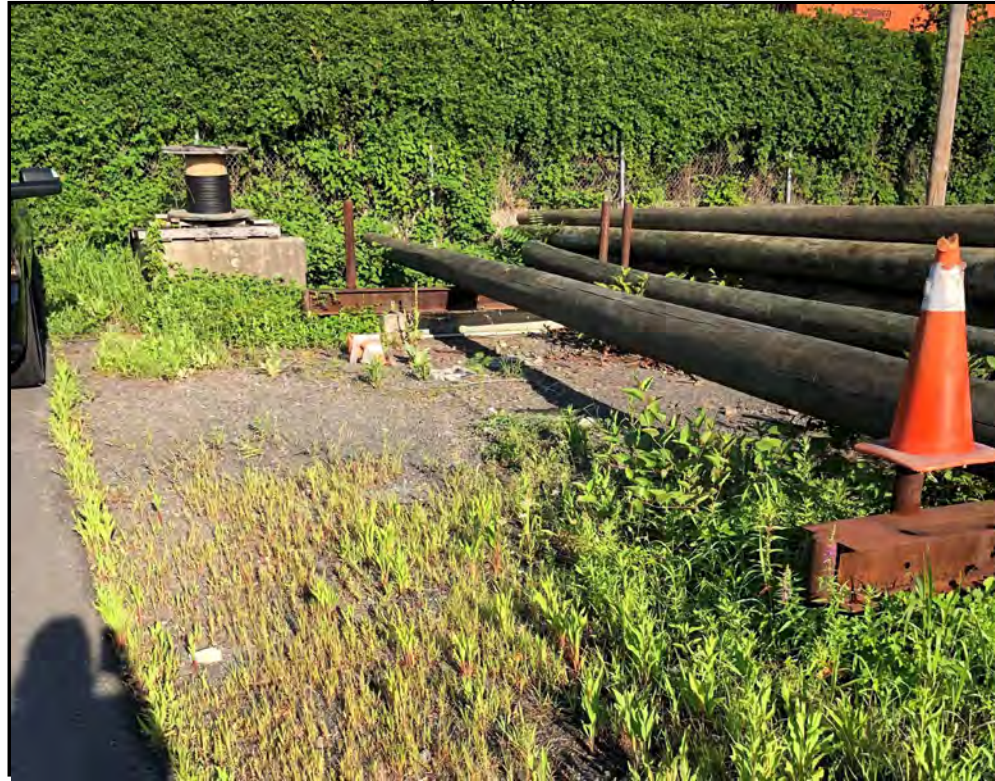
**PHOTOGRAPH 5**  
Pole Rack Along Northwestern Fence Line

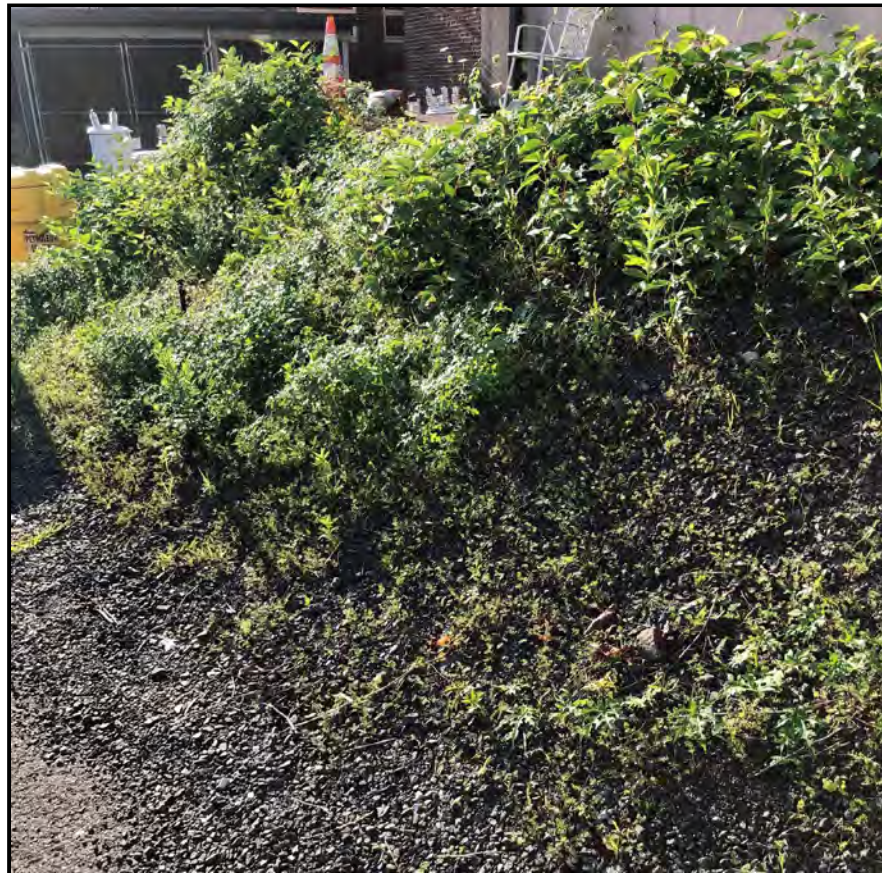
- Consistent with previous inspections, there is some erosion of the oil stone chips on the sloped areas adjacent to the southwestern side of the building and cracked pavement was observed along the top of the sloped area adjacent to the building. There is also erosion of a concrete platform above the slope in this area; conditions are consistent with those documented in 2013, 2018 and 2019 however, additional vegetation appeared to be present during the 2020 inspection (Photograph 6). The oil stone chips, asphalt and concrete are still present and preventing exposure to the underlying soil. Since the oil chips were placed in the rear of the building to protect the integrity of the asphalt cap, future maintenance of this area should be considered to prevent further erosion.

**PHOTOGRAPH 6**  
Southwestern Side of Building – Oil Stone Chips Adjacent to Building

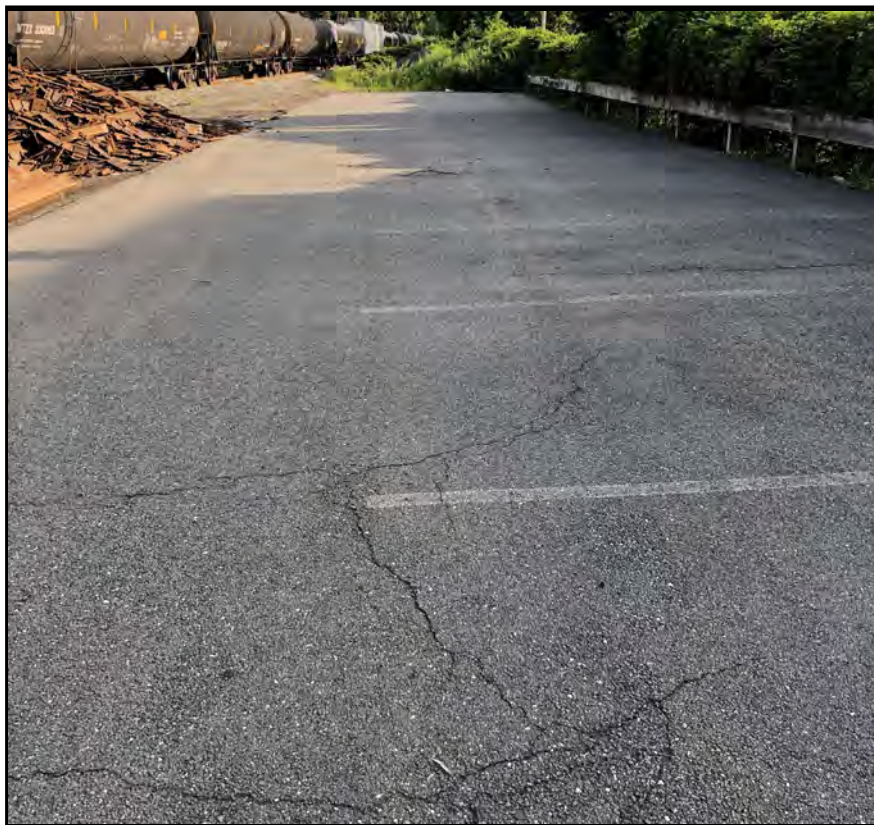
- Minor cracks were observed within the pavement on Lot 48 west of the fence-line and east of the RR that were not observed during the 2019 inspection (Photograph 10). There is no exposure to subsurface soil.

**PHOTOGRAPH 10**  
Pavement on Lot 48 – West of Fence-line, East of RR, looking North

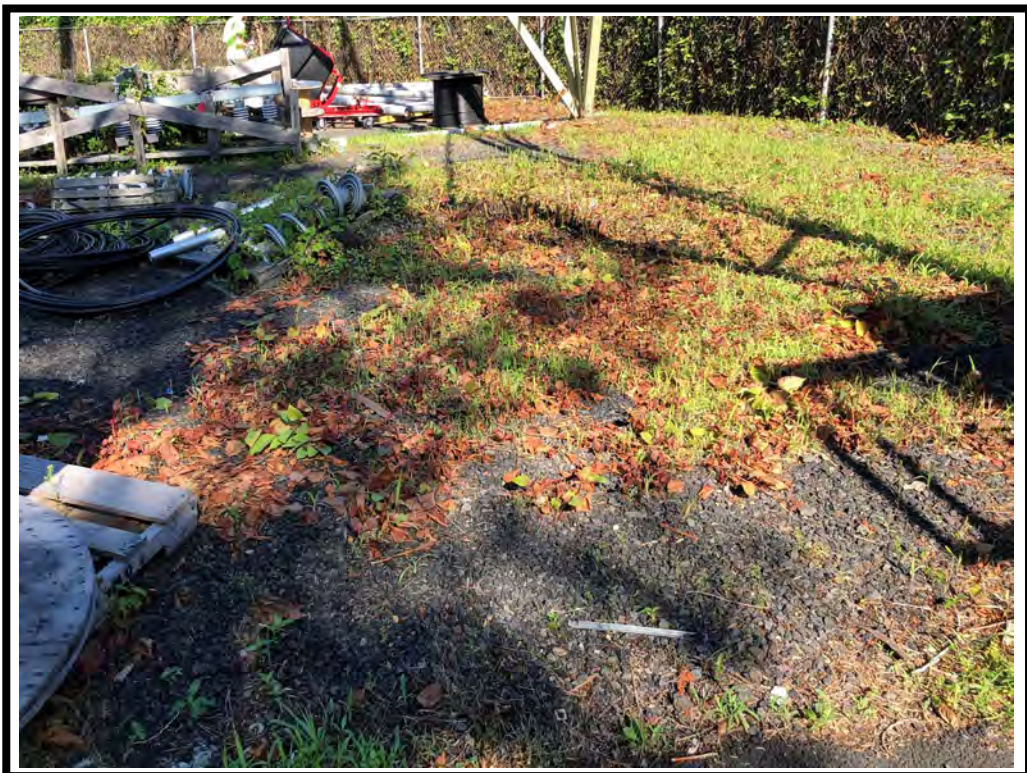
- The oil stone chips are present beneath the transmission towers. There is significant vegetation and debris in these areas. The integrity of the cap preventing exposure to subsurface soil at these locations appears to be intact (Photograph 4).

**PHOTOGRAPH 4**  
Base of Northern Transmission Tower – Oil Stone Chips Present

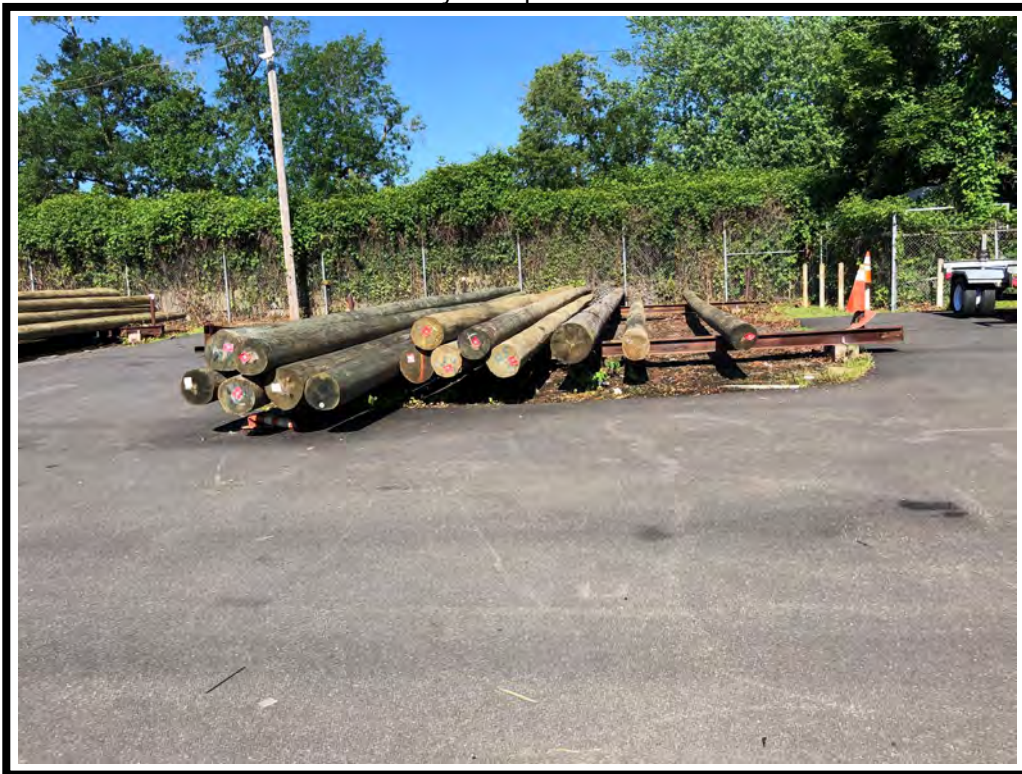
- There is no asphalt cover in the area beneath the pole rack storage along the western fence line (Photograph 5). This is consistent with conditions noted during the 2013 and 2018 inspection. The paving plan submitted to and approved by the NYSDEC in 2016 did not include these areas in the areas to be paved.

**PHOTOGRAPH 5**  
Pole Racks and Fencing along Northern Fence Line

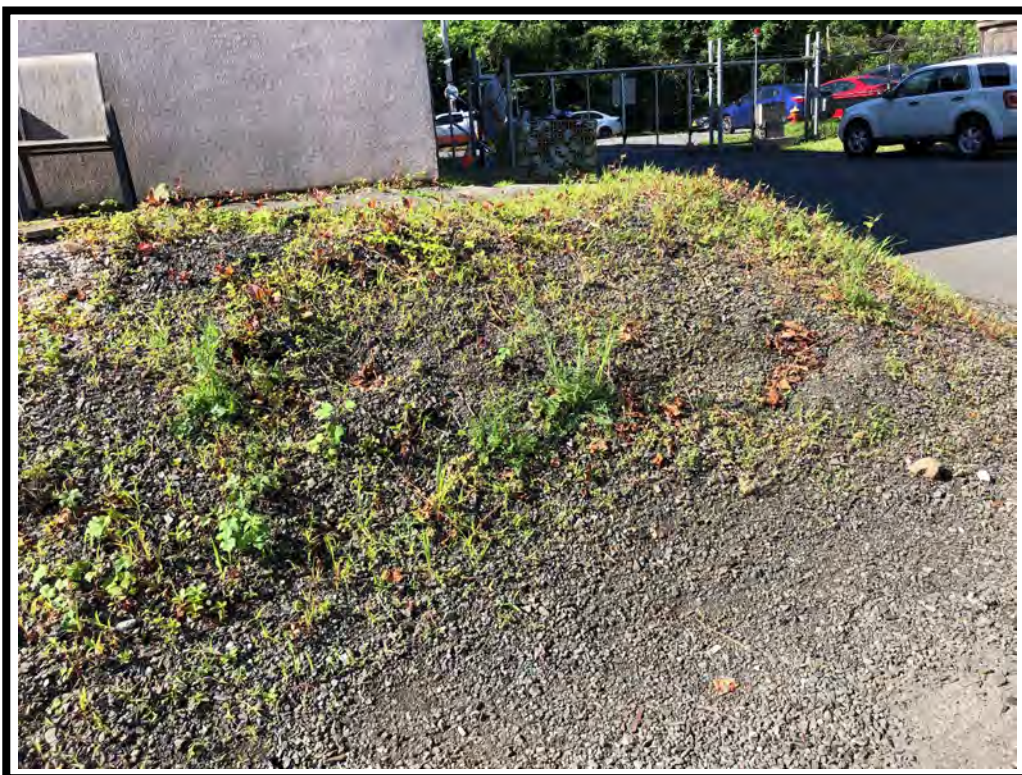
- Consistent with the 2013 and 2018 inspections, there is some erosion of the oil stone chips on the sloped areas adjacent to the southwestern side of the building and cracked pavement was observed along the top of the sloped area adjacent to the building. There is also erosion of a concrete platform above the slope in this area; conditions are consistent with those documented in 2013 and 2018 (Photograph 6). The oil stone chips, asphalt and concrete are still present and preventing exposure to the underlying soil. Since the oil chips were placed in the rear of the building to protect the integrity of the asphalt cap, future maintenance of this area should be considered to prevent further erosion.

**PHOTOGRAPH 6**  
Western Side of Building (looking South) – Oil Stone Chips Adjacent to Building

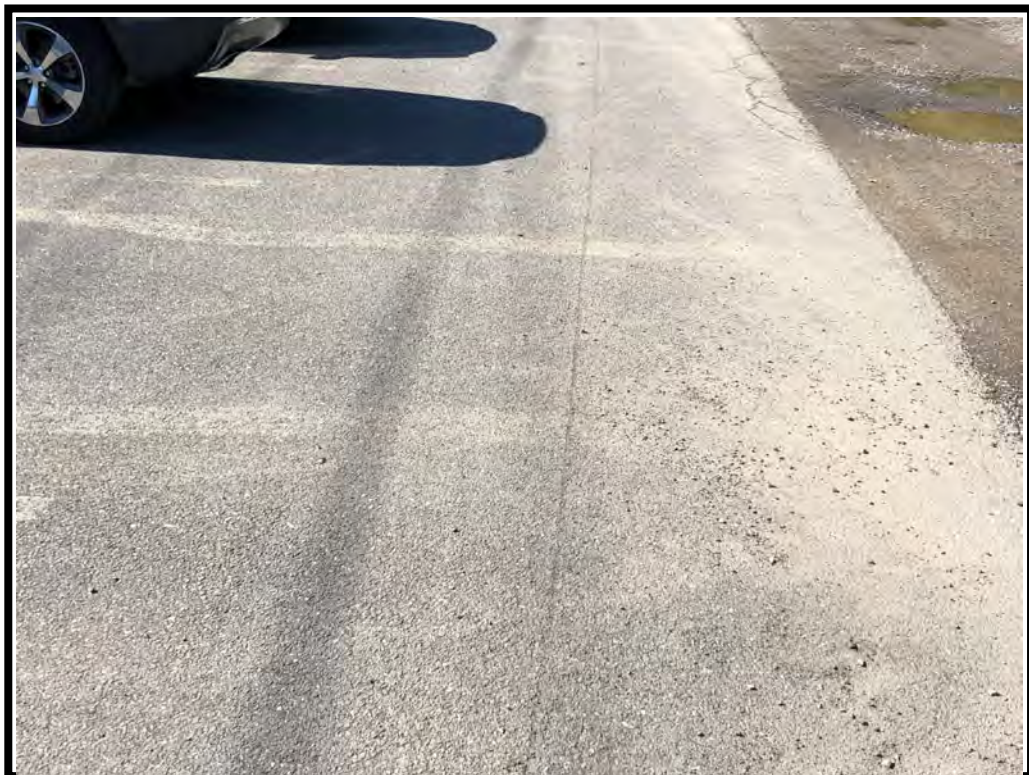
- Minor cracks were observed along the edge of the pavement on Lot 48 west of the fence-line and east of the RR (Photographs 10 and 11).

**PHOTOGRAPH 10**  
Pavement on Lot 48 – West of Fence-line, East of RR, looking South

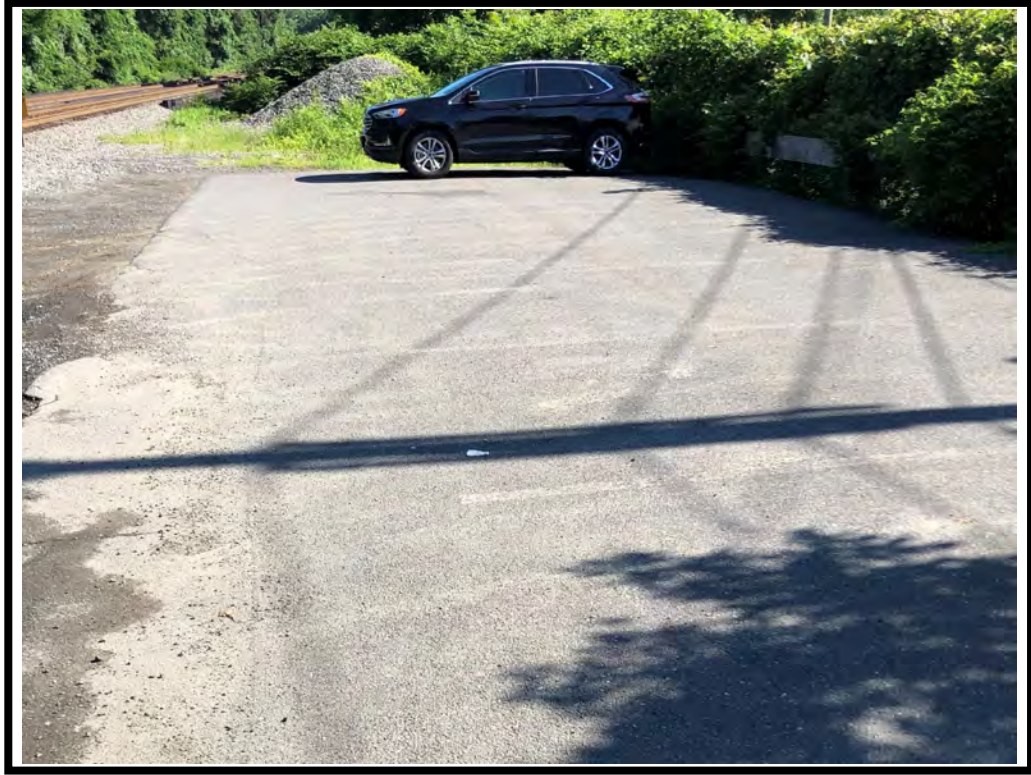
**PHOTOGRAPH 11**

Pavement on Lot 48 – West of Fence-line, East of RR, looking North
