**2017 ANNUAL  
RESTORATION MONITORING REPORT**

**Ford Motor Company Site: Operable Unit 2 Remediation Project  
Ramapo, Rockland County, New York, Site No. 3-44-065**

**December 2017**

AMY S. GREENE ENVIRONMENTAL  
CONSULTANTS, INC.  
4 Walter E. Foran Blvd., Suite 209  
Flemington, NJ 08822

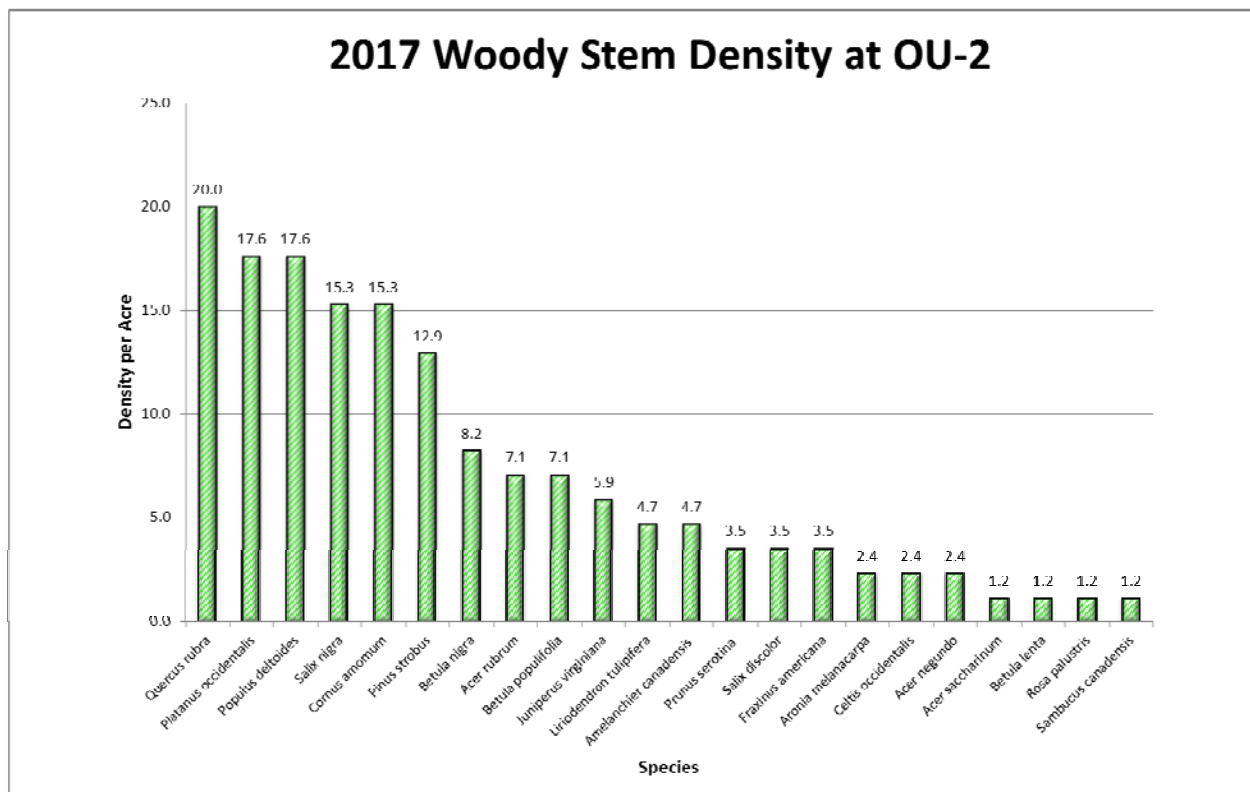
Average density of planted species is estimated to be 159 trees and shrubs per acre (see Table 1 below). No naturally-regenerating species were identified within the sample plots. Initial survival was considered fair, however supplemental planting of like species have brought the survival and establishment back to a successful level. Planted tree and shrub density for individual species ranged from approximately 1 to 20 stems per acre (see Table 1 and Figure 3 below).

**FIGURE 3:** Average woody stem density for all species recorded within monitoring plots at the OU-2 Restoration following the 2017 growing season.

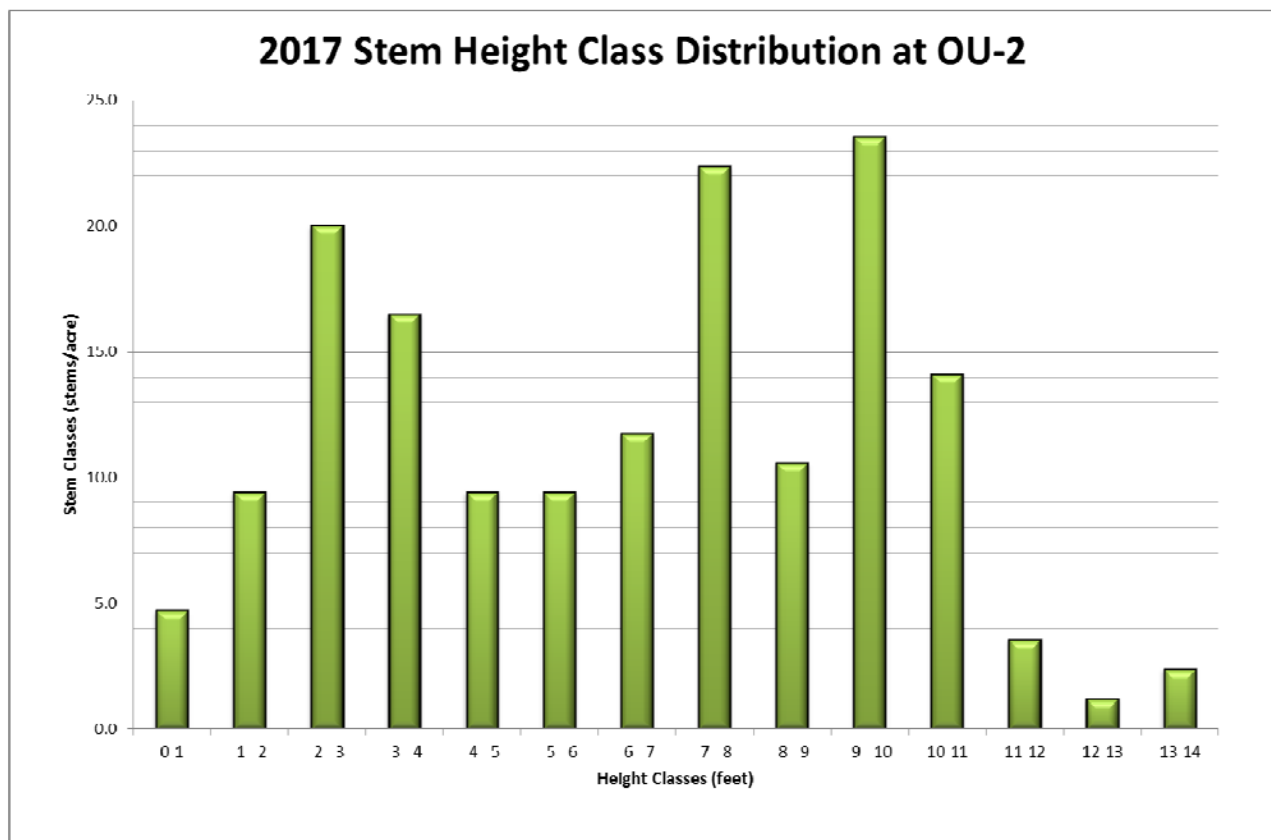
**FIGURE 4:** Woody stem height class distribution for planted species within the OU-2 restoration area following the 2017 growing season.

Average height class of planted species sampled within the monitoring plots during 2017 was estimated at 6.4 feet. Individual species ranged from saplings to trees approximately 13 feet tall. The highest number of trees and shrubs fell within the 7 to 8 and 9 to 10 feet average height classes. However, a significant number of trees and shrubs also occurred within the 2 to 3 feet and 3 to 4 feet average height classes (See Figure 4). This can be attributed to the many newly planted individuals, which were placed in April, 2017.
