OPERATIONS & MAINTENANCE STATUS REPORT
PERIOD: DECEMBER 31, 2005 THROUGH JULY 11, 2006

OPERABLE UNIT I
FORMER WASTEWATER TREATMENT AREA
METRO NORTH RAILROAD HARMON YARD
CROTON-ON-HUDSON, NEW YORK

Prepared by: Day Engineering, P.C.
40 Commercial Street
Rochester, New York 14614

Date: August 2006

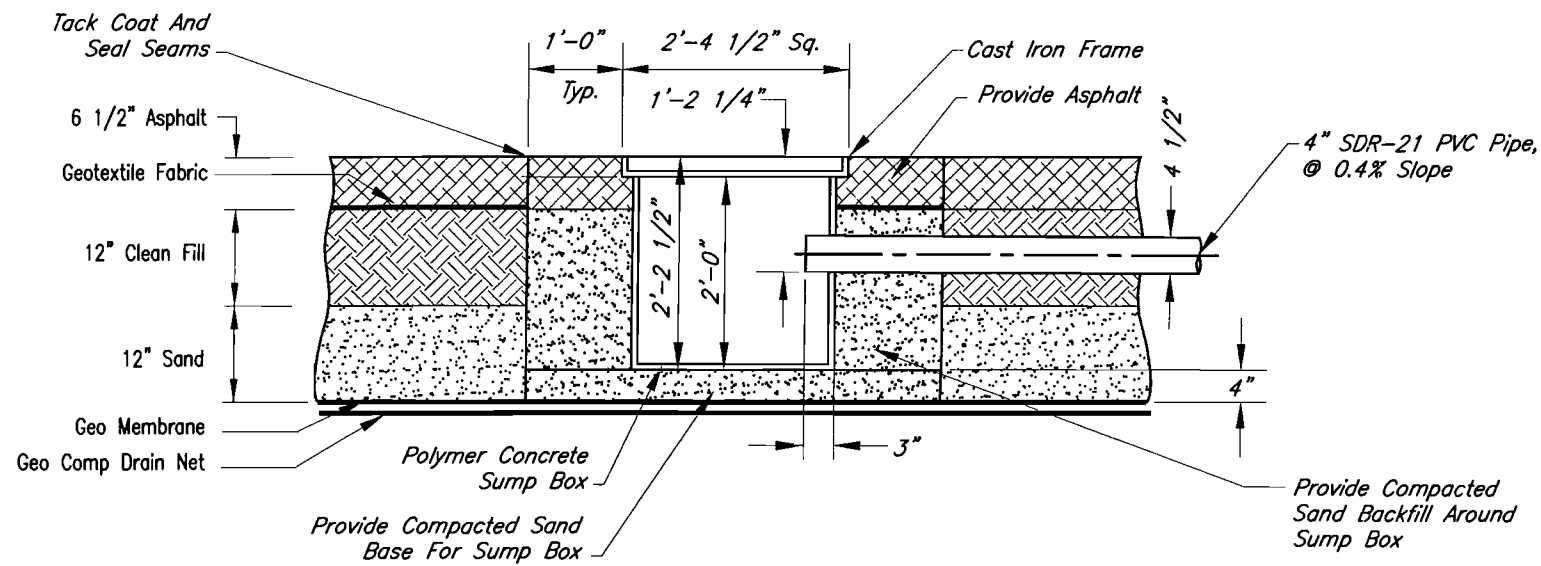
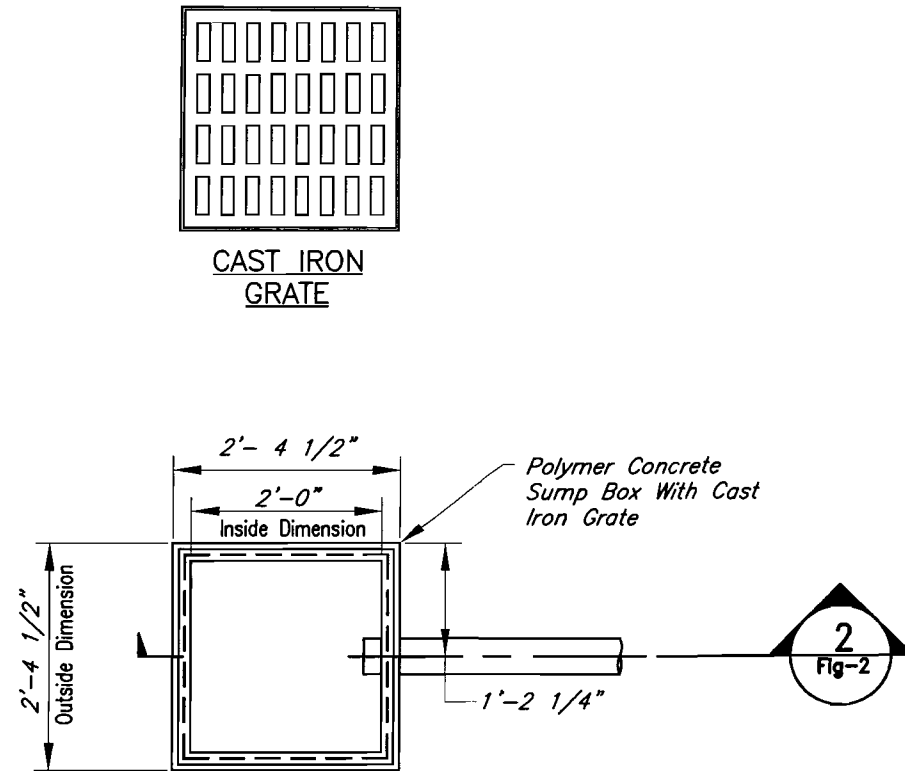
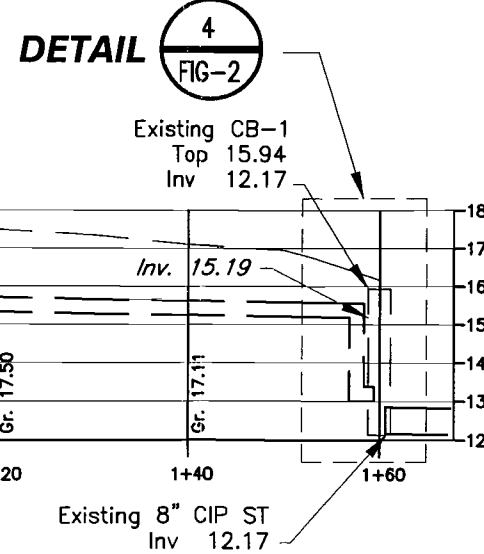
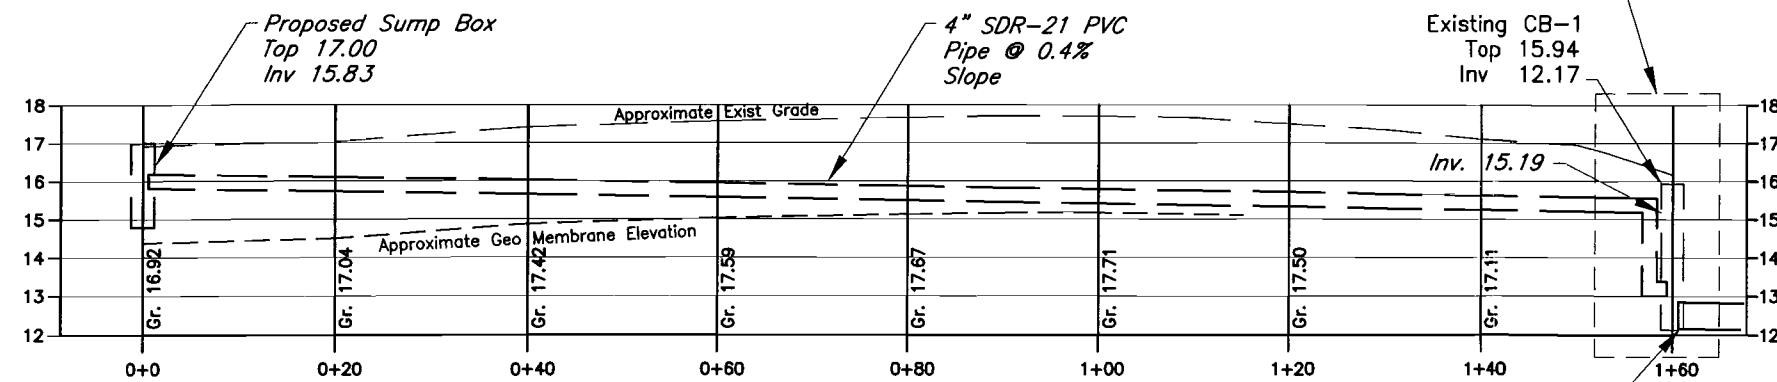
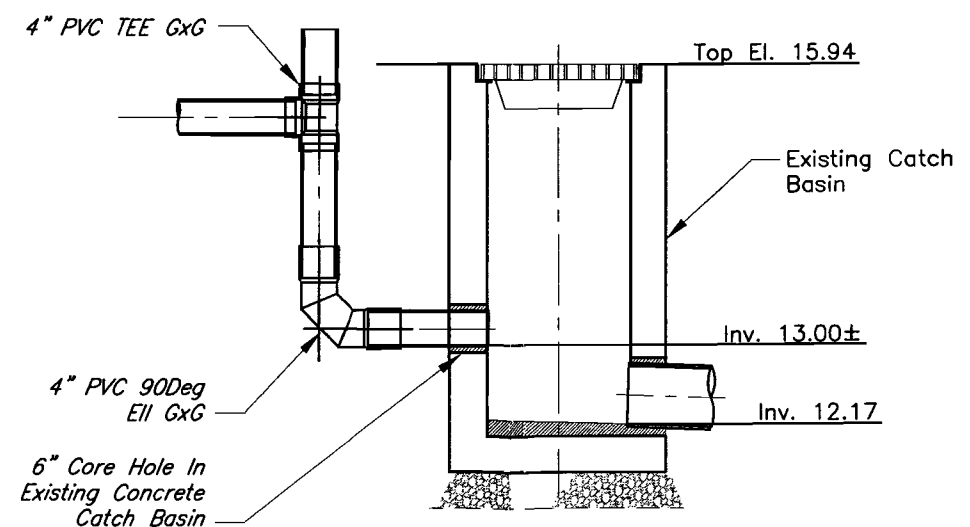
FIGURE 2

Harmon Yard storm sewer system. The location of the drainage modification is shown on Figure 2 and a sheet depicting the profile, section and detail of the drainage modification is presented as Figure 3. [Note: This drainage system was installed as an alternative to repaving the asphalt cap, which was deemed to be an excessive cost that would not serve to eliminate future settlement or degradation of the OU-I cover system.]

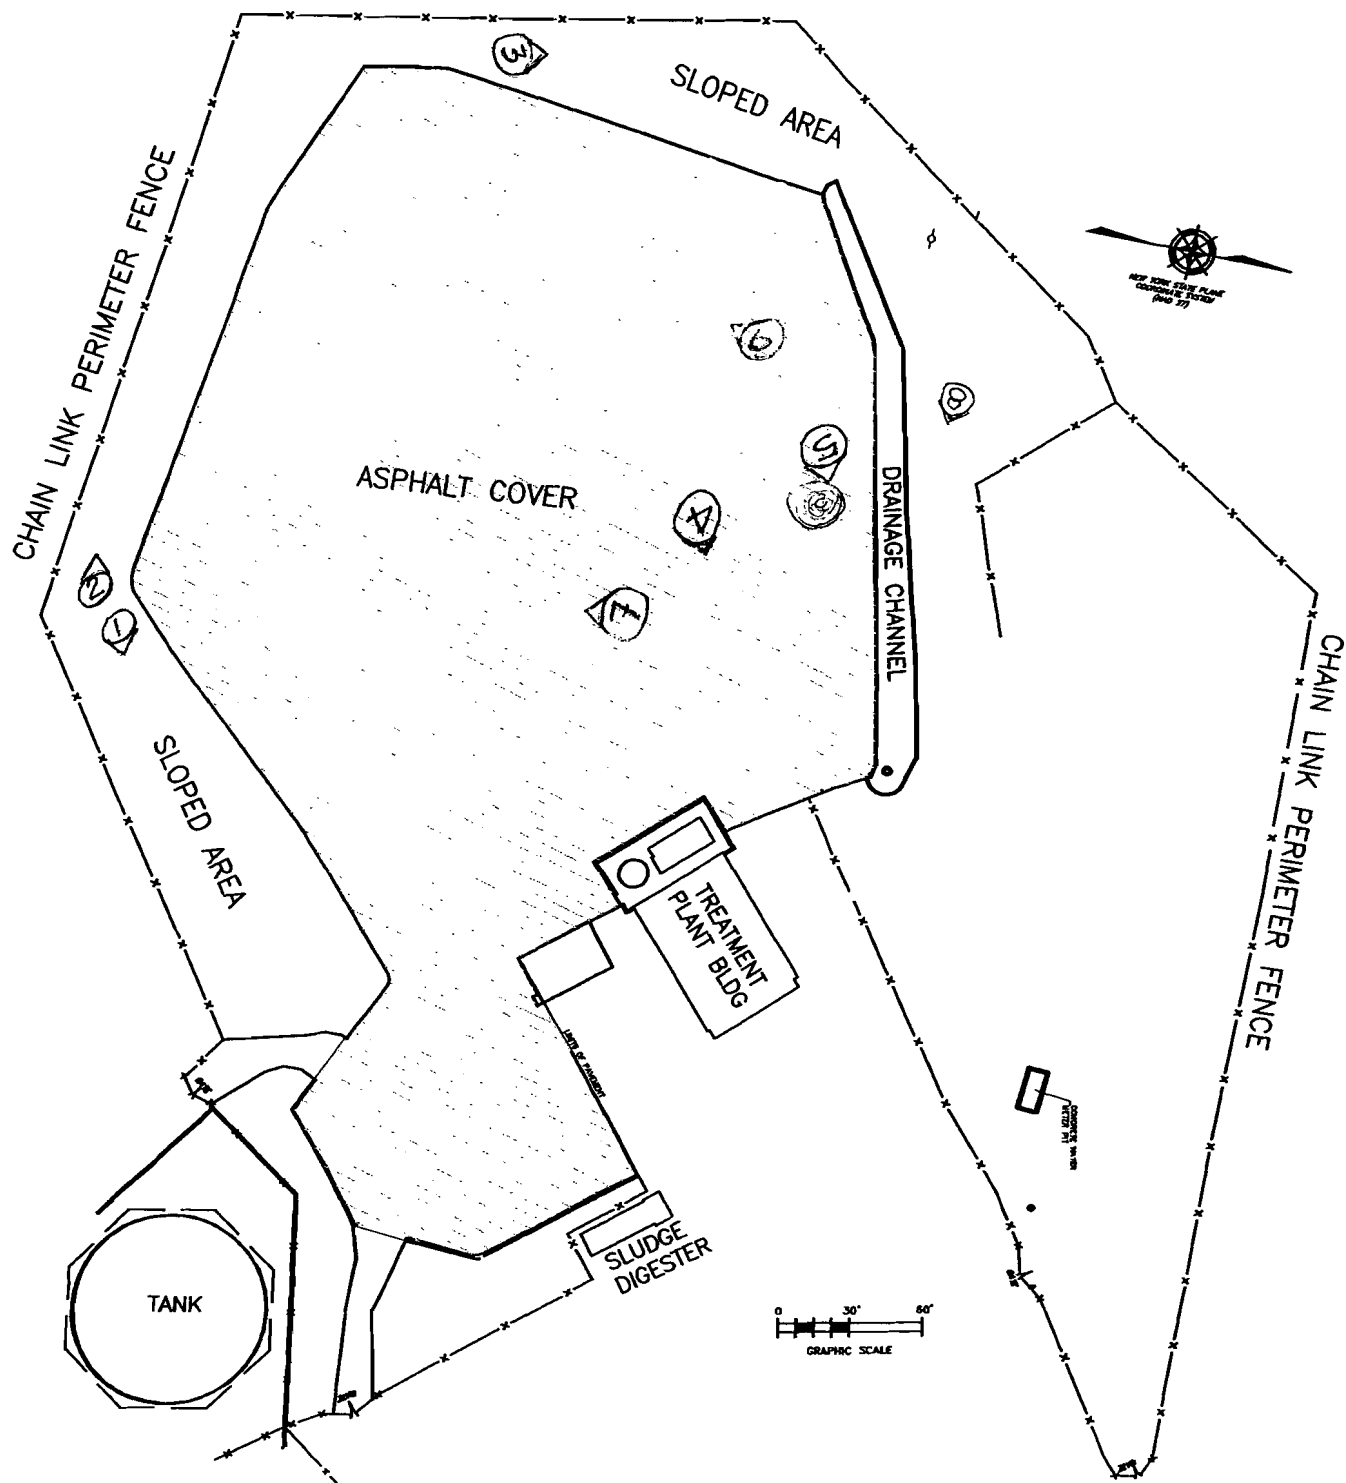
FIGURE 1

Minor cracking (see photos 6 and 7) should be sealed, various locations on cover. catch basin and drain (photo 4) installed in low spot. Second low spot (photo 5) is self draining to catch basin.

scrub trees along various portions of fence (photos 1, 2, 3)
