HARRISON SUB-RESIDENCY FIELD INSPECTION

Name of Inspector: Chris Kappeller and Val Basil

Date: 10/30/07

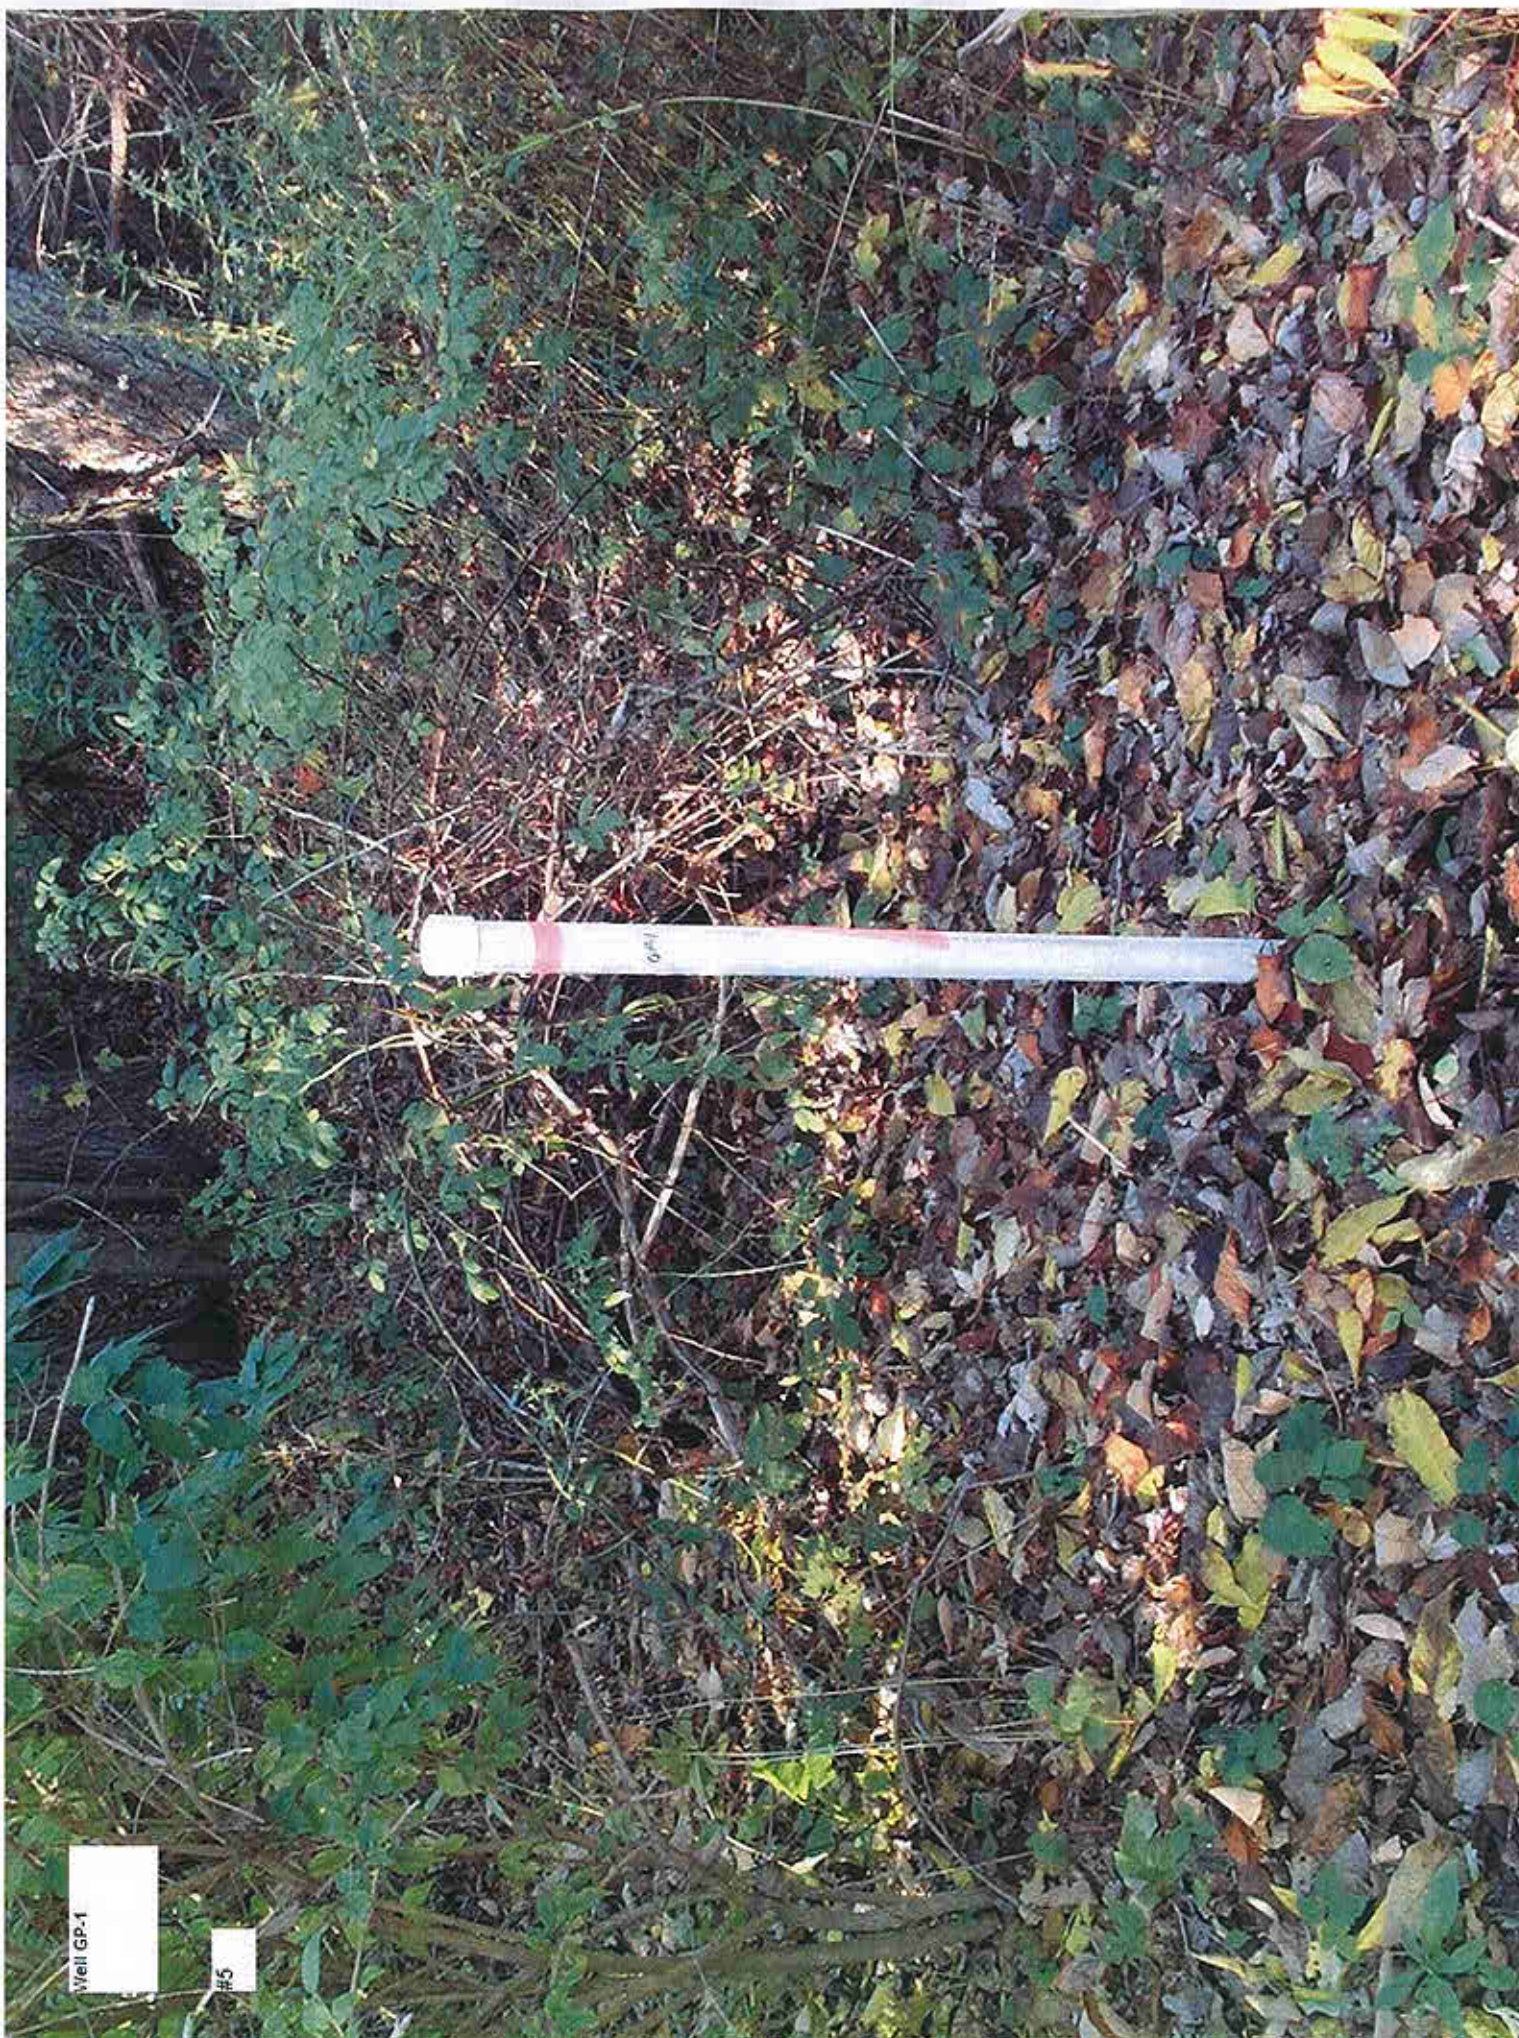
Well GP-1

All wells inspected and found to be in good condition. See Pictures # 5-11 and # 13-15 attached.

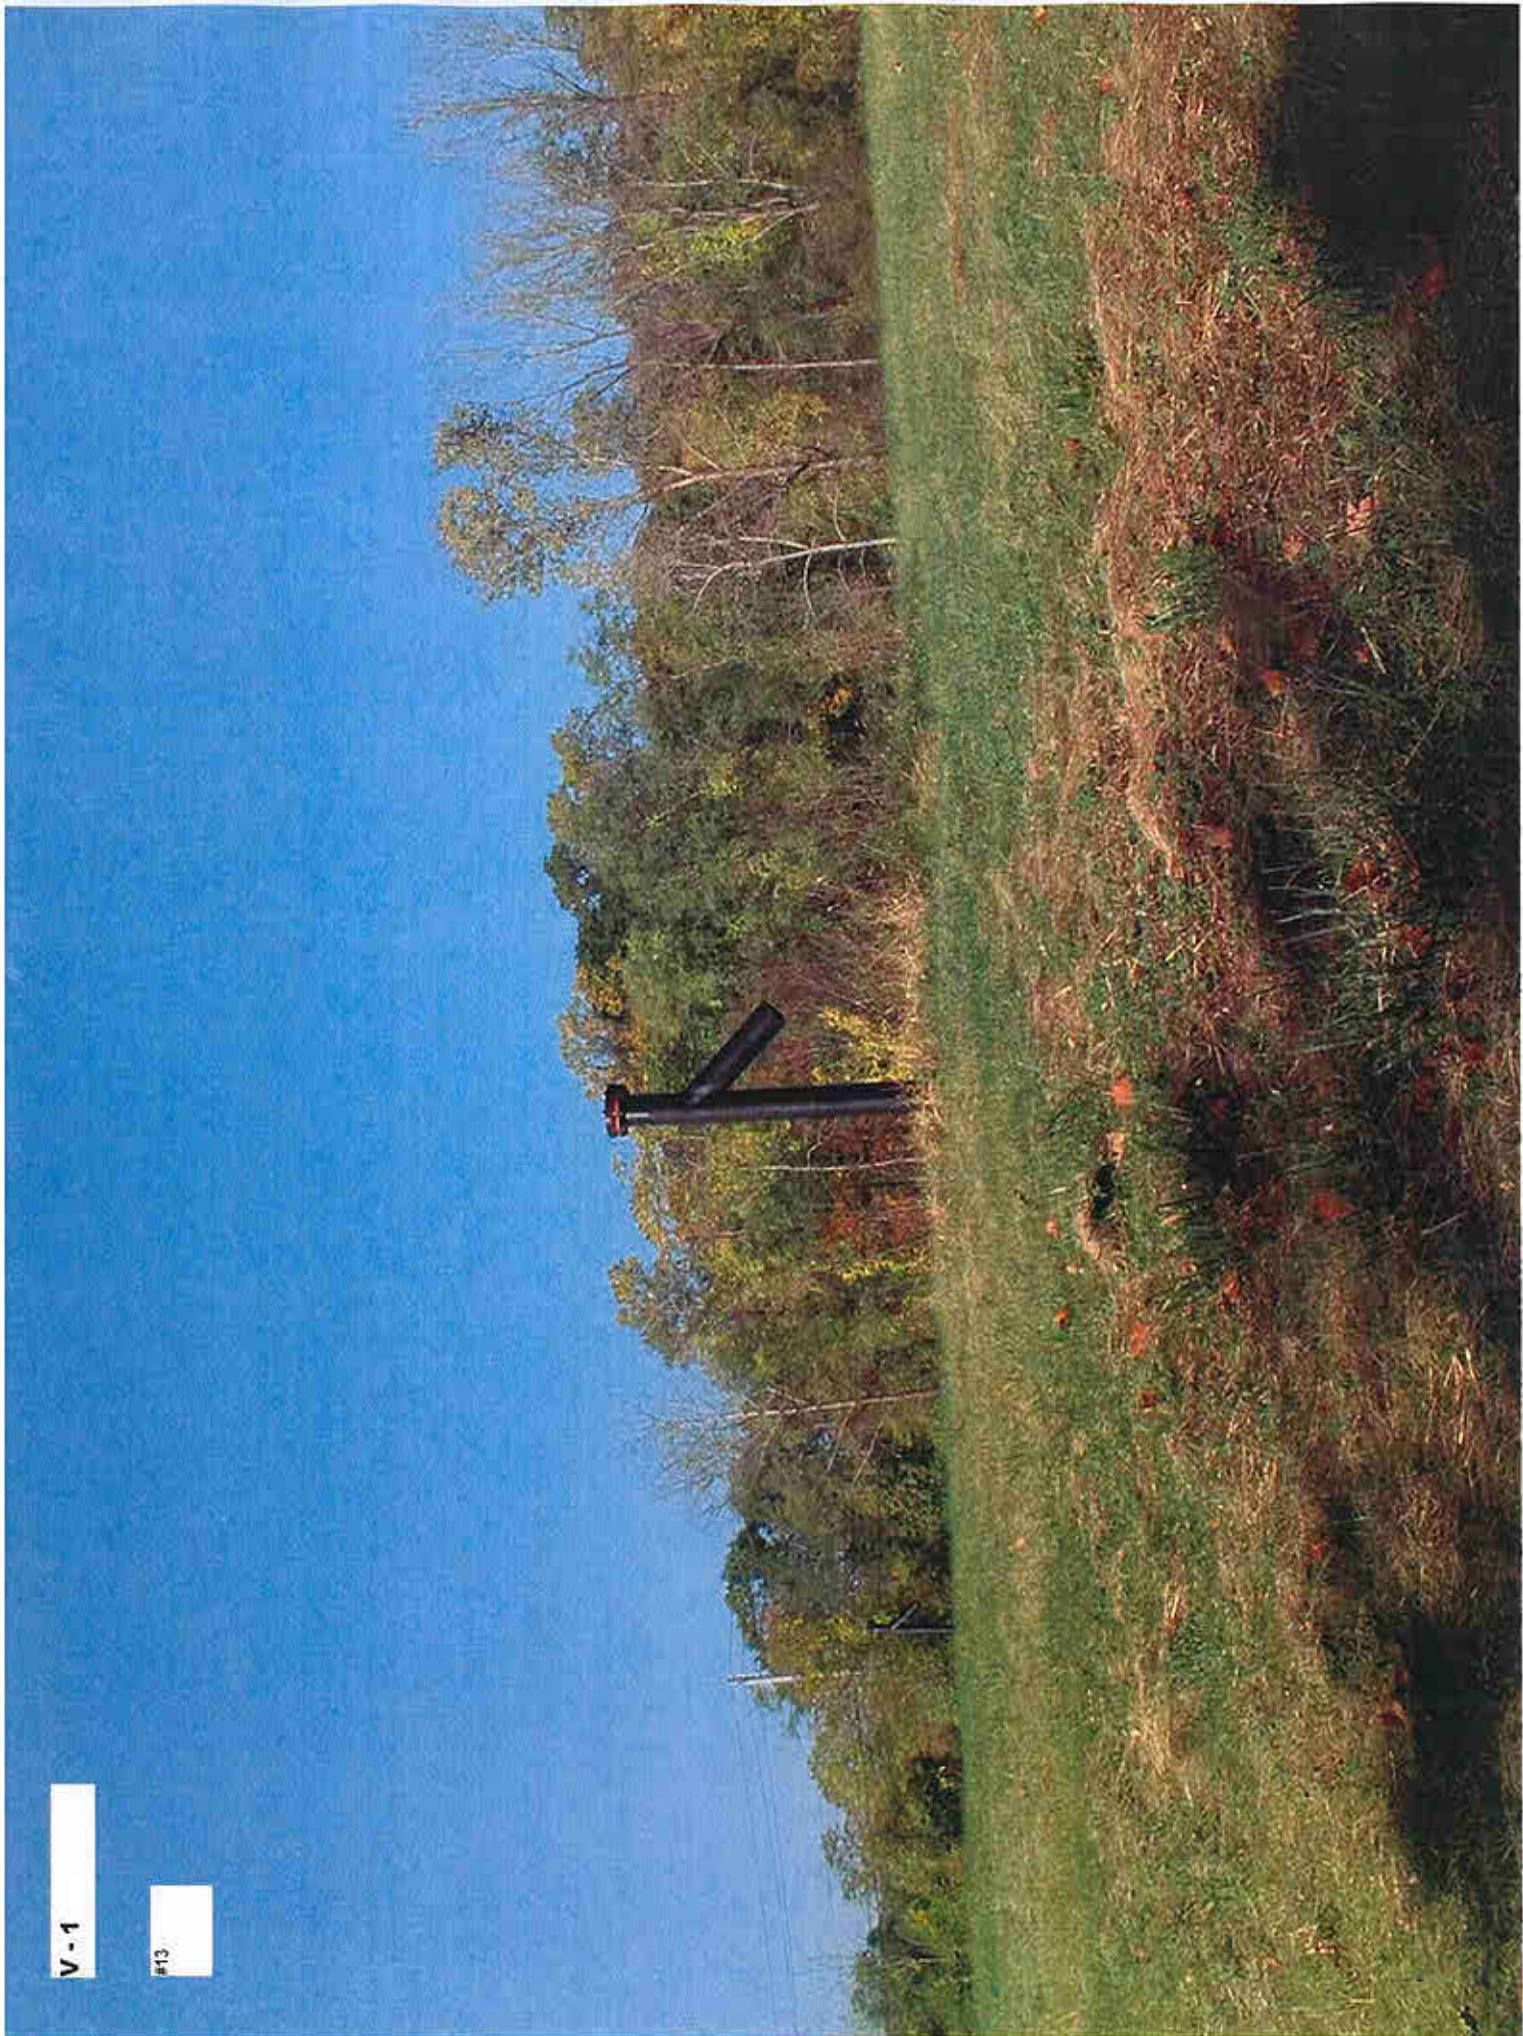
V-1

1. Vegetation short. See Pictures # 13-15
2. Soil slump on west side. See Pictures # 1&2

Four vents, (V1 – V4) were inspected. Found OK. See Pictures # 13-15
