HARRISON SUB-RESIDENCY FIELD INSPECTION

Name of Inspector: Chris Kappeller

Date: 2/29/08

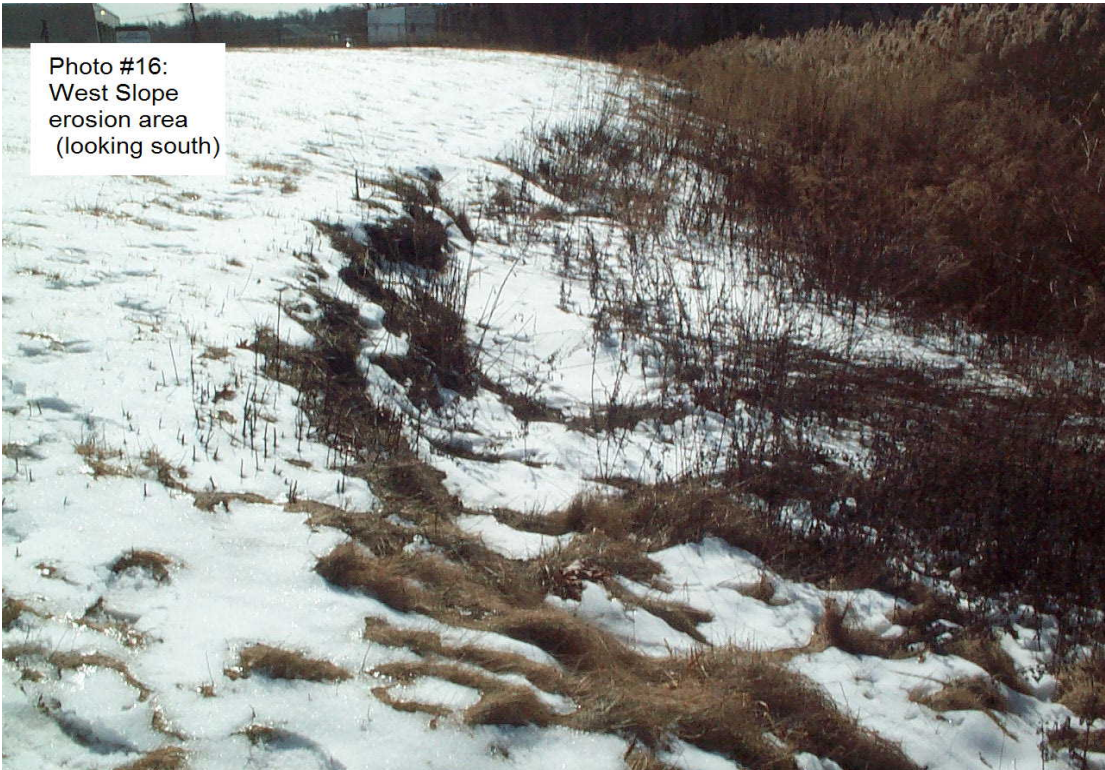
Photo #17:
West Slope
erosion area
(looking
southeast)

1. Vegetation is short and snow covered (See Pictures #1-4)
2. Soil slump on west slope of landfill (See Pictures #15-17)

2. Soil slump area on the west side of the landfill will need some stone, top soil and a vegetated mat to prevent any further erosion. Some potential work specifications were prepared by NYSDOT Regional Office and Environmental Science Bureau. This may be repaired in-house by Region 8's Geotechnical Group and Highway Maintenance. If not, then the contractor hired by HDR/LMS will be asked to do this.
