HARRISON SUB-RESIDENCY FIELD INSPECTION

Name of Inspector: Chris Kappeller

Date: 2/27/09

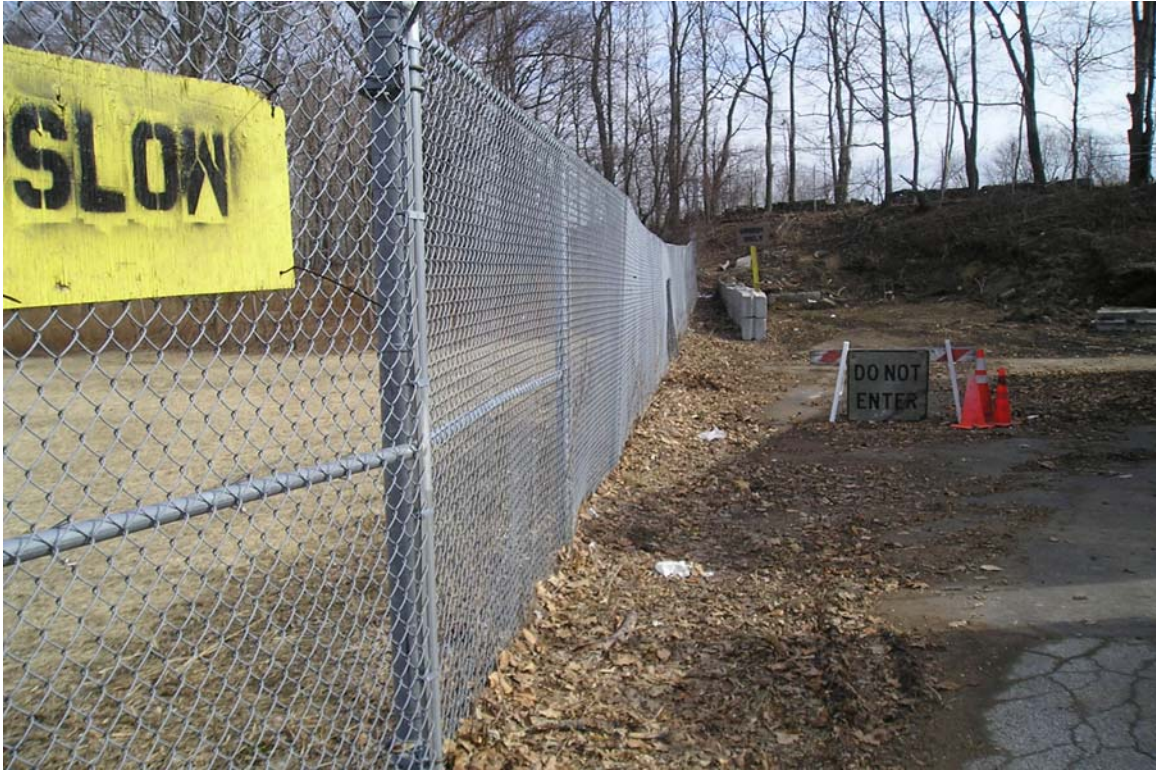
The north fence (towards the east) has a section of its top rail bent and dislodged by a fallen branch (Photo #20) and at the midpoint of the north fence by a fallen tree (Photo #16).

Photo 16: Fallen tree on north fence

1. The northern fence needs to be repaired at the NE section and near the midpoint of the north fence length. Any tree limbs resting on the fence in these areas need to be removed. This should be done by the NYSDOT 8-9 Residency in Valhalla.
